November 29, 2022

Alberta Transportation
4th Floor, Provincial Building
4920 – 51st Street
Red Deer, Alberta
T4N 6K8

**CON0022160 Central Region GRMP Instrumentation Monitoring
Site C003; H872:06, km 0.278 Burma Park Slide
Section C – 2022 Fall Readings**

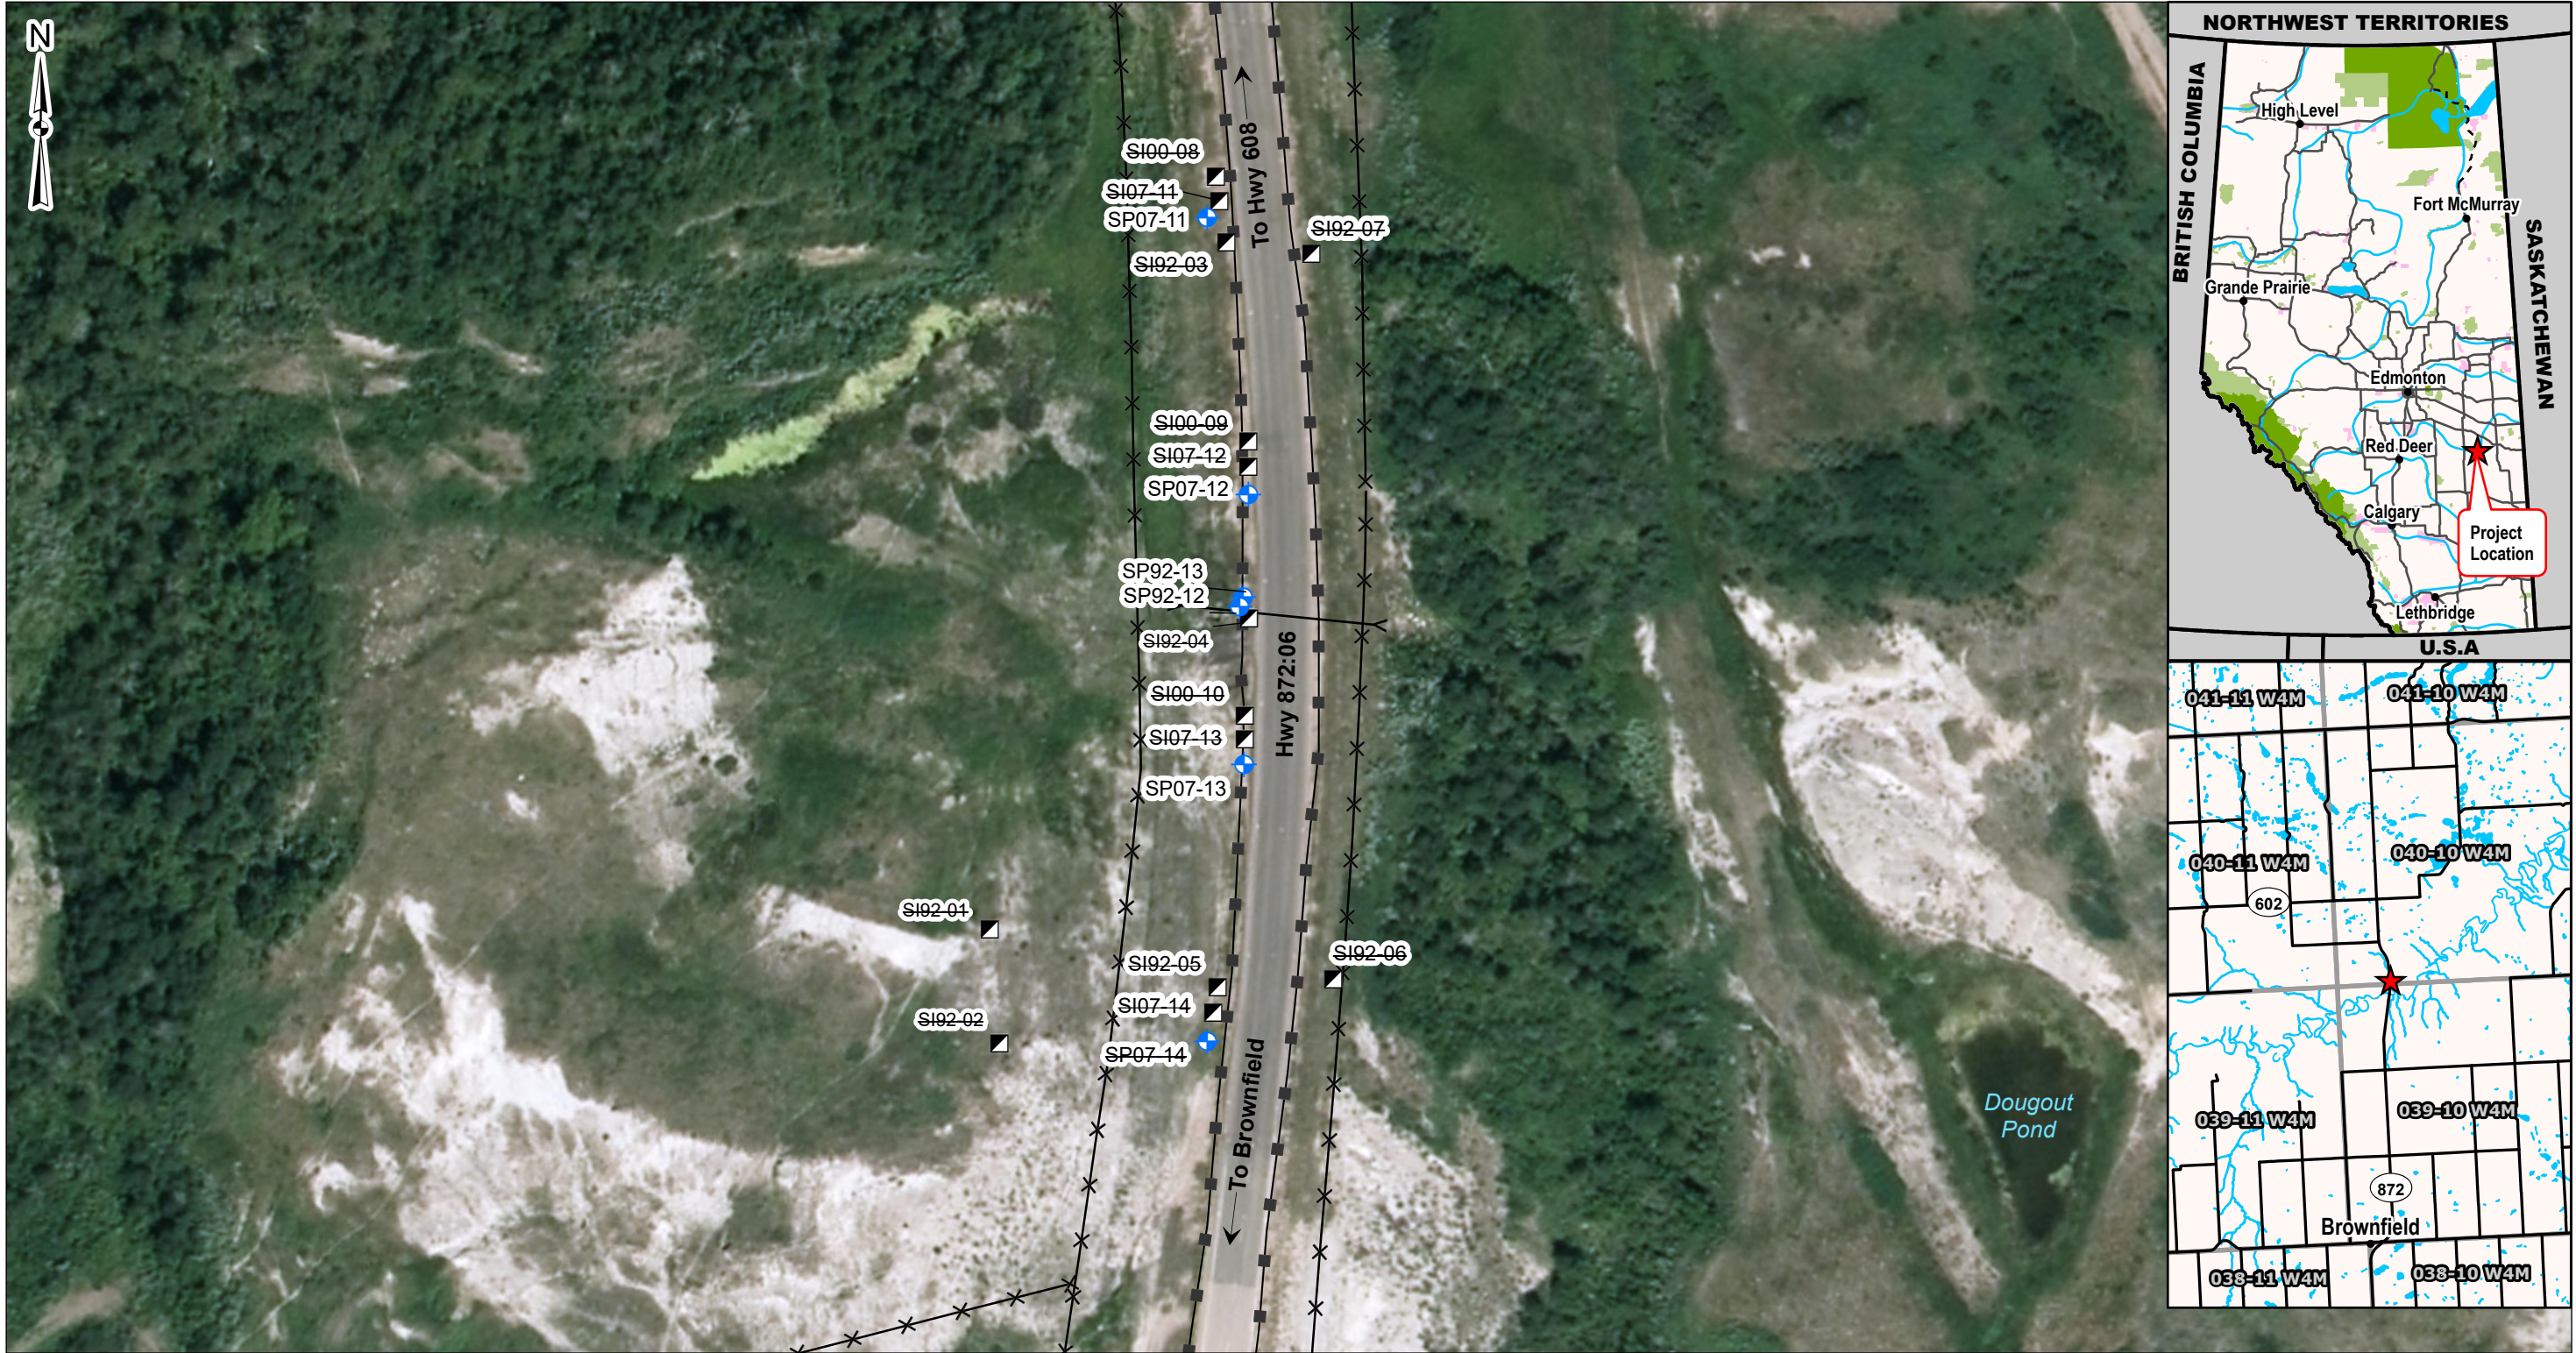
PROJECT CENTRAL REGION GEOHAZARD RISK MANAGEMENT PROGRAM		
TITLE Site Plan C003 - Burma Park Slide Hwy 872:06, km 0.278		
SCALE 1:1,000	PROJECT No. A05116A02	FIG No. 1

Five standpipe piezometers (SPs) (SP92-12, SP92-13, and SP07-11 through SP07-13) were read at the C003 site in the Central Region on September 8, 2022 by Ms. Katrina Cereno of Klohn Crippen Berger Ltd. (KCB). These instruments were read as part of the Central Region Geohazard Risk Management Program (GRMP). The site is located on Hwy 872:06, km 0.278, approximately 0.5 km north of the Battle River crossing and 10 km north of Brownfield, Alberta. The approximate site coordinates are 5806345 N, 471780 E (UTM Zone 12, NAD 83). A site plan is presented in Figure 1.

KCB began reading the instruments at this site in 2021. AT did not request KCB to complete readings before 2021 due to most of the instruments being inoperable, and no significant changes being observed during the Central Region GRMP Section B inspections. Instrumentation installation details are tabulated in Table 1.1. Instrument locations are shown in Figure 1.

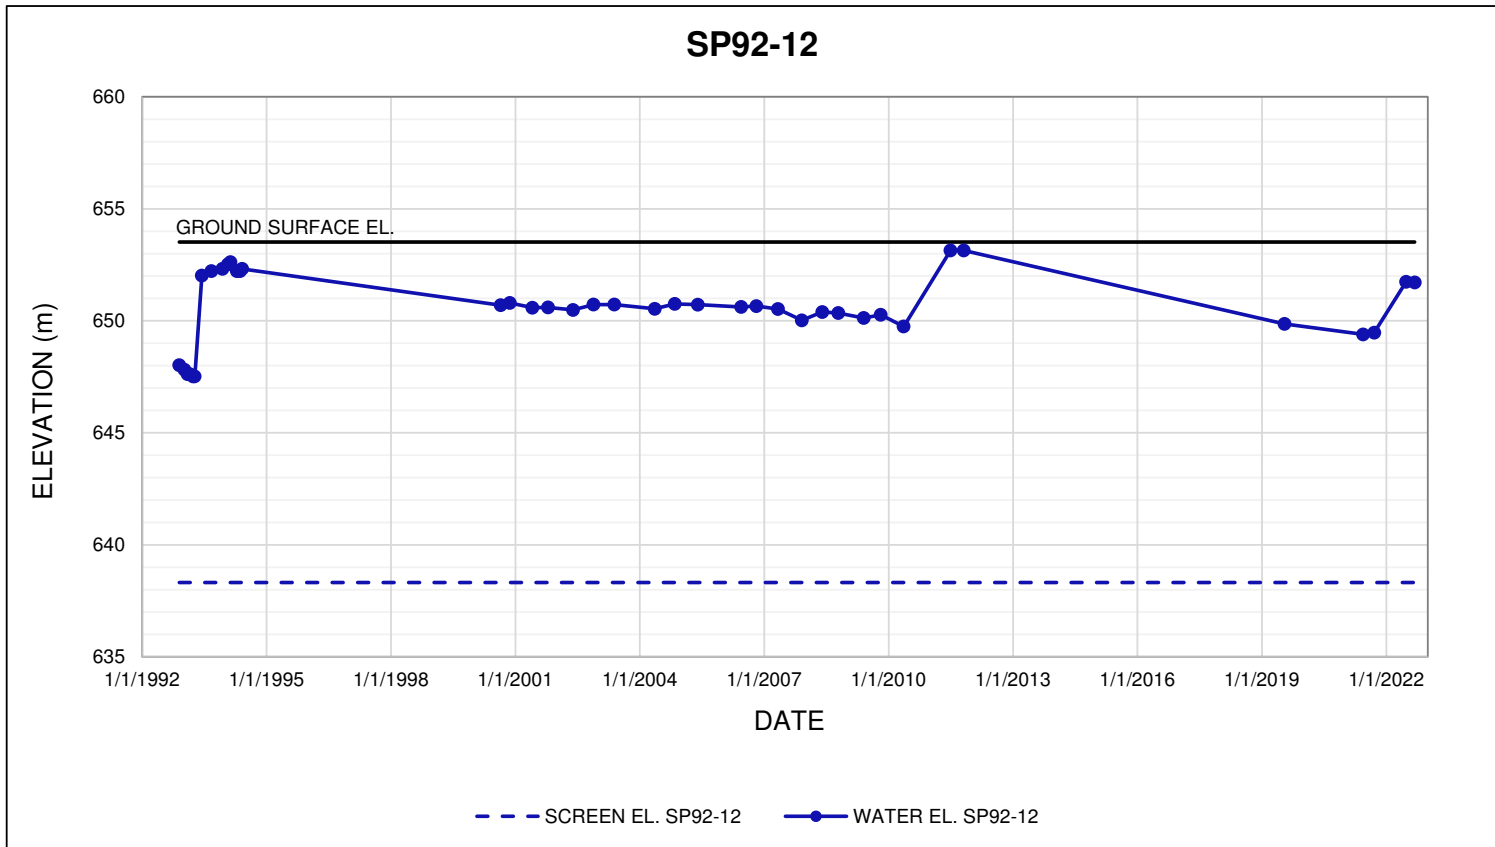
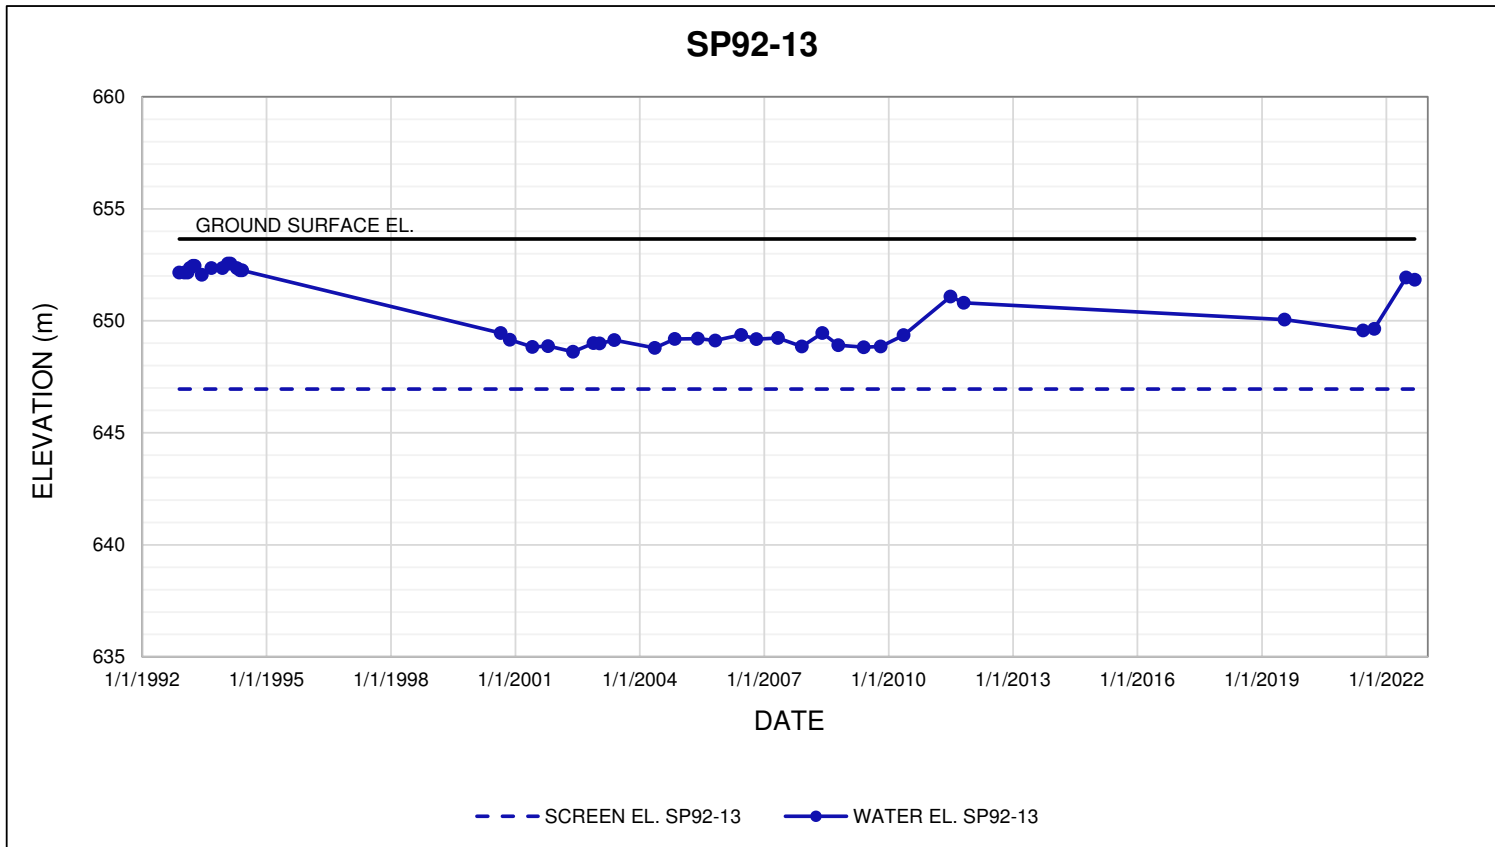
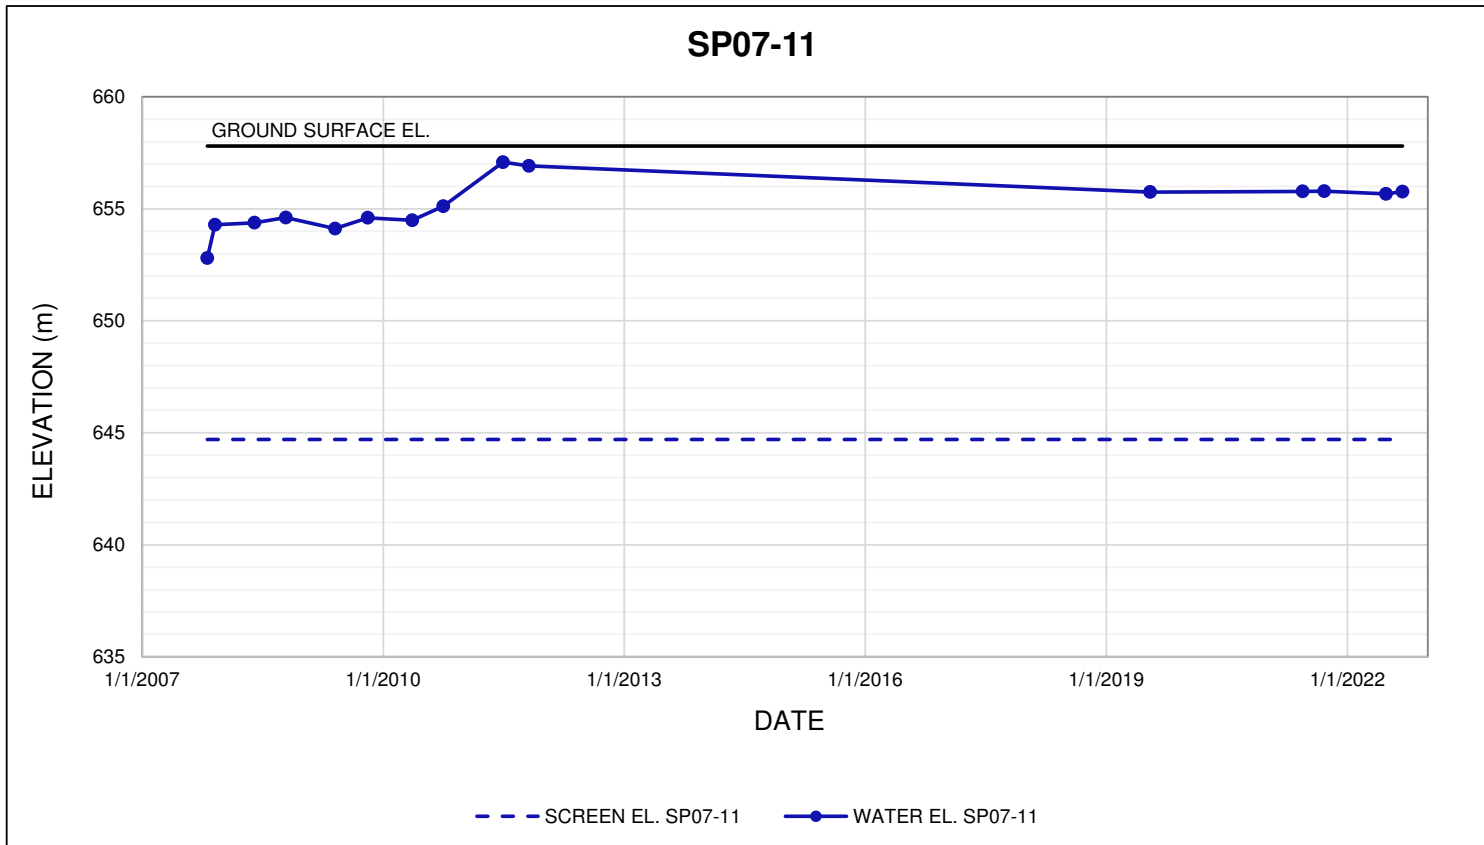
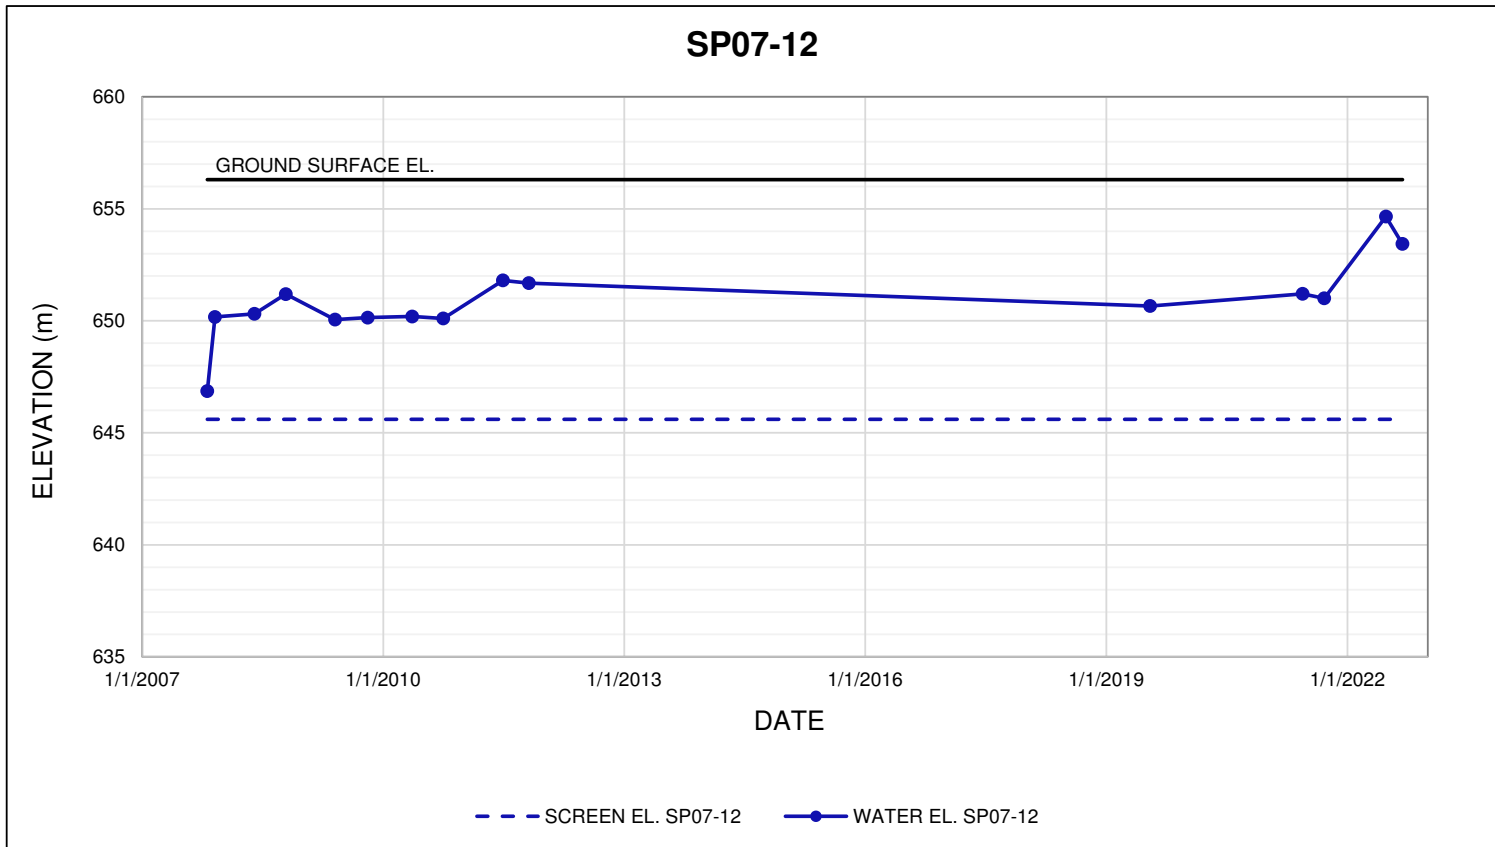
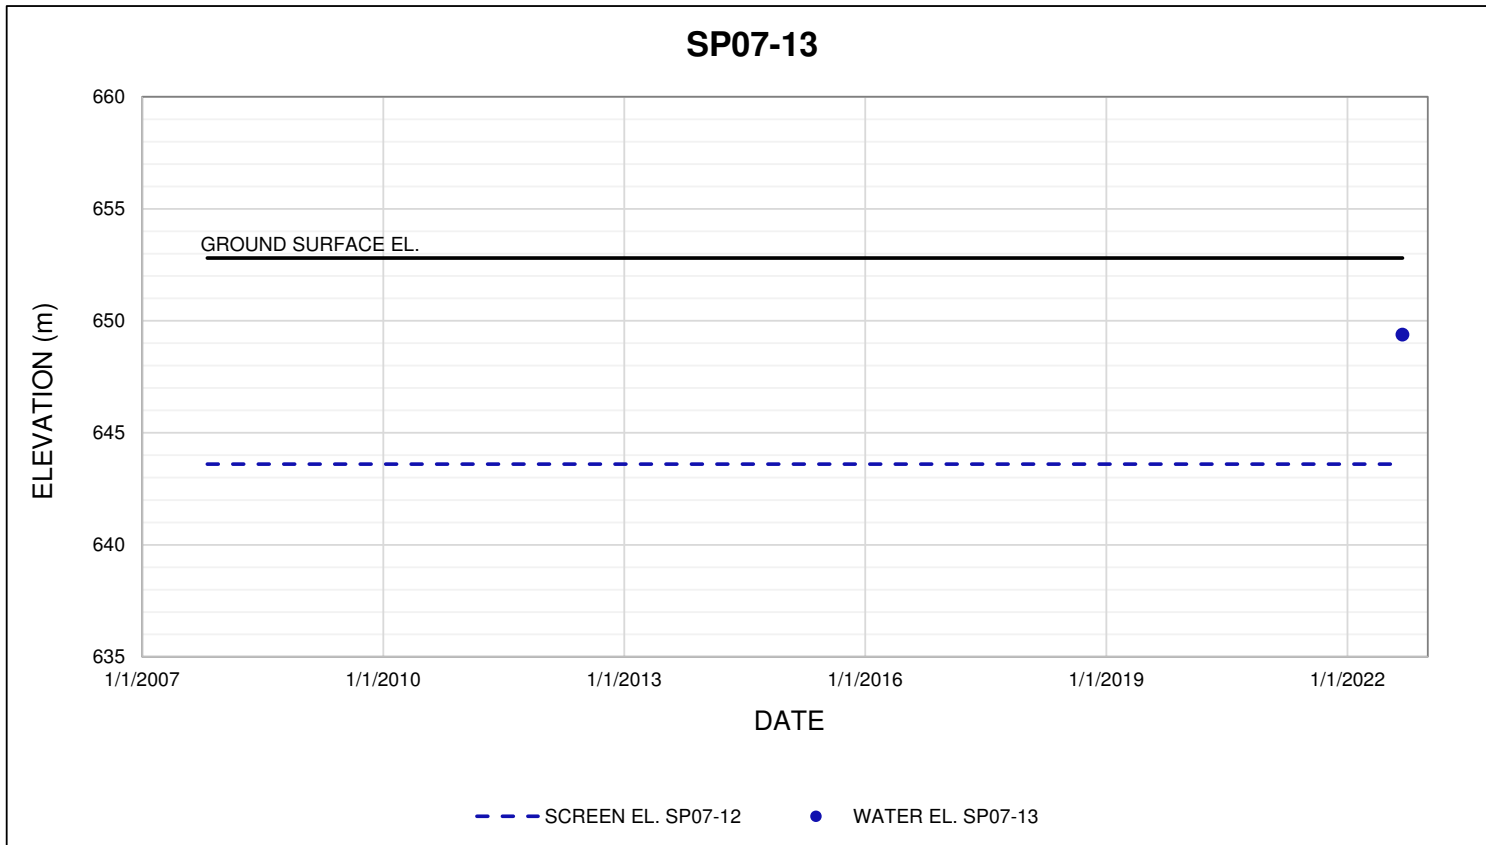
Water levels recorded in all the SPs (except SP07-11, see below) in the fall of 2022 were 2.2 m to 2.4 m higher than the fall of 2021 and within 0.1 m of the spring 2022 readings (except SP07-12, which recorded a 1.2 m decrease). These instruments were not read between 2011 and 2020, except for one reading taken in 2019, so it is difficult to assess the long-term trends of these instruments. The elevated water levels recorded in these instruments in June and September 2022 are likely due to wet weather in June and July 2022 as 2021 and the spring of 2022 were relatively dry. The previous period of wet weather occurred in 2020 and no readings are available for this period for comparison. Based on the piezometer data, it is likely that the recent movement observed at the site occurred in response to elevated groundwater levels within the slide mass.

The variation in water level recorded in SI92-12, SP92-13, and SP07-12 is likely due to these instruments being installed on either side of a culvert that receives flows from a wet area upslope and to the east of the instruments. Whereas water levels recorded in the instrument upslope to the north (SP07-11) have remained relatively steady since the spring of 2021 and are similar to water levels recorded in 2011.

Historically, SP07-13 (instrument downslope to the south) has been dry since installation. However, a water level approximately 4.2 m below ground surface was recorded in this instrument during the fall 2022 readings. More data is needed to assess the recent water level trend for this instrument.
