September 12, 2022

Alberta Transportation
4th Floor, Provincial Building
4920 51 Street
Red Deer, Alberta
T4N 6K8

CON0022160 Central Region GRMP Instrumentation Monitoring
Site C074; H27:10, km 23.976 Red Deer River Bridge
Section C – 2022 Spring Readings

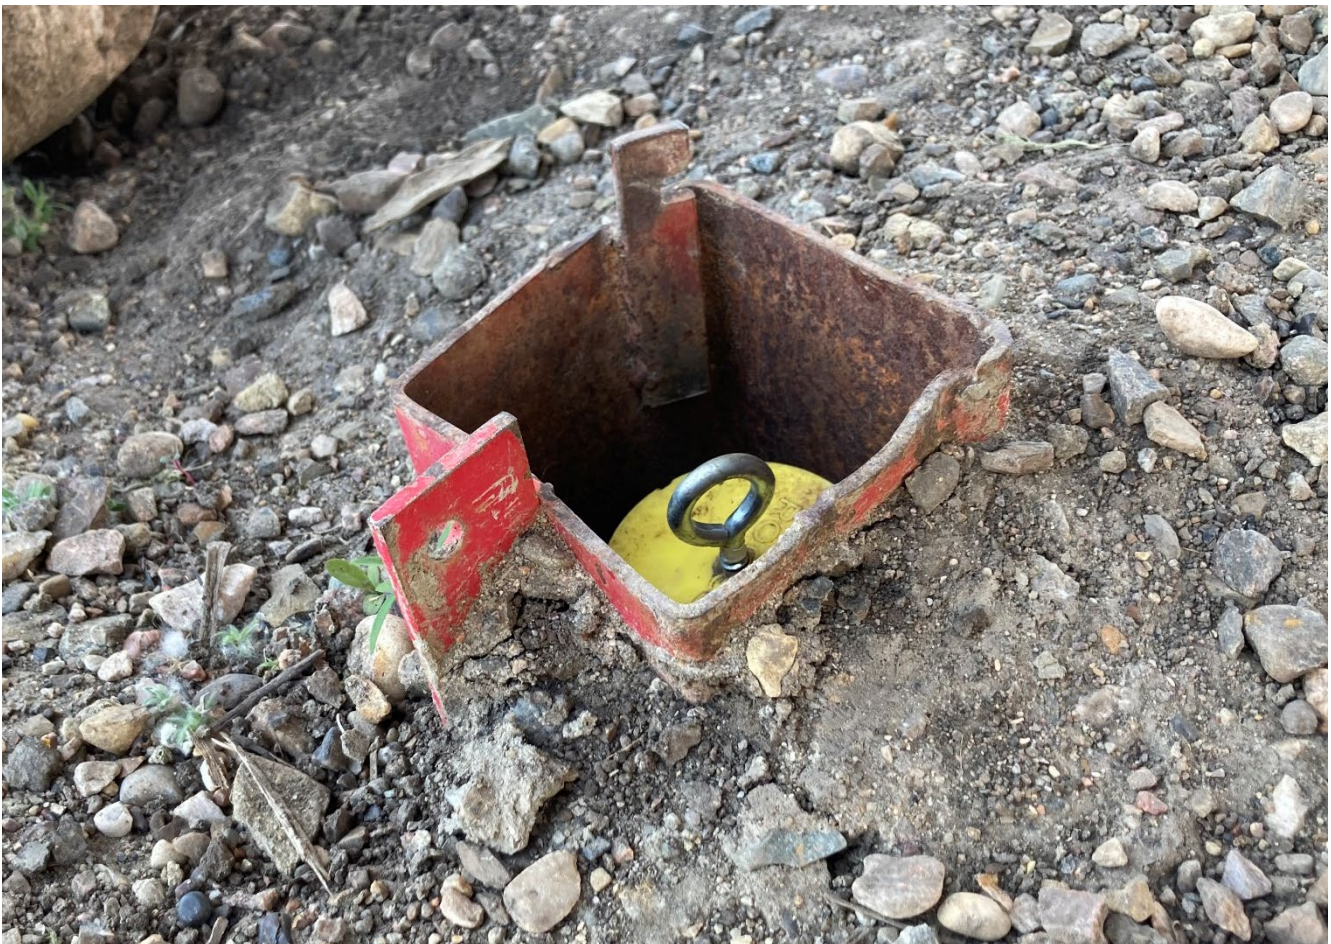
No instrument repairs or maintenance is required. However, the above-ground casing protector caps were damaged and removed between the June 2021 and June 2022 readings (KCB suspects they were damaged from vandalism) (Photo 1). The SI caps are still in place on the casing within the casing protectors. Since the casing protectors are damaged, this could lead to future damage of the SIs.

Photo 1 The casing protector cap at SI-P06 was completely removed between the June 2021 and June 2022 readings. Photo taken June 27, 2022.

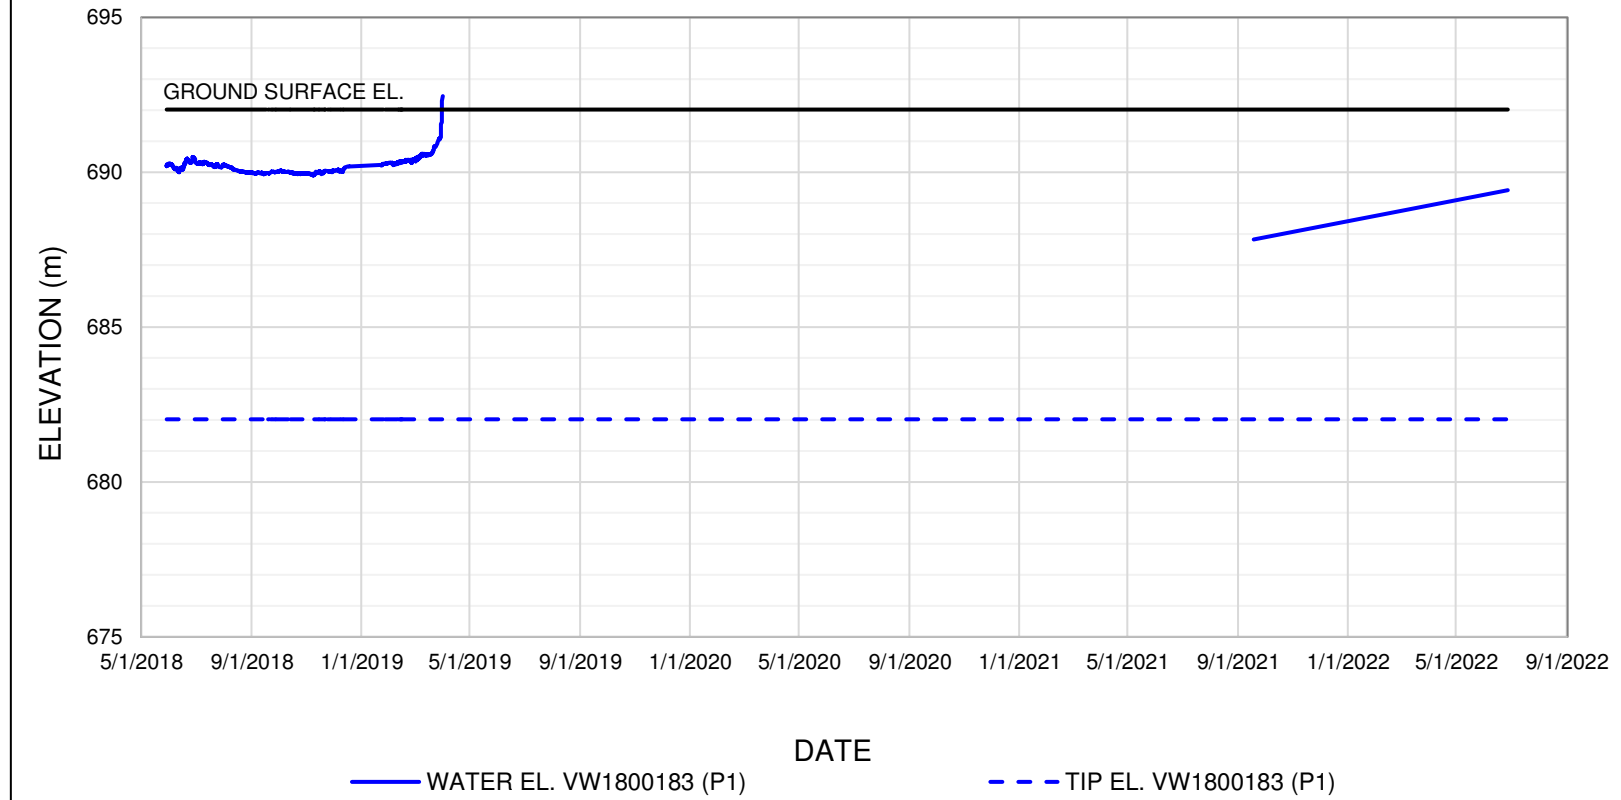
VW1800183 (P1)

The first reading obtained by KCB in September 2021, indicated water levels recorded in P1, P3, and P4 had decreased 2.7 m to 5.9 m below peak water levels recorded during fill placement in 2018. Whereas the water level recorded in P2 was similar to the peak water level recorded during fill placement (approximately decrease of 0.5 m).

Data obtained in June 2022 reading, indicates water levels recorded in P1 and P4 (both installed in the shallow clay shale unit) increased approximately 1.6 m to 1.1 m since September 2021, respectively. Whereas water levels recorded in P2 and P3 (installed in the weak bentonite unit and deeper sandstone unit, respectively) increased approximately 0.6 m and 0.4 m, respectively. It is likely that the elevated water levels recorded in these instruments in June 2022 were due to recent wet weather (i.e., higher-than-average precipitation) in June 2022. The previous period of wet weather occurred in 2020 and no readings are available for this period for comparison.

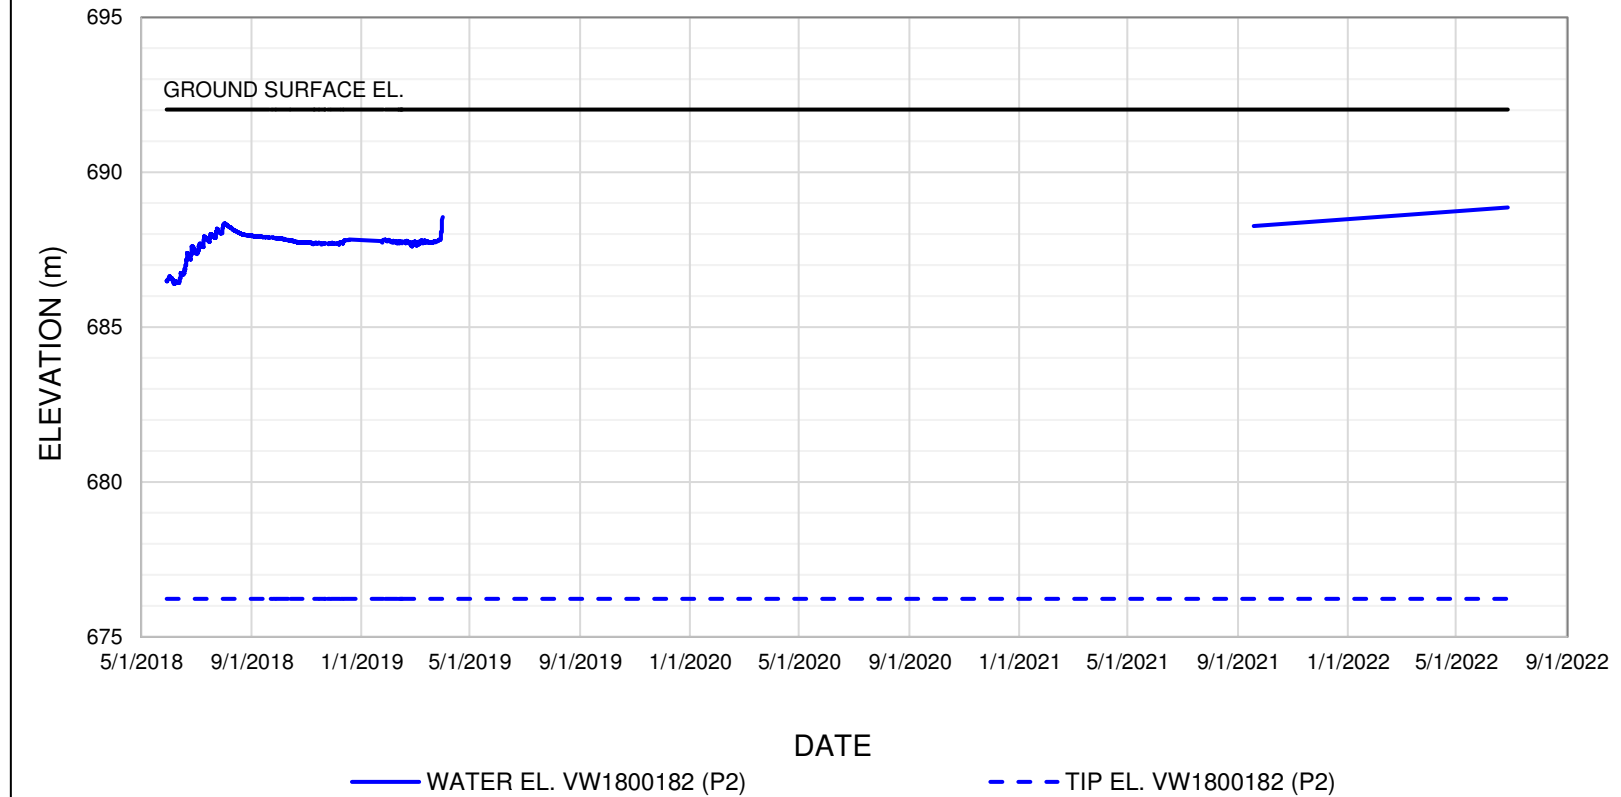
VW1800182 (P2)

Between early-June 2018 to late-July 2018, the equivalent water levels recorded in three of the VWPs (P2 through P4) steadily increased approximately 2.0 m to 4.5 m in response to fill placement on the east abutment. Whereas water levels recorded in P1, which was installed in the clay shale unit beneath the north side slope of the east abutment, remained relatively steady. After fill placement was complete, water levels slowly decreased, except for slight increases (less than 1 m) recorded in late-2018 likely in response to pile wall installation and another increase recorded in late-March 2019 likely in response to the flood event caused by ice jamming in the Red Deer River. This flood event also damaged the data logger, so no further readings were taken of the VWPs until September 2021 when KCB started reading the instruments manually.

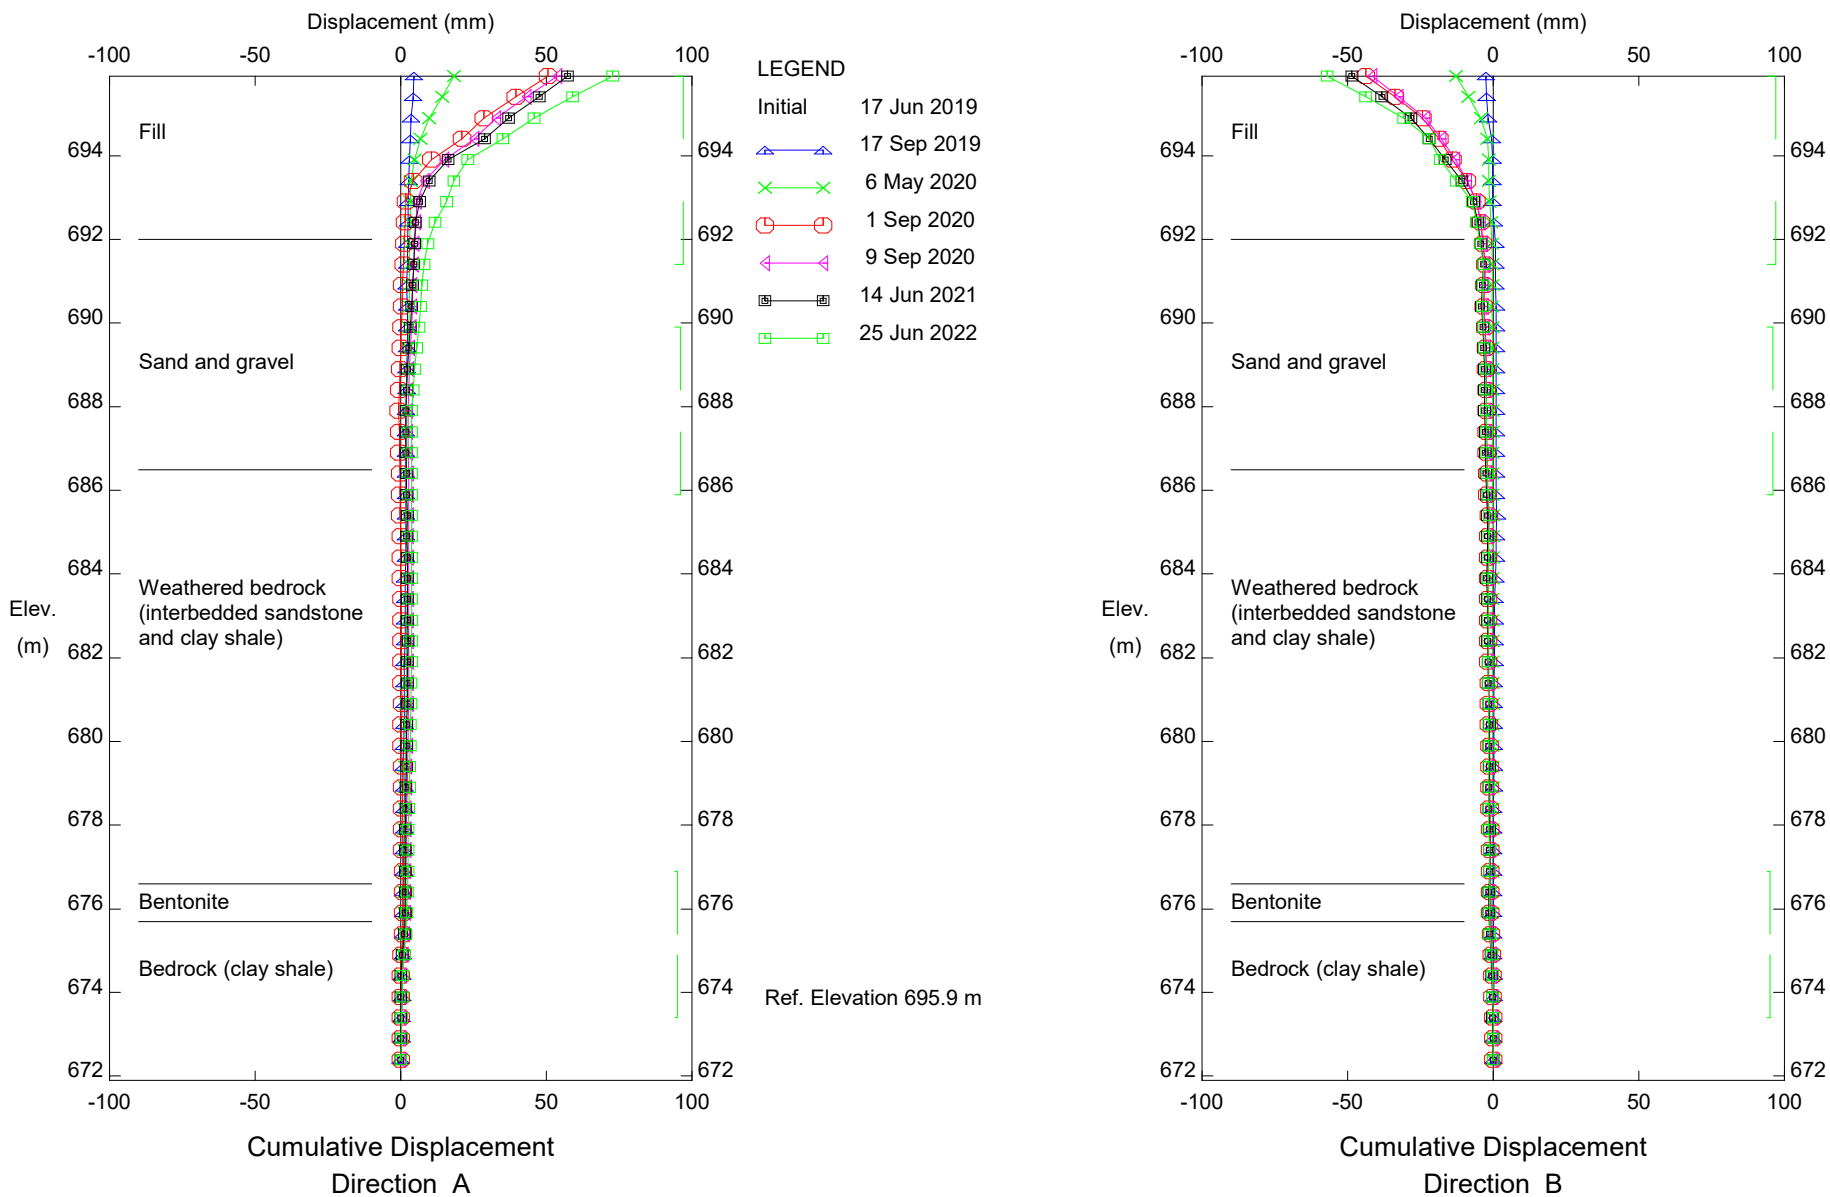
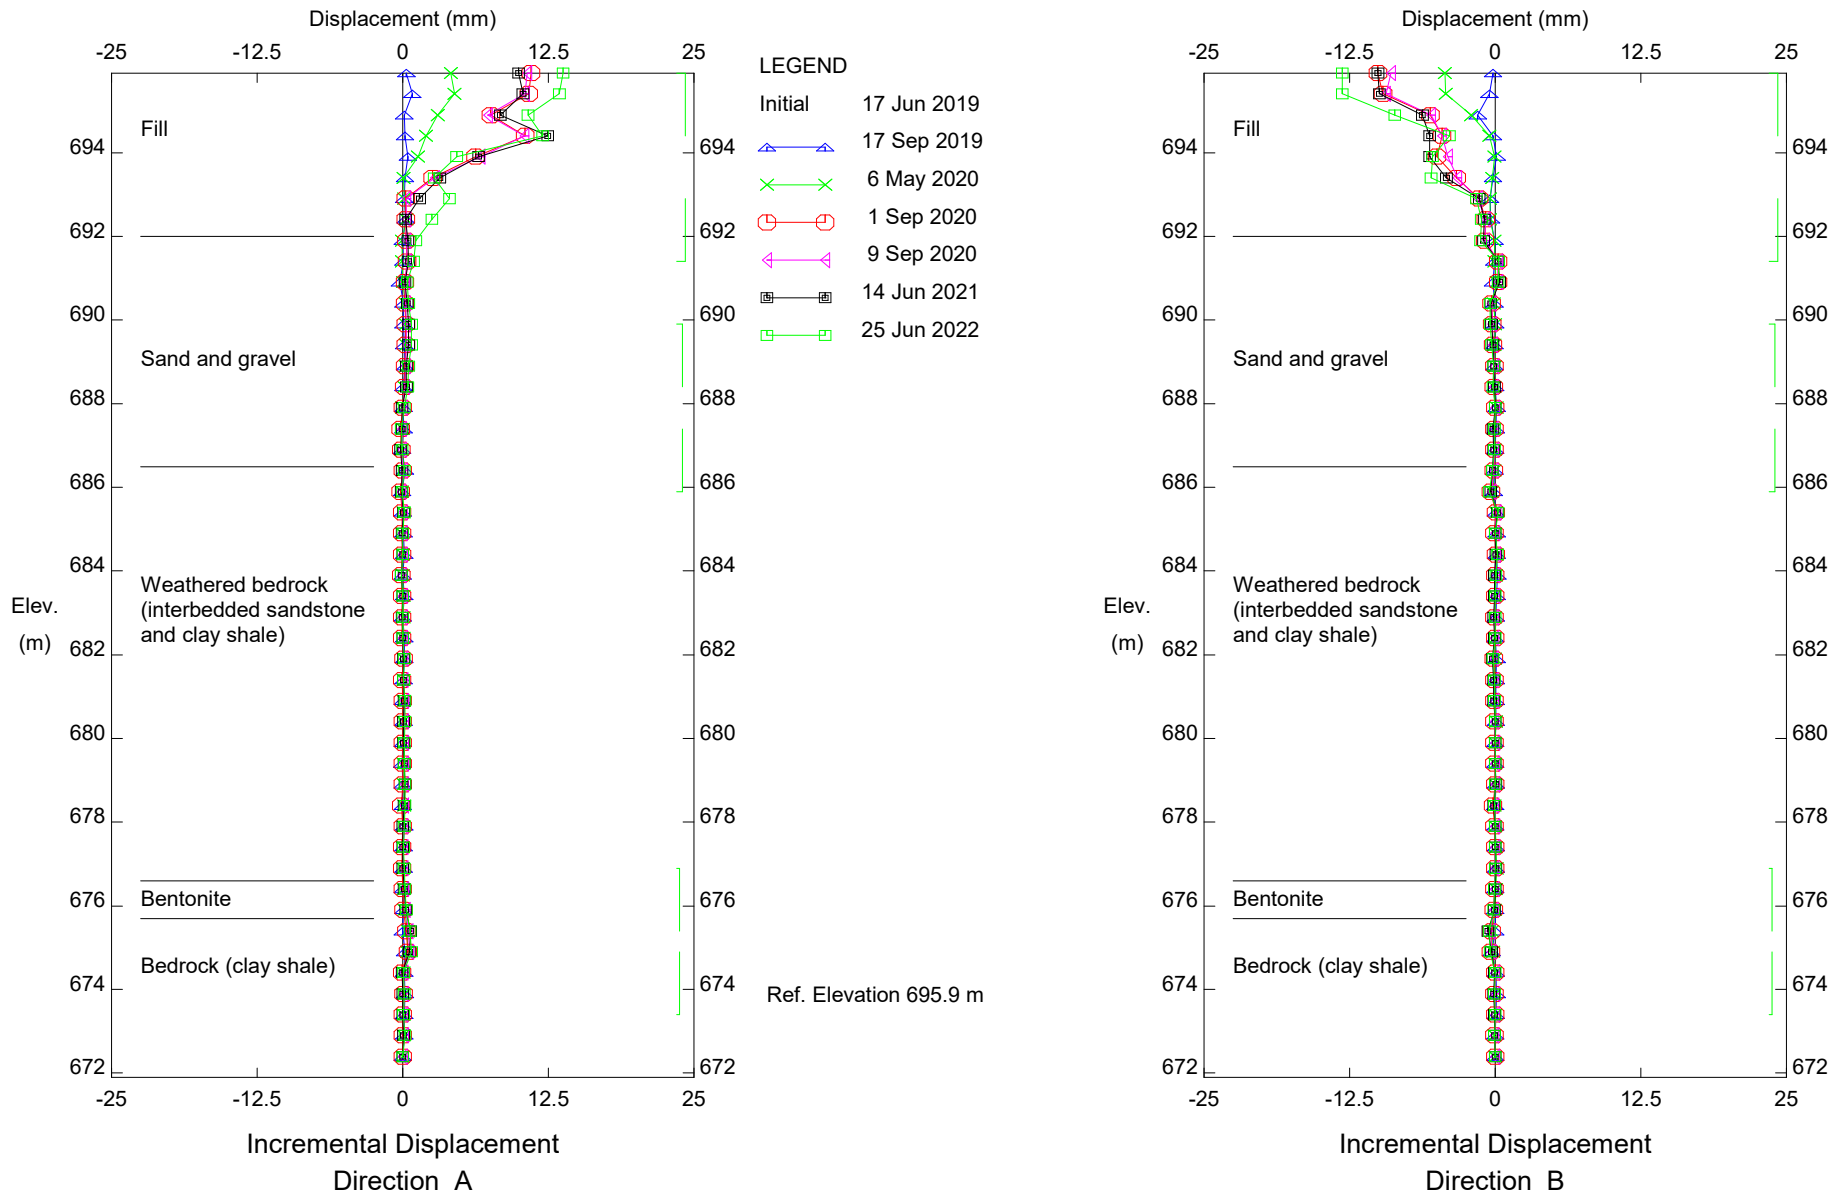
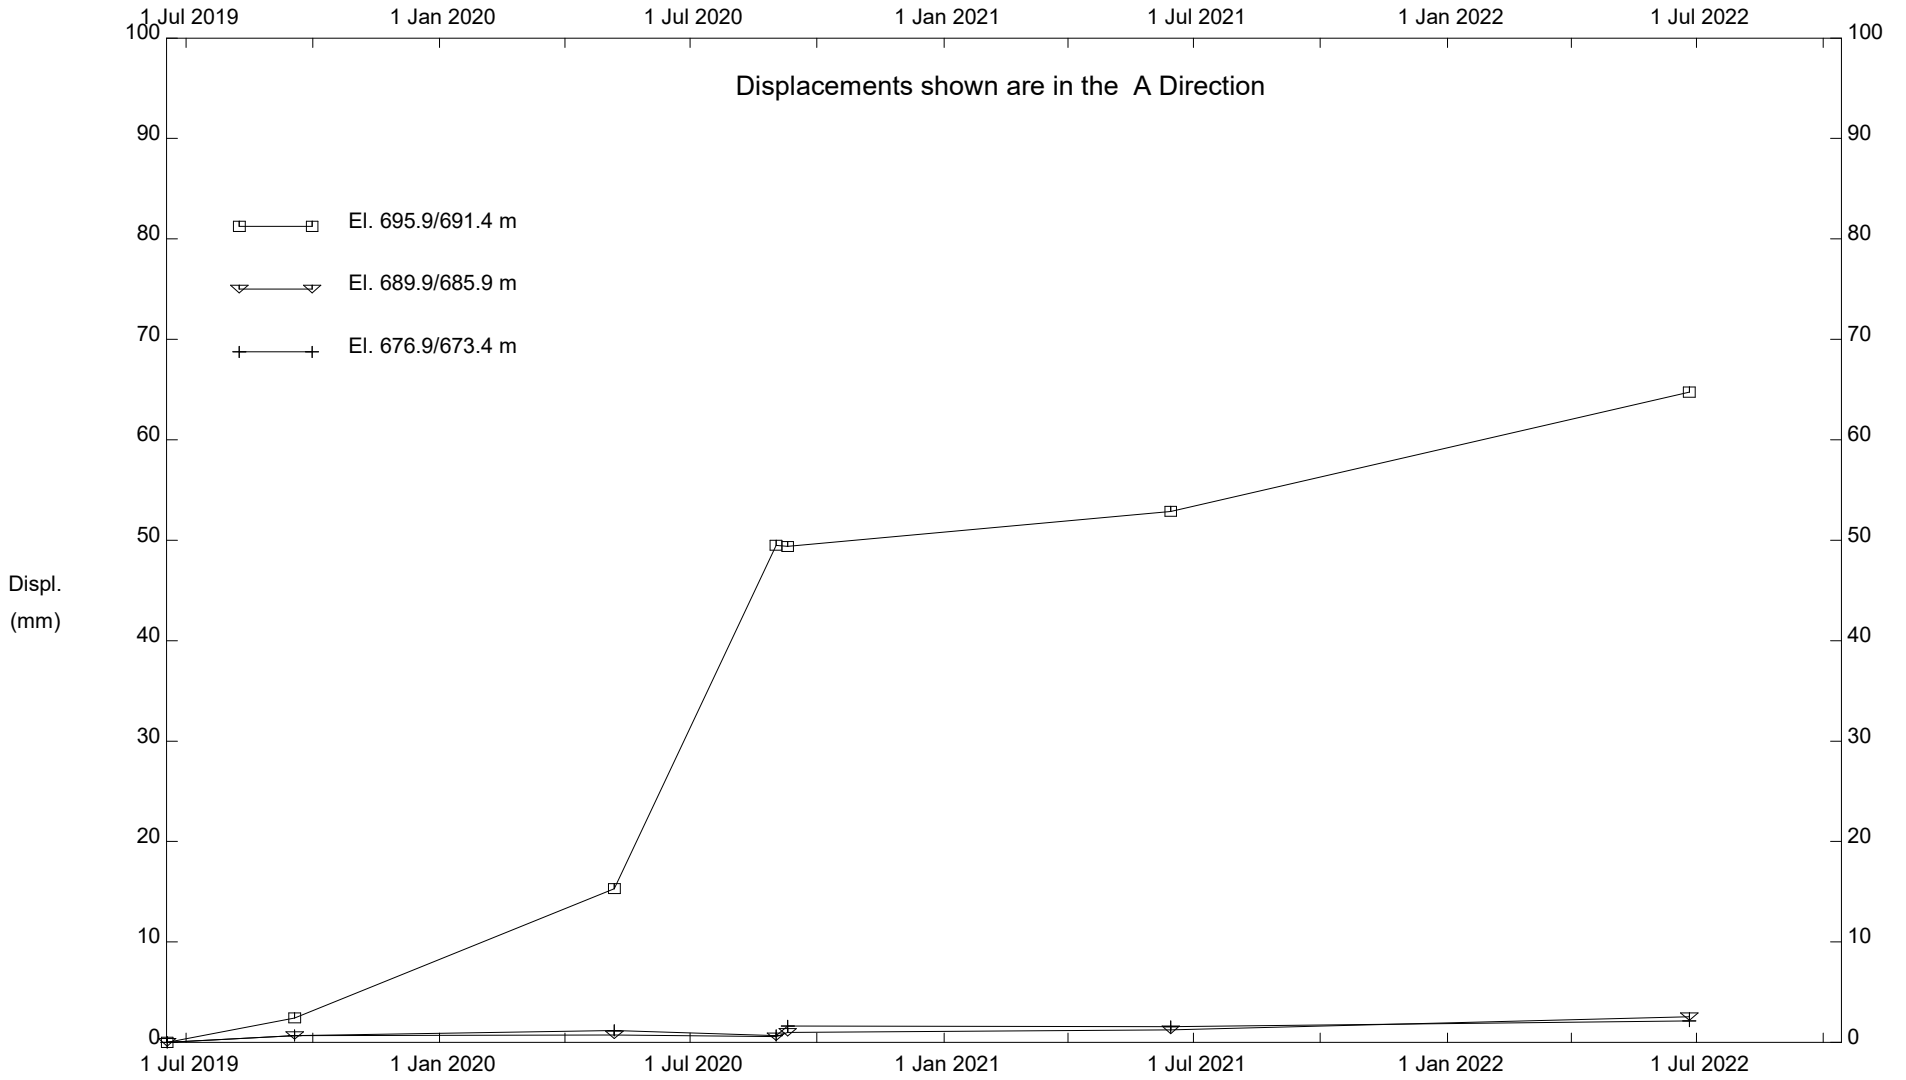
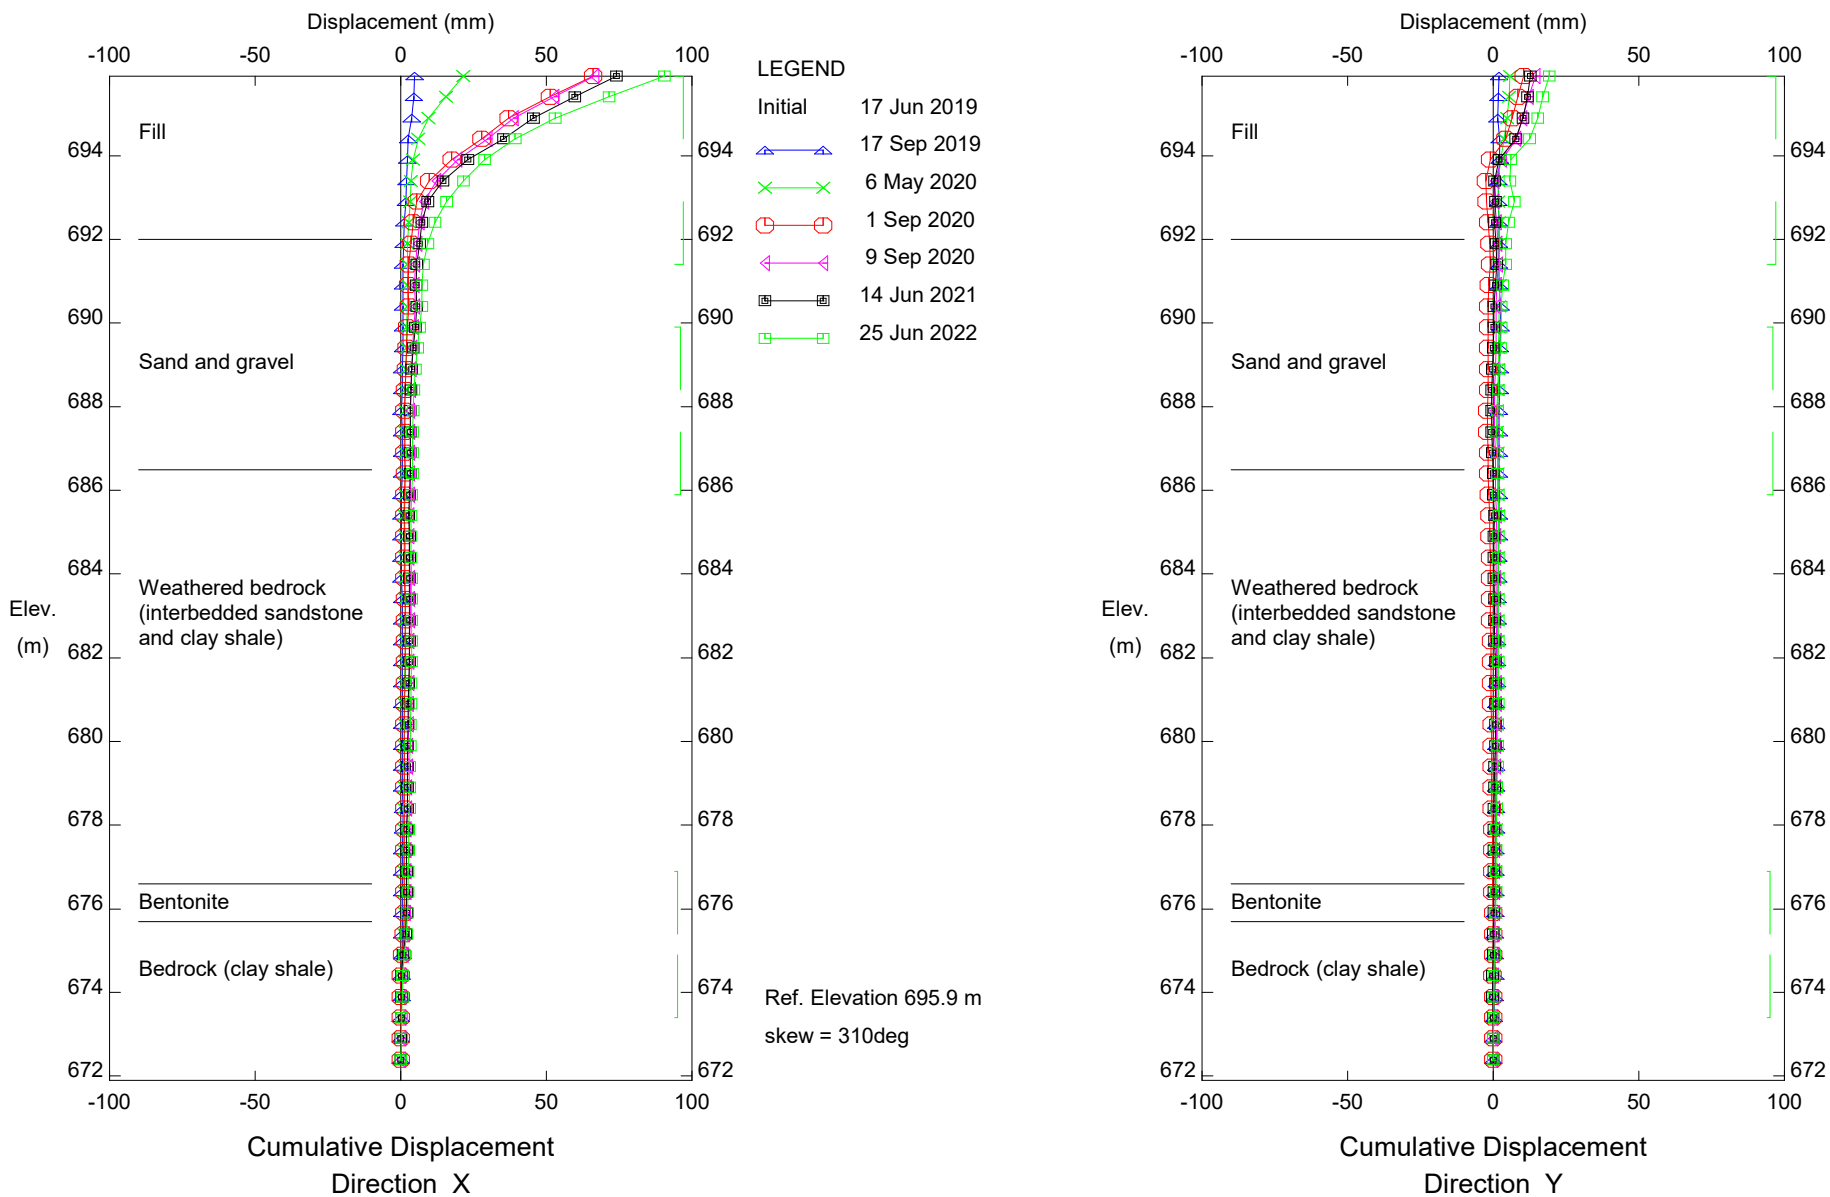
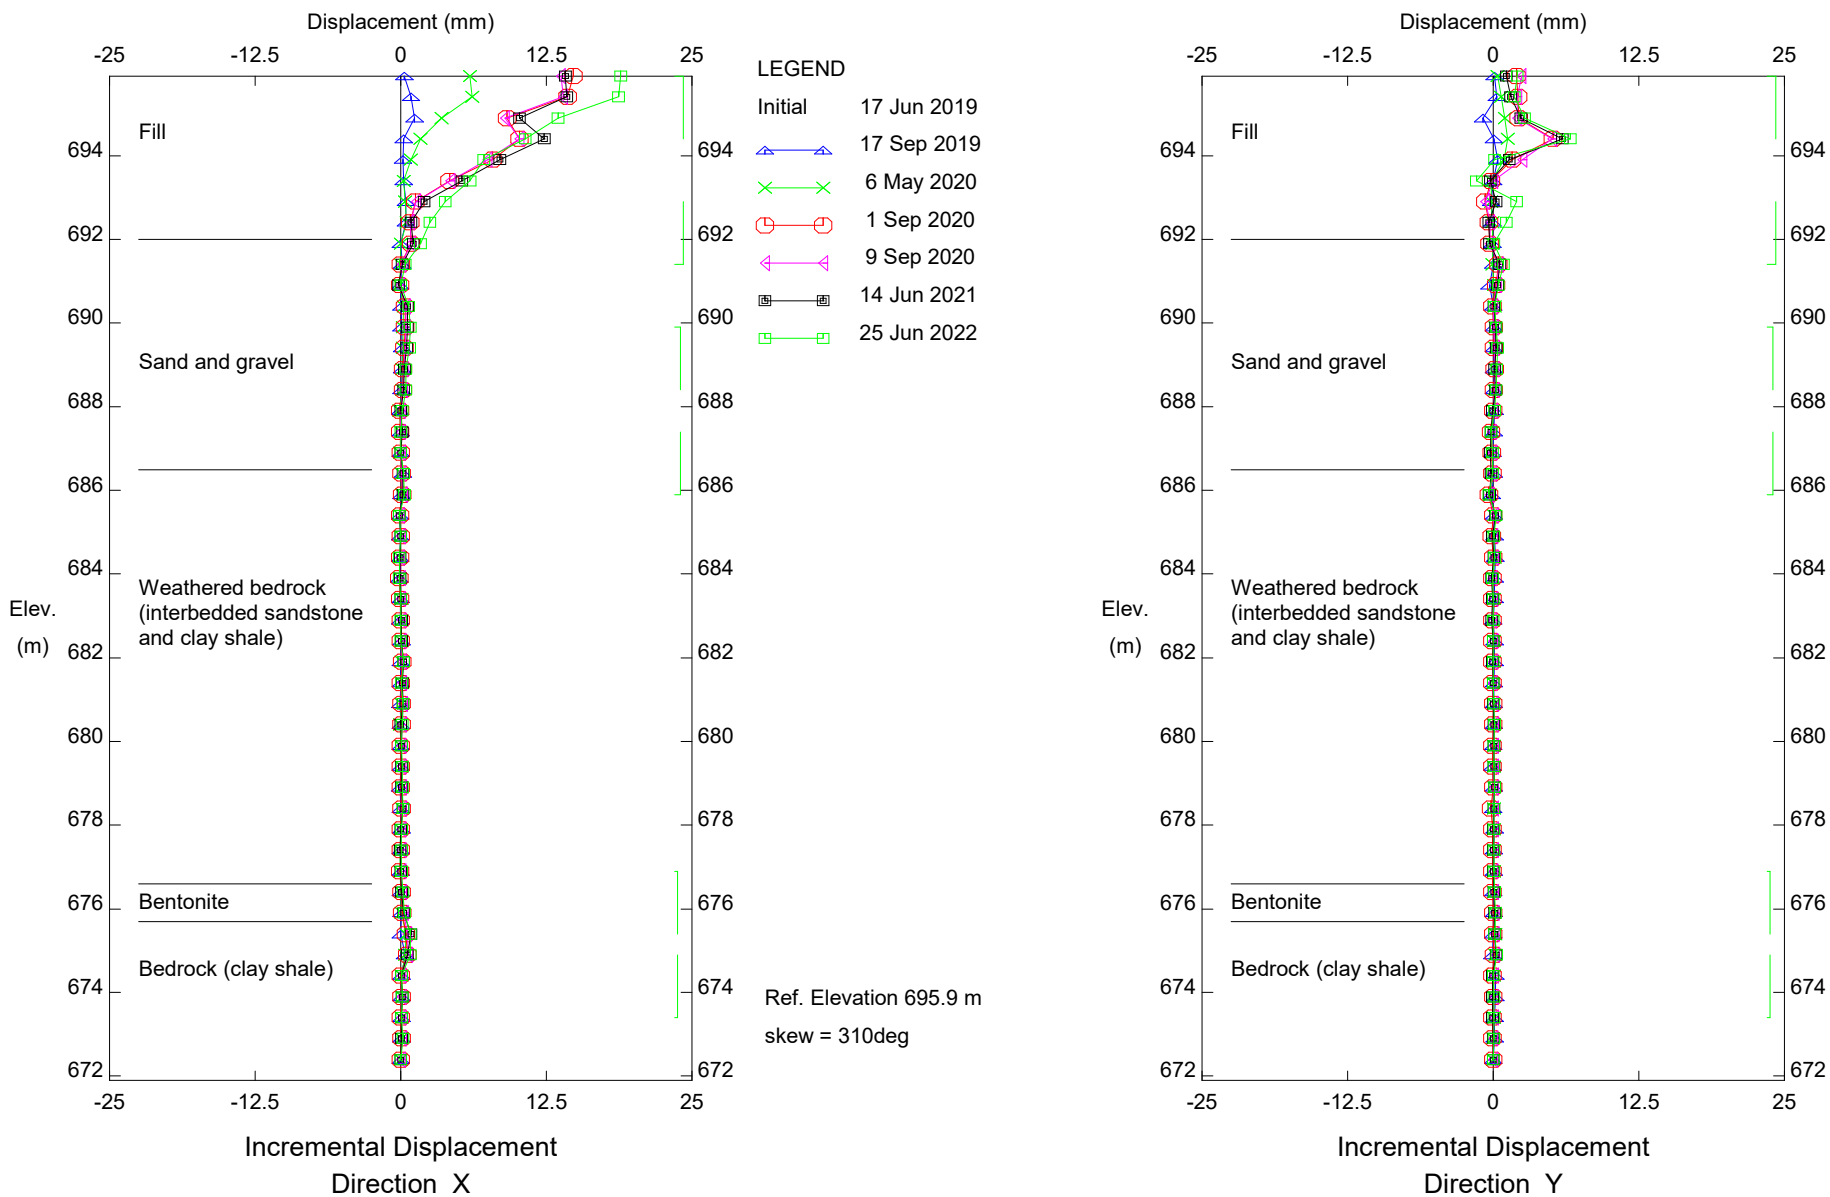
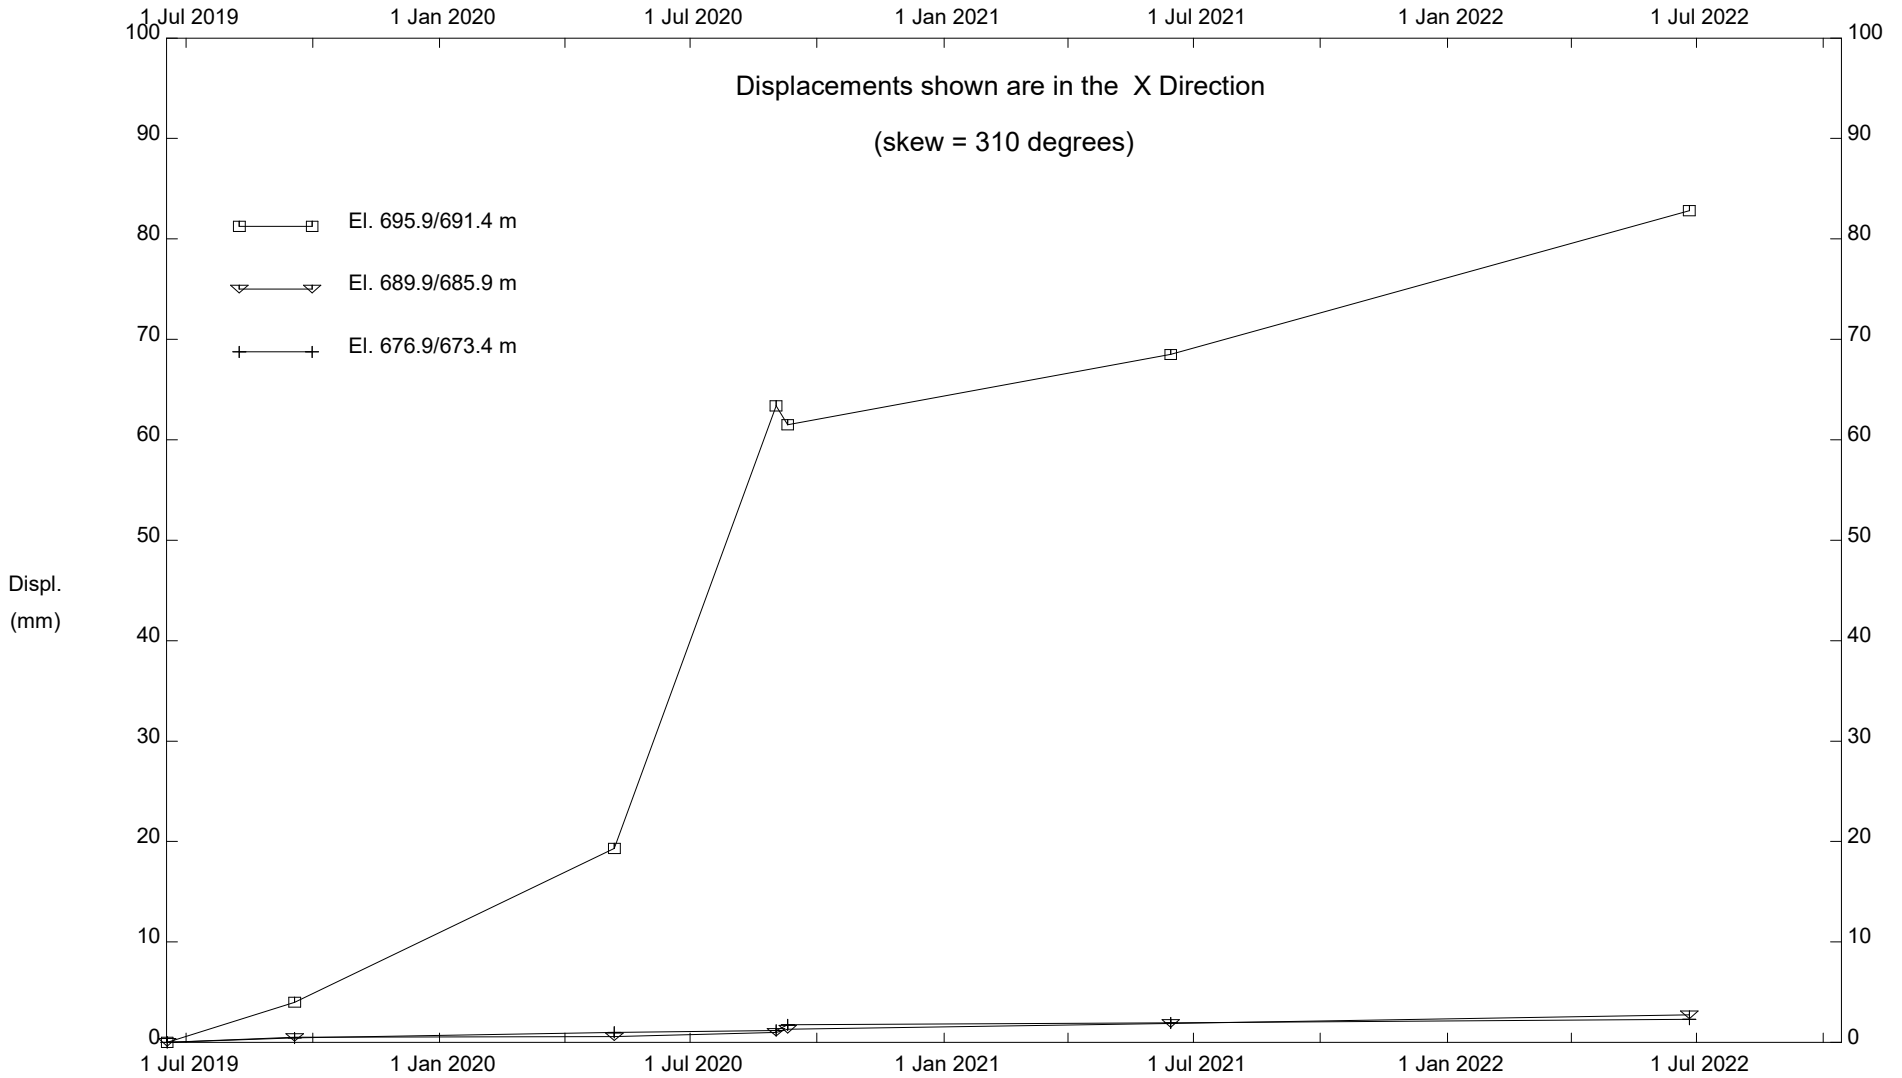
C074; H27:10, Morrin Bridge, Inclinometer SI18-1

- distributed movement from ground surface to an approximate depth of 4 m below ground surface (mbgs) in the abutment fill;
- lateral spreading of the sand and gravel foundation at an approximate depth of 8 mbgs (which may be contributing to movement in the abutment fill); and
- discrete movement at an approximate depth of 21 mbgs below the contact between the bentonite layer and underlying clay-shale bedrock.

The maximum rate of movement recorded in SI18-01 was 67.6 mm/year and 150.7 mm/year at an approximate depth of 8 mbgs and 21 mbgs, respectively. These maximum rates of movement were recorded on July 18 and August 1, 2018 respectively, during fill placement on the east abutment. The rate of movement has since decreased and is now less than 1 mm/year.

Overall, the slow (attenuating) rate of movement recorded in SI18-01 indicates the east abutment is performing well. However, KCB does not have documentation of the expectations of the designers to compare to the abutment behavior. The design engineer for the abutment should review the data in this report to assess if the pile wall is performing adequately.
