September 12, 2022

Alberta Transportation
4th Floor, Provincial Building
4920 51 Street
Red Deer, Alberta
T4N 6K8

CON0022160 Central Region GRMP Instrumentation Monitoring
Site C074; H27:10, km 23.976 Red Deer River Bridge
Section C – 2022 Spring Readings

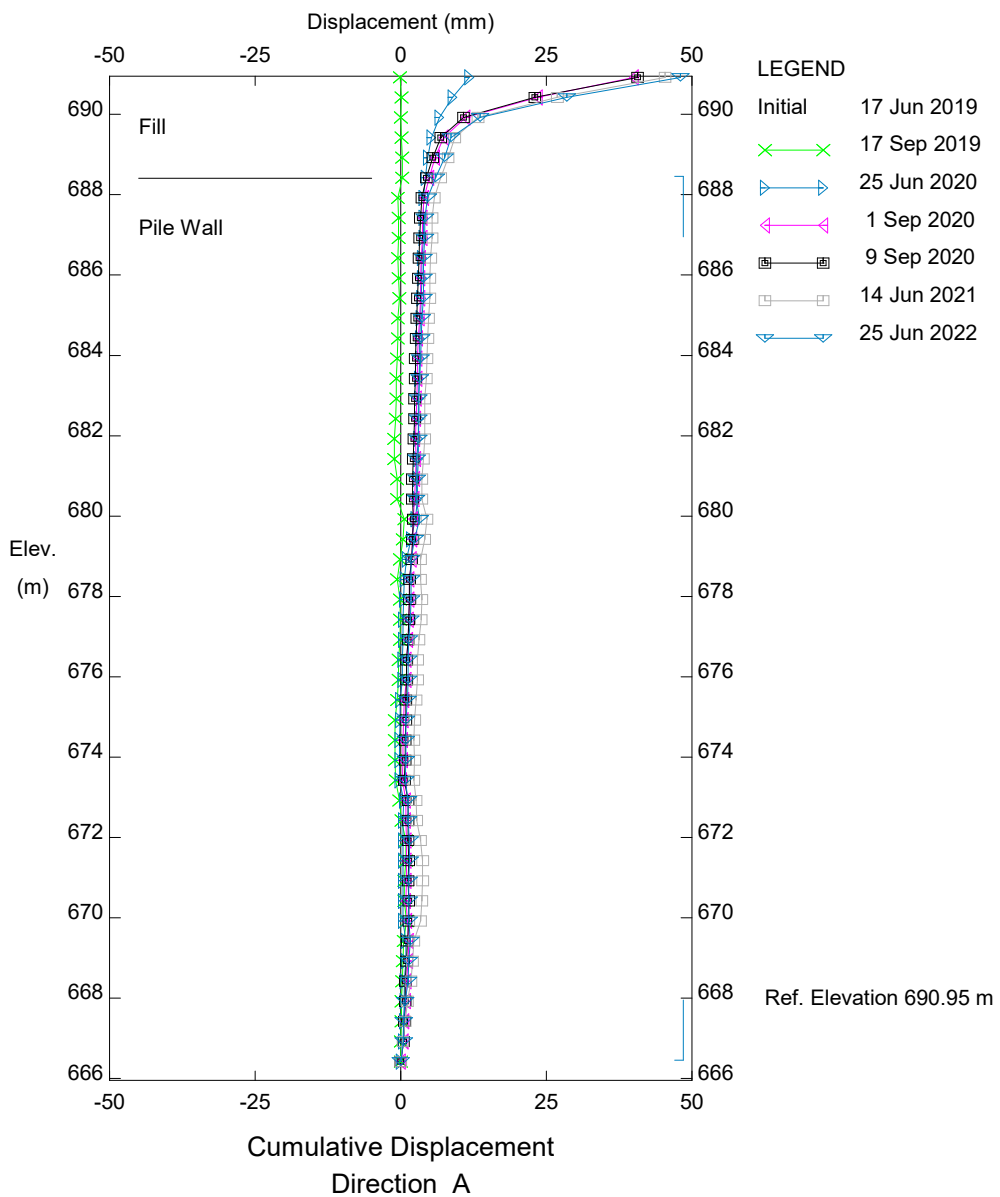
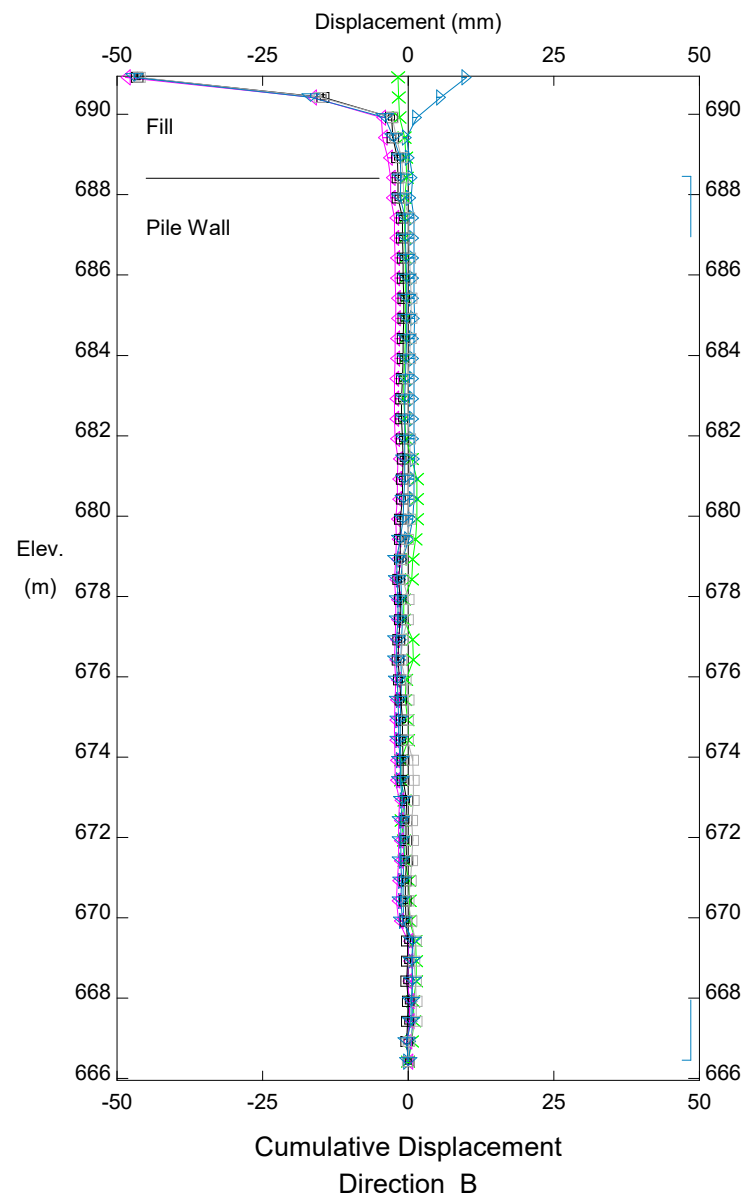
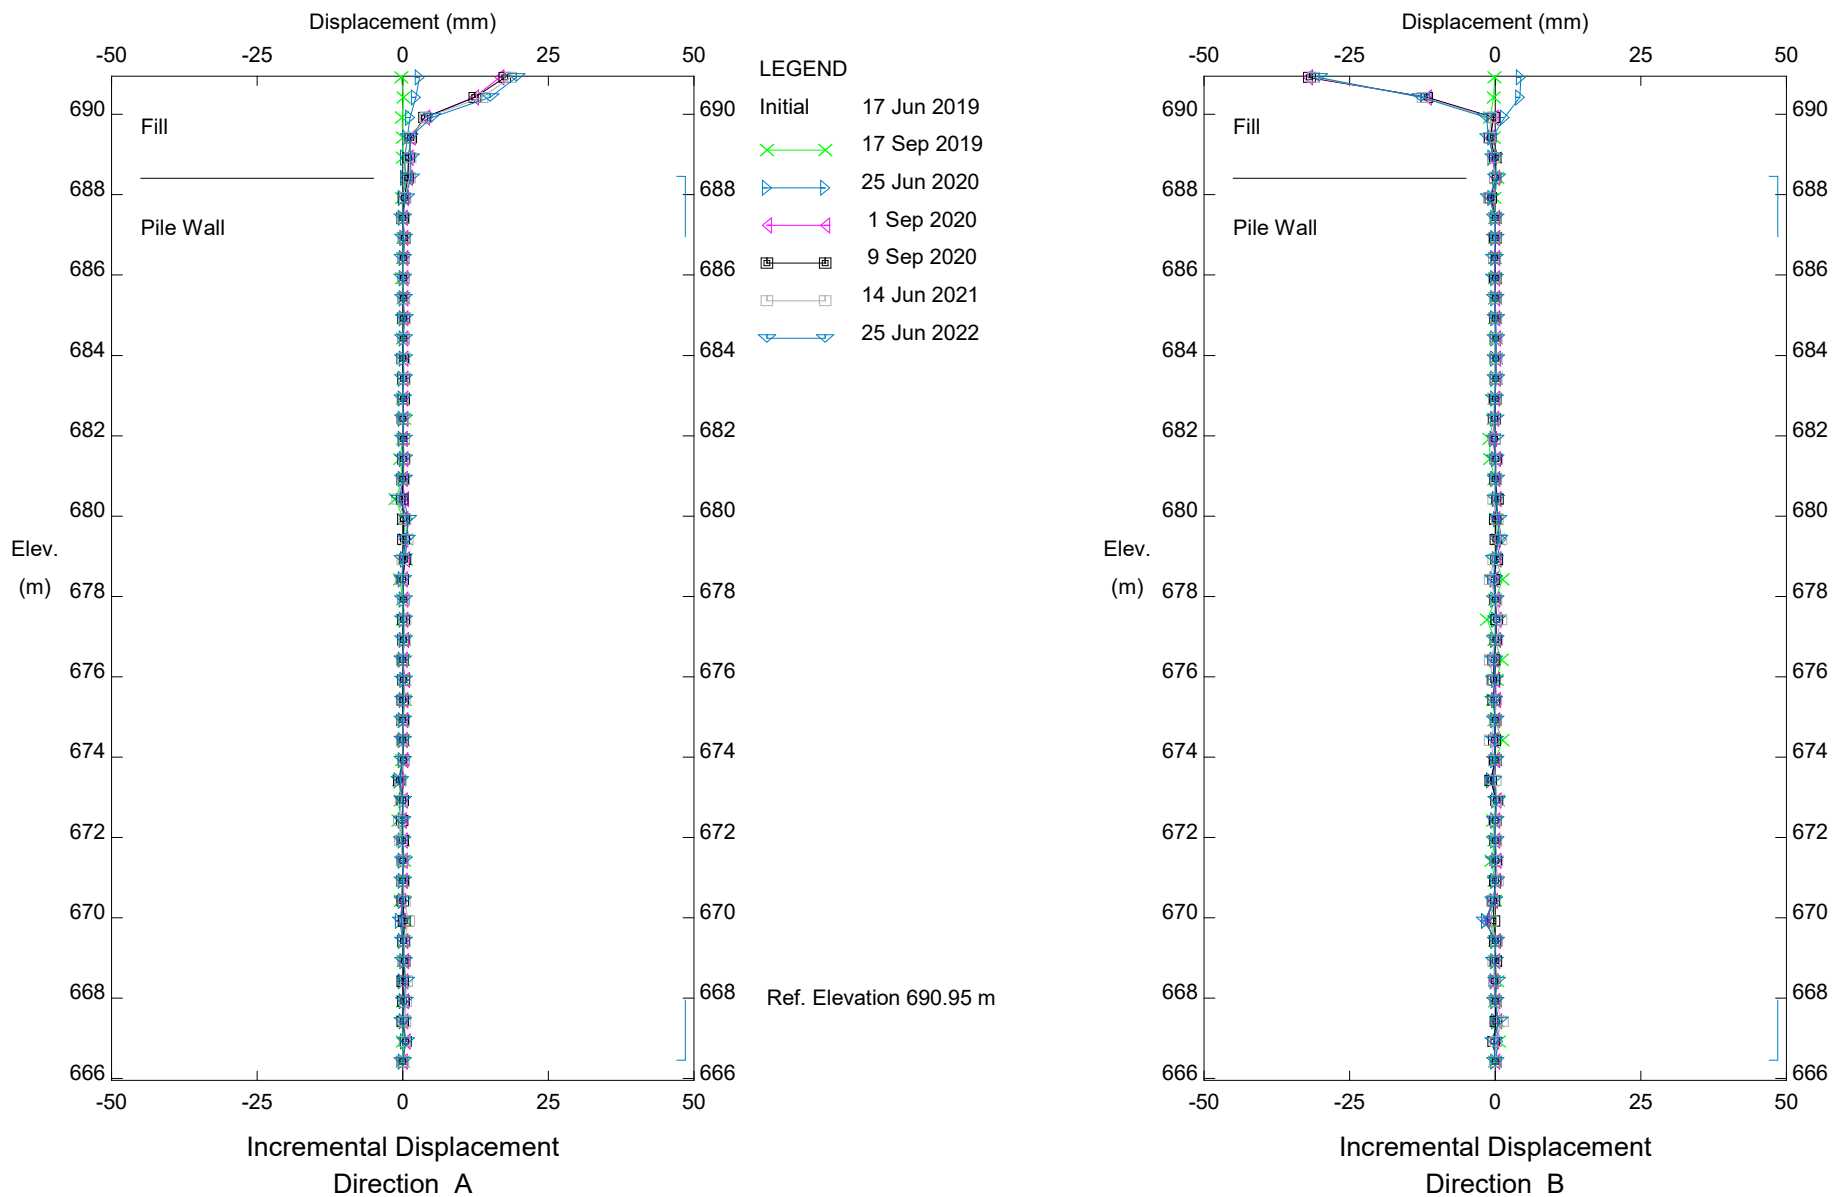
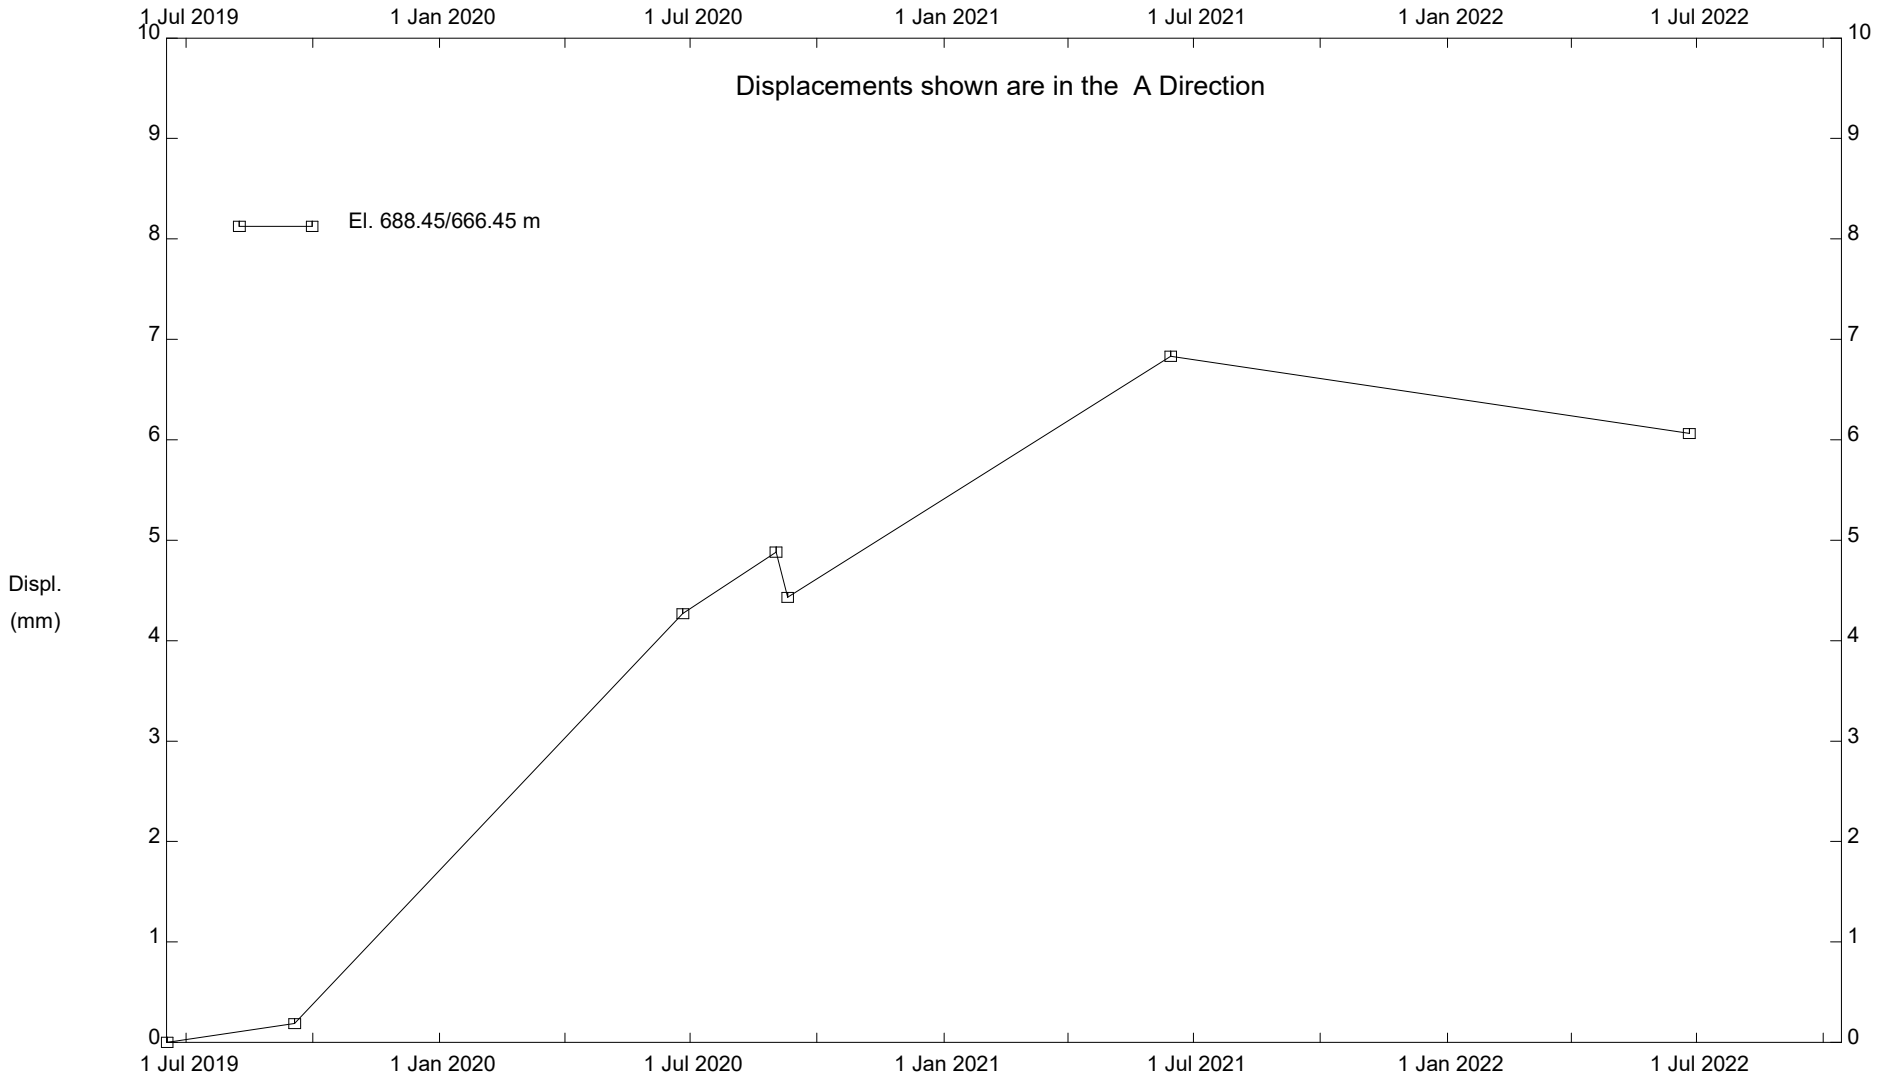
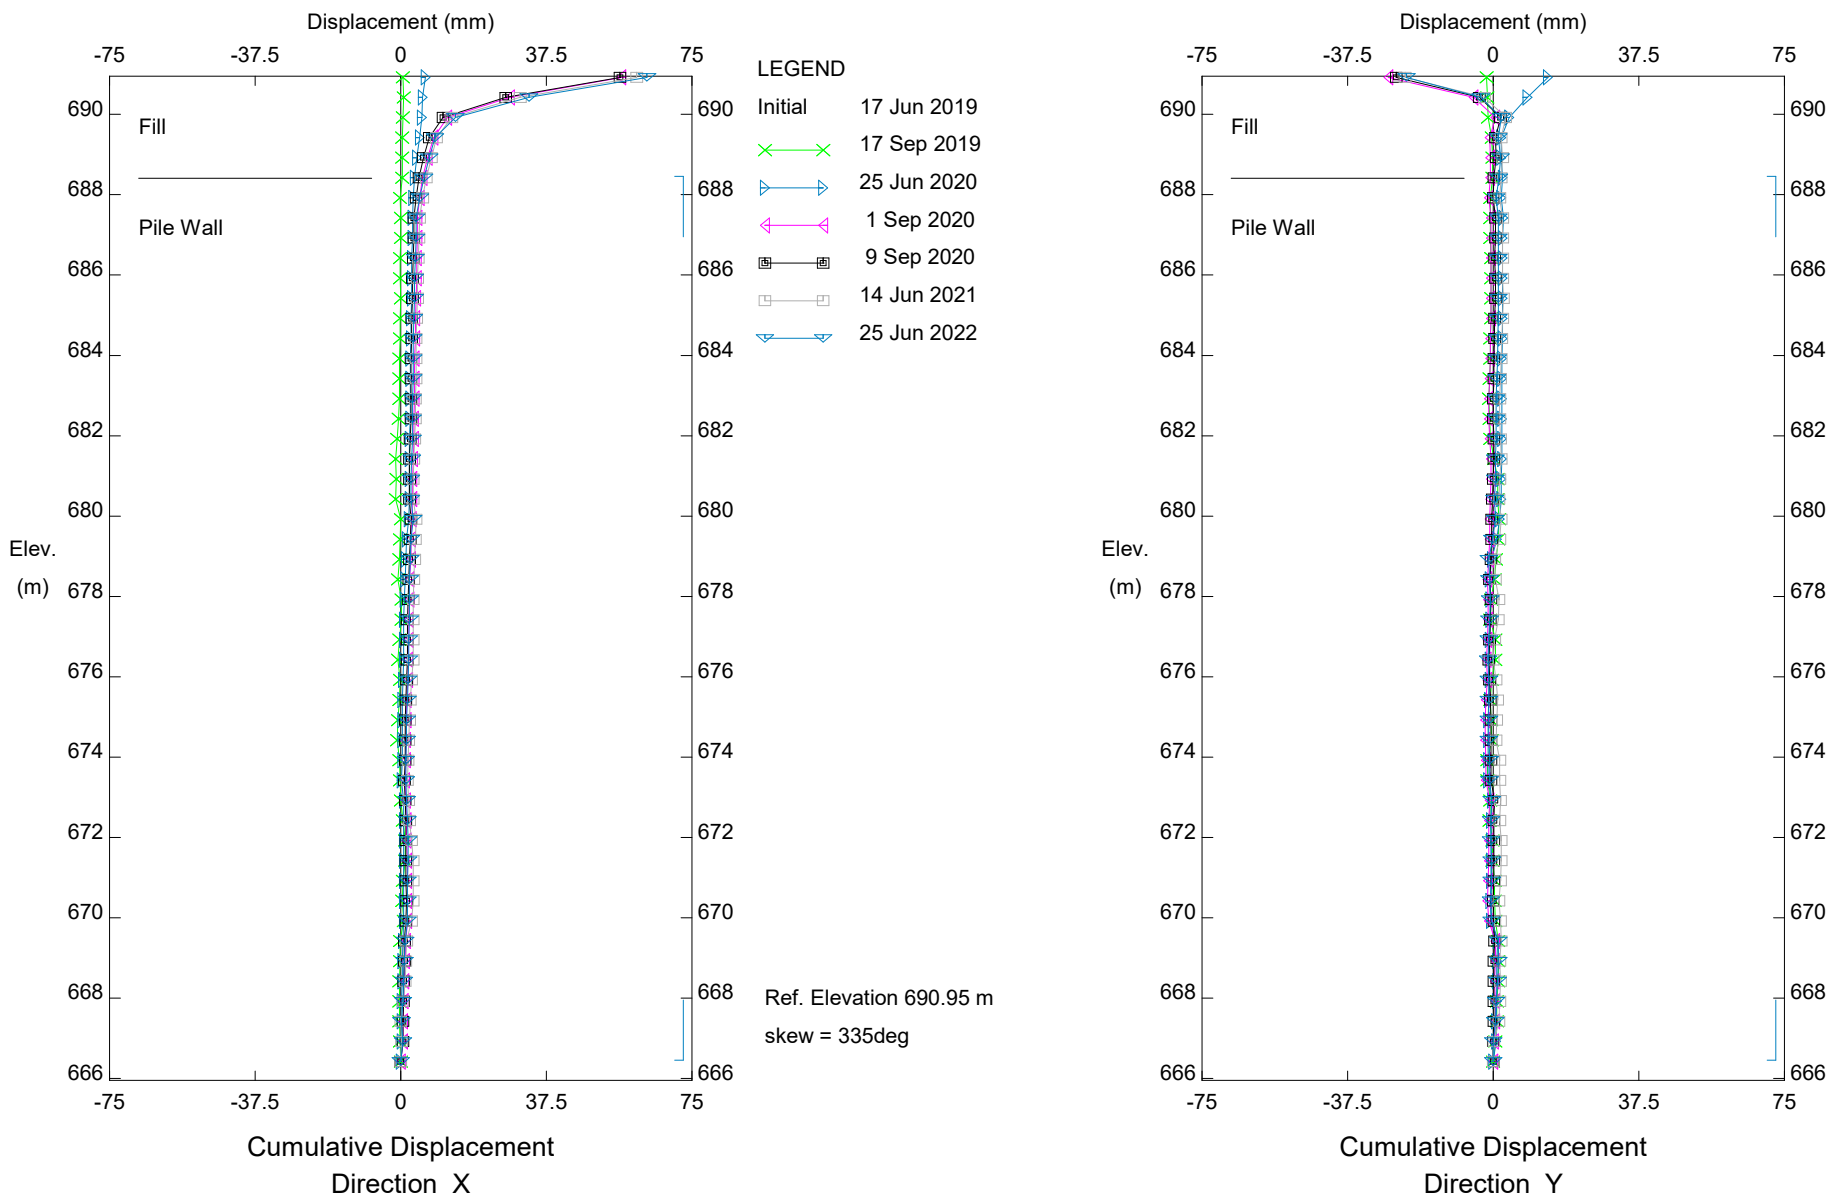
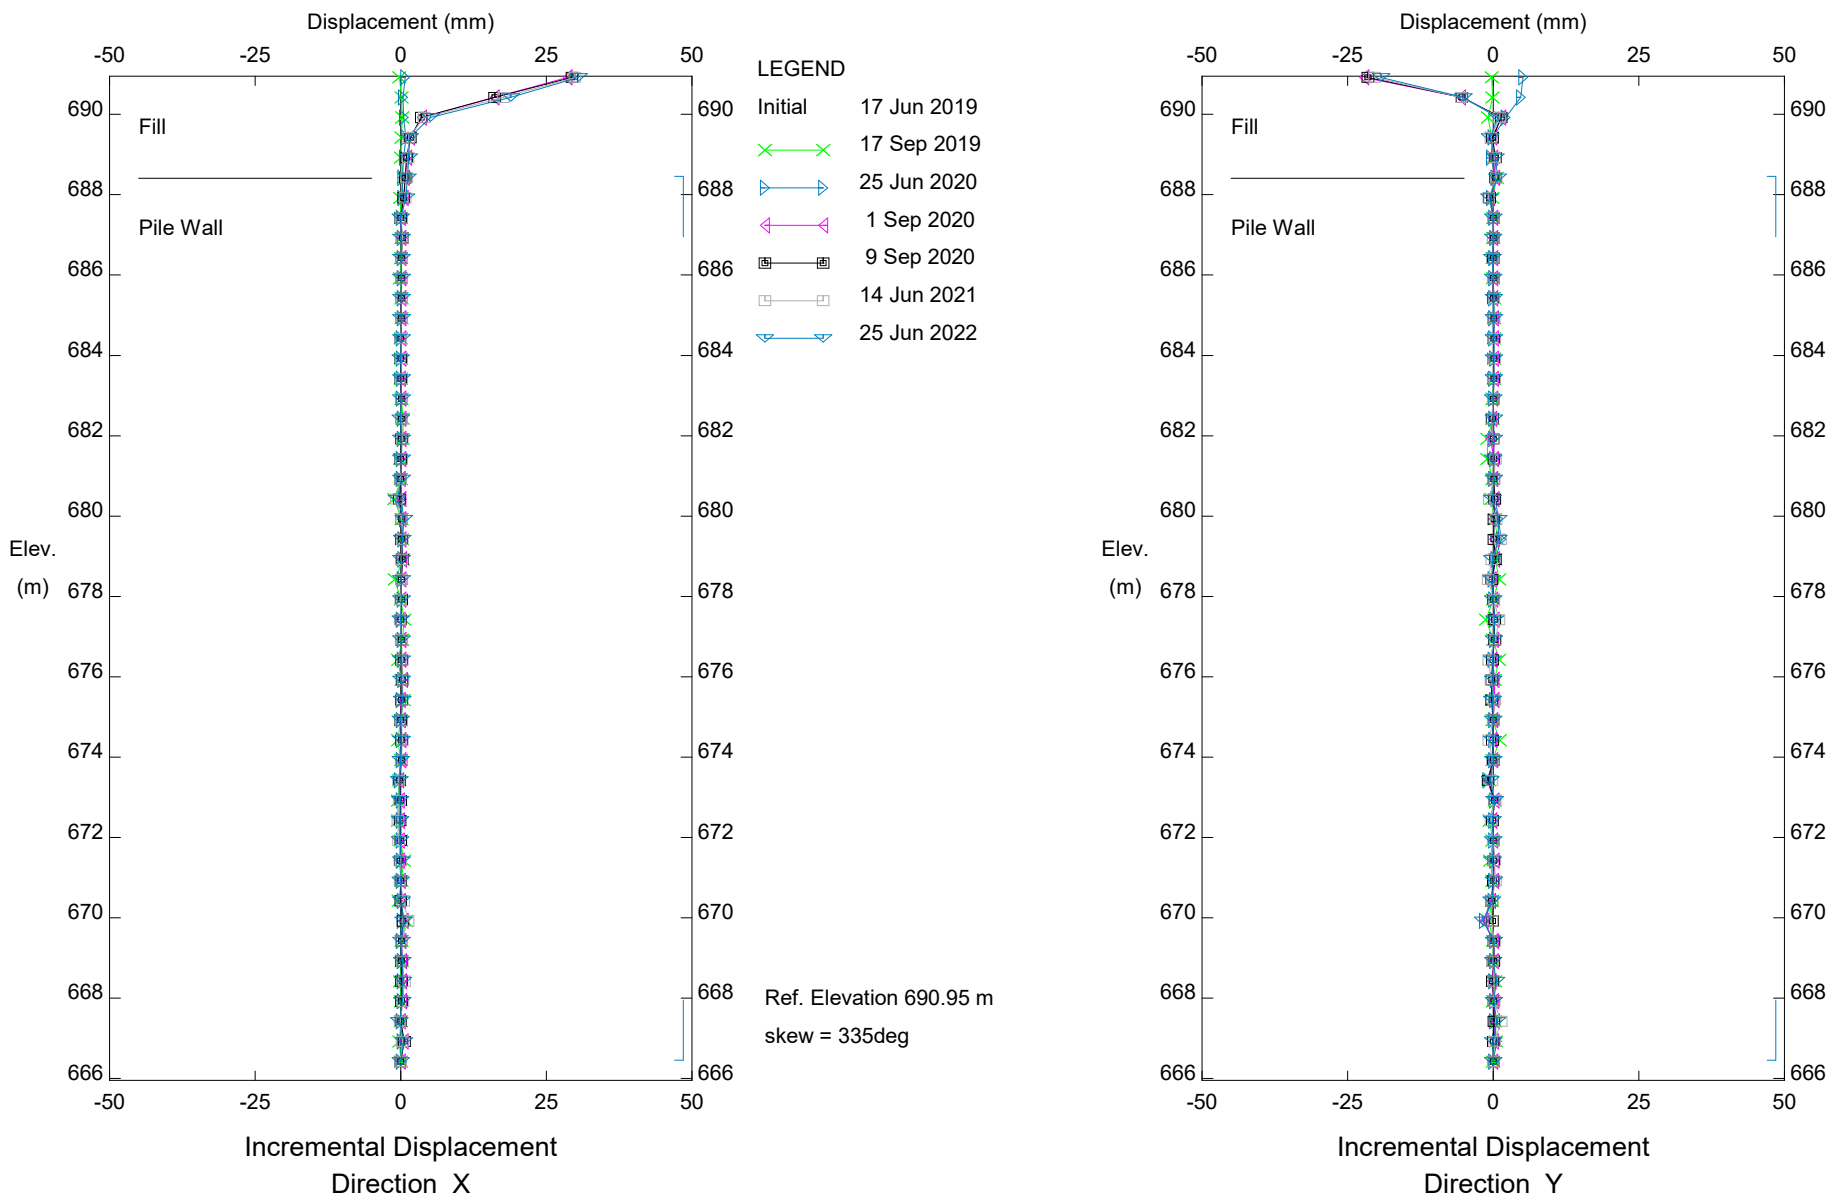
C074; H27:10, Morrin Bridge, Inclinator SI-P01

The data obtained from the pile-wall SIs indicates the top of the pile wall deflected approximately 16 mm to 26 mm between June 2018 (installation) and January 2019 (the last reading obtained by the previous consultant), and up to approximately 6 mm since June 2019 (the first reading obtained by the KCB). Most of the deflection occurred between June 2018 and August 2018 when (or just after) fill was being placed on the east abutment.

The maximum rate of movement recorded in the X-direction of the pile-wall SIs was between approximately 128 mm/year and 229 mm/year. This maximum rate of movement was recorded between July and August 2018 during fill placement on the east abutment. The rate of movement has since decreased and is now less than 1 mm/year. Additional displacement of the pile wall may occur in response to periods of heavy or prolonged rainfall, resulting in higher groundwater conditions or river levels.

Since distributed movement is being recorded in SI-P01, SI-P06, and SI-P11 to the bottom of the SI casing and the depth to the design failure surface is unknown, KCB cannot conclude if the pile wall has intercepted the failure surface and whether loads are being transferred to depths below the failure surface as the piles stabilize the sliding mass.

The design engineer for the pile wall should review the data in this report to assess if the pile wall is performing adequately.

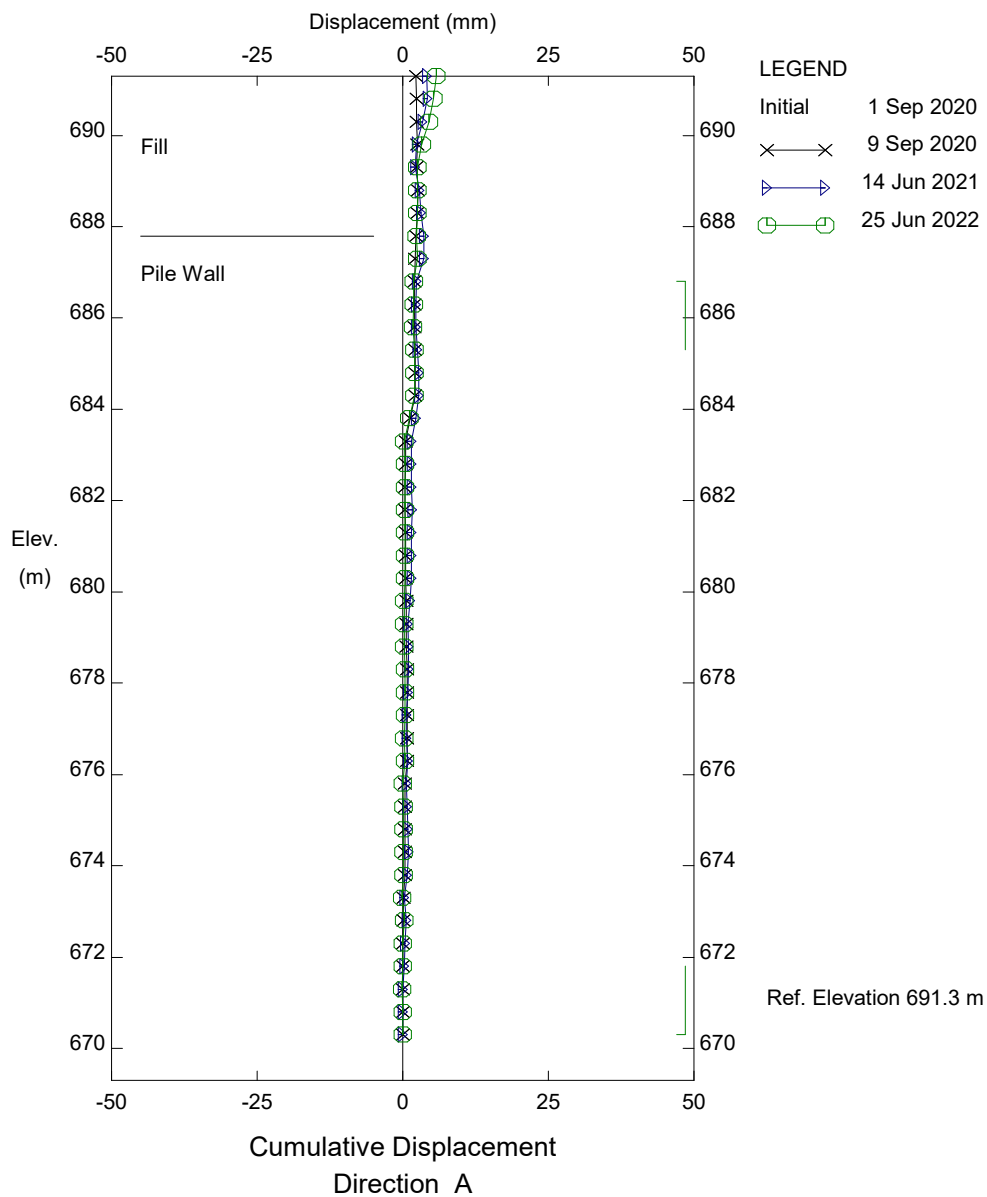
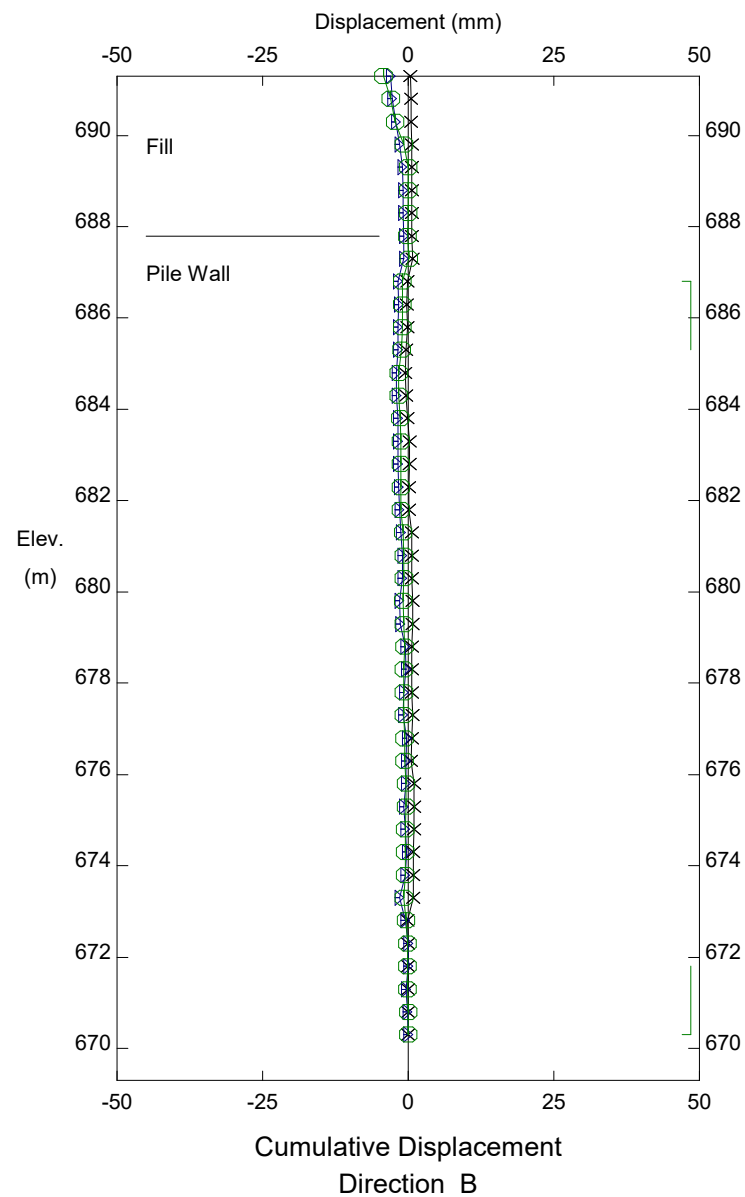
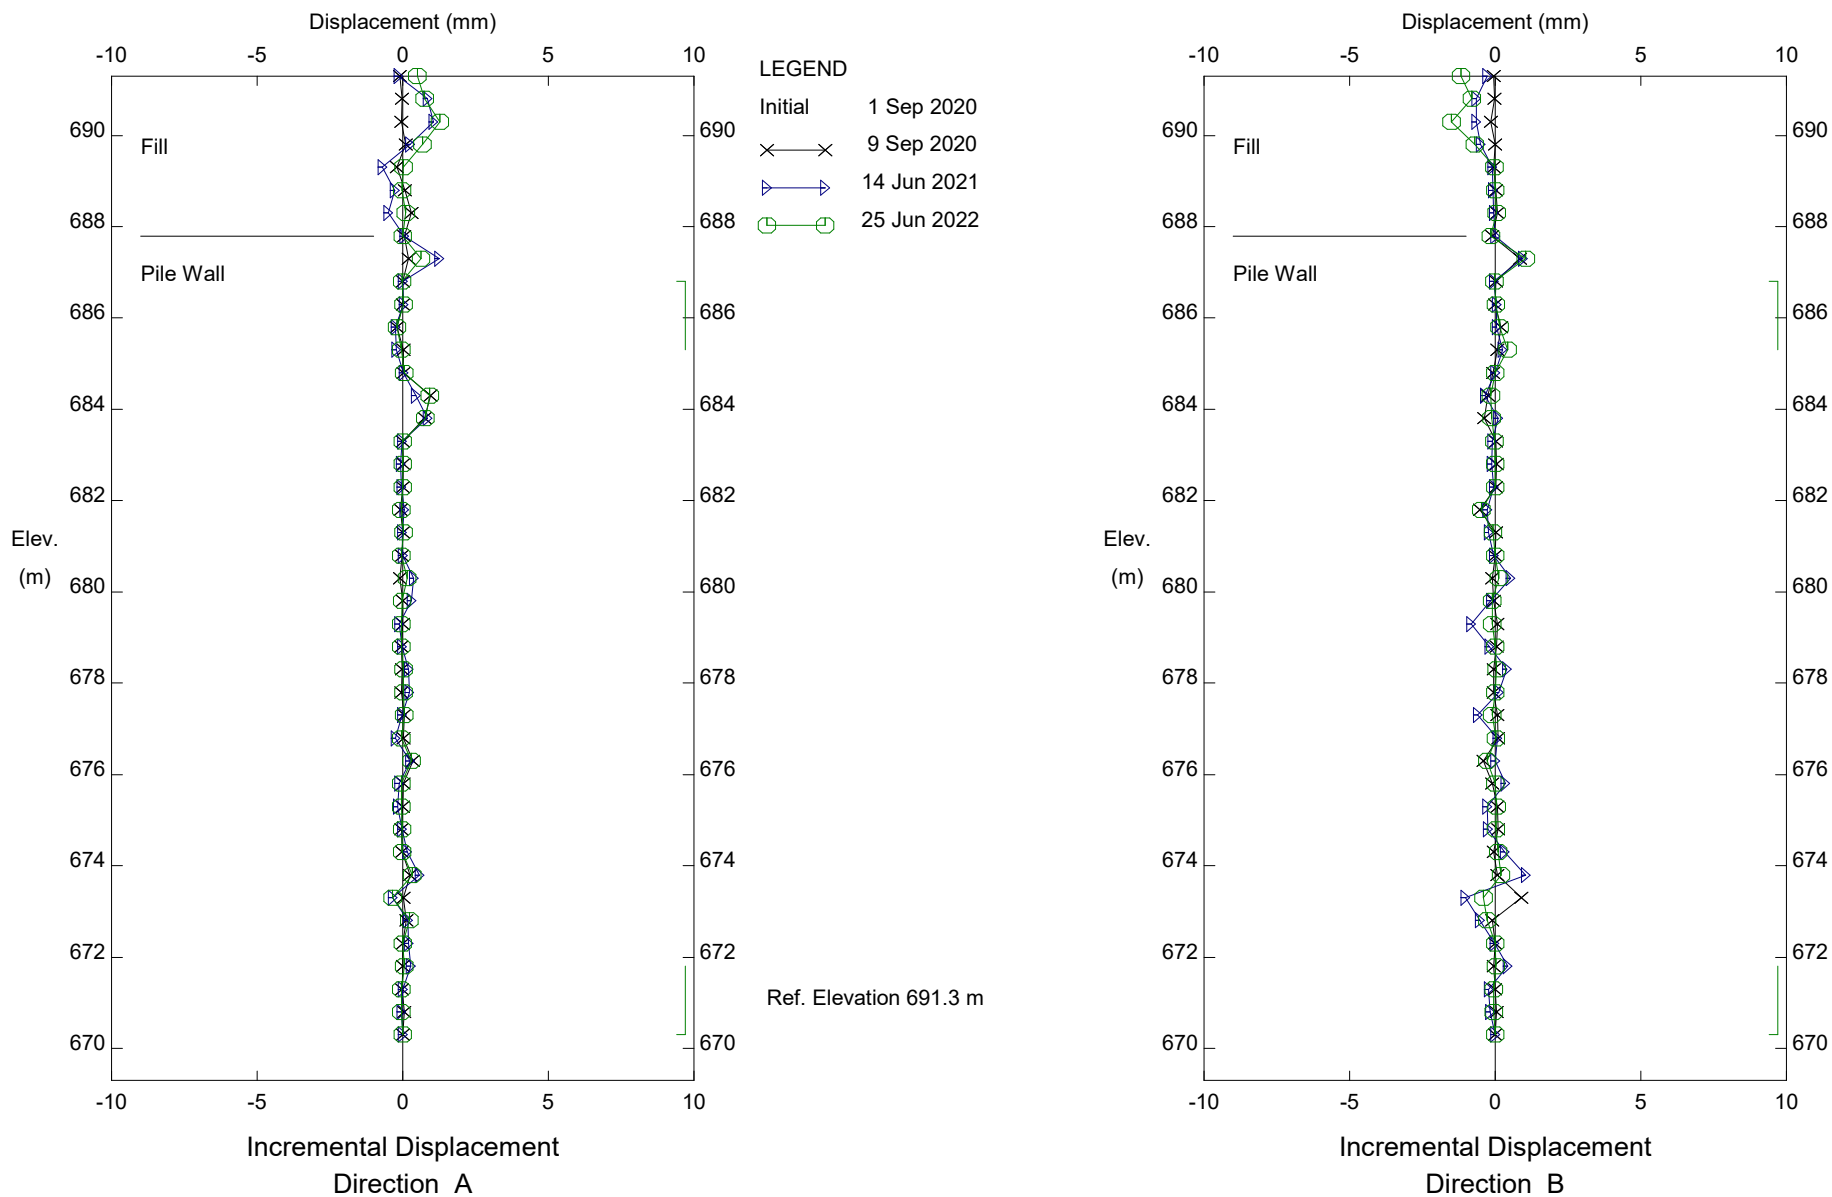
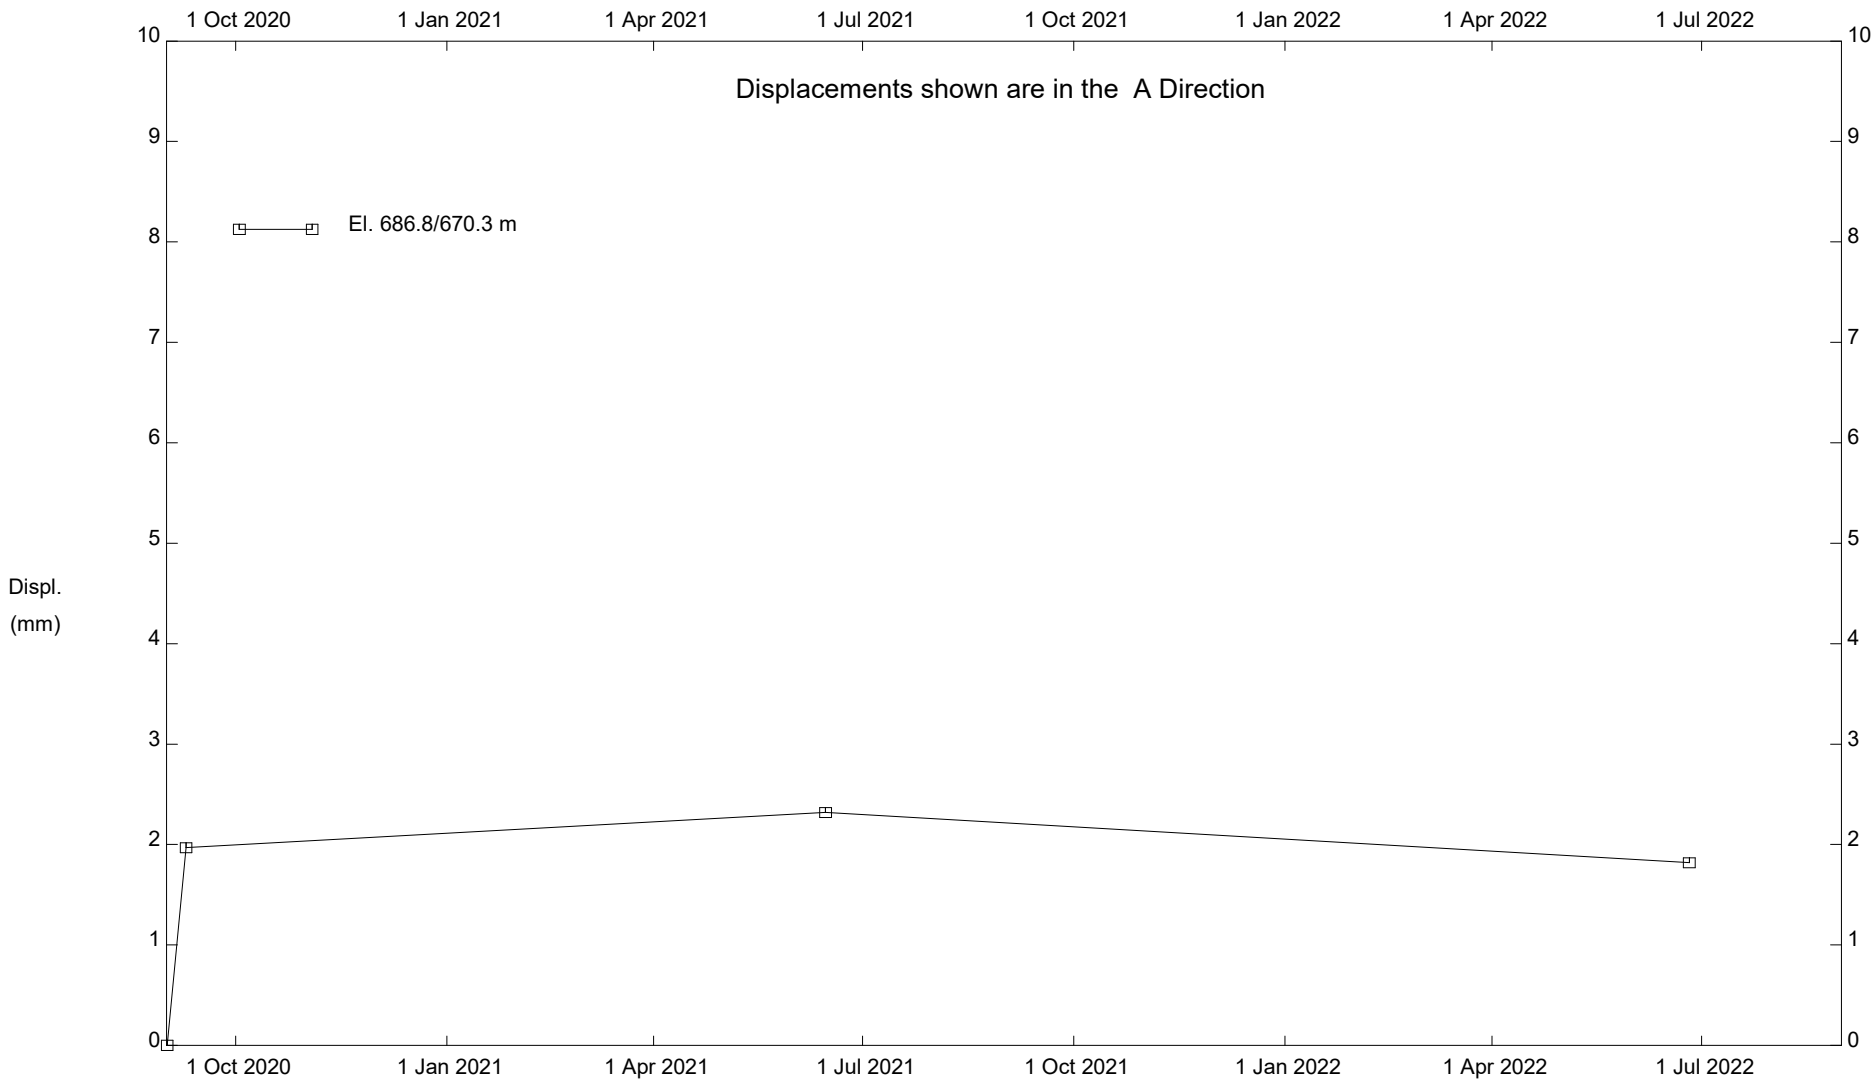
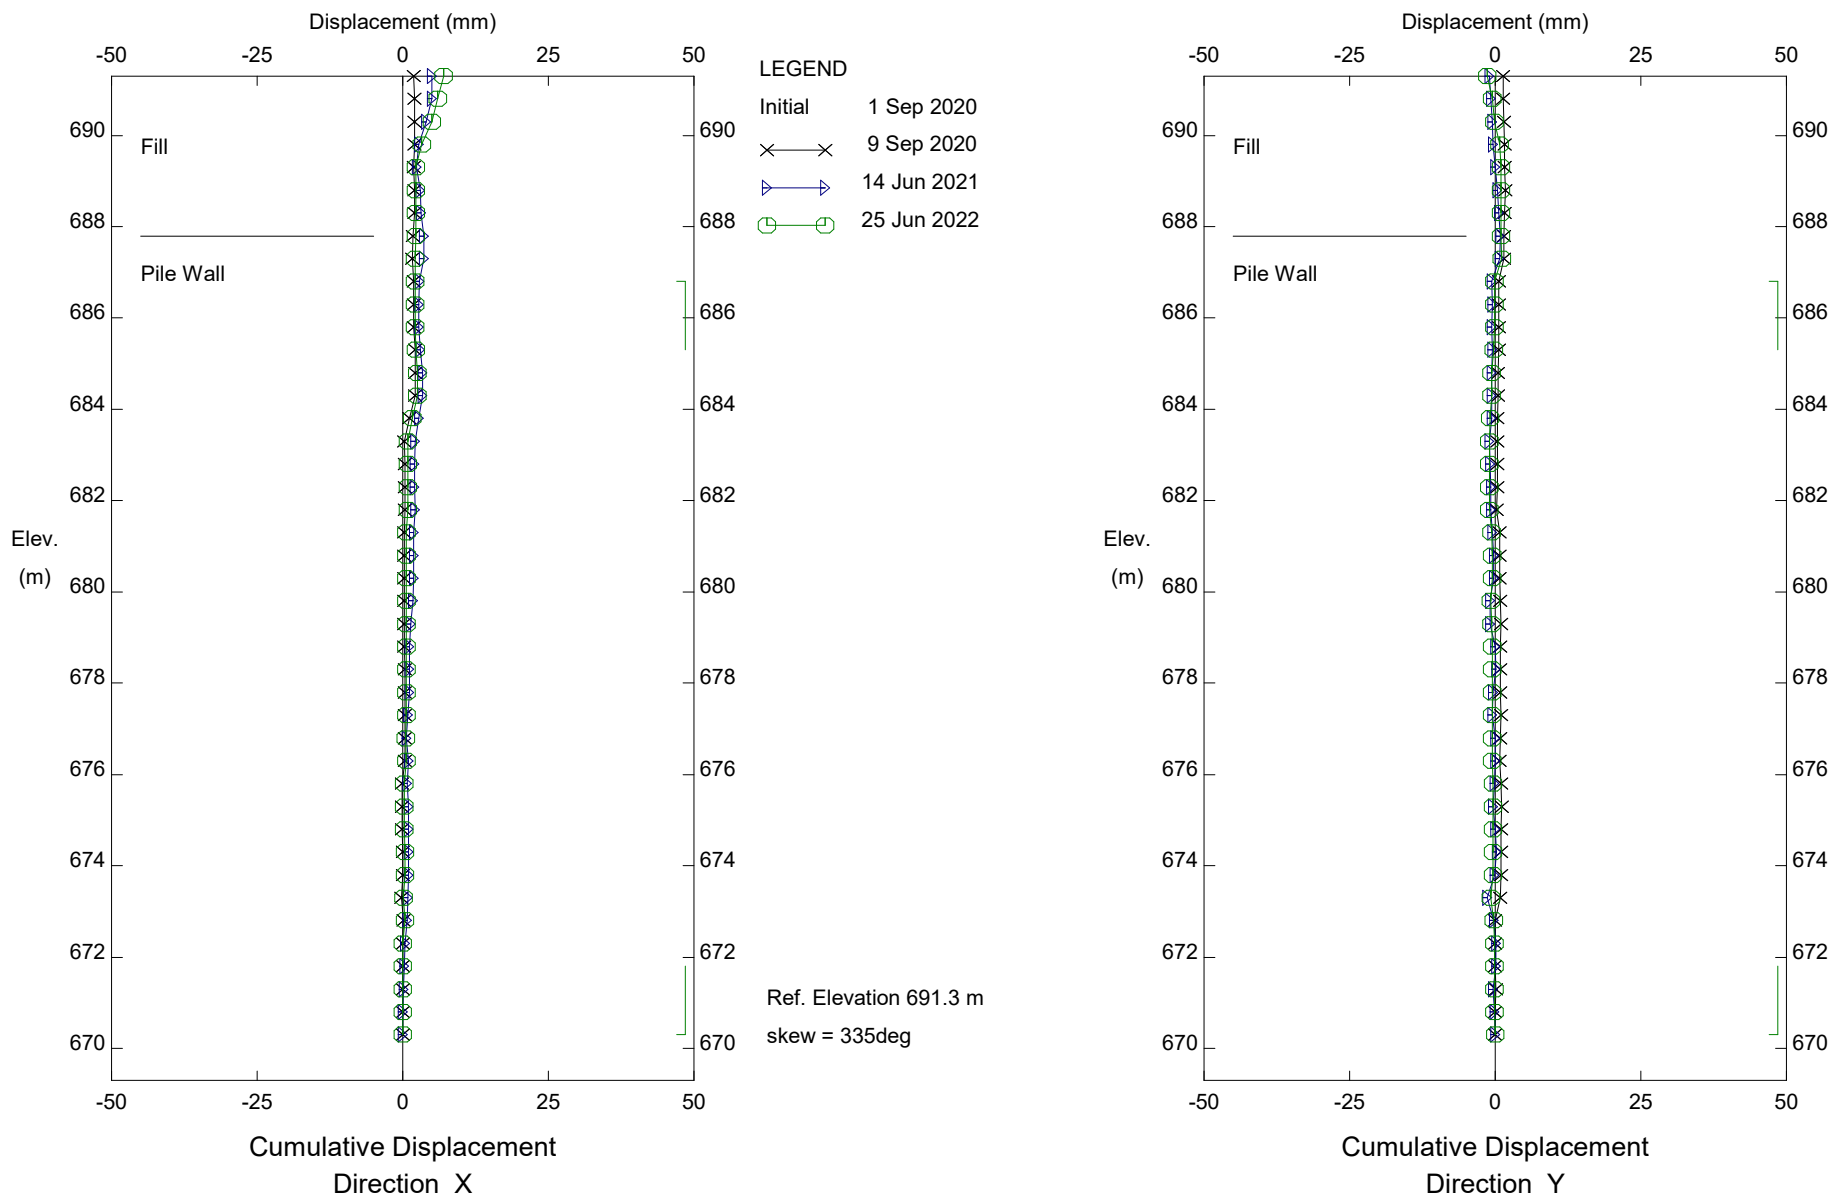
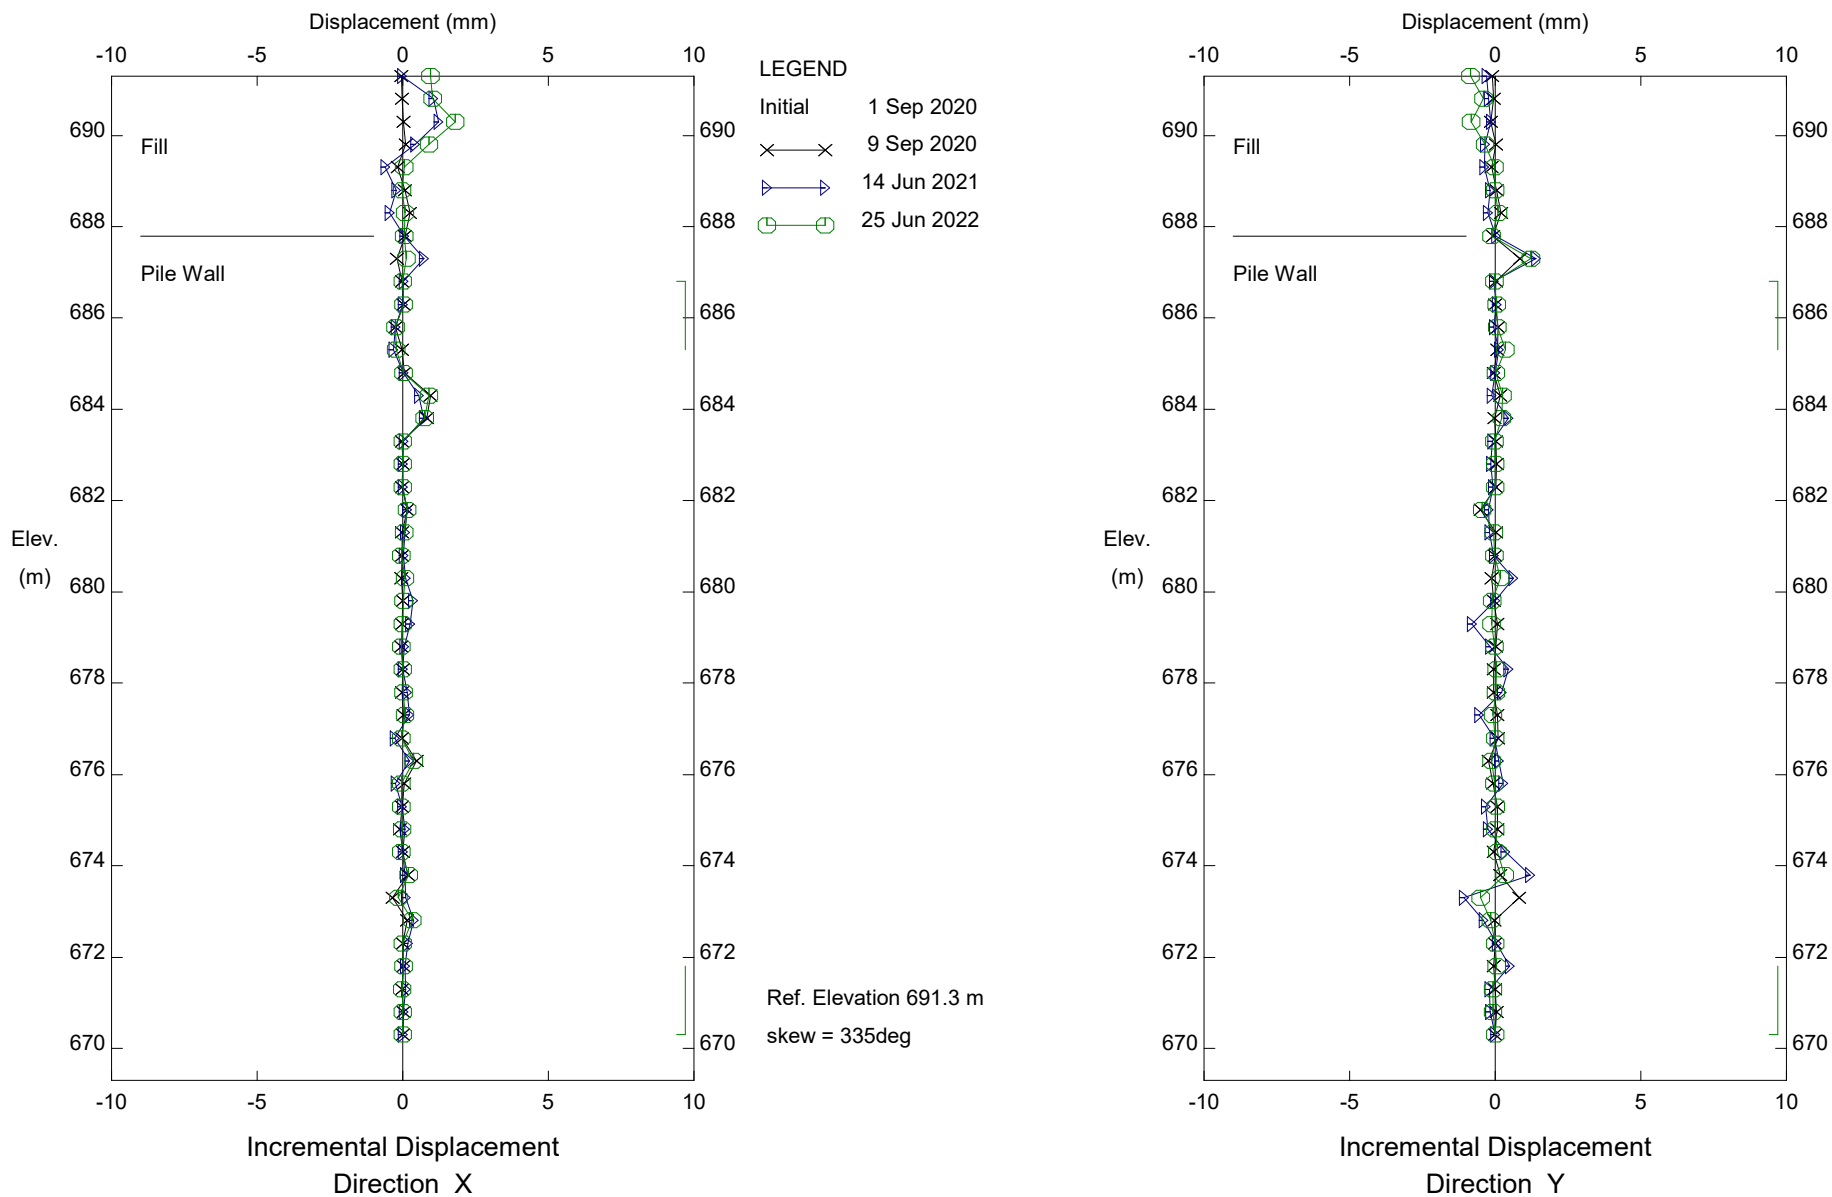
C0174; H27:10, Morrin Bridge, Inclinometer SI-P06

It also noted that the casing for SI-P11 was extended and then repaired by KCB in June 2019, and the casing for SI-P06 was damaged between the September 2019 and June 2020 readings, then cut off (not by KCB) between the June and September 2020 readings.
