September 12, 2022

Alberta Transportation
4th Floor, Provincial Building
4920 51 Street
Red Deer, Alberta
T4N 6K8

CON0022160 Central Region GRMP Instrumentation Monitoring
Site C074; H27:10, km 23.976 Red Deer River Bridge
Section C – 2022 Spring Readings

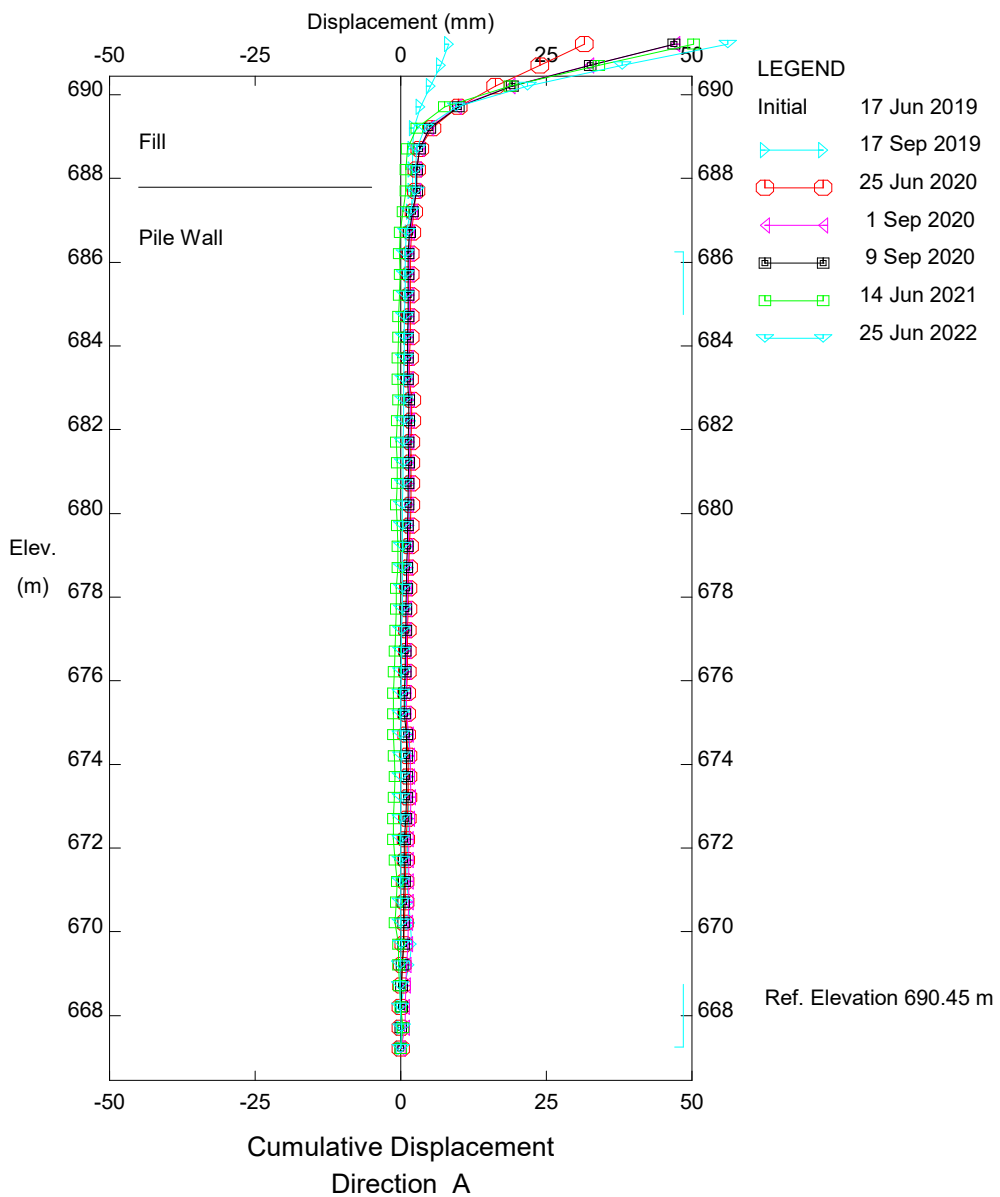
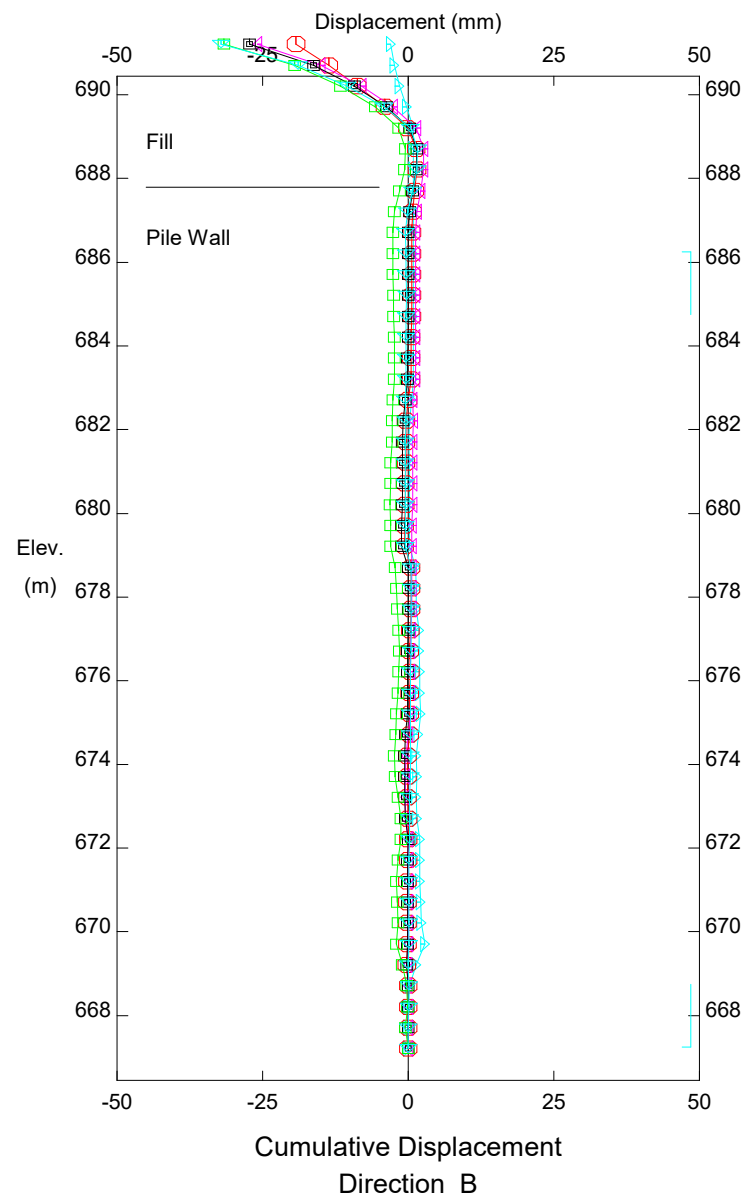
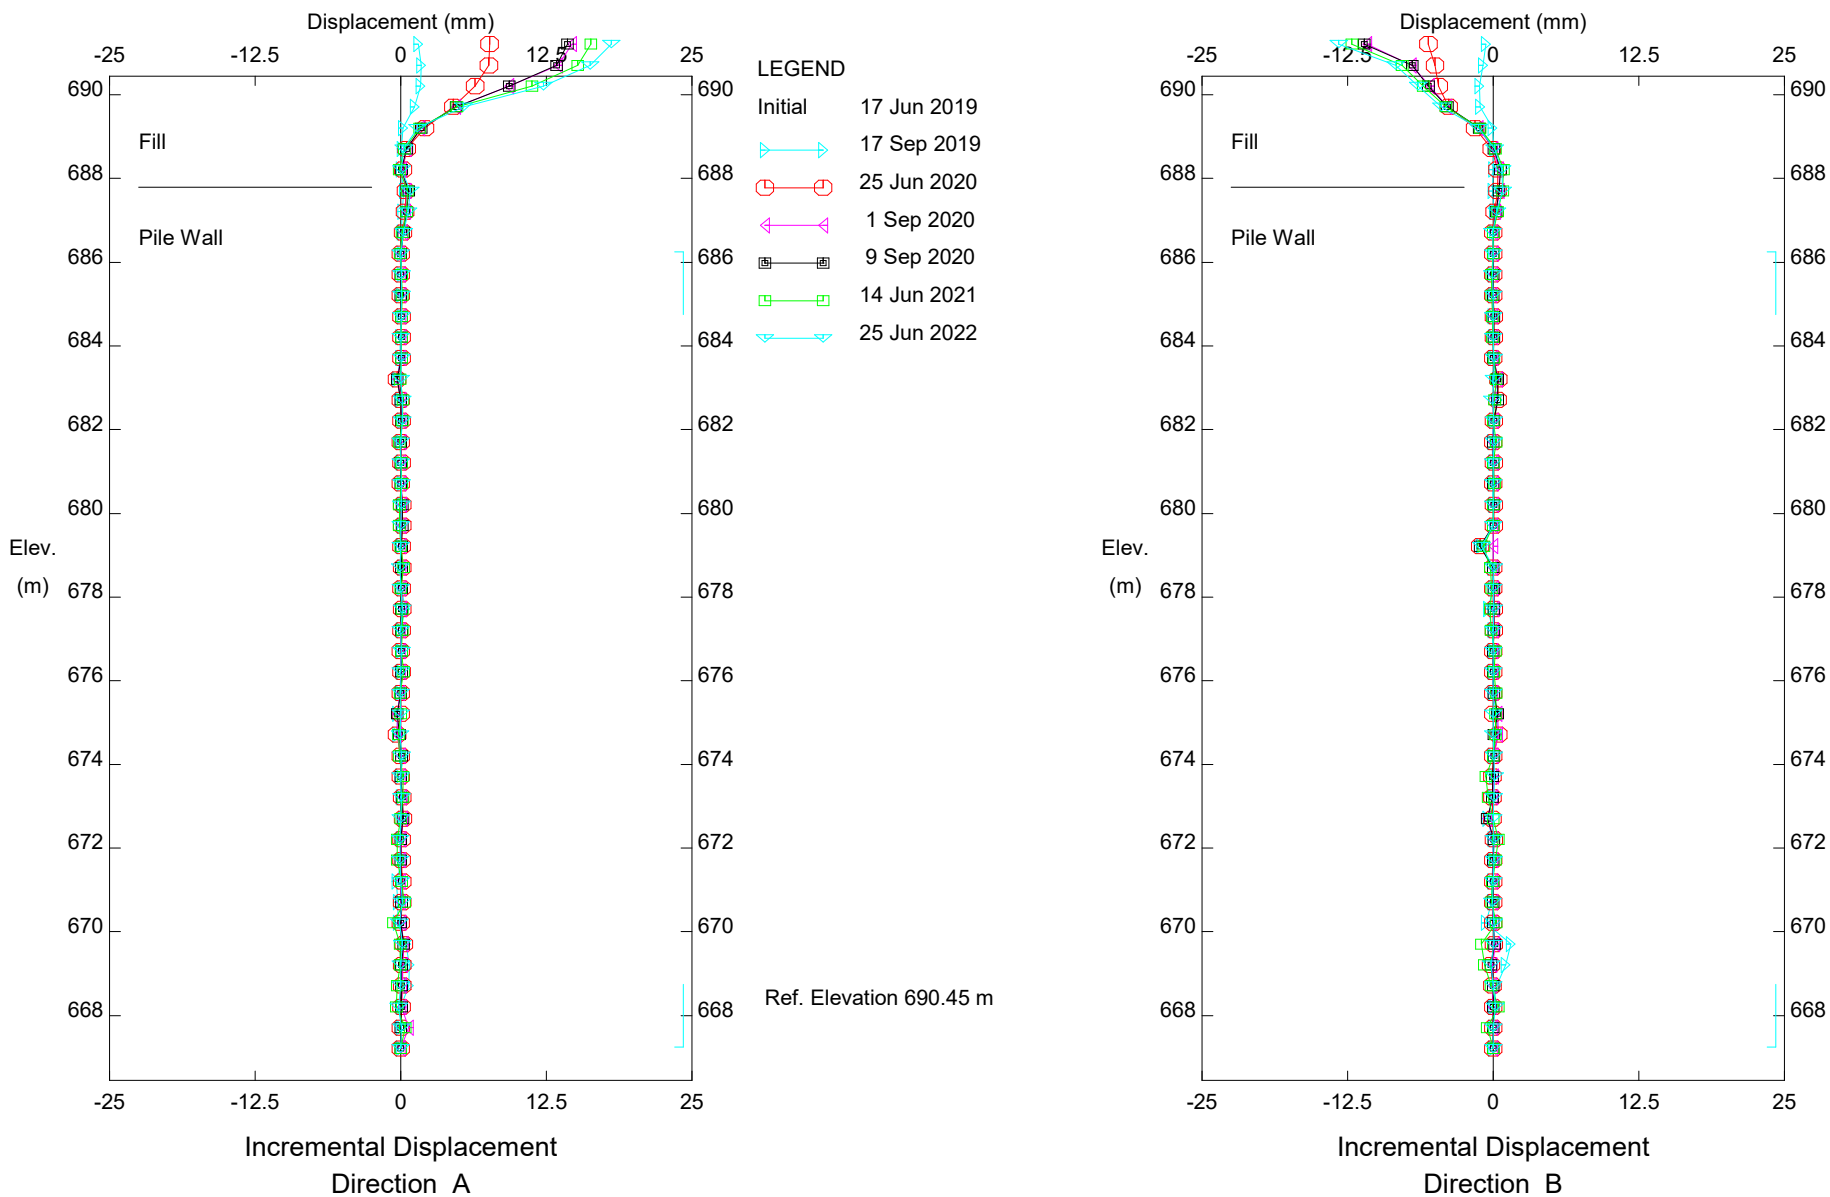
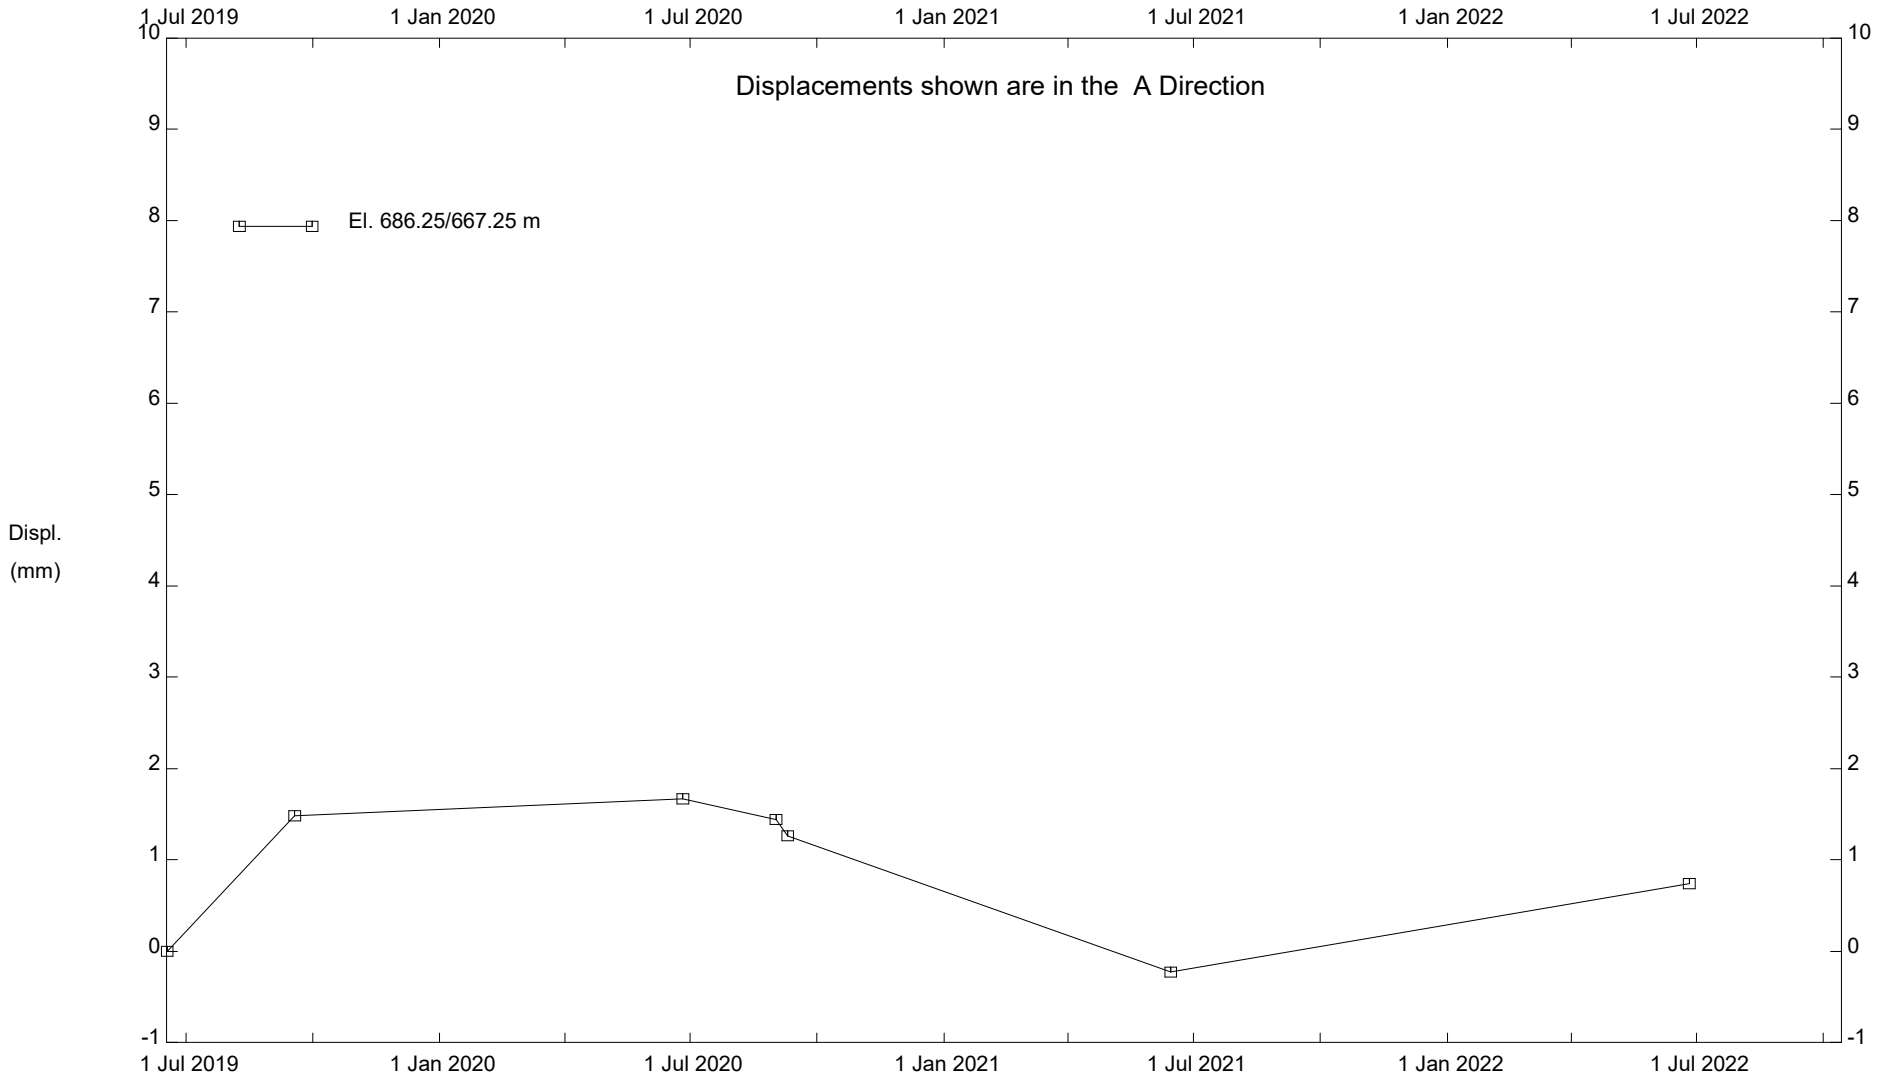
C074; H27:10, Morrin Bridge, Inclinometer SI-P11

It also noted that the casing for SI-P11 was extended and then repaired by KCB in June 2019, and the casing for SI-P06 was damaged between the September 2019 and June 2020 readings, then cut off (not by KCB) between the June and September 2020 readings.

The data obtained from the pile-wall SIs indicates the top of the pile wall deflected approximately 16 mm to 26 mm between June 2018 (installation) and January 2019 (the last reading obtained by the previous consultant), and up to approximately 6 mm since June 2019 (the first reading obtained by the KCB). Most of the deflection occurred between June 2018 and August 2018 when (or just after) fill was being placed on the east abutment.

The maximum rate of movement recorded in the X-direction of the pile-wall SIs was between approximately 128 mm/year and 229 mm/year. This maximum rate of movement was recorded between July and August 2018 during fill placement on the east abutment. The rate of movement has since decreased and is now less than 1 mm/year. Additional displacement of the pile wall may occur in response to periods of heavy or prolonged rainfall, resulting in higher groundwater conditions or river levels.

Since distributed movement is being recorded in SI-P01, SI-P06, and SI-P11 to the bottom of the SI casing and the depth to the design failure surface is unknown, KCB cannot conclude if the pile wall has intercepted the failure surface and whether loads are being transferred to depths below the failure surface as the piles stabilize the sliding mass.

The design engineer for the pile wall should review the data in this report to assess if the pile wall is performing adequately.
