SITE NUMBER AND NAME: NC111 – Hwy 16 Pembina River Bridge Erosion (BF75014)	HIGHWAY AND KM: 16:10, km 28.44	PREVIOUS INSPECTION: June 13, 2024	CURRENT INSPECTION: May 20, 2025
LEGAL DESCRIPTION: SW-20-53-7-W5	NAD83 COORDINATES: UTM11U 5939985 N, 632165 E		RISK ASSESSMENT: PF: 13 CF: 8 Total: 104
AVERAGE ANNUAL DAILY TRAFFIC (AADT): 7,800 (2024)		CONTRACTOR MAINTENANCE AREA (CMA): 508 / 509

2025 Site Inspection Photos at NC111

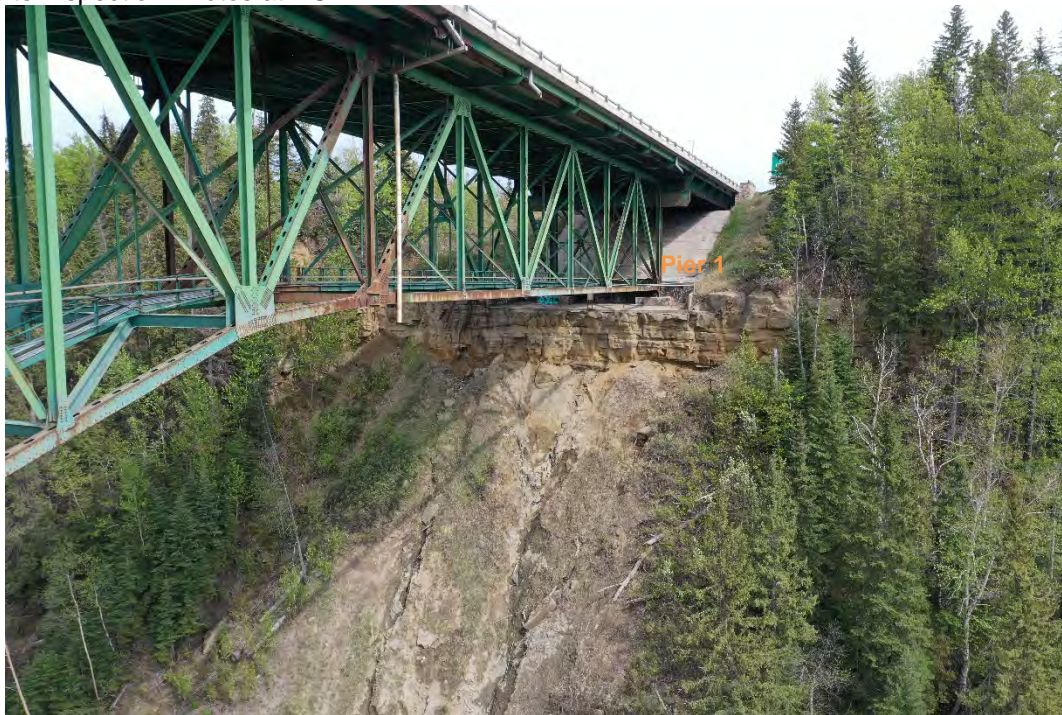
- Erosion is present along the east riverbank (Photos 1 to 4, 9 & 10).
 - A deep gully is present at the top of the bank, south from Pier 1. This gully is very close to existing power/telephone poles. The gully appears generally unchanged from the 2024 inspection.

- The sandstone outcrop was observed to be horizontally bedded and had near vertical joints closely parallel to the valley sides, which result in rockfall and further loosened slabs of rock potentially in unstable conditions below the abutment and potentially undermining the abutment (Photos 1, 2 & 3).

Photo 1: Gullies downslope of east abutment, facing north.

- Repair of the erosion gullies under and adjacent to the bridge abutments. The loose material and debris may be excavated, and the area should be backfilled with compacted engineered fill. Given the inclination of the abutments, steep slope safety measures will be required. The high-level cost for repairing the erosion gullies is between \$350,000 and \$650,000, excluding engineering costs.

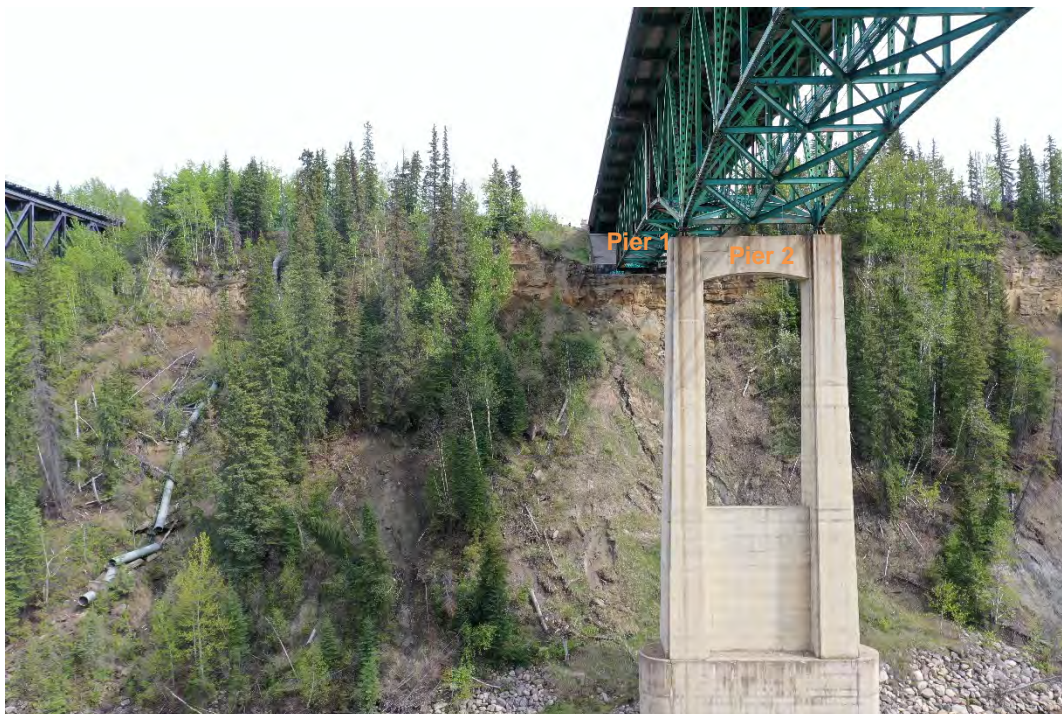
Photo 2: Gullies downslope of east abutment and broken culvert north of east embankment. Facing southeast.

- Construction of a new stormwater discharge system on both abutments. Alternatives may comprise an above-ground CSP or HDPE pipe supported on a steel truss resting on footing, or reinforced concrete outfalls, or a system of long reinforced concrete drainage ditches descending the riverbank. The high-level cost for construction of a new stormwater discharge system is between \$1,000,000 and \$1,600,000, not including engineering and depending on the selected design.

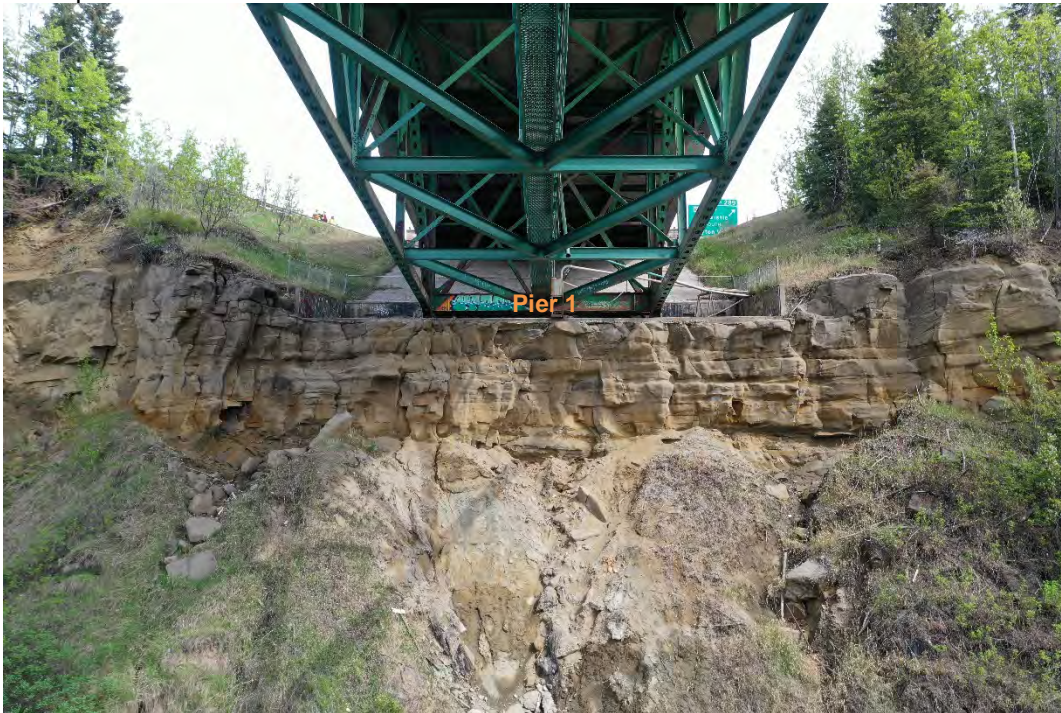
- Sandstone blocks fallen from the outcrop were observed between Piers 1 and 2 (Photo 3). The number of blocks on the slope appears similar to observations during the 2024 inspection.

Photo 3: Sandstone outcrop and gullies downslope of east abutment, facing southeast.

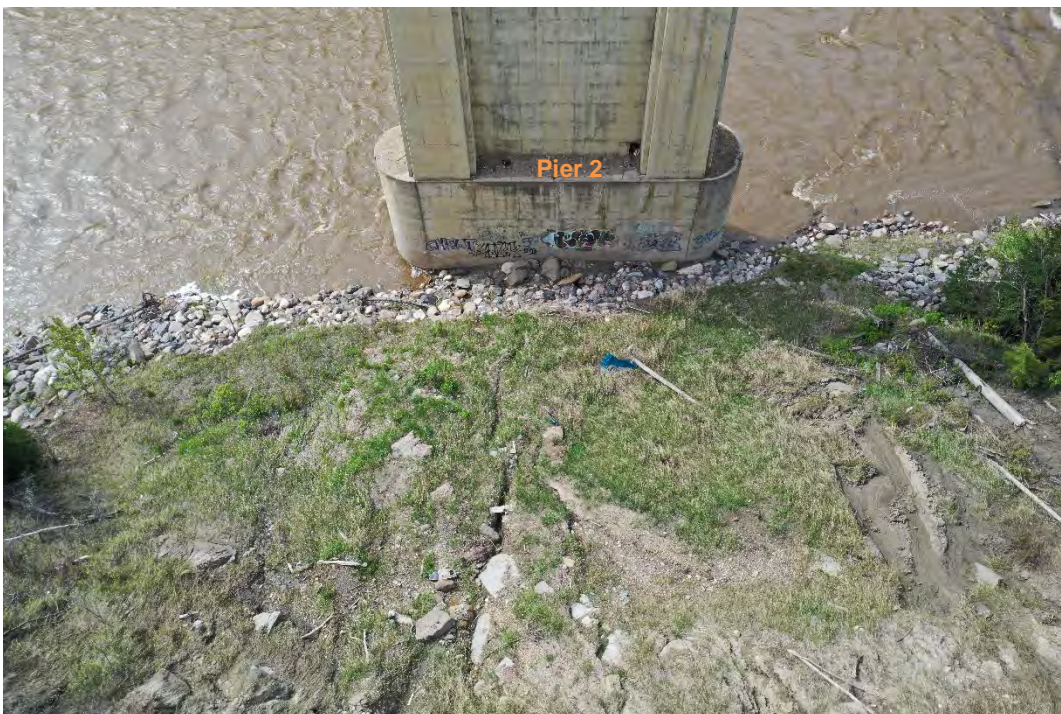
- The pier within the river on the east side (Pier 2) does not appear to be affected by the erosion. Some sediment and rocks are collecting against the east side of the pier (Photo 4).

Photo 4: Lower portion of east riverbank near Pier 2. Looking northwest.

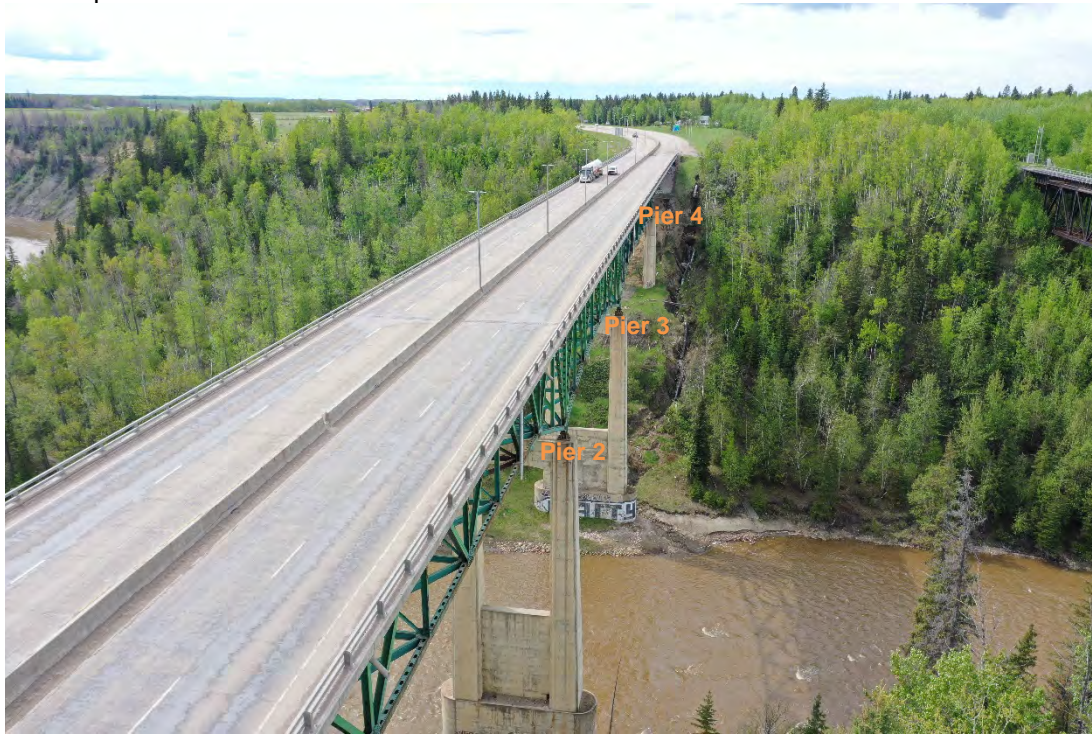
- The separated culvert down the west riverbank, on the north side of the abutment, appears to be in similar condition as observed previously in 2024 (Photos 5 & 6). The erosion gully that has resulted from the water exiting the top piece of culvert appeared to be relatively unchanged, with a depth up to around 4 m and width up to around 8 m near the headslope. This gully continues down to the river, where it runs along the side of Pier 3 (Photo 7).

Photo 5: Overview of west slope and bridge surface, facing west.

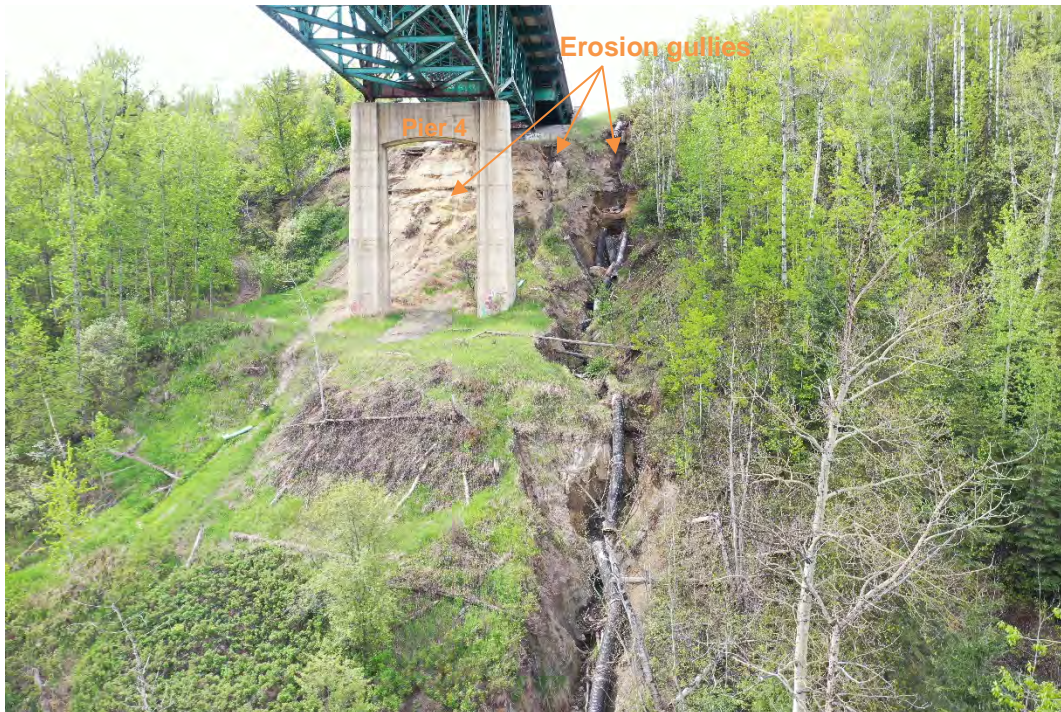
- A second erosion gully is roughly parallel to the gully that resulted from the culvert, and extends below the north corner of Pier 5 to approximately 5 m upslope from Pier 4 (Photo 6). The maximum size of the second gully on the west abutment is about 2.5 m deep and 6 m wide. Geotextiles can be seen in this erosion gully.

- The sandstone outcrop below the west abutment shows erosion and gullying, which continues down along the south side of the piers (Photo 6). These gullies begin at the abutment where they are beginning to undermine the concrete (Photo 8).

- Sandstone rock blocks fallen from the outcrop were observed between Piers 4 and 5 (Photos 6 & 8).
- No anchors were observed on the west abutment.

Photo 6: Broken culvert and gully on the north side of the west abutment. Looking northwest.

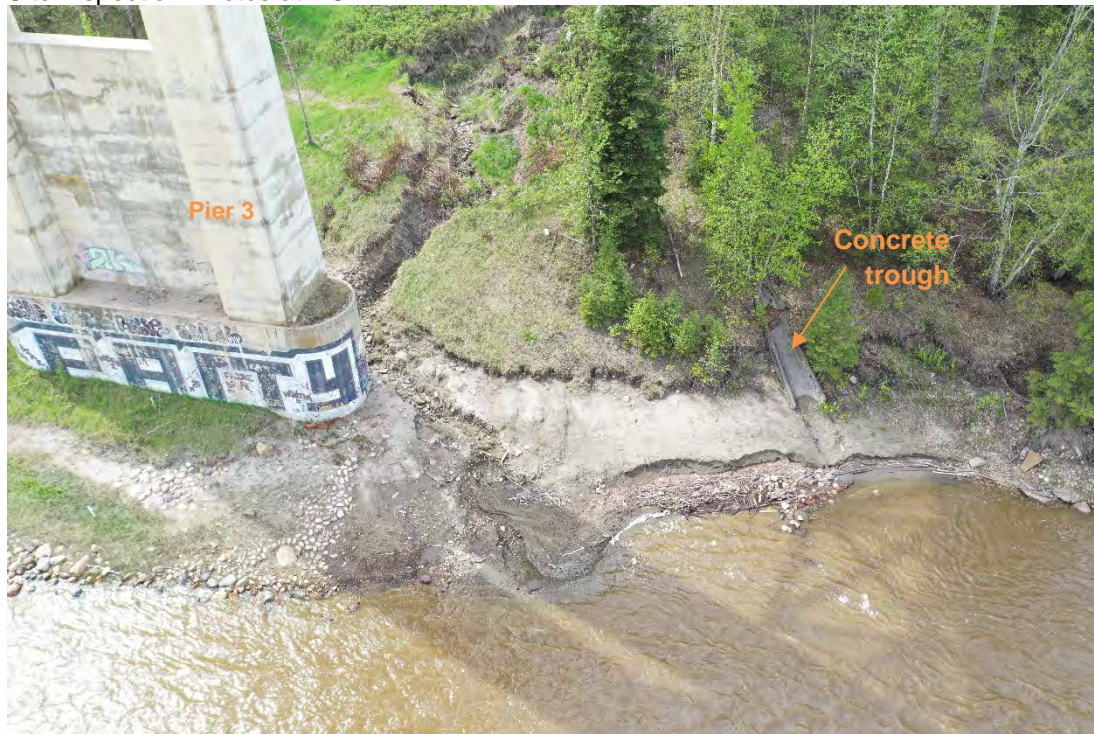
Photo 7: Erosion gully next to west pier at river level, facing west.

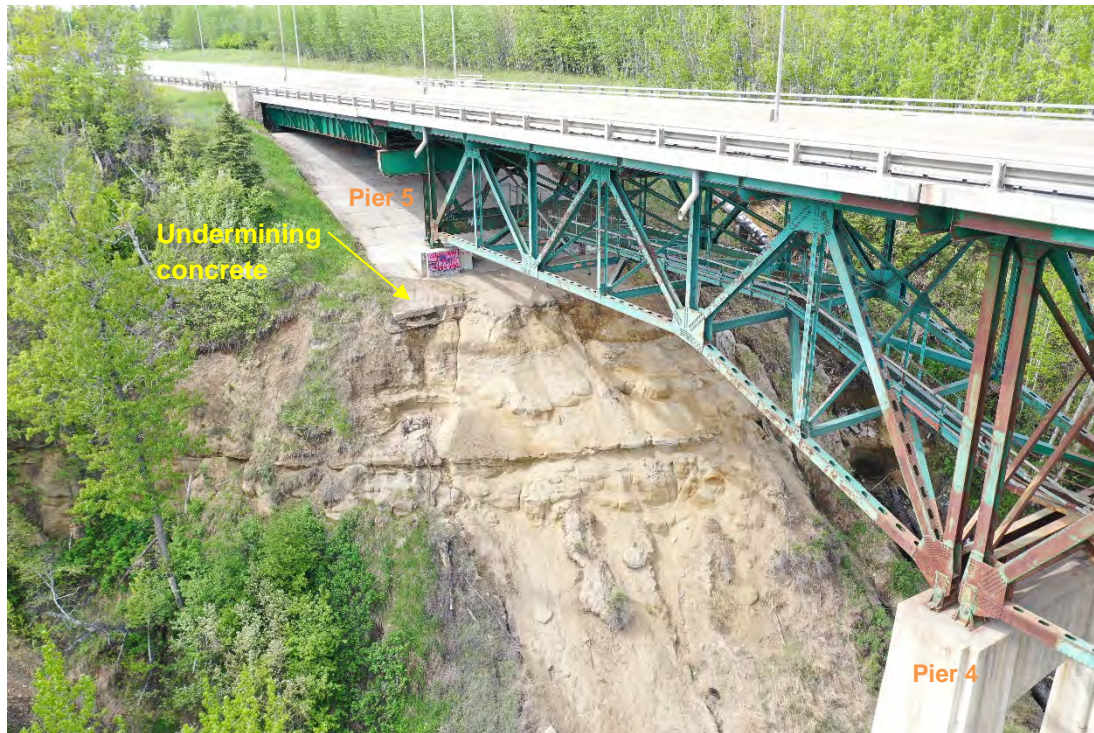
Photo 8: West abutment and riverbank, facing northwest.

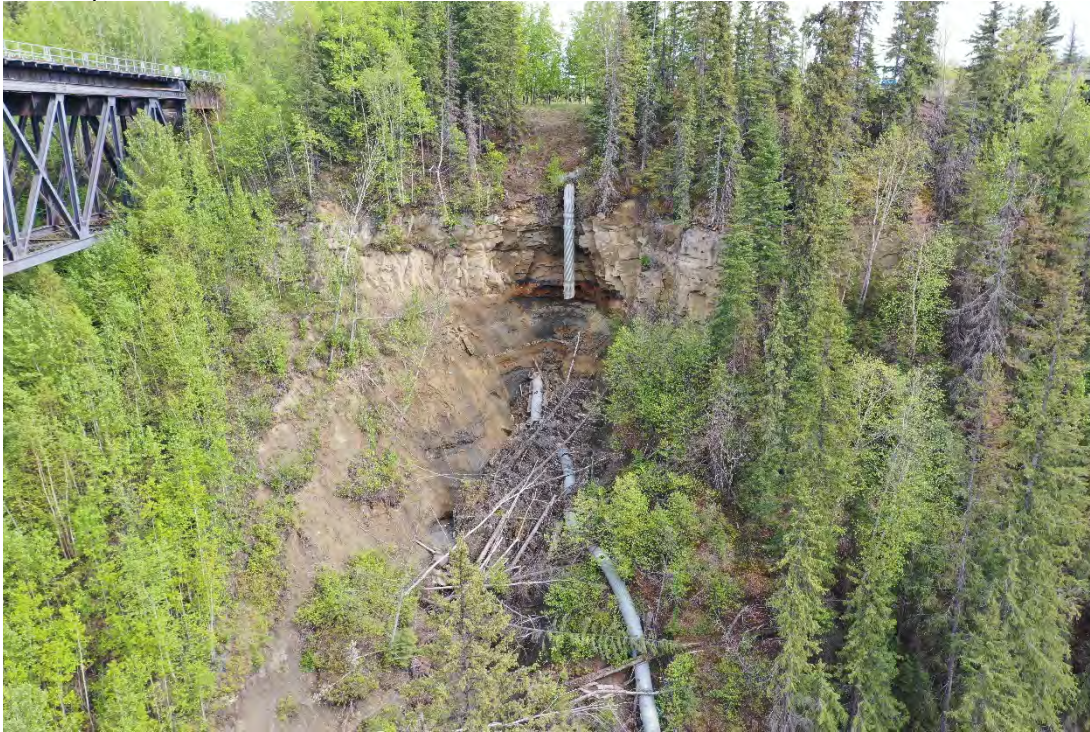
Photo 9: Broken culvert north from the east bridge abutment. Facing southeast.

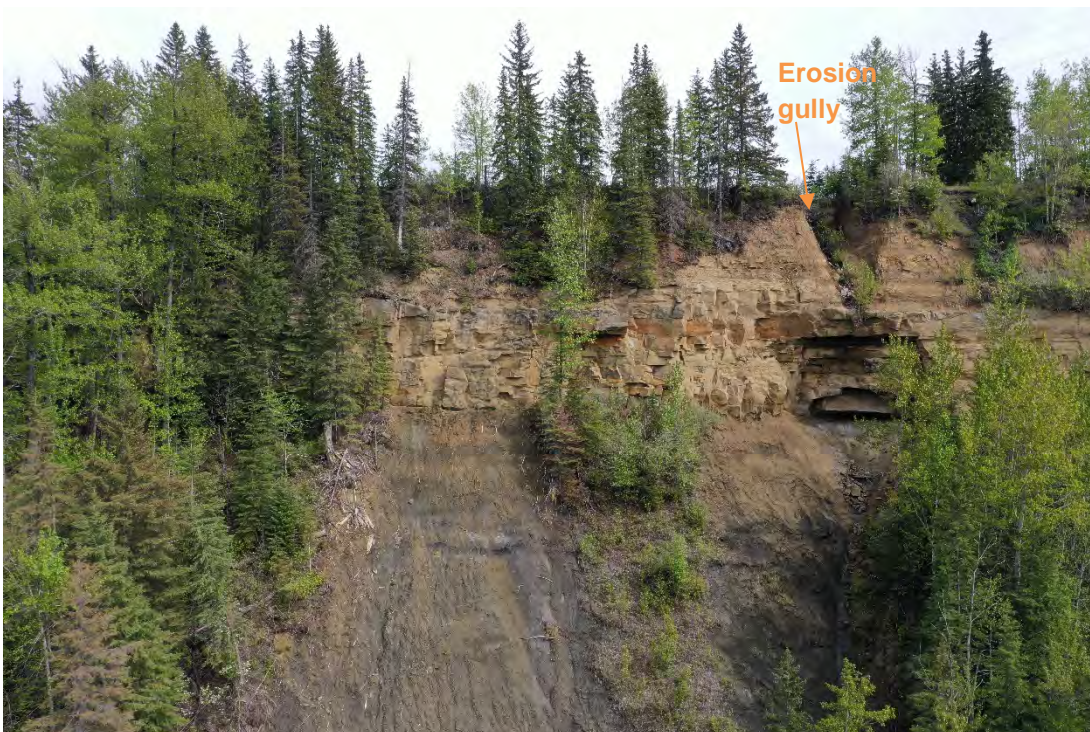
Photo 10: Erosion of east bank, south from east abutment. Facing southeast.

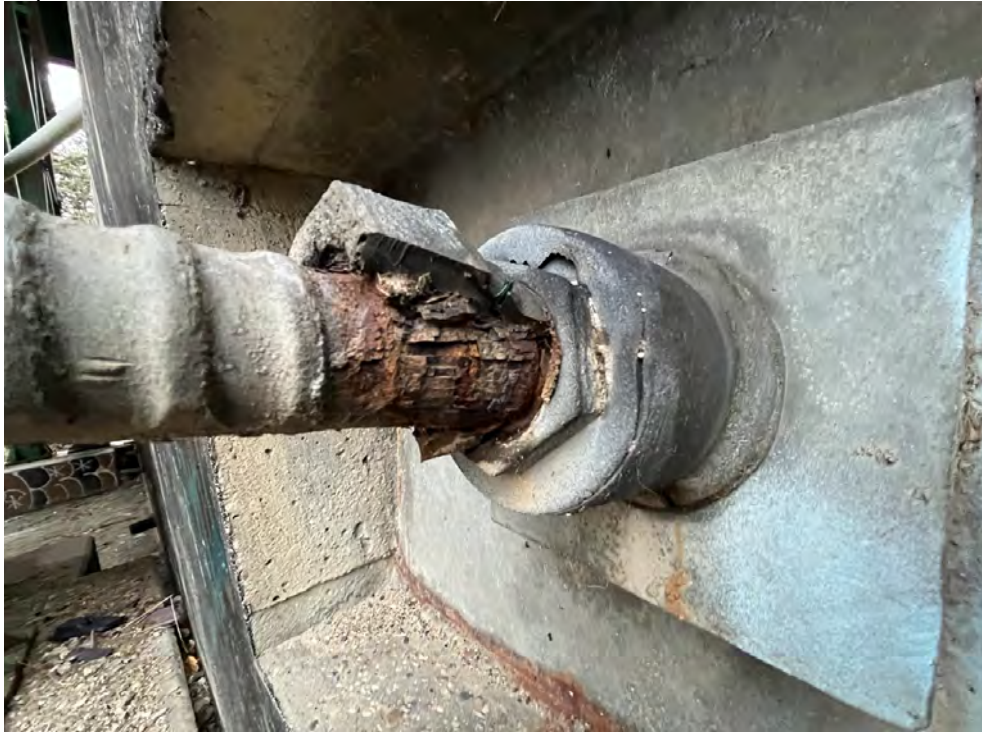
- The bridge was visited by Stantec's bridge team on November 14, 2024, where it was noted that the soil anchors on the east abutment were corroded, possibly impacting the stability of the retaining wall under the bridge (Photo 11).

- The anchors on the east abutment were inspected further on July 23, 2025 by Stantec and a contractor specializing in anchors. A total of 14 anchors were observed, with all showing wear and tear. Two of the 14 anchors have significant rust, however the metal still appears to be competent.

Photo 11: Corroded soil anchor on east abutment. Photo taken by Stantec bridge team, November 14, 2024.

- Repair/maintenance of the 14 corroded soil anchors on the east abutment. The high-level cost for a specialty subcontractor to mobilize to site, remove and install new grease caps, clean and remove the rust, and apply a spray-on galvanizing paint for corrosion protection is approximately \$15,000, excluding engineering costs.
