SITE NUMBER AND NAME: NC031 – Deer Lodge	HIGHWAY AND KM: 22:32, km 28.857	PREVIOUS INSPECTION: May 31, 2023	CURRENT INSPECTION: May 22, 2025
LEGAL DESCRIPTION: SE 20-56-08-W5M	NAD83 COORDINATES: UTM11U 5968389N, 622217E		RISK ASSESSMENT: PF: 3 CF: 5 Total: 15
AVERAGE ANNUAL DAILY TRAFFIC (AADT): 1,370 (2024)		CONTRACTOR MAINTENANCE AREA (CMA): 509

TRANSPORTATION AND ECONOMIC CORRIDORS
GEOHAZARD MONITORING PROGRAM
NC31 HWY 22-32
SITE PLAN

2025 Site Inspection Photos at NC031

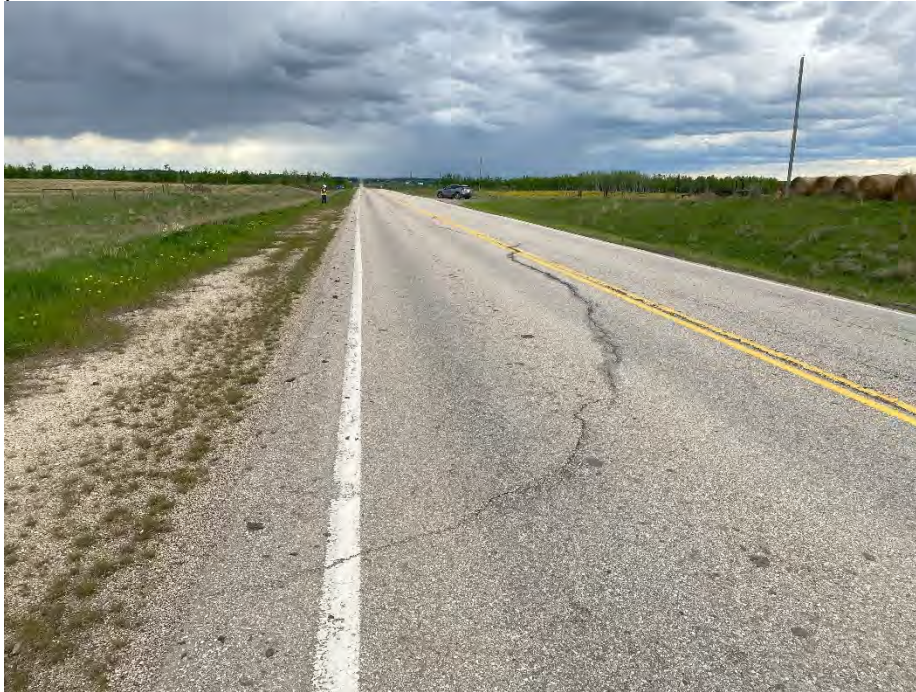
COMMENTS
<ul style="list-style-type: none"> The site appears similar to the previous inspection. <ul style="list-style-type: none"> A semi-circular pavement crack was observed north of SI-1R. A slight dip of about 5 mm to 10 mm towards the west was observed since 2020. The crack is mostly contained within the SBL with a small section (about 1 m to 2 m long) that encroaches into the northbound lane (NBL) by about 0.3 m (Photos 1 to 3). Longitudinal cracking observed on both lanes in front of the farm access at the north limits of the site (Photo 4). These new cracks do not appear to be related to landslide activity. A longitudinal crack and a transverse crack have formed within the pavement at the south end of the site, in the NBL. These cracks do not appear to be related to landslide activity. The culvert was flowing during the current inspection, with ponded water at the outlet (Photo 5). The invert at the outlet appears to be graded backwards. As previously observed, a sag exists about one-quarter to one-third of the way in from the outlet, approximately below the west highway edge. The culvert inlet appeared to be in similar condition to previous inspections, with water actively flowing into the culvert from a stream (Photo 6).

Photo 1: South limits of semi-circular crack. Looking north.

- Pavement cracks should be sealed to reduce surface water infiltration into the embankment.
- Both SIs are inoperable, therefore replacement slope inclinometers could be considered to monitor the site.
- This site could be removed from the GRMP, with site visits completed only as needed.

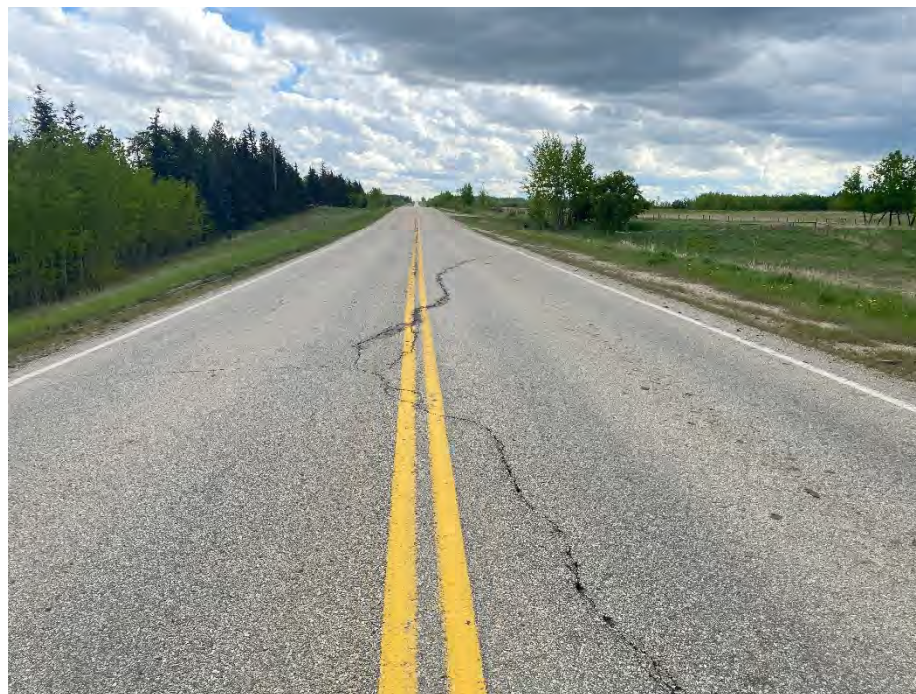
Photo 2: Approximately midway of semi-circular crack near SI-1R. Looking south.

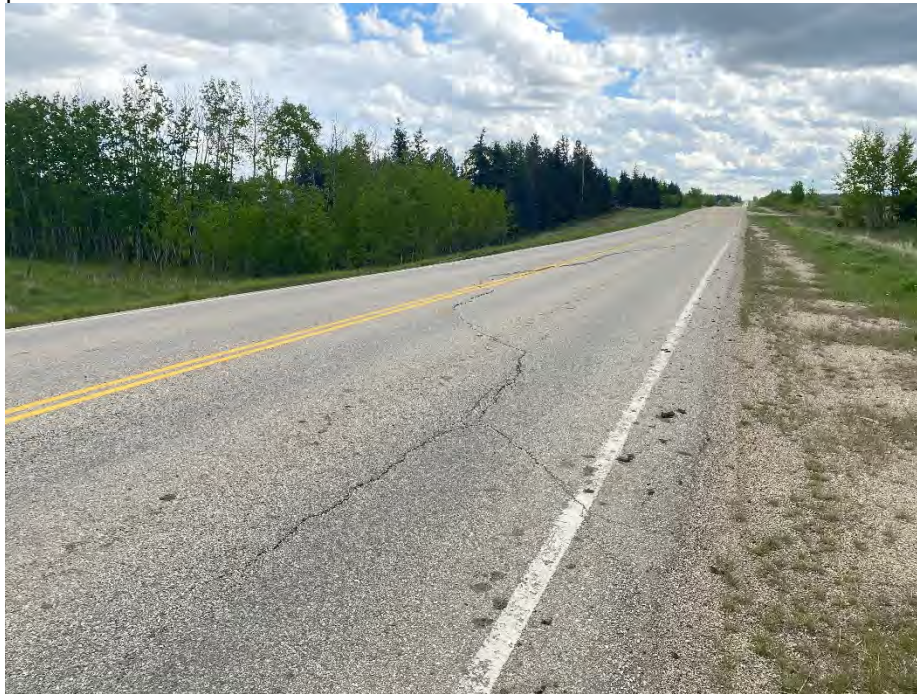
Photo 3: North limits of semi-circular crack. Looking southeast.

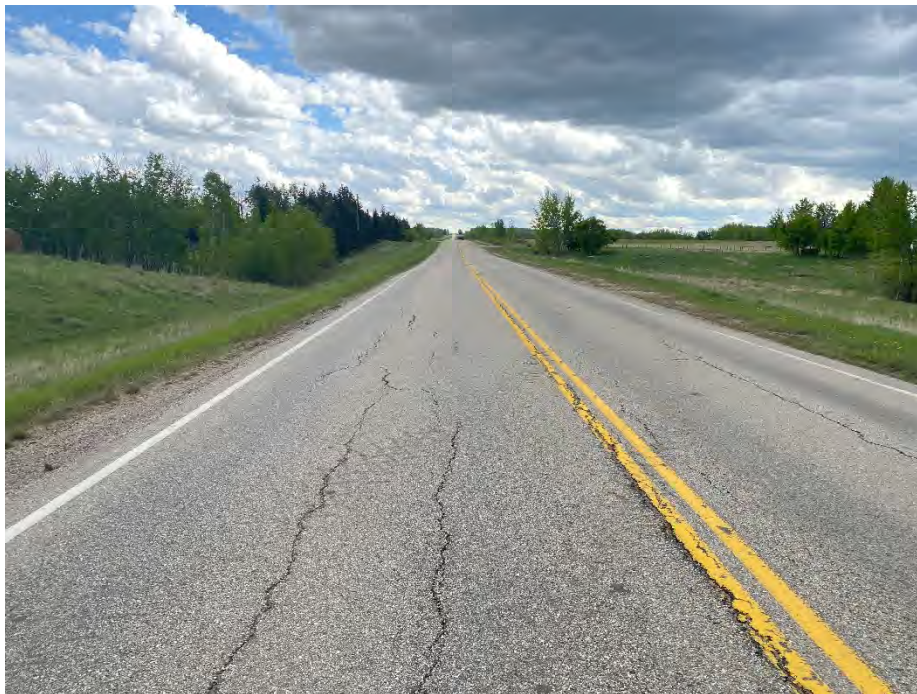
Photo 4: Longitudinal cracks in front of farm access at north limits of site. Looking south.

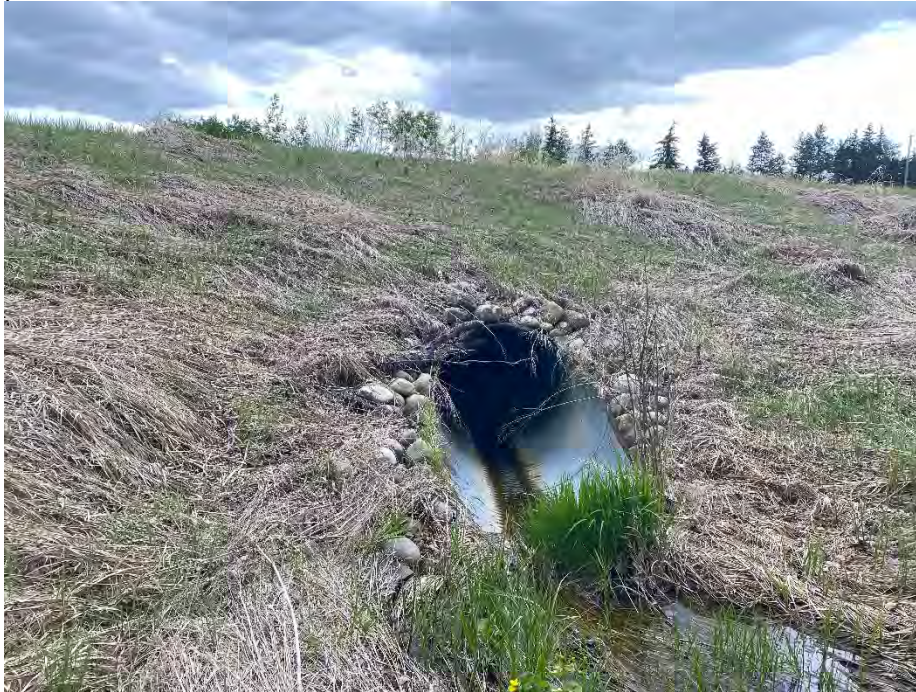
Photo 5: Culvert outlet. Looking southeast.

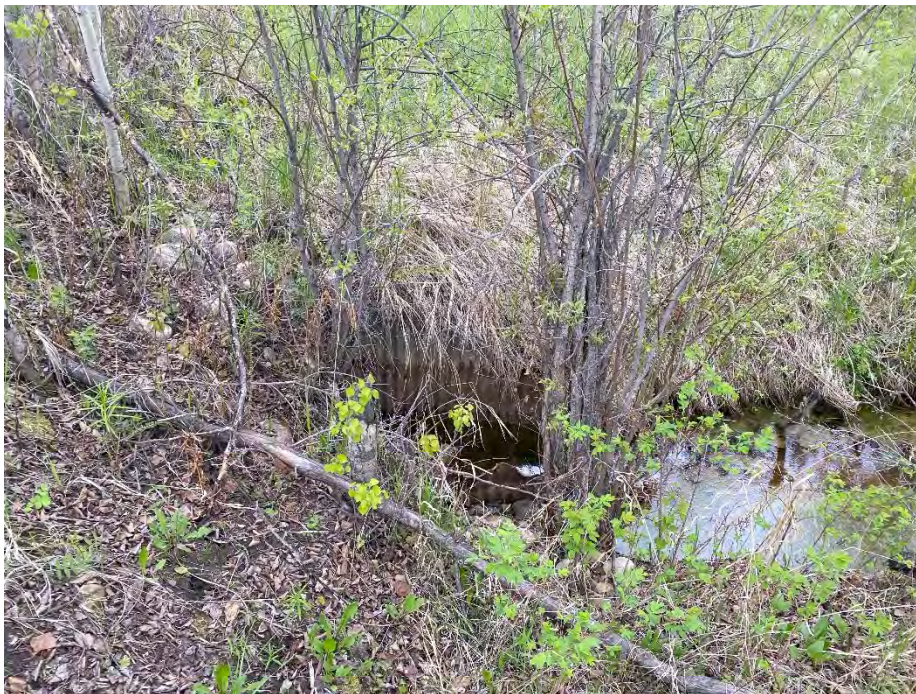
Photo 6: Culvert inlet. Looking northeast.
