SITE NUMBER AND NAME: NC050 – Gregg River Slide	HIGHWAY AND KM: 40:28, km 11.752	PREVIOUS INSPECTION: May 30, 2023	CURRENT INSPECTION: May 23, 2025
LEGAL DESCRIPTION: NW-33-47-24-W5	NAD83 COORDINATES: UTM11U 5883282N, 469320E		RISK ASSESSMENT: PF: 3 CF: 4 Total: 12
AVERAGE ANNUAL DAILY TRAFFIC (AADT): 340 (2024)		CONTRACTOR MAINTENANCE AREA (CMA): 508

TRANSPORTATION AND ECONOMIC CORRIDORS
GEOHAZARD MONITORING PROGRAM
NC50 GREGG RIVER SLIDE
PILE WALL SITE PLAN

2025 Site Inspection Photos at NC050

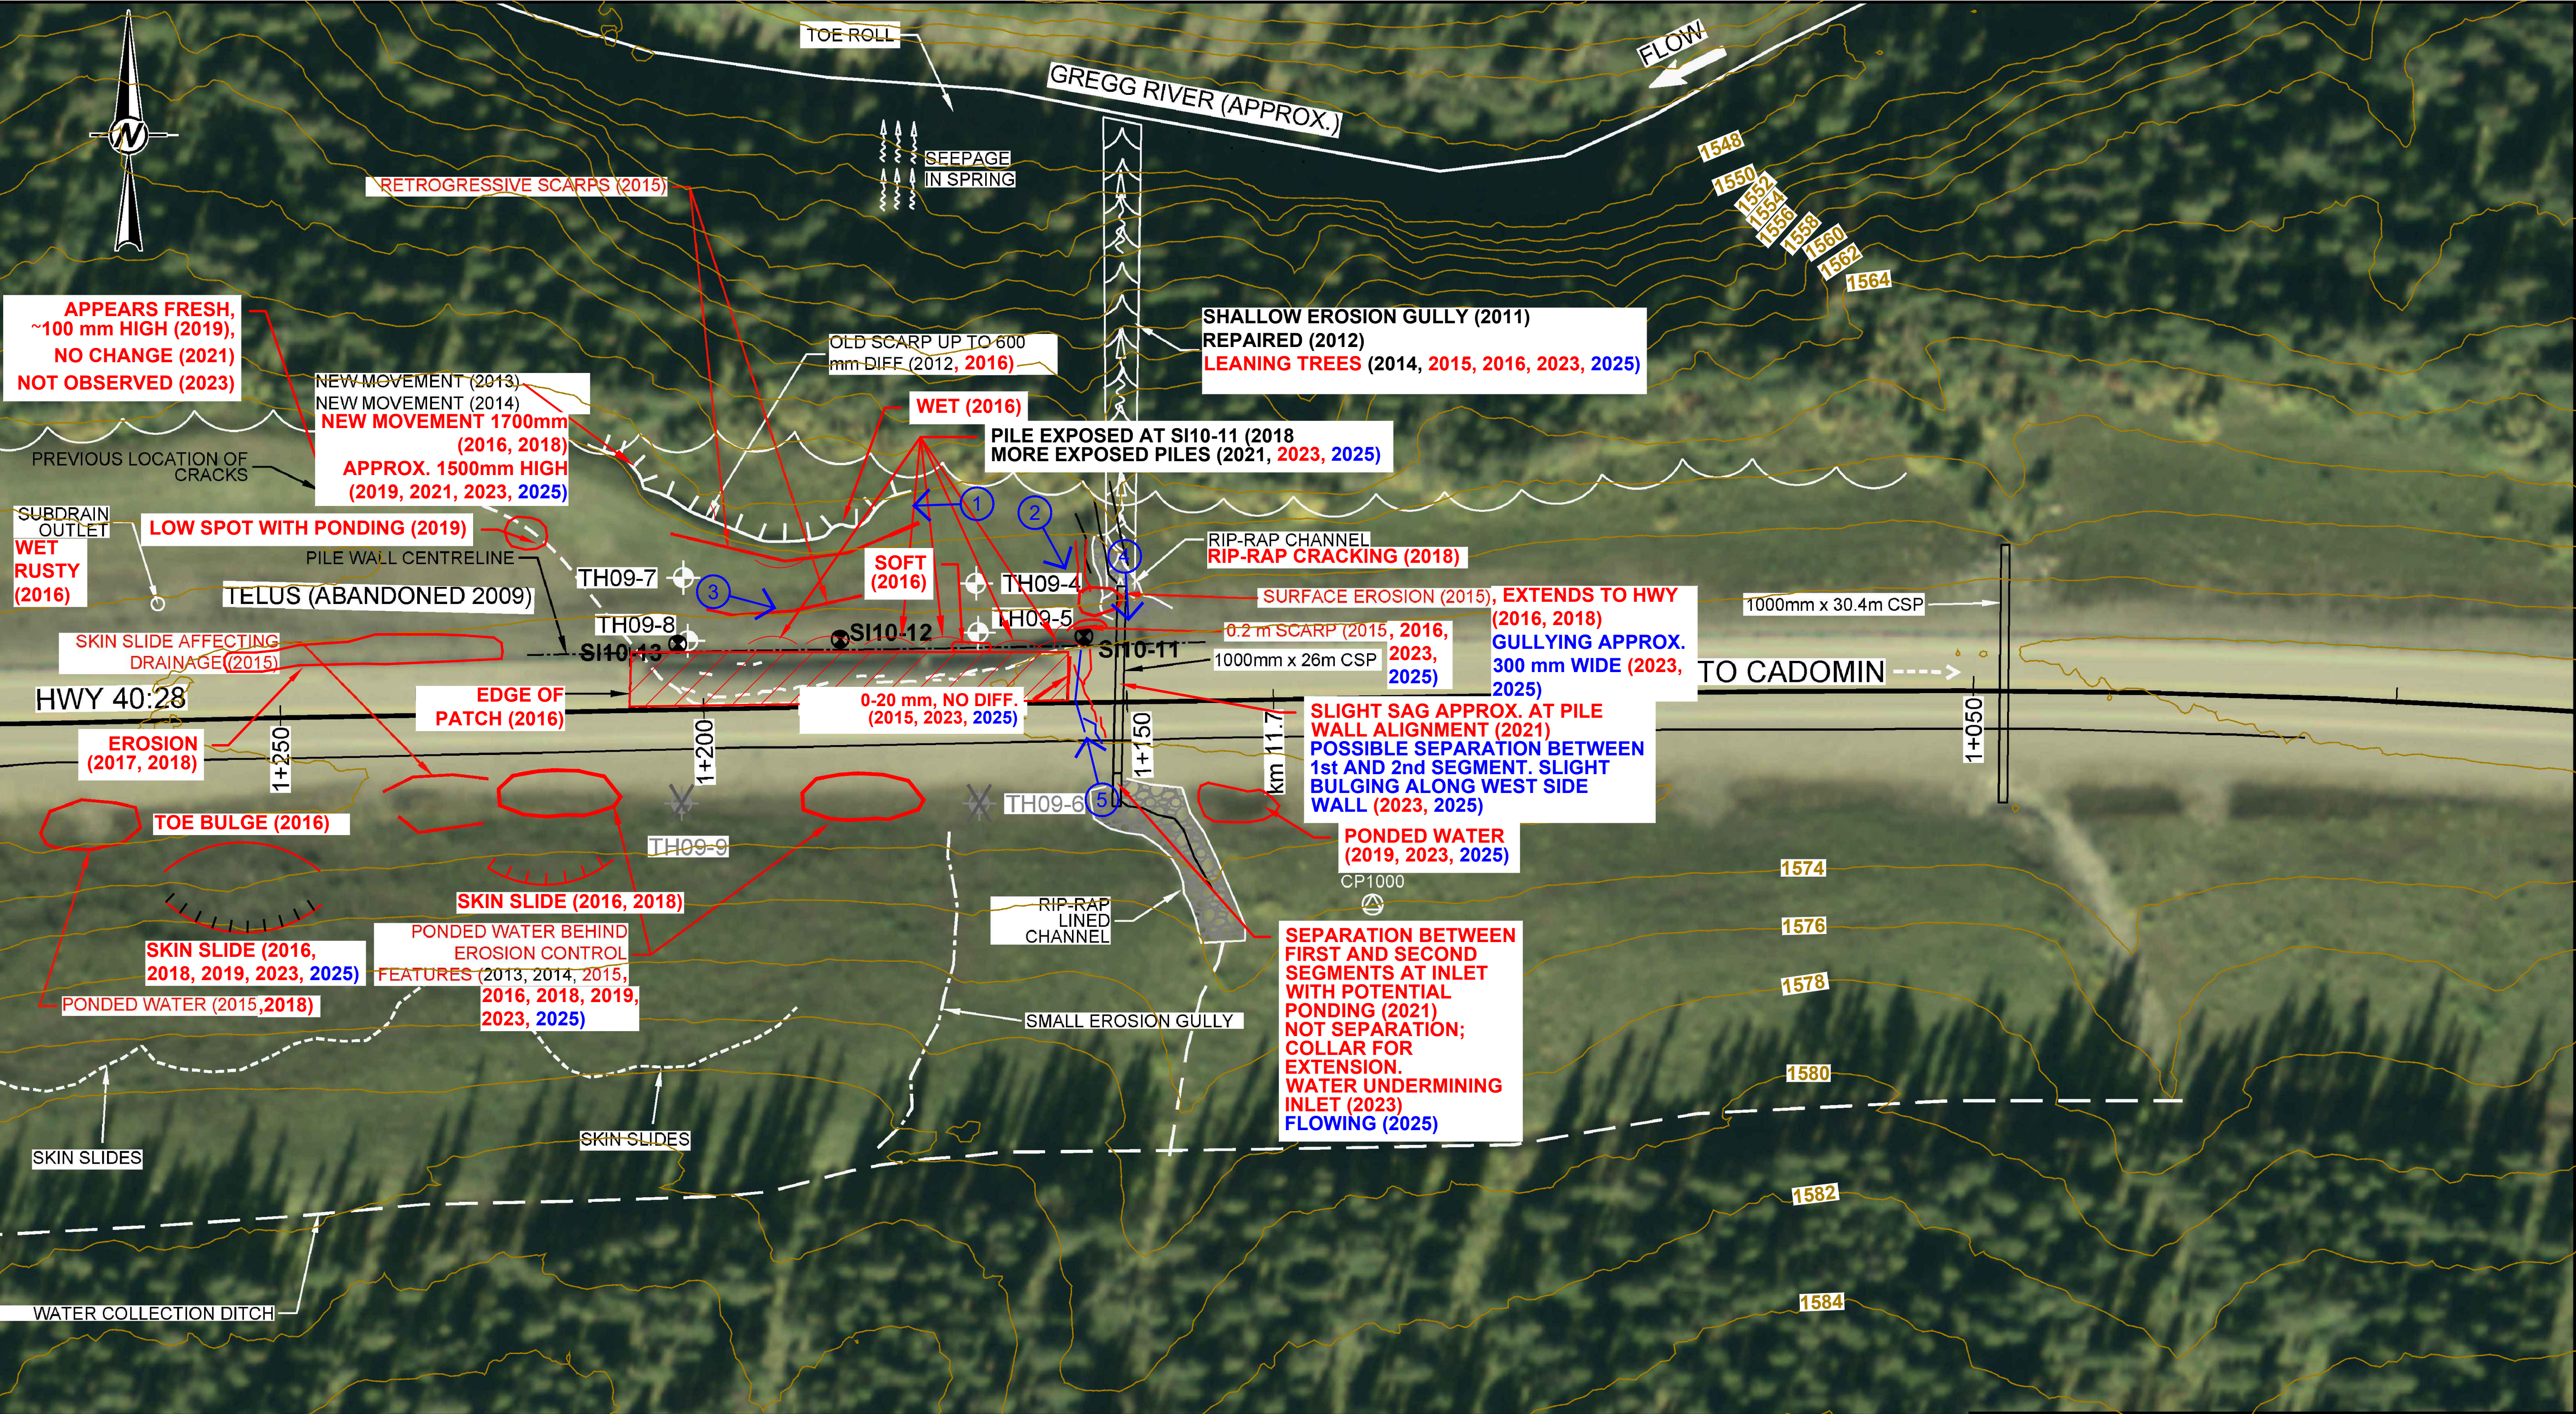
FIGURE 1

COMMENTS
<ul style="list-style-type: none"> The <u>pile wall site</u> had little change from the previous site visit in 2023 (Figure 1). Observations include: <ul style="list-style-type: none"> An old retrogressive scarp downslope from the pile wall, about 1.5 m high (Photo 1). The erosion gully previously noted along the south ditch shoulder to the west of the C/L culvert remains approximately 300 mm wide (Photo 2).

- The concrete piles are slightly exposed at ground surface. The number of piles effected and the amount of the concrete piles exposed along the downslope side appears similar to observations in 2023 (Photo 3).

- SI10-11 to SI10-13 were installed in the concrete piles. Monitoring results of the remaining operational SIs (SI10-11 and SI10-12) suggest the pile wall is performing well with little to no deflection in the piles. Total cumulative movement ranges from -1 mm to 1 mm since 2010.

- The C/L culvert at the pile wall site had a slight bulge along the west side wall near the outlet approximately in line with the pile wall location (Photo 4). The first and second segment at the inlet was previously thought to be separated, but it was confirmed by TEC that this is a collar for an extension. It is possible from previous site observations that water is ponding or infiltrating the ground at the collar. The culvert had approximately 25 mm of water in the bottom during the site visit.

- Transverse pavement cracking was observed a few meters west of the C/L culvert at the pile wall site. The cracks appeared relatively unchanged from the last inspection (Photo 5).

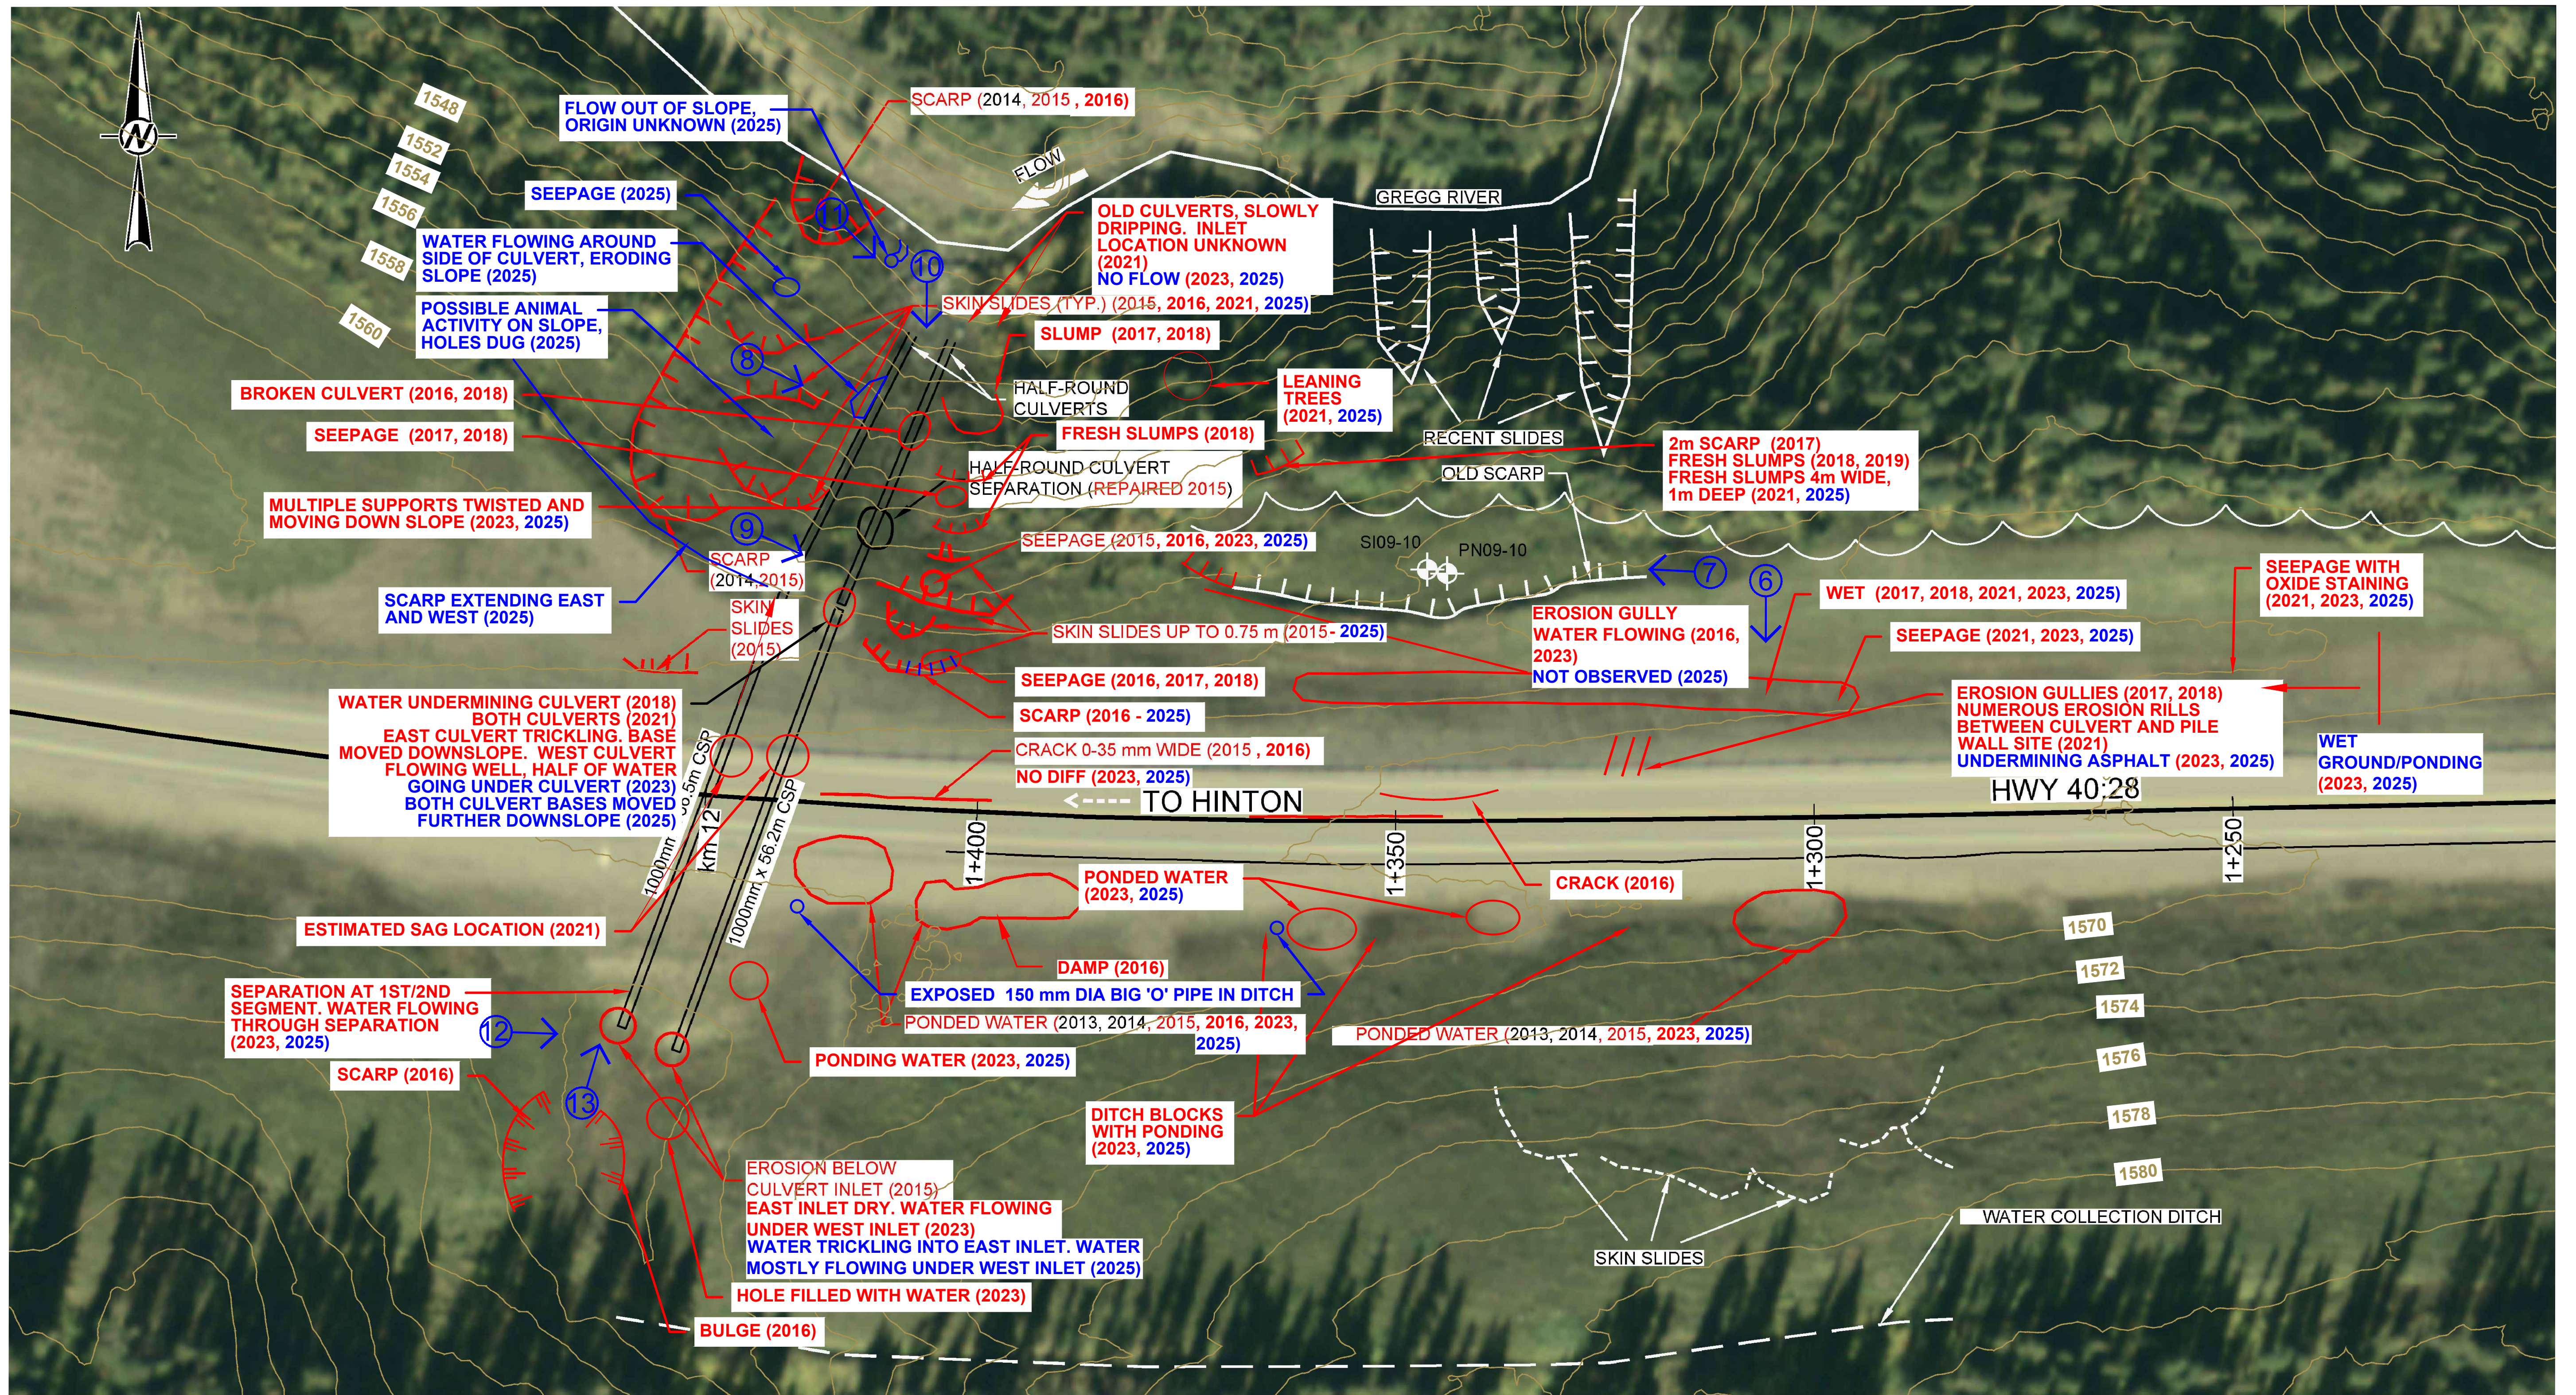
FIGURE - 2

- The old scarp to the east of the culvert site appears unchanged (Photo 7).
- The skin slides on the highway backslope were well vegetated.
- The culvert site had some noticeable change since the previous inspection (Figure 2).

- There was no apparent change to pavement cracking upslope from the skin slides.
 - The skin slides appeared unchanged on the slope east of the culverts with changes more apparent on the west slope. Possible animal activity was observed on the west slope, with small areas of exposed soils (Photo 8).

- Seepage was observed on the slope west of the half-round culverts, within the skin slides.
 - The west culvert had heavier flow down to the creek while the east culvert was trickling (Photo 10).

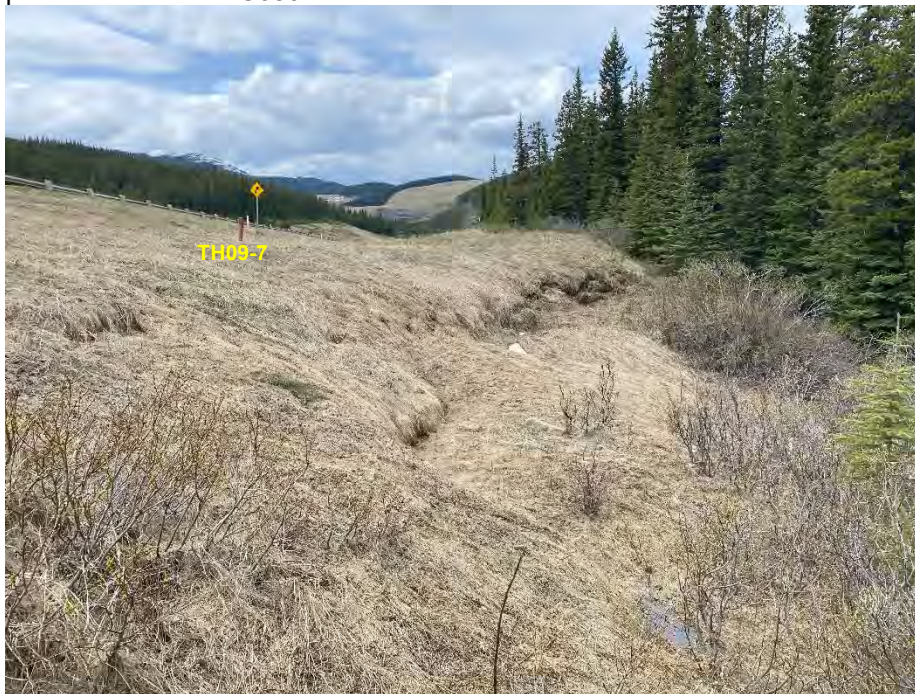
Photo 1: Retrogressive scarp on the north side of the pile wall, looking west.

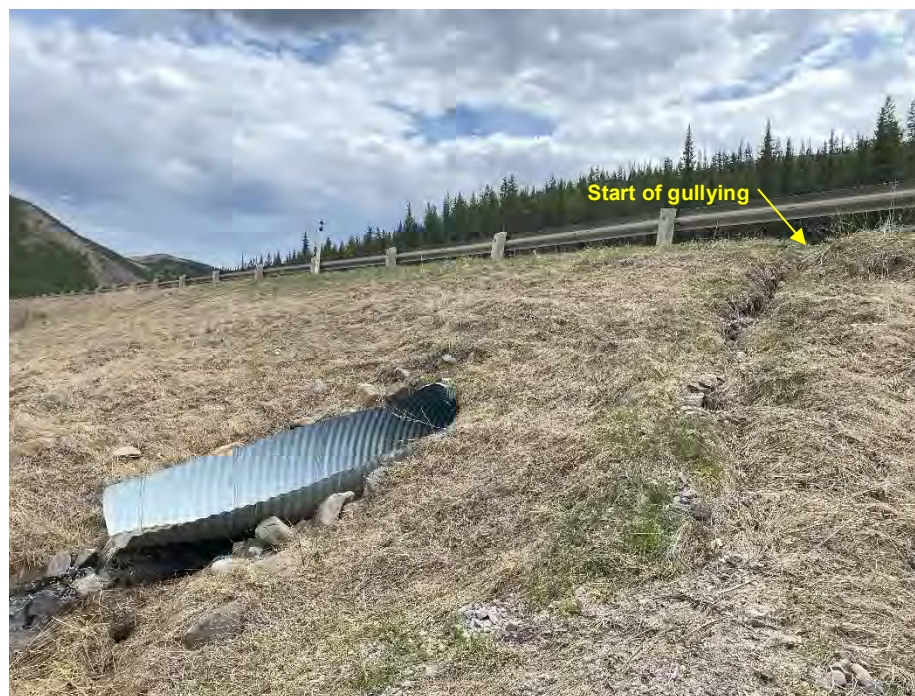
Photo 2: Gully on north side of the highway and undermining of C/L culvert outlet. Looking southeast.

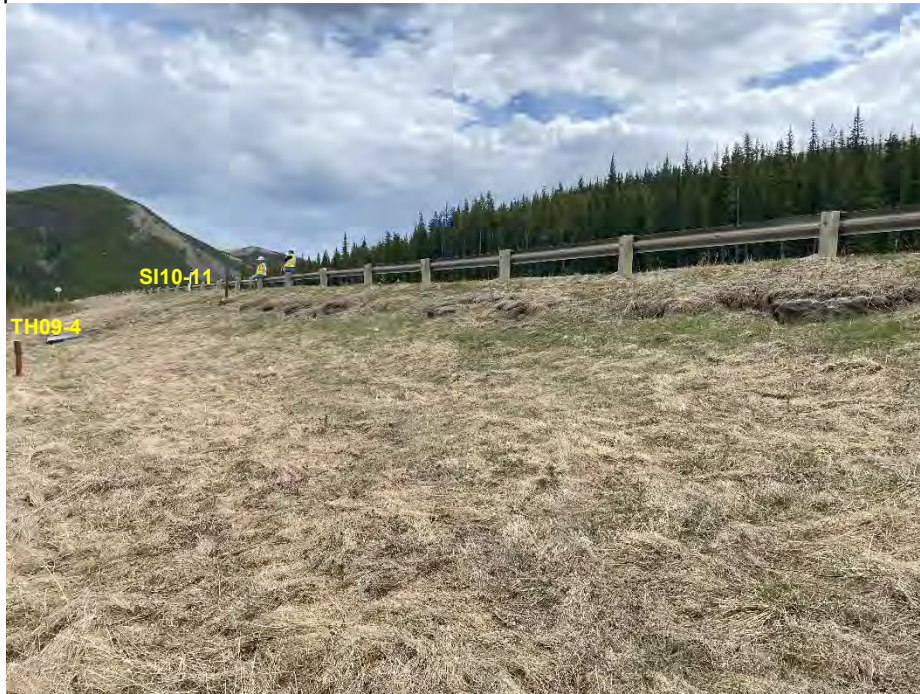
Photo 3: Exposed tops of concrete piles. Looking southeast.

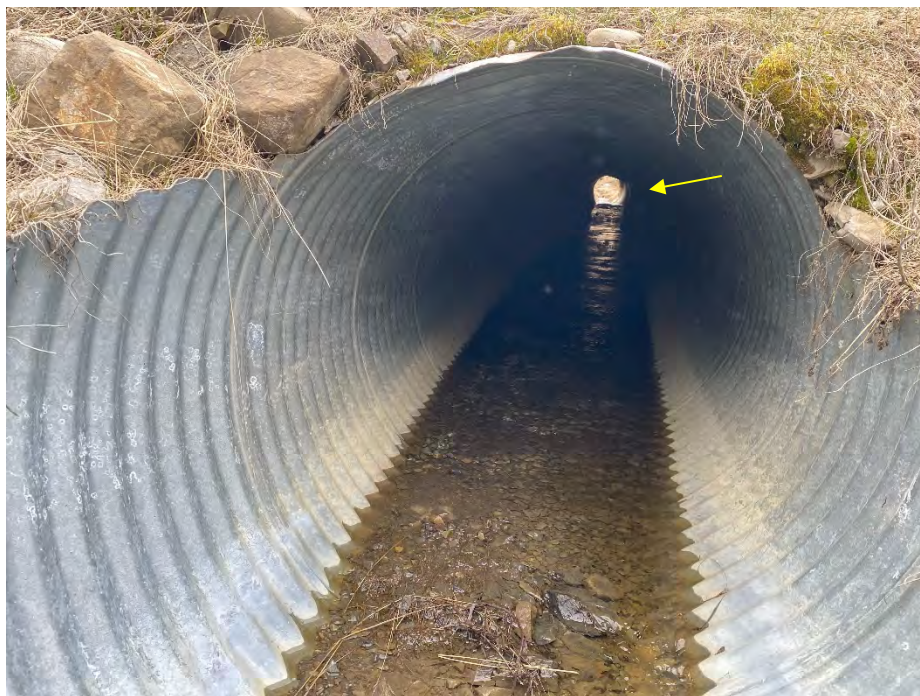
Photo 4: Bulge in west sidewall of C/L culvert. Looking south.

- All culverts should be inspected to reduce the risk of water seeping into the slope.
- The extension collar at the C/L culvert on the pile wall side should be inspected for any leaks and repaired as required.
- The culvert inlets and outlets at the culvert site should be re-set to reduce the amount of water currently undermining the culverts at these locations. Additionally, vegetation should be cleared from the inlets.
- The ditch blocks in the south ditch should be removed and replaced with rock check dams or similar to allow continued flow.

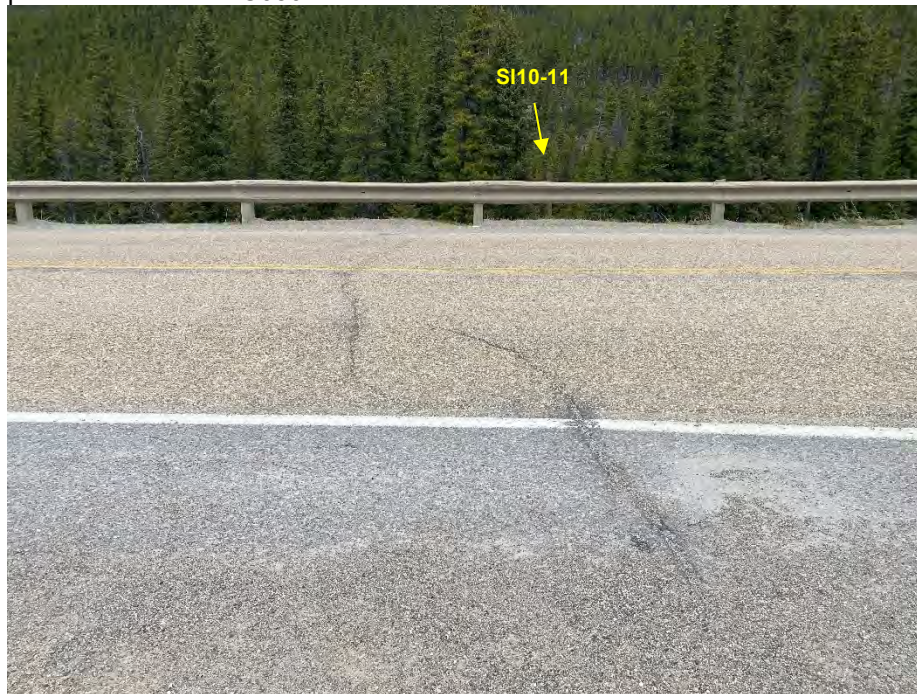
Photo 5: Pavement crack west of C/L culvert at pile wall site. Looking north.

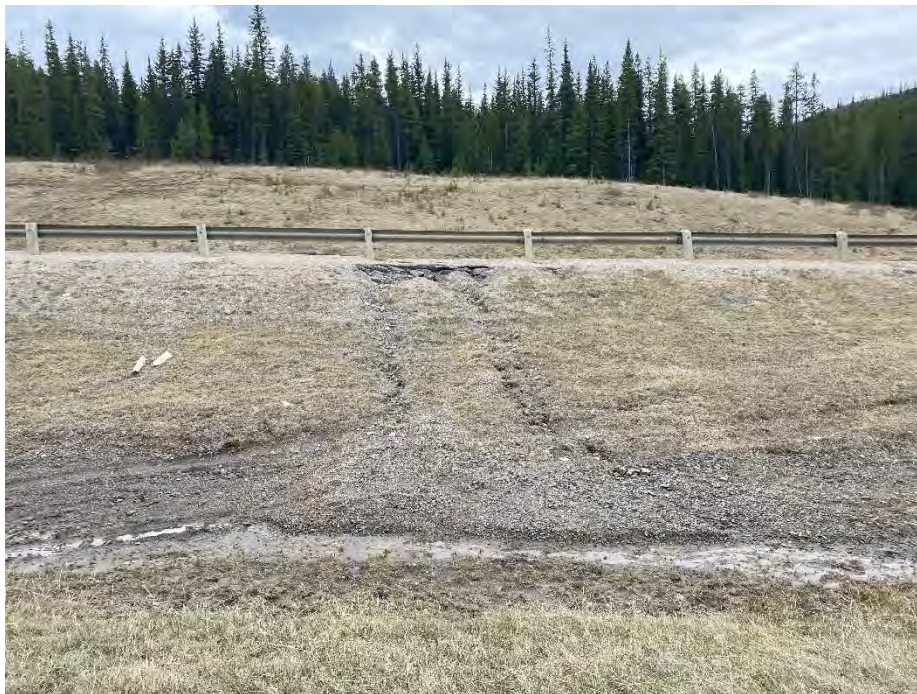
- Several seepage locations with oxide staining in the north ditch between the culvert site and the pile wall site were observed. The north ditch was also wet (Photo 6).

- The north ditch shoulder had numerous erosion rills and gullies between the culvert site and the pile wall site. Several rills have progressed to gullies and have begun to undermine the asphalt (Photo 6).

Photo 6: Seepage along north ditch between pile wall site and culvert site with erosion rills and gully on the north ditch highway shoulder. Looking south.

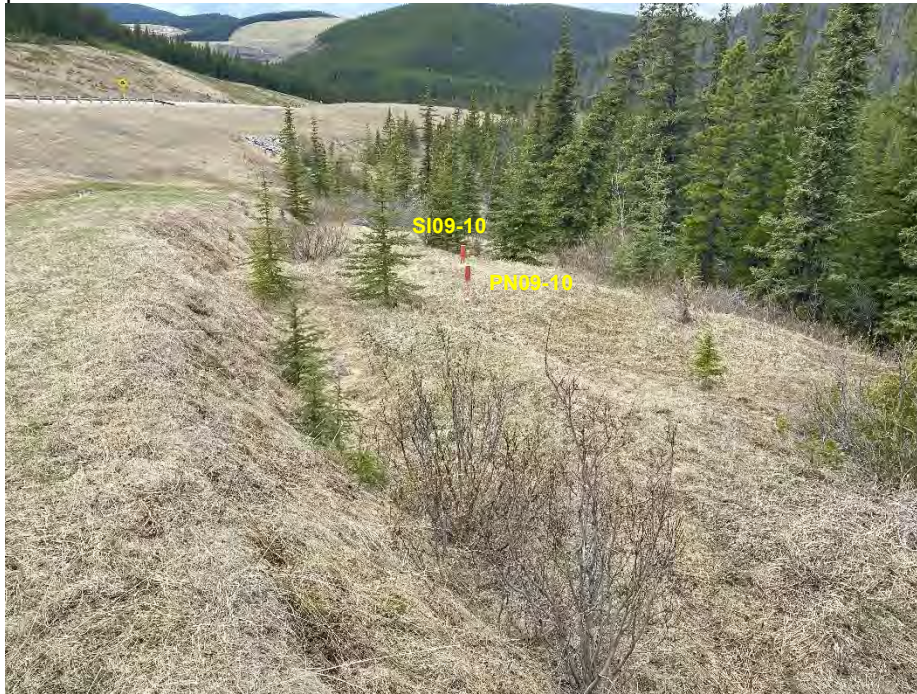
Photo 7: Old scarp east of culvert site, looking west.

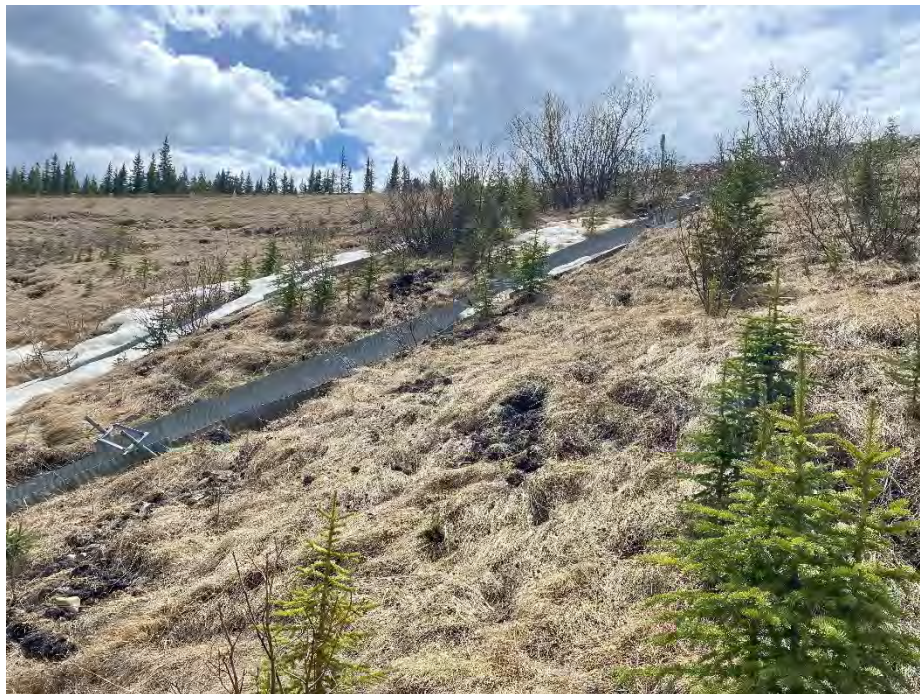
Photo 8: View of culvert site and slope, looking southeast.

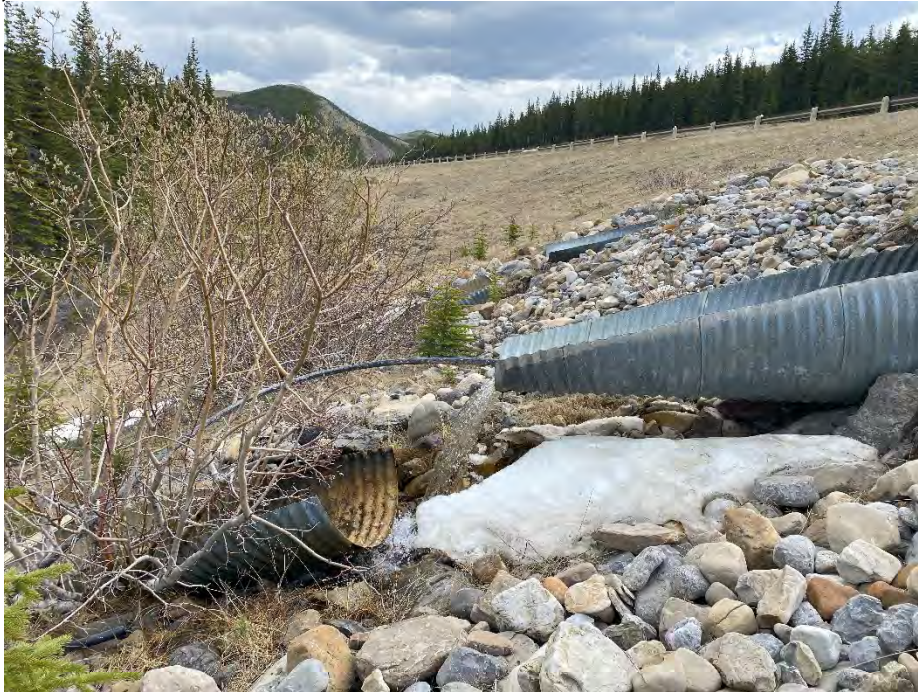
- A sag was observed in both 1000 mm dia. culverts approximately at the highway location, similar to previous observations.
- Surface water flow is still undermining both culverts at the transition from full-round to half-round culvert. The half-round culverts appear to have shifted further downslope since the previous inspection. At the west culvert transition area, water is flowing out of the full-round and is now completely missing the half-round culvert (Photo 9). At the east culvert transition, water is trickling out and completely missing the half-round culvert, though some water does make it into the half-round culvert after trickling over rocks.

Photo 9: Water undermining culvert, which has slid further downslope. Looking east.

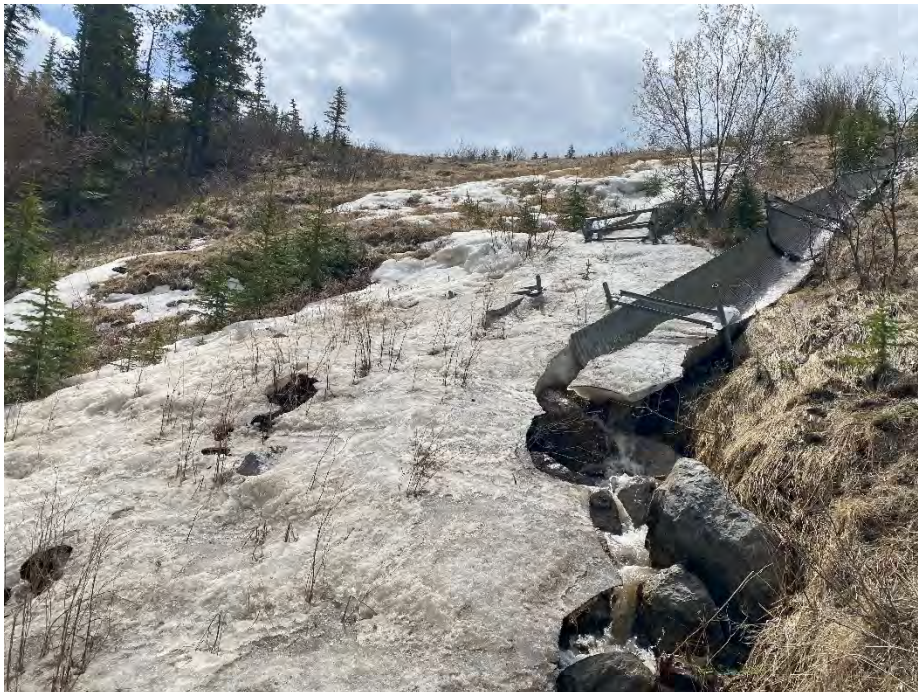
- The bracings along the half-round culverts appeared twisted and distressed (Photo 10). The lower portion of the east half-round culvert was under snow.

Photo 10: Twisted bracing along half-round culverts, east culvert under snow. Looking south.

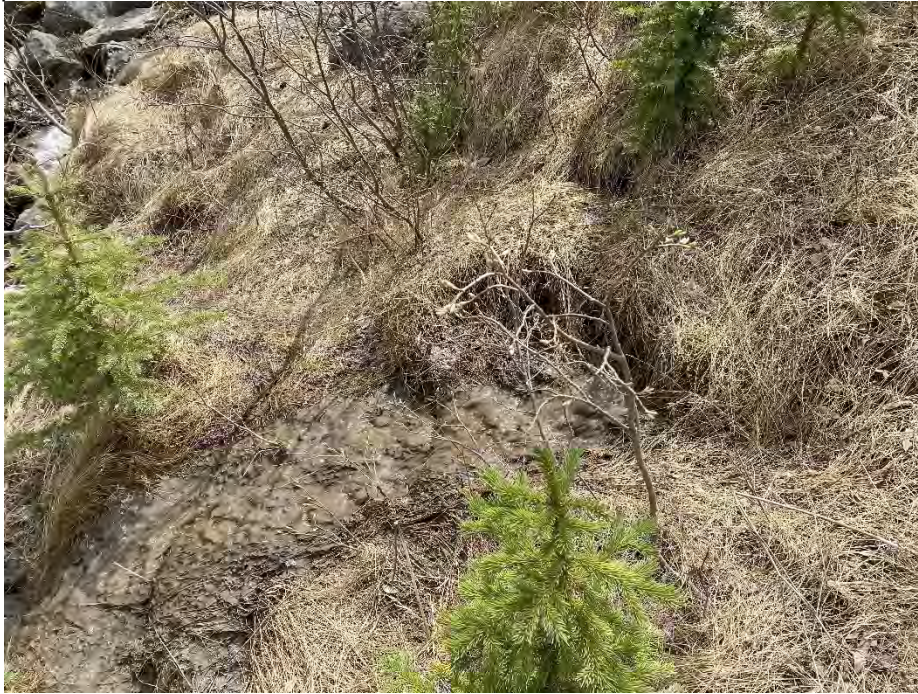
- Water was observed to be visibly flowing out of the slope northwest from the end of the half-round culverts. The origin of this water is unknown (Photo 11).

Photo 11: Flow exiting from the slope west from half-round culverts. Looking southeast.

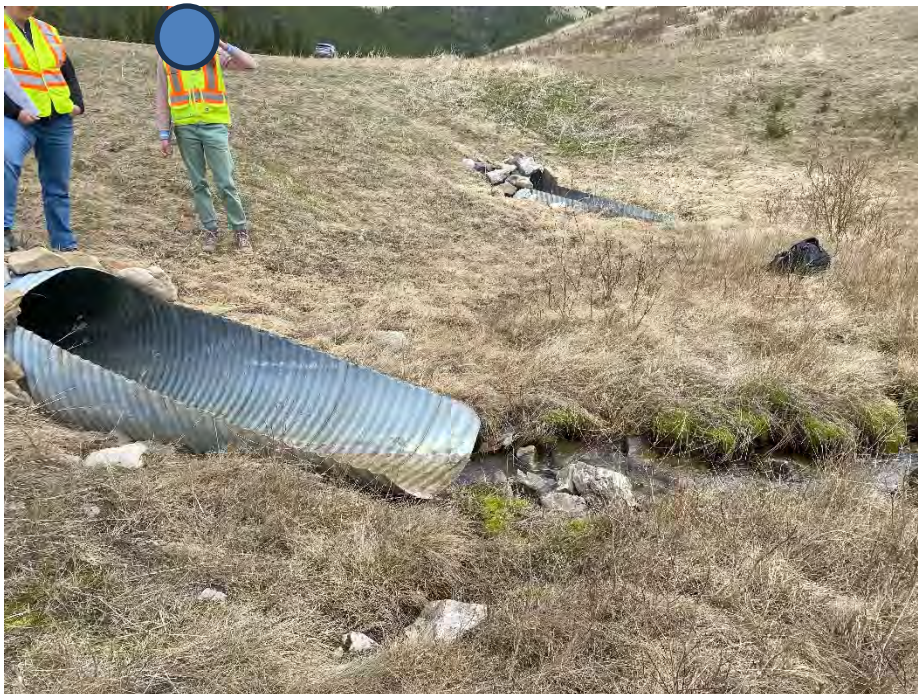
- At the culvert inlets on the south side of the highway, it was observed that water was trickling into the east culvert inlet. The west culvert inlet was being mostly undermined by water, which appears to be entering the culvert from a separation between the 1st and 2nd culvert segments, similar to previous observations (Photos 12 and 13).

Photo 12: Culvert inlets on south side of highway at culvert site, looking east.

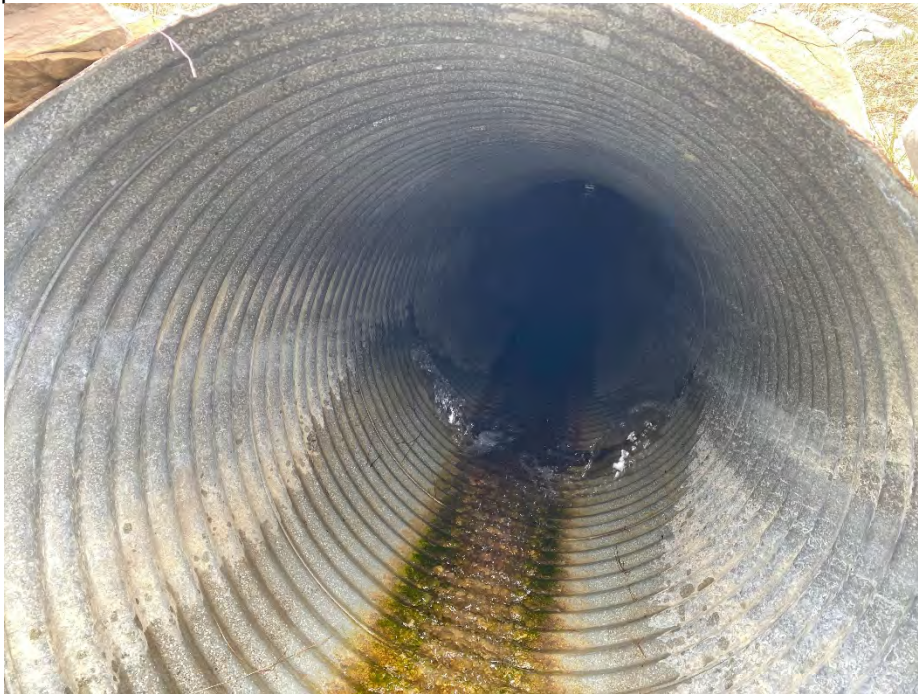
Photo 13: Water undermining west culvert inlet and entering between the first and second culvert segments at the culvert site. Looking northeast.
