| To: | Amy Driessen | From: | Leslie Cho and Lawrence Onwude |
| File: | 123315222 | Date: | October 31, 2025 |

**Reference: North Central Region, Edson, Site NC083 - Highway 40:30 West of Wildhay River, Fall 2025 Instrumentation Monitoring Report**

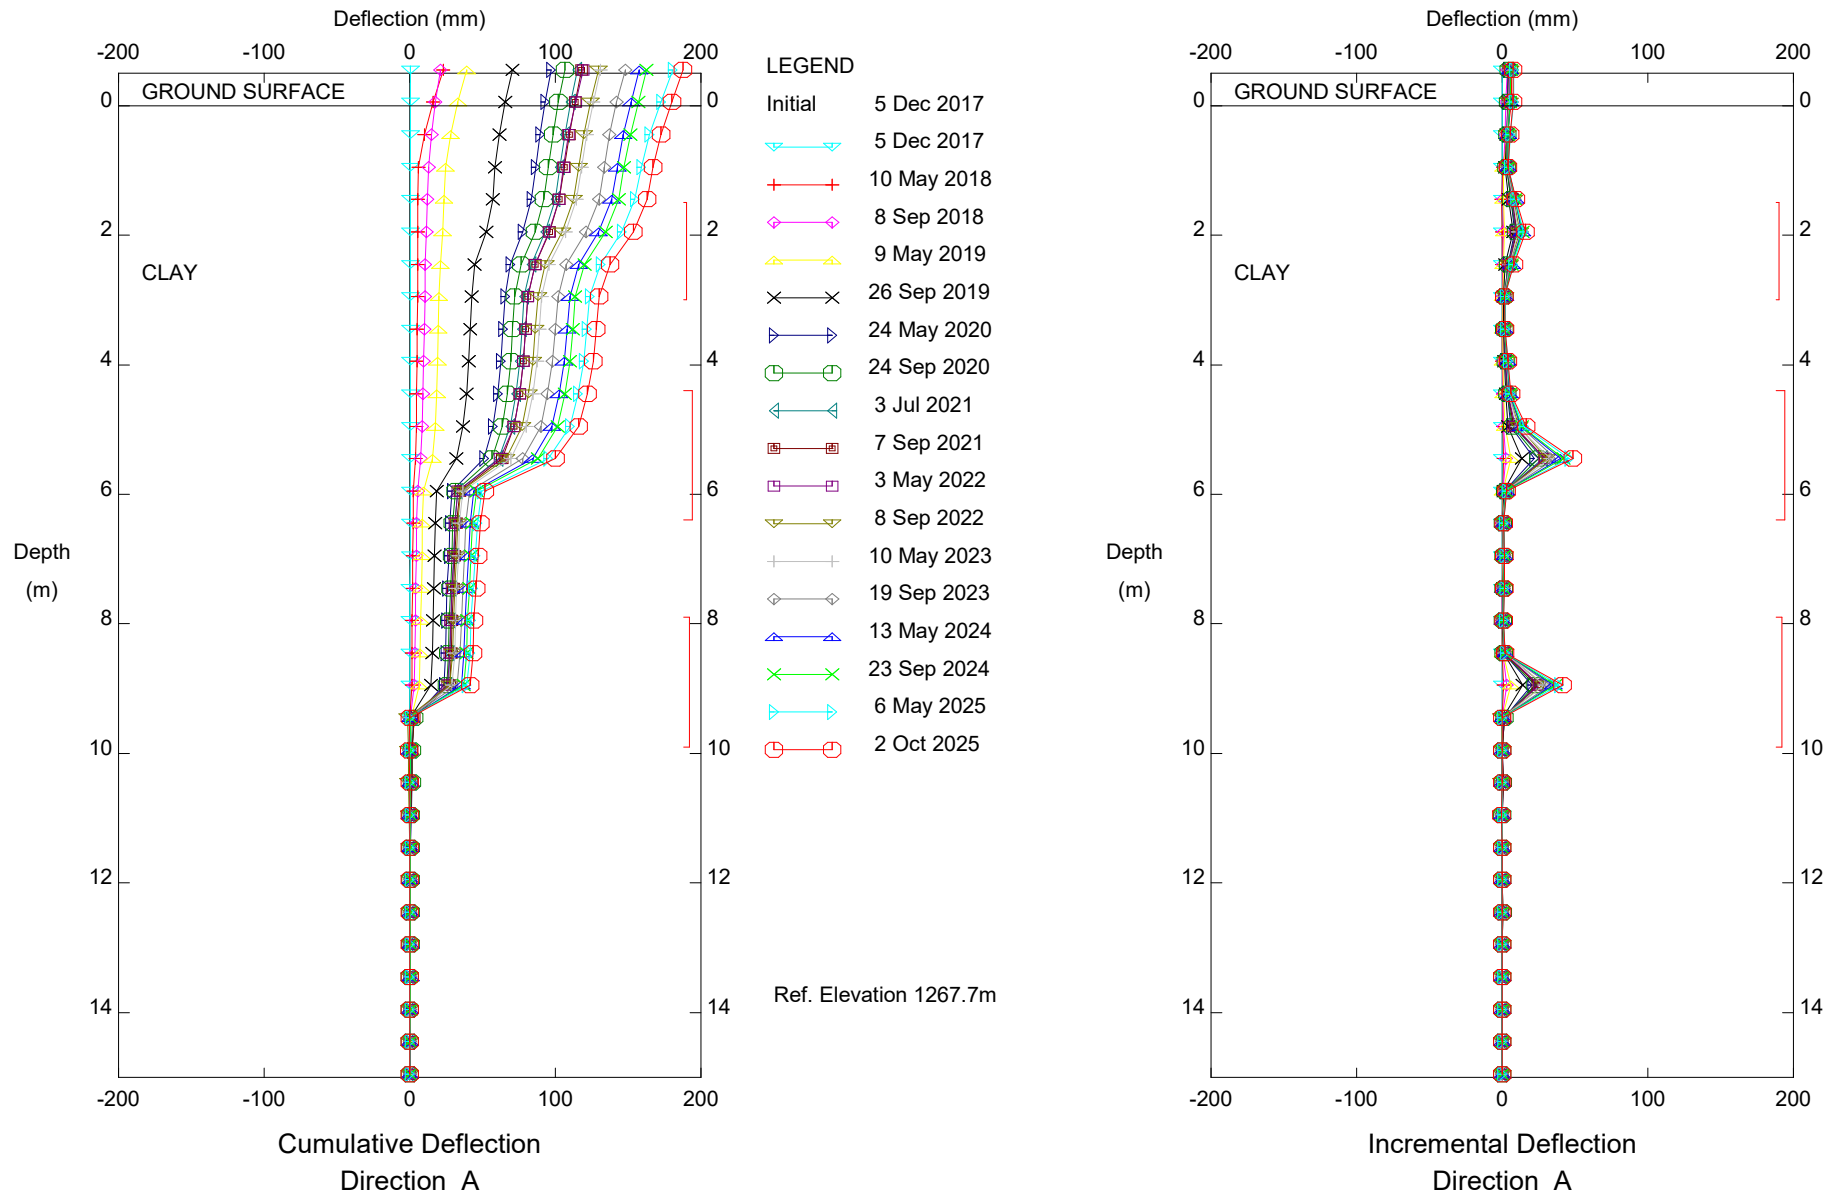
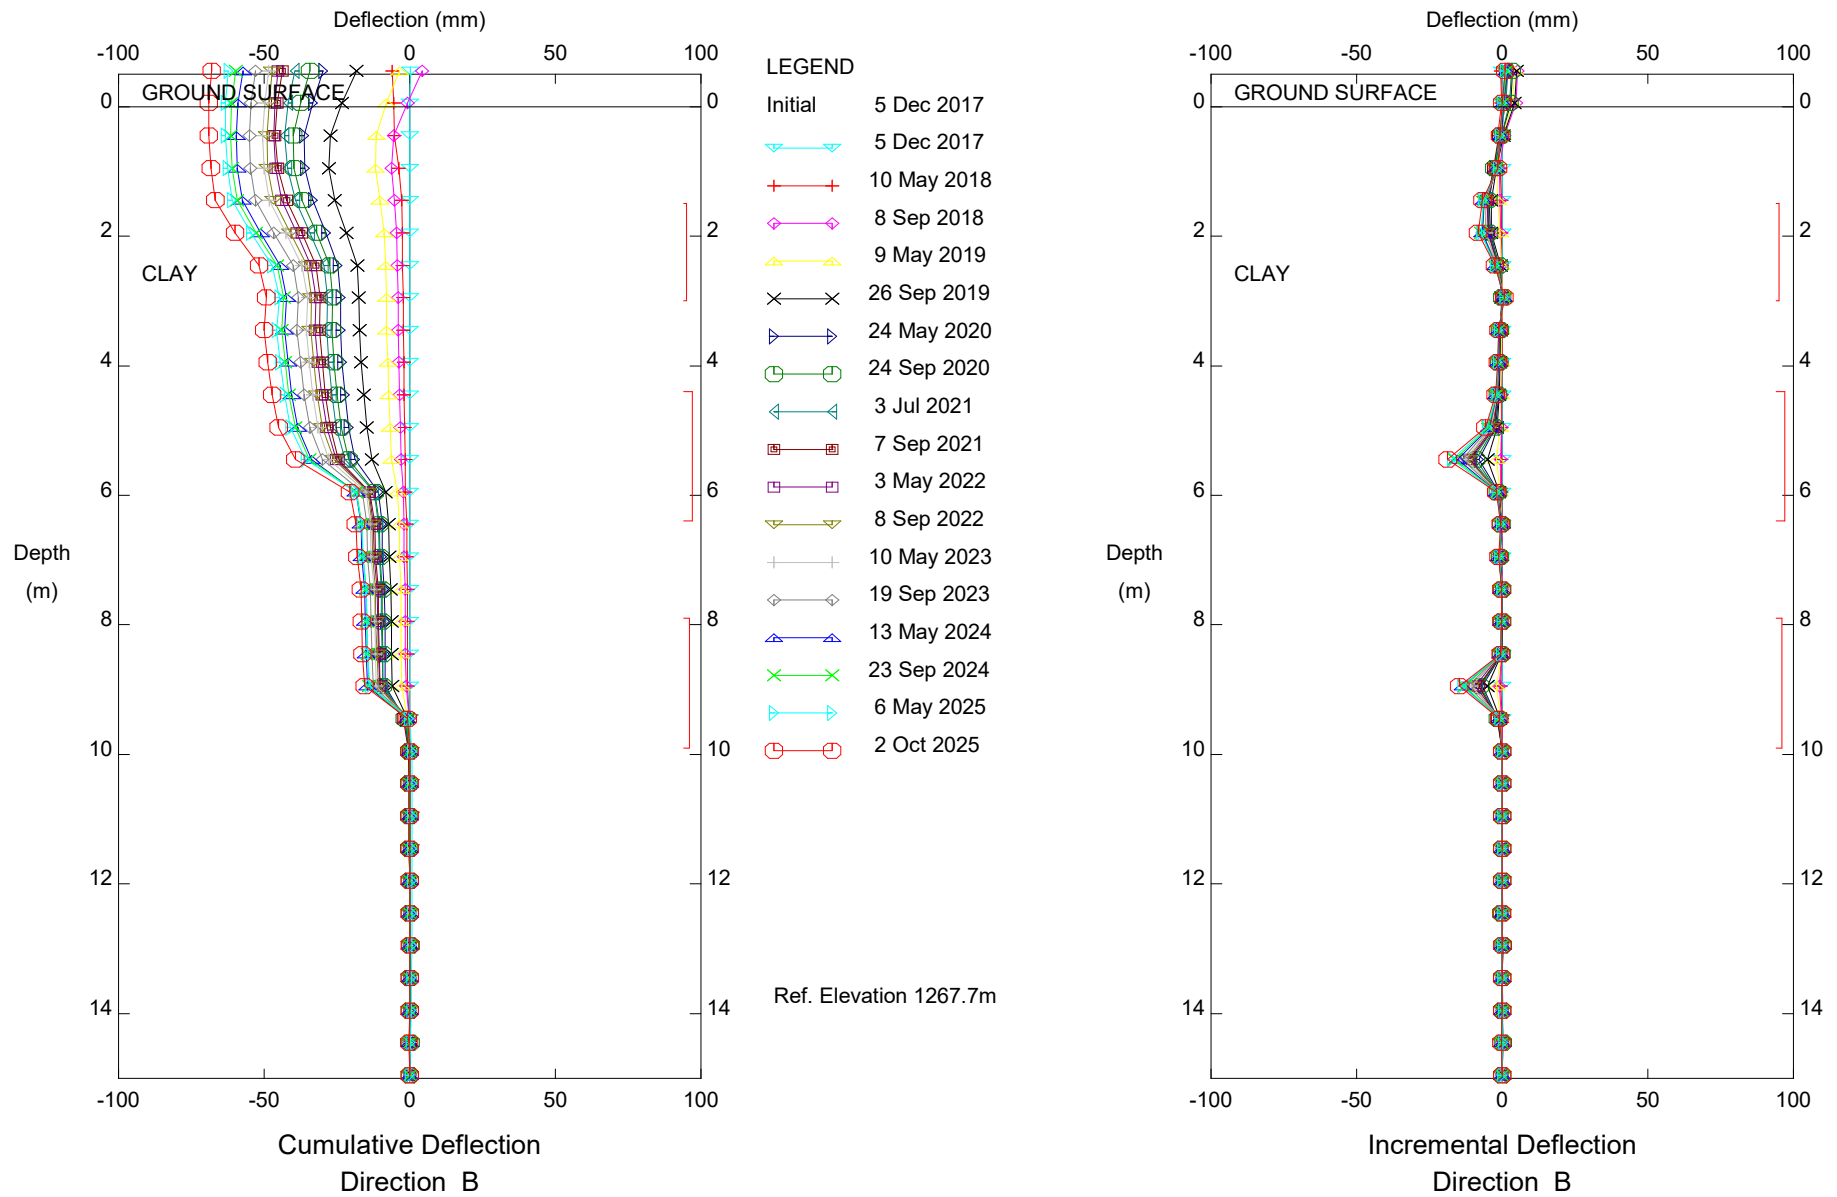
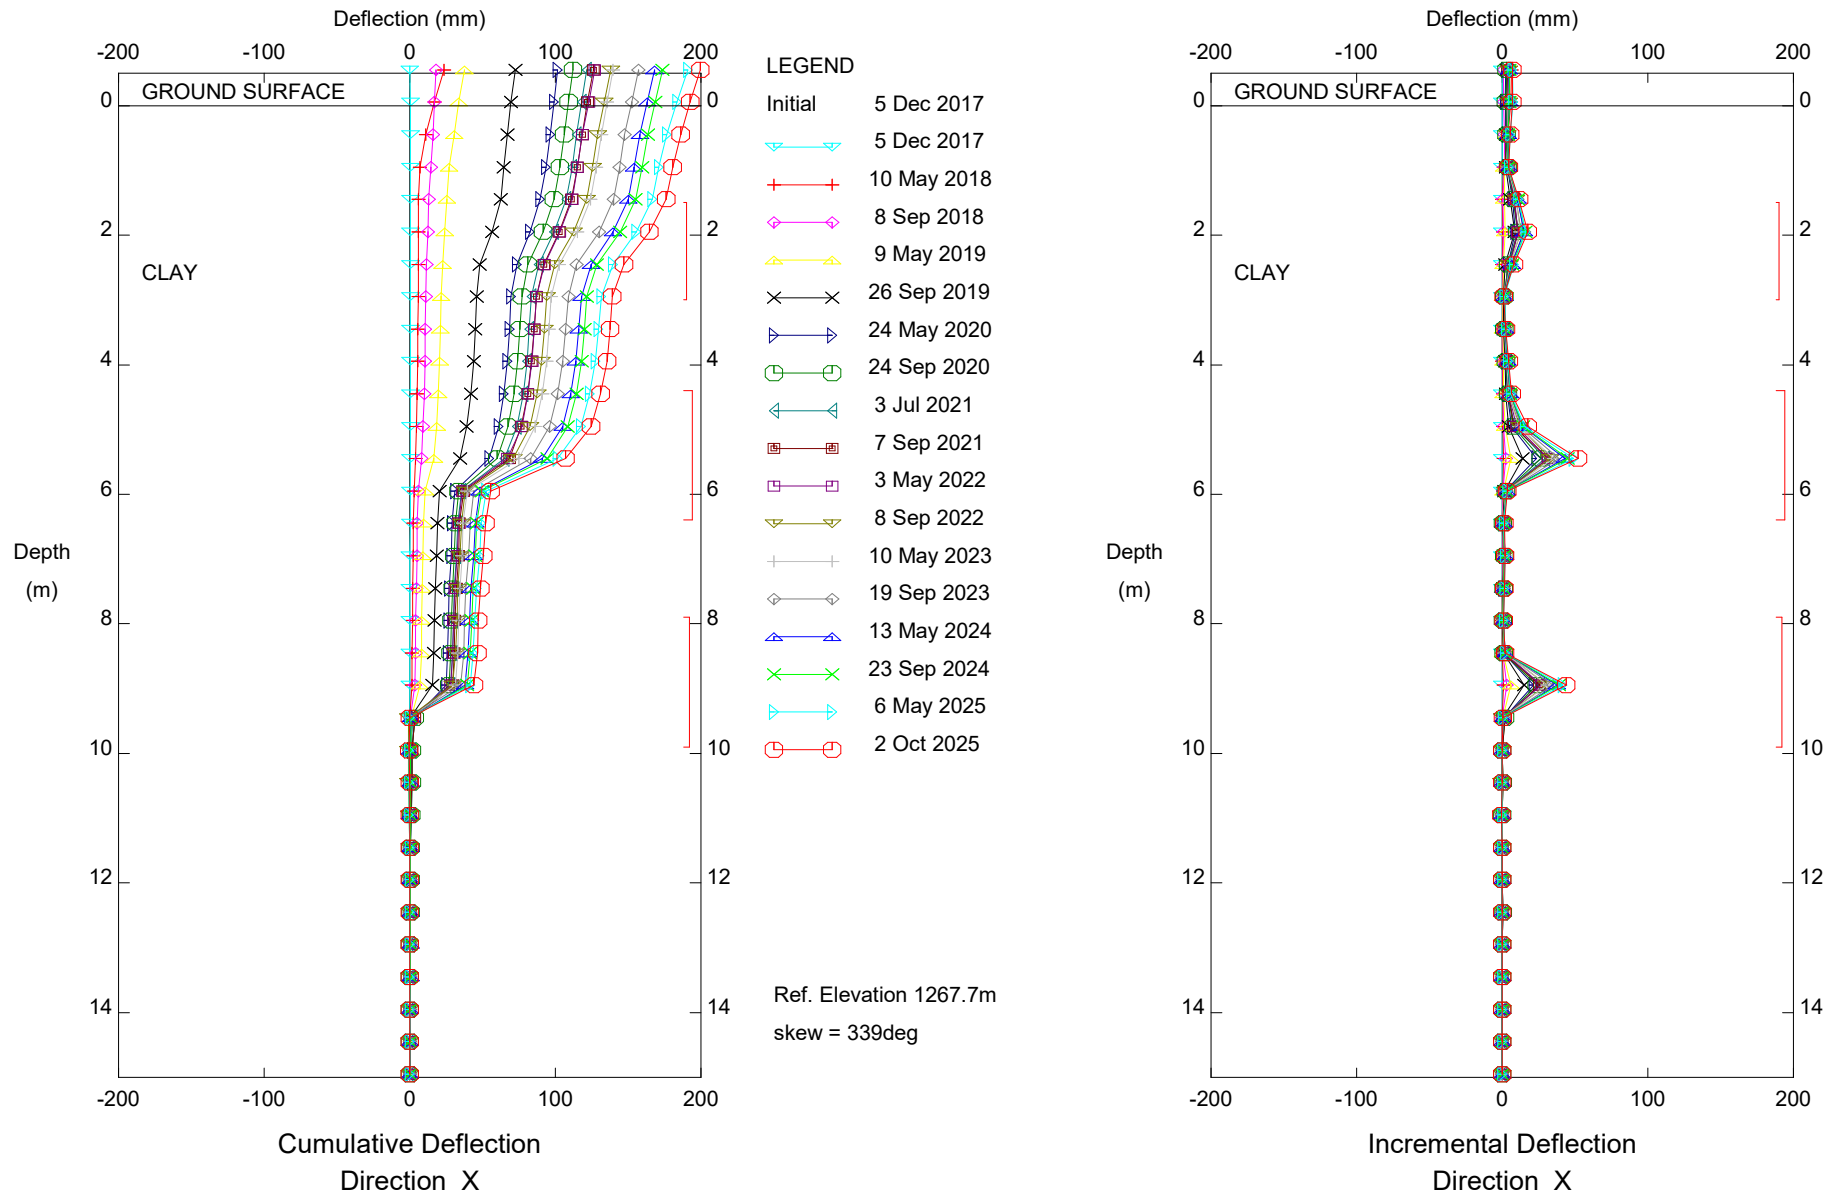
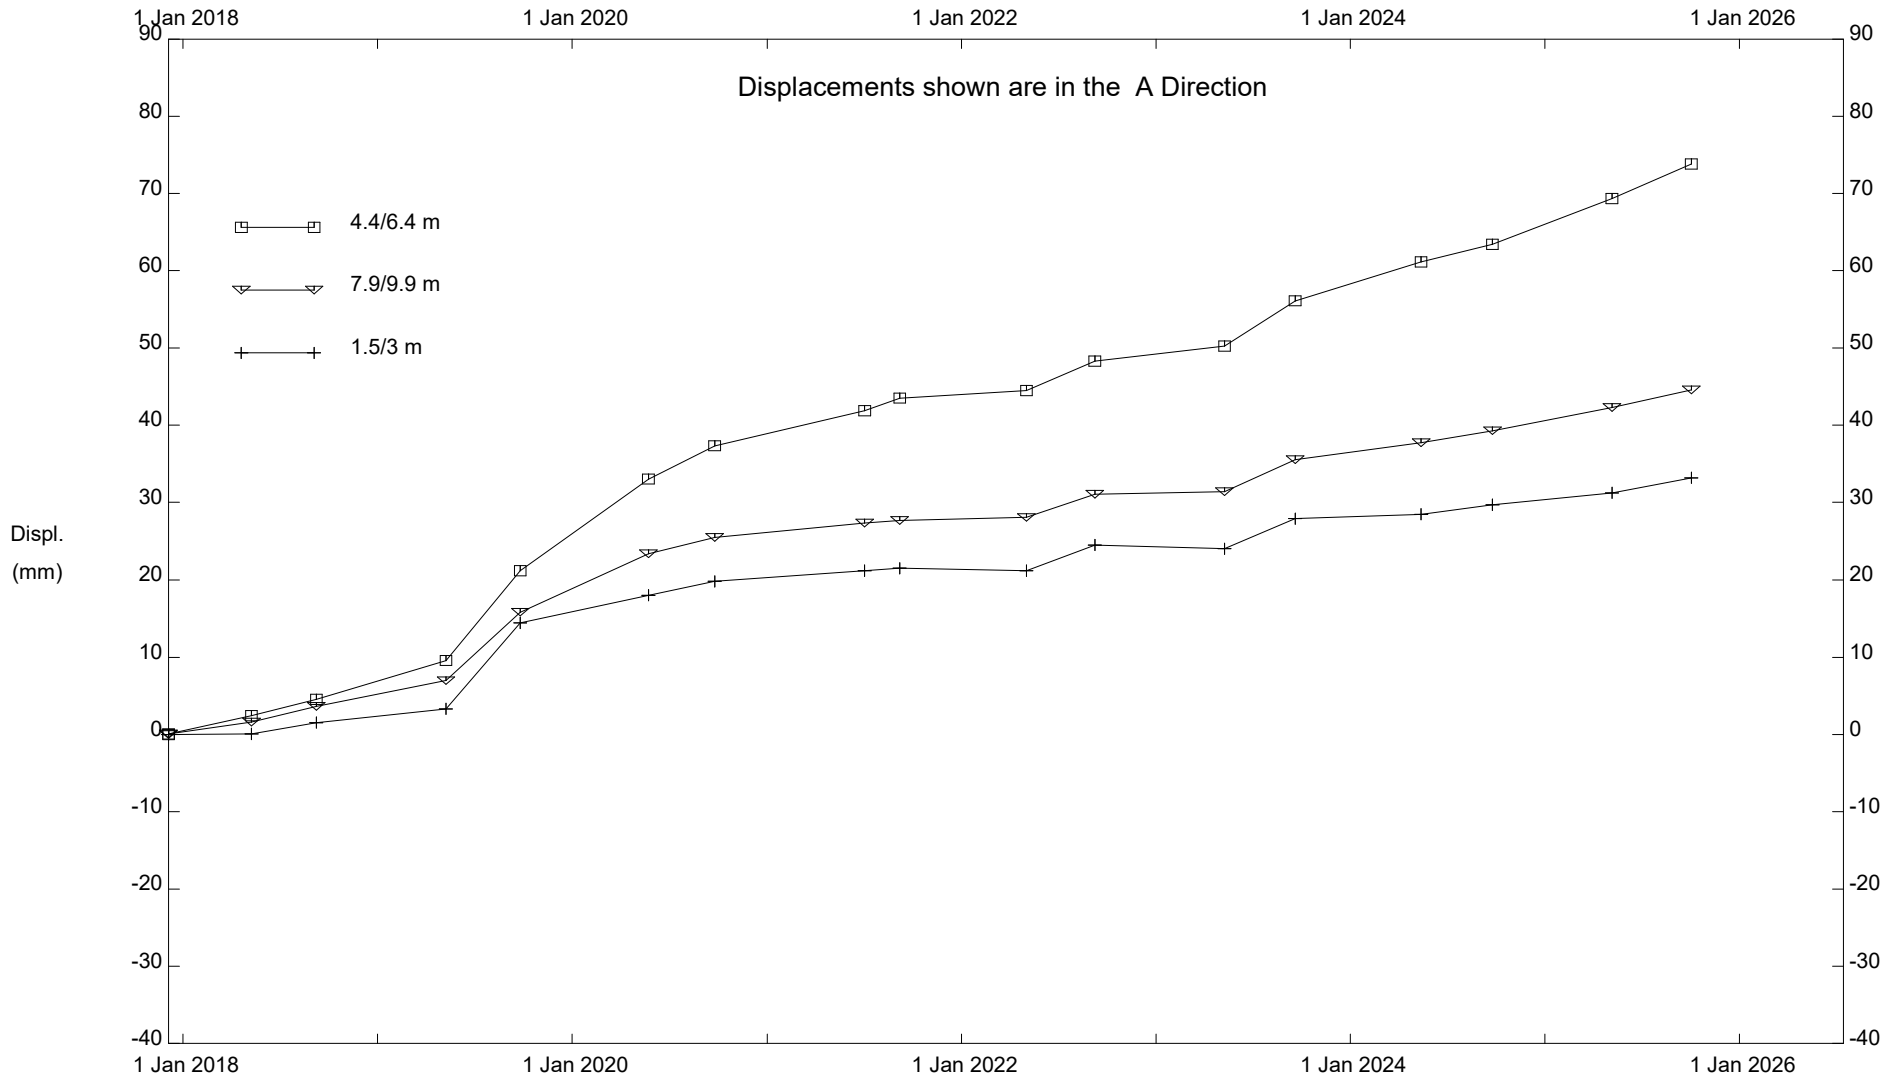
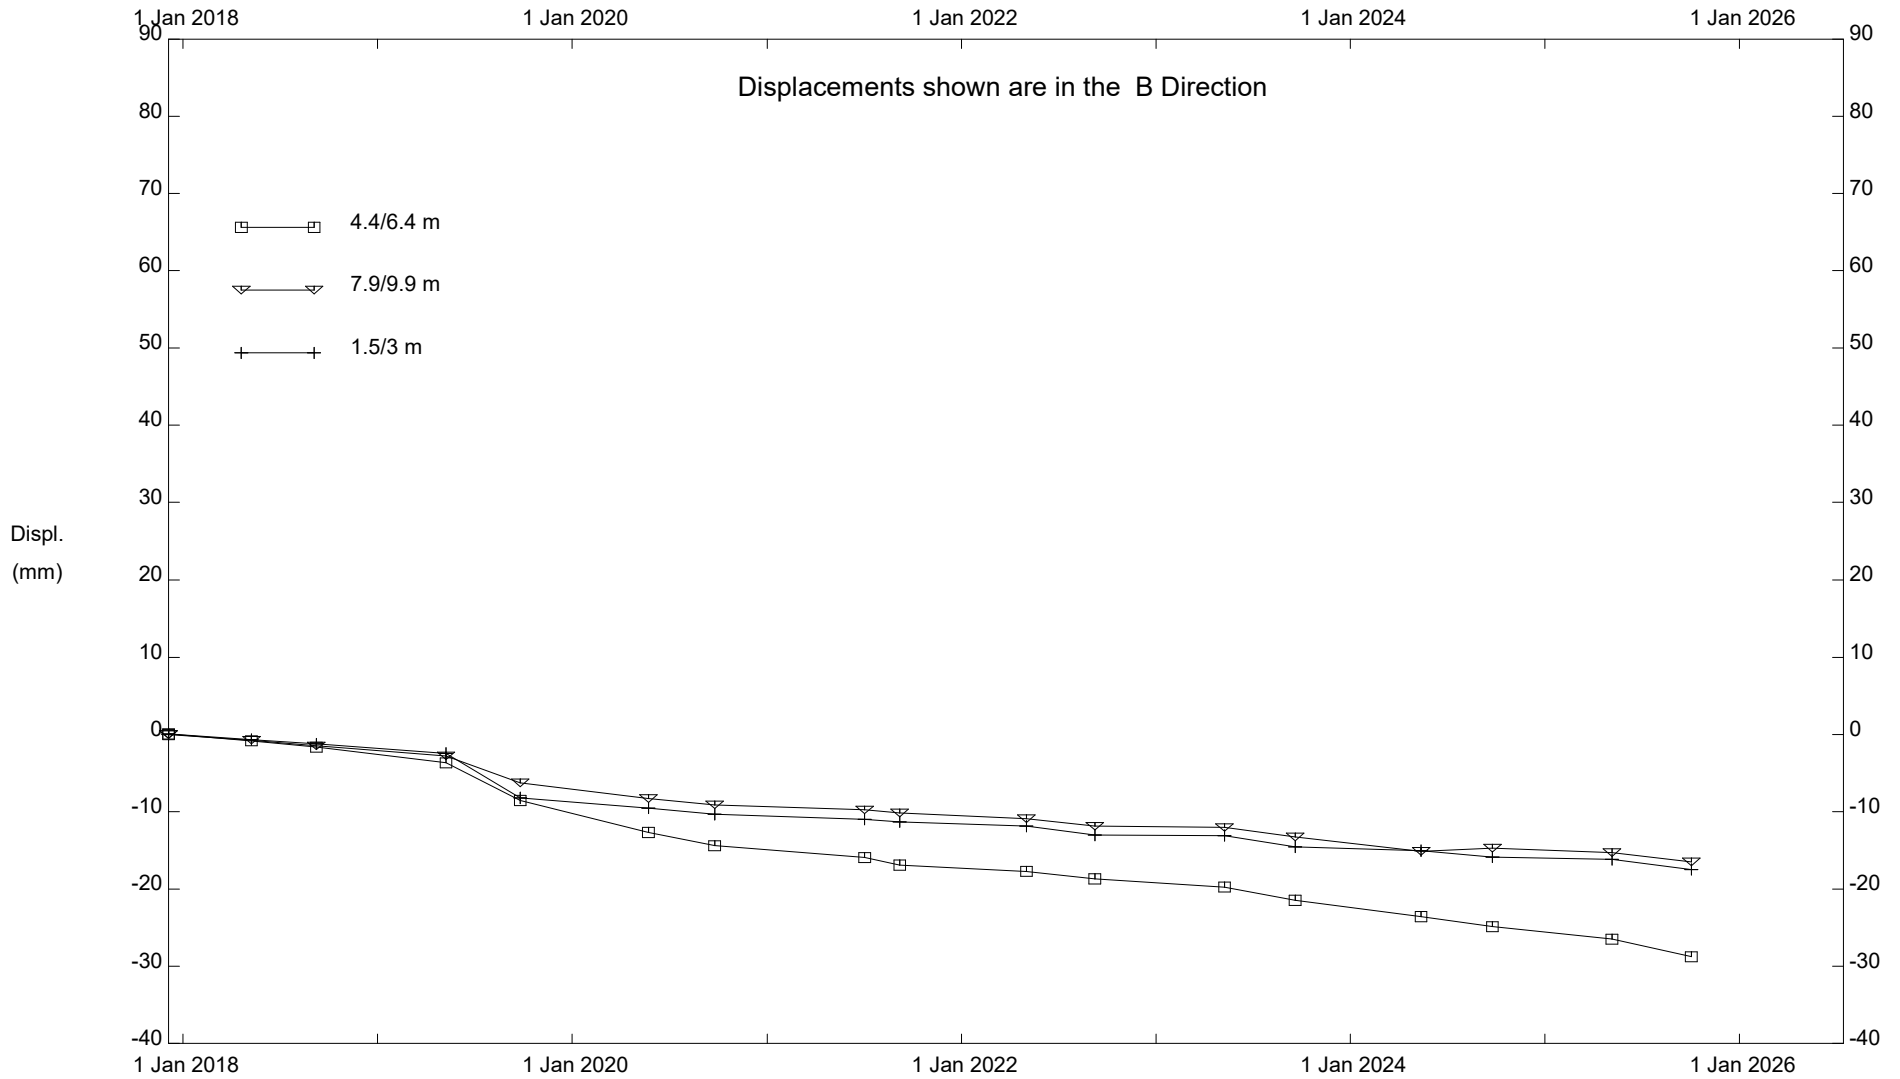
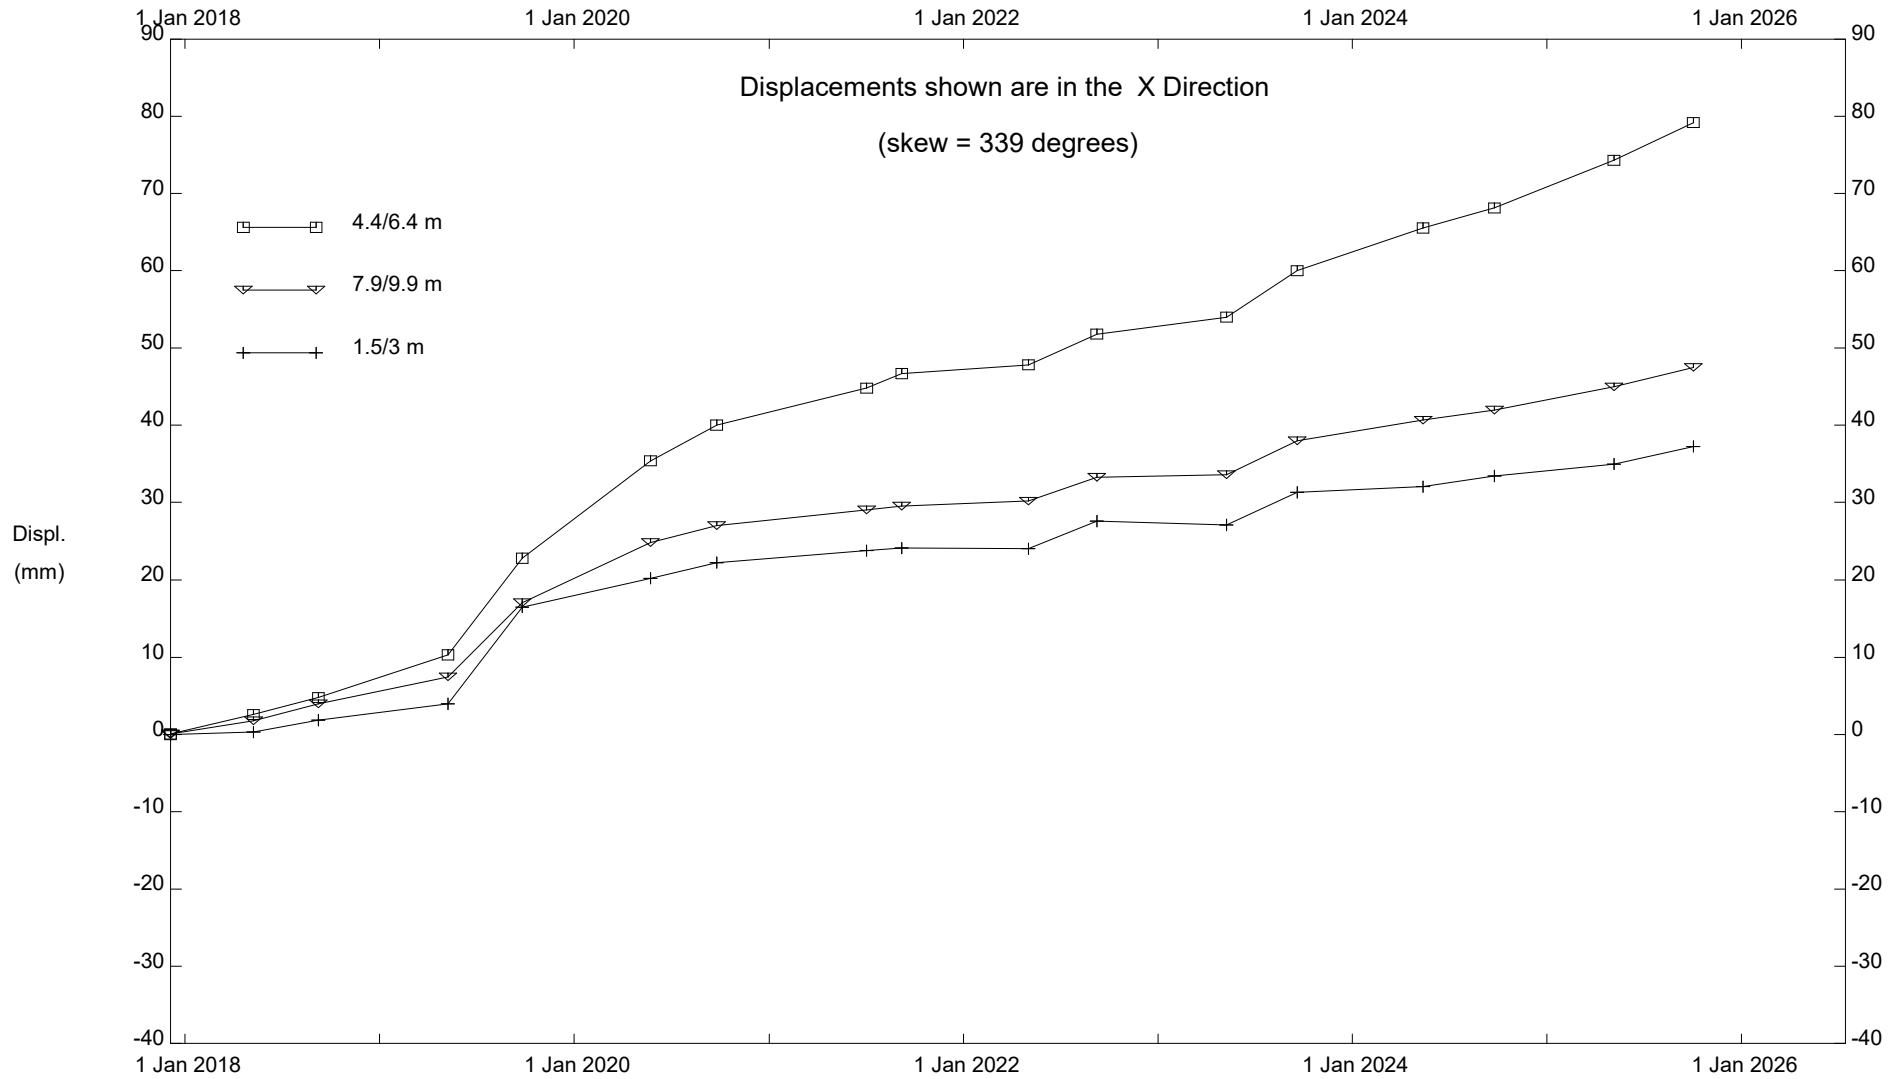
HWY 40:30 West of Wildhay River (NC83), Inclinometer SI17-01

**SI17-01** shows three zones of movement at depths of 1.5 m to 3.0 m, 4.4 m to 6.4 m and 7.9 m to 9.9 m below ground surface (bgs). Since initialization in December 2017, SI17-01 has accumulated 37 mm, 79 mm and 48 mm of movement in the upper, middle and lower shear zones, respectively. Their current respective rates of movement for the three zones are 6 mm/yr, 12 mm/yr and 6 mm/yr.
