| To: | Amy Driessen | From: | Leslie Cho and Lawrence Onwude |
| File: | 123315222 | Date: | October 31, 2025 |

**Reference: North Central Region, Edson, Site NC083 - Highway 40:30 West of Wildhay River, Fall 2025 Instrumentation Monitoring Report**

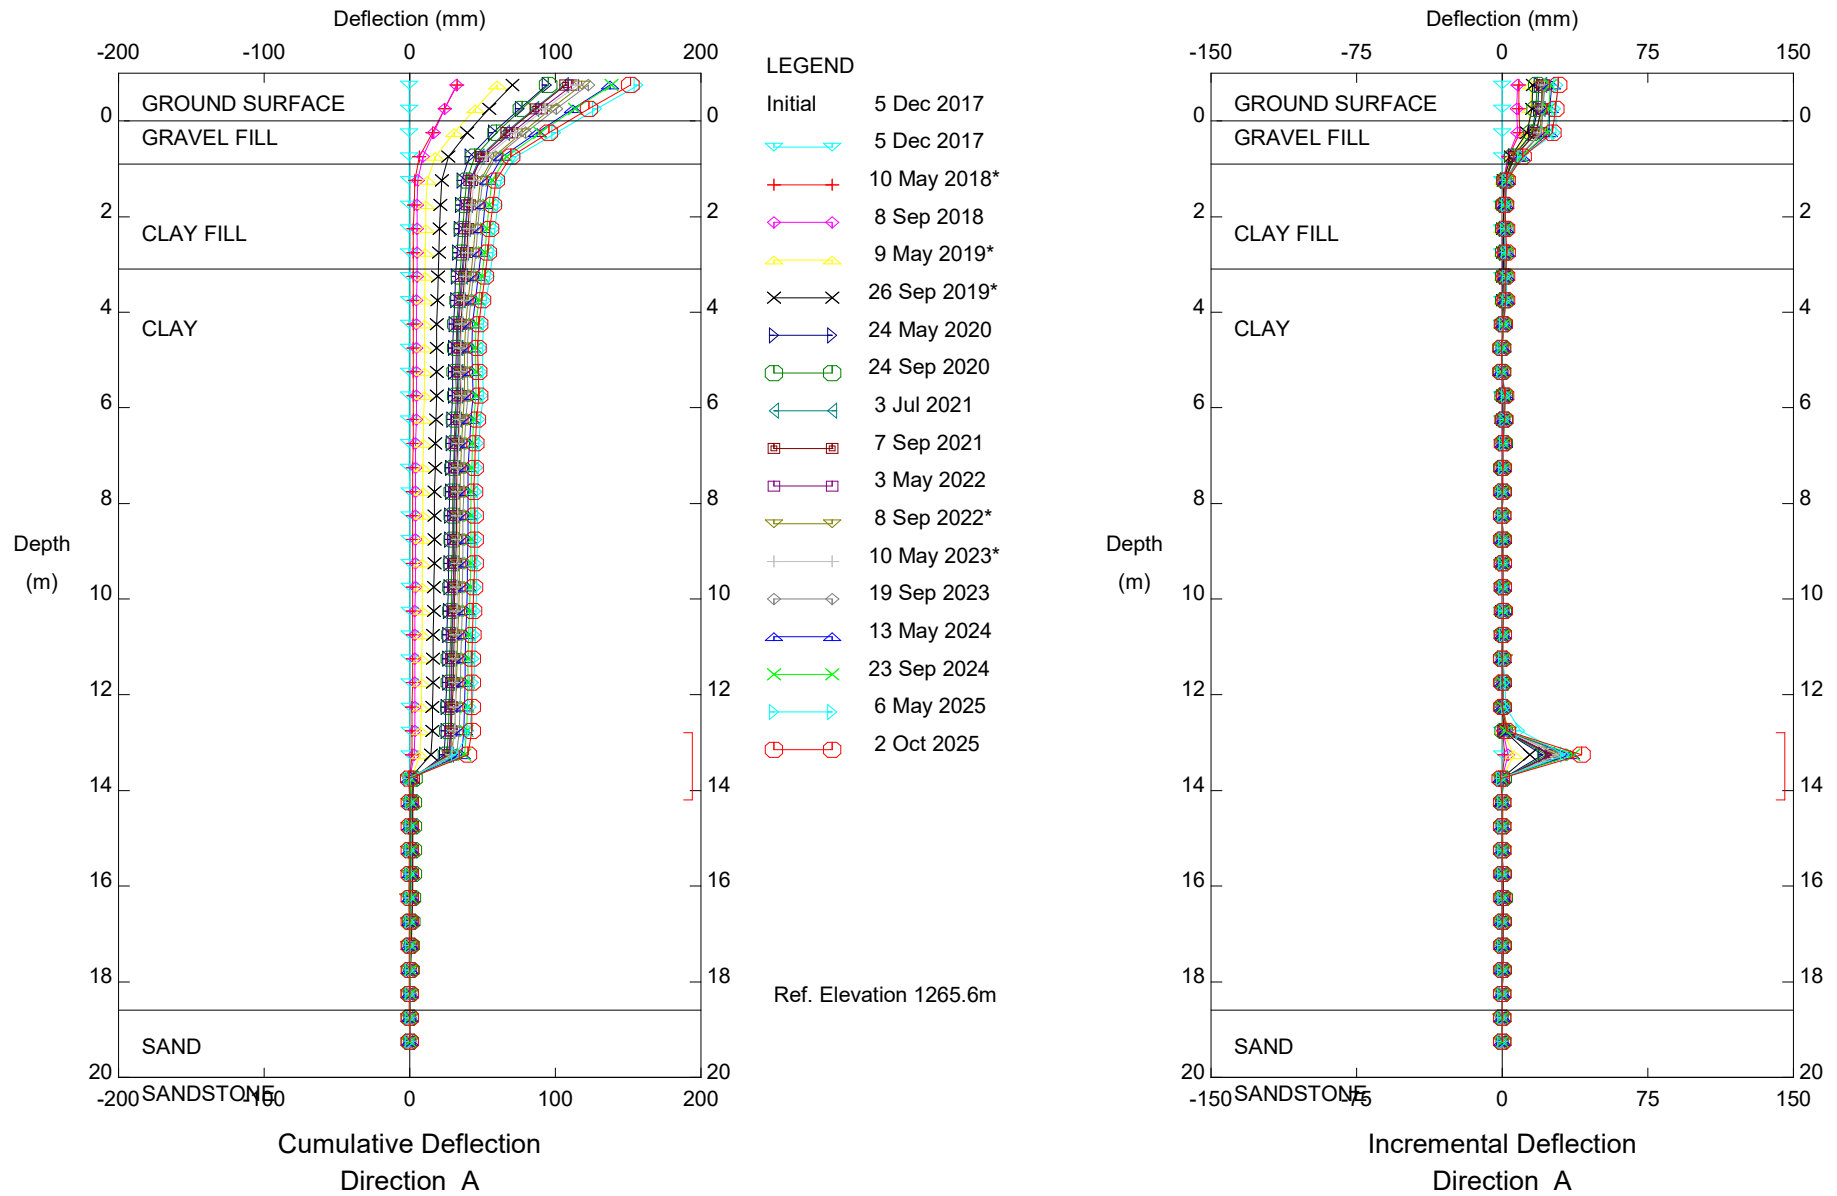
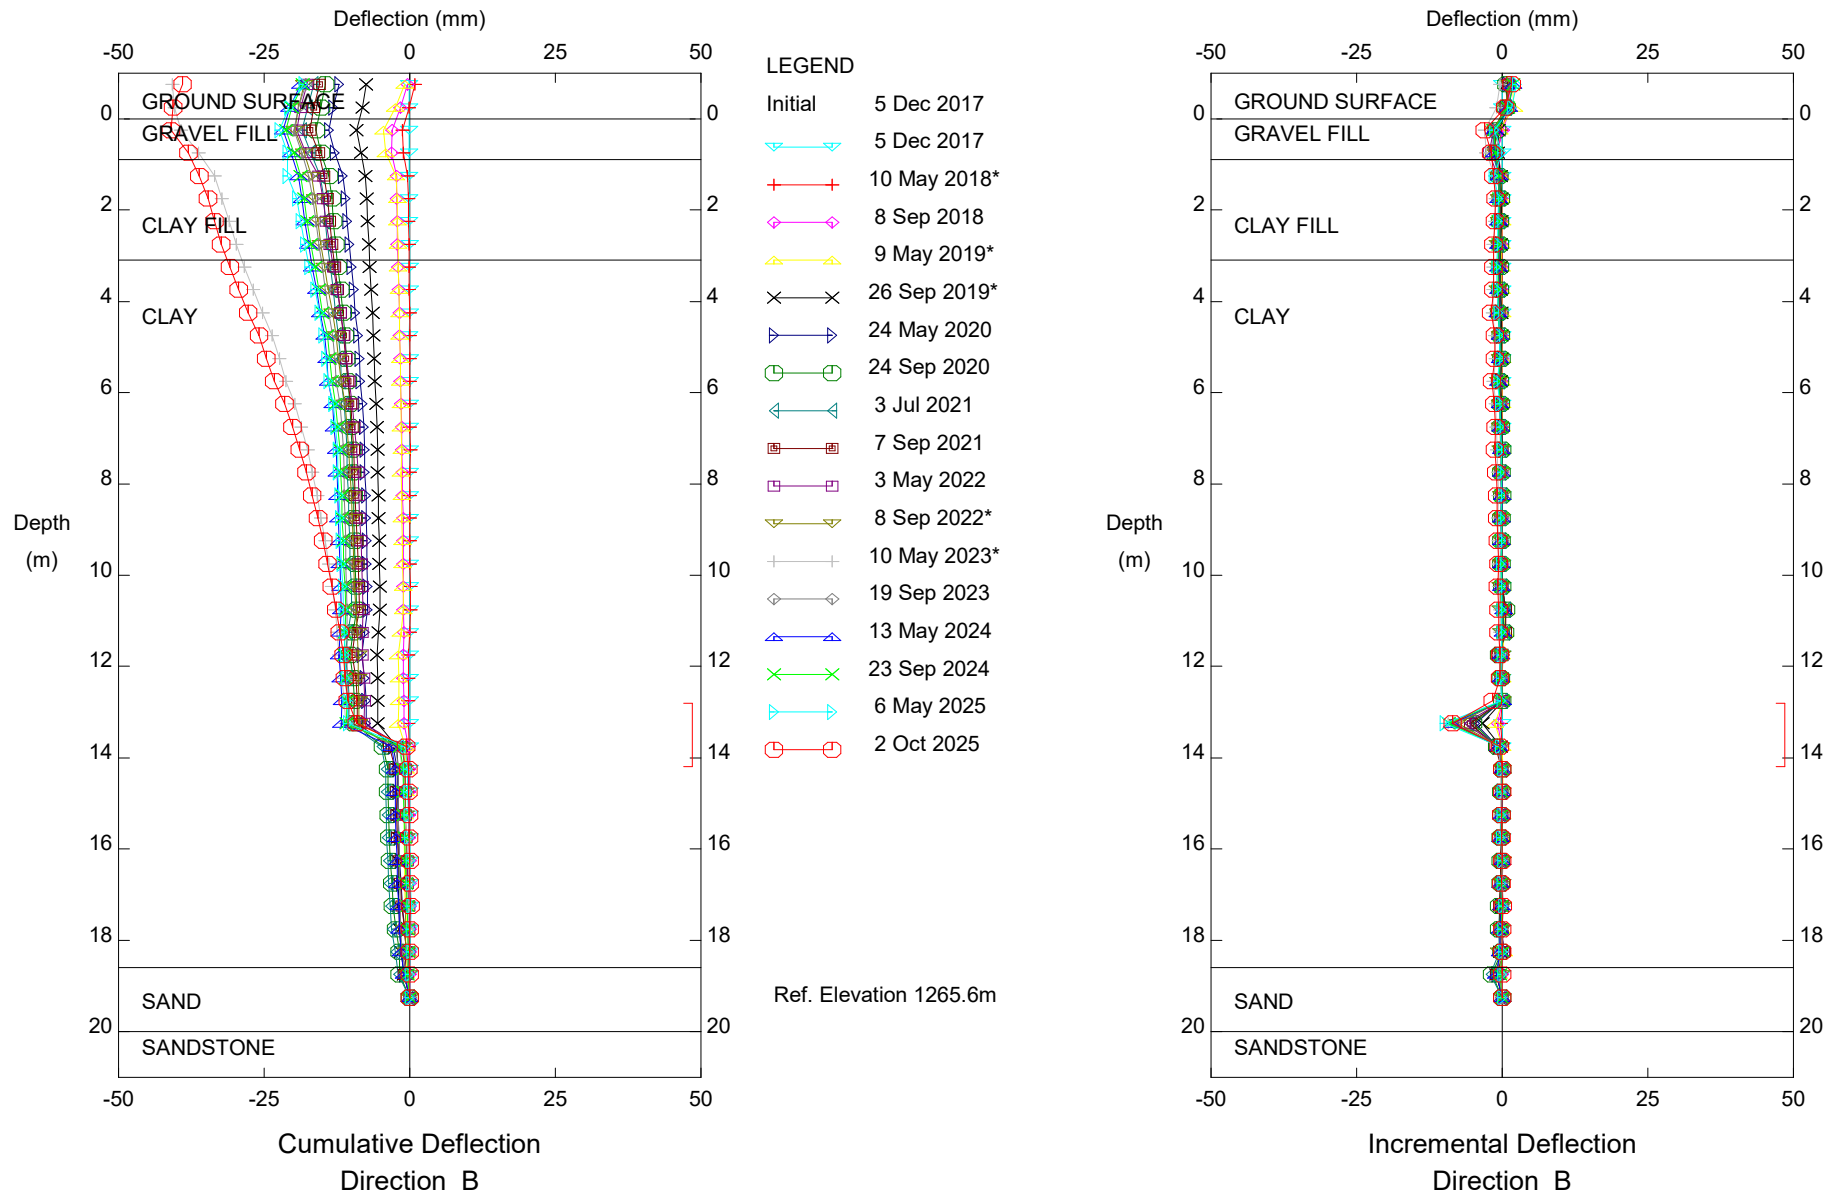
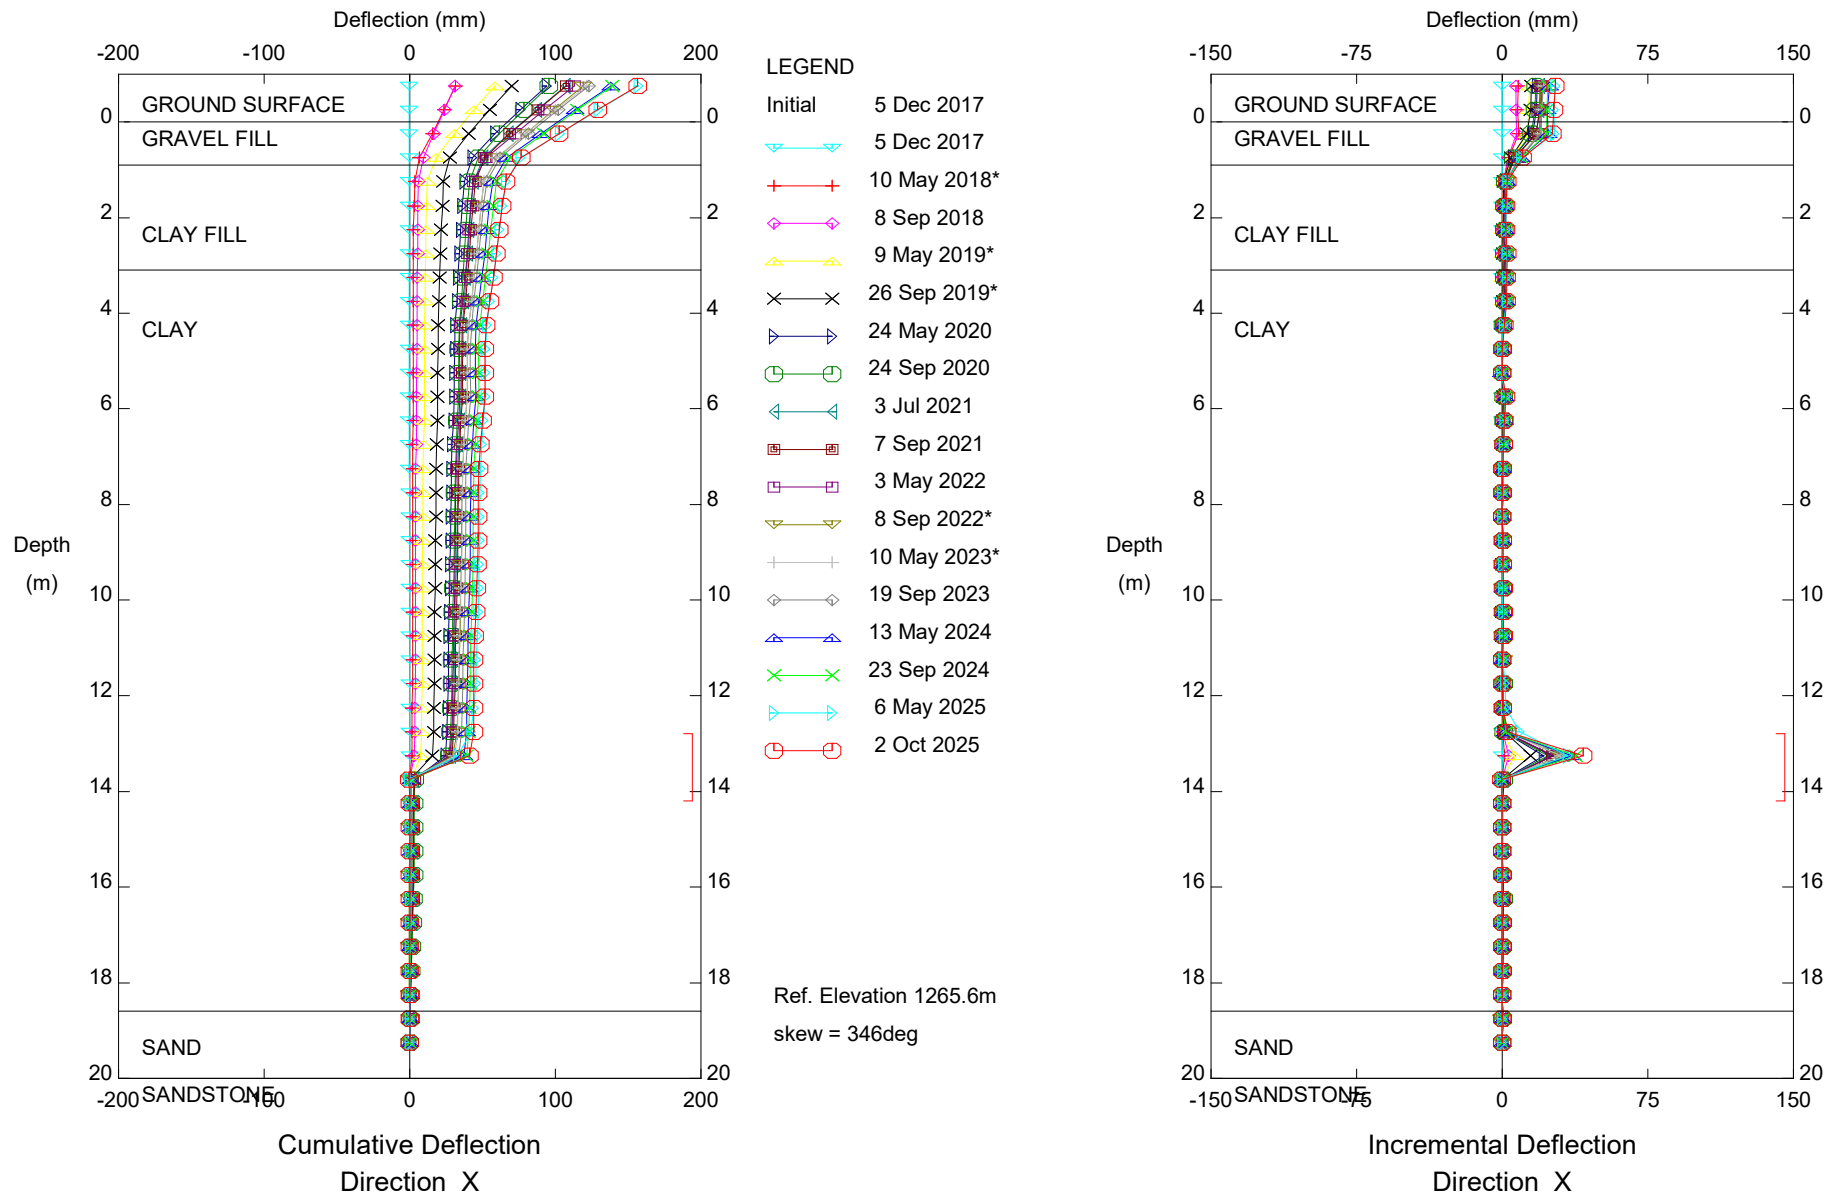
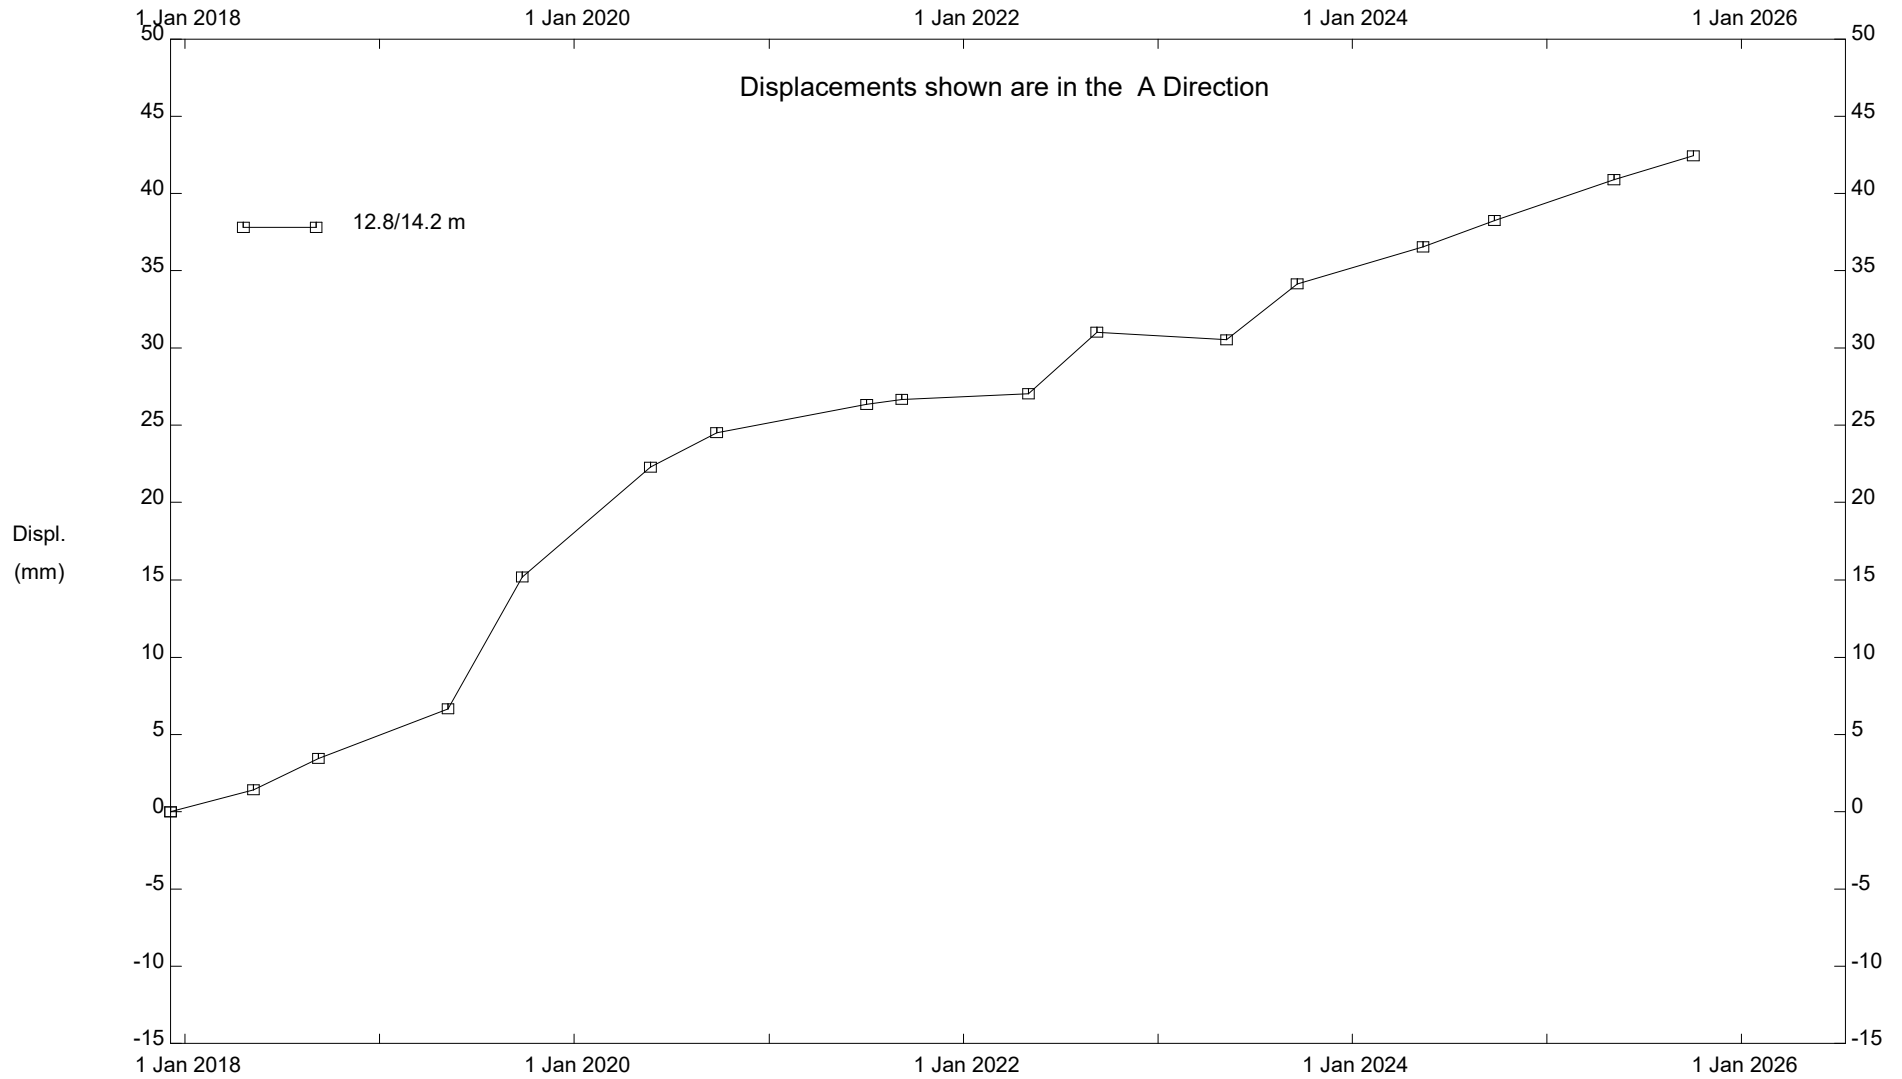
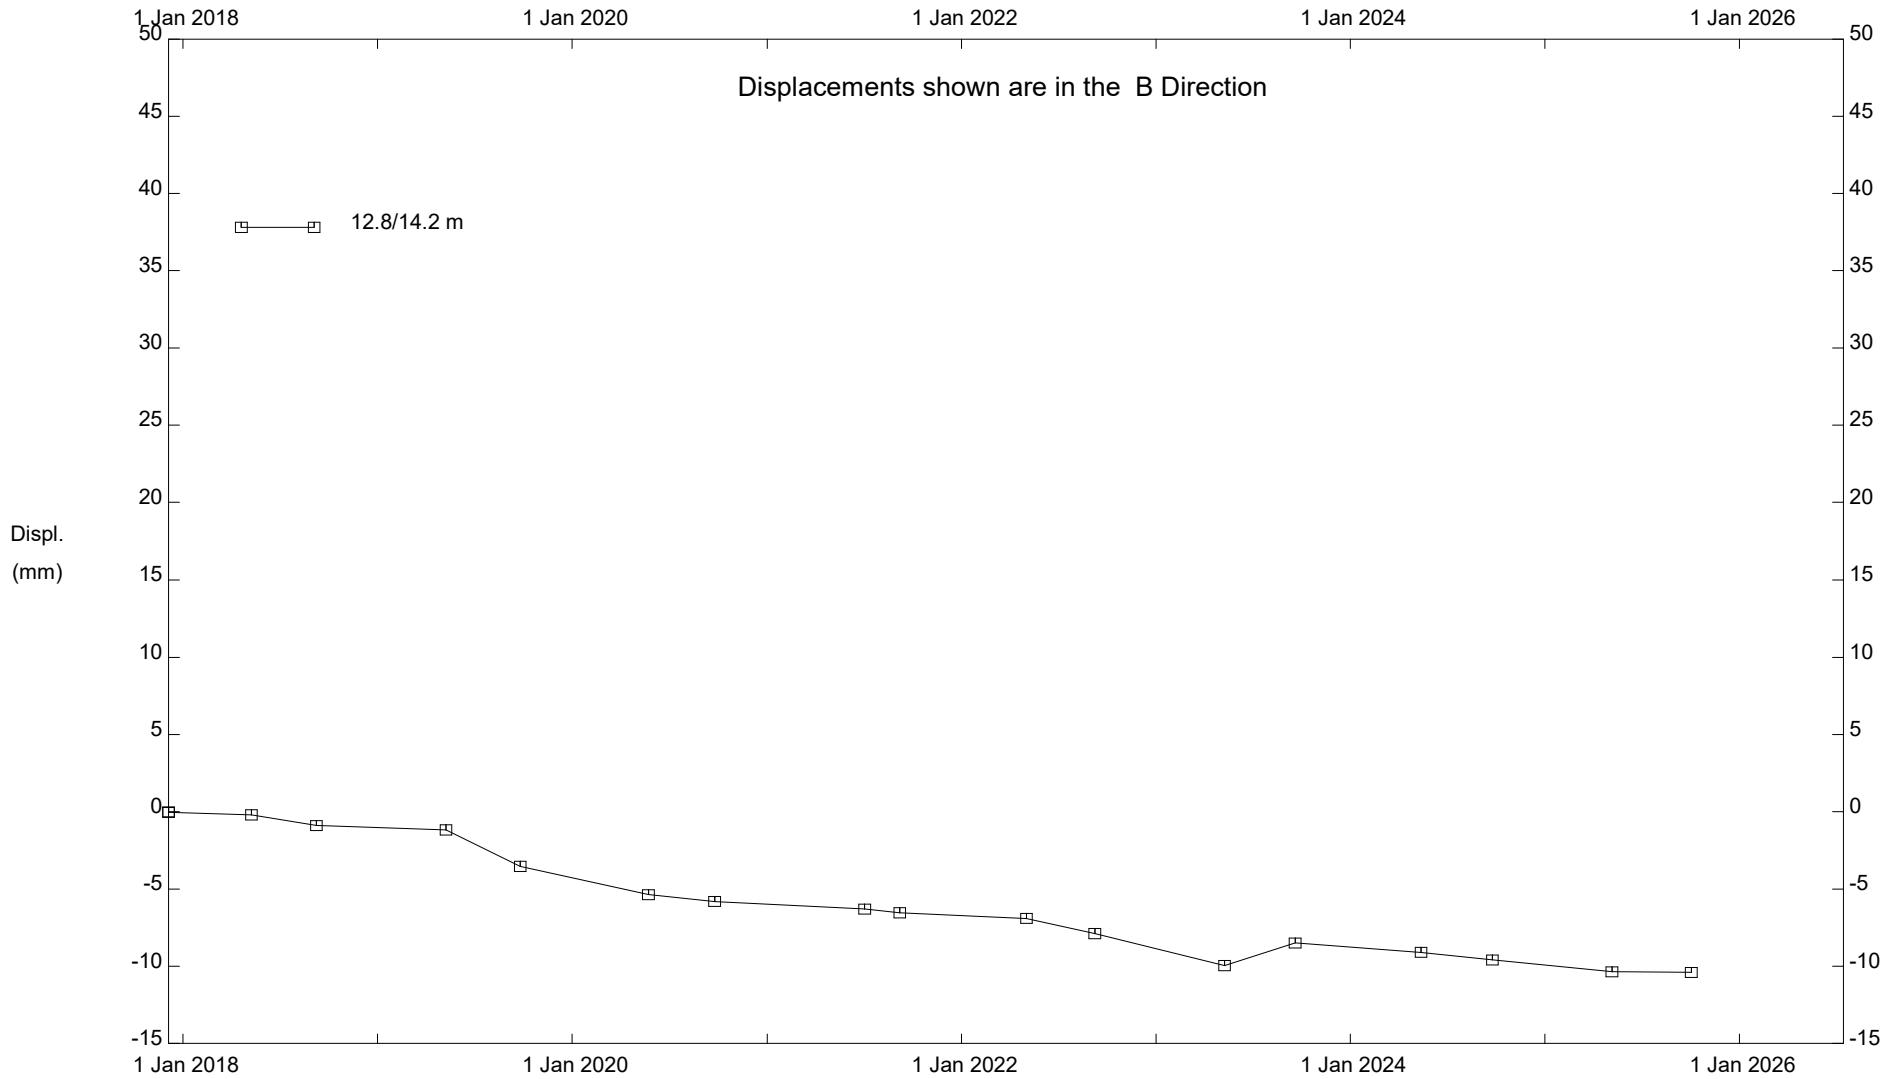
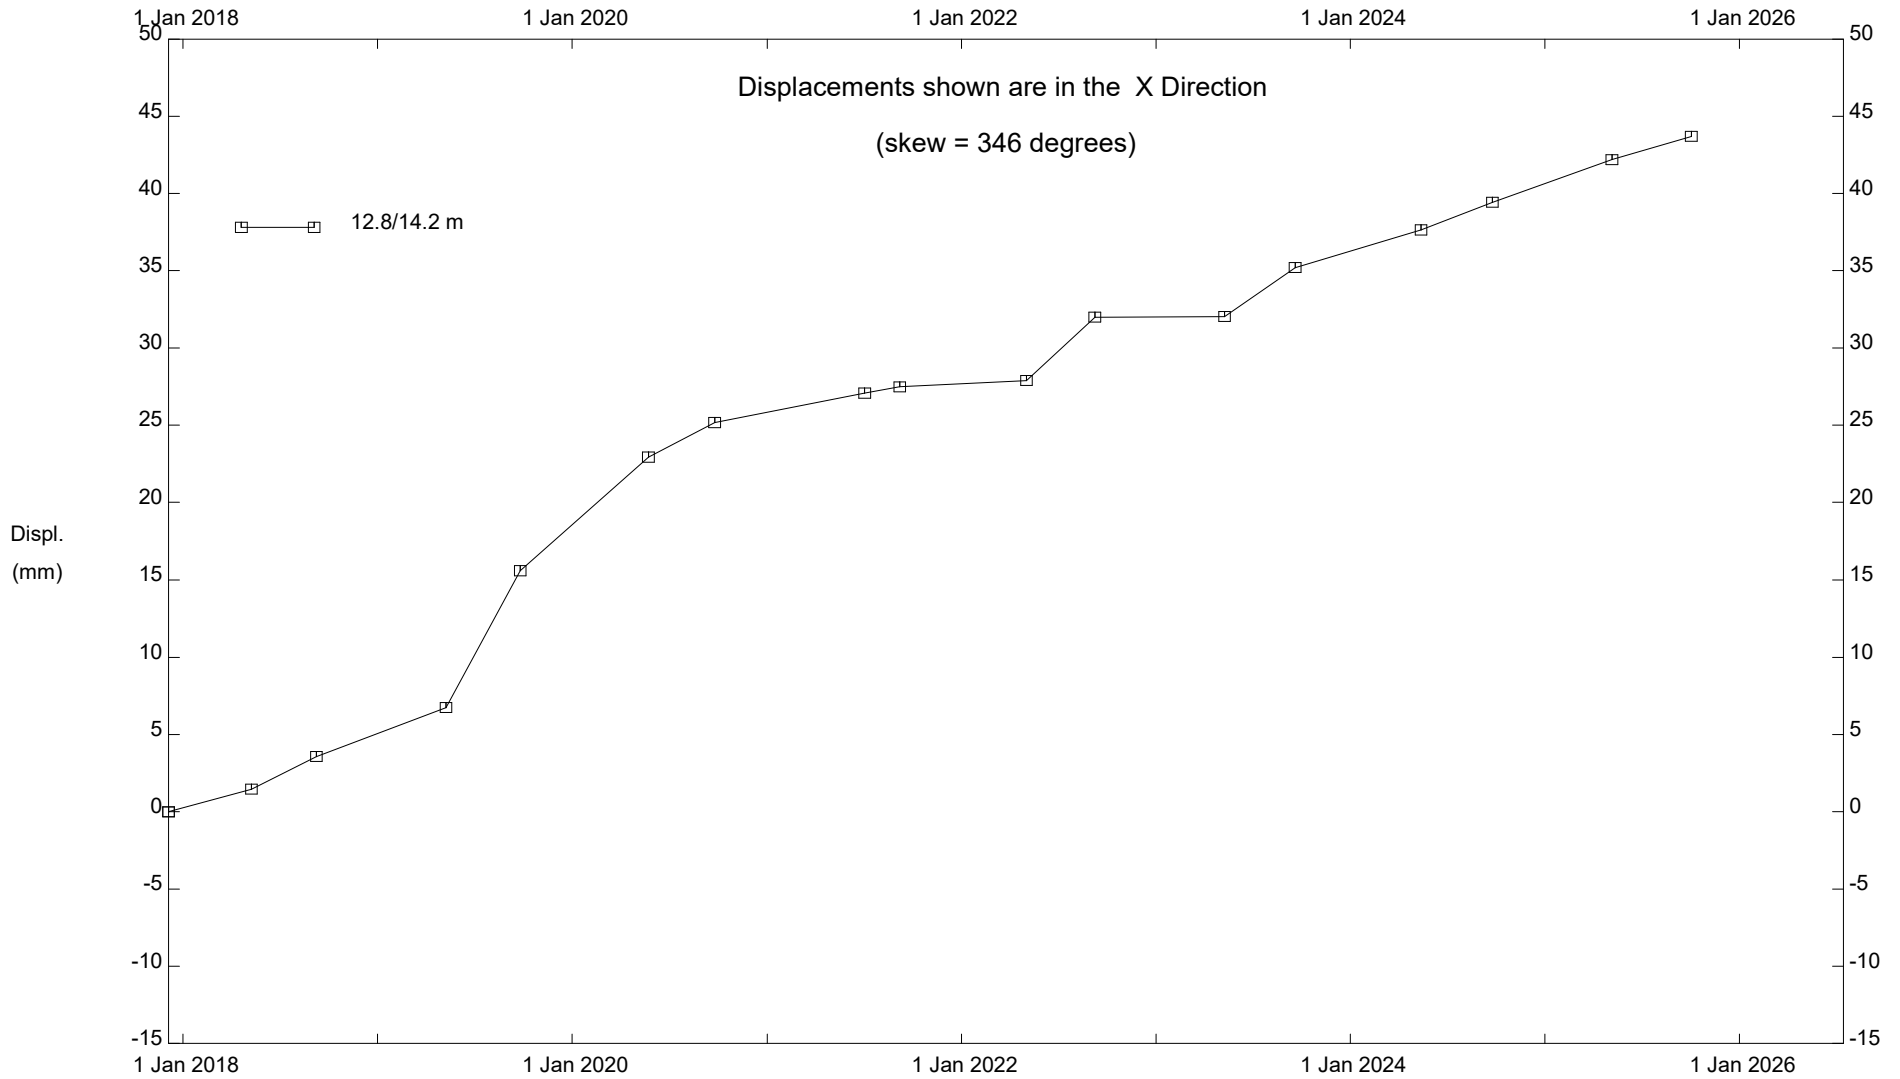
HWY 40:30 West of Wildhay River (NC83), Inclinometer SI17-02

**SI17-02** shows one zone of movement at a depth of 12.8 m to 14.2 m below ground surface and has a current rate of movement of approximately 4 mm/yr with 44 mm of cumulative movement.
