| To: | Amy Driessen | From: | Leslie Cho and Lawrence Onwude |
| File: | 123315222 | Date: | October 31, 2025 |

**Reference: North Central Region, Edson, Site NC083 - Highway 40:30 West of Wildhay River, Fall 2025 Instrumentation Monitoring Report**

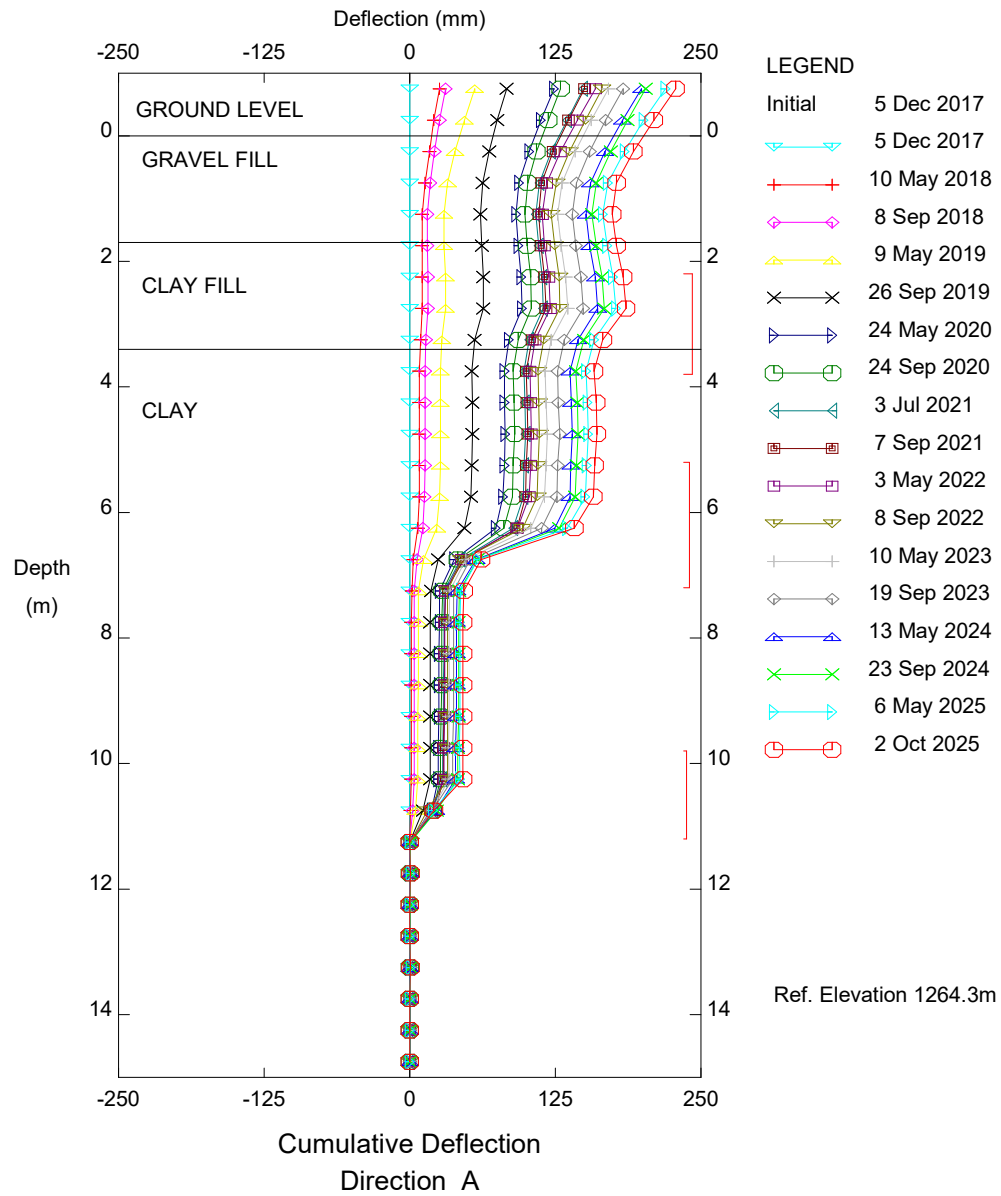
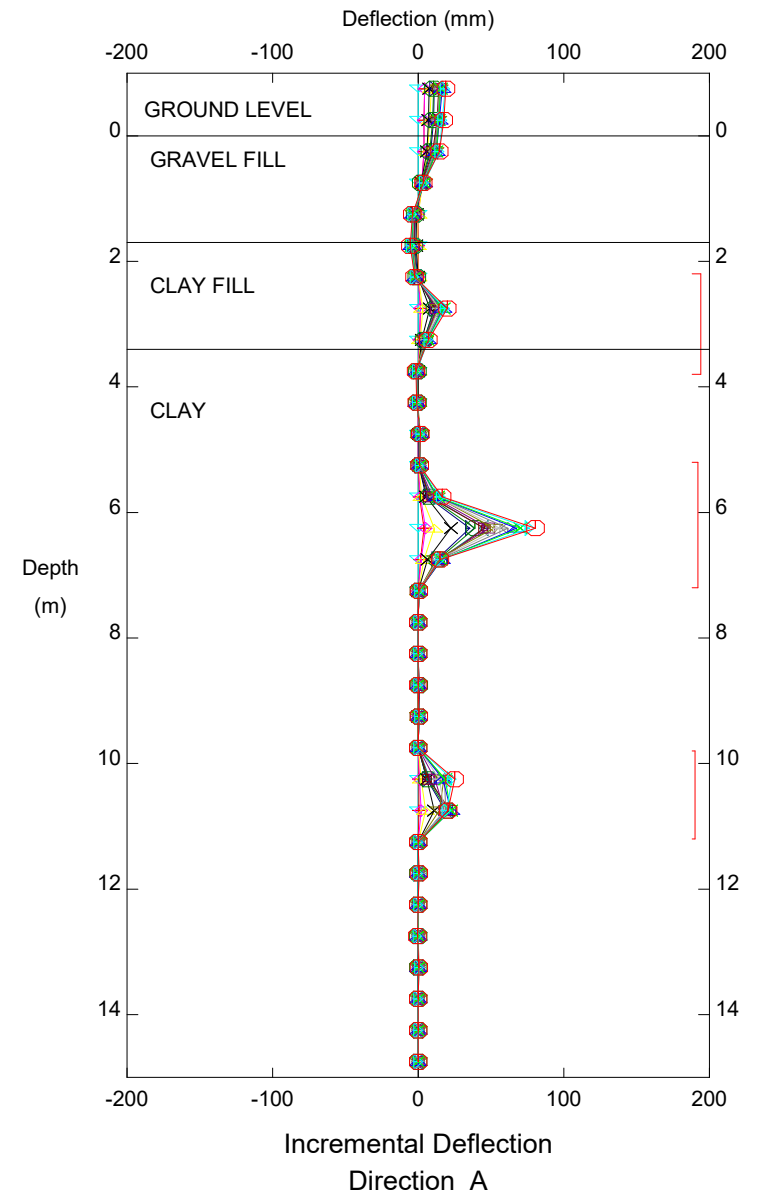
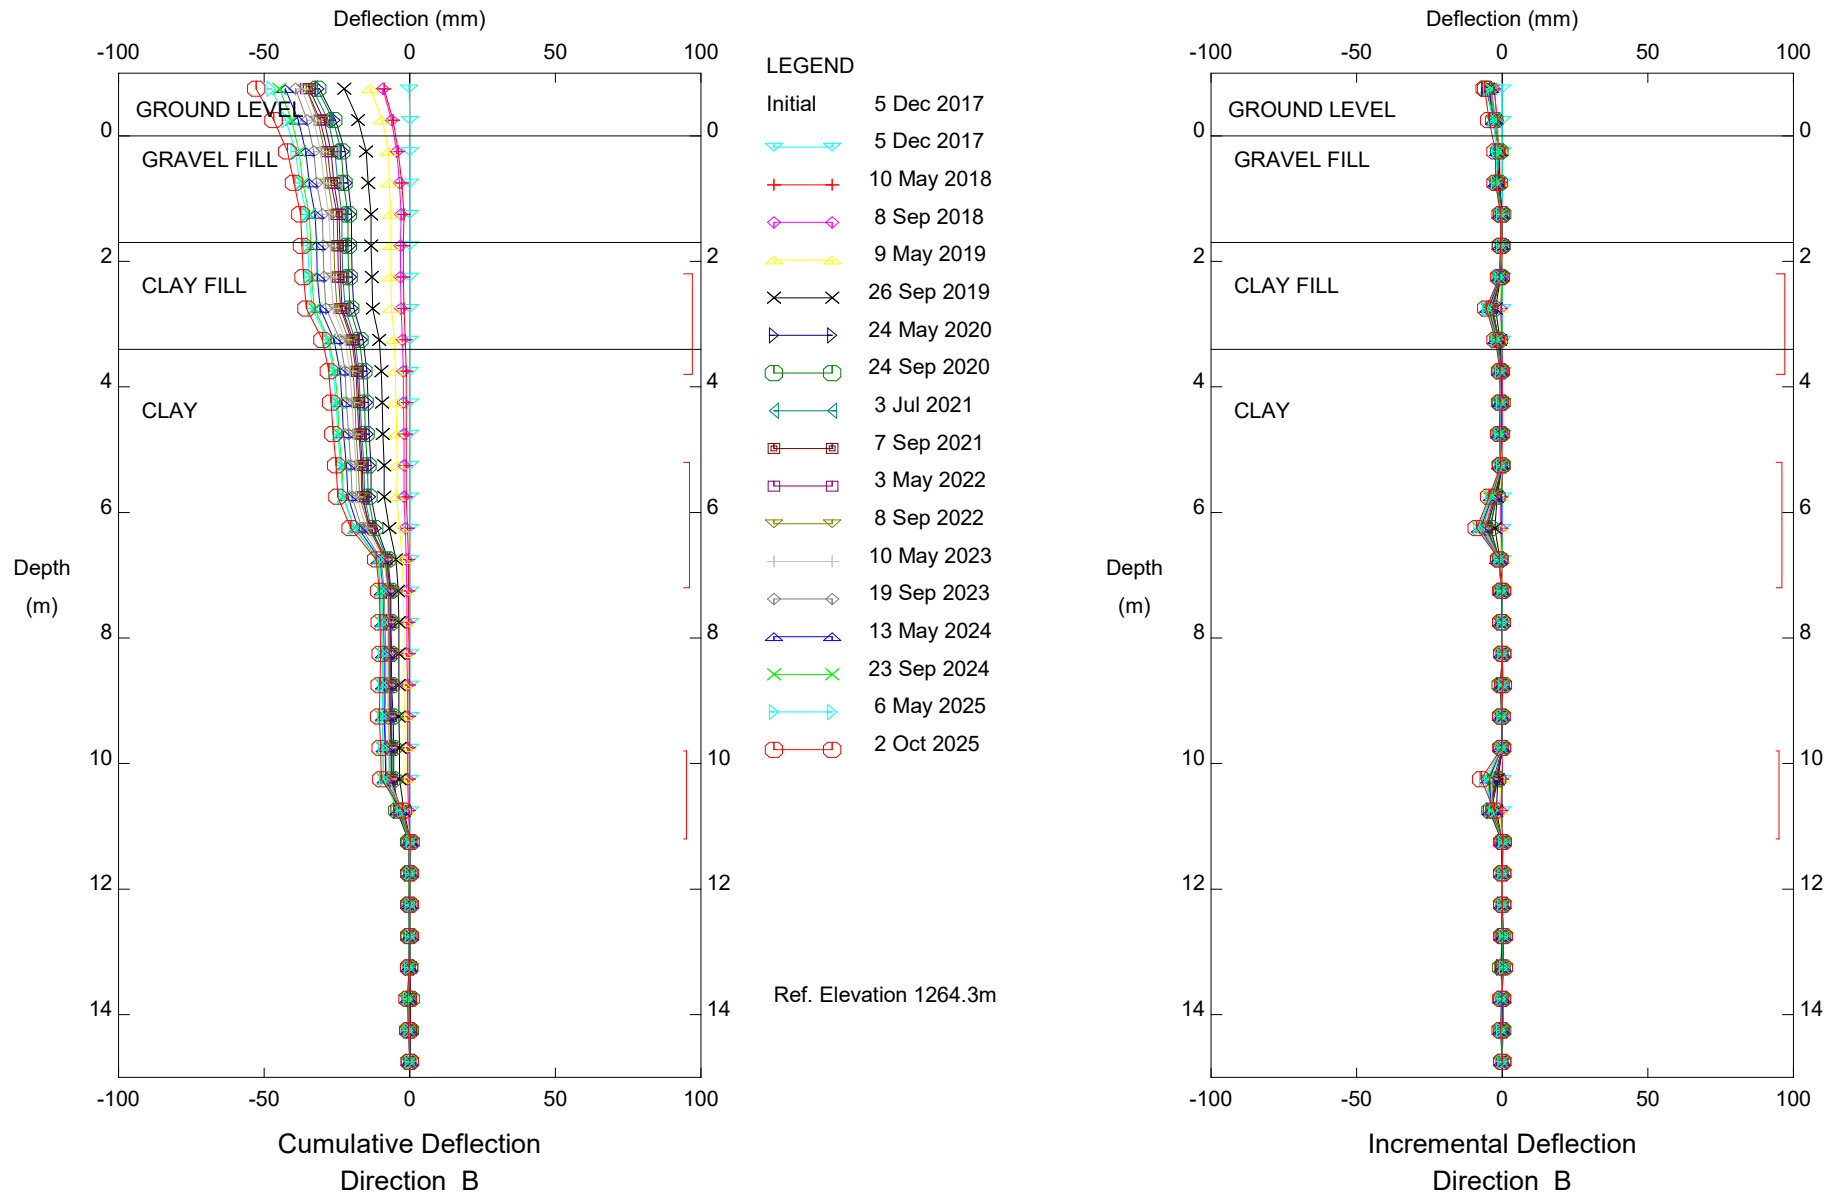
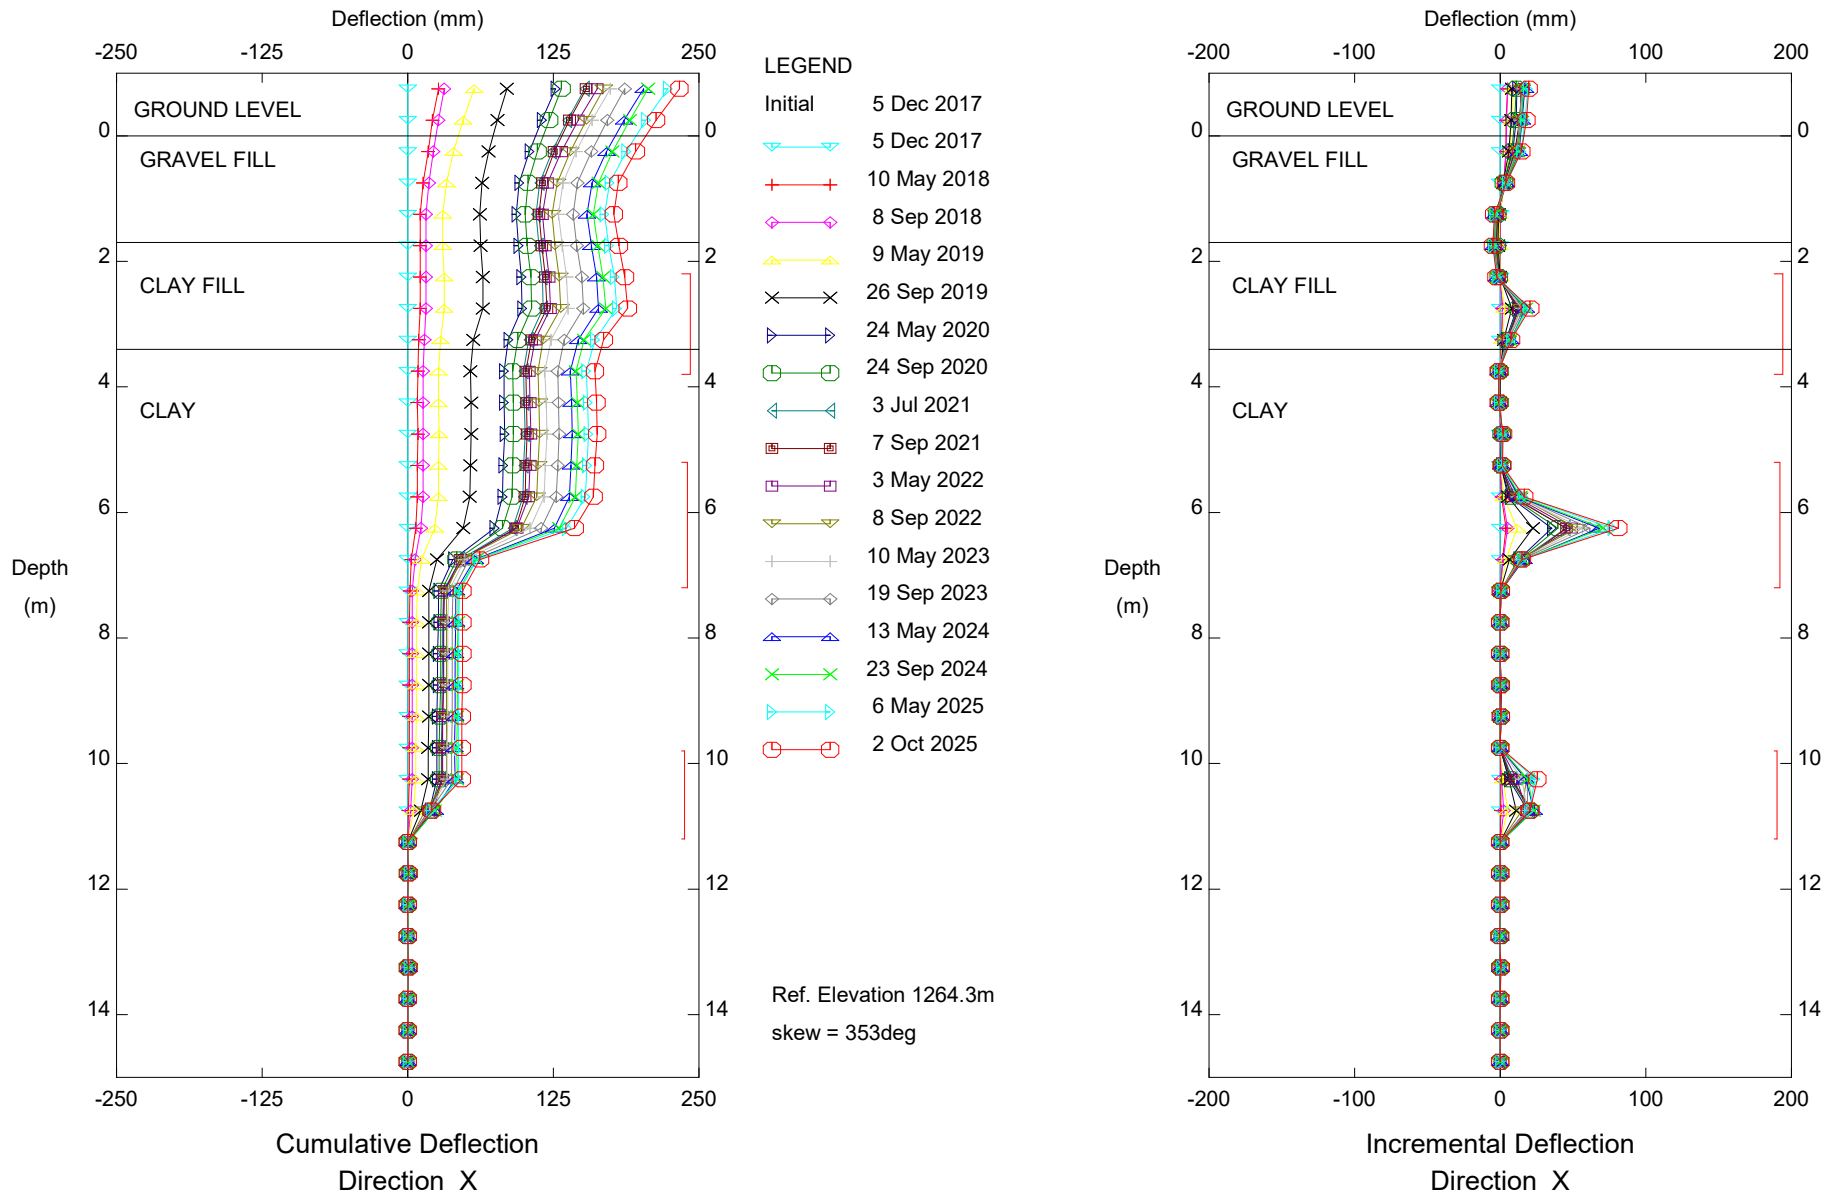
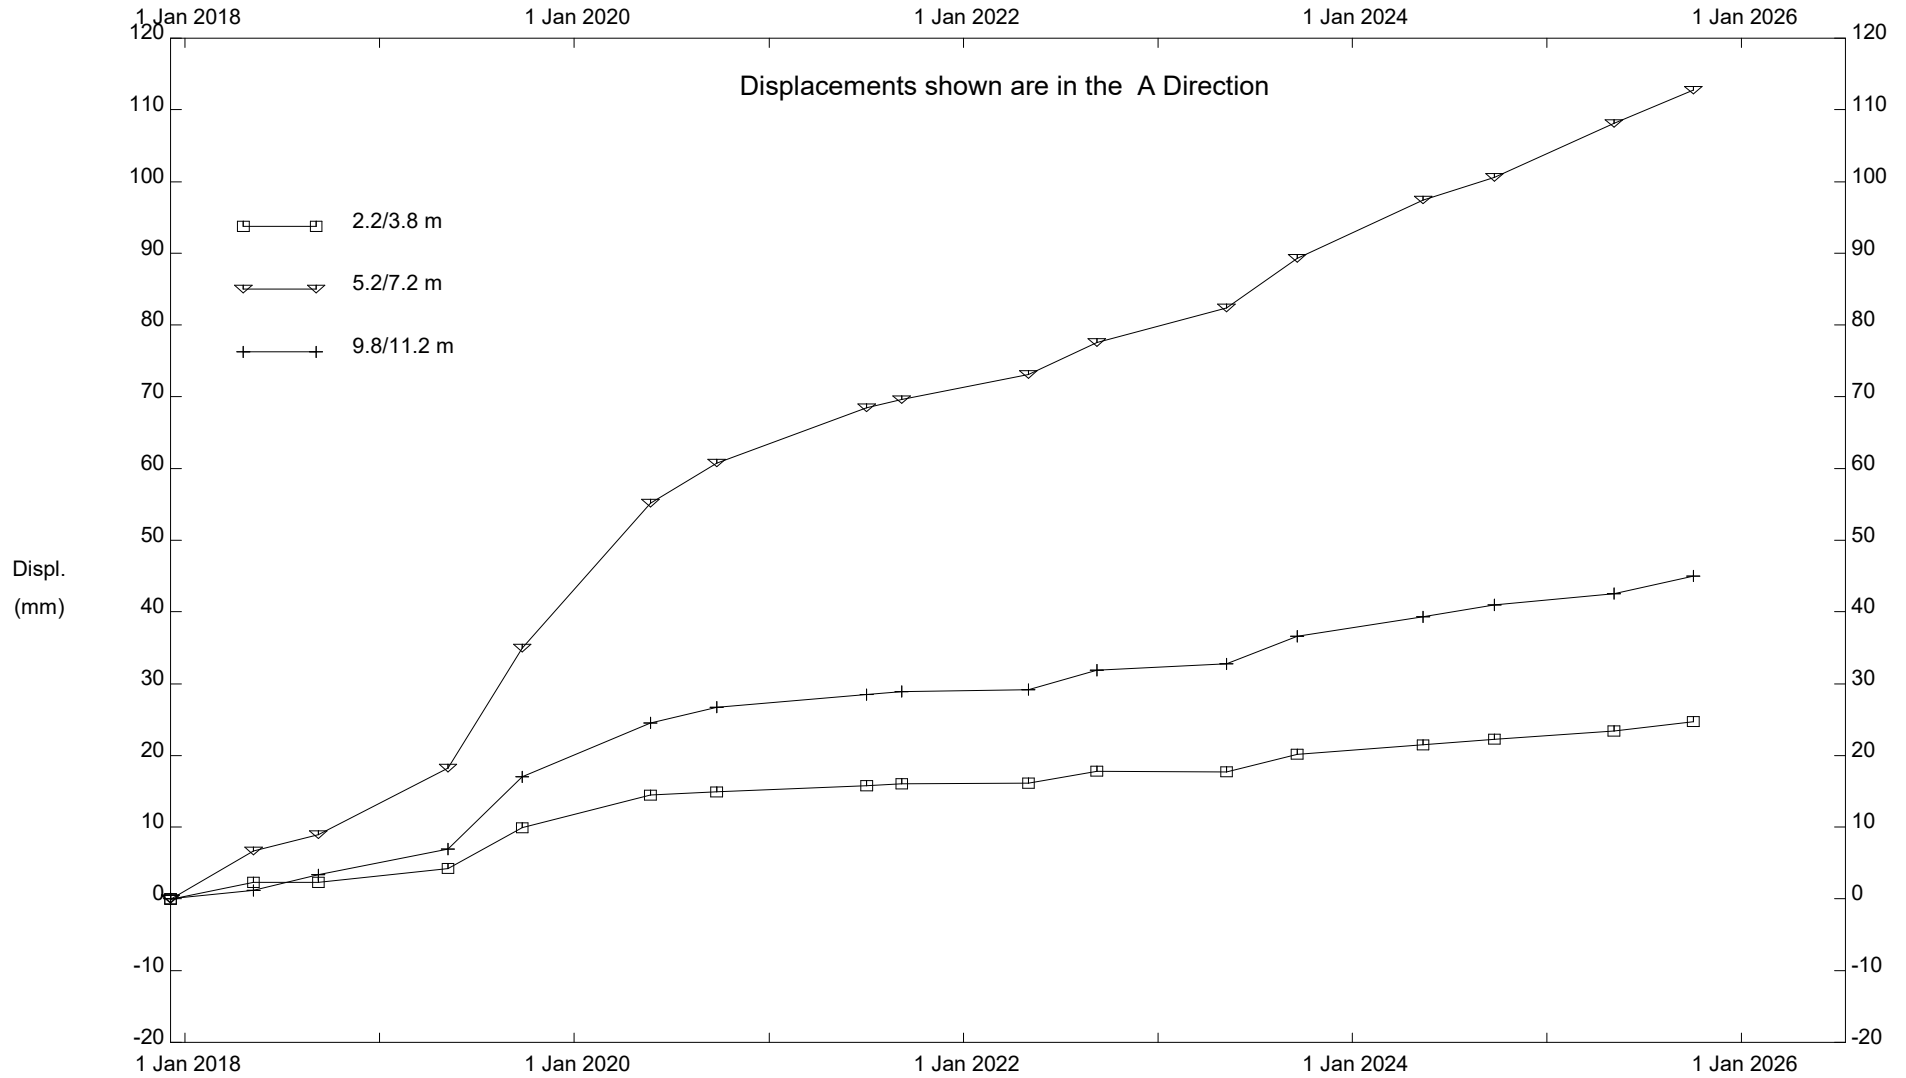
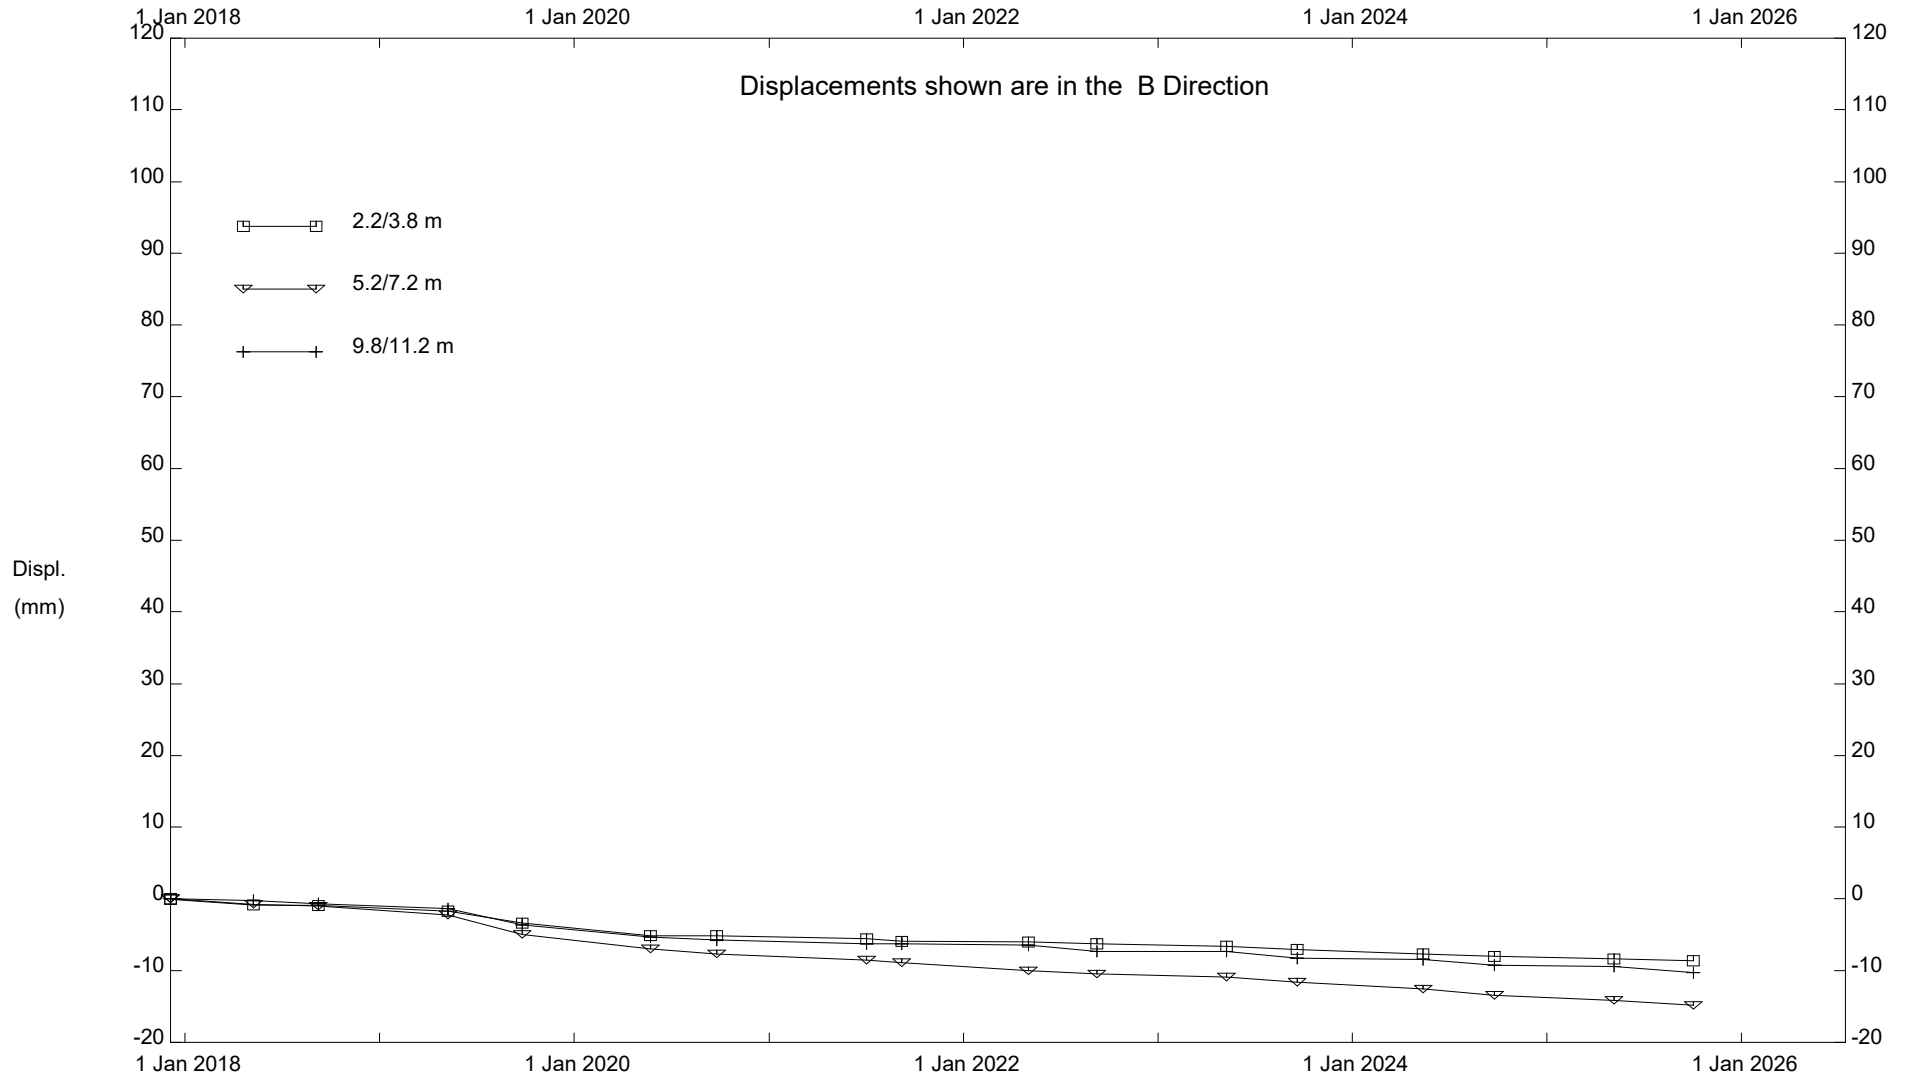
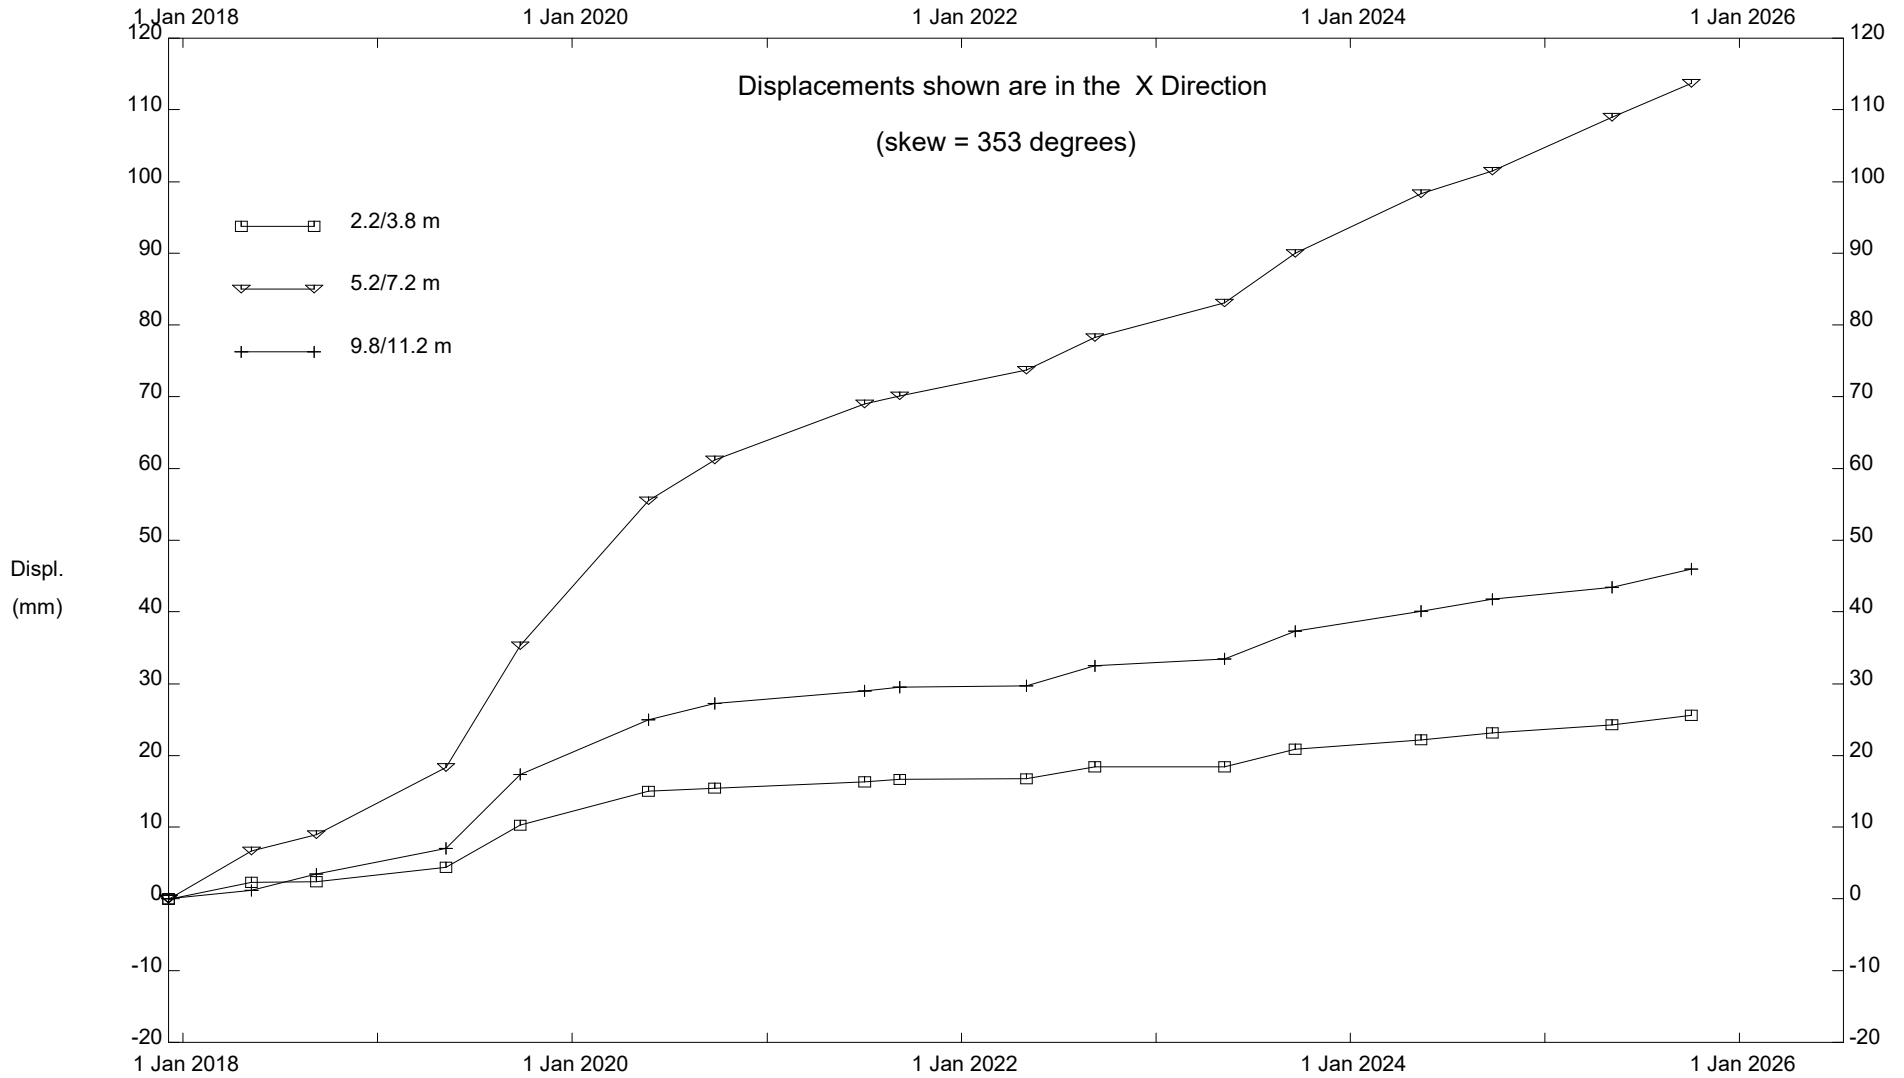
HWY 40:30 West of Wildhay River (NC83), Inclinator SI17-03  
Transportation & Economic Corridors

**SI17-03** has three zones of movement at depths of 2.2 m to 3.8 m, 5.2 m to 7.2 m and 9.8 m to 11.2 m bgs. The upper movement zone is located within the fill and shows a rate of movement of about 3 mm/yr. The middle movement zone shows a current movement rate of 12 mm/yr and the lower movement zone shows a current rate of movement of 6 mm/yr.

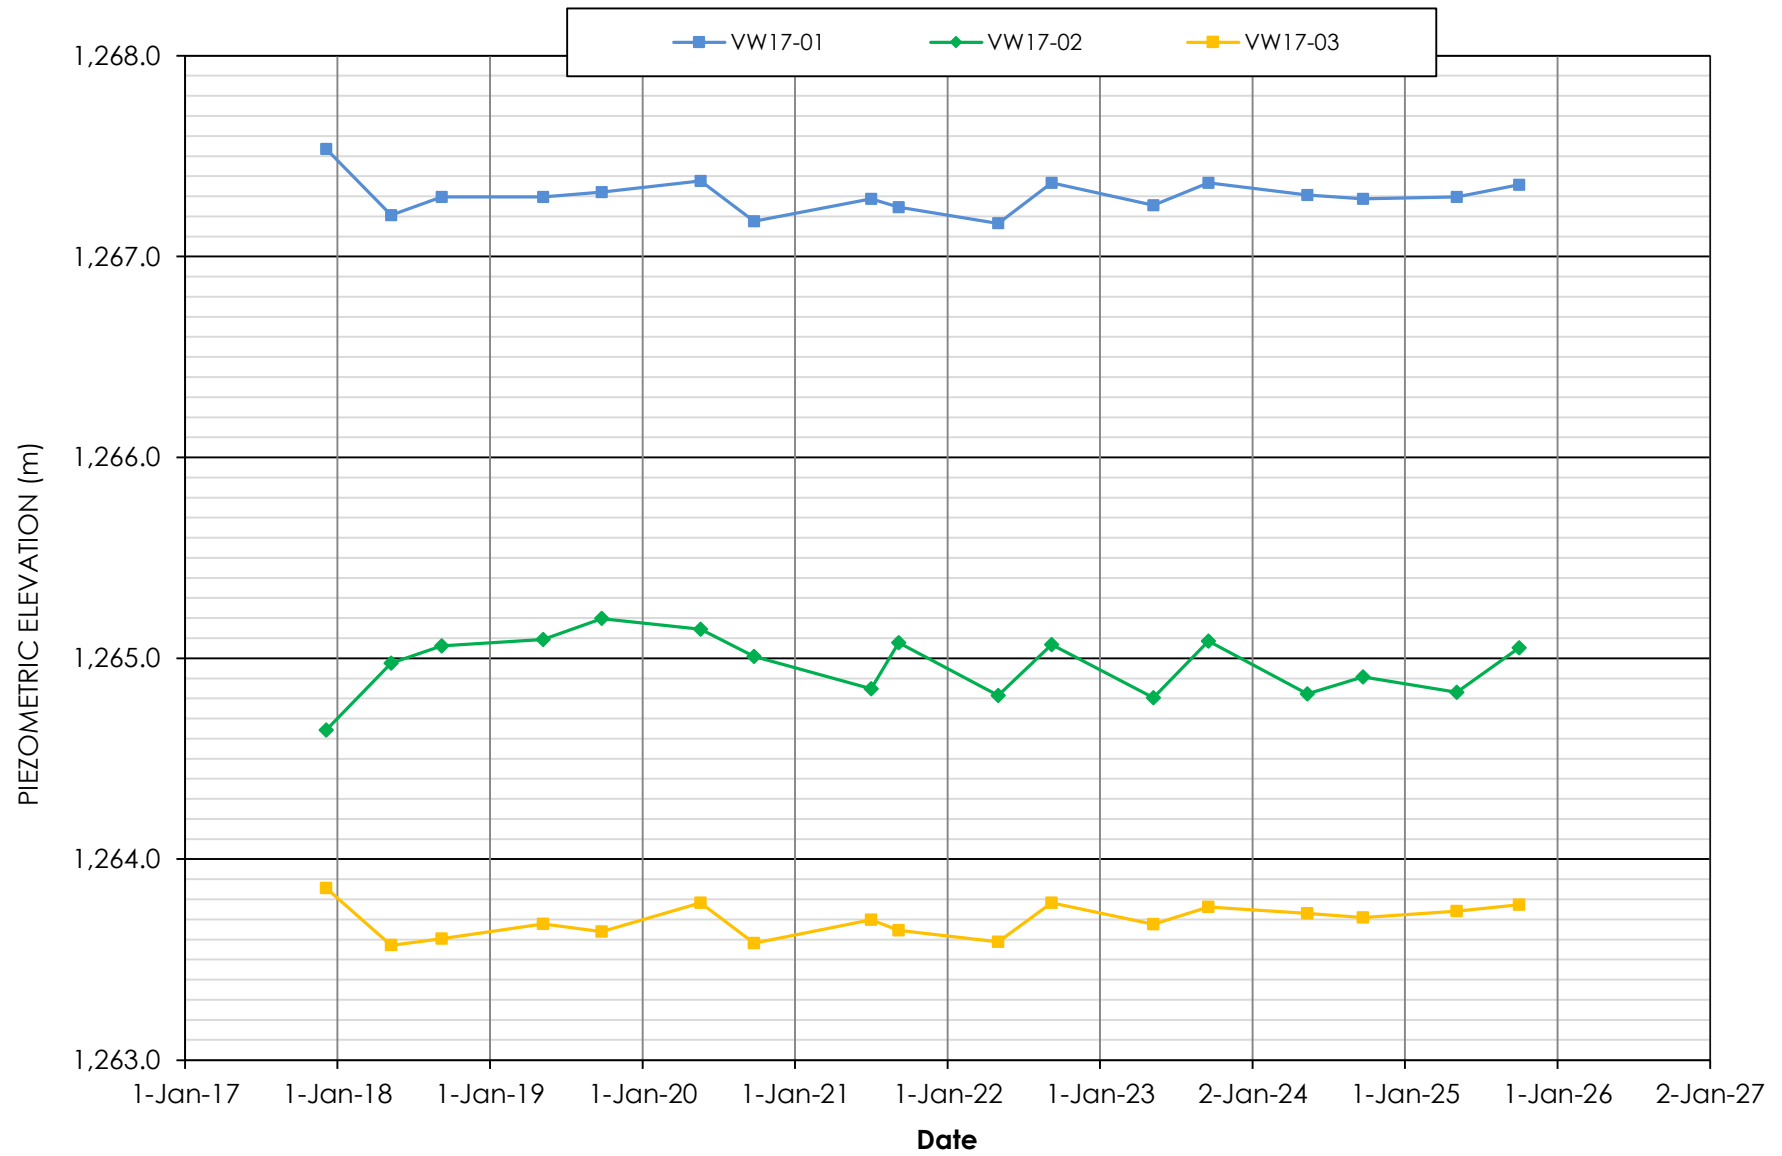
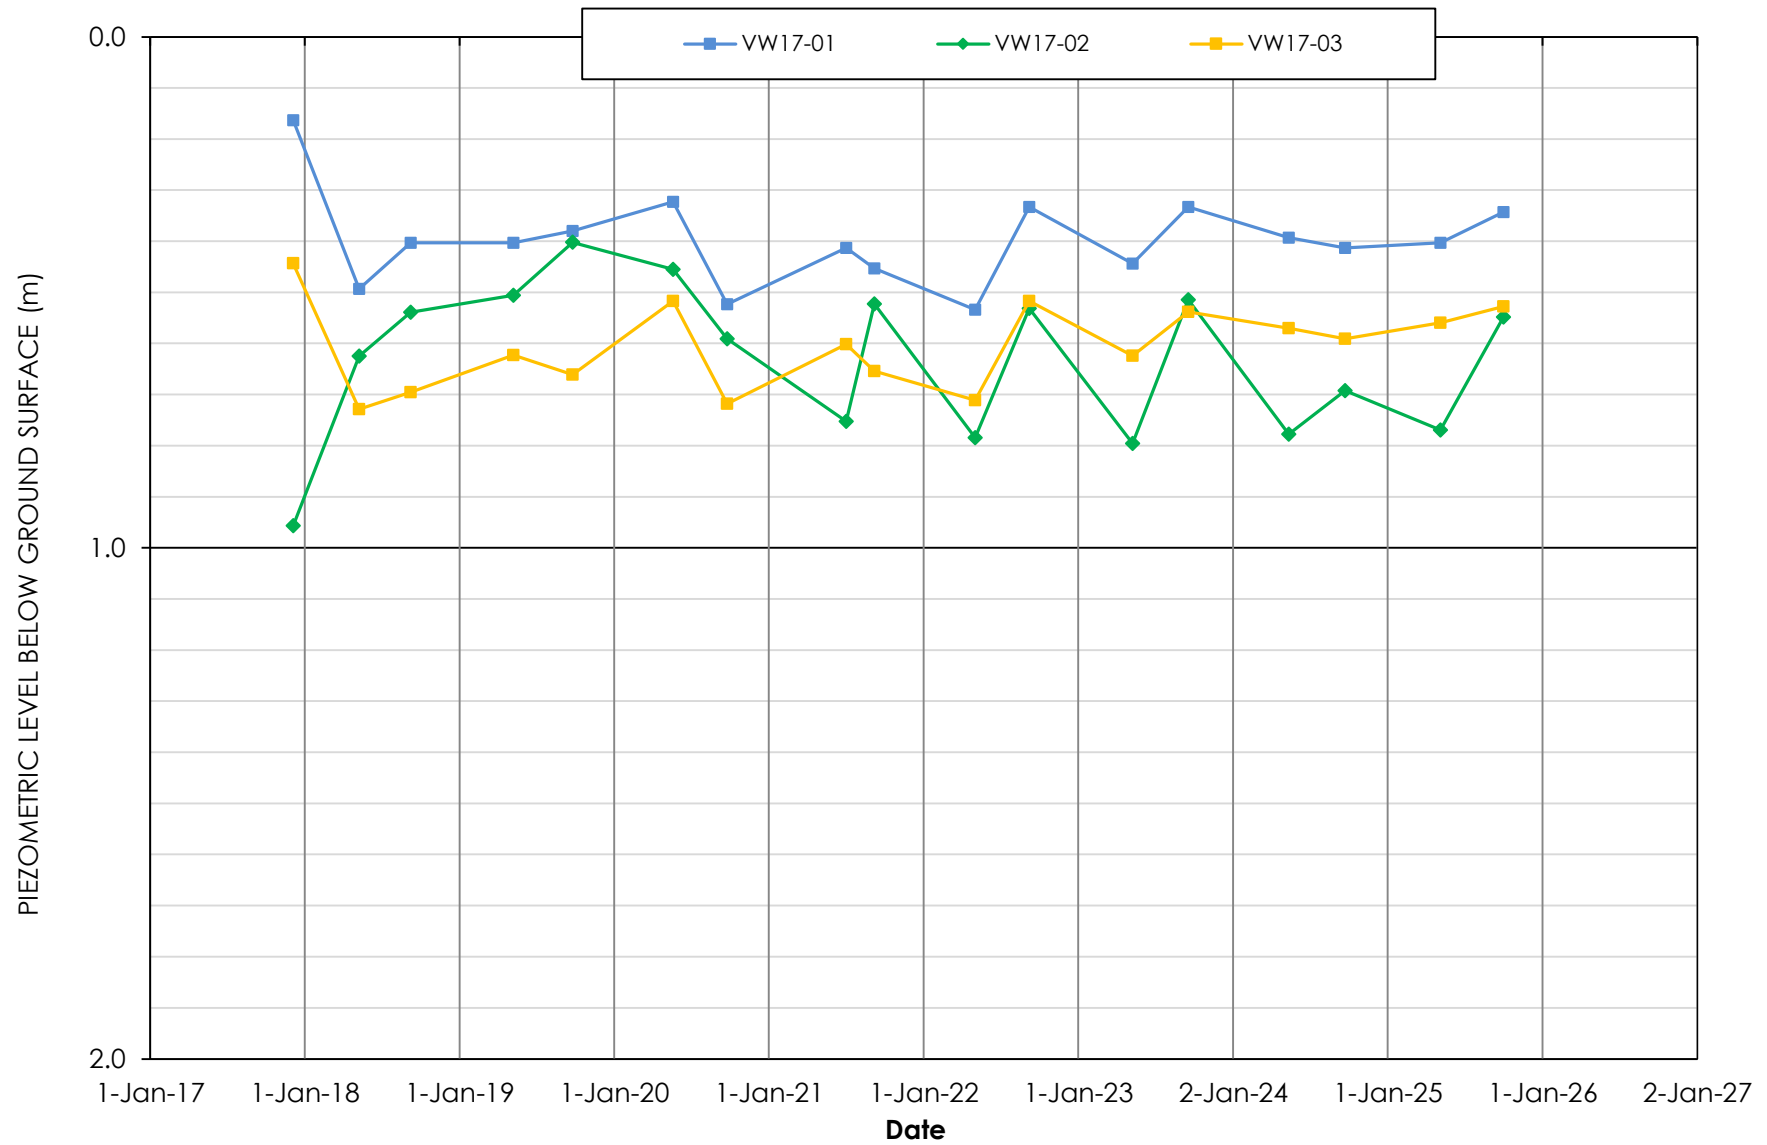
## PIEZOMETER DATA

The piezometers showed a change in water level ranging from an increase of less than 0.1 m to increase of 0.2 m for the current reading cycle. The piezometric levels measured were between 0.3 m and 0.5 m below ground surface (bgs). In general, the piezometric levels have been in the same range since Spring 2018. Seasonal fluctuations of higher groundwater table in the Fall are observed in the piezometers.
