SITE NUMBER AND NAME: NC083 – West of Wildhay River	HIGHWAY AND KM: 40:30, km 37.368	PREVIOUS INSPECTION: June 11, 2024	CURRENT INSPECTION: May 23, 2025
LEGAL DESCRIPTION: SE-08-53-27-W5	NAD83 COORDINATES: UTM11U 5935069N, 437757E		RISK ASSESSMENT: PF: 11 CF: 5 Total: 55
AVERAGE ANNUAL DAILY TRAFFIC (AADT): 1,250 (2024)		CONTRACTOR MAINTENANCE AREA (CMA): 508

Client/Project:
Transportation and Economic Corridors
Geohazard Monitoring Program
NC83 – West of Wildhay River

2025 Site Inspection Photos at NC083

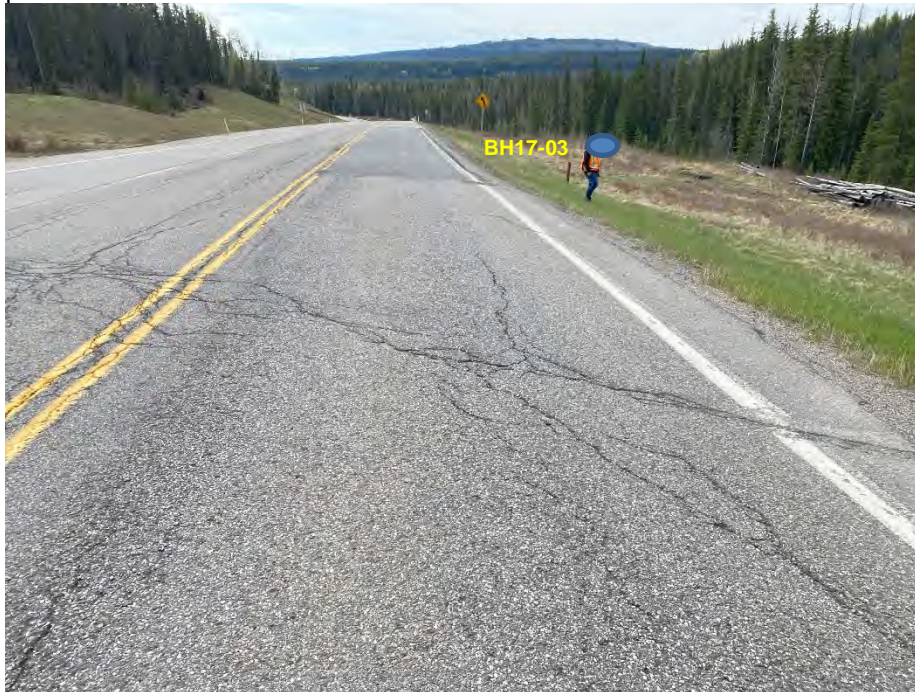
COMMENTS
<ul style="list-style-type: none"> • Pavement cracks not covered by the 2023 milling and filling in the south bound lane (SBL) appeared to have worsened in comparison to the 2024 inspection and consisted of: <ul style="list-style-type: none"> – Semi-circular crack across all 3 lanes at the entrance to the gravel pit access road shows additional, small cracks forming nearby (Photos 1 and 11). – Semi-circular crack along SBL between BH17-02 and BH17-03 appears similar to 2024 with some additional smaller cracks nearby. – 50 mm high crack along SBL shoulder northwest of BH17-03, extending past the C/L culvert crossing. – 20 mm wide pavement crack along the alignment of the C/L culvert, reflecting through pavement patch, appears similar to 2024 (Photo 5).

Photo 1: Pavement cracking in SBL near BH17-02. Looking southeast.

- All pavement cracks should be sealed to reduce surface water infiltration into the landslide.
- Riprap or gravel should be placed at the C/L culvert outlet. If the erosion is left unchecked, it could lead to further channeling and embankment movement.

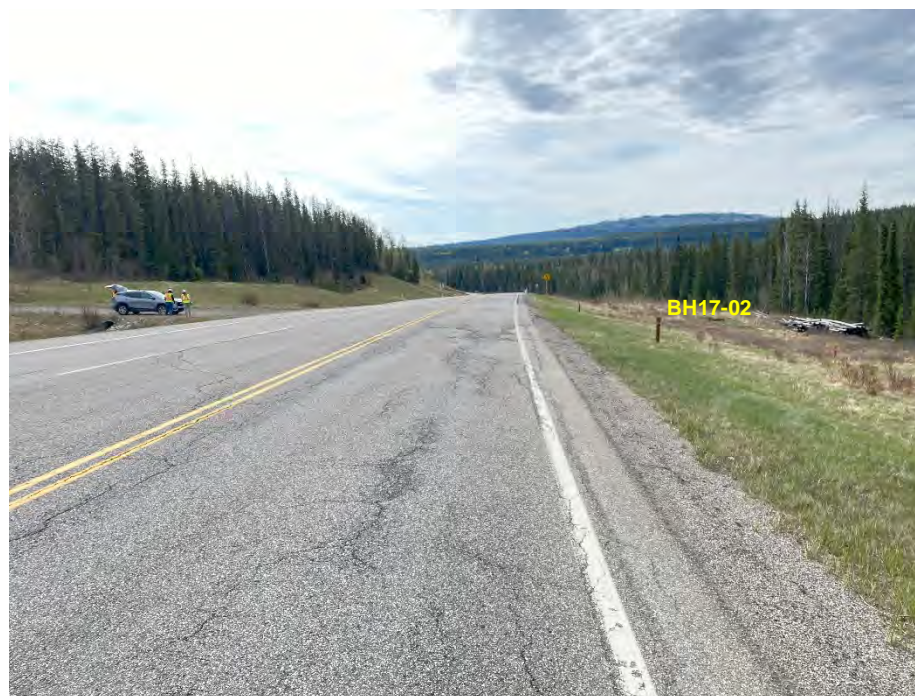
Photo 2: Pavement cracking on highway near BH17-02. Looking southeast.

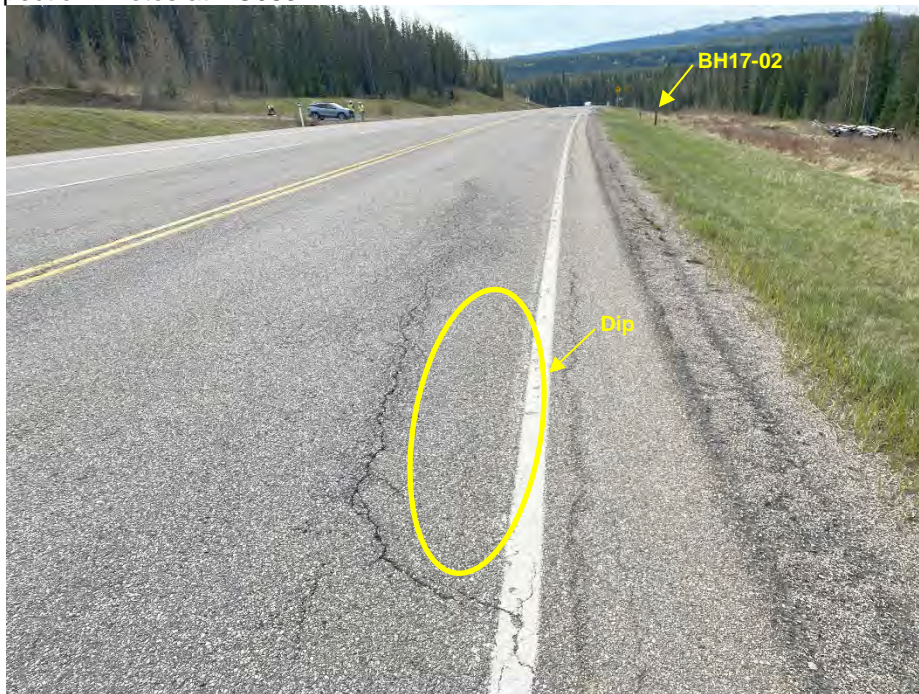
- New curved crack observed on south side of SBL, north from BH17-02. Small dip (approx. 10 mm) apparent in the pavement surface (Photo 3).
- Additional pavement cracks originating near the highway centerline and curving towards the south were observed further south from the C/L culvert (Photo 4).

Photo 3: New cracking and ~10 mm dip in SBL northwest from BH17-02 and north from vehicle tracks with seepage. Looking southwest.

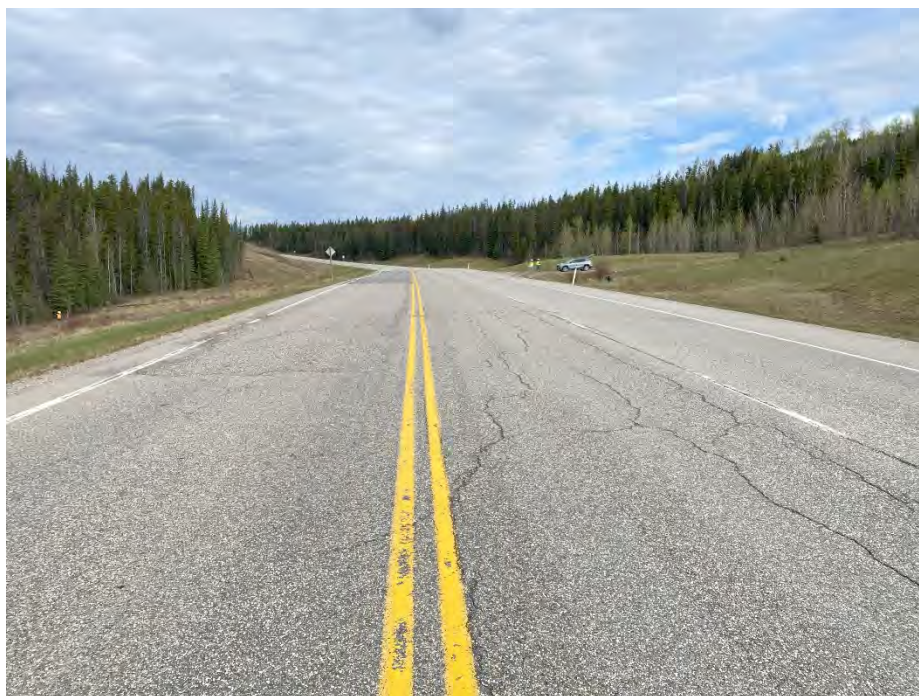
Photo 4: Curved cracks extending further south. Looking northwest.

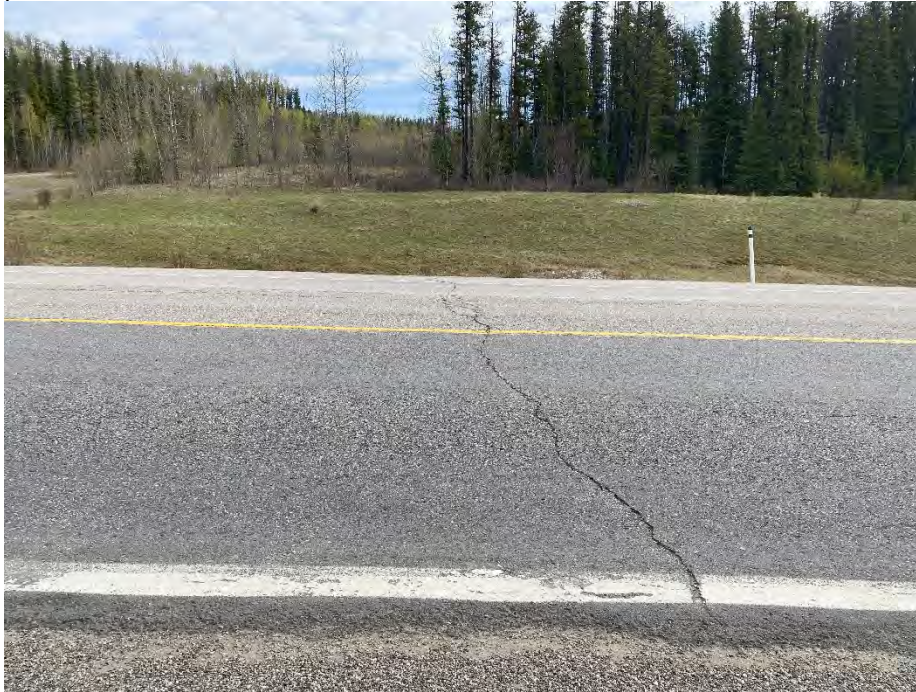
Photo 5: Pavement crack along C/L culvert alignment. Looking northeast.

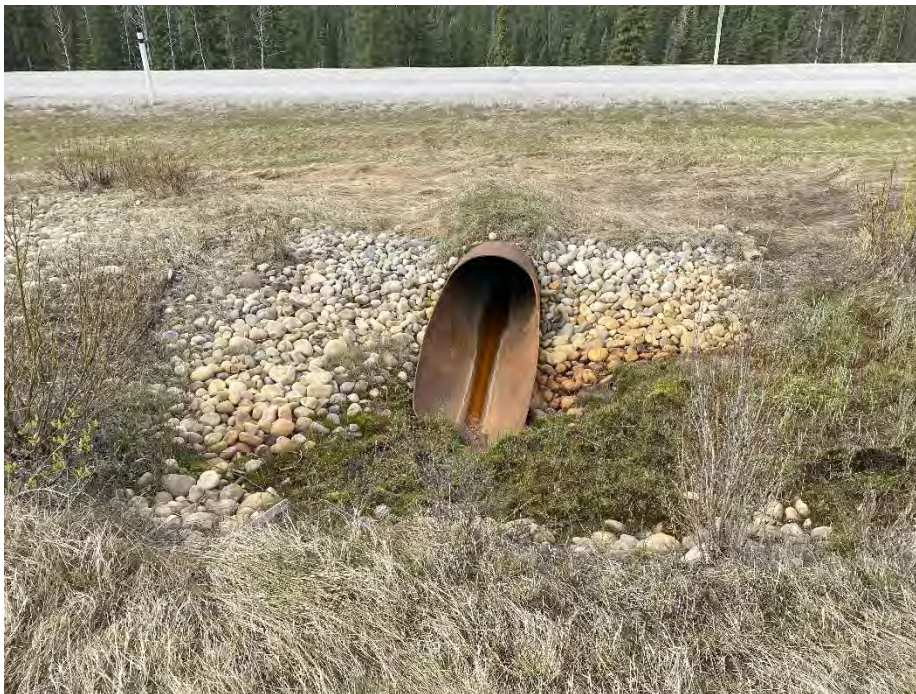
- The angled pavement crack within the northern end of the milled and filled section of the SBL has begun to reflect.
- Both culverts at the site appear to be in good condition. The ditch near the inlet of the C/L culvert is saturated and soft (Photo 6). The erosion channel at the C/L culvert outlet was about 400 mm wide and deep, similar to 2024. The C/L culvert outlet continues to be blocked by vegetation resulting in slow drainage out of the culvert (Photo 7).

Photo 6: North ditch at C/L culvert inlet. Looking southwest.

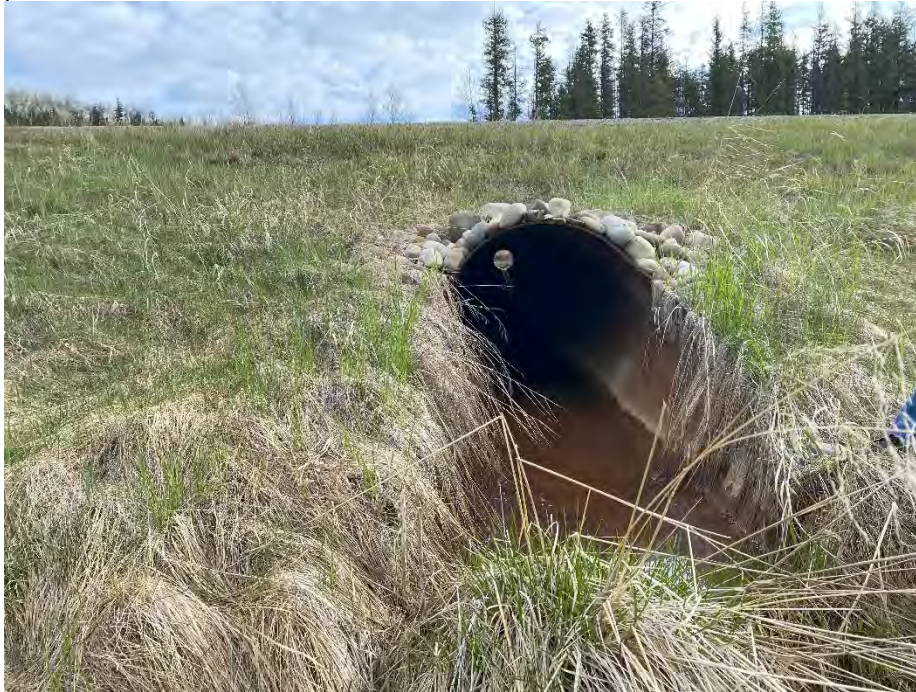
Photo 7: Vegetation blocking C/L culvert outlet. Looking northeast.

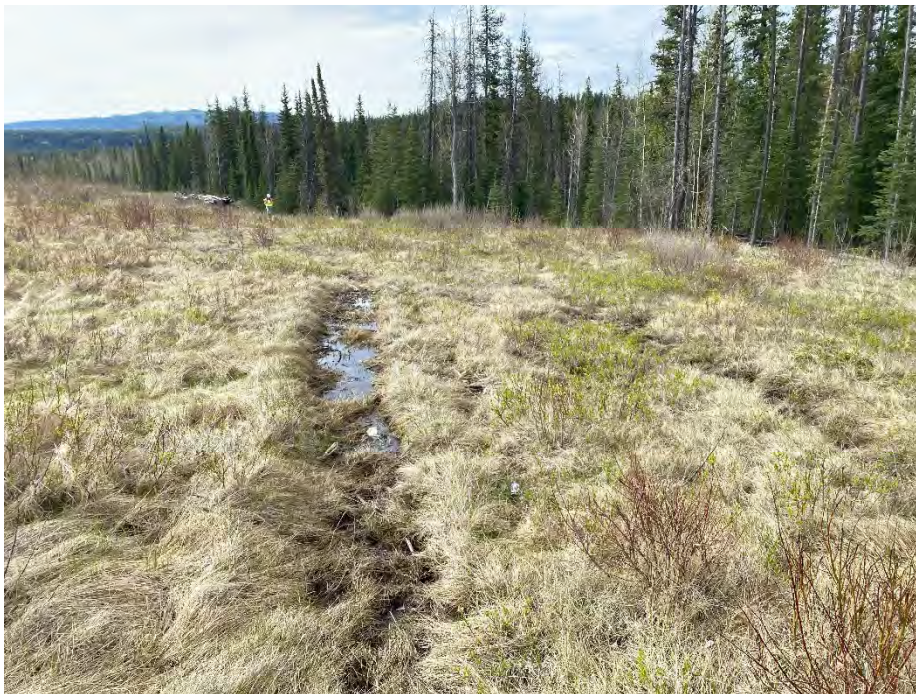
- The south slope has a “hummocky” appearance and was soft and spongy to traverse (Photos 8 to 12).
- Erosion features with ponded water were observed near the timber stockpile, in a similar condition to the previous site inspection.

- Seepage was observed in the previously observed vehicle tracks at the south slope and northwest of BH17-02 (Photo 8).
- Seepage has formed a new erosion channel southeast of BH17-01 (Photos 10 and 11). Two areas were found to have ponded water and saturated, soft ground, lacking vegetation.

Photo 8: Seepage in vehicle track northwest from BH17-02. Looking southeast.

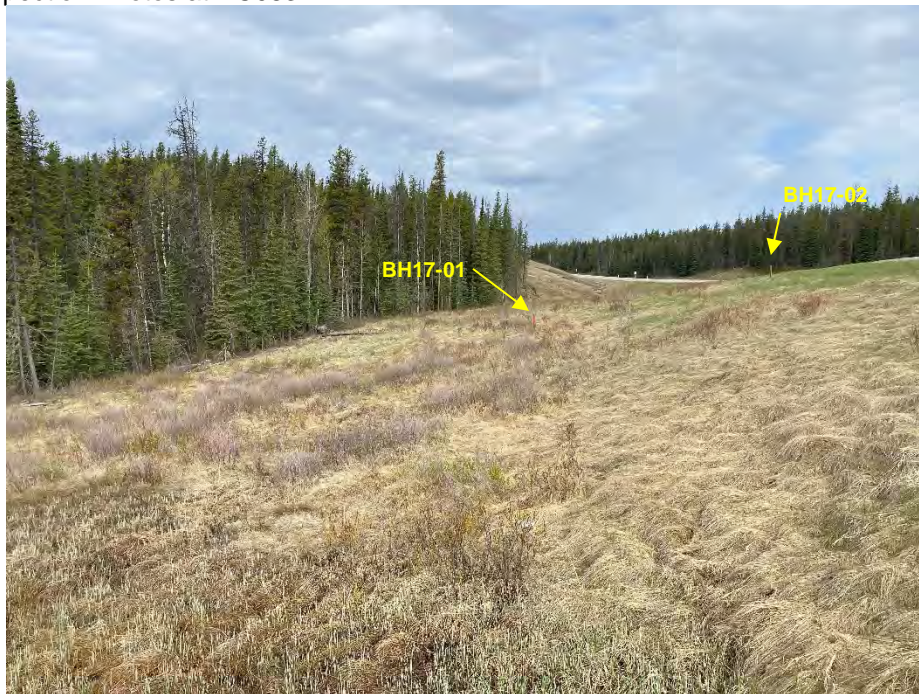
Photo 9: Overall view of south slope. Looking northwest.

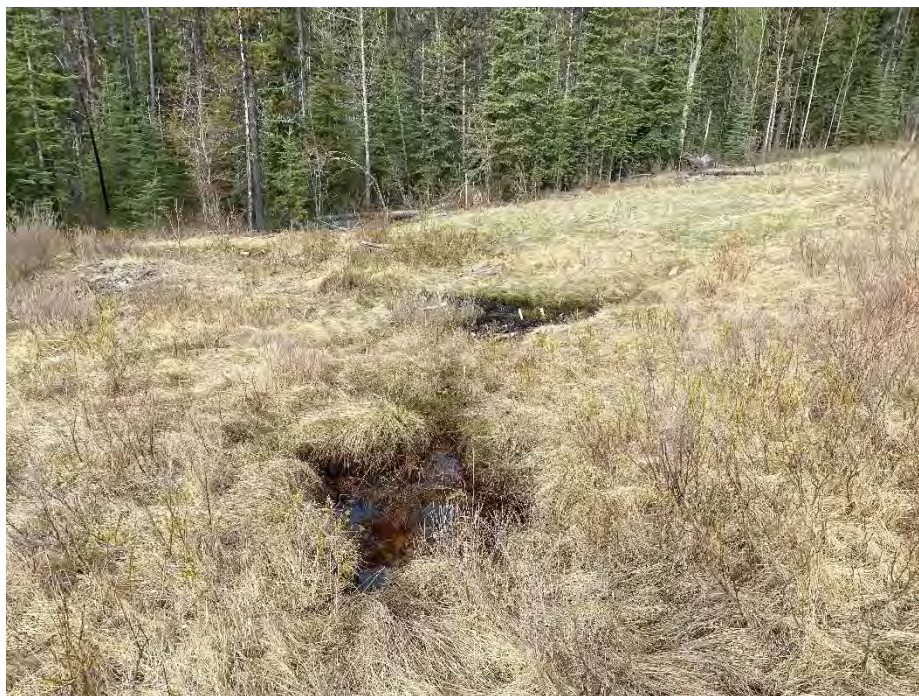
Photo 10: Saturated ground with ponded water and erosion channeling near BH17-01 on south slope. Looking southwest.

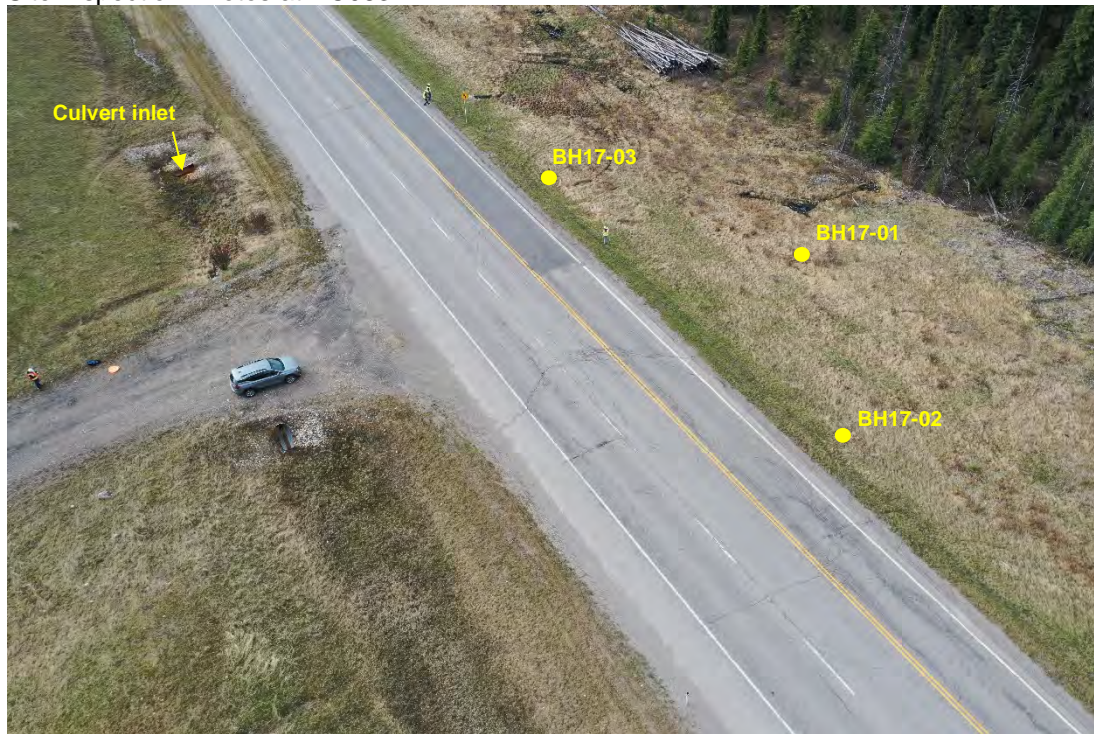
Photo 11: Site overview photo, taken by drone. Looking south.

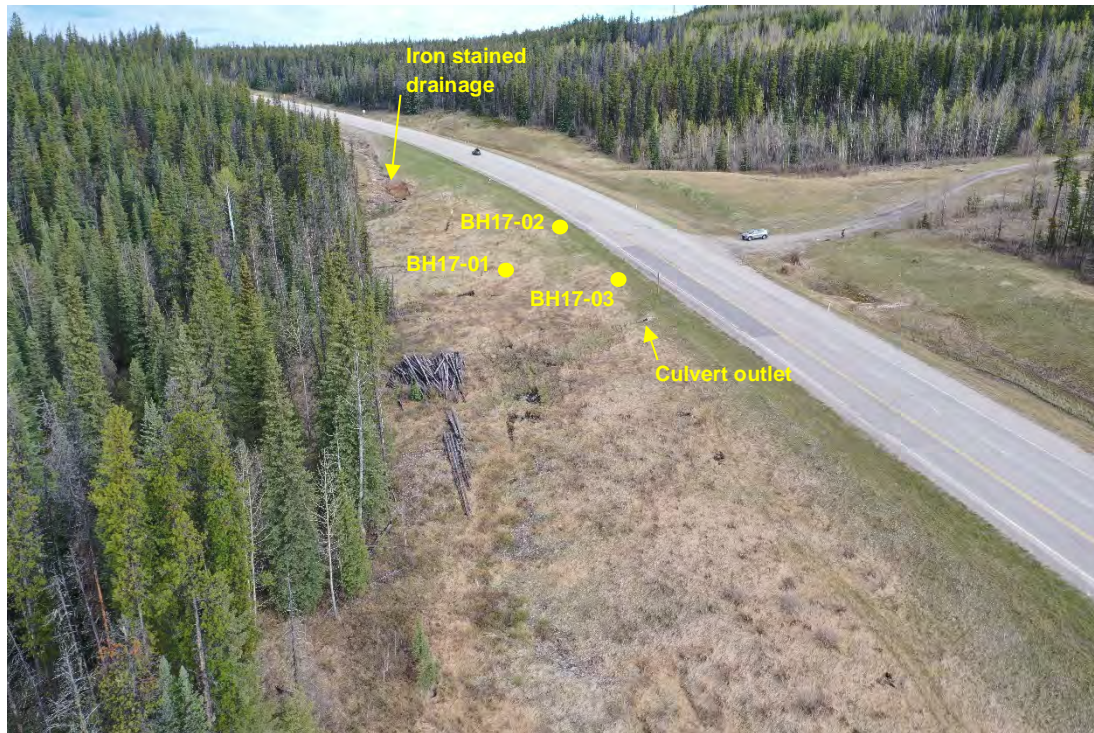
- Water was observed to be flowing into the creek / drainage from the western ditch into the channel that runs south from the site. Iron staining was observed within the western ditch (Photo 12).

Photo 12: Site overview photo, taken by drone. Looking north.
