SITE NUMBER AND NAME: NC081 – Evansburg Slide	HIGHWAY AND KM: 16A:08, km 8.230	PREVIOUS INSPECTION: June 13, 2024	CURRENT INSPECTION: May 20, 2025
LEGAL DESCRIPTION: SW 30-53-07-W5M	NAD83 COORDINATES: UTM11U 5941007N, 630586E		RISK ASSESSMENT: PF: 3 CF: 3 Total: 9
AVERAGE ANNUAL DAILY TRAFFIC (AADT): 550 (2024)		CONTRACTOR MAINTENANCE AREA (CMA): 508

TRANSPORTATION AND ECONOMIC CORRIDORS
GEOHAZARD MONITORING PROGRAM
NC81 HWY 16A:08, KM 8.23 EVANSBURG SLIDE
SITE PLAN

2025 Site Inspection Photos at NC081

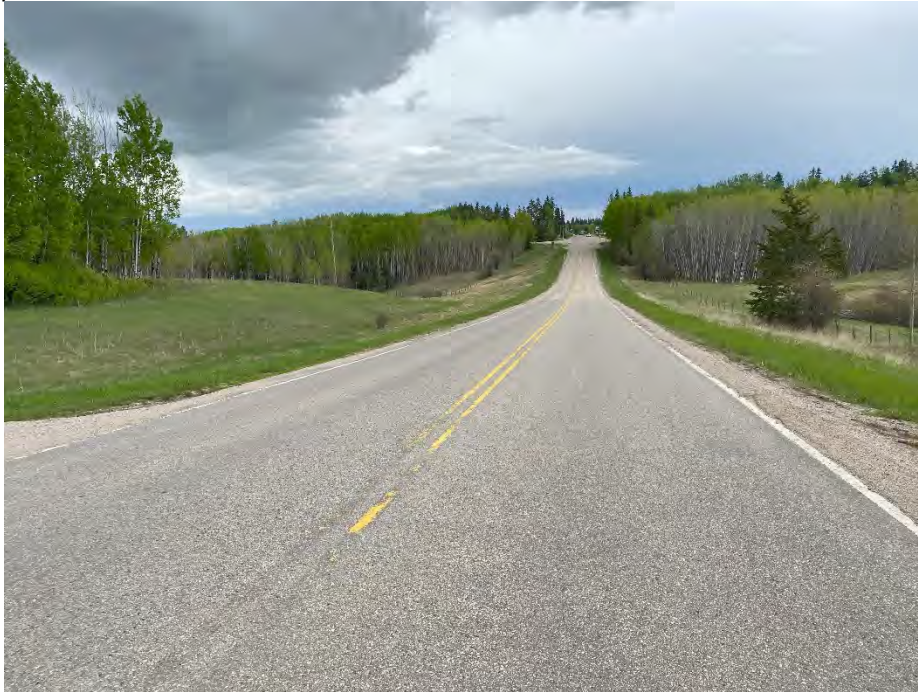
COMMENTS
<ul style="list-style-type: none"> Pavement cracks approximately 3 mm to 5 mm wide and 250 mm long were observed in the westbound lane's northern wheel path, and appear similar to the 2022 inspection. The repaired pavement appears in good condition (Photos 1 & 9) Pavement cracking was observed on either side of the 2021 repair zone due to the joint between old and new pavement (Photos 2 & 3). SI21-01 and SI21-02 are installed within the pile wall. Small deflections were observed at the pile top which is likely due to loading and deflection of the pile wall. Piezometric levels range from 2.1 m to 4.2 m below ground surface and are approximately at creek elevation, similar to previous years. Erosion/bare ground was noted at the west end of the culvert crossing the property access road at the southwest corner of the project extents (Photo 4). The east end of the culvert is well vegetated. The ground around the flush mounts installed for SI21-01 and SI21-02 has settled, similar to the condition in 2022 and 2024. This is likely due to less compaction around the inclinometers by the Contractors to avoid damage to the instrument.

Photo 1: Pavement and embankment repair along Highway 16A. Looking east.

- Pavement cracks should be monitored by the MCI and sealed to prevent water infiltration into the embankment and pavement structure.
- The ground crack along the fence line should be regraded to prevent water infiltration into the embankment.

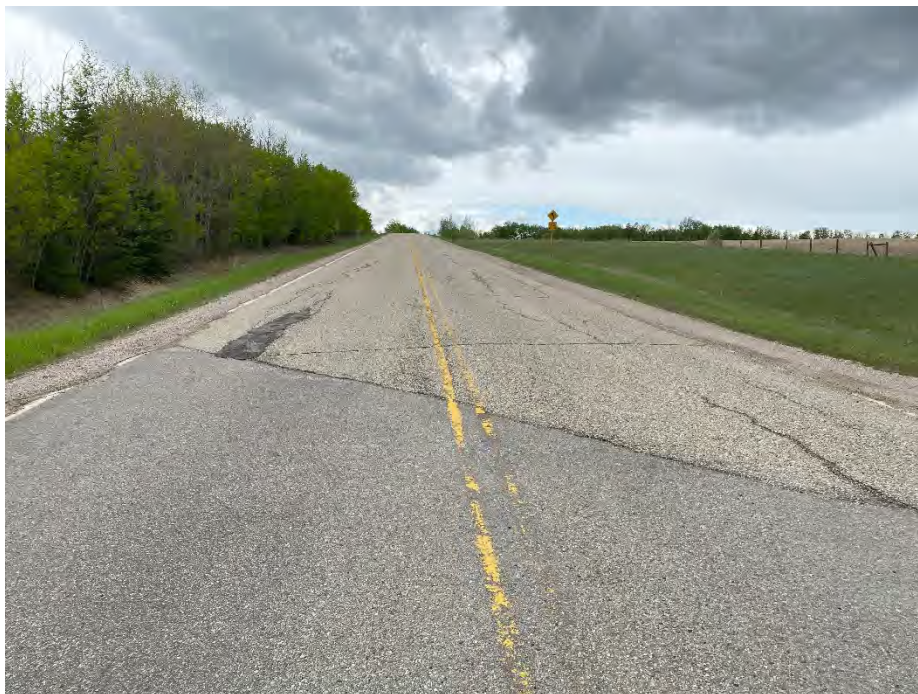
Photo 2: Pavement repair along Highway 16A. Looking west.

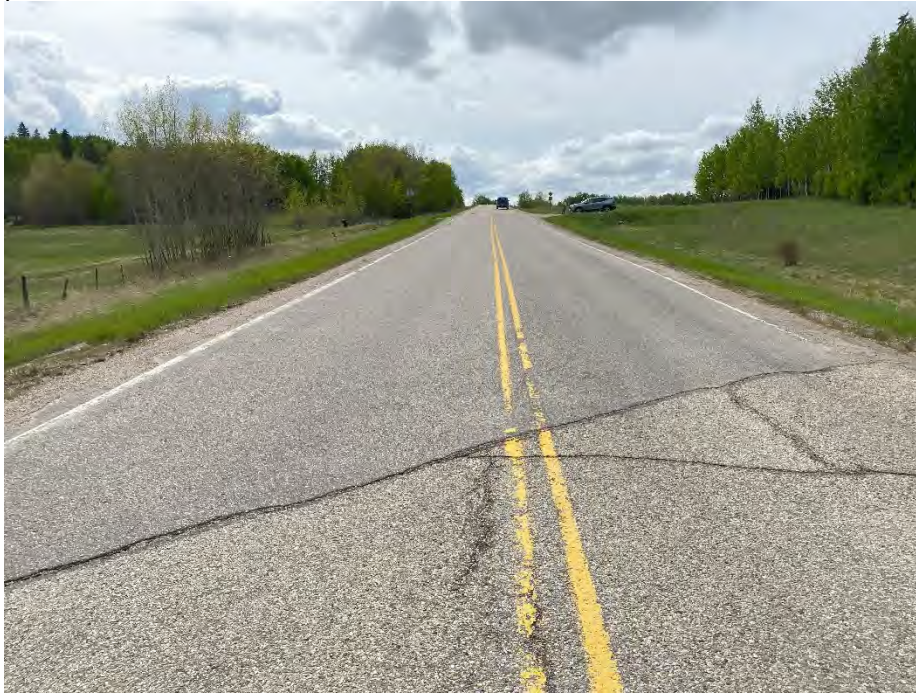
Photo 3: East end of repair zone. Looking west.

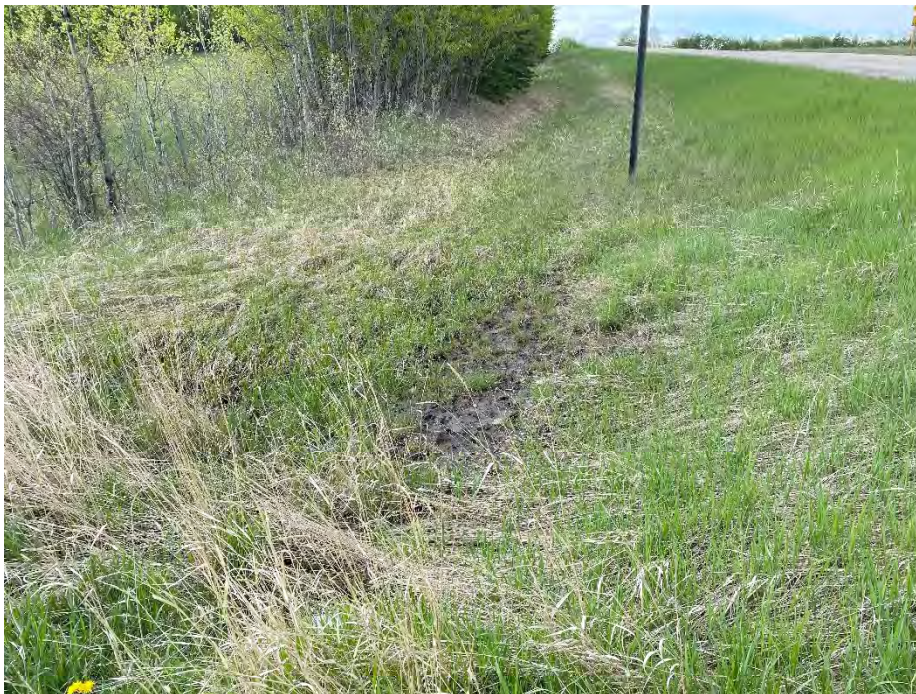
ITEM	CONDITIONS EXIST		DESCRIPTION AND LOCATION	NOTICEABLE CHANGE FROM LAST INSPECTION	
	YES	NO		YES	NO
Pavement Distress		X	Pavement is still in good condition since repair.		X
Slope Movement	X		SI21-01 and 02 show small movements at the pile top. Bulging on south slope near creek.		X
Erosion	X		Minor erosion in the south ditch, on west side of culvert adjacent to property access road.		X
Seepage		X			X
Bridge/Culvert Distress		X			X

Photo 4: Erosion at west end of culvert across property access road. Looking west.

- Re-vegetation of the bare ground west of the culvert below the south access road should be completed to reduce the likelihood of further erosion.
- The MCI should continue to monitor the culverts on a regular basis to ensure they are free flowing to reduce surface water penetration of the embankment and pavement structure.

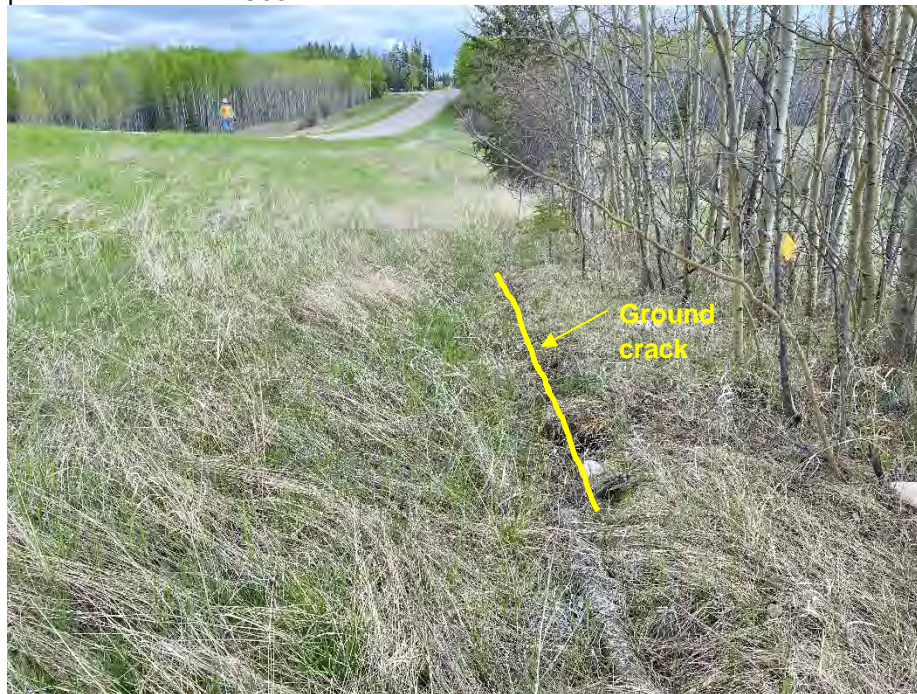
- The south ditch was observed to be dry and well vegetated. A ground crack, approximately 8 m long and 60 mm wide was observed near the south fence line (Photos 5 & 6). This crack may be due to removal of the silt fencing, and appeared unchanged from 2024.
- The private trail across the property south of Highway 16A had some areas with ponded water, and saturated soils.
- The toe bulge located on the south slope, near the creek appears unchanged since previous inspections and is up to 1 m high (Photo 10).
- The culvert (BF71355) is in good condition and does not appear to have been affected by the landslide or construction (Photos 7, 8, 11).
- The erosion channel near BH20-02 was vegetated and appears unchanged since 2024.
- The south slope beyond the tree line was very well vegetated at the time of inspection and may have obscured some landslide features.

Photo 5: South ditch, looking east. Ground crack visible near fence line, possibly due to removal of silt fence.

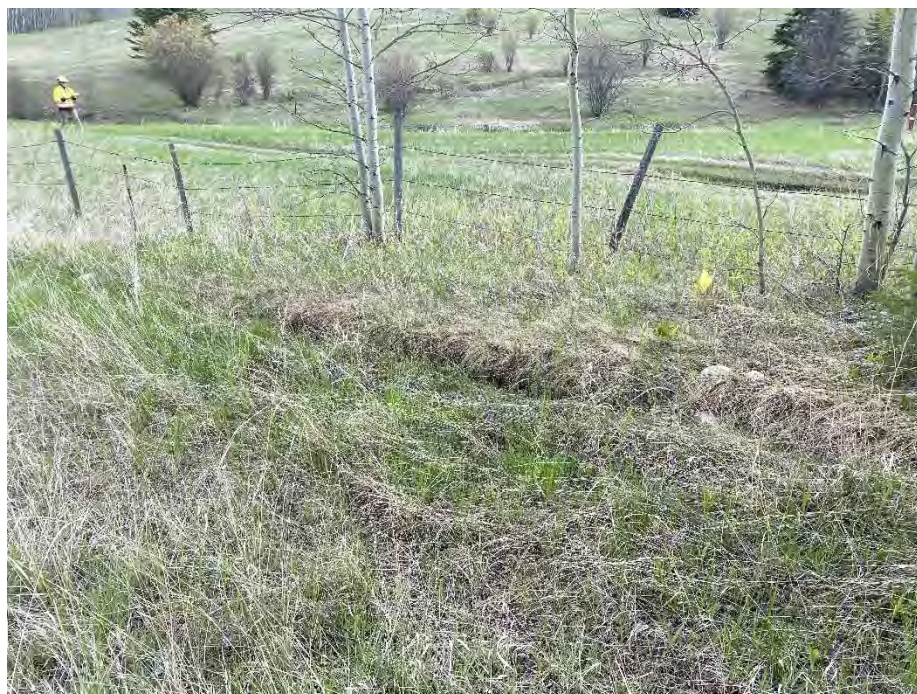
Photo 6: Possible ground crack in south ditch near fence line. Looking south.

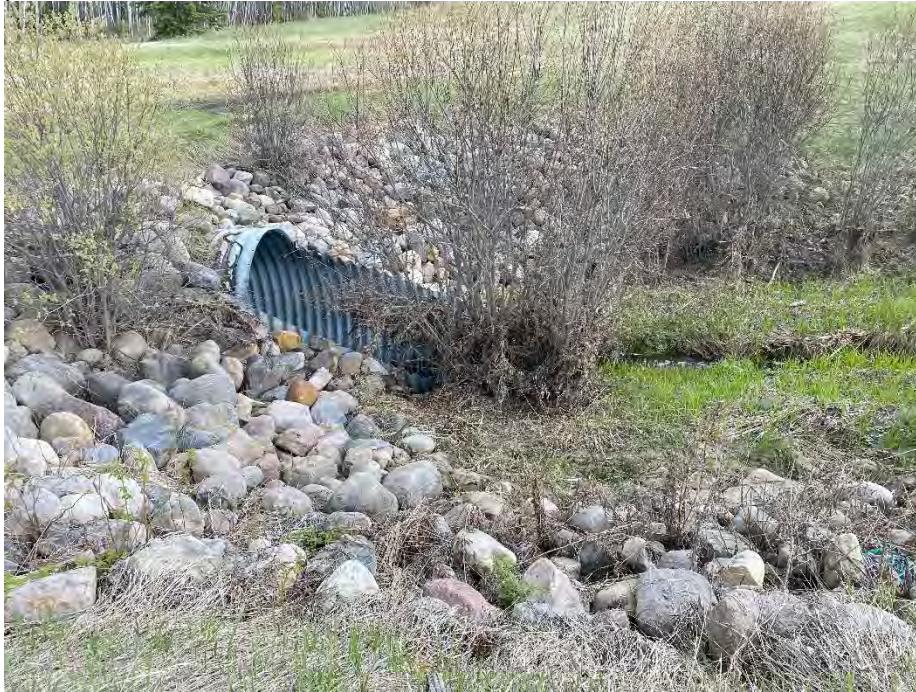
Photo 7: Culvert on south side of highway. Looking southeast.

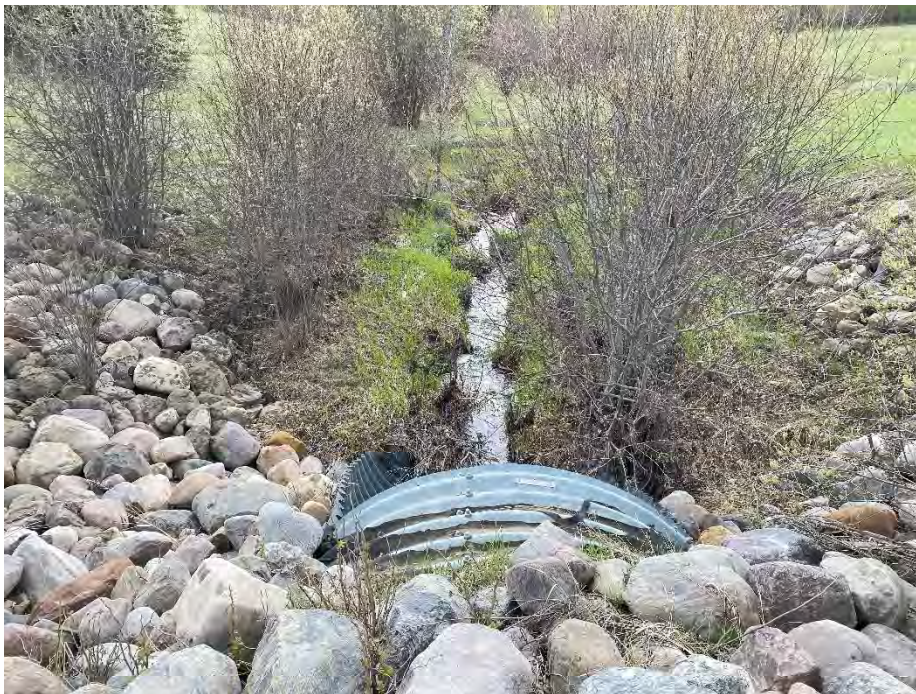
Photo 8: Looking down channel beyond culvert outlet on south side of highway. Facing southwest.

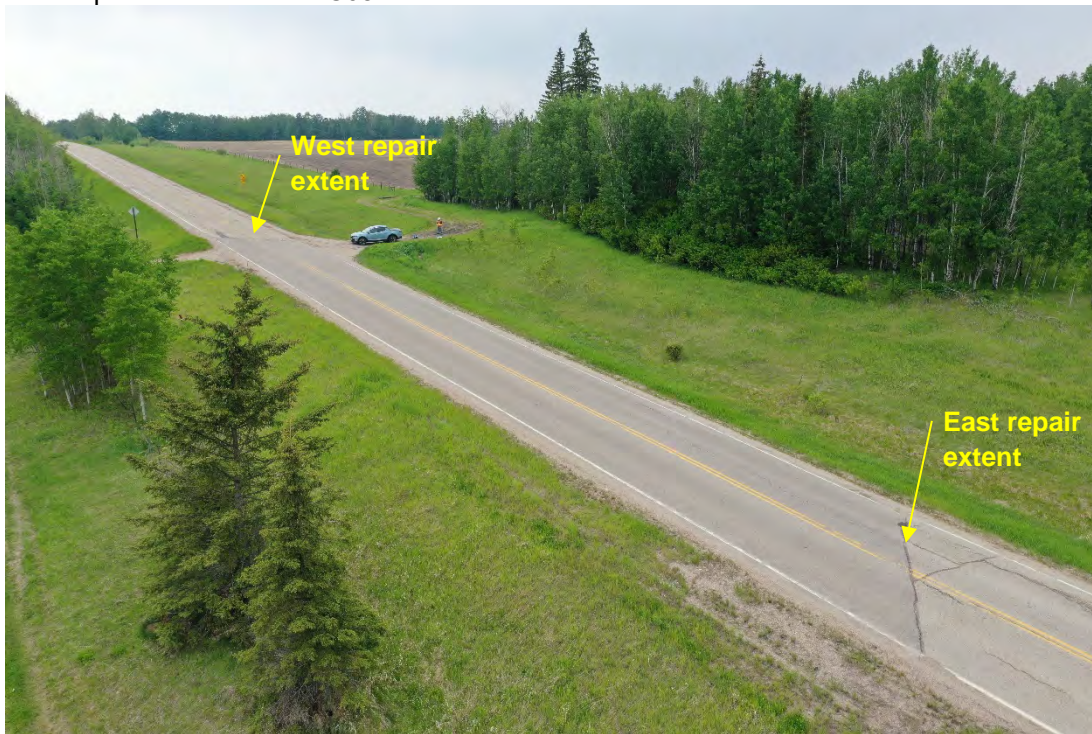
Photo 9: Aerial photo of Highway 16A pavement repair area. Facing northwest, taken by drone.

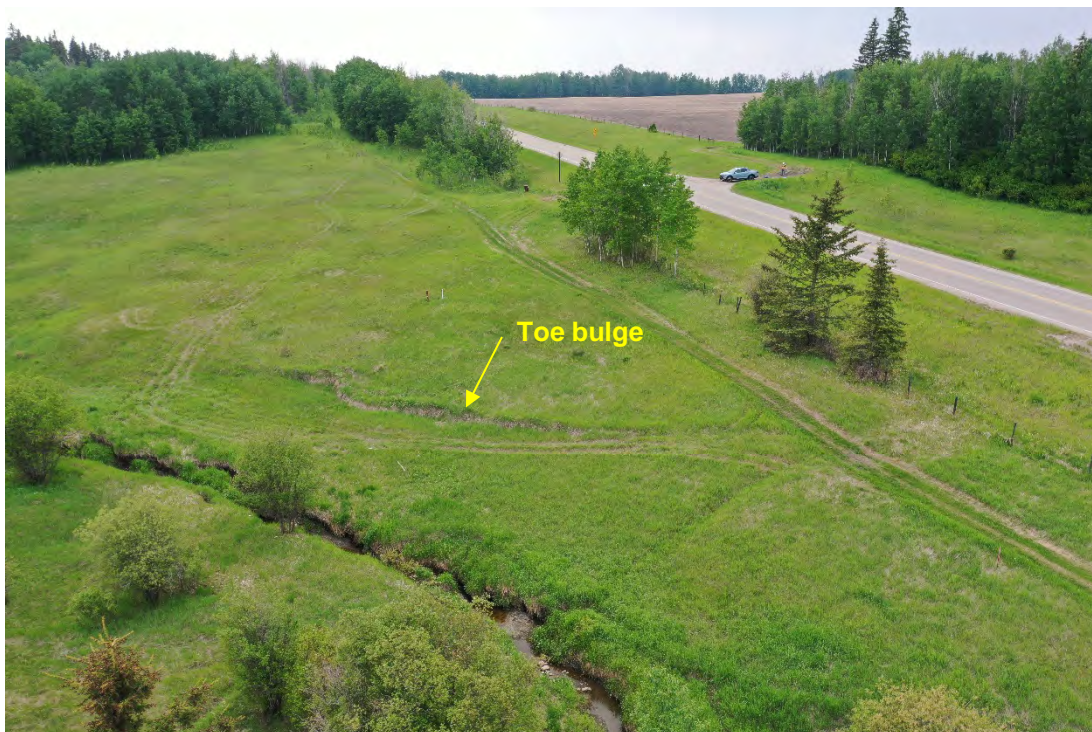
Photo 10: Aerial photo of toe bulge and creek to the south of Highway 16A, facing northwest. Taken by drone.

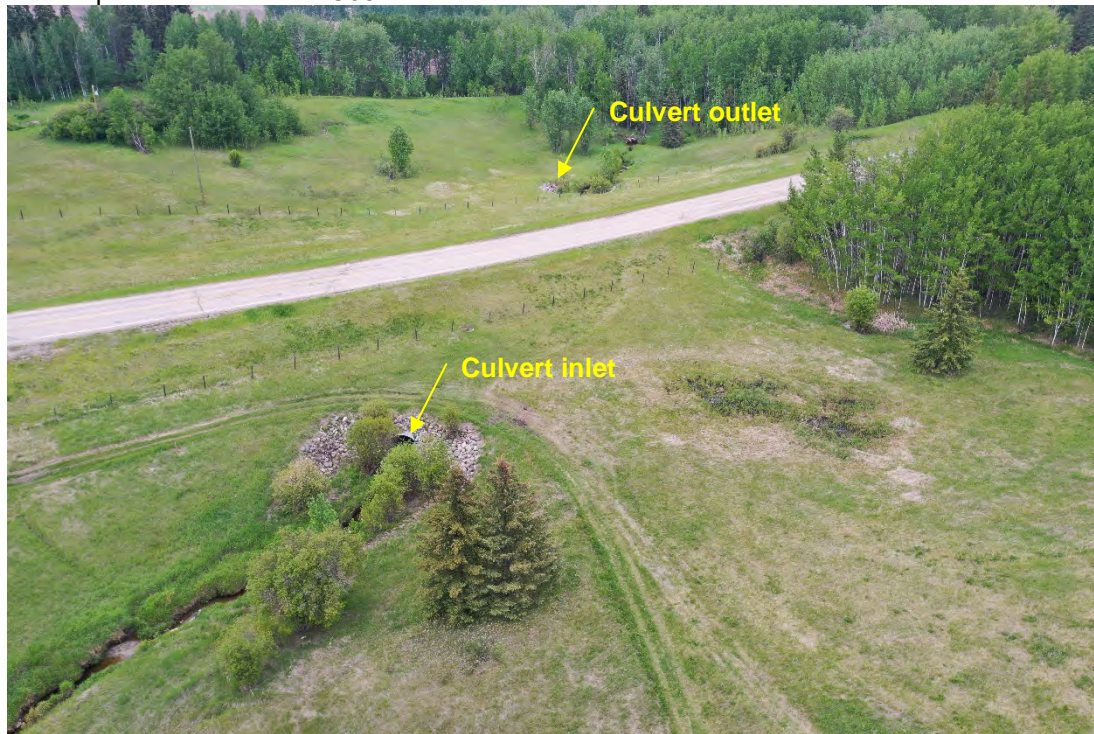
Photo 11: Aerial photo of culvert below Highway 16A, facing northeast. Taken by drone.
