NORTH CENTRAL REGION GRMP  
EDSON / STONY PLAIN  
SITE INSPECTION FORM

<b>SITE NUMBER AND NAME:</b> NC014 – North of Fort Assiniboine	<b>HIGHWAY AND KM:</b> 661:02, km 1.8	<b>PREVIOUS INSPECTION:</b> June 13, 2024	<b>CURRENT INSPECTION:</b> May 22, 2025
<b>LEGAL DESCRIPTION:</b> NW-01-62-06-W5	<b>NAD83 COORDINATES:</b> UTM11U 6023391N, 644779E		<b>RISK ASSESSMENT:</b> PF: 8 CF: 10 Total: 80
<b>AVERAGE ANNUAL DAILY TRAFFIC (AADT):</b> 270 (2024)		<b>CONTRACTOR MAINTENANCE AREA (CMA):</b> 508

**Client/Project**  
Transportation and Economic Corridors  
Geohazard Monitoring Program  
NC014-1: HWY 661:02 Fort Assiniboine (km 1.8)

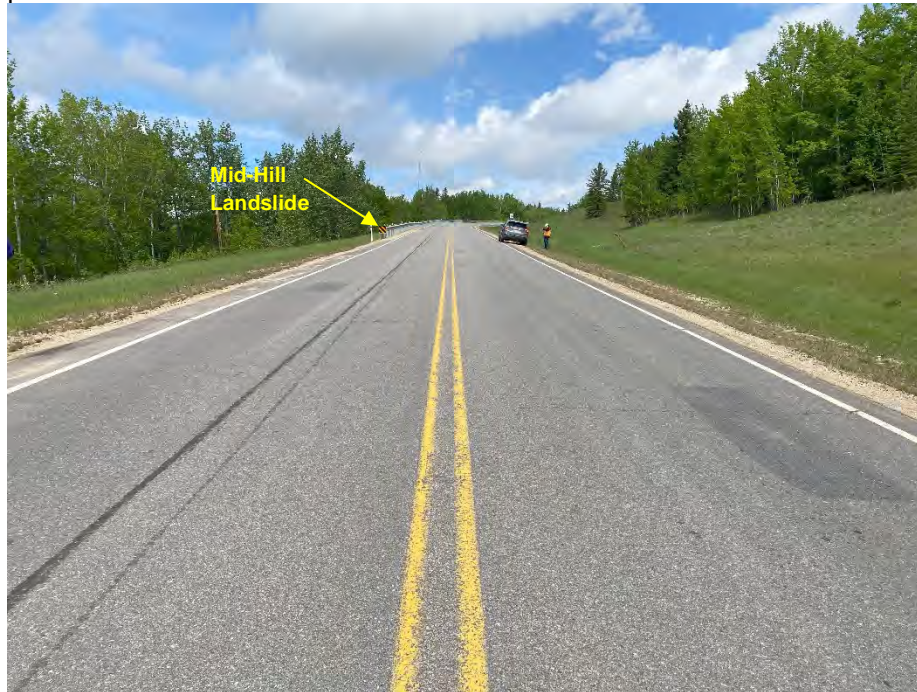
**Photo 1:** Pavement condition southeast of mid-hill landslide. Looking northwest.

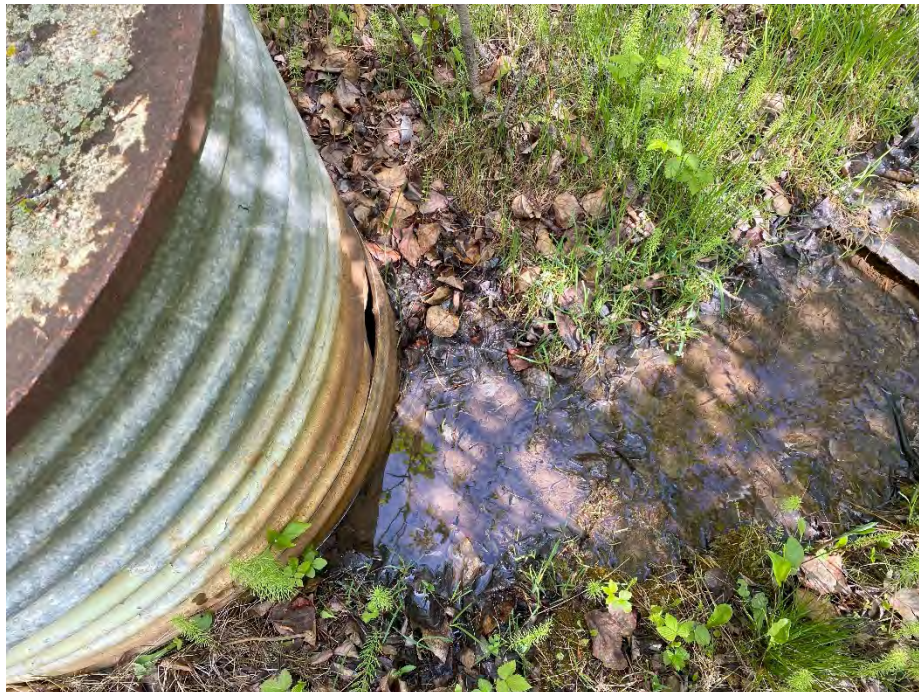
**Photo 2:** Pooling/flowing water adjacent to MH#1. Water entering culvert at ground surface. Looking northeast.

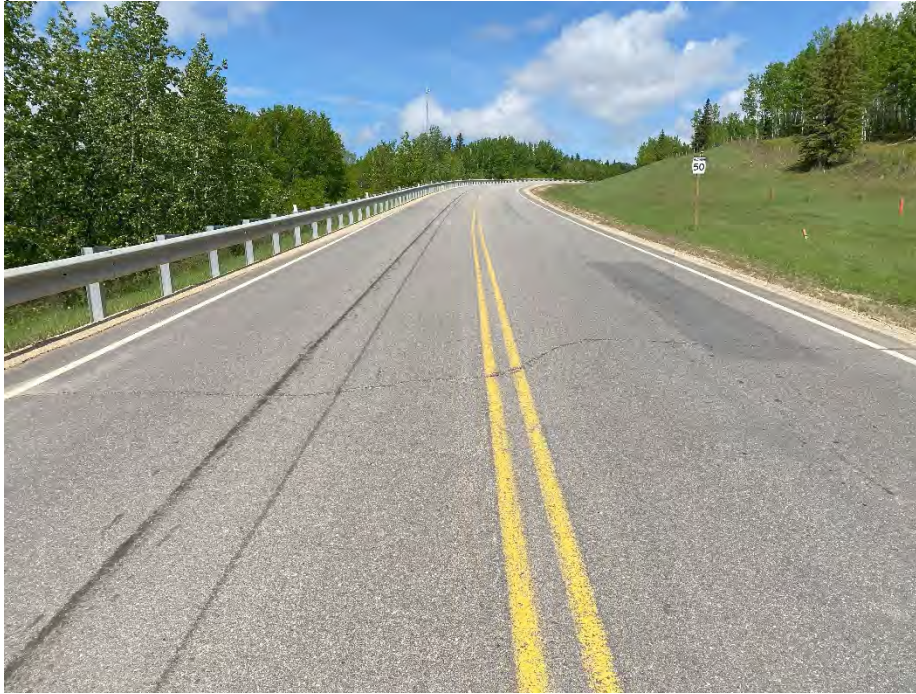
**Photo 3:** Cracks reflecting through pavement repair at south extent of mid-slope landslide. Looking northwest.

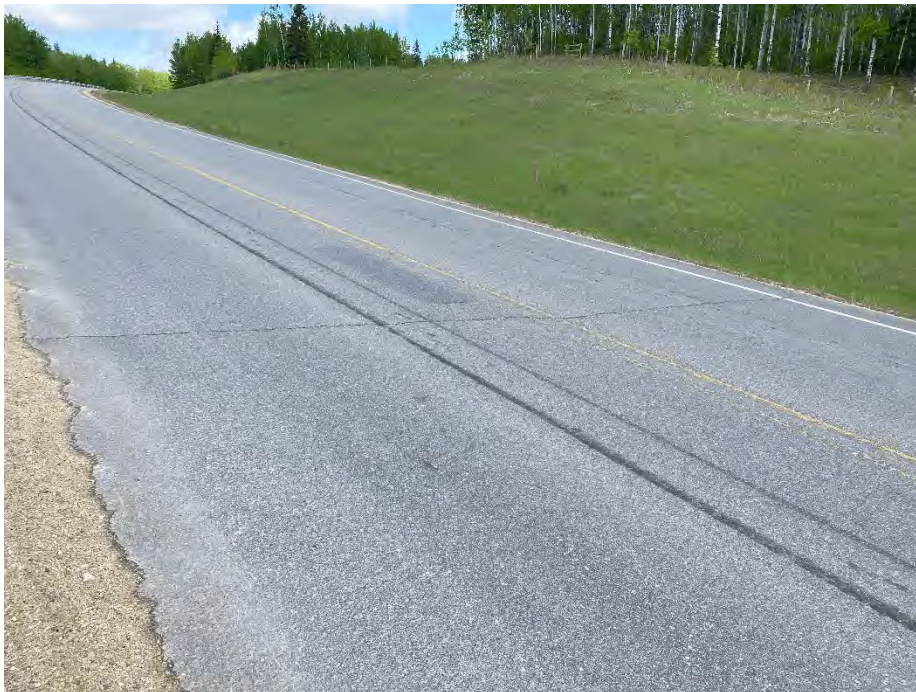
**Photo 4:** Pavement cracking north of mid-slope landslide. Looking northwest.

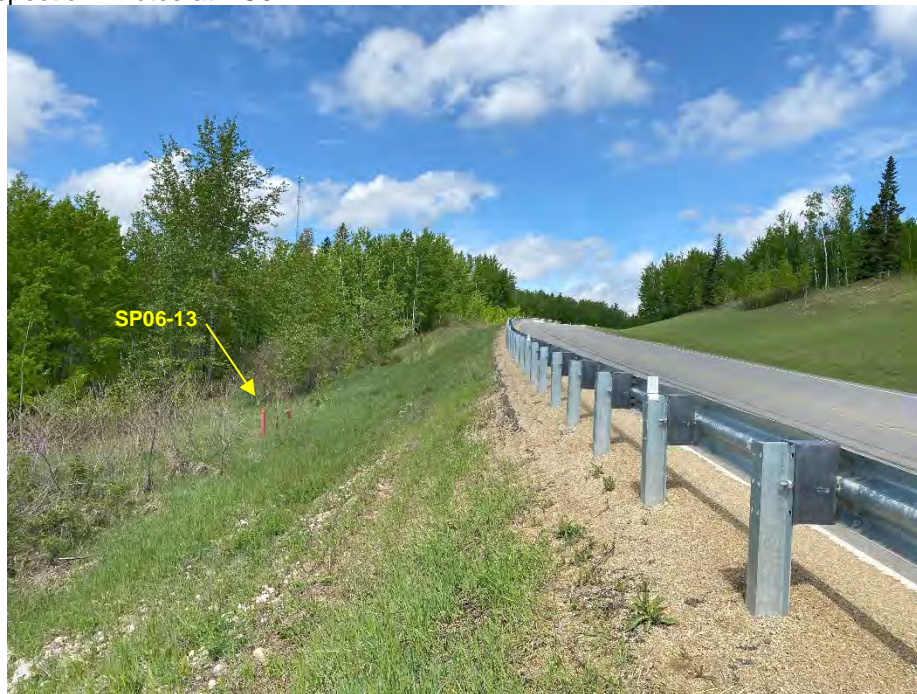
**Photo 5:** Landslide at uphill section. Looking northwest.

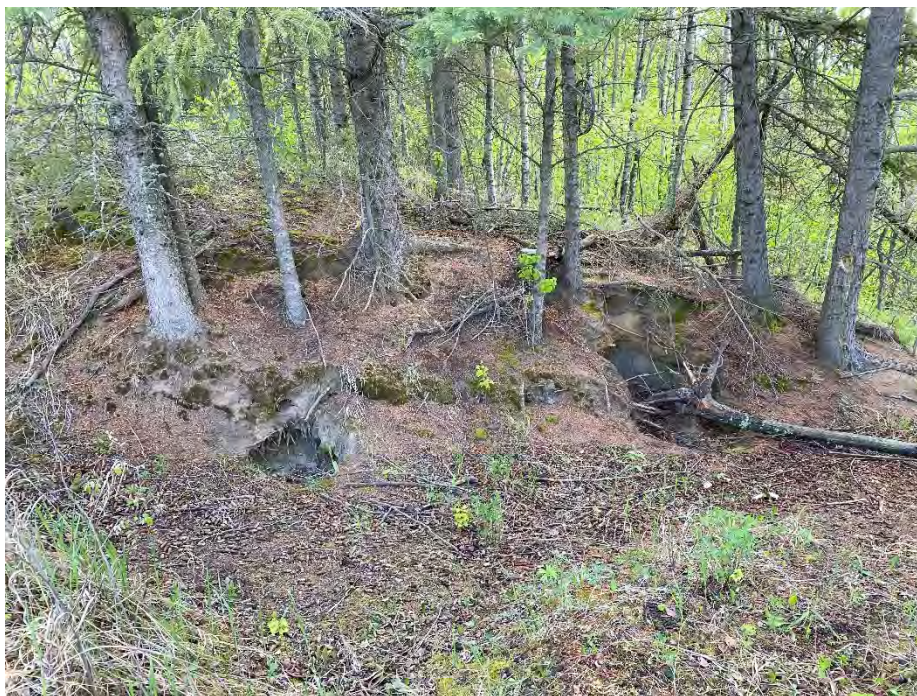
**Photo 6:** Two sinkholes in ravine. Looking southeast.

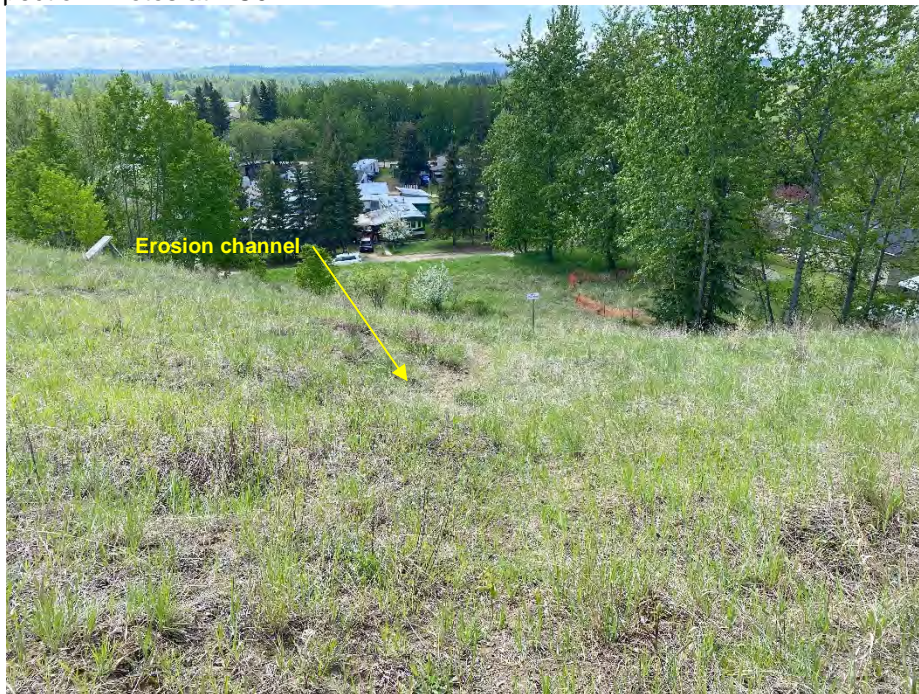
**Photo 7:** Erosion channel heading downslope to the bench. Looking southwest.

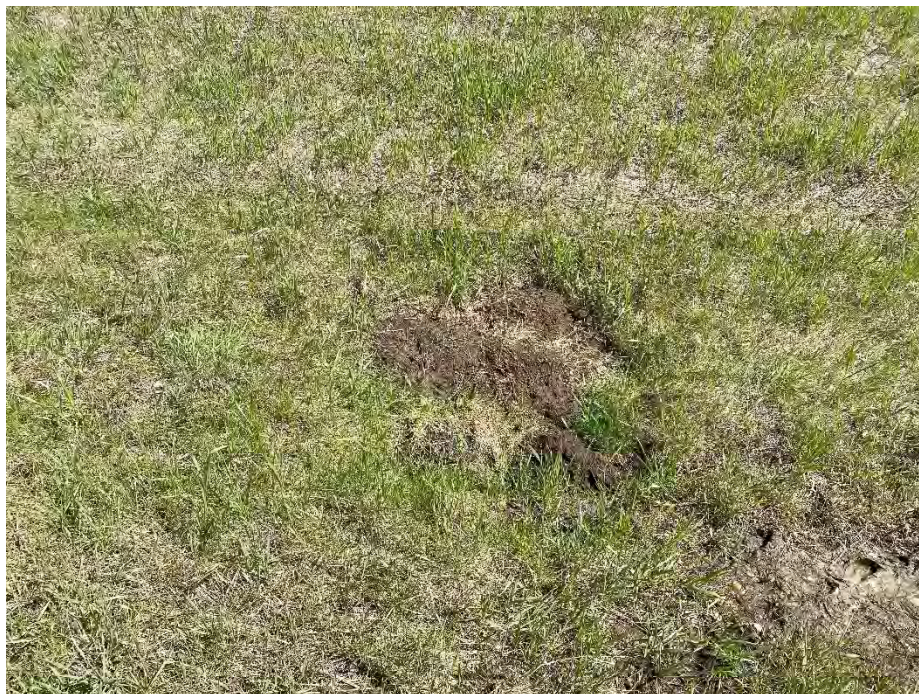
**Photo 8:** Sinkhole backfilled with soil, southeast from the utility box in the east ditch near the mid-hill landslide area. Looking north.

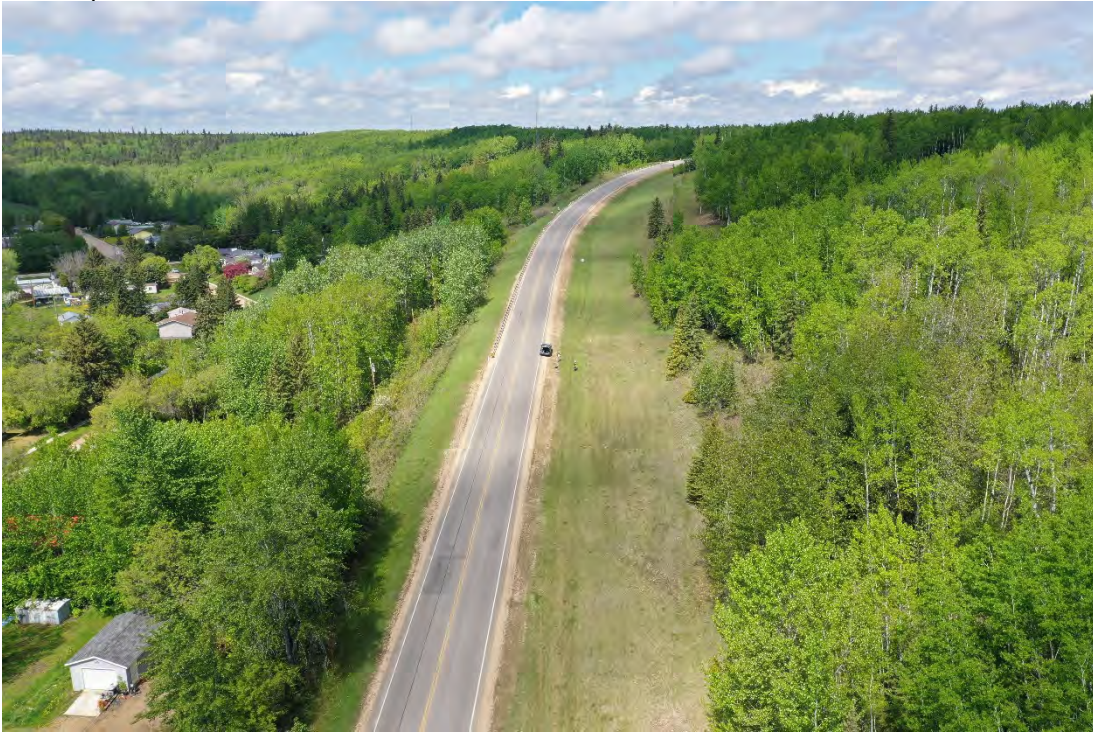
**Photo 9:** Overview of site, taken by drone. Looking northwest.

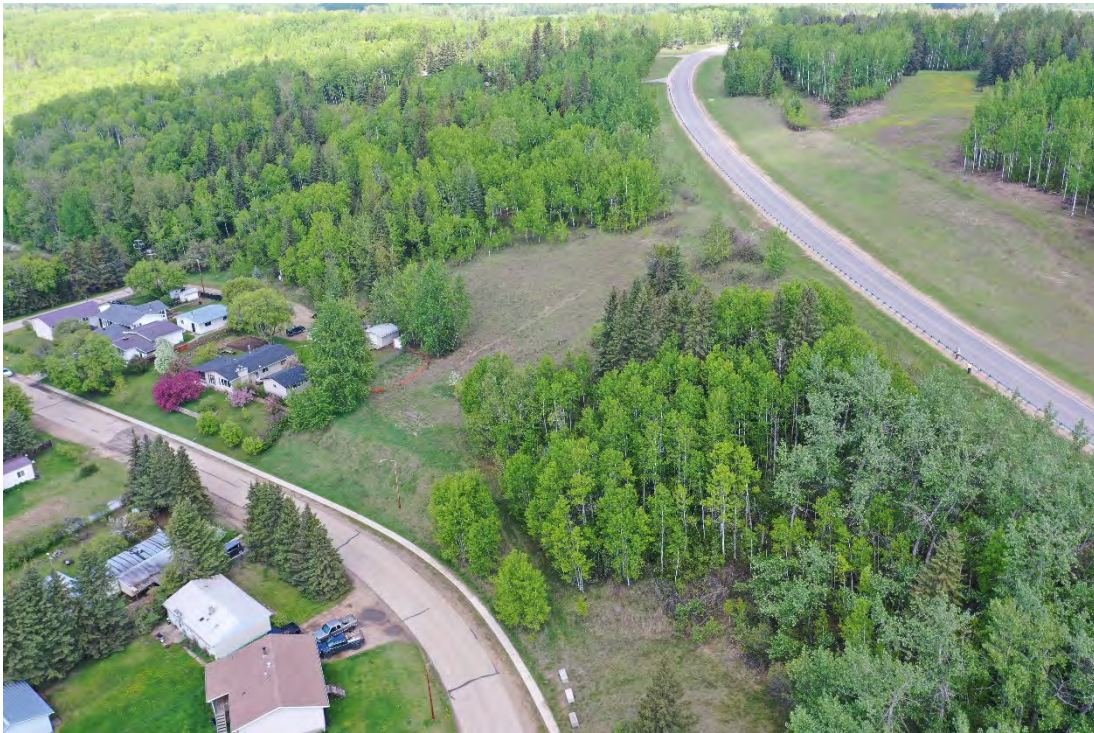
**Photo 10:** Overview of slide areas on highway embankment. Looking northwest.
