<b>SITE NUMBER AND NAME:</b> NC018 – Pembina River Bridge (North of Cherhill)	<b>HIGHWAY AND KM:</b> 764:02, km 12.052	<b>PREVIOUS INSPECTION:</b> June 13, 2024	<b>CURRENT INSPECTION:</b> May 22, 2025
<b>LEGAL DESCRIPTION:</b> NW-15-57-5-W5	<b>NAD83 COORDINATES:</b> UTM11U 5978069 N, 652940 E		<b>RISK ASSESSMENT:</b> PF: 3 CF: 10 Total: 30
<b>AVERAGE ANNUAL DAILY TRAFFIC (AADT):</b> 460 (2024)		<b>CONTRACTOR MAINTENANCE AREA (CMA):</b> 509

2025 Inspection Photos at NC018

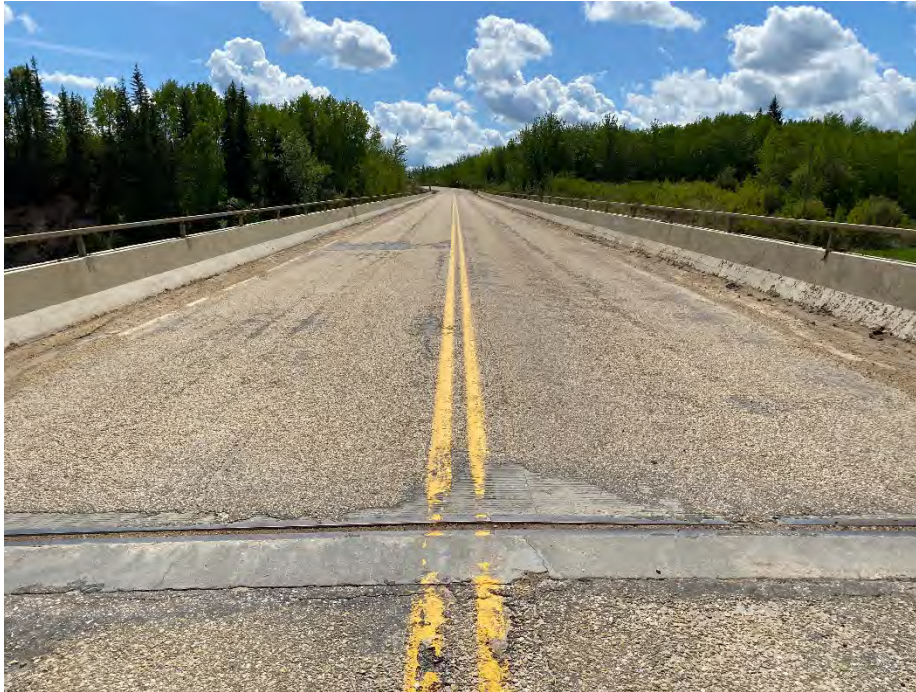
- The highway surface contains some cracks and potholes, but does not appear to have been affected by the previous failure of the northern head slope (Photos 1 to 4).
- Erosion and sedimentation was observed at the concrete troughs on both sides of the north abutment. Gaps were observed between the trough and the highway surface, where surface water is undermining the trough (Photo 5). Additionally, erosion rills were observed on the slope below each concrete trough.
- The significant drift accumulation observed on the upstream side of the bridge during the 2023 call-out inspection was largely removed or washed away (Photo 6).
- The north head slope was repaired in 2024, and armoured with riprap. The previous riprap channel was regraded and covered with riprap along the slope (Photos 6 to 9). The ditch on the northeast side of the

**Photo 1:** Highway surface at north abutment. Looking southwest.

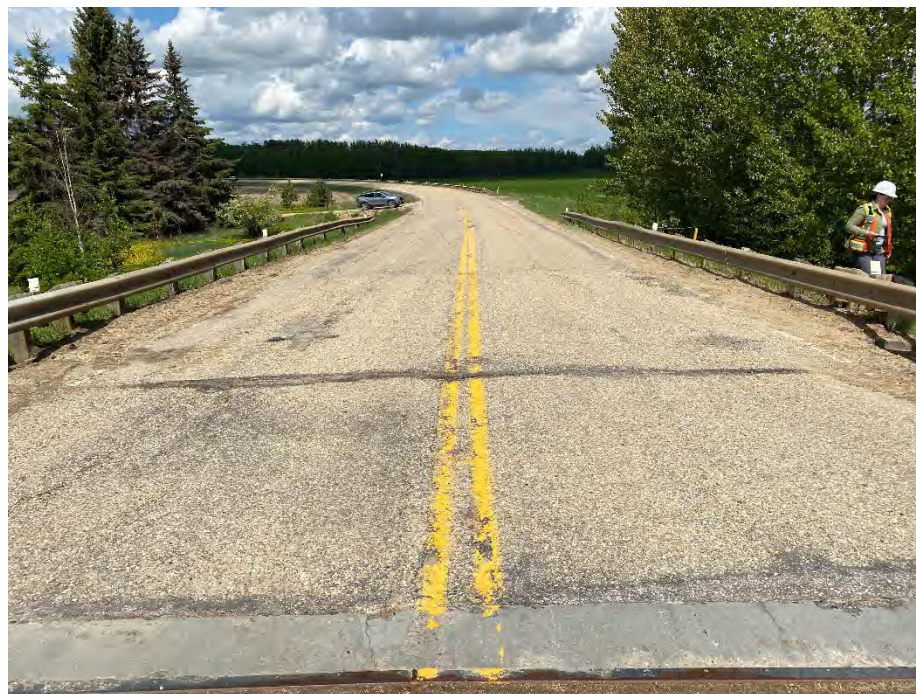
**Photo 2:** Highway surface at north abutment. Looking northeast.

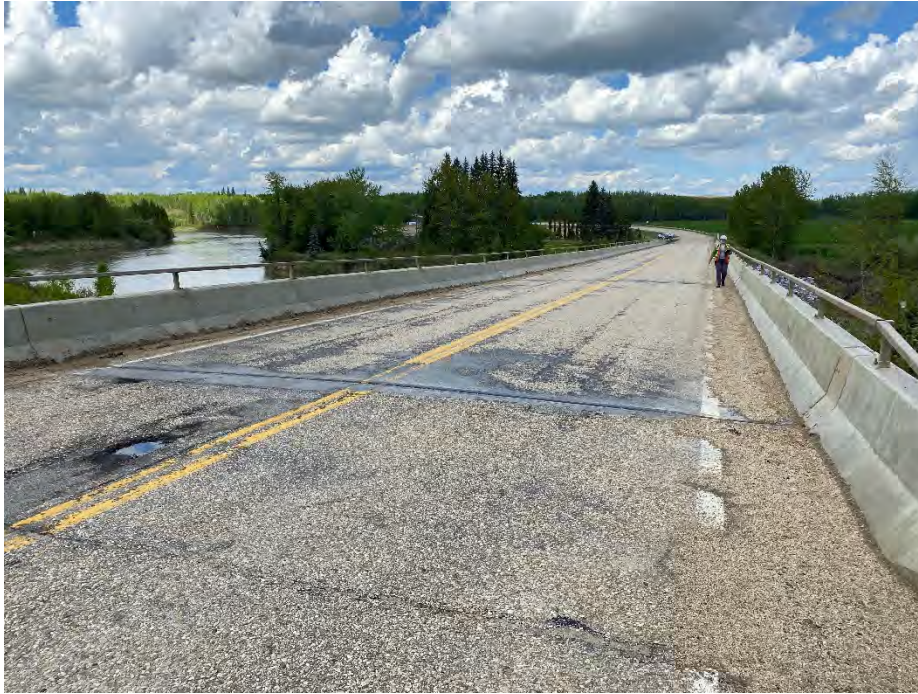
**Photo 3:** Highway surface at south abutment. Looking north.

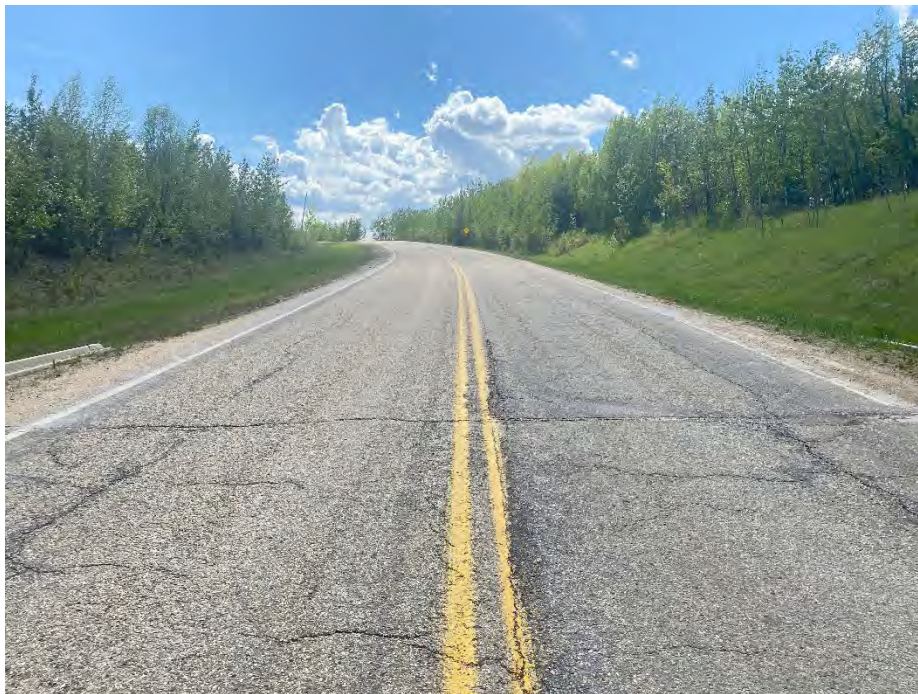
**Photo 4:** Highway surface at south abutment. Looking southwest.

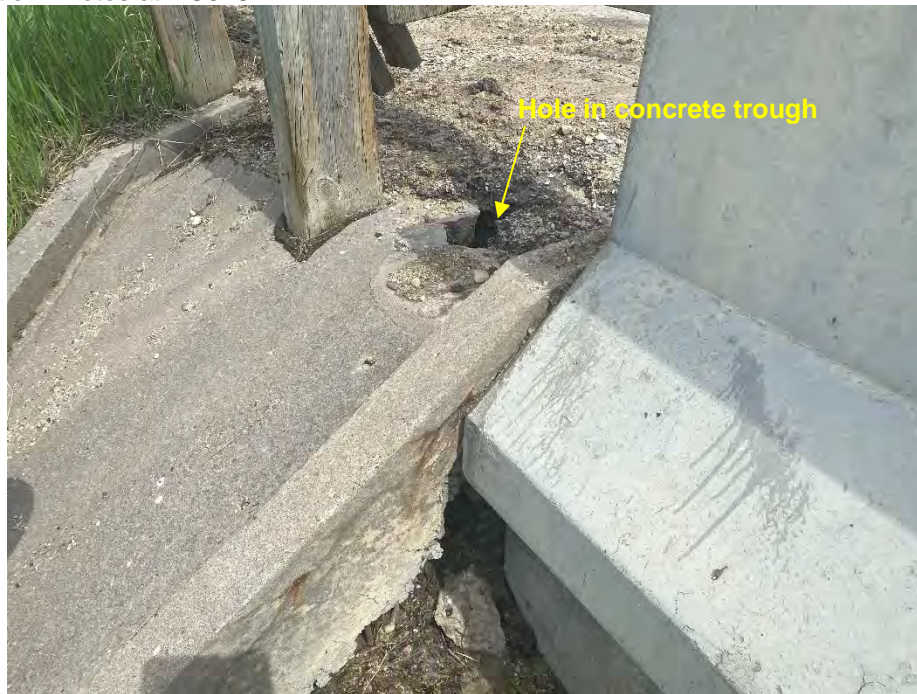
**Photo 5:** Hole in concrete trough at northwest bridge abutment allowing water to drain through. Facing northeast.

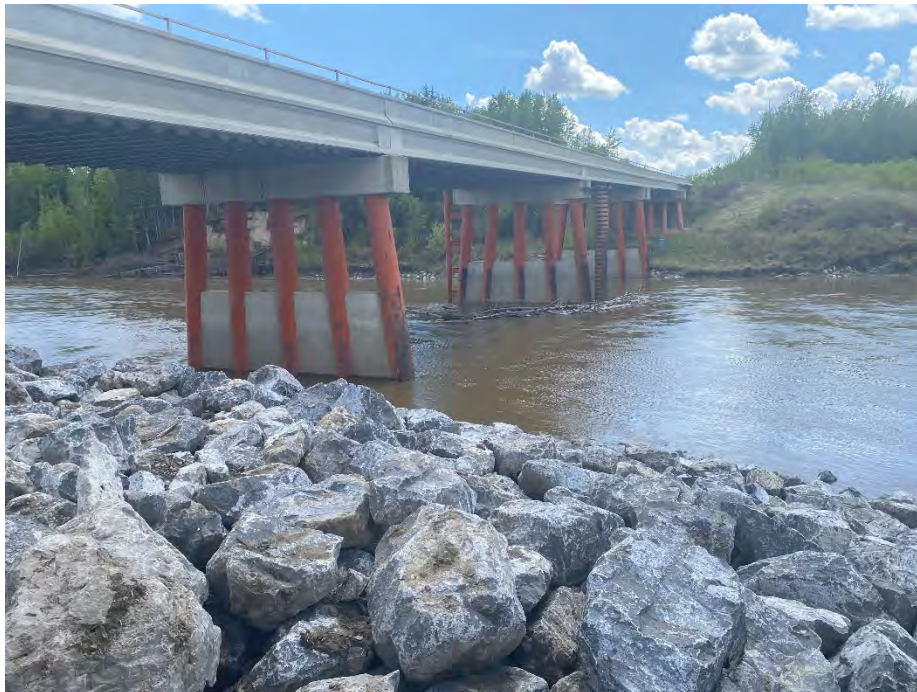
**Photo 6:** Few driftwood present, north headslope armoured with riprap. Looking south.

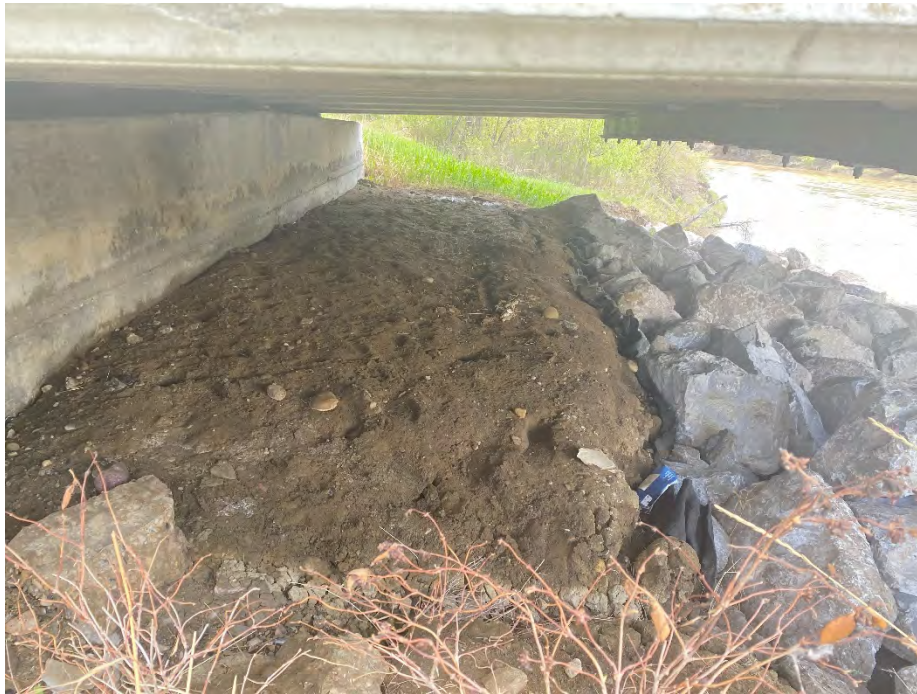
headslope was regraded, however vegetation has not taken to this area yet. Minor erosion and sedimentation was observed within the ditch and down to the river (Photo 7).

**Photo 7:** North abutment head slope repaired and armoured with riprap. Looking southeast.

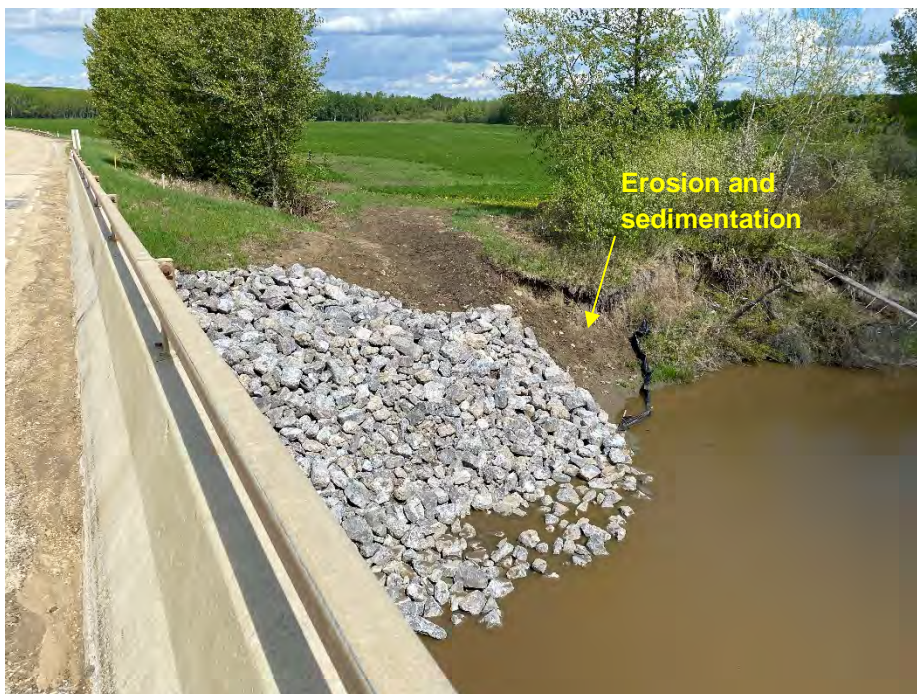
**Photo 8:** East side repair with riprap at north abutment. Looking northeast.

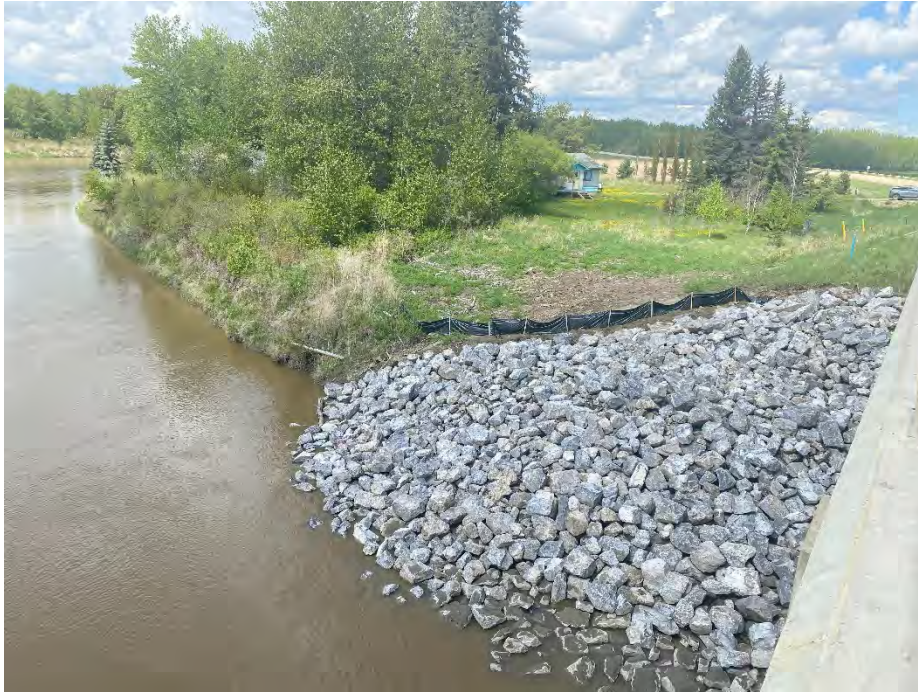
**Photo 9:** West extent of repair at north abutment. Looking north.

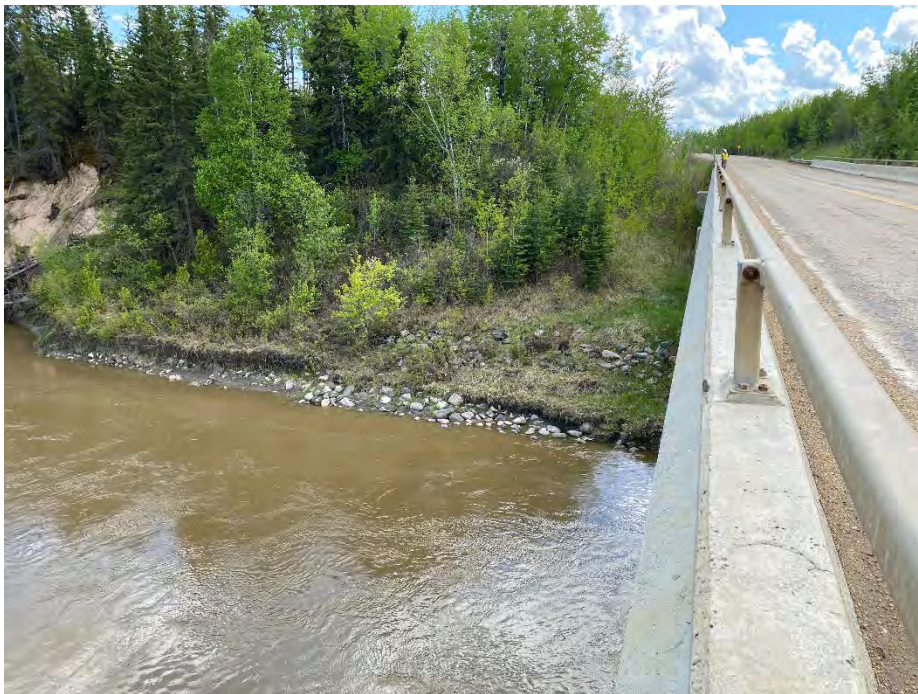
- Riprap armouring was observed along the water line on the south riverbank (Photos 10 & 11). A small slump along the riverbank was observed about 15 m to 20 m west of the south abutment and appeared to be in a similar state as observed during the past two inspections. It is unlikely this slump is affecting the bridge.

**Photo 10:** East side of south abutment. Looking southeast.

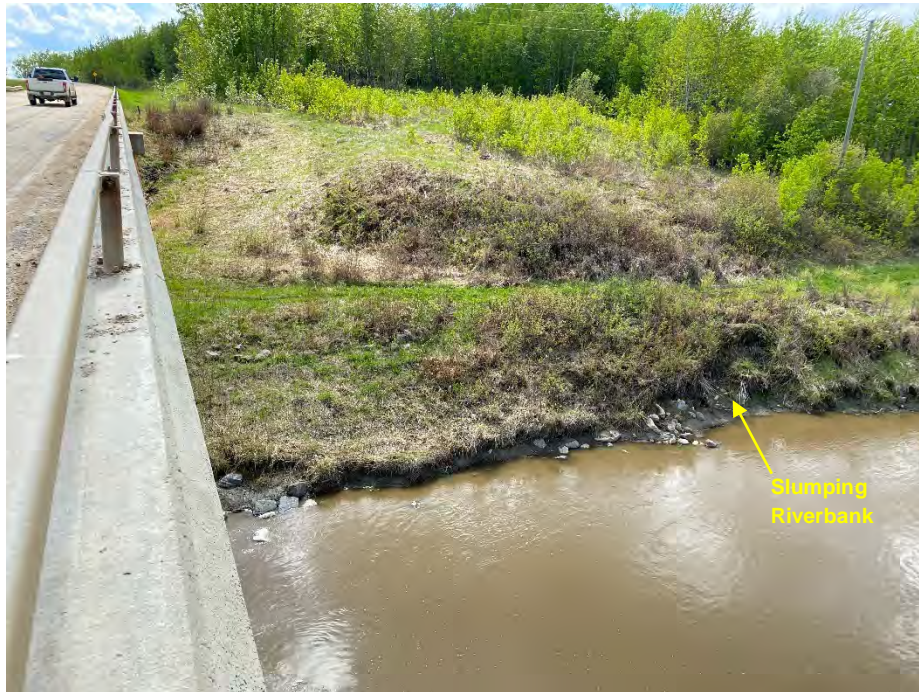
**Photo 11:** Upstream side of south abutment. Looking southwest.

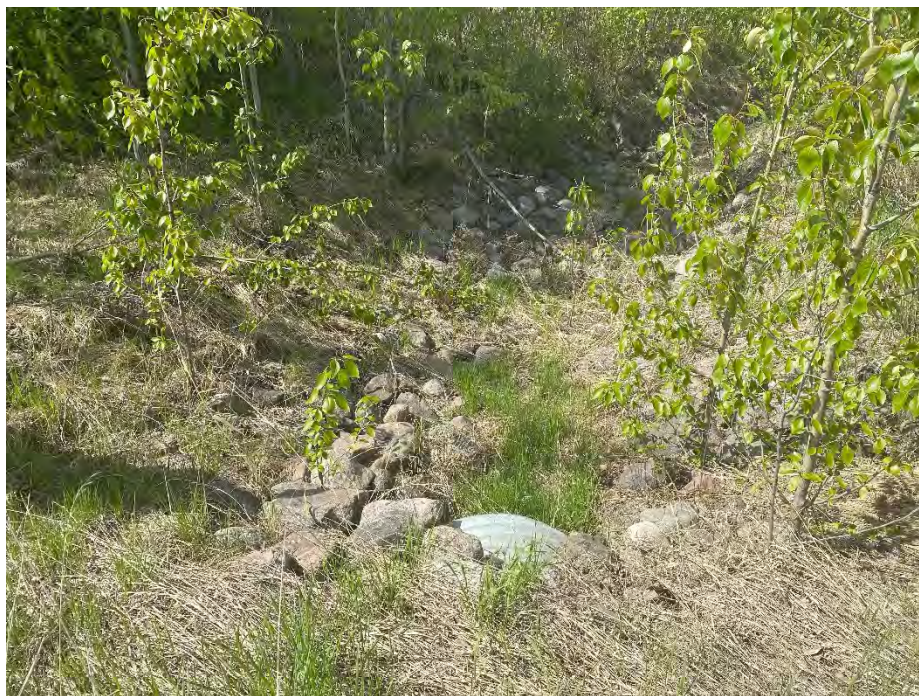
- The culvert outlet near the southeast abutment was observed to be in a similar condition to the previous inspections. Standing water was observed in the culvert. The outlet channel is lined with riprap and well vegetated (Photo 12).

**Photo 12:** Culvert outlet near southeast abutment. Looking northwest.

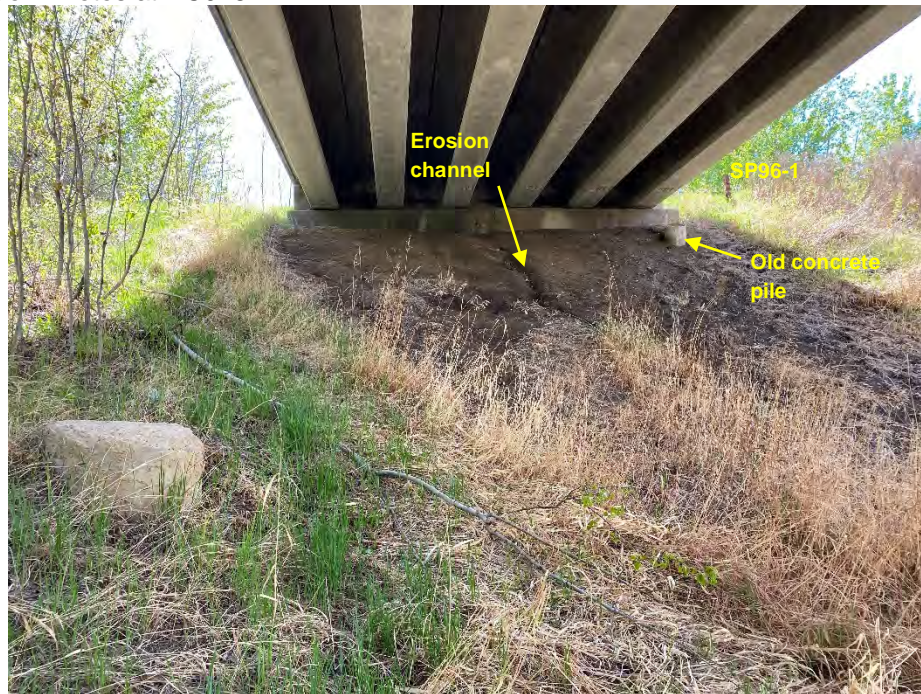
- A small erosion channel exists along the south head slope, and appeared to be in a similar condition to 2024 (Photo 13).
- The area between the south head slope and drainage galleries was observed to be wet, similar to 2024 (Photo 14). Water was pooling in this area and the ground was very soft.

**Photo 13:** South abutment head slope. Looking southwest.

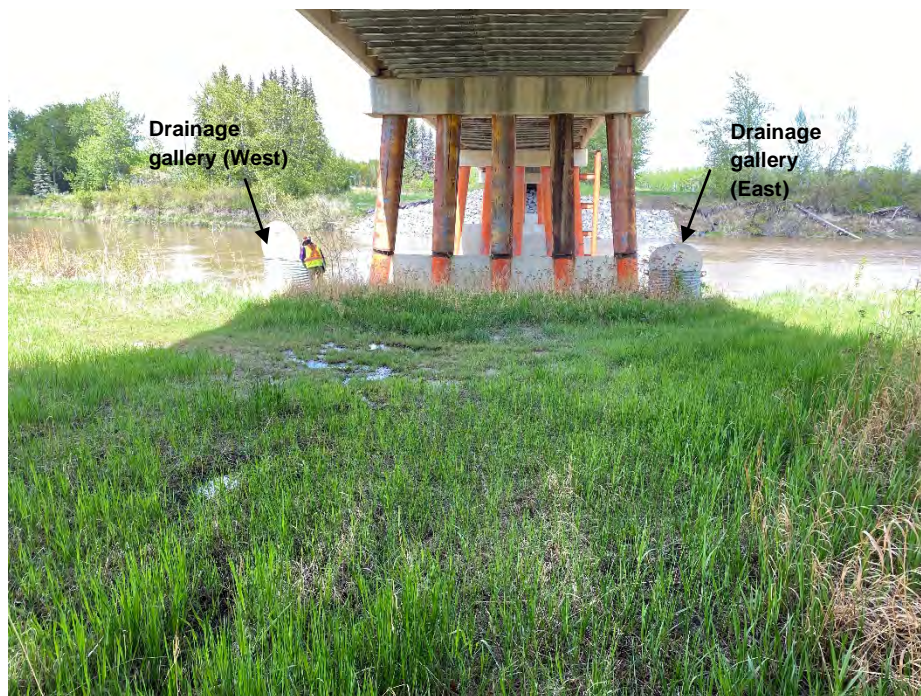
**Photo 14:** Saturated ground between drainage galleries and Pier 1. Looking northeast.
