SITE NUMBER AND NAME: NC010 – Willow Bend Slide	HIGHWAY AND KM: 33:04, km 25.005	PREVIOUS INSPECTION: May 31, 2023	CURRENT INSPECTION: May 22, 2025
LEGAL DESCRIPTION: SE 28-57-03-W5	NAD83 COORDINATES: UTM11U 5981185N, 672306E		RISK ASSESSMENT: PF: 13 CF: 6 Total: 78
AVERAGE ANNUAL DAILY TRAFFIC (AADT): 2,190 (2024)		CONTRACTOR MAINTENANCE AREA (CMA): 509

**NORTH CENTRAL REGION GRMP
EDSON / STONY PLAIN
SITE INSPECTION FORM**

Alberta Transportation and Economic Corridors
Geohazard Monitoring Program
NC010-1: HWY 33:04 Willow Bend (KM 25)

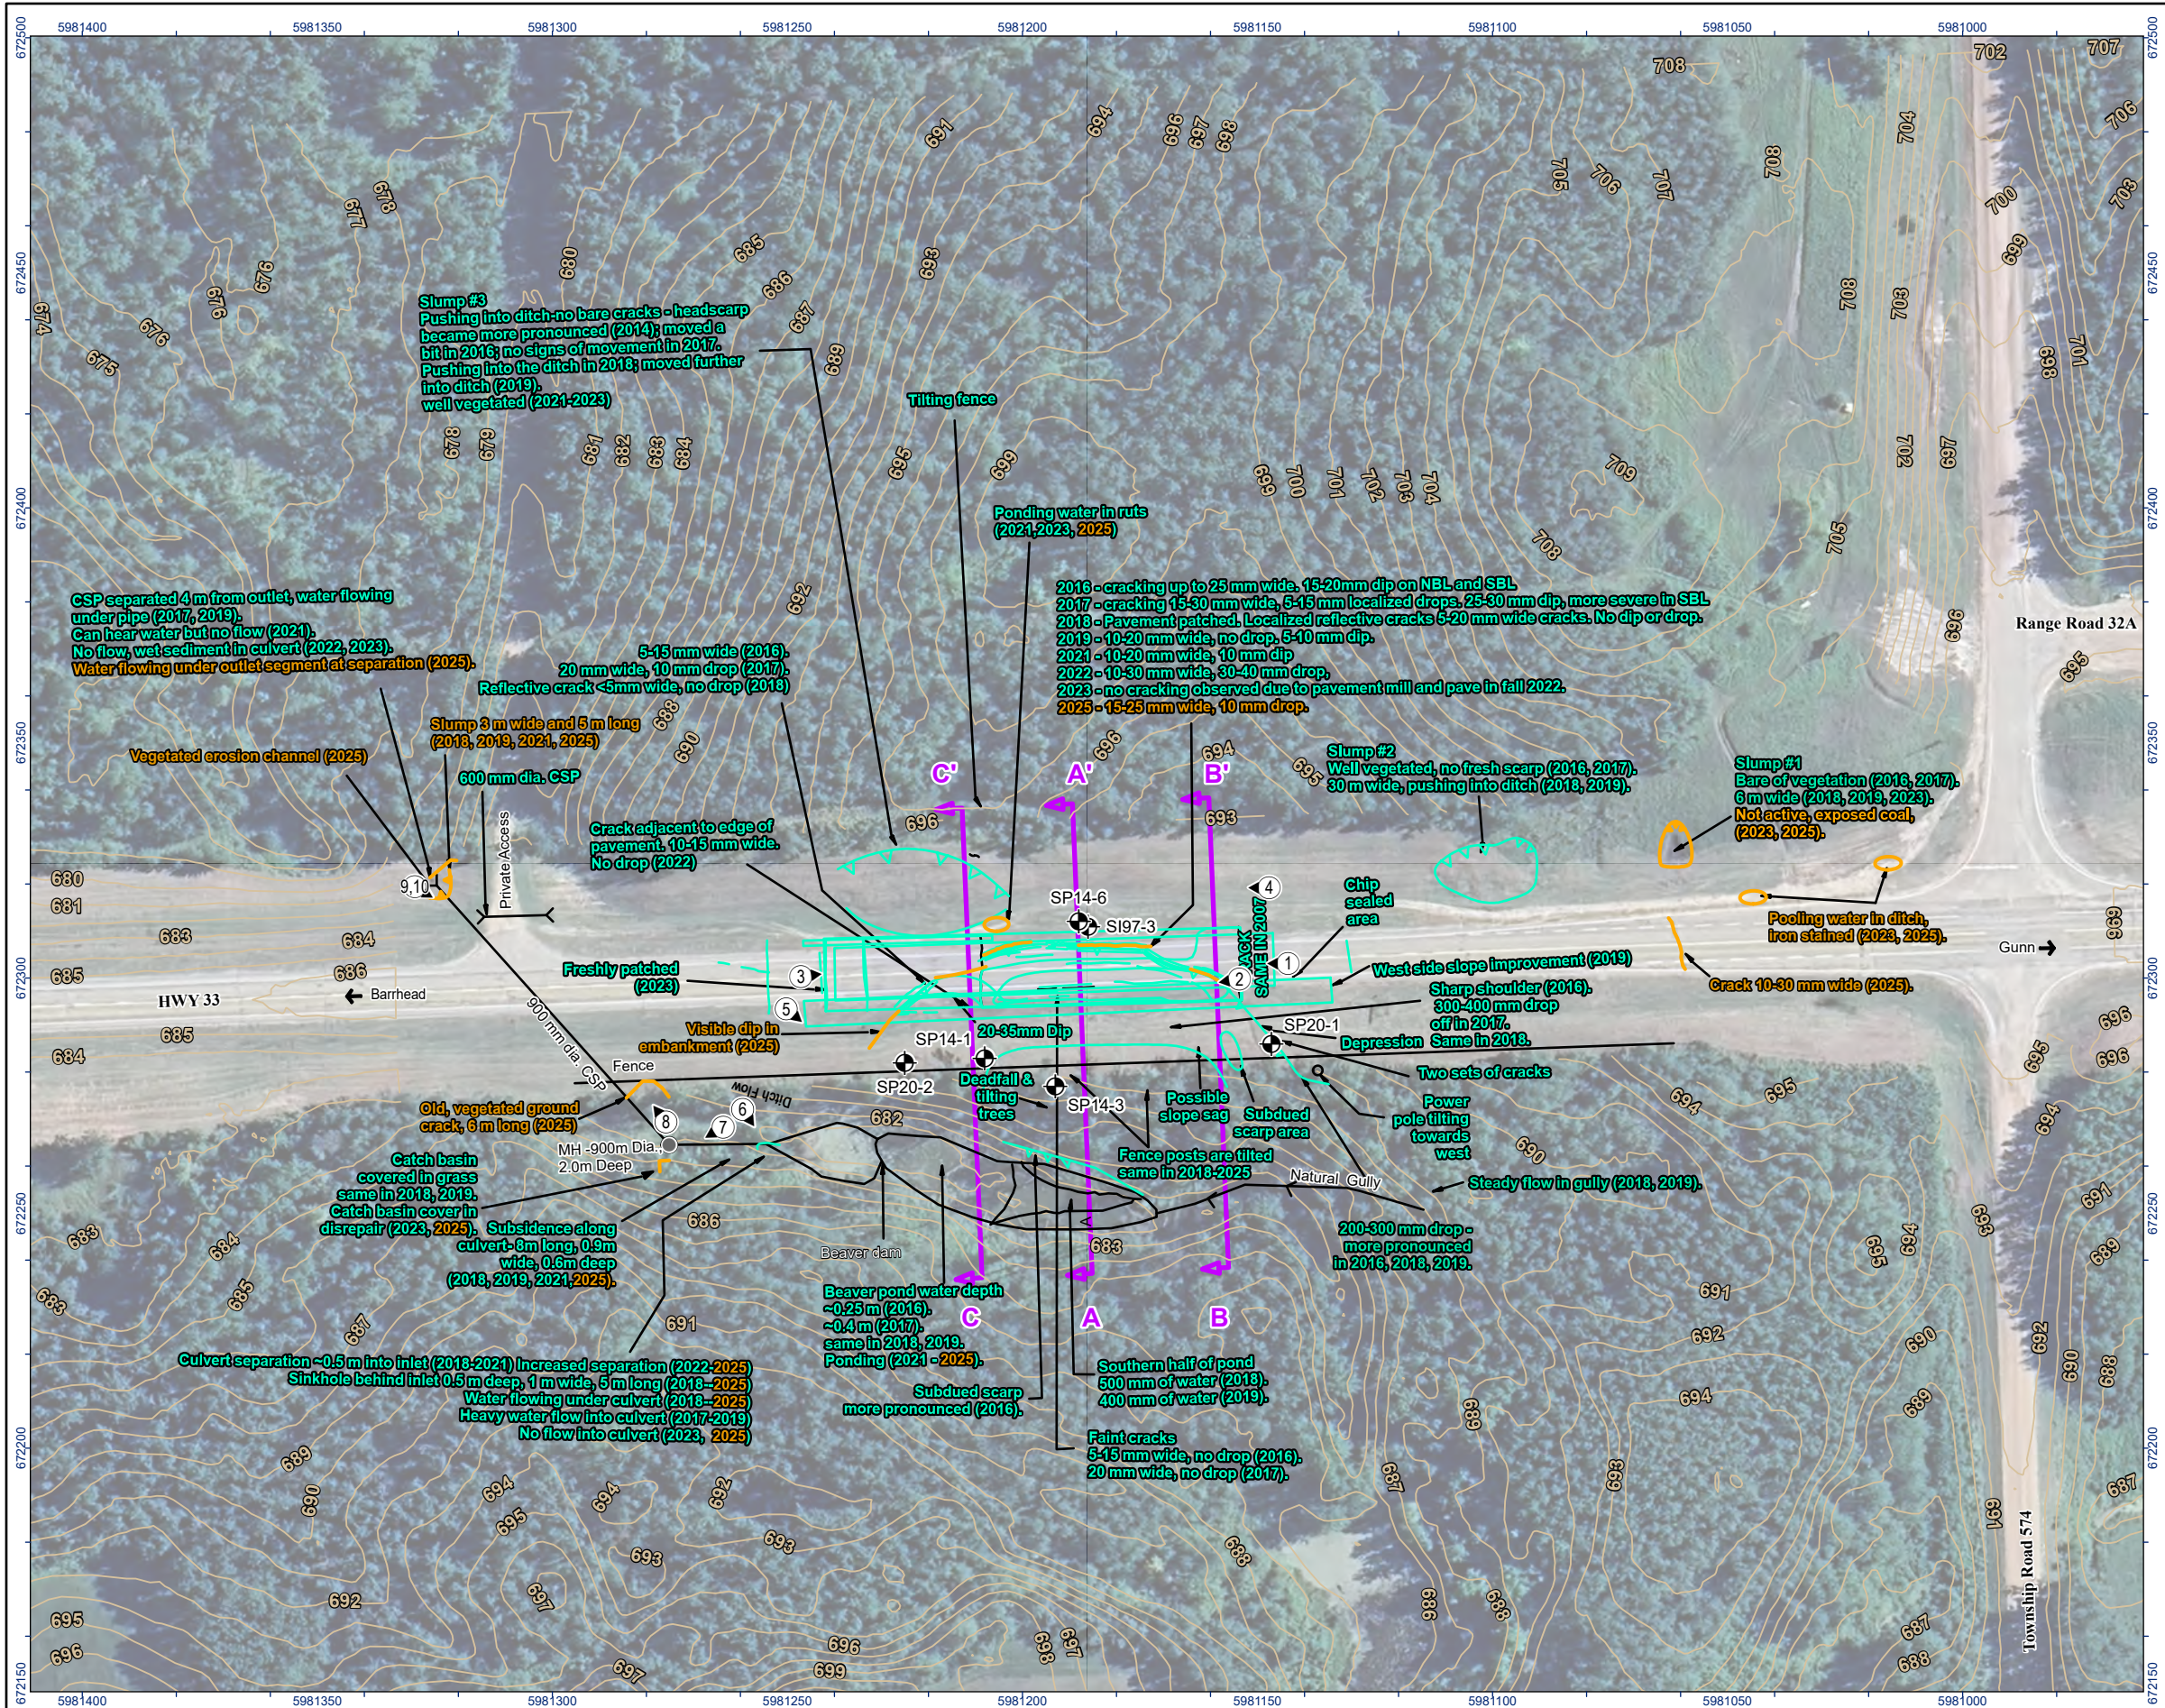
Figure No.
1

COMMENTS
<ul style="list-style-type: none"> Pavement left as milled surface some time after the 2023 inspection. Site conditions were generally unchanged since the 2023 site inspection (Figure 1) except for cracks that have reflected through the milled surface (Photos 1 to 3). Pavement cracking pattern appear similar to previous inspections. The semi-circular pavement crack is approximately 0.5 m away from the shoulder line on the northbound lane (Photo 2). The crack is approximately 0-10 mm wide. The NBL shoulder appears to be relatively steep and may constitute a safety hazard to motorists. Water was observed to be ponding throughout the east ditch.

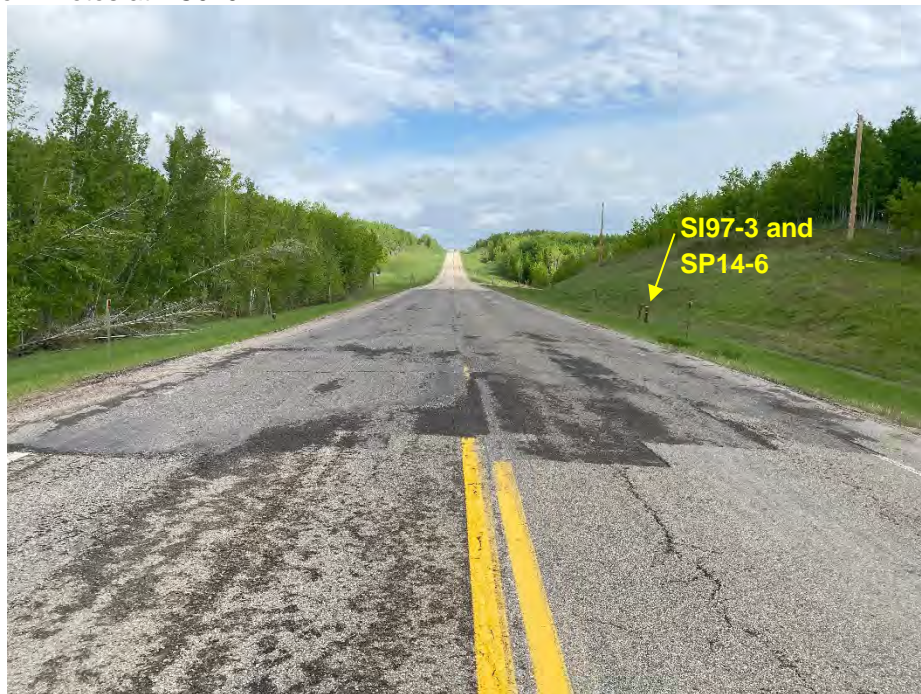
Photo 1: South end of milled / patched highway area. Looking north.

- The local MCI should continue to monitor the highway condition for development of new cracks and progression of existing cracks.
- Crack sealing should be completed to reduce surface water infiltration into the landslide.

- Milling and paving may continue as a short-term solution until long-term repairs can be performed. For any planned milling, the highway should be overlaid such that the final elevation matches the existing elevation or lower (i.e., no net addition of loads).

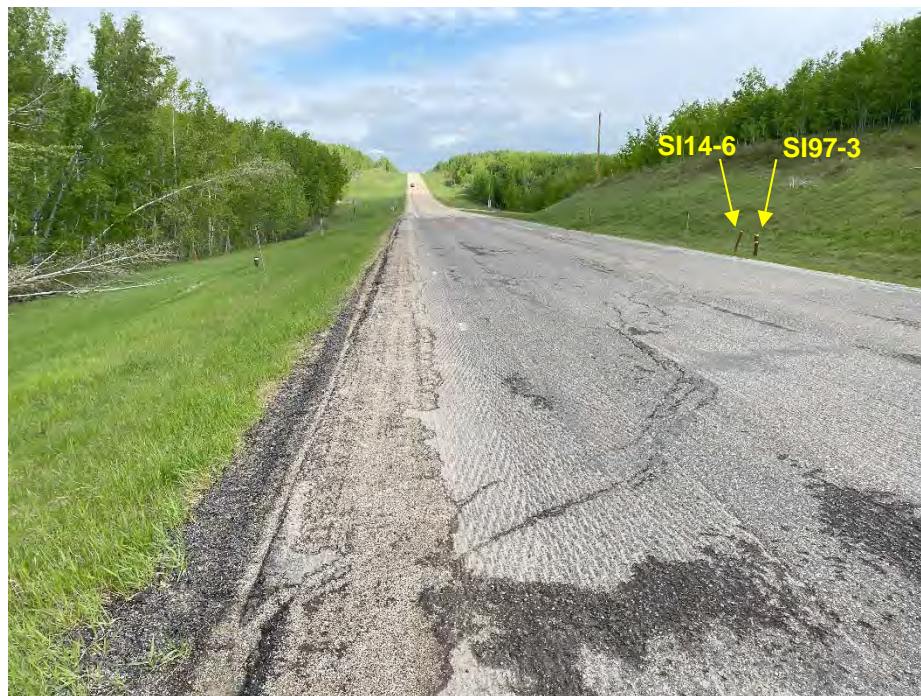
Photo 2: South end of landslide pavement cracking. Looking north.

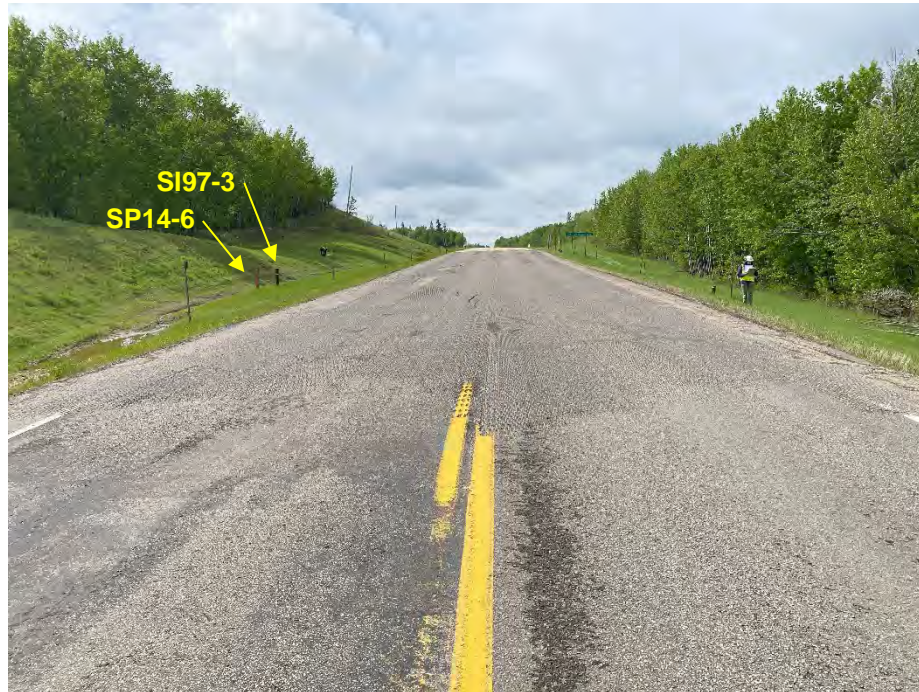
Photo 3: North end of milled / patched highway area. Looking south.

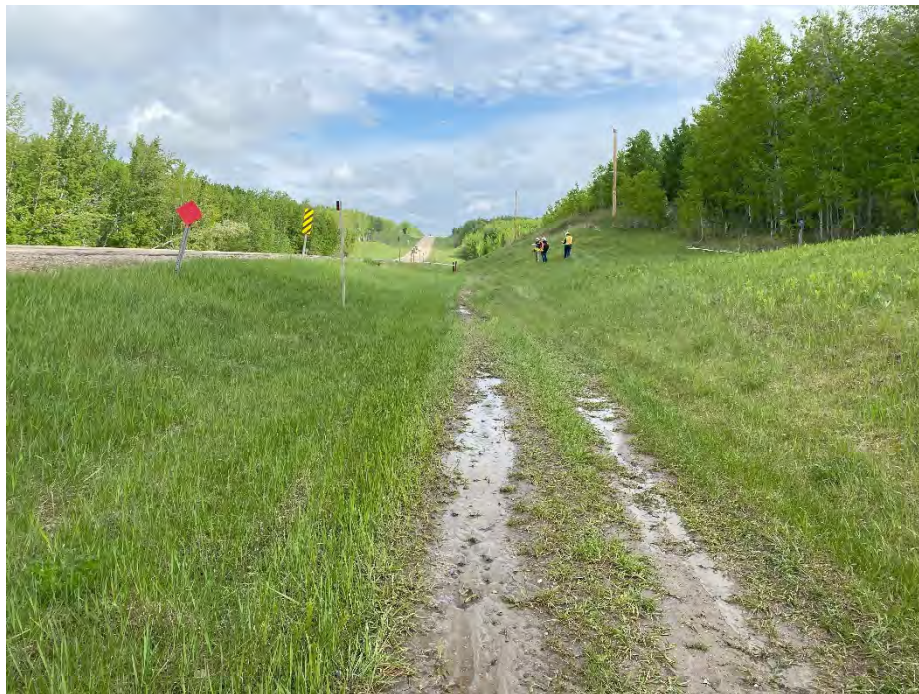
- Sedimentation was observed in the wheel tracks on the east side of the highway, south from backslope slump #3 (Photo 4).
- No changes to the backslope slumps #2 and #3 were observed due to thick vegetative cover.

Photo 4: Flowing water and sedimentation in wheel tracks on east side of highway, south from backslope slump #3. Looking north.

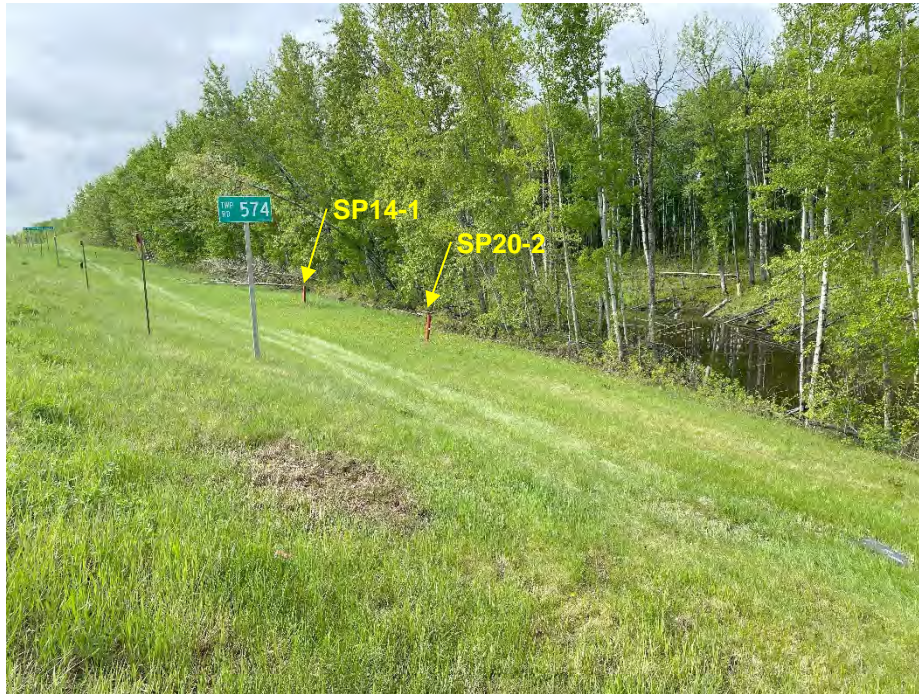
- The west embankment appeared to be in good condition, with no fresh ground cracks observed (Photo 5).
- The beaver dam at the 900 mm diameter culvert inlet continues to dam water upstream of the culvert.

Photo 5: West embankment slope, looking southwest.

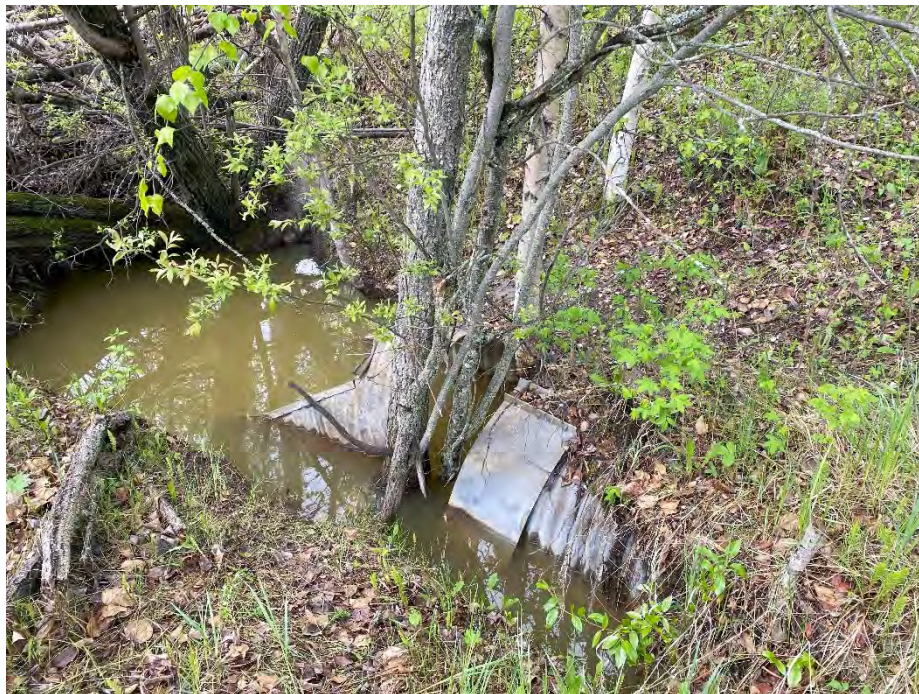
- Standing water was observed at the culvert inlet.
- A separation was observed about 0.5 m into the inlet of the 900 mm diameter culvert. Further erosion has occurred on the east side of the inlet, creating a gap between the ground surface and the culvert which is full of standing water (Photo 6).

Photo 6: Separation at 900 mm diameter culvert inlet. Looking southwest.

- A small amount of fill could be placed to reduce the steepness of the NBL shoulder. Sharp shoulder signs may also be placed to warn motorists.
- The 900 mm diameter culvert should be inspected via CCTV to check for separation below the highway. Separated sections of the culvert should be excavated and replaced. Repair of the slump at the outlet can also be completed concurrently for efficiency.

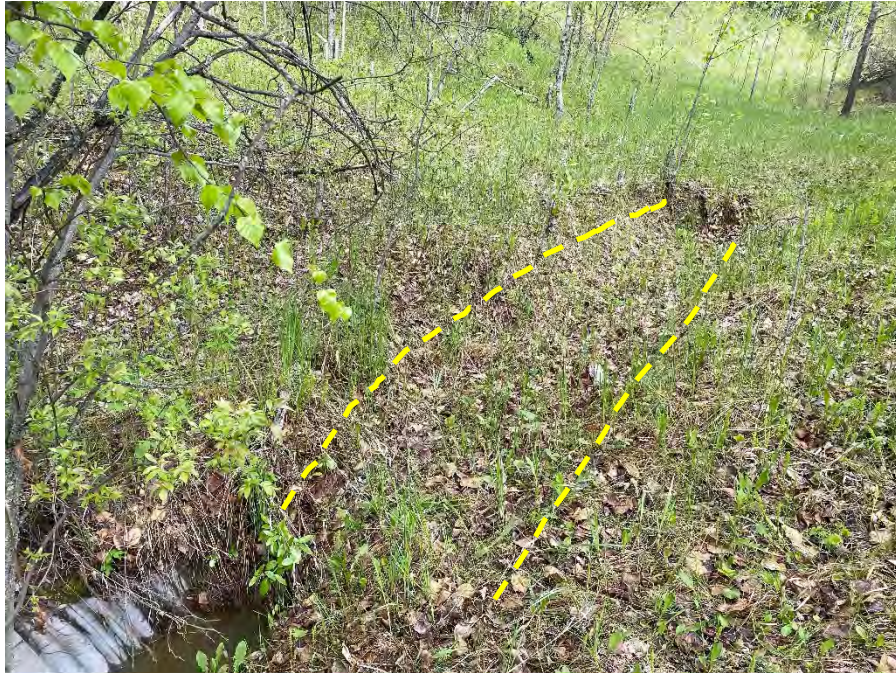
- Subsidence of the ground along the 900 mm diameter culvert alignment between the inlet and the catch basin was observed, similar to 2023 (Photo 7).
- The catch basin cover north of the inlet of the 900 mm diameter culvert was observed to be in a state of disrepair, similar to 2023. The metal is extremely weak and falling apart due to heavy rusting. This may present a hazard to anyone/ wildlife walking in the area. The depth from the top of the catch basin to the bottom of the culvert was measured to be approximately 2.4 m.

Photo 7: Subsidence along culvert alignment. Looking northwest.

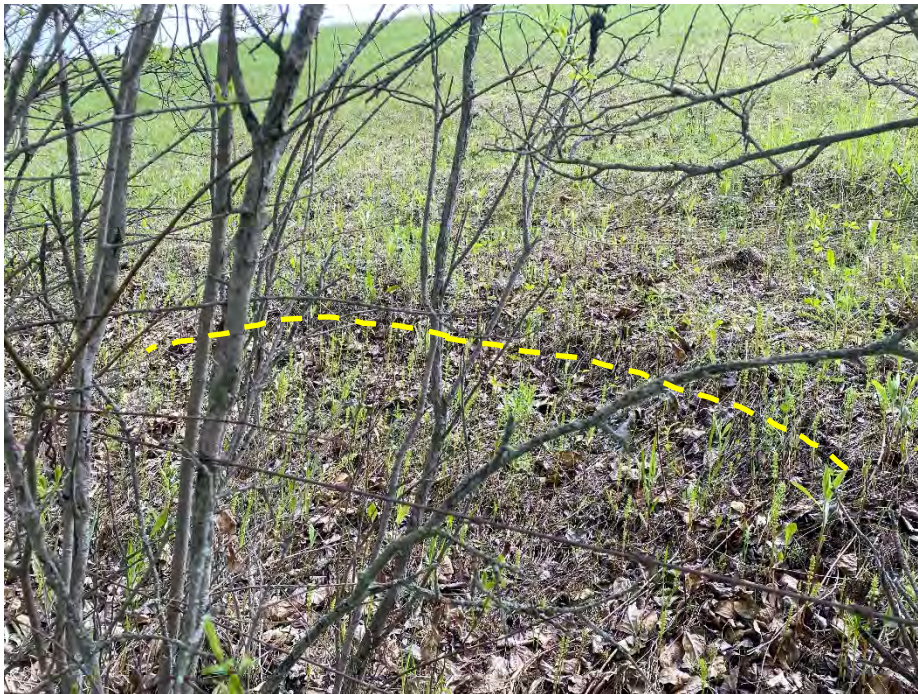
- An old, vegetated ground crack was observed near the toe of the west embankment slope. The crack is near both the 900 mm diameter CSP alignment and the north extent of the slide zone (Photo 8).

Photo 8: Old, vegetated ground crack near the north extent of the landslide zone. Looking northeast.

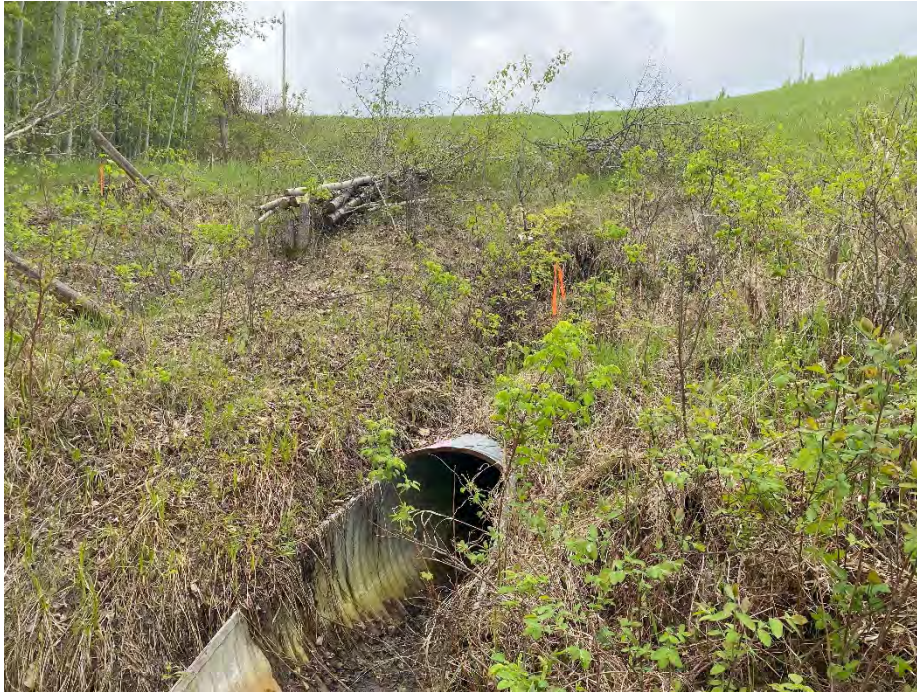
- The local slump was observed above the 900 mm diameter culvert outlet (Photo 9), likely due to saturation of the embankment fill at the location of the separation (Photo 10).

Photo 9: Culvert outlet and settlement above culvert. Looking southeast.

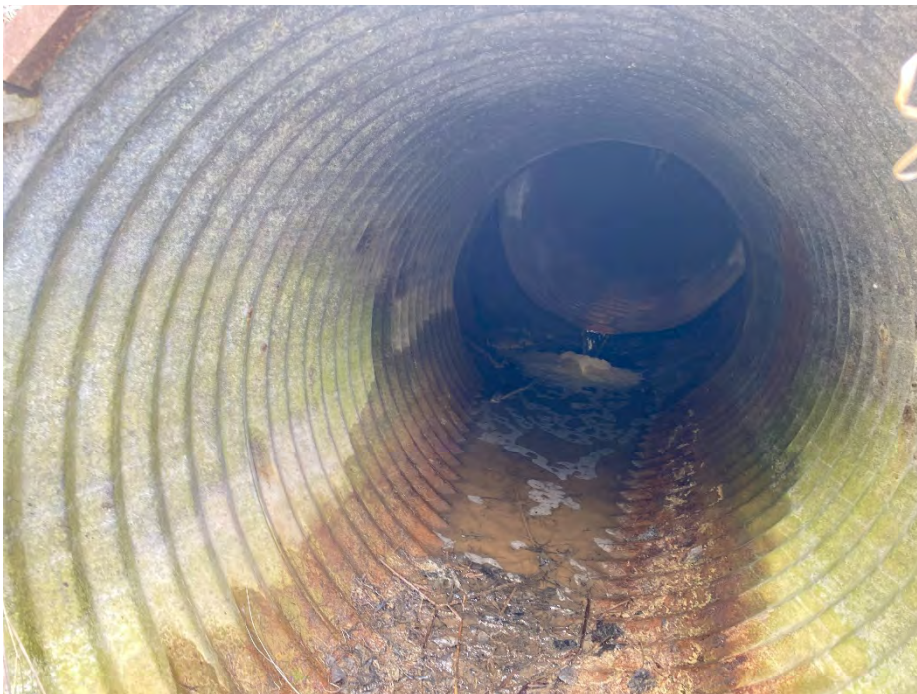
- No flow was observed from the culvert outlet, however, water was observed to be flowing under the outlet from the next segment directly behind the outlet (Photo 10).

Photo 10: Separation at first joint from culvert outlet. Looking southeast.

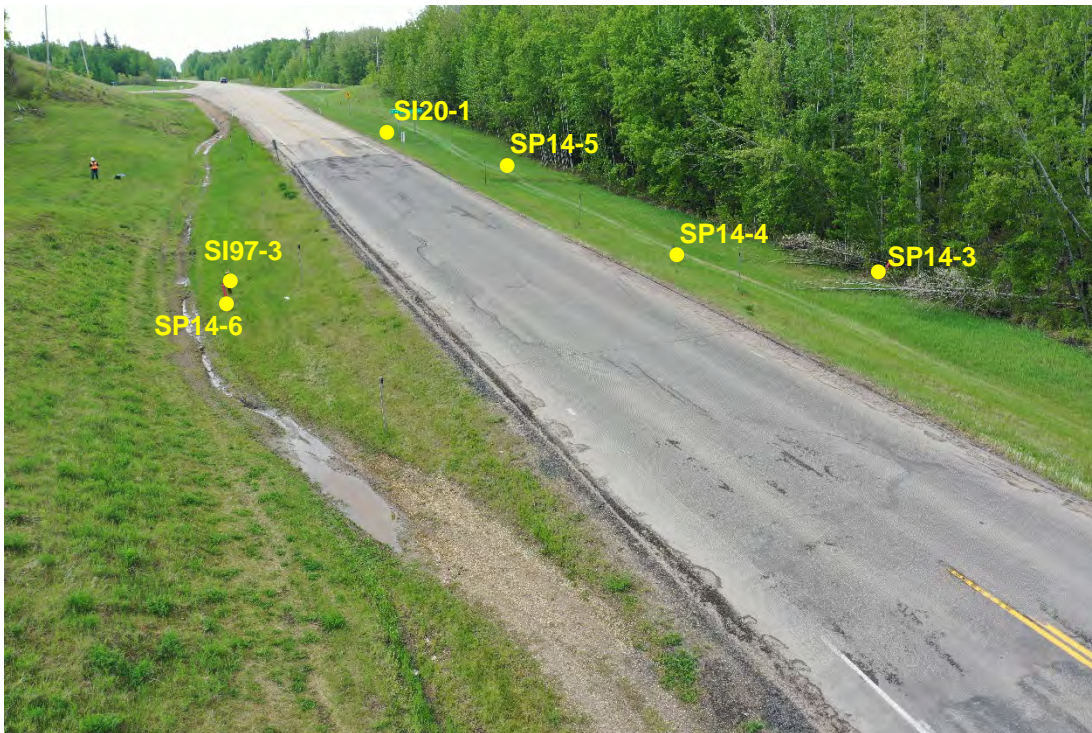
Photo 12: Aerial view of pavement cracking, taken by drone. Facing southwest.
