To:	Amy Driessen	From:	Leslie Cho and Lawrence Onwude
	Transportation and Economic Corridors		Stantec Consulting Ltd.
File:	123315222	Date:	October 31, 2025

Reference: North Central Region, Stony Plain Area, Site NC092 - Highway 37:02 Cattlepass Culvert BF 80823, Fall 2025 Instrumentation Monitoring Report

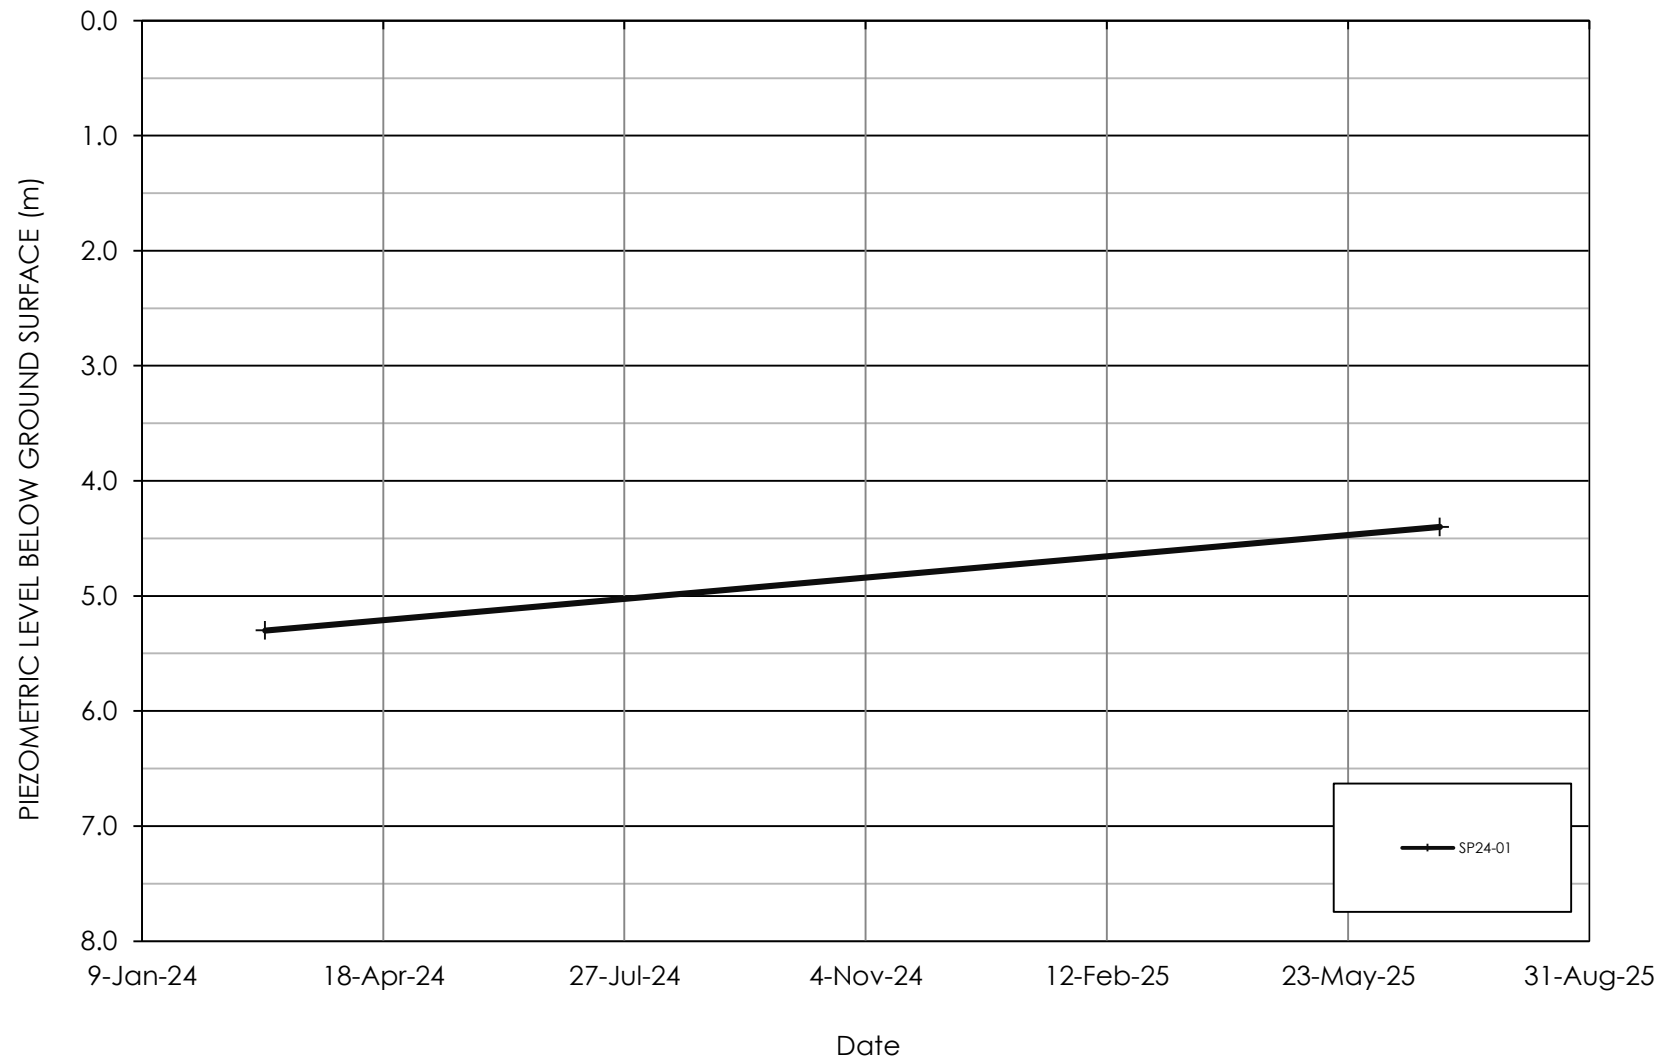
PIEZOMETER DATA

Prior to being paved over, water levels in SP24-01 increased by 0.9 m during the Spring 2025 reading cycle.

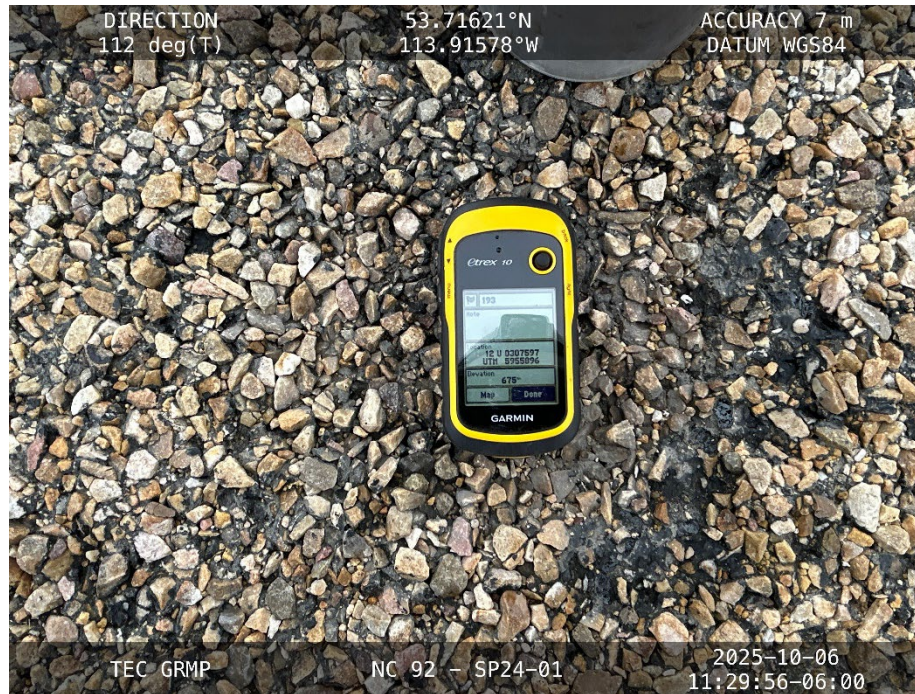
NC092 was added to the Spring 2025 reading cycle and consisted of instrument readings for one standpipe piezometer (SP24-01). SP24-01 was initialized on February 12, 2024. **Figure 1** attached provides a schematic of the site. The instrument could not be read since the flush mount protective cover was paved over with asphalt. The site visit and observation were carried out by Akintola Fakinlede, GIT on October 6, 2025.

Photo 1: Location of SP24-01 marked by the handheld GPS device.

The slope inclinometer is now buried under pavement and cannot be monitored without removal of the pavement surface. As such, it is recommended that this site be removed from the instrumentation monitoring program until replacement instruments are installed.

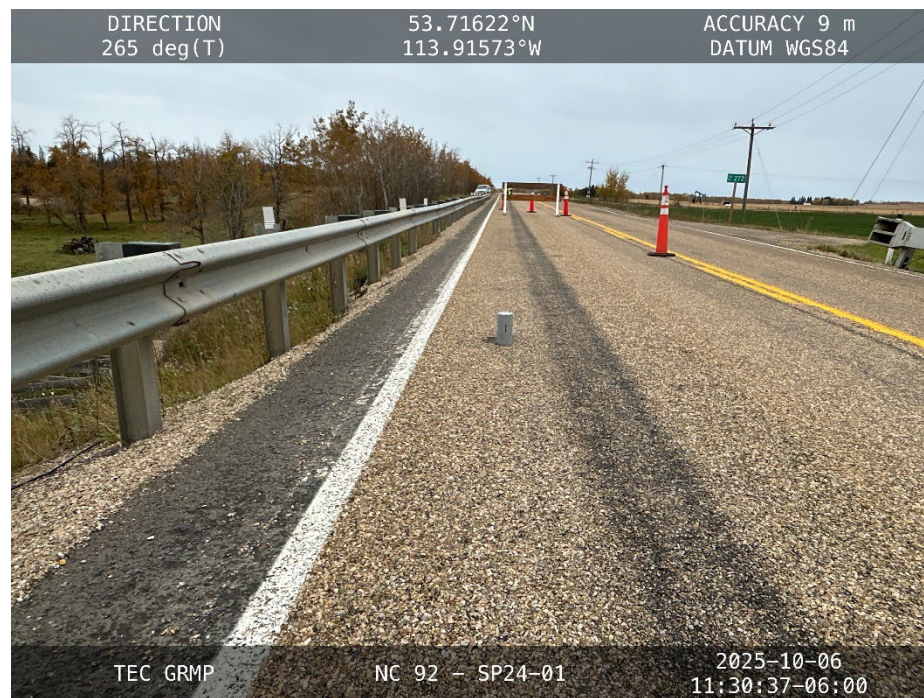
Photo 2: An overview of SP24-01 location, facing west.

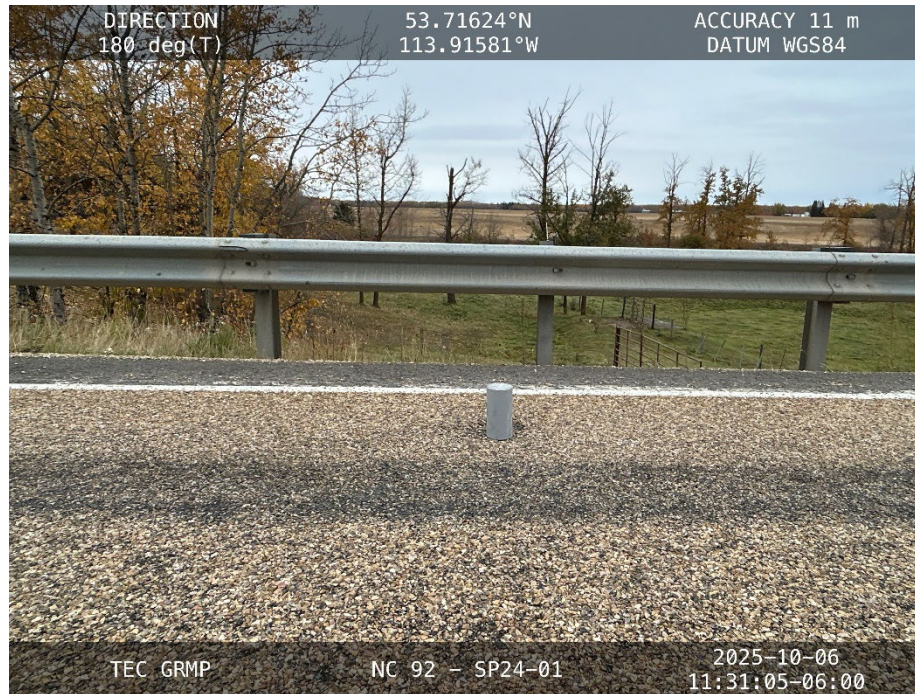
Photo 3: An overview of SP24-01 location, facing south.

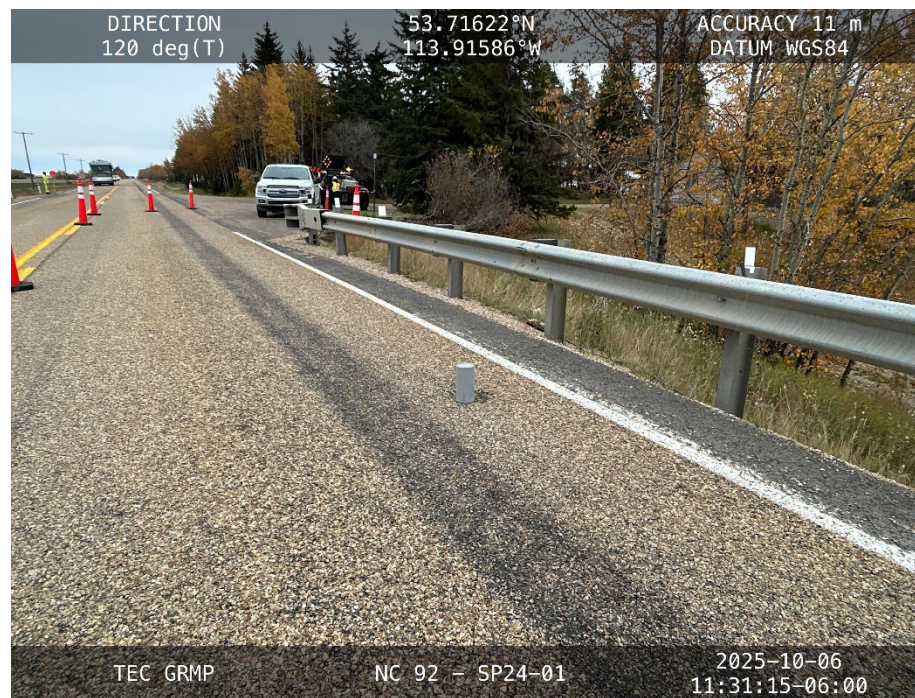
Photo 4: An overview of SP24-01 location, facing east.

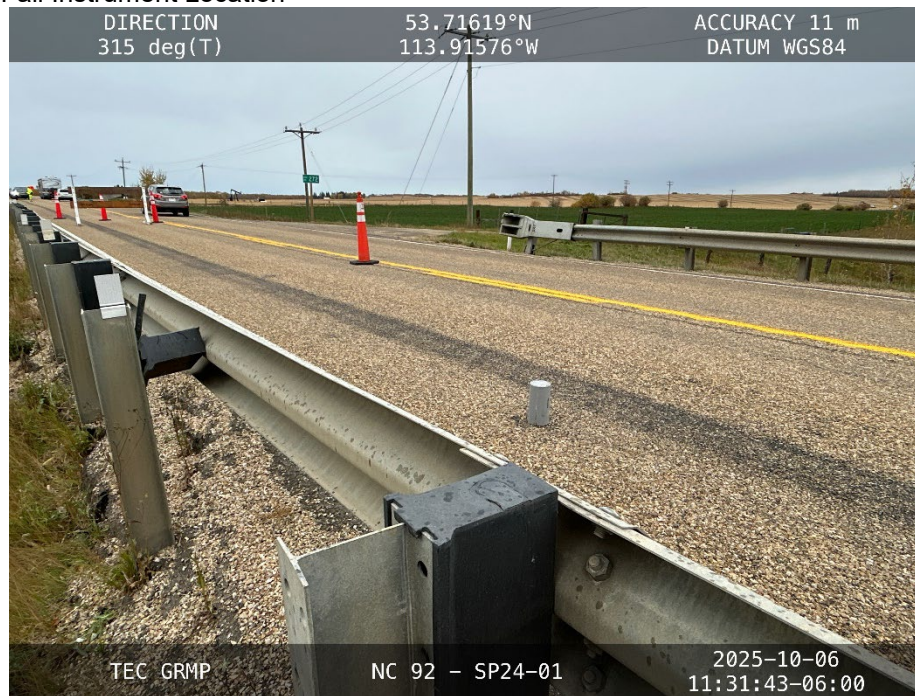
Photo 5: An overview of SP24-01 location, facing north.
