SITE NUMBER AND NAME: NC092 – Cattlepass Culvert BF 80823	HIGHWAY AND KM: 37:02, km 23.855	PREVIOUS INSPECTION: June 20, 2024	CURRENT INSPECTION: May 21, 2025
LEGAL DESCRIPTION: NE 33-54-27-W4M	NAD83 COORDINATES: UTM12U 5955908N, 307552E		RISK ASSESSMENT: PF: 10 CF: 6 Total: 60
AVERAGE ANNUAL DAILY TRAFFIC (AADT): 3000 (2024)		CONTRACTOR MAINTENANCE AREA (CMA): 510

**NORTH CENTRAL REGION GRMP
EDSON / STONY PLAIN
SITE INSPECTION FORM**

Client/Project
Transportation and Economic Corridors
Geohazard Monitoring Program
NC92 - Highway 37:2 Cattlepass Culvert

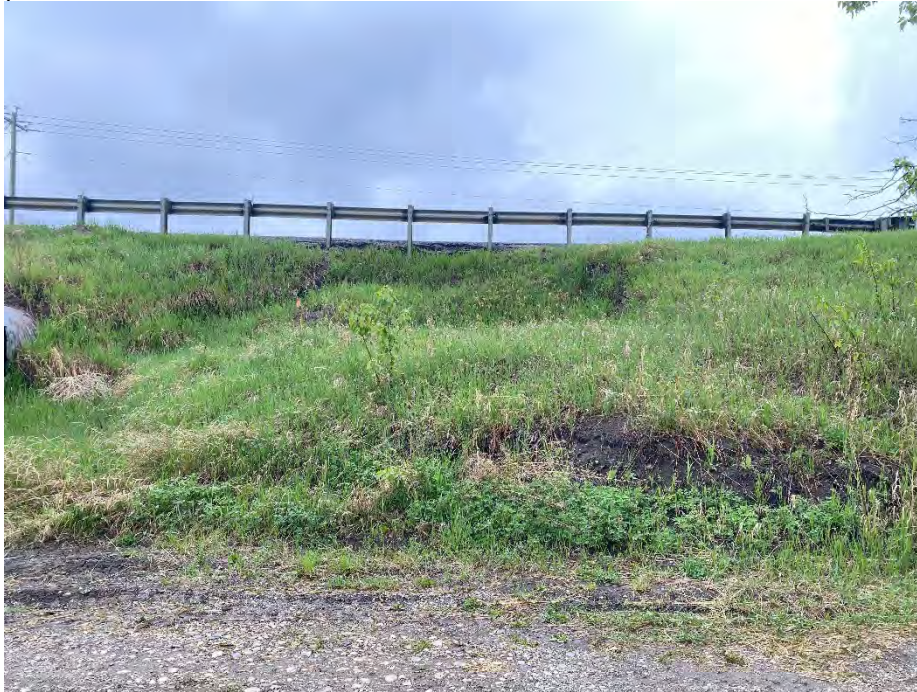
COMMENTS <ul style="list-style-type: none"> Little to no change was observed at the slump on the southeast side of the cattlepass, with the scarp up to about 2.5 m high. The scarp at the east extent next to the pavement remains approximately 0.3 m high (Photos 1 and 2). The height of the toe bulge was about 700 mm high, similar to observations in 2024 (Photo 1). Four guardrail posts have been exposed by the scarp, one more than observed in previous inspections. Ponded water was observed at the base of one guardrail post.
--

- Regrading of the landslide toe on the east side of the cattlepass has been completed in the past, and may have taken place this year as well. The toe appears to have been cut back in an area 1.7 m wide, 4.0 m long, and 0.7 m high. A section of exposed soil was observed on the landslide toe during the recent inspection, which may be the result of recent grading (Photo 1).

Photo 1: Slump on east side of culvert. Looking north.

- The MCI should continue to monitor the highway surface and guardrails until remediation can be undertaken.
- The MCI should discuss possible solutions with the farmer to maintain functionality of the gate but to refrain from further grading work at the toe of the landslide. Loss of soil support at the toe can trigger additional slope movements.

- Cracks in the pavement should be sealed to prevent surface water from entering the embankment.
- In the short-term, fill can be placed at the base of the slope failure to act as a temporary buttress. The nearby Calahoo pit may be a potential source of granular material for this purpose.

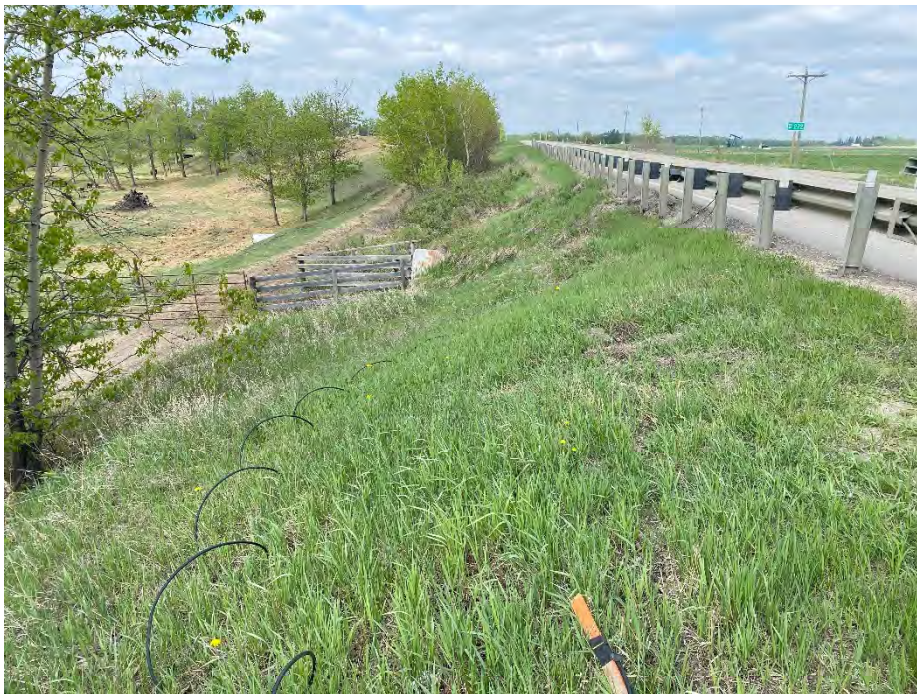
- The guardrail appeared to be mostly in good condition.
- A black utility cable (likely Telus) continues to be observed running east-west, though it is above the landslide now (Photo 2). It appears to be a newly installed line that hasn't yet been buried.

Photo 2: Slump across cattlepass culvert. Looking west.

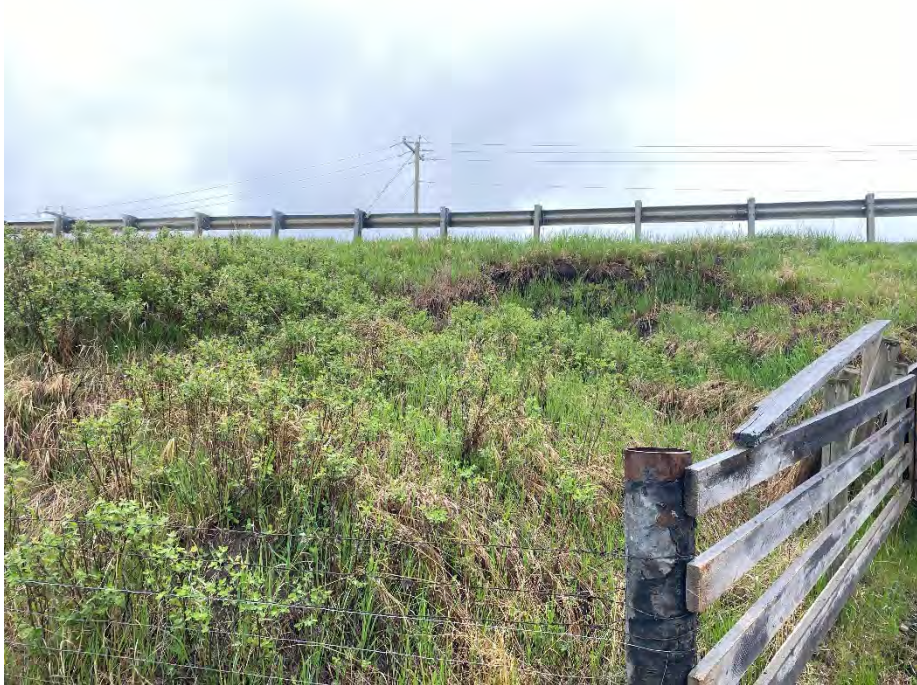
- The west slump appeared to have retrogressed compared to the 2024 inspection. The scarp west of the cattlepass was about 3.0 m high and 1.8 m away from the guardrail (Photos 3 and 4).

Photo 3: Scarp at west slump. Looking north.

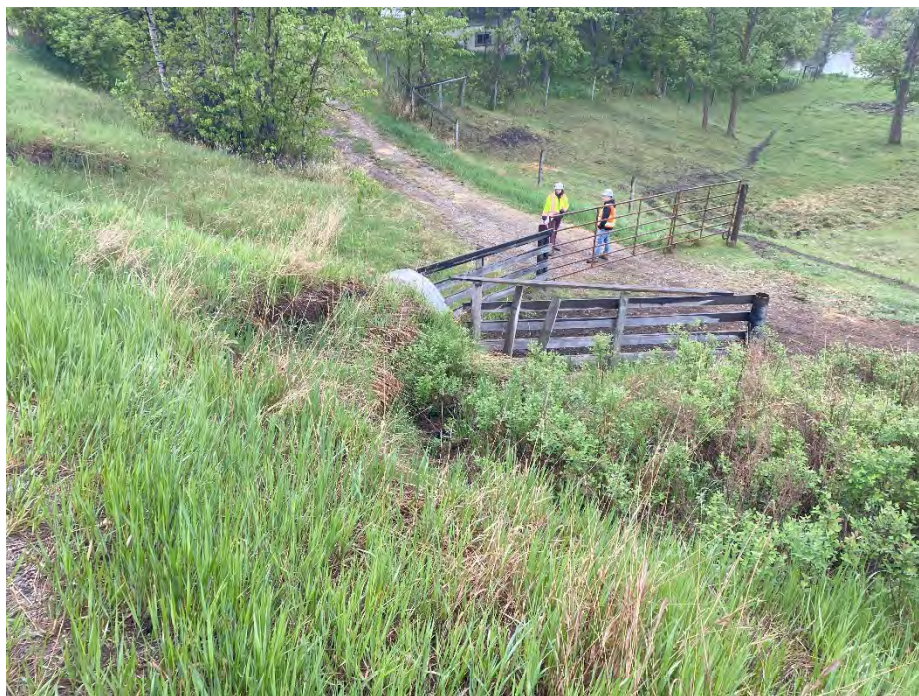
Photo 4: West slump next to culvert entrance. Looking southeast.

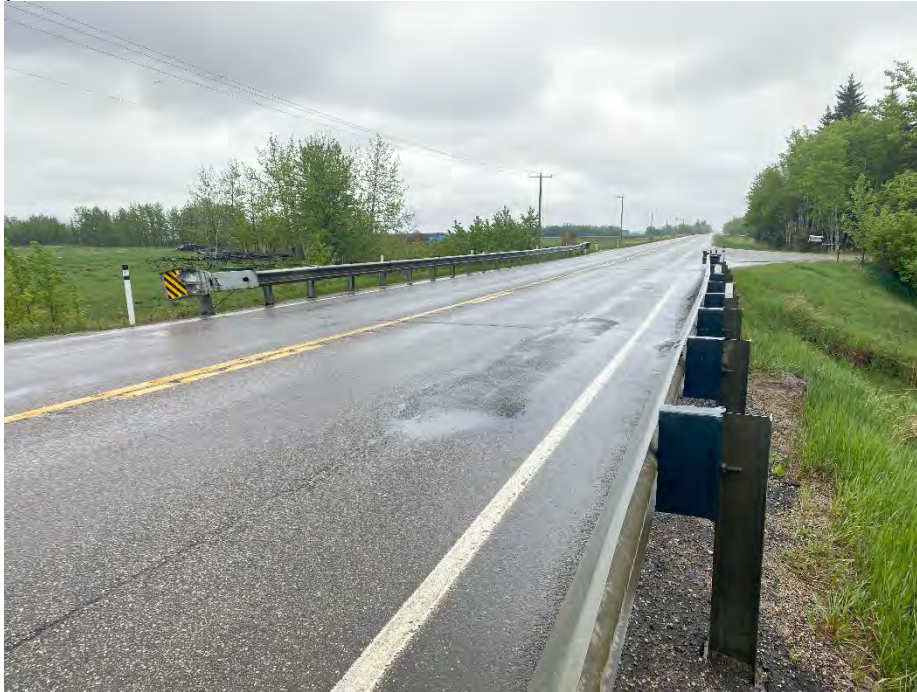
- A longitudinal crack in the EBL was observed above the culvert and is partially patched. The crack extends past the patch on both sides and is up to 10 mm wide (Photo 5).

Photo 5: Highway surface above culvert. Looking east.

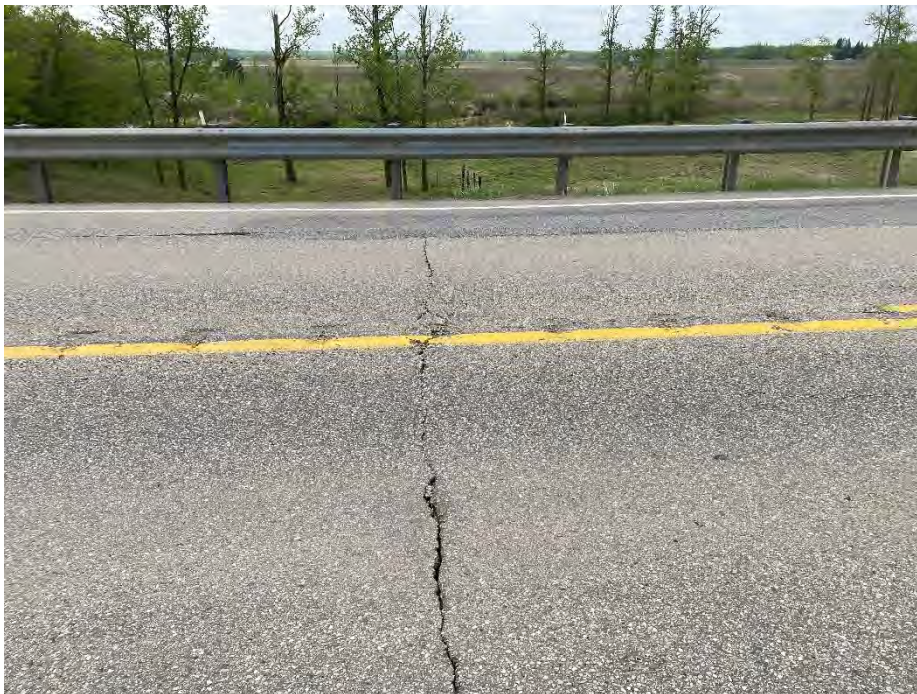
- The transverse cracks above the eastern scarp and cattlepass culvert (Photo 6) appeared unchanged, and have reflected through their respective pavement patches.

Photo 6: Transverse pavement crack above cattlepass culvert. Looking south.

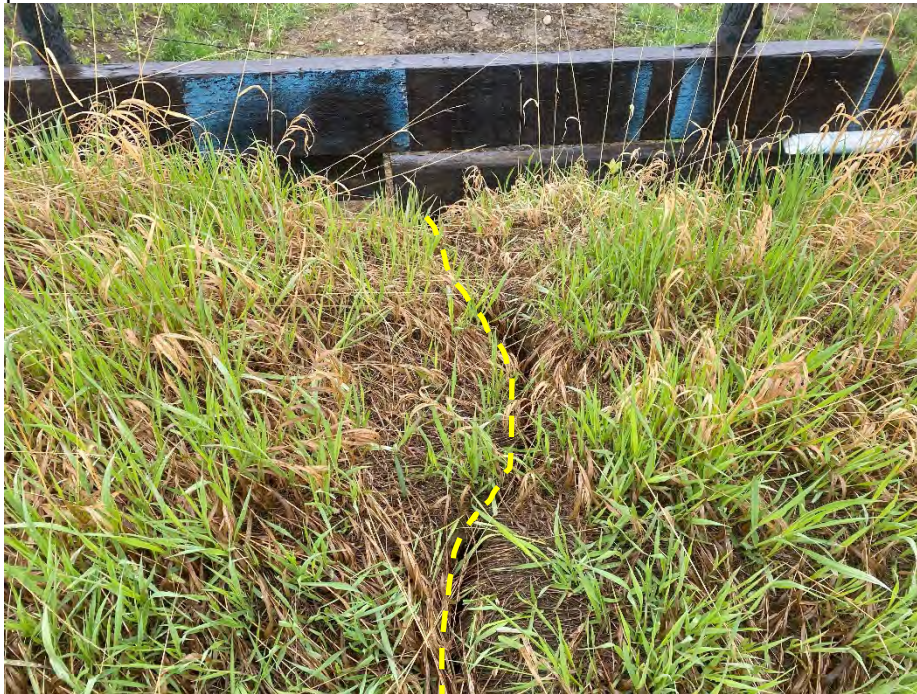
- A ground crack approximately 50 mm wide was observed in 2024 above the north end of the cattlepass culvert, at the fence line (Photo 7). The crack has progressed and is now approximately 2.6 m long, 2.2 m longer than observed last year.

Photo 7: Ground crack along centreline of cattlepass culvert at north end. Looking north.

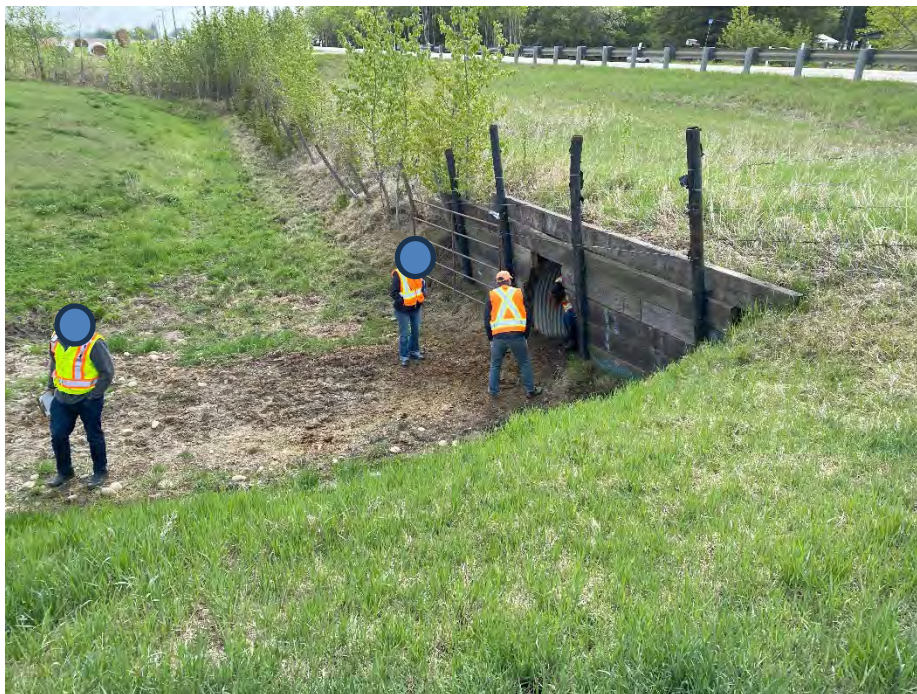
- The retaining wall constructed by the landowner at the north end of the cattlepass is leaning away from the slope, and fenceposts beyond the cattlepass can also be seen to be leaning downwards (Photo 8), suggesting that the north slope may be slowly moving as well. The gap between the backside of the timber lagging and the ground surface was measured to be approximately 60 mm.

Photo 8: North end of the cattlepass culvert. Looking southeast. Photo taken May 16, 2025, prior to annual site inspection.

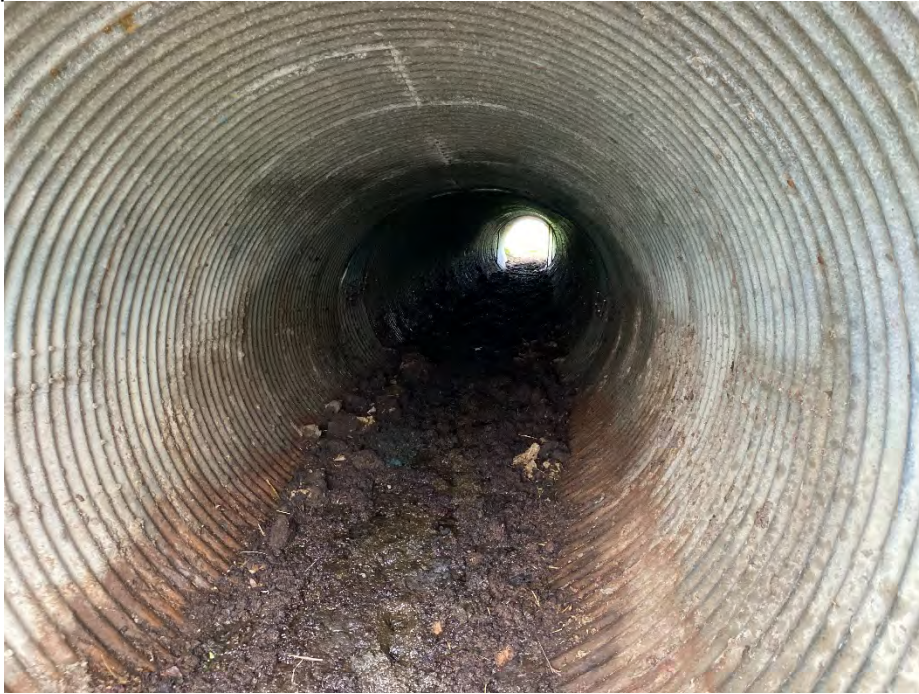
- A sag was observed about 3 m to 4 m inside the south end of the cattle pass culvert since 2021. The sag location appeared to be approximately in line with the two scarps and is potentially separated at the joint. A splice has been installed at this section as well (Photo 9).

Photo 9: Inside of cattlepass culvert, looking north from southern end.

- An alternative design was also submitted following the site visit with the landowners on May 16, 2025, to include partial culvert replacement either with replacement CSP or a box culvert. The alternative design is currently with TEC for review.

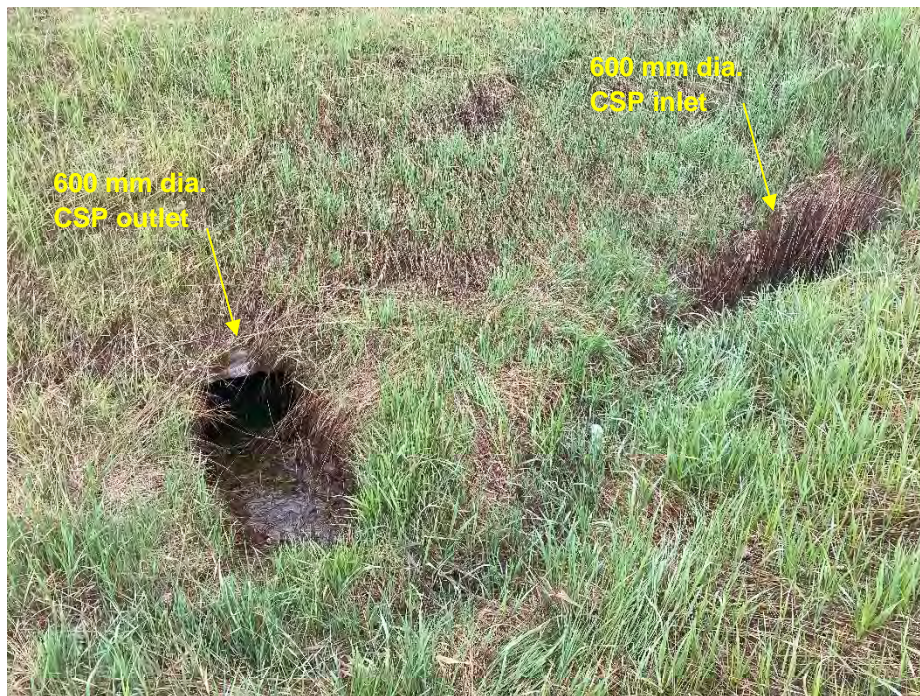
- The culvert inlet in the ditch to the east of the private driveway, on the south side of the highway is sunken into the ground. The outlet in the north ditch is also sunken into the ground, and water is pooling in the outlet, unable to flow out (Photo 10). The culvert inlet to the west of the outlet in the northeast ditch appears to be at a higher elevation than the neighbouring outlet.

Photo 10: Water ponded in sunken culvert outlet in ditch east of private access, north side of highway. Looking south.

- Regrade the ground around the 600 mm dia. culvert inlet and outlets east of the private access road to promote positive surface water drainage.
- Site inspections should be completed annually.
