SITE NUMBER AND NAME: NC086 – Poplar Creek Slide	HIGHWAY AND KM: 39:06, km 4.915	PREVIOUS INSPECTION: June 14, 2024	CURRENT INSPECTION: May 20, 2025
LEGAL DESCRIPTION: SW 11-49-06-W5	NAD83 COORDINATES: UTM11U 5897673N, 648158E		RISK ASSESSMENT: PF: 9 CF: 3 Total: 27
AVERAGE ANNUAL DAILY TRAFFIC (AADT): 3,660 (2024)		CONTRACTOR MAINTENANCE AREA (CMA): 509

2025 Site Inspection Photos at NC086

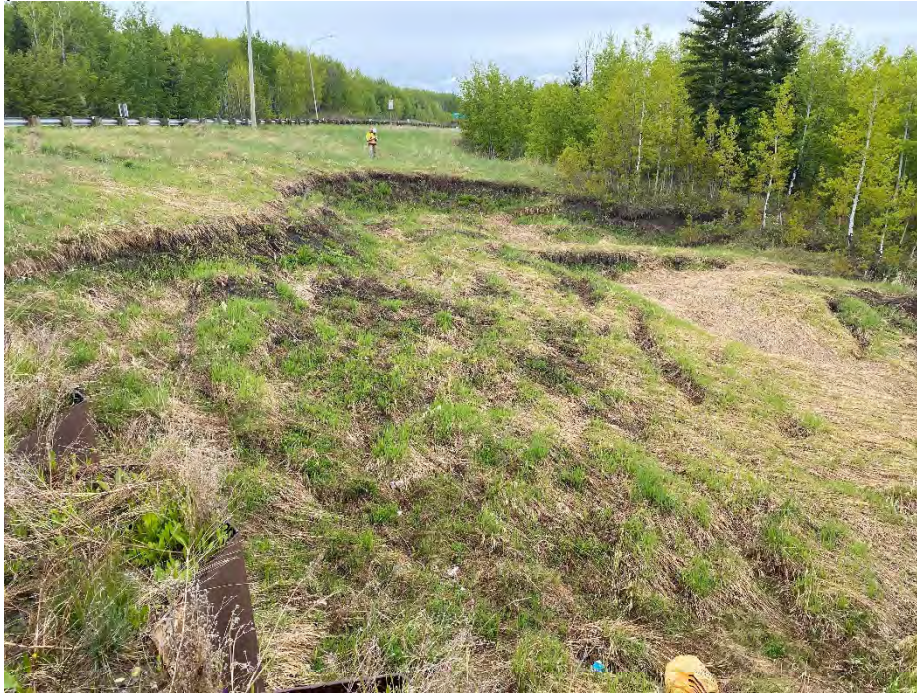
COMMENTS
<ul style="list-style-type: none"> The landslide downslope of the wall continues to progress slowly (Photos 1 to 3, 9 and 10). A measurement from the top of pile wall to the top of ground was taken between the 9th and 10th guardrail post south of the stop sign. The height was measured to be 3.6 m, same as the past two inspections. The landslide mass appears to have extended east beyond the limits of the pile wall. The current east limit is approximately 5.6 m east from the light standard. This is approximately in line with the east limit of the pile wall. The scarp is approximately 8.4 m south of the guardrail, meaning that the slide has retrogressed 0.3 m since the 2024 inspection. The height of the scarp remains similar to 2024, varying between about 2 and 3 m high. The southeast extent of the scarp extends into the tree line as noted in 2024. The scarp is less vegetated than observed during the previous inspection. The tension cracks above the current landslide scarp appeared similar to 2023 observations.

Photo 1: Slope movement downslope of pile wall. Looking northeast.

- The site should be regularly monitored by the MCI. In particular, the landslide should be monitored for additional progression towards the light standard which would indicate the slide is beyond the extent of the pile wall. In addition, the depth of the landslide from the top of the pile wall should be checked to ensure that it does not exceed the design cantilever height of 6 m.

- To facilitate monitoring of the slide, lathe may be installed within the slide zone, and to the northeast of the slide zone, to provide repeatable reference points. Measurements between lathe and from features outside of the slide zone could be taken during the annual instrument readings in the spring.

- Should the landslide progress beyond the east extent of the pile wall, the pile wall can be extended to protect the highway. The high-level cost of extending the pile wall by 20 m is \$315,000, excluding engineering. Conflicts with streetlight power and communications cable are expected if the pile wall is extended east.

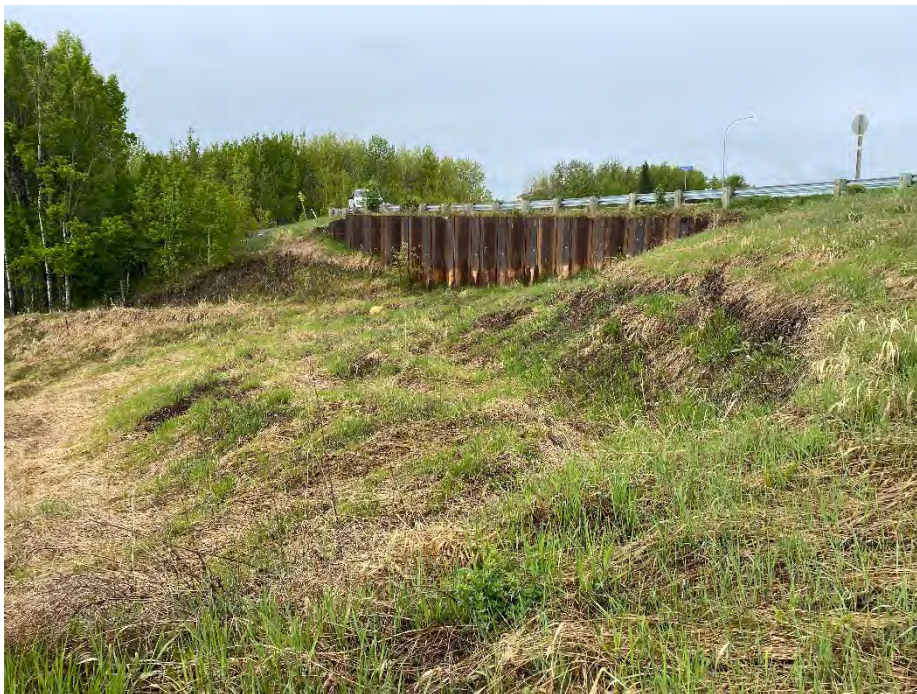
Photo 2: Slope movement downslope of pile wall. Looking southwest.

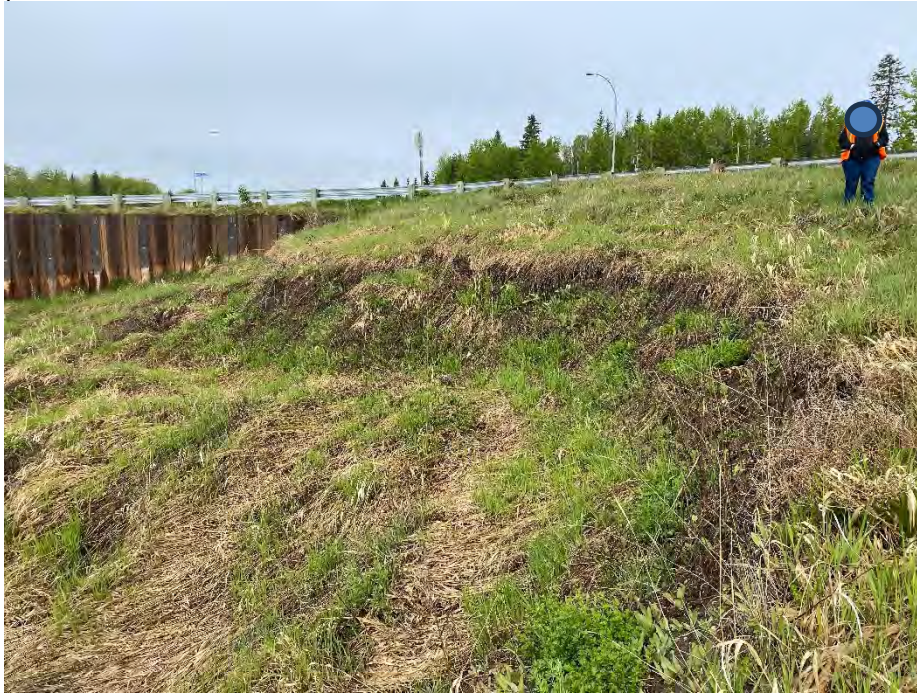
Photo 3: Scarp less vegetated than previous inspection. Looking northwest.

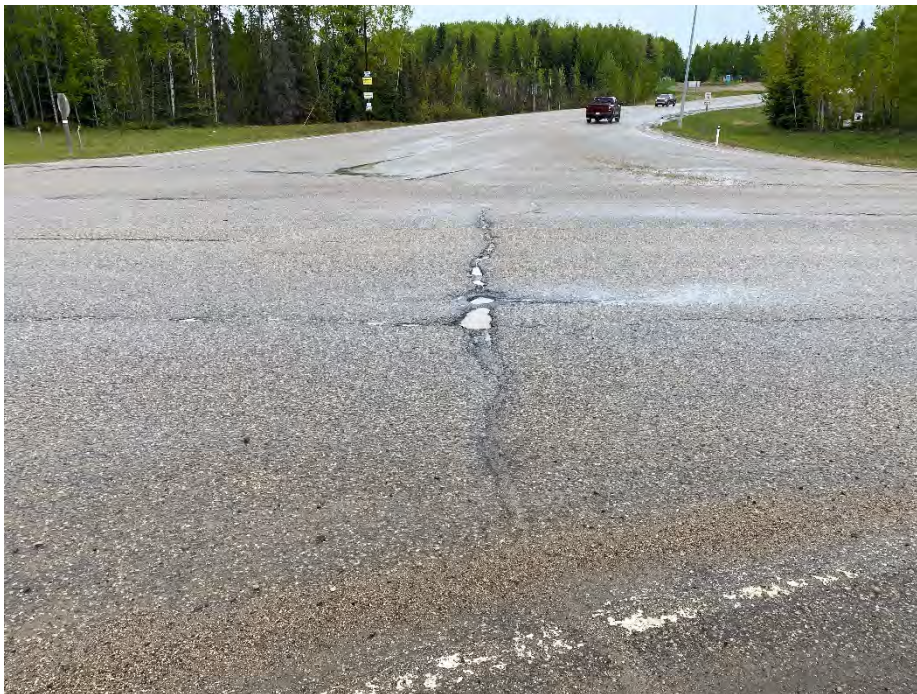
- Transverse pavement cracks up to 50 mm wide were observed east of the intersection (Photo 4). A pothole around 0.1 m diameter and 50 mm deep was observed within one of the cracks. The cracking and rutting appeared to be extending further east.

Photo 4: Crack on east side of intersection. Looking north.

- Pavement cracks should be sealed to reduce surface water infiltration into the slope.
- The ditch on the north side of Highway 39 should be regraded for water flow. Additional check dams or other structures should be installed to reduce surface water flow velocity.

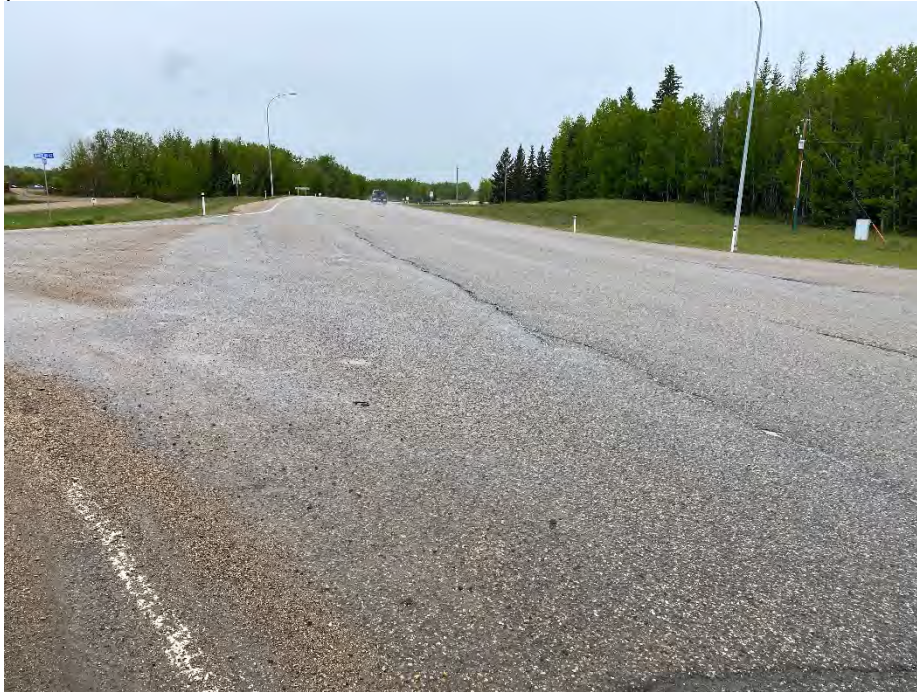
- Longitudinal cracking of Highway 39 was observed and appeared similar to 2024, with cracks up to 10 mm wide (Photo 5). The observed cracking does not appear to be related to landslide activity (Photo 11).

Photo 5: Pavement condition at intersection. Looking west.

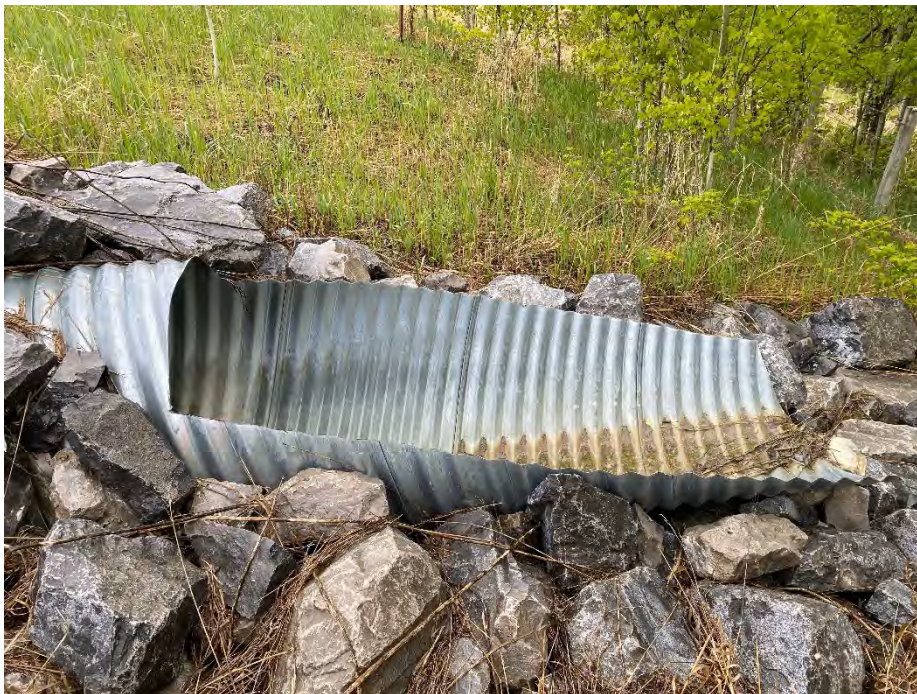
- The culvert and ditch across TWP RD 491A were wet (raining during site inspection). The riprap at both ends of the culvert was cracked (Photo 6).
- The separation between the new and old pavement could not be observed as the area was covered in dirt and gravel, similar to 2024.

Photo 6: Culvert outlet south of the pile wall. Looking northeast.

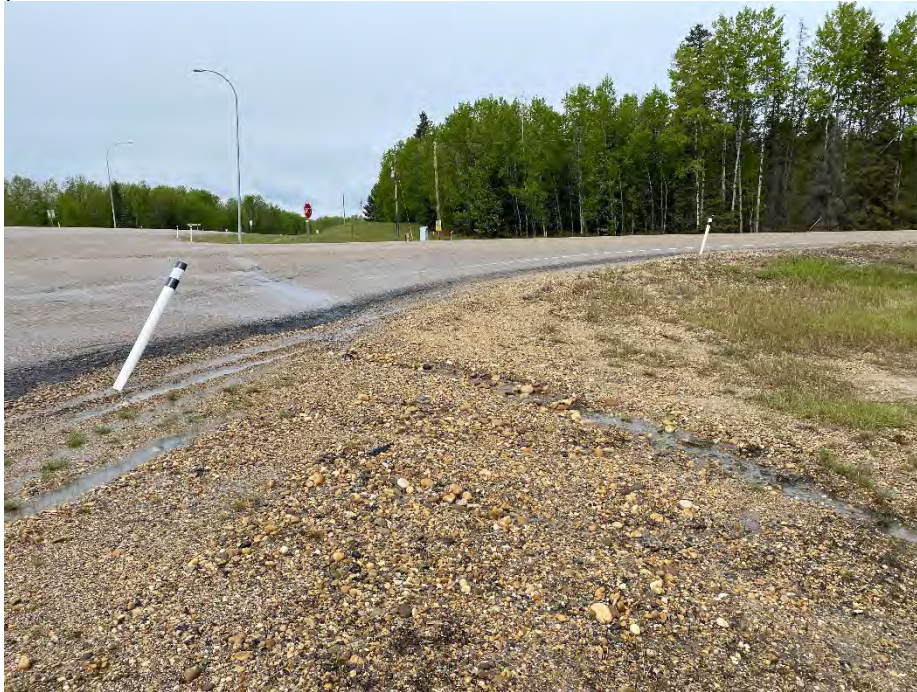
- The north ditch of Highway 39 was wet, with some erosion and ponded water (Photo 7). One larger area of ponded water exists near the north end of the culvert that was grouted and abandoned in 2018 (Photos 8 and 11). Water was observed to be flowing east towards the check dams.

Photo 7: Erosion occurring off the east corner of Hwy 759 and Hwy 39, into the north ditch. Looking west.

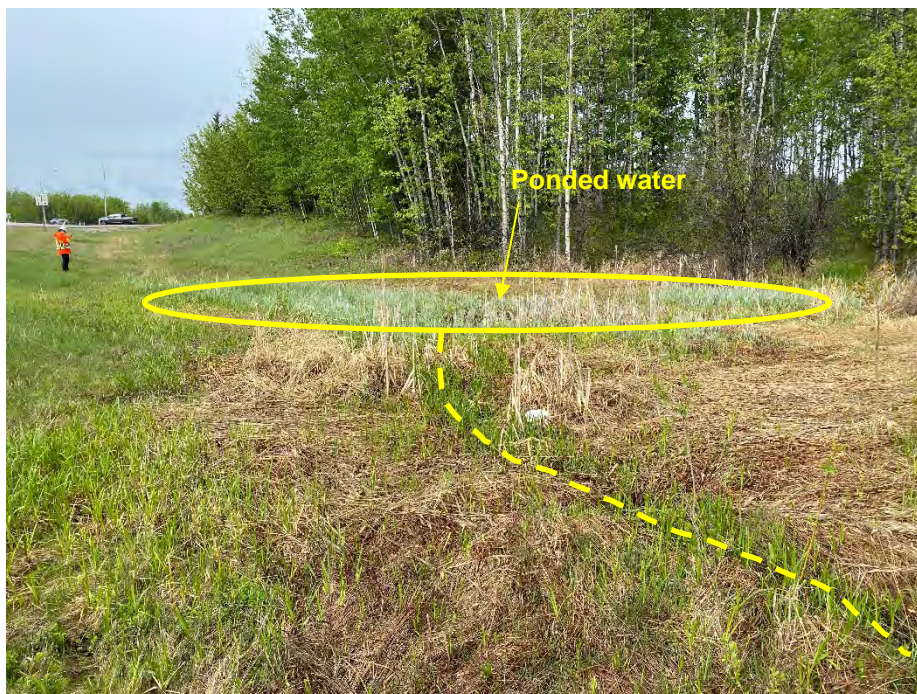
Photo 8: Ponded water located in the north ditch, water flowing towards east. Facing southwest.

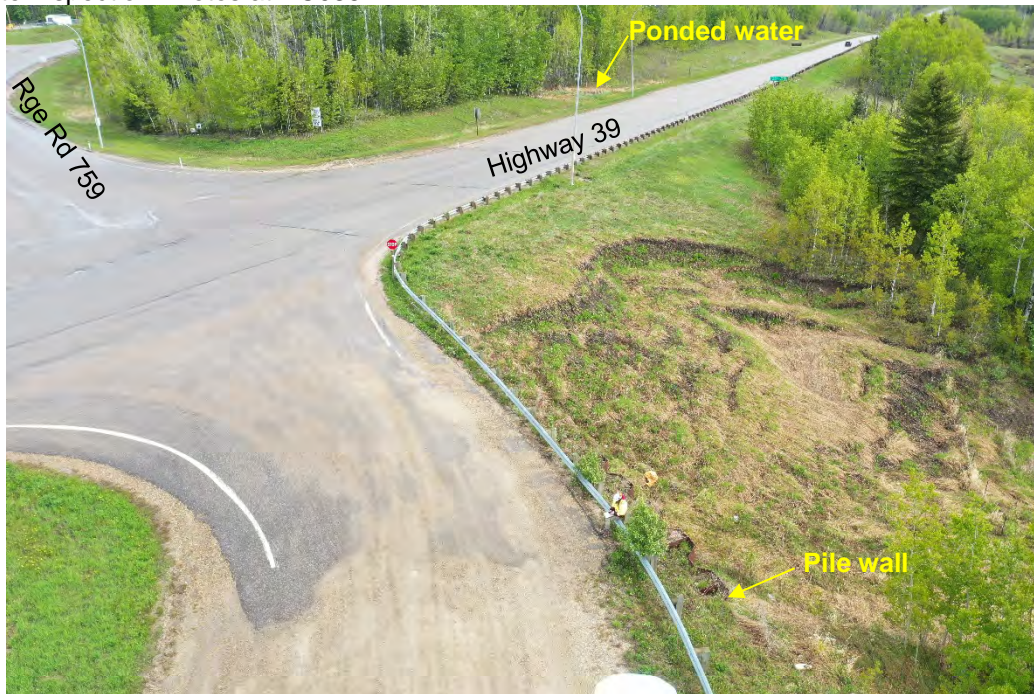
Photo 9: Aerial view of the slide and surrounding pavement. Taken by drone, facing northeast.

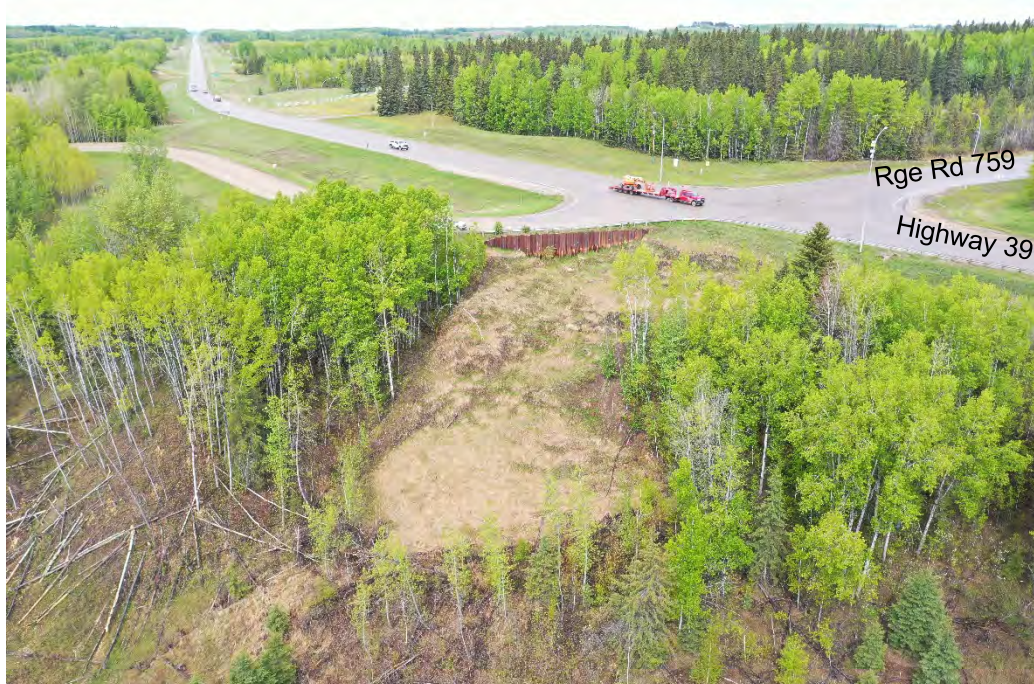
Photo 10: Aerial view of the slide, from the south end. Taken by drone, facing northwest.

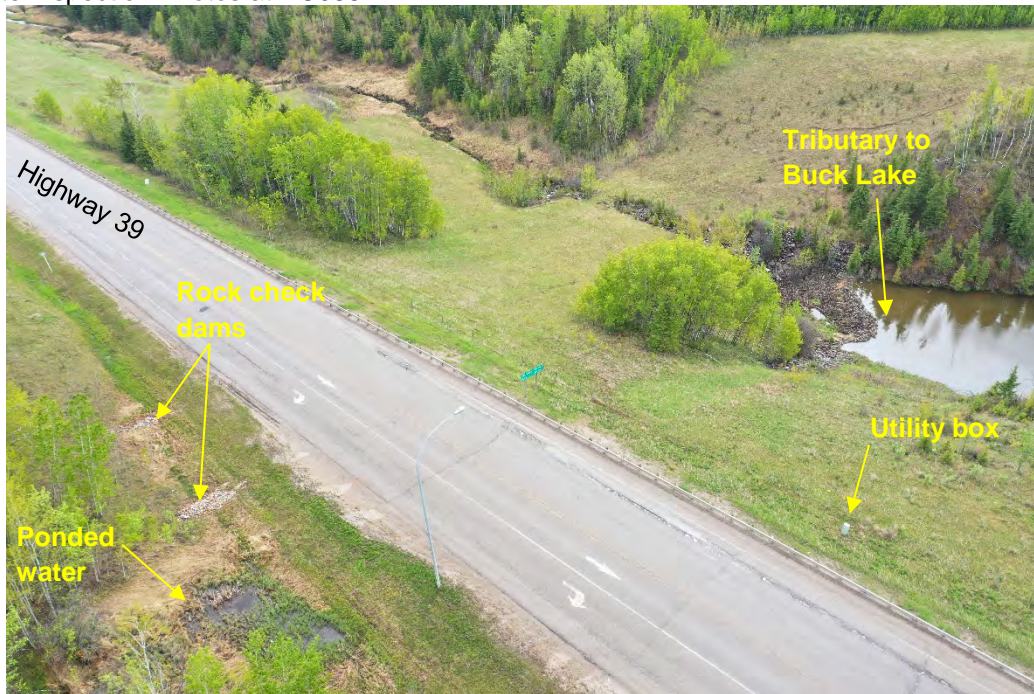
- Both check dams were observed to the east of the light standard, with the check dam furthest west partially obscured by vegetation (Photo 11).

Photo 11: Aerial view of Highway 39, east from the intersection with Range Road 759. Facing east.
