| To: | Amy Driessen | From: | Leslie Cho and Lawrence Onwude |
| File: | 123315222 | Date: | October 31, 2025 |

**Reference: North Central Region, Stony Plain, Site NC067 - Highway 216:06 Anthony Henday Bridge, Fall 2025 Instrumentation Monitoring Report**

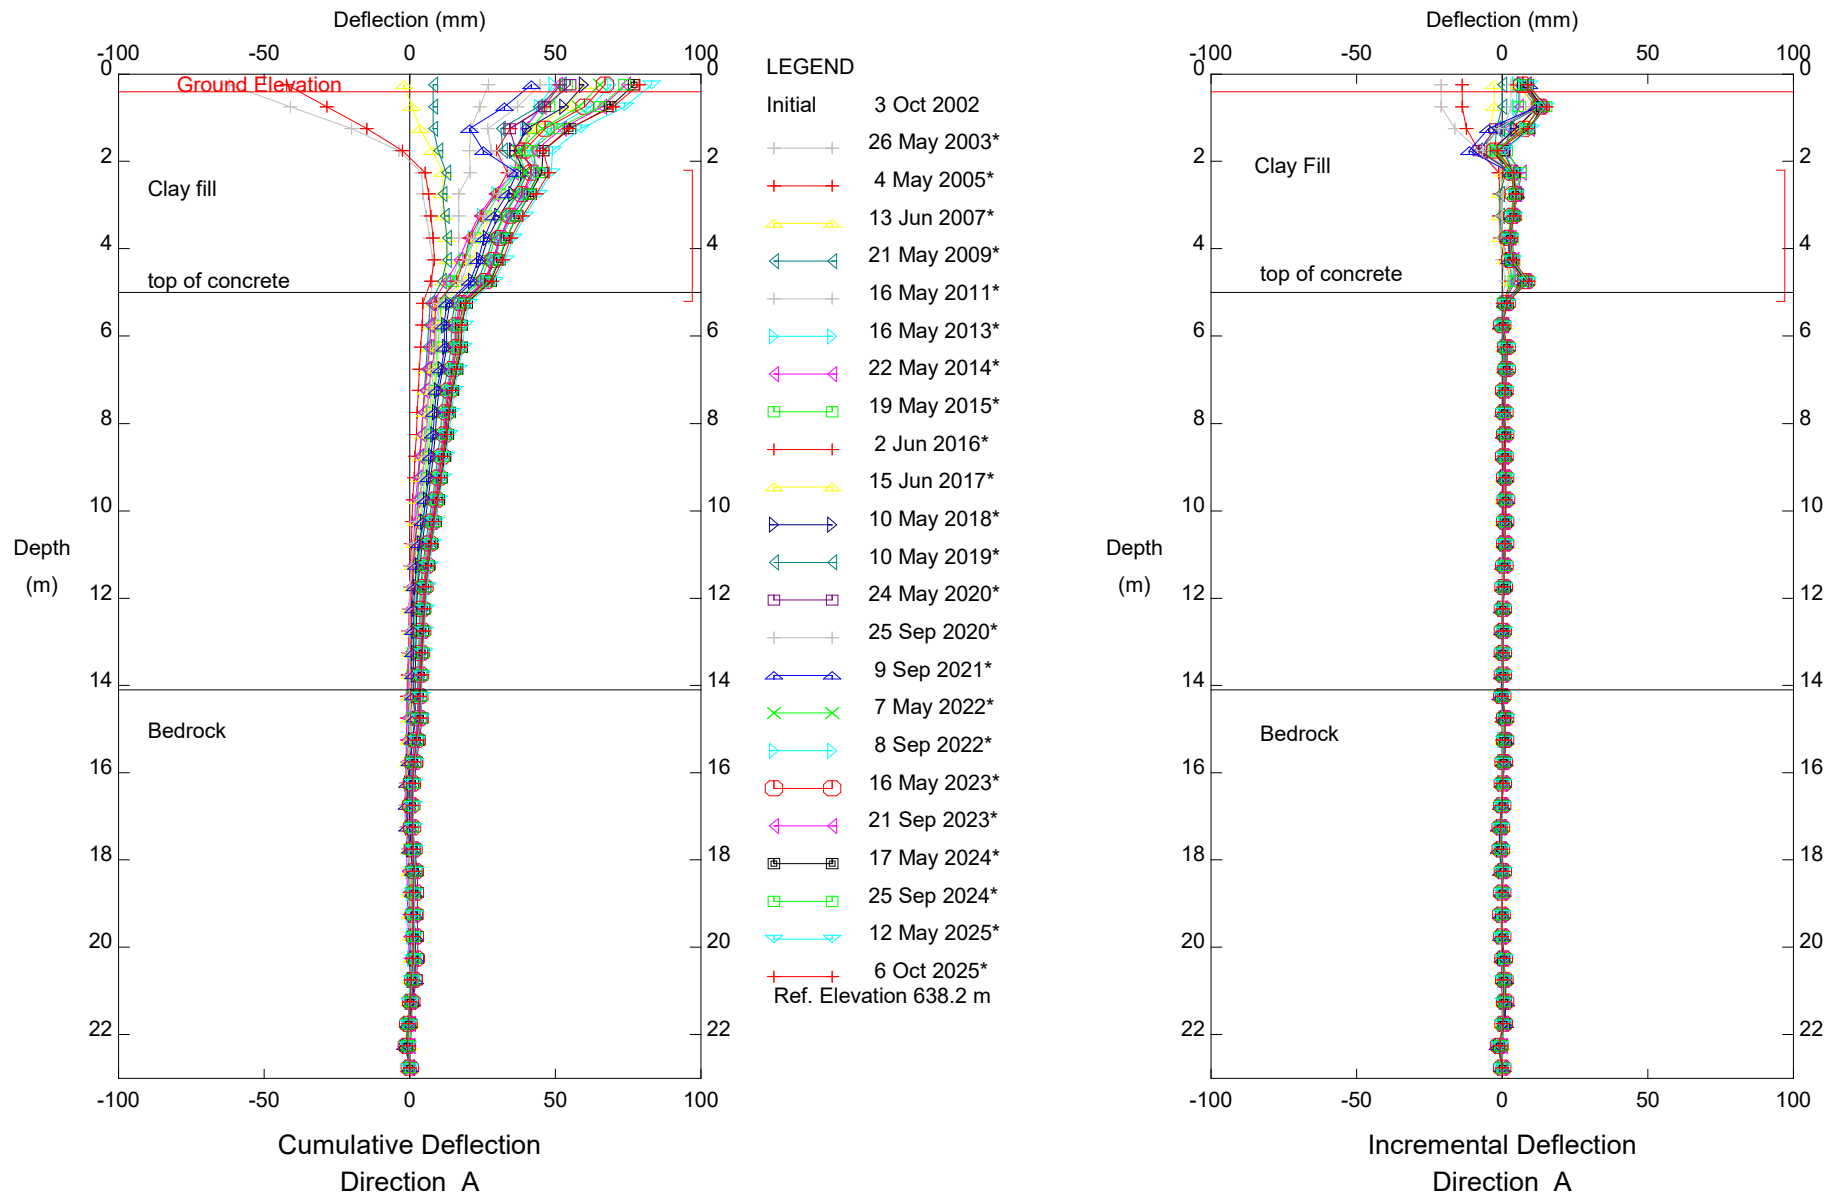
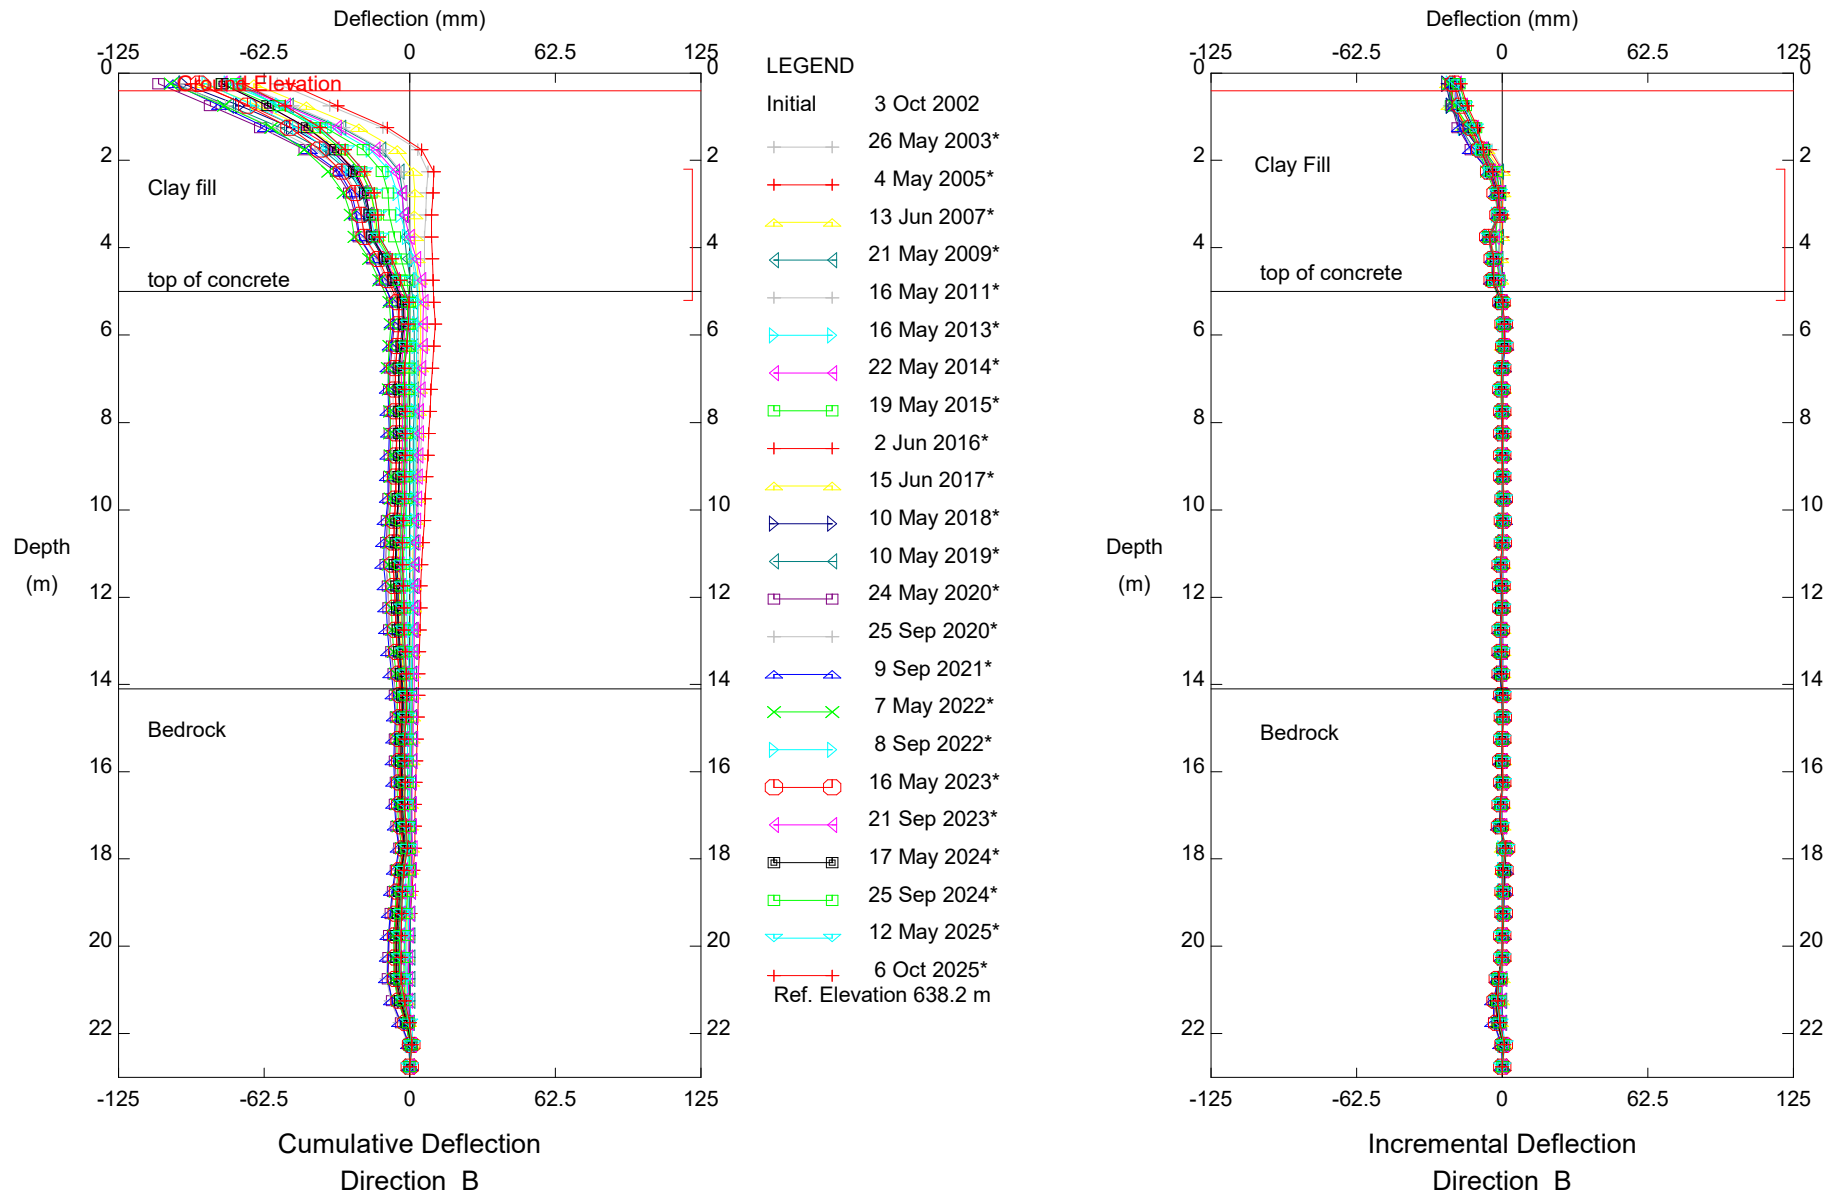
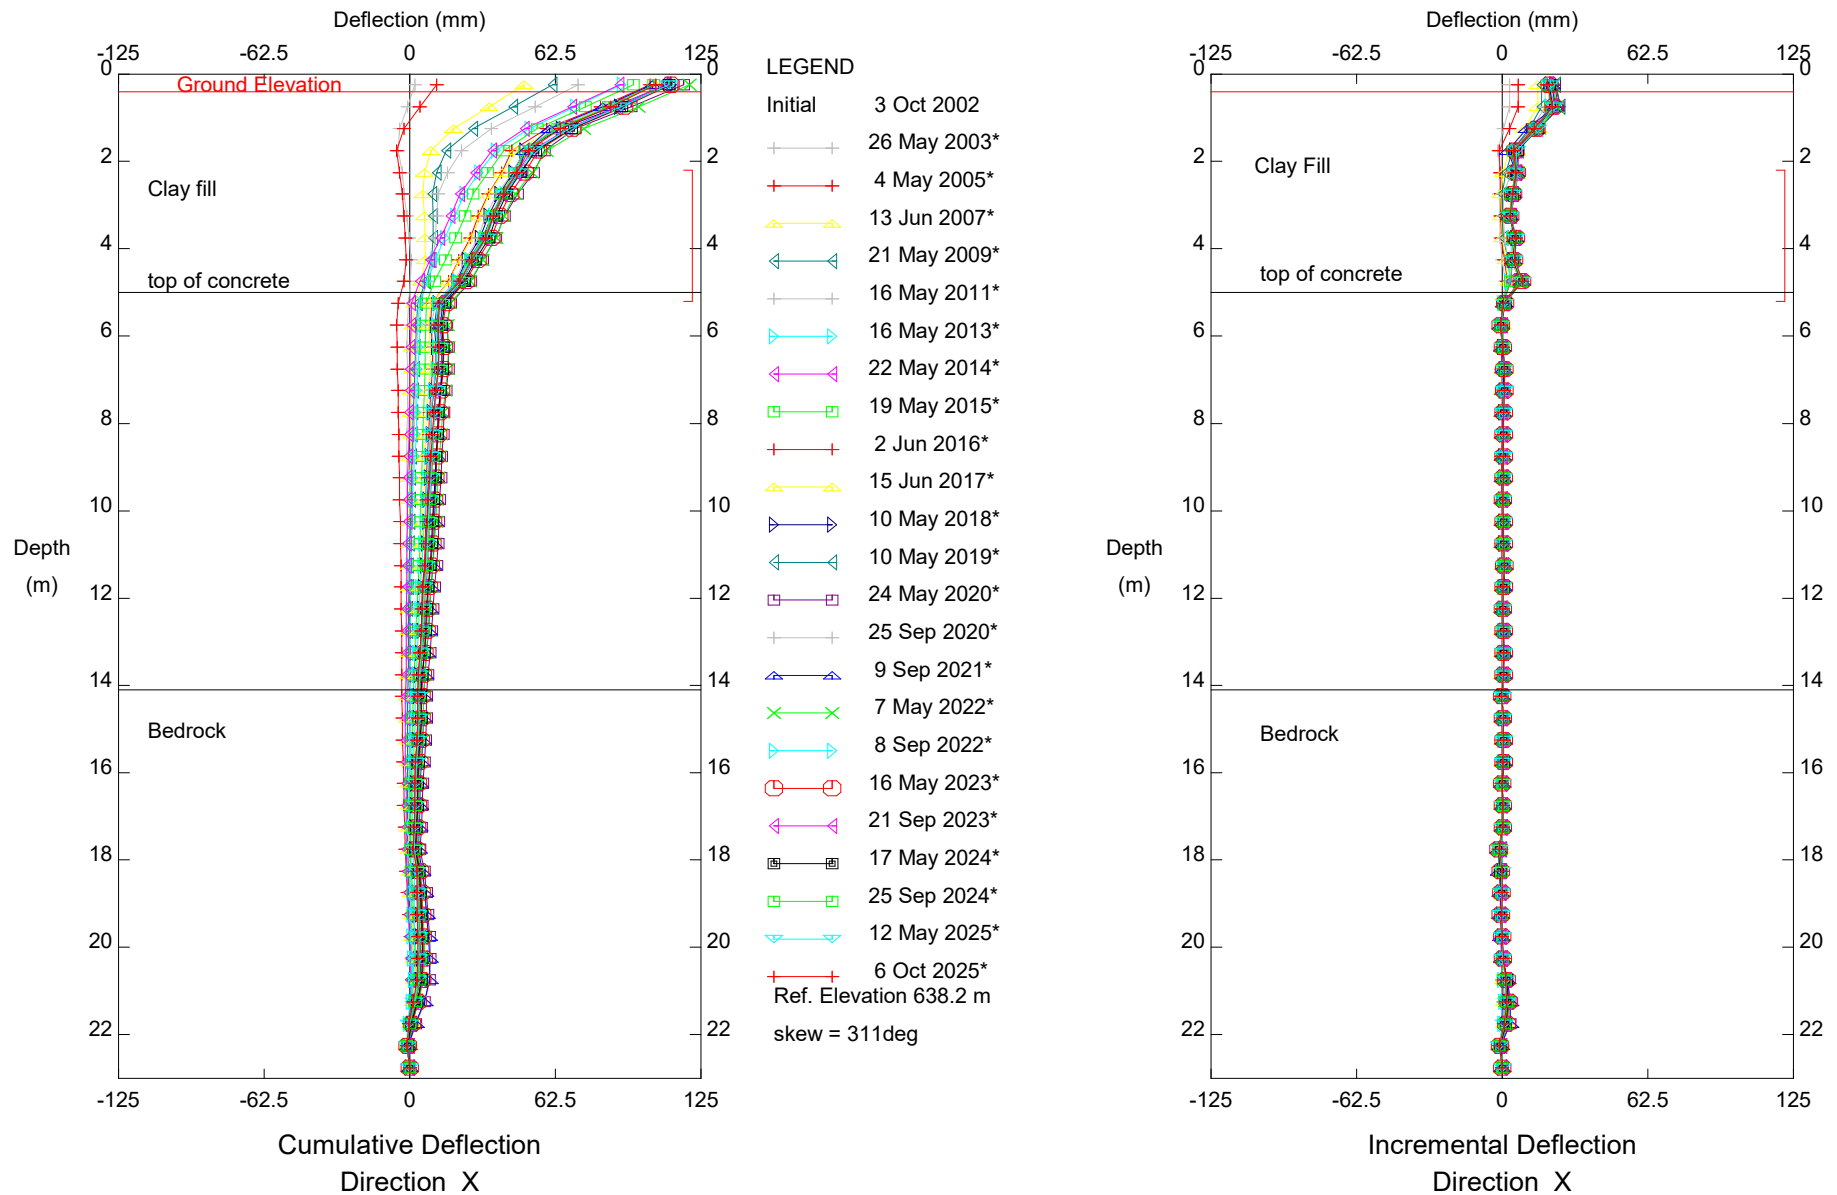
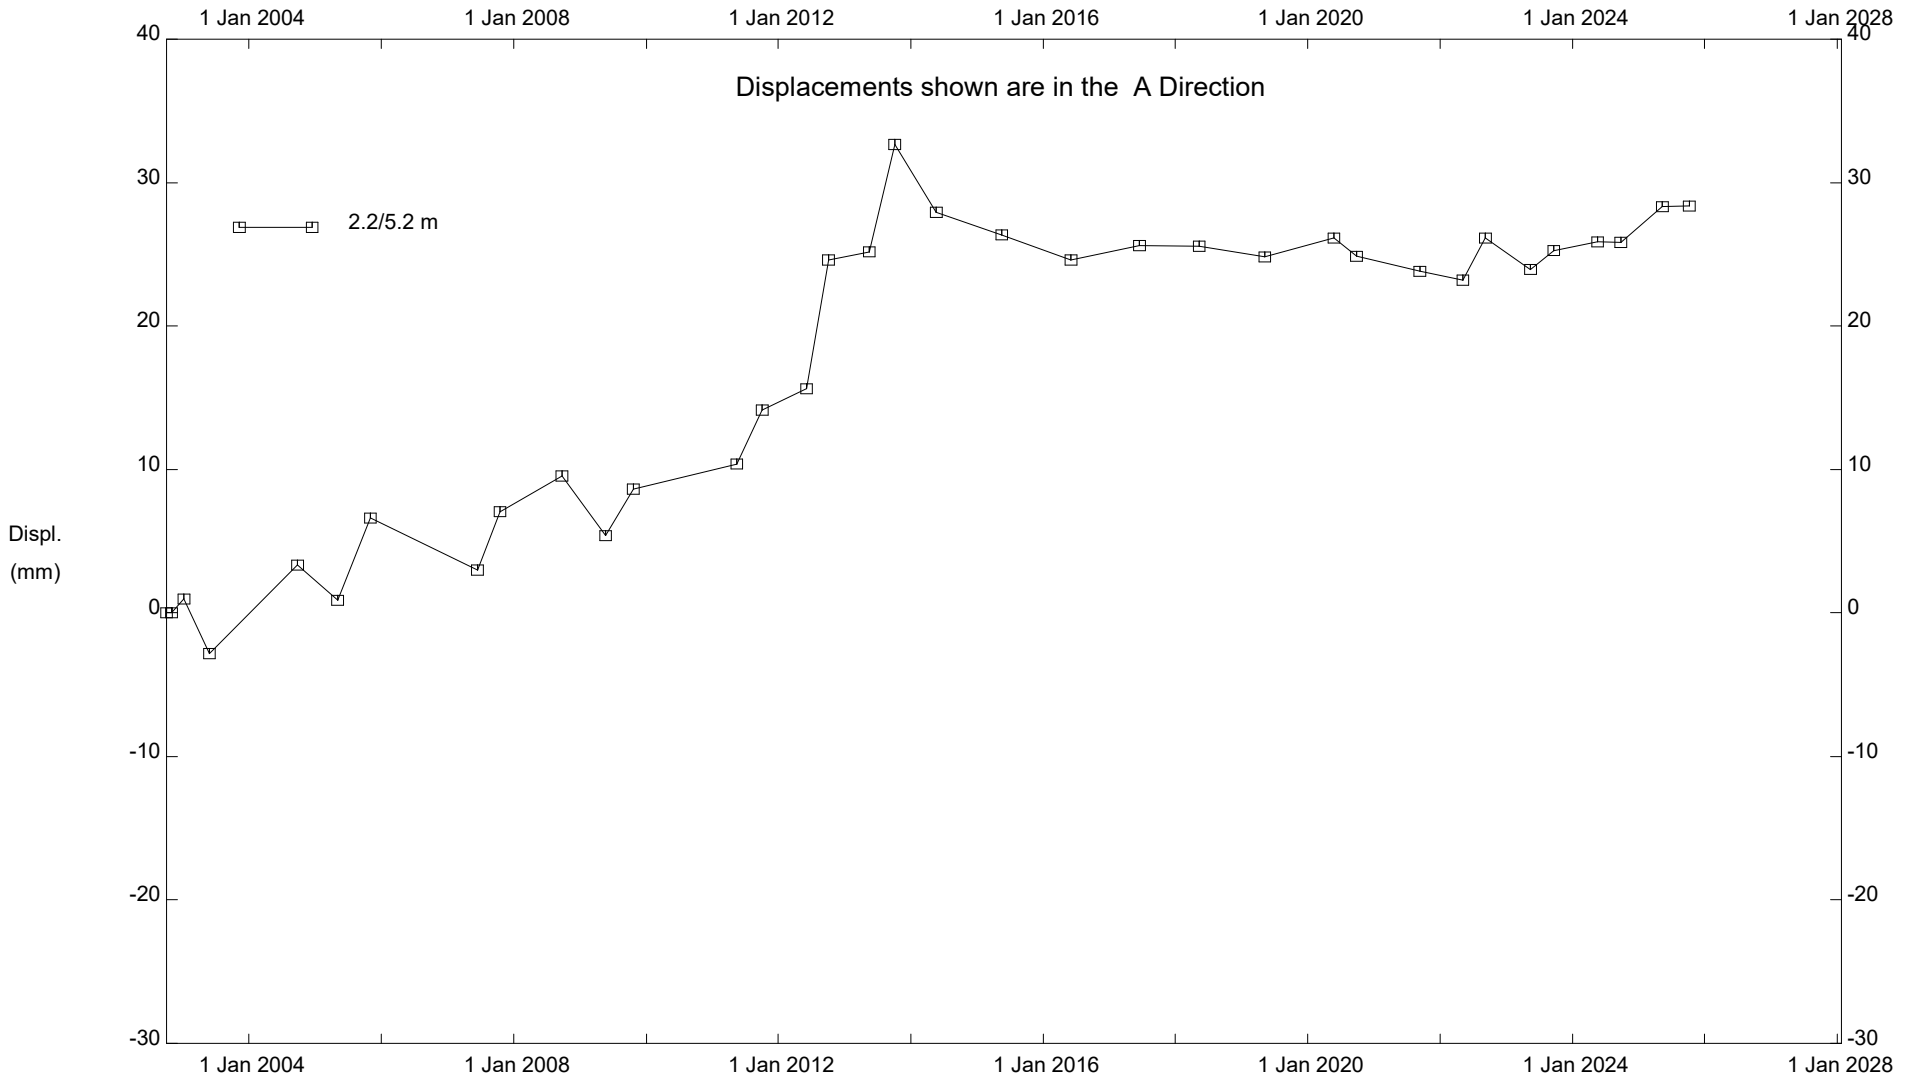
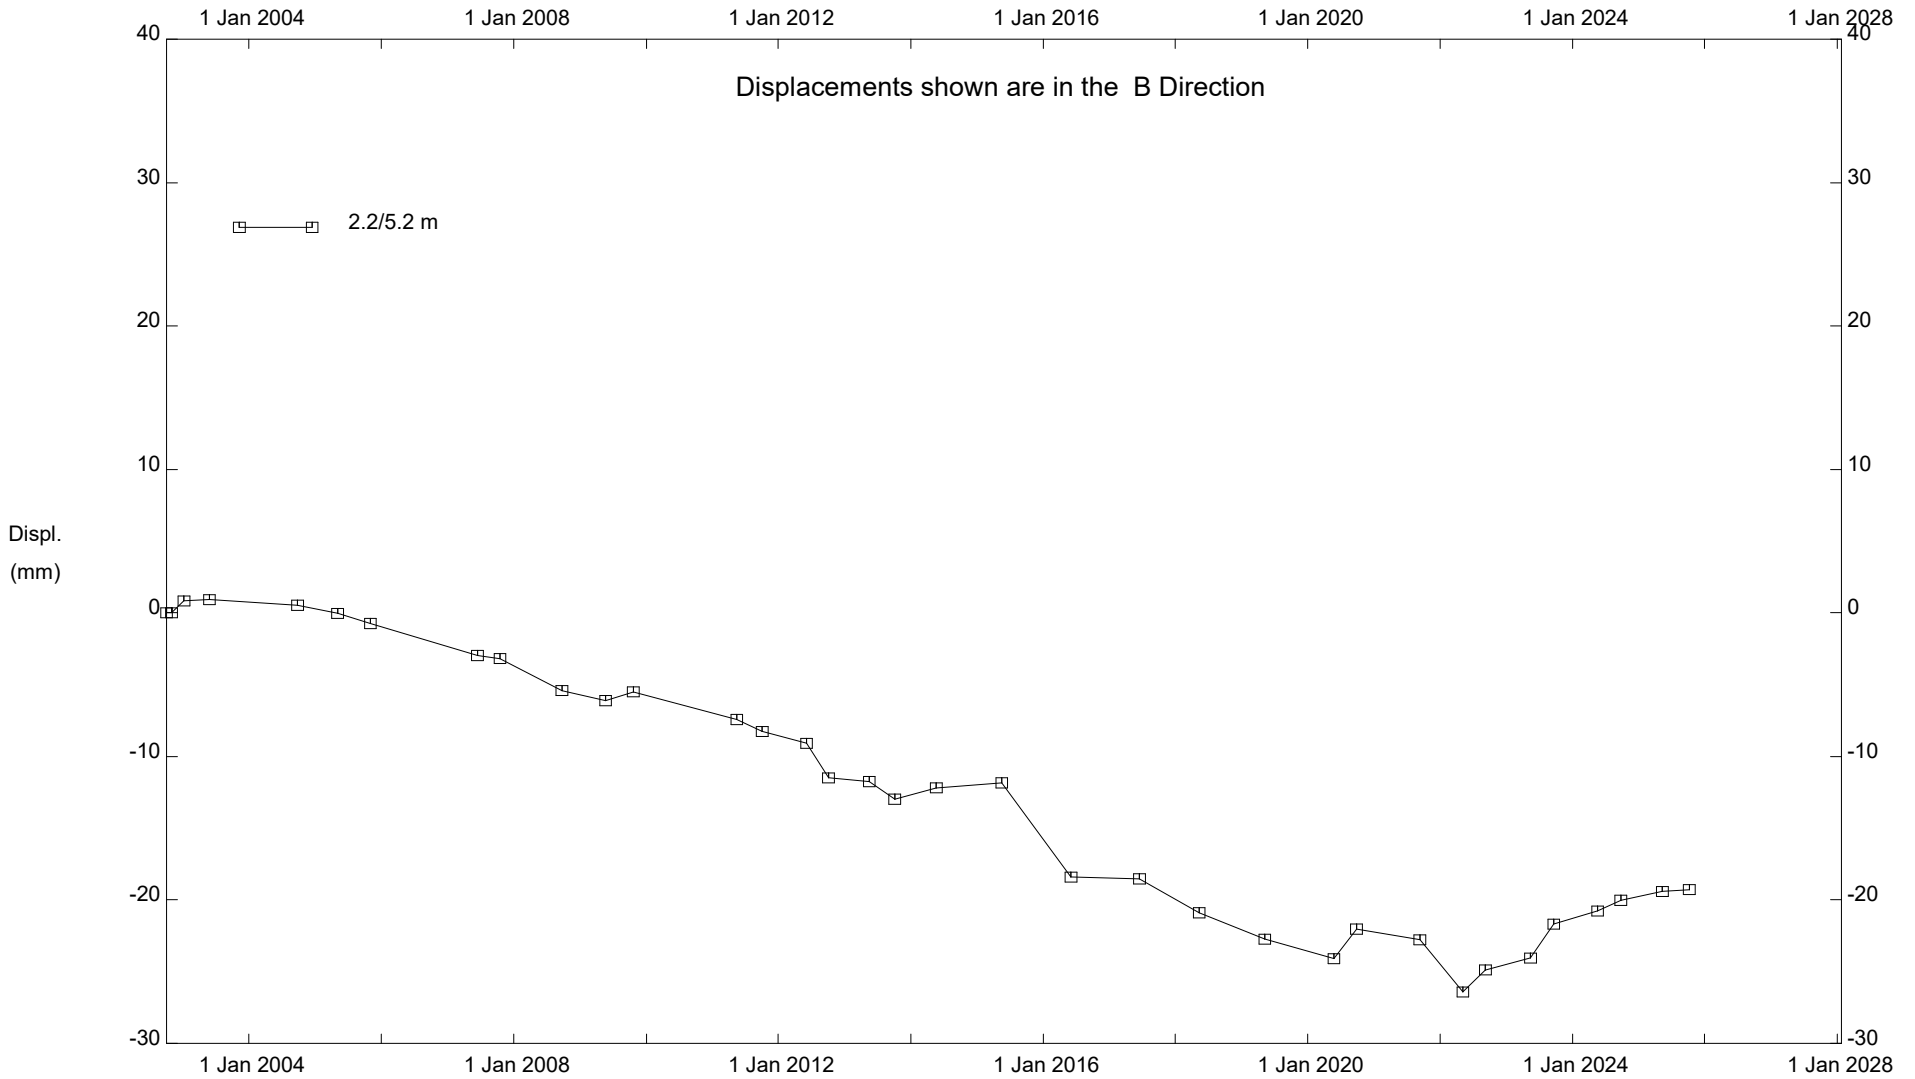
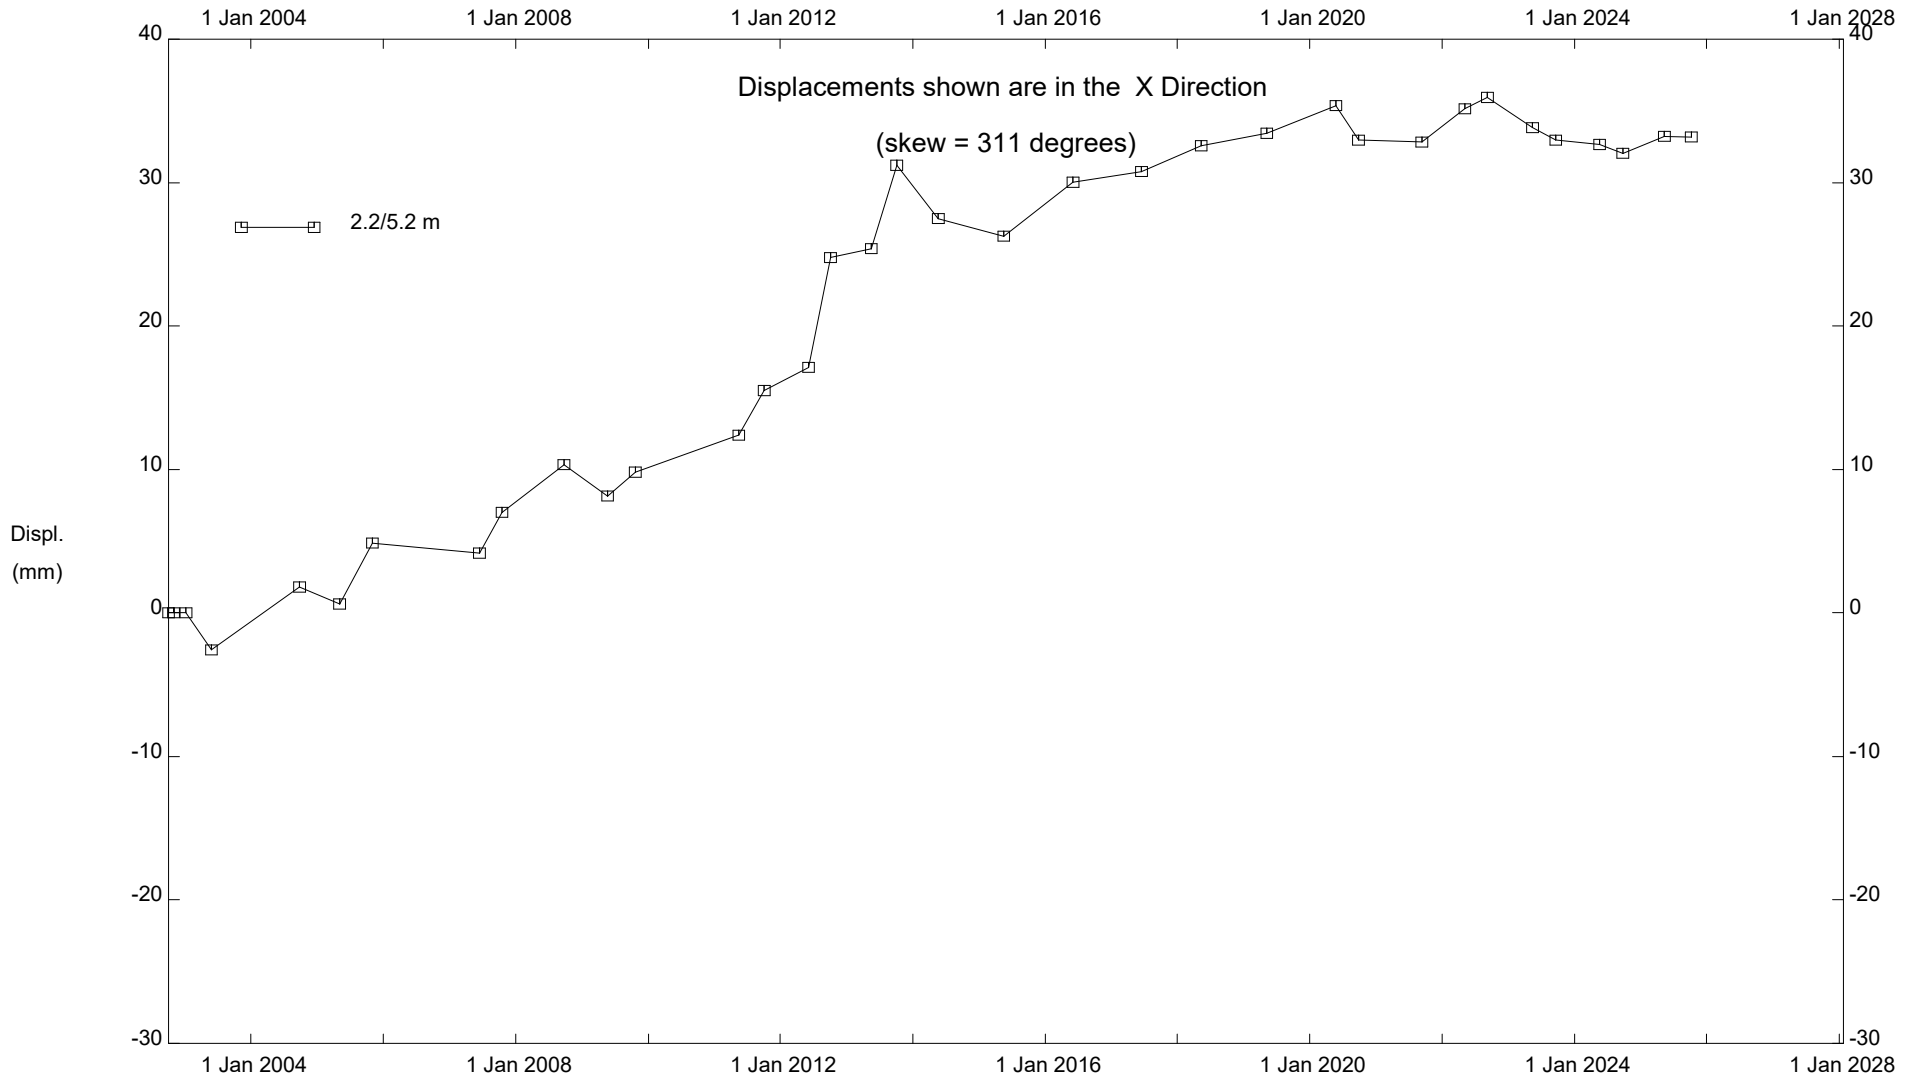
NC67, Inclinometer SI-01

- SI-01 showed little to no change since the Spring 2025 reading cycle. The current movement rate is less than 1 mm/yr.
- SI-03 showed decreasing cumulative movement between 2018 and 2021 before returning to 2018 values. The cumulative movement increased by 1 mm to 106 mm during the Fall 2025 readings with a rate of movement of 2 mm/yr.

| Instrument Name | Date Initialized | Coordinates <sup>(1)</sup><br>(UTM 12U, NAD1983)<br>(m) | | Total Cumulative Resultant Movement, and Depth of Movement (mm) | Maximum Rate of Movement (mm/yr) | Current Status | Date of Previous Reading | Incremental Movement Since Previous Reading (mm) | Current Rate of Movement (mm/yr) | Change in Rate of Movement Since Previous Reading (mm/yr) |
|---|---|---|---|---|---|---|---|---|---|---|
| SI-01 | Oct. 3, 2002 | 5926771 | 326314 | 33 over 2.2 m to 5.2 m depth in 311° direction | 28 mm/yr in Oct. 2012 | Operational | May 12, 2025 | <1 | <1 | -2 |
