| To: | Amy Driessen | From: | Leslie Cho and Lawrence Onwude |
| File: | 123315222 | Date: | October 31, 2025 |

**Reference: North Central Region, Stony Plain, Site NC067 - Highway 216:06 Anthony Henday Bridge, Fall 2025 Instrumentation Monitoring Report**

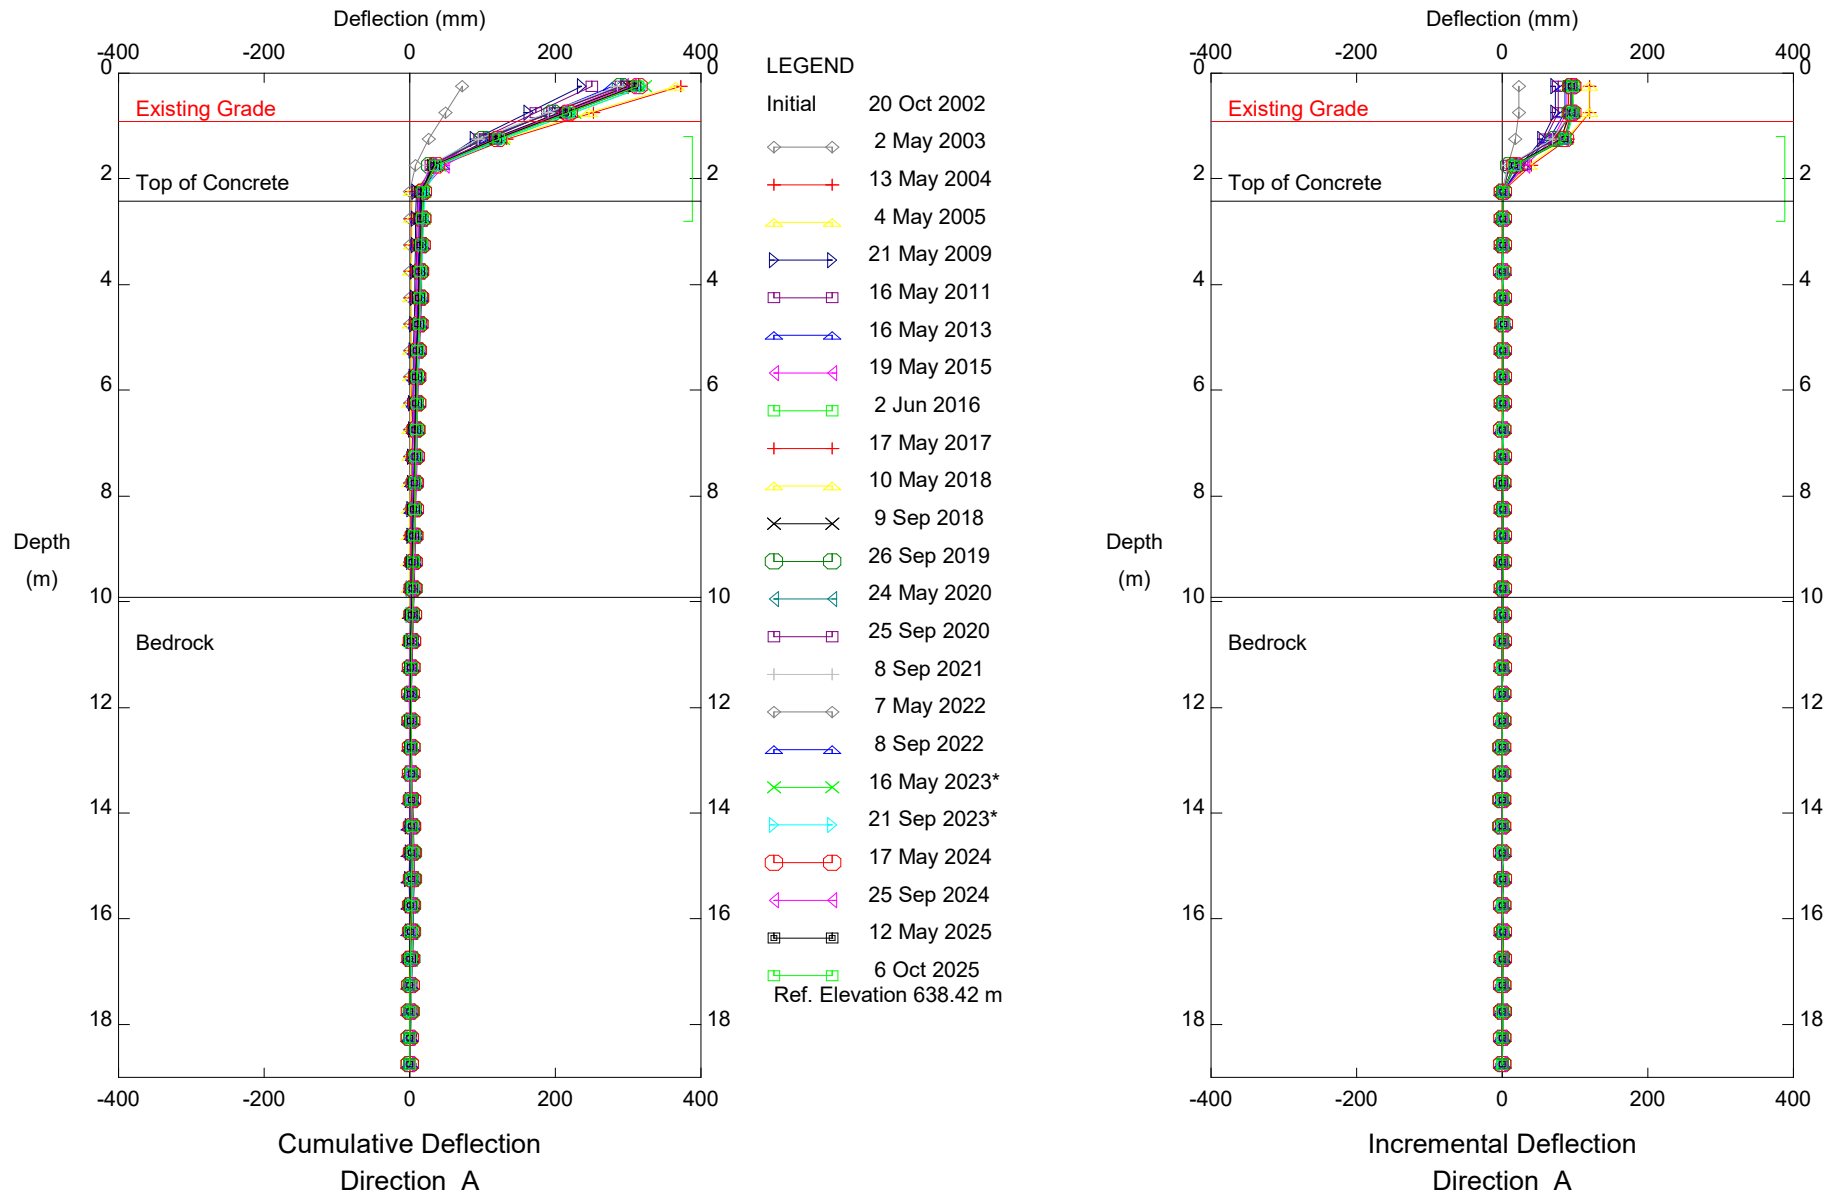
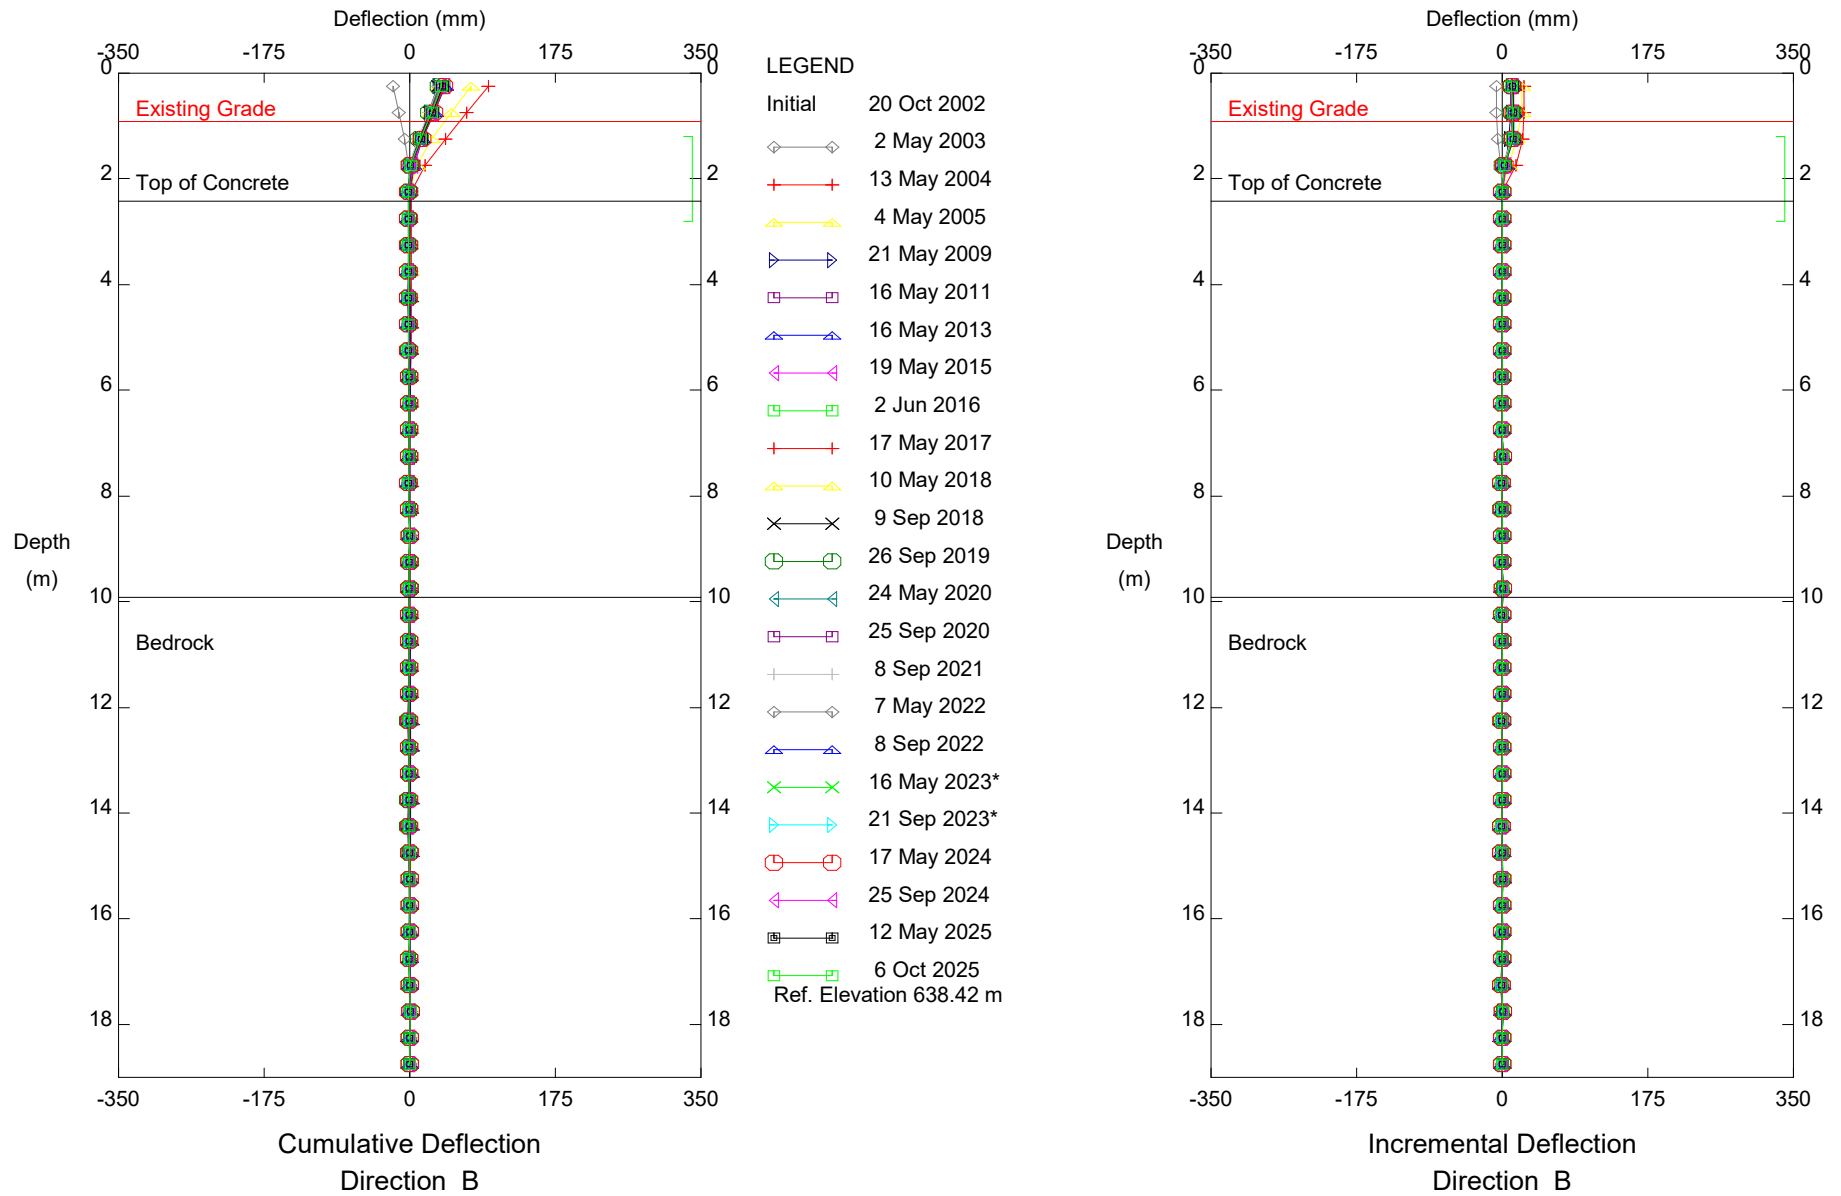
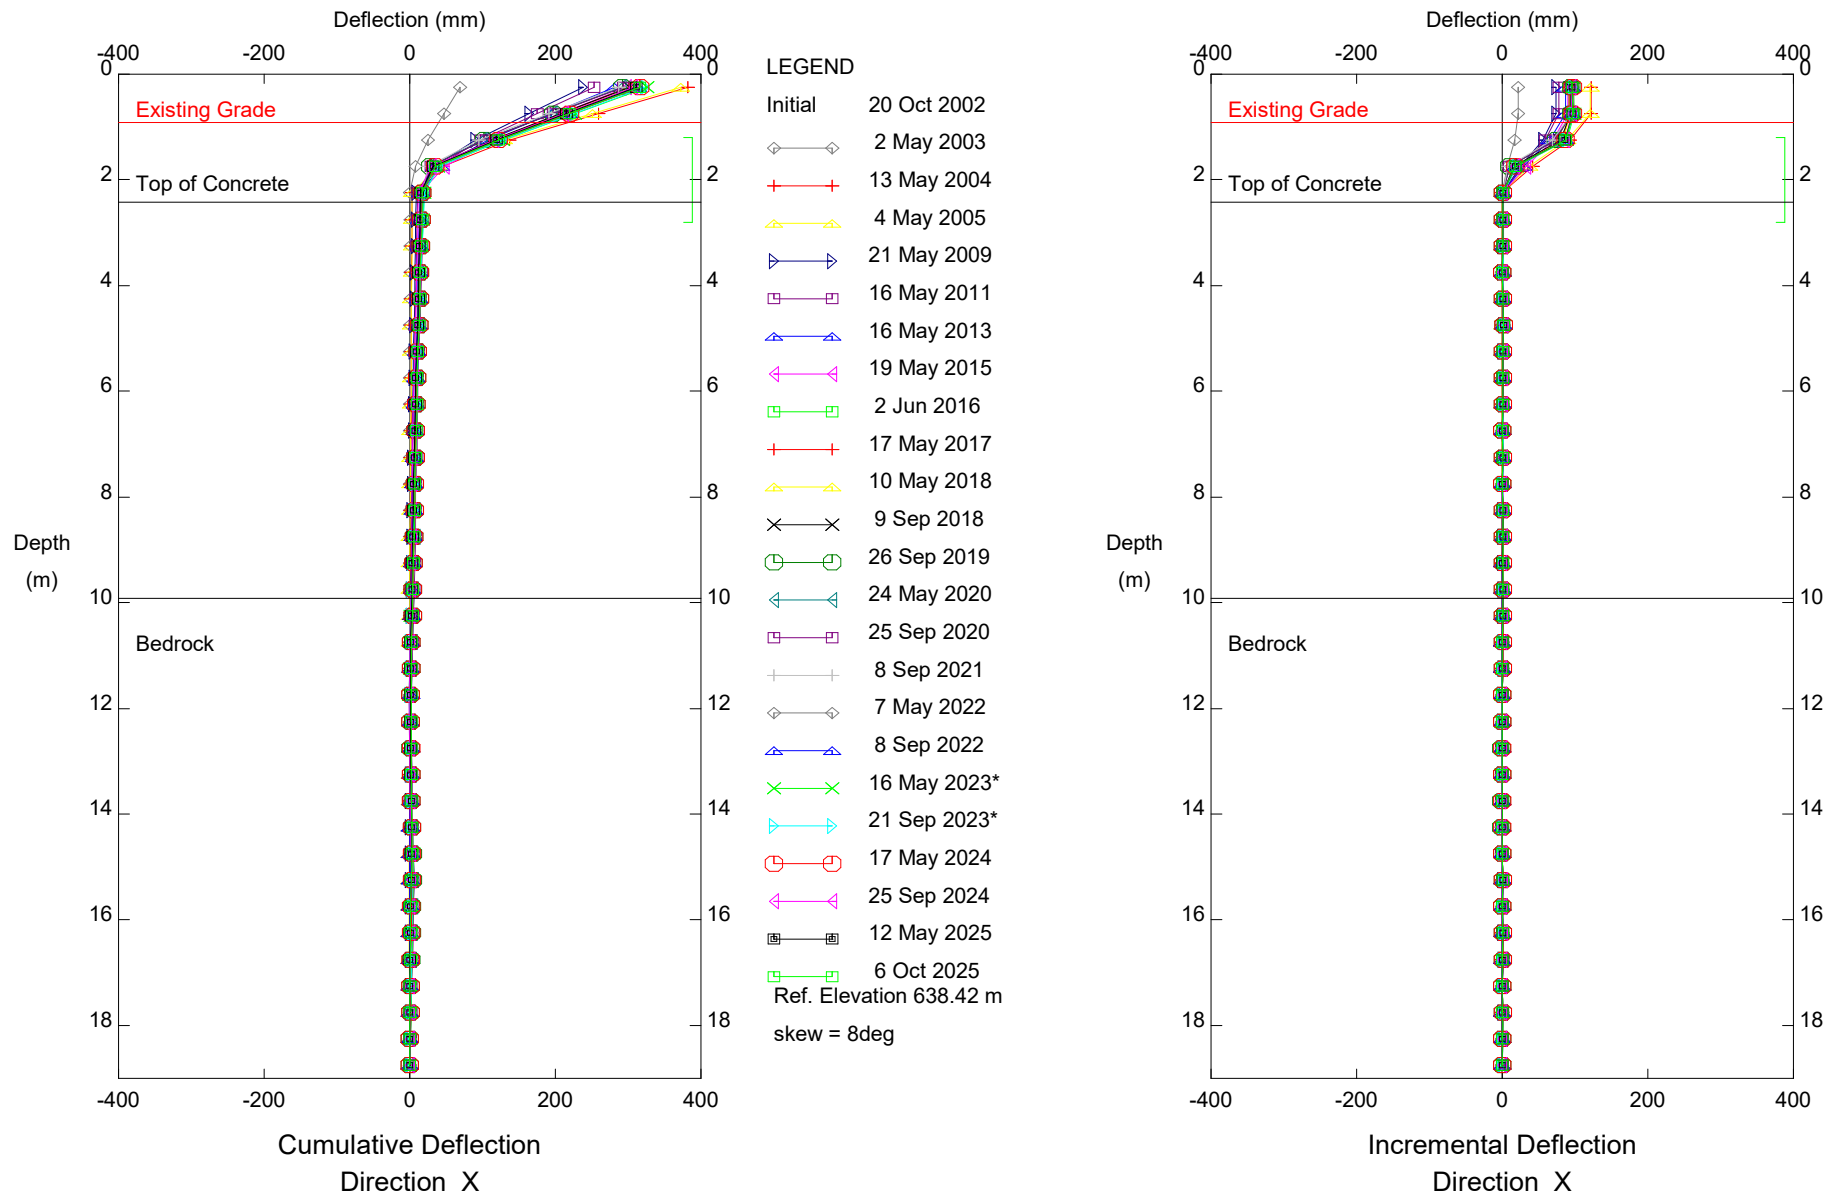
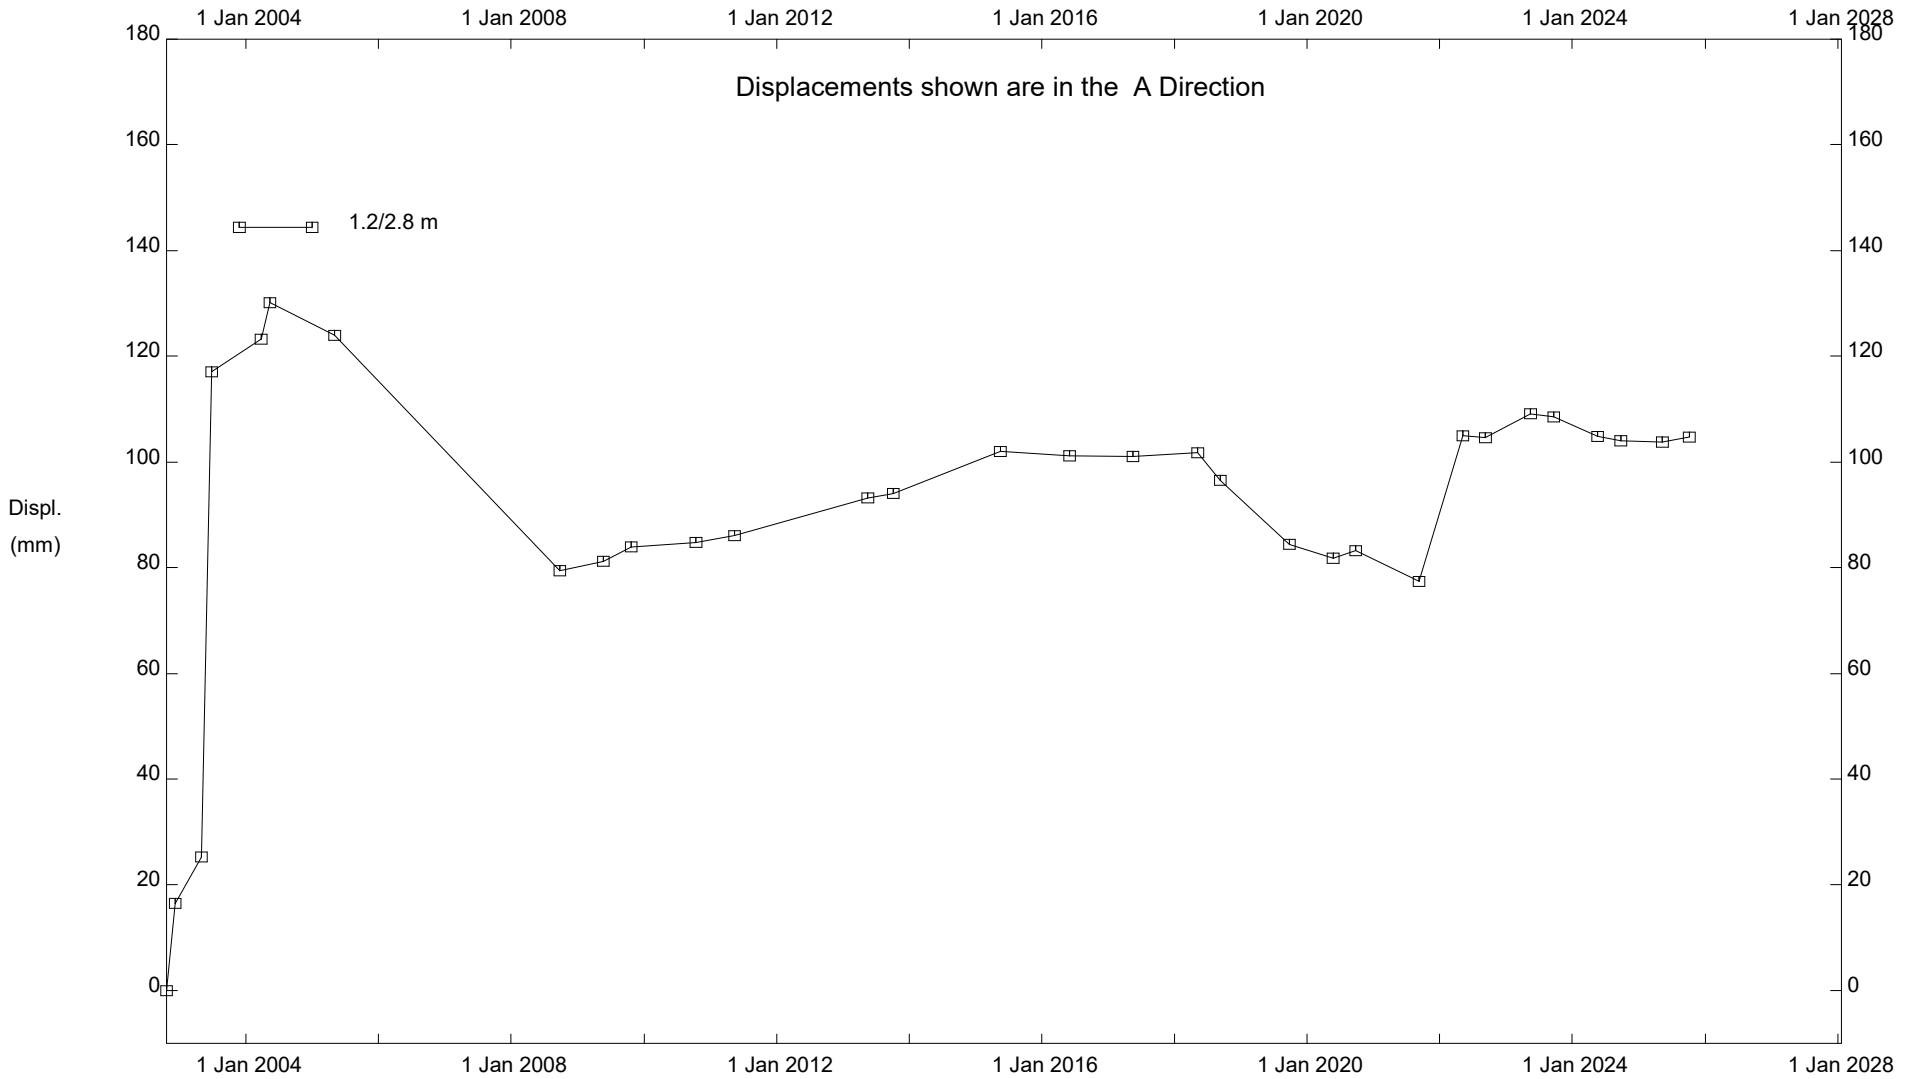
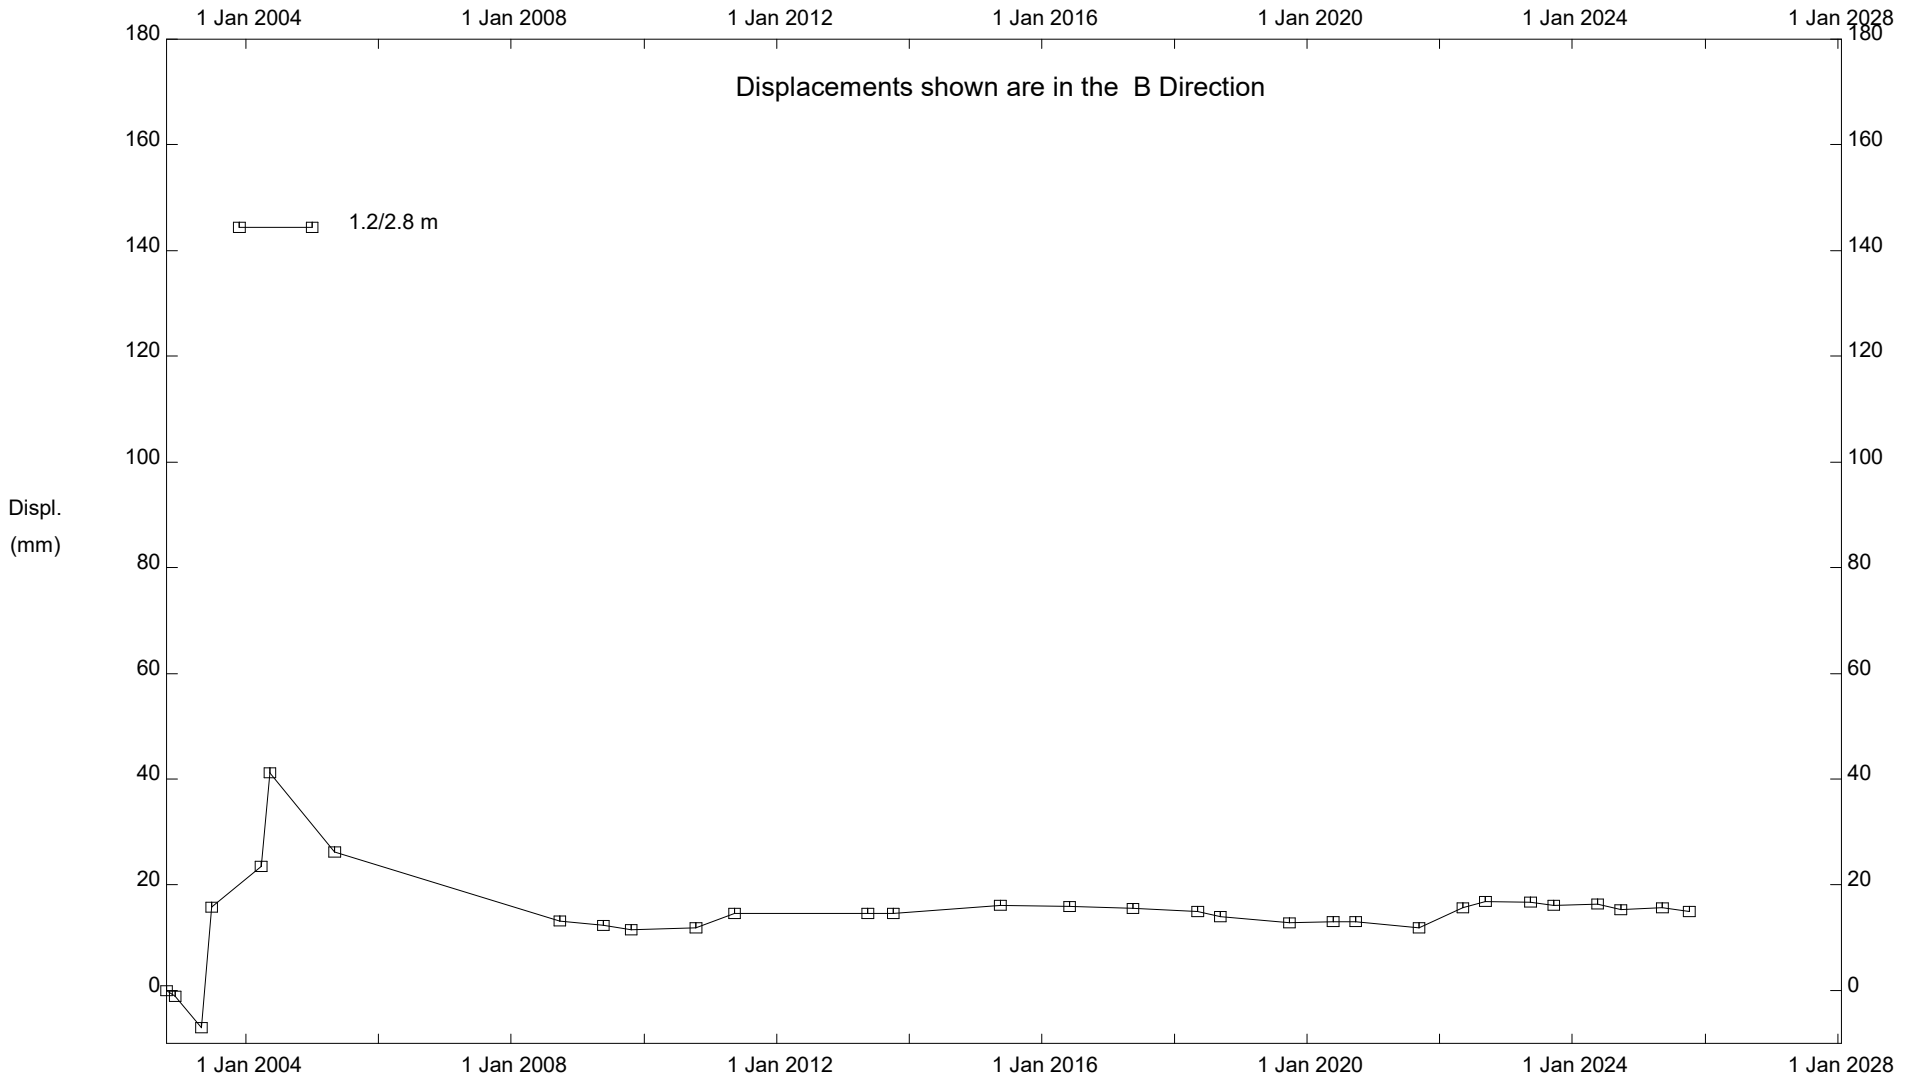
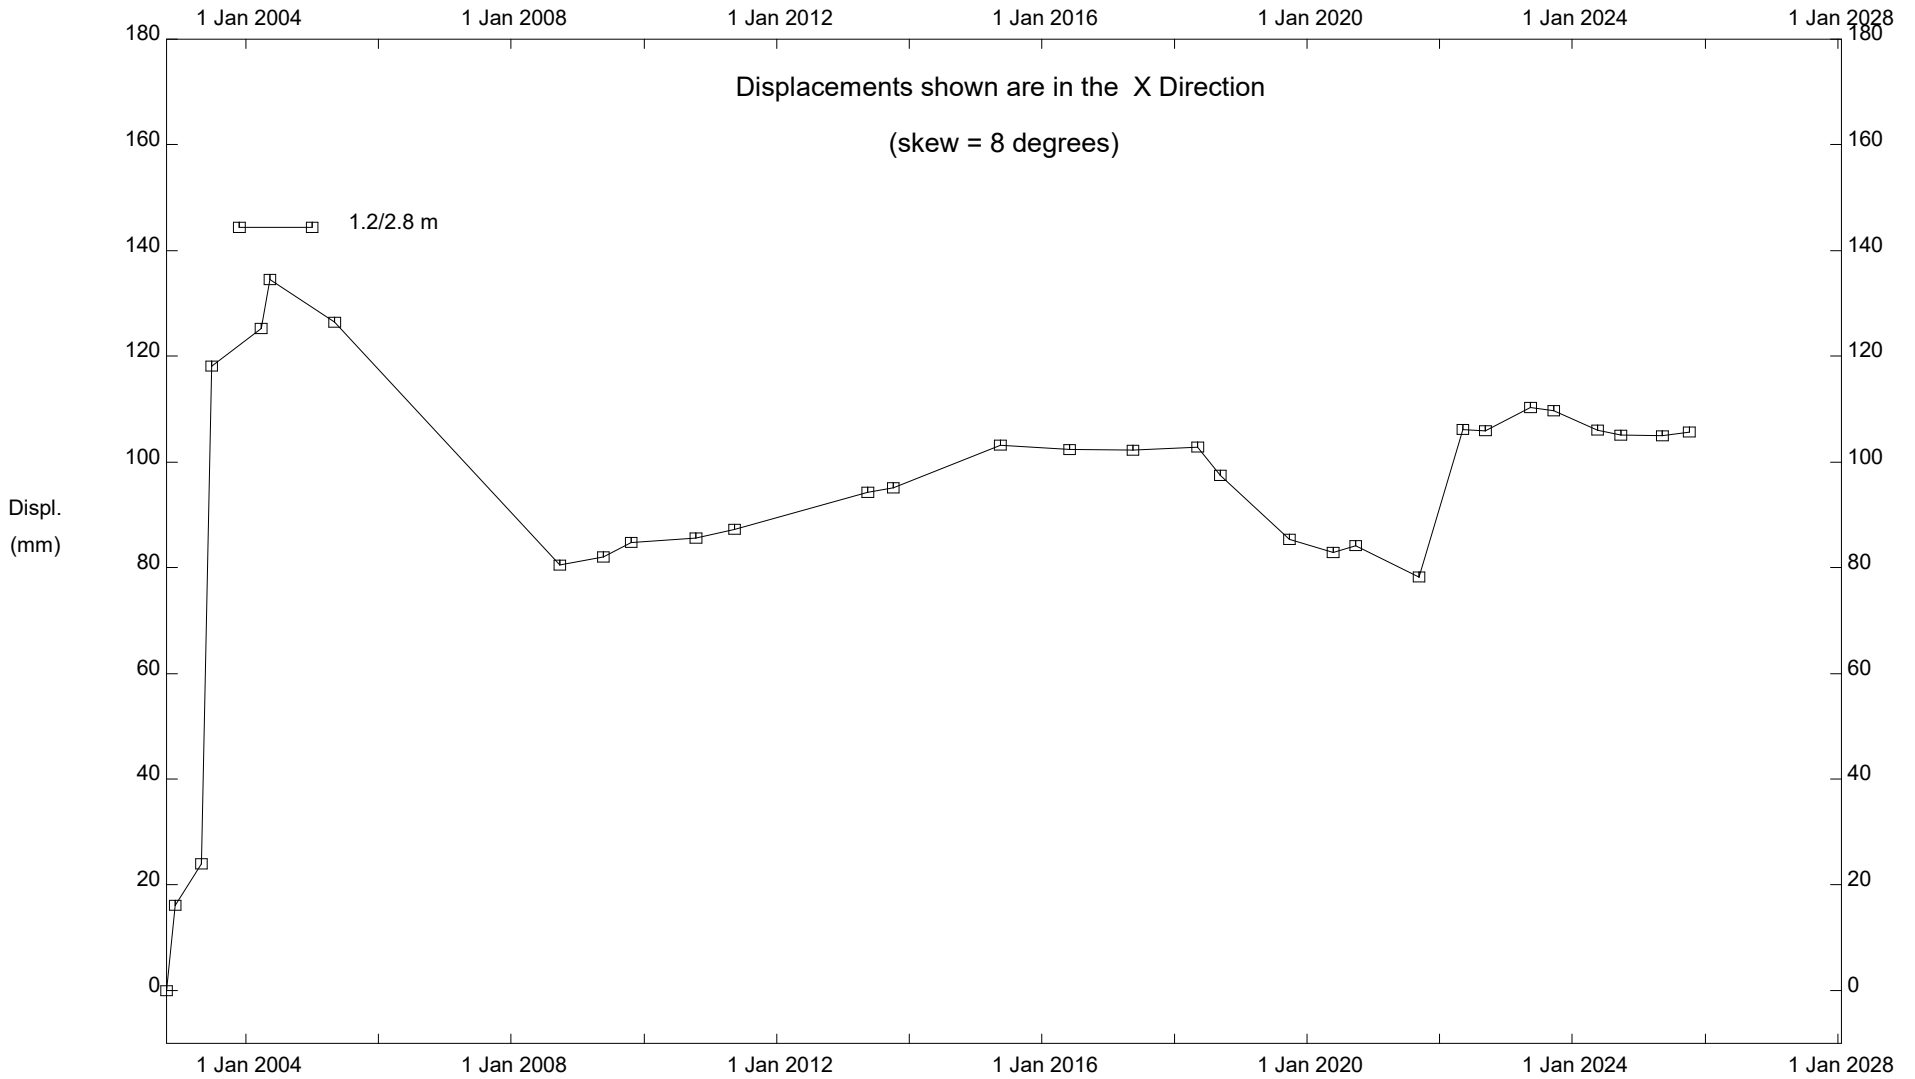
NC67, Inclinometer SI-03

- SI-01 showed little to no change since the Spring 2025 reading cycle. The current movement rate is less than 1 mm/yr.
- SI-03 showed decreasing cumulative movement between 2018 and 2021 before returning to 2018 values. The cumulative movement increased by 1 mm to 106 mm during the Fall 2025 readings with a rate of movement of 2 mm/yr.

| Instrument Name | Date Initialized | Coordinates <sup>(1)</sup><br>(UTM 12U, NAD1983)<br>(m) | | Total Cumulative Resultant Movement, and Depth of Movement (mm) | Maximum Rate of Movement (mm/yr) | Current Status | Date of Previous Reading | Incremental Movement Since Previous Reading (mm) | Current Rate of Movement (mm/yr) | Change in Rate of Movement Since Previous Reading (mm/yr) |
|---|---|---|---|---|---|---|---|---|---|---|
| SI-03 | Oct. 20, 2002 | 5926709 | 326283 | 106 over 1.2 m to 2.8 m depth in 8° direction | 42 mm/yr in May 2022 | Operational | May 12, 2025 | 1 | 2 | 2 |
