| To: | Amy Driessen | From: | Leslie Cho and Lawrence Onwude |
| File: | 123315222 | Date: | October 31, 2025 |

**Reference: North Central Region, Stony Plain, Site NC067 - Highway 216:06 Anthony Henday Bridge, Fall 2025 Instrumentation Monitoring Report**

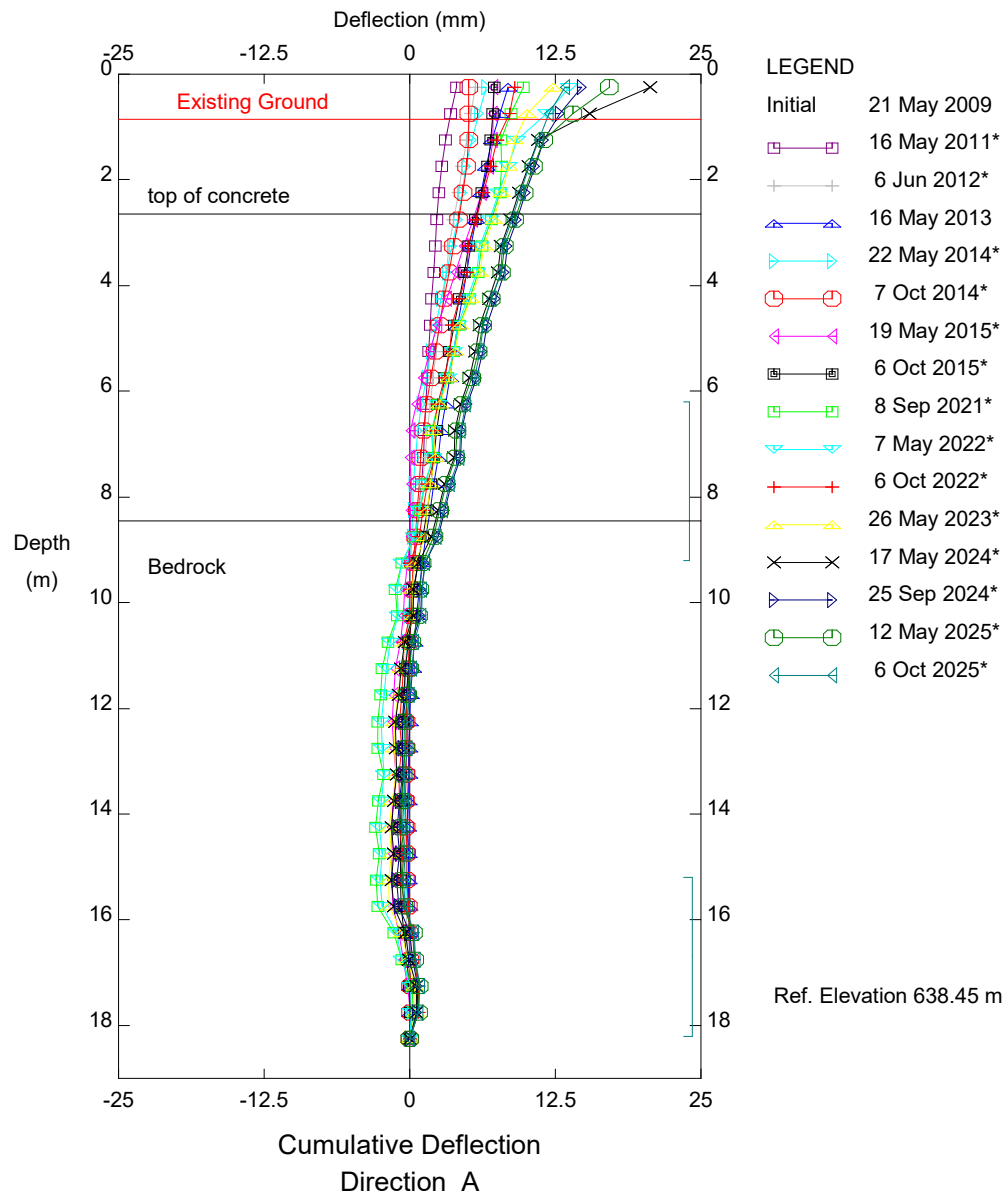
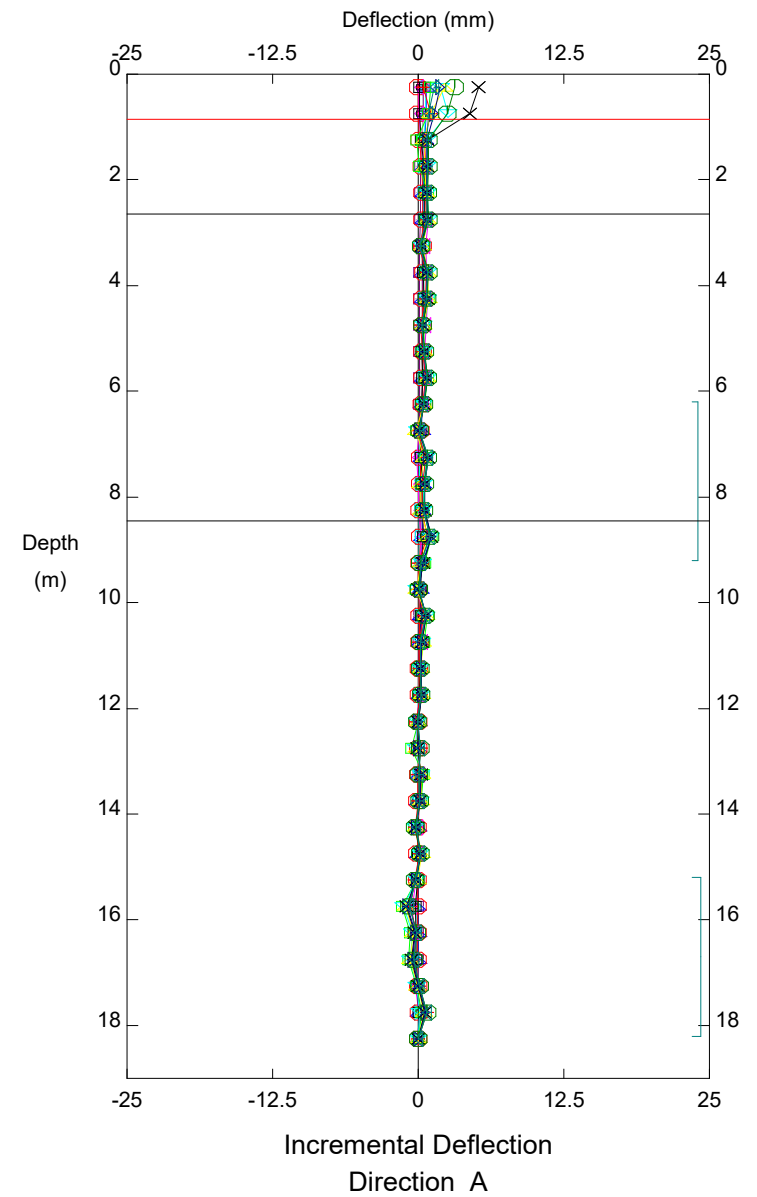
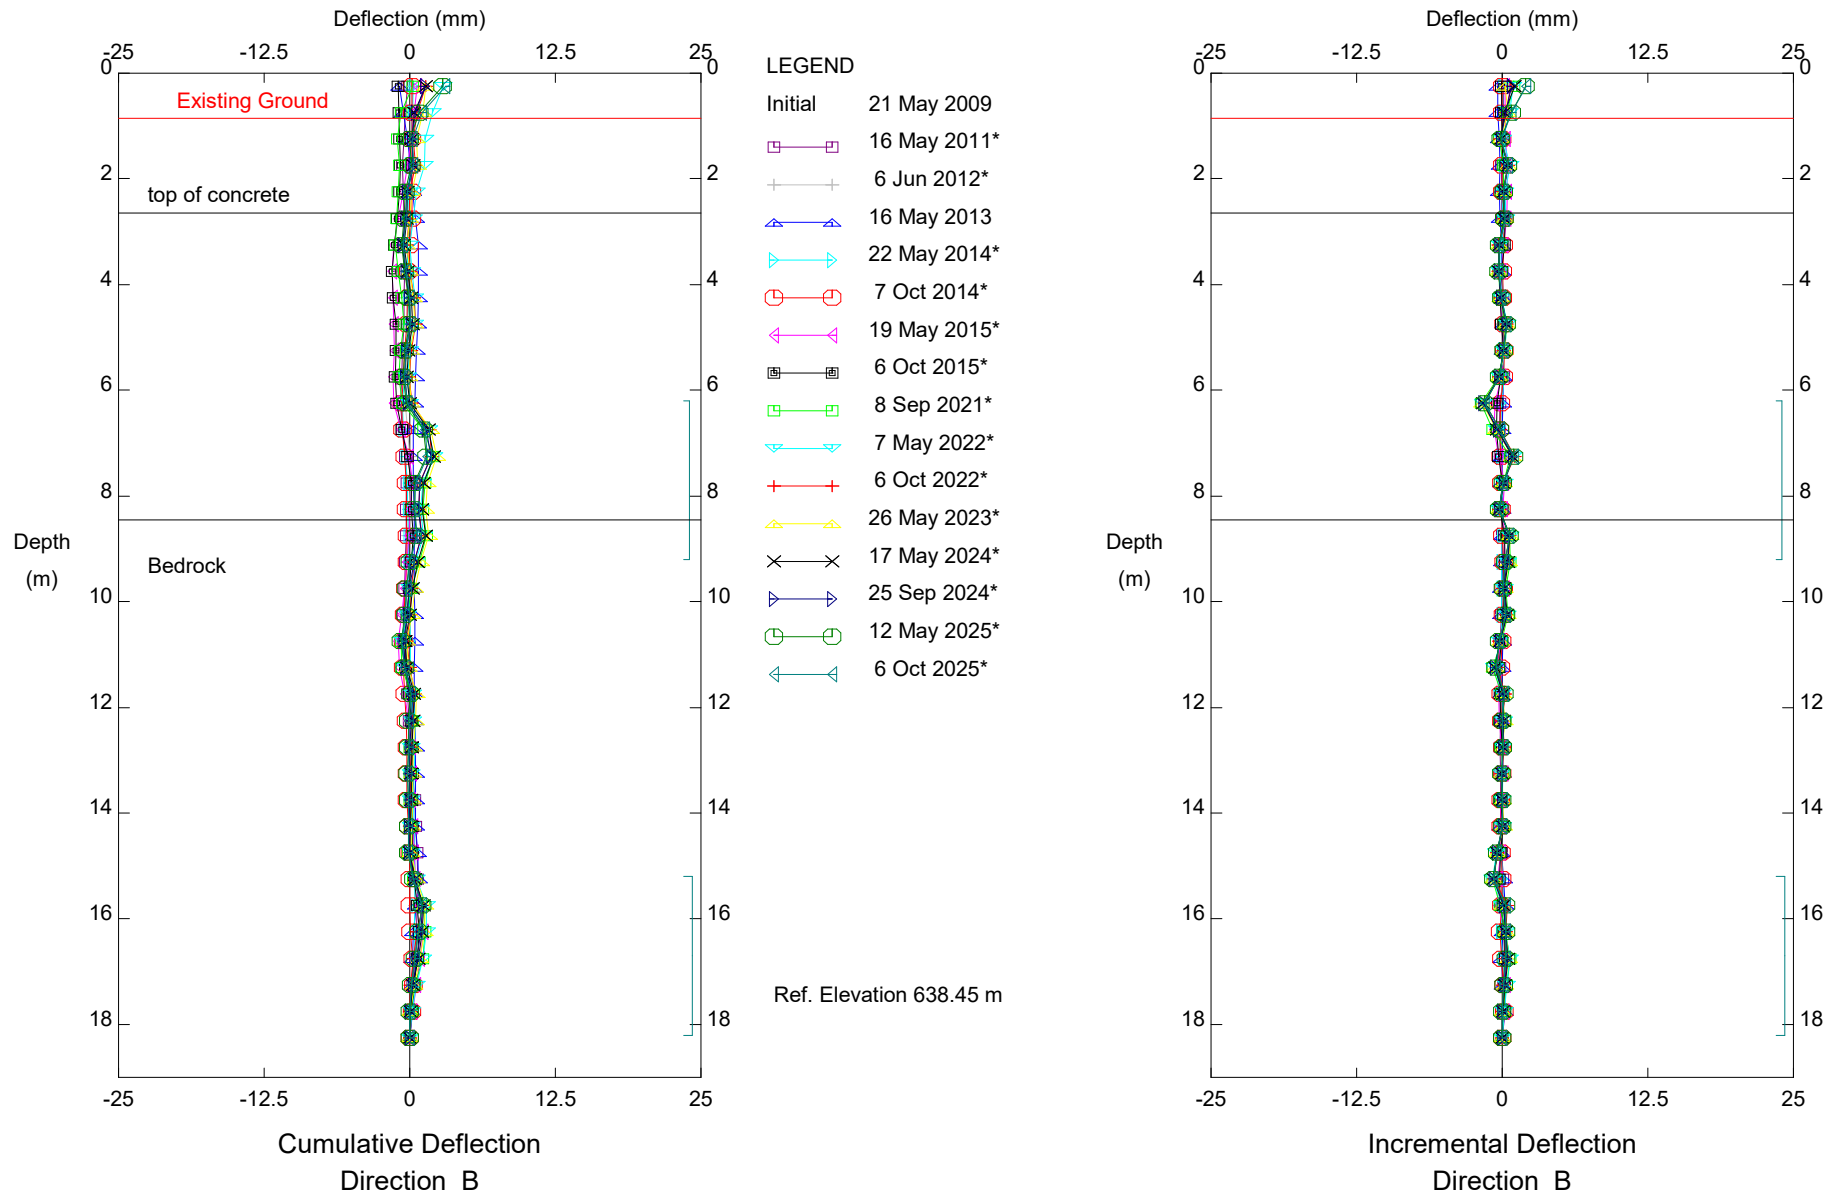
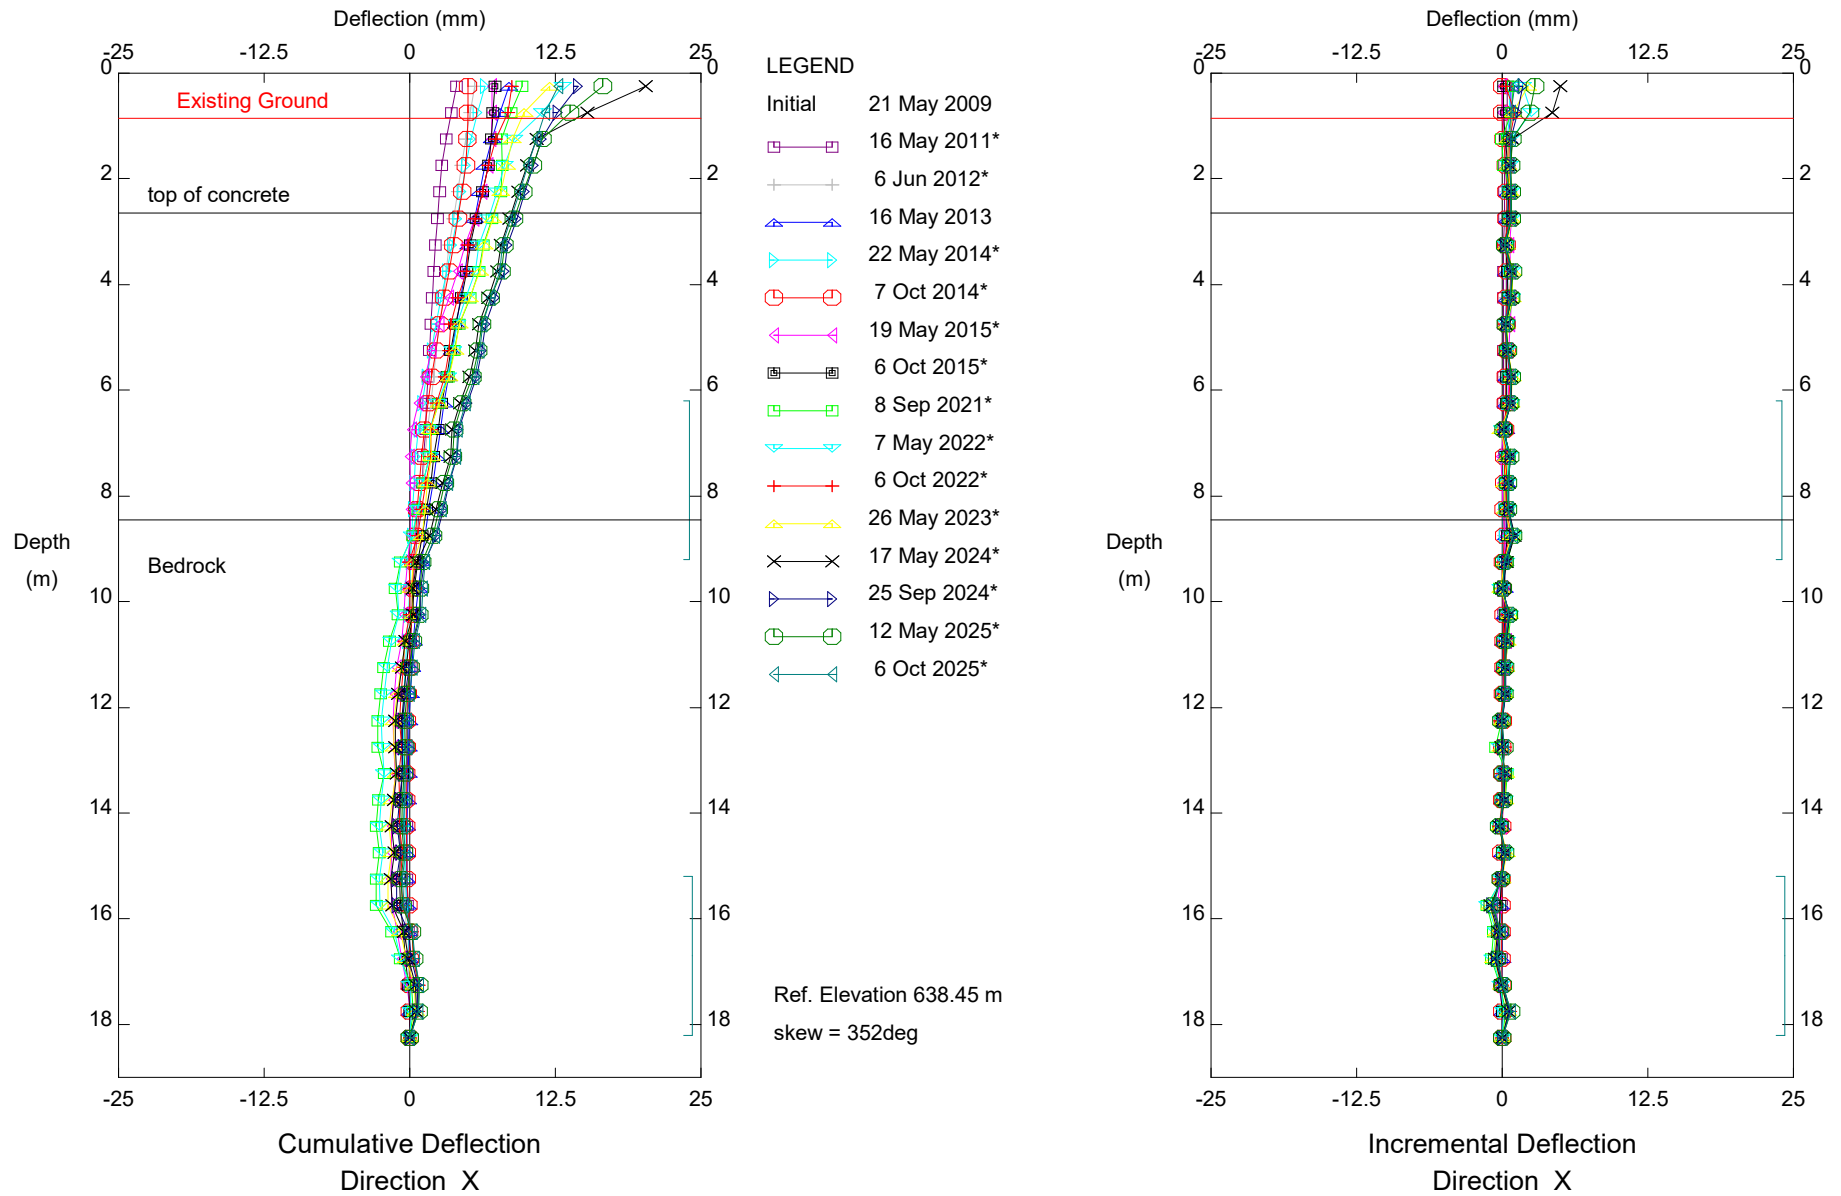
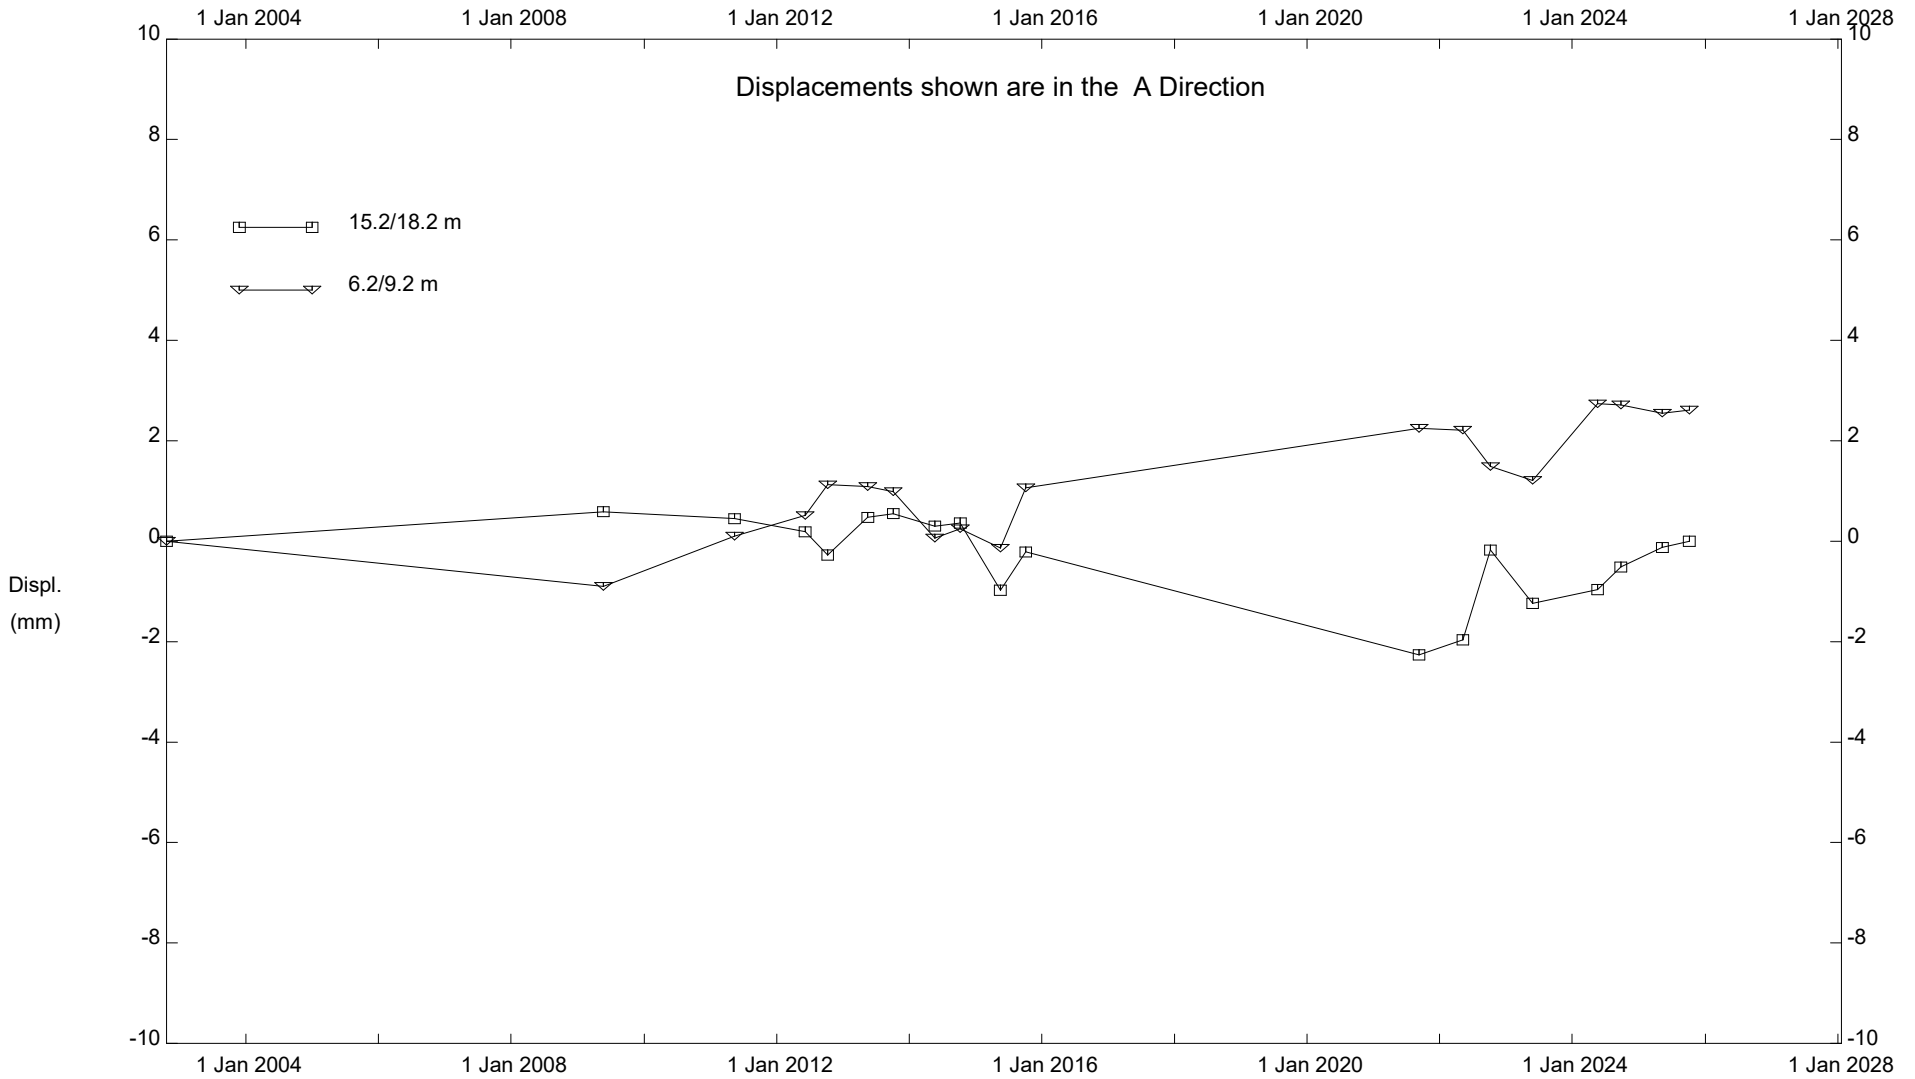
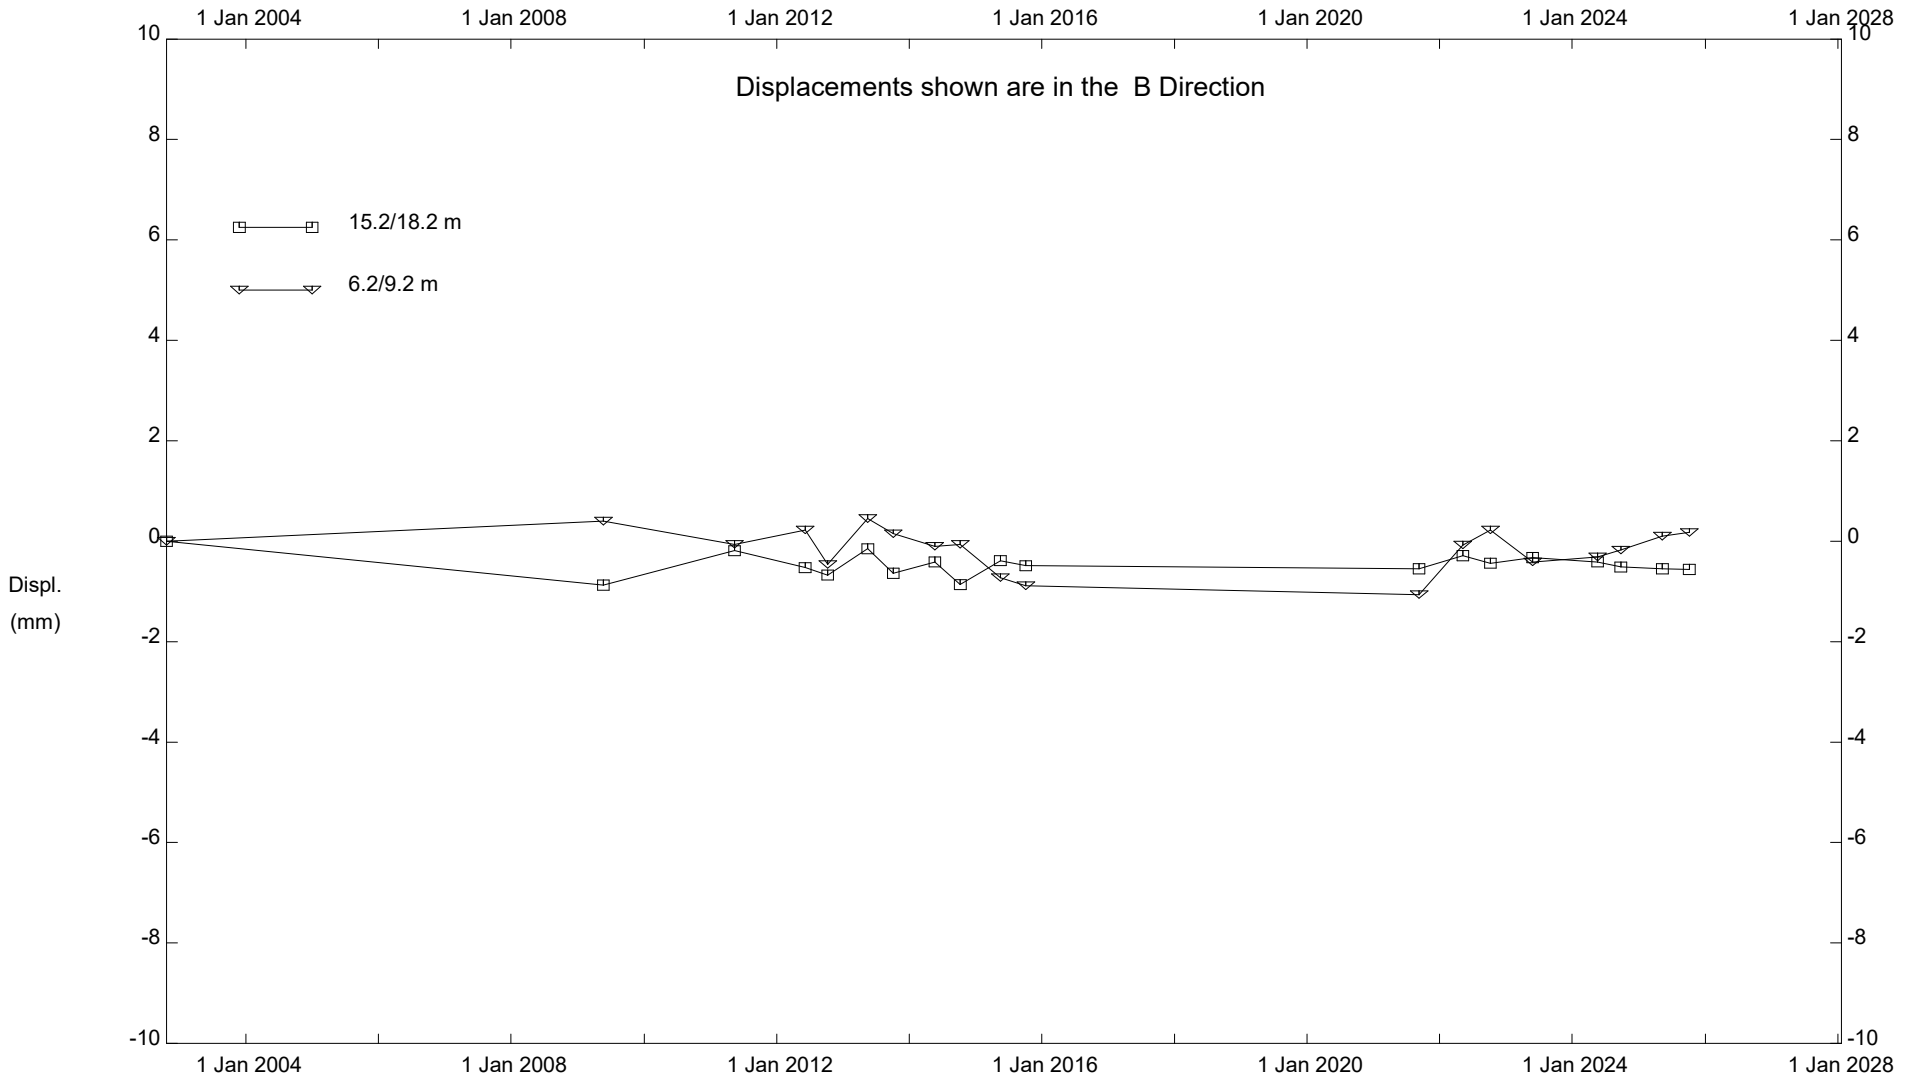
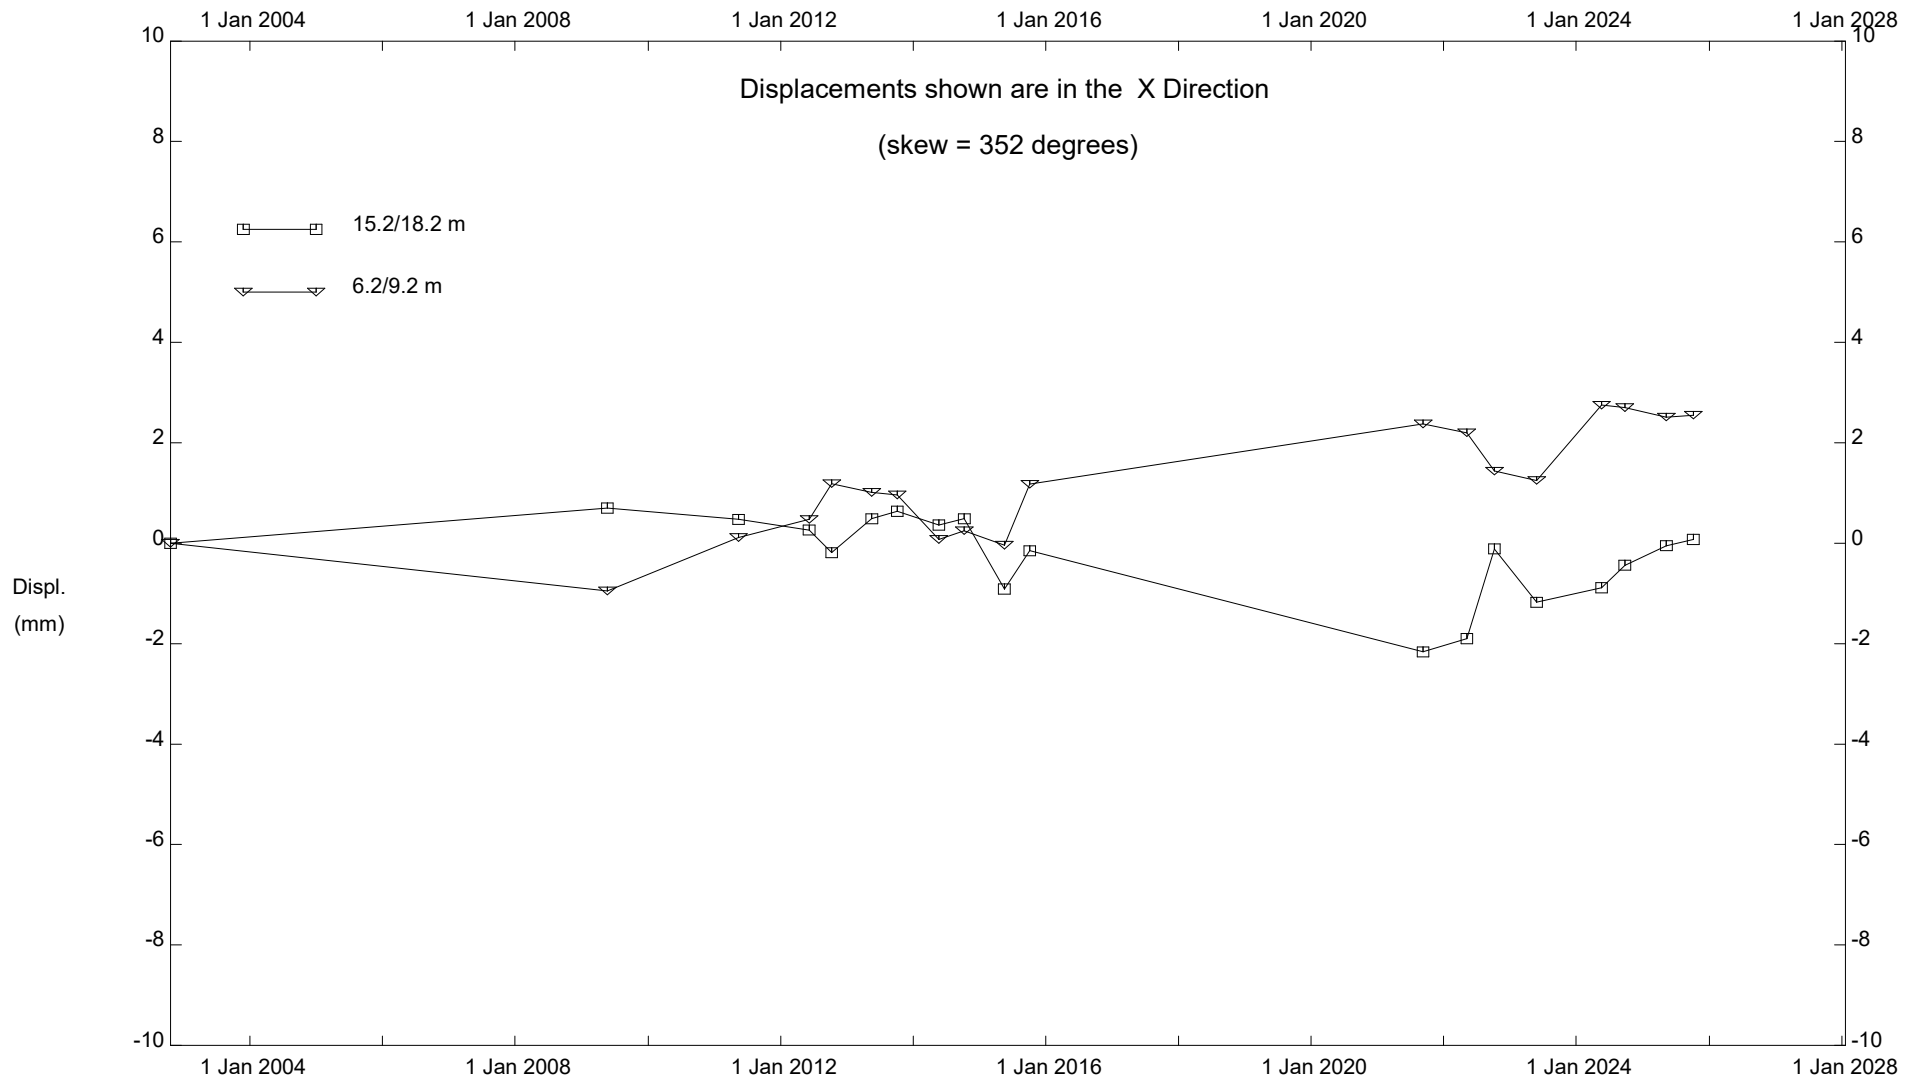
NC67, Inclinator SI-04

SI-04 has two potential zones of movement. The zone between 6.2 m and 9.2 m has a movement rate of less than 1 mm/yr and a total cumulative movement of 3 mm. The movement zone between 15.2 m and 18.2 m has a movement rate less than 1 mm/yr and a total cumulative movement of less than 1 mm.

| Instrument Name | Date Initialized | Coordinates <sup>(1)</sup><br>(UTM 12U, NAD1983)<br>(m) | | Total Cumulative Resultant Movement, and Depth of Movement (mm) | Maximum Rate of Movement (mm/yr) | Current Status | Date of Previous Reading | Incremental Movement Since Previous Reading (mm) | Current Rate of Movement (mm/yr) | Change in Rate of Movement Since Previous Reading (mm/yr) |
|---|---|---|---|---|---|---|---|---|---|---|
| SI-04 | Oct. 20, 2002 | 5926665 | 326251 | 3 over 6.2 m to 9.2 m depth in 352° direction | 2 mm/yr in May 2024 | Operational | May 12, 2025 | <1 | <1 | <1 |
| | | | | <1 over 15.2 m to 18.2 m depth in 352° direction | 2 mm/yr in May 2021 | | | <1 | <1 | <1 |
