| To: | Amy Driessen | From: | Leslie Cho and Lawrence Onwude |
| File: | 123315222 | Date: | October 31, 2025 |

**Reference: North Central Region, Stony Plain, Site NC067 - Highway 216:06 Anthony Henday Bridge, Fall 2025 Instrumentation Monitoring Report**

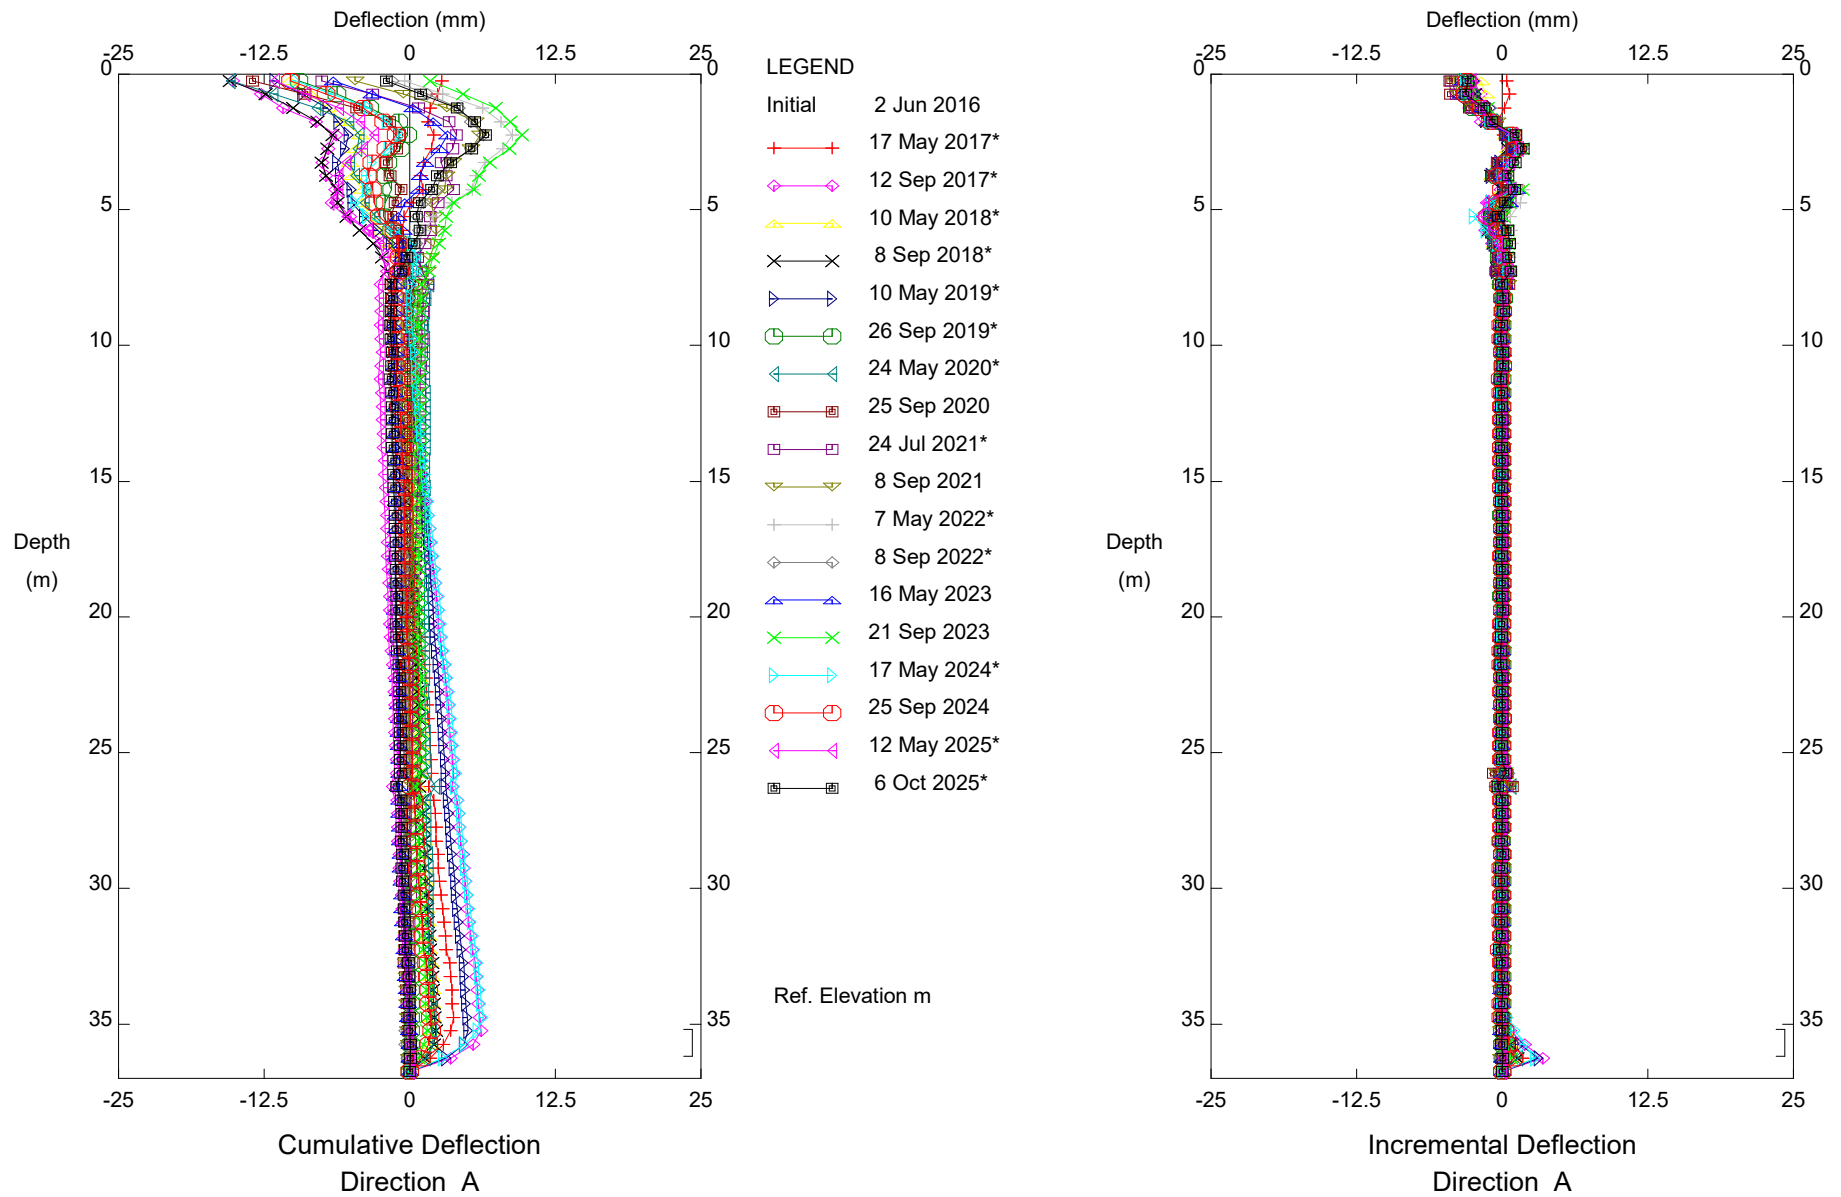
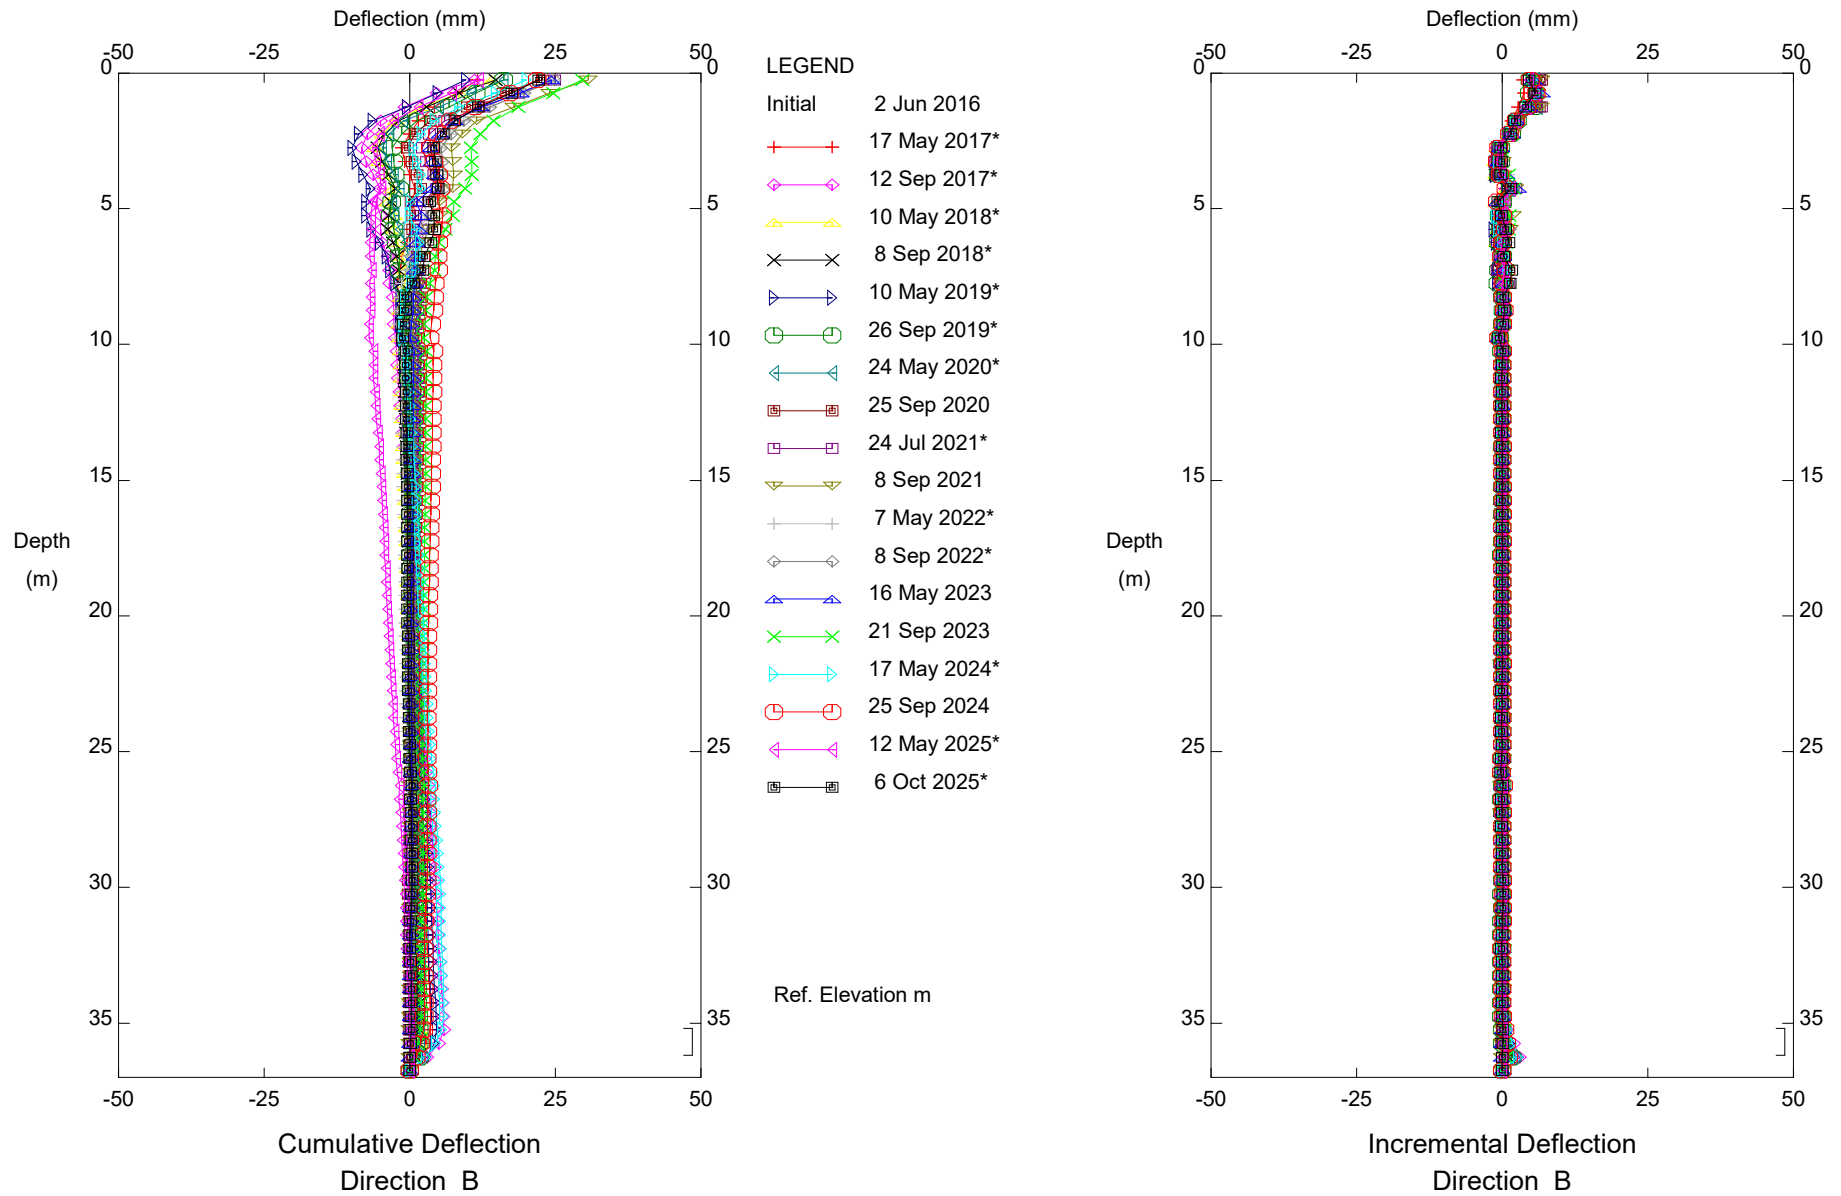
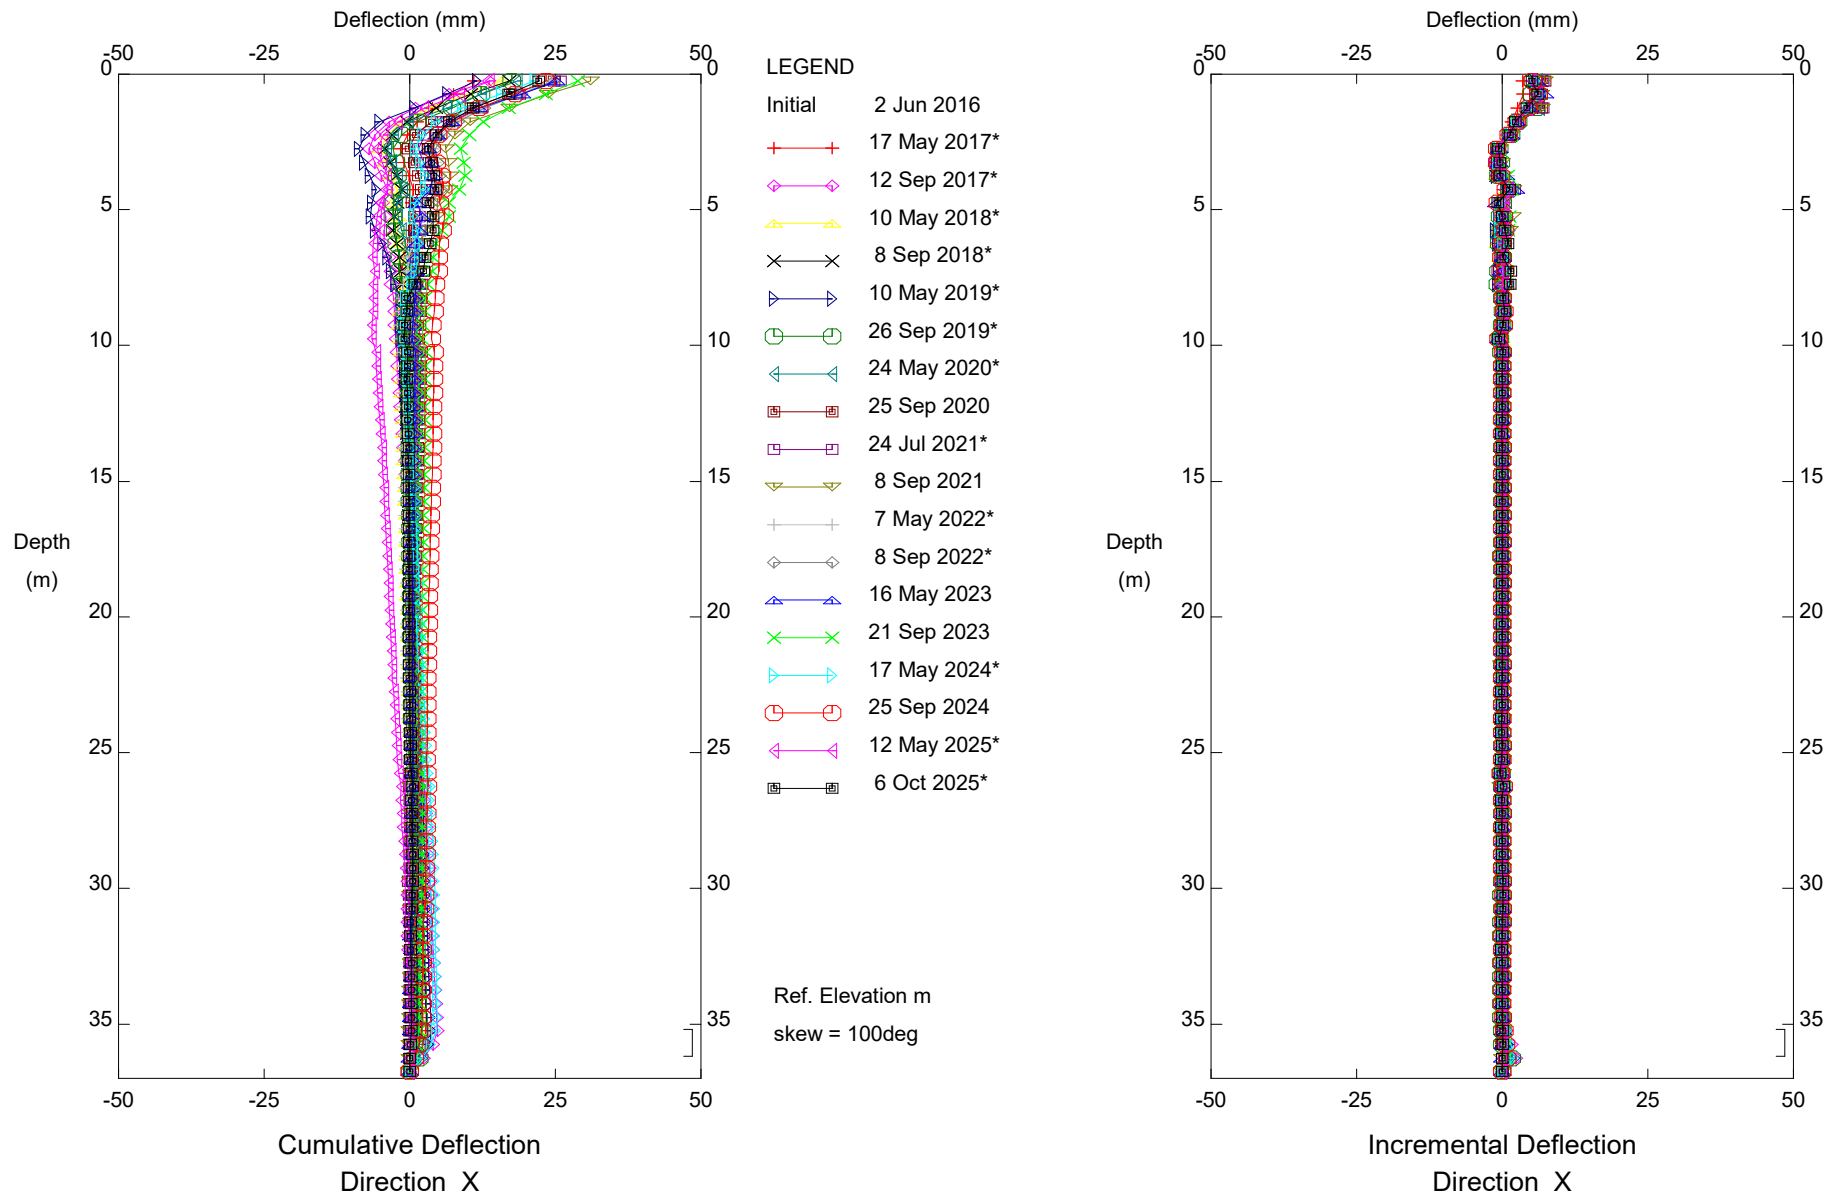
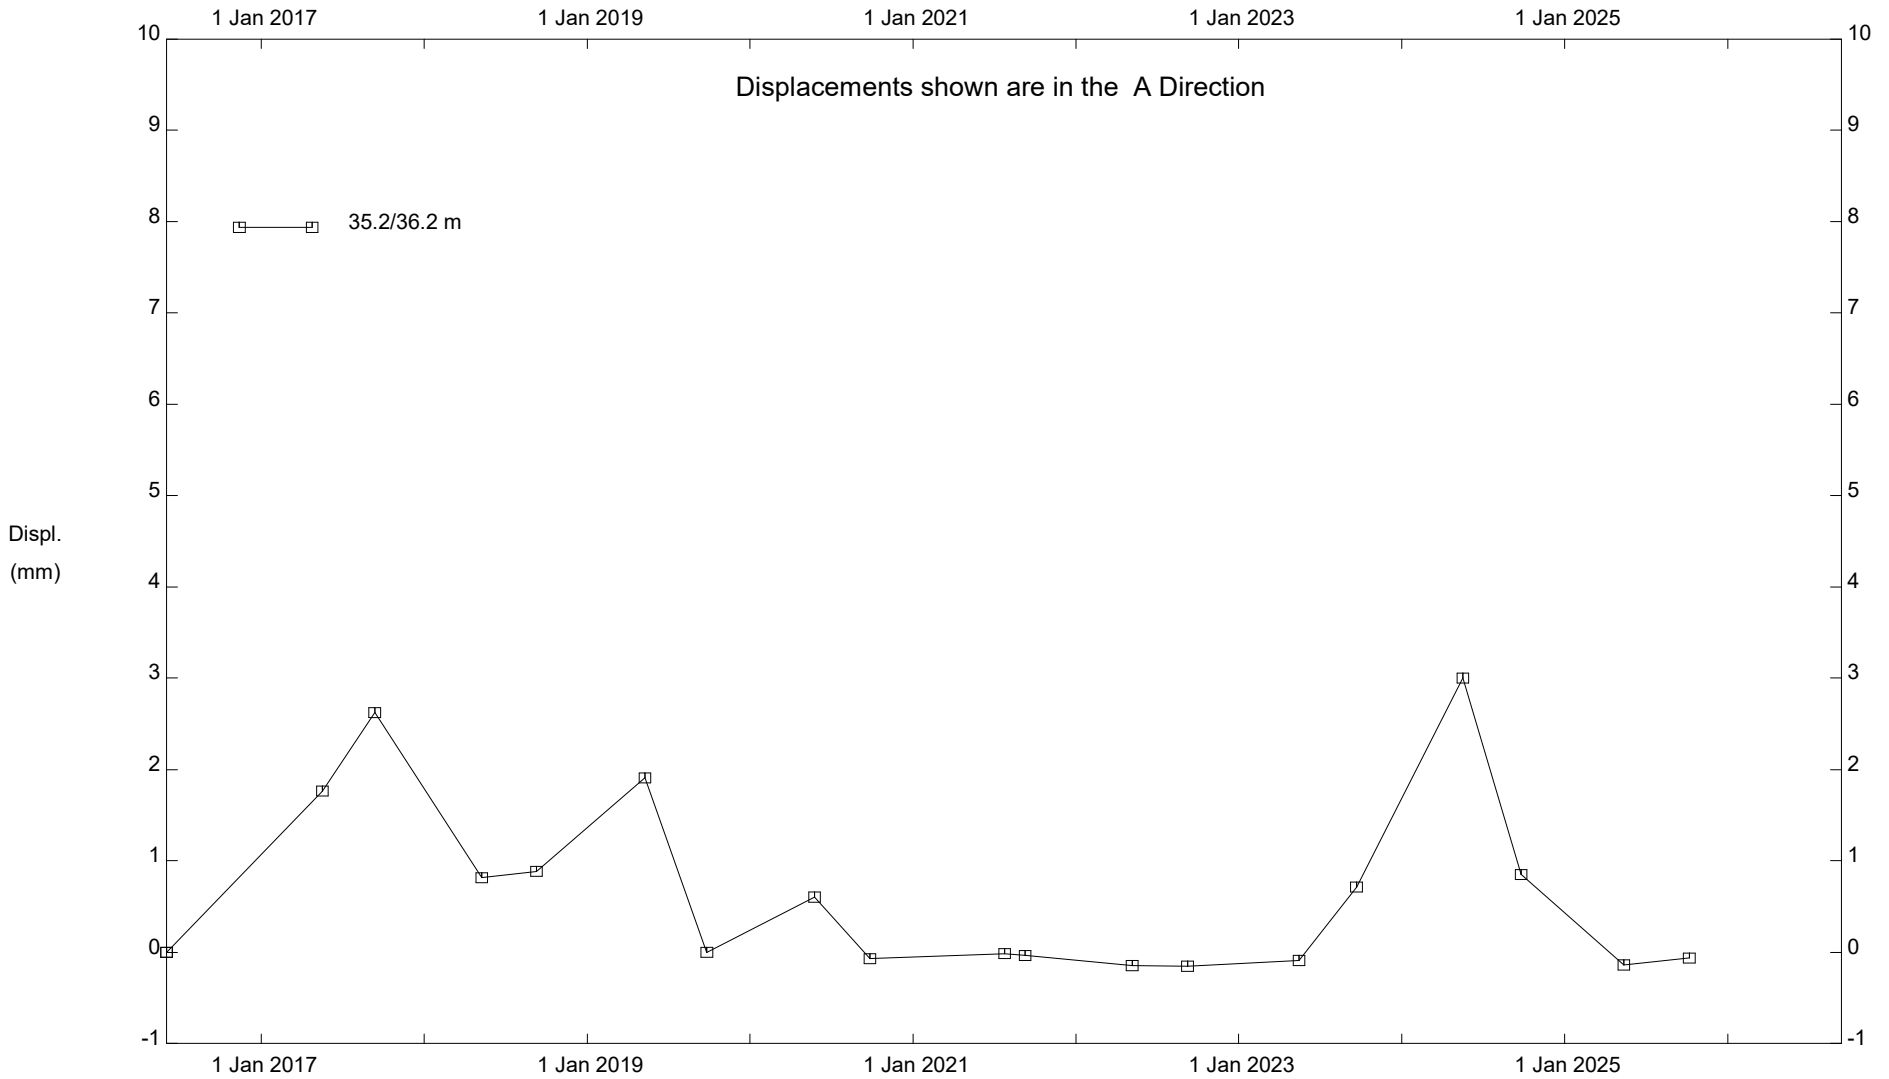
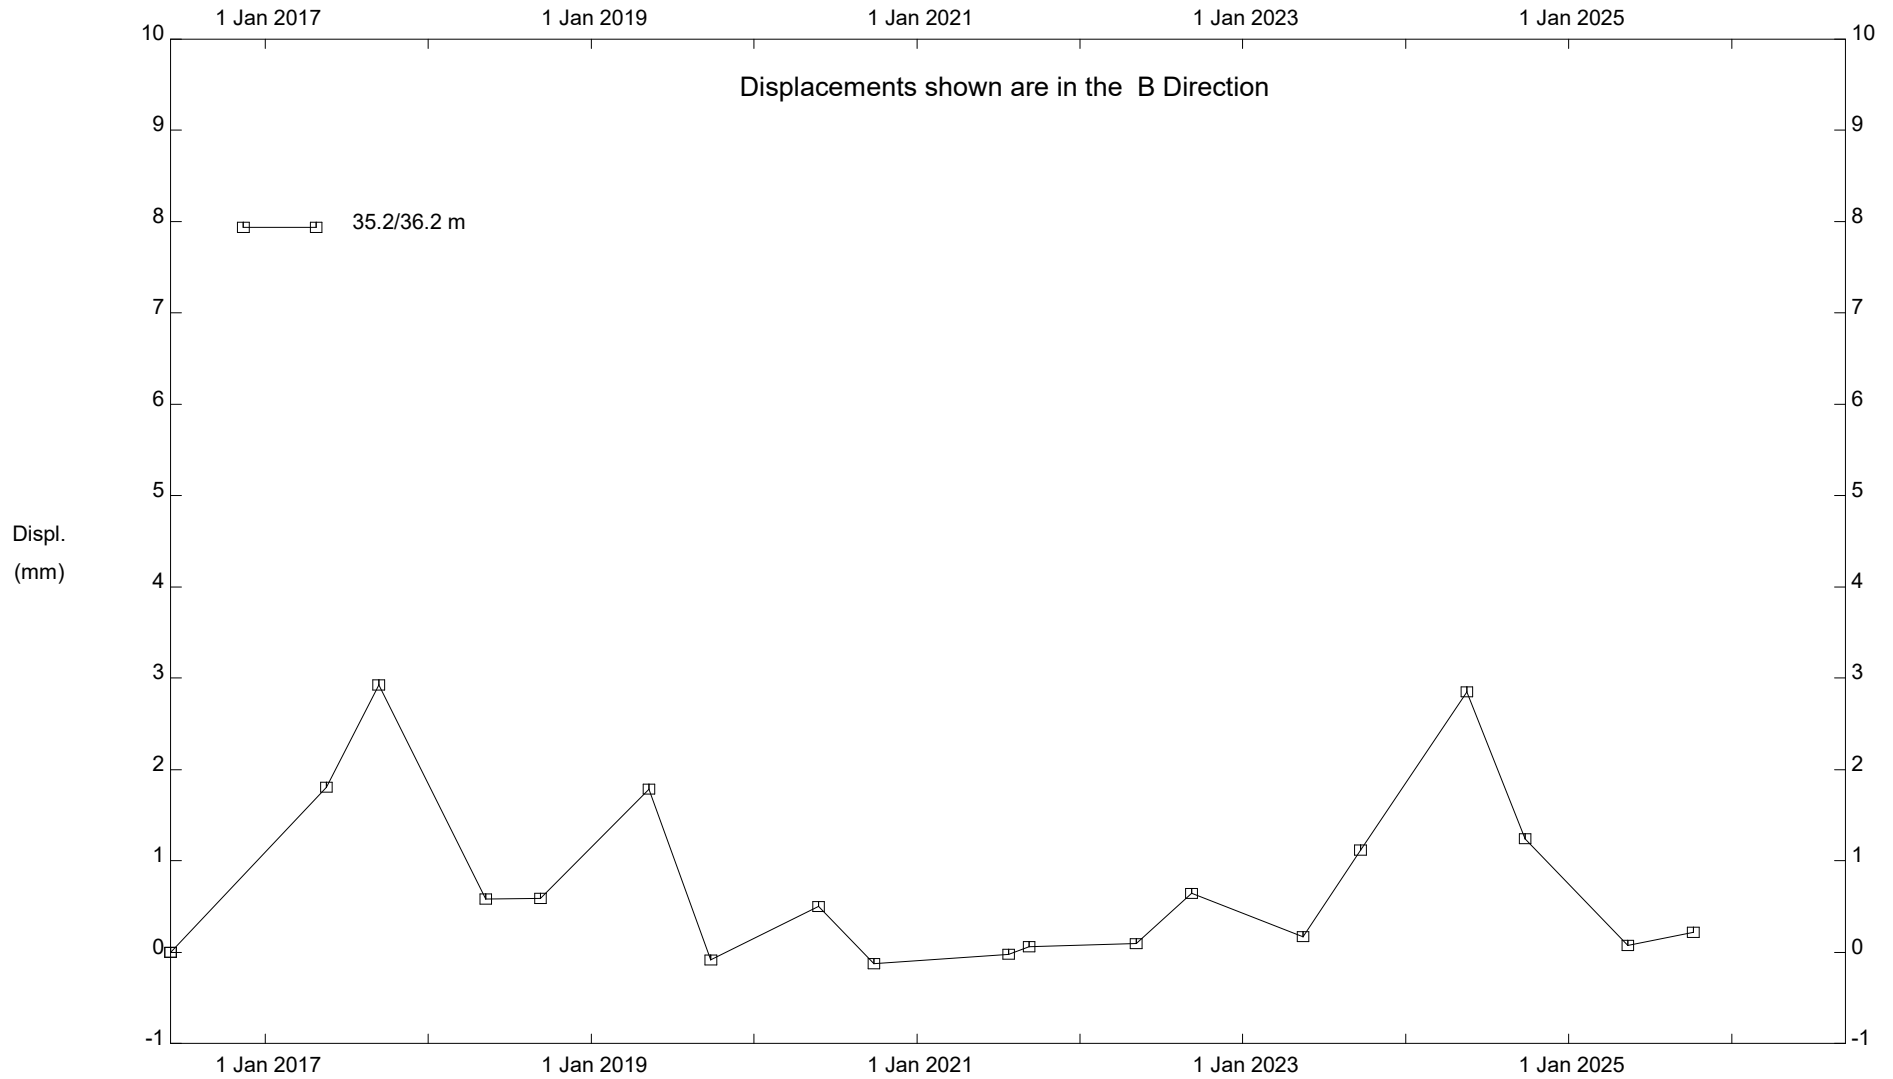
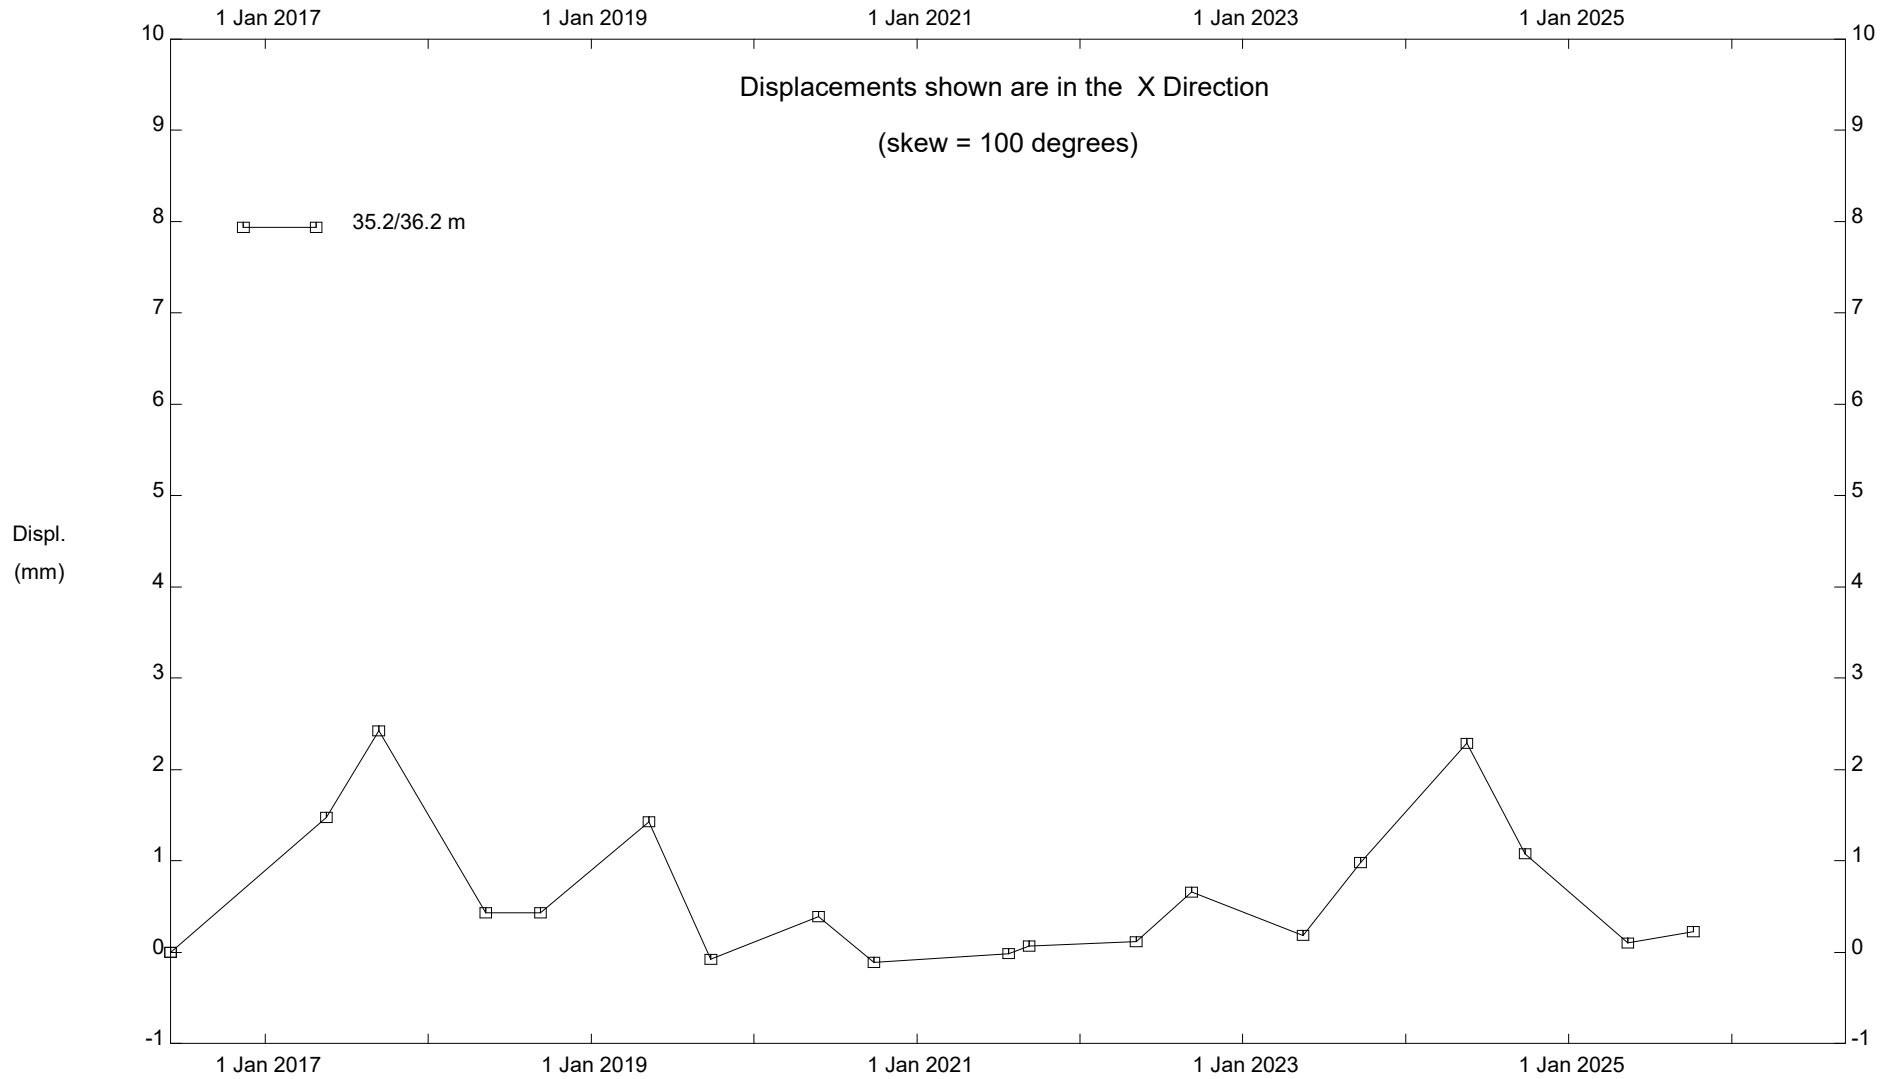
NC67, Inclinator SI-06

SI-06 has historically shown some erratic movement near the base of the casing. Currently, SI-06 shows a movement rate of less than 1 mm/yr with a cumulative movement of 0 mm. Additional readings will be required to confirm slope movement.

| Instrument Name | Date Initialized | Coordinates <sup>(1)</sup><br>(UTM 12U, NAD1983)<br>(m) | | Total Cumulative Resultant Movement, and Depth of Movement (mm) | Maximum Rate of Movement (mm/yr) | Current Status | Date of Previous Reading | Incremental Movement Since Previous Reading (mm) | Current Rate of Movement (mm/yr) | Change in Rate of Movement Since Previous Reading (mm/yr) |
|---|---|---|---|---|---|---|---|---|---|---|
| SI-06 | Oct 20, 2002 | 5926709 | 326278 | 0 over 35.2 m to 36.2 m depth in 100° direction | 4 mm/yr in Sep. 2019 | Operational | May 12, 2025 | <1 | <1 | -2 |
