| To: | Amy Driessen | From: | Leslie Cho and Lawrence Onwude |
| File: | 123315222 | Date: | October 31, 2025 |

**Reference: North Central Region, Stony Plain, Site NC067 - Highway 216:06 Anthony Henday Bridge, Fall 2025 Instrumentation Monitoring Report**

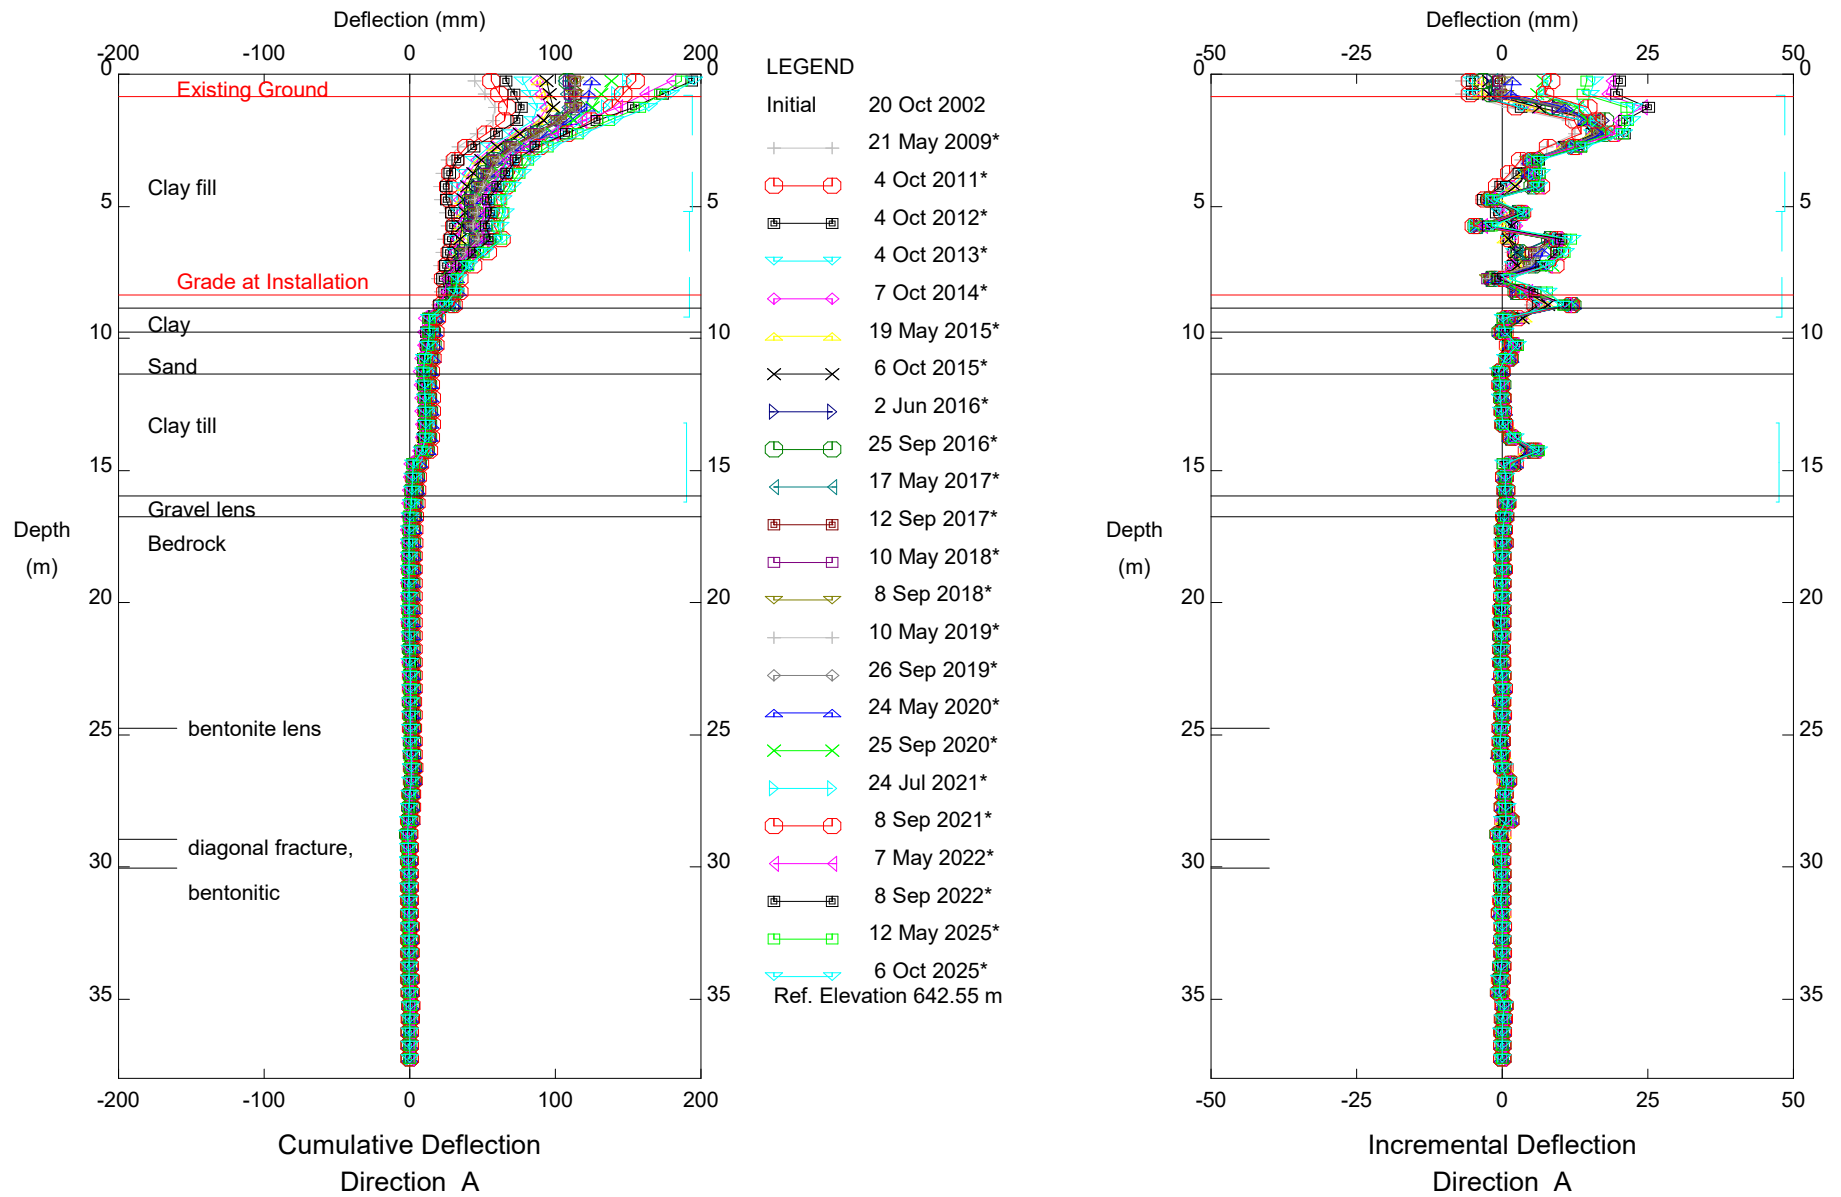
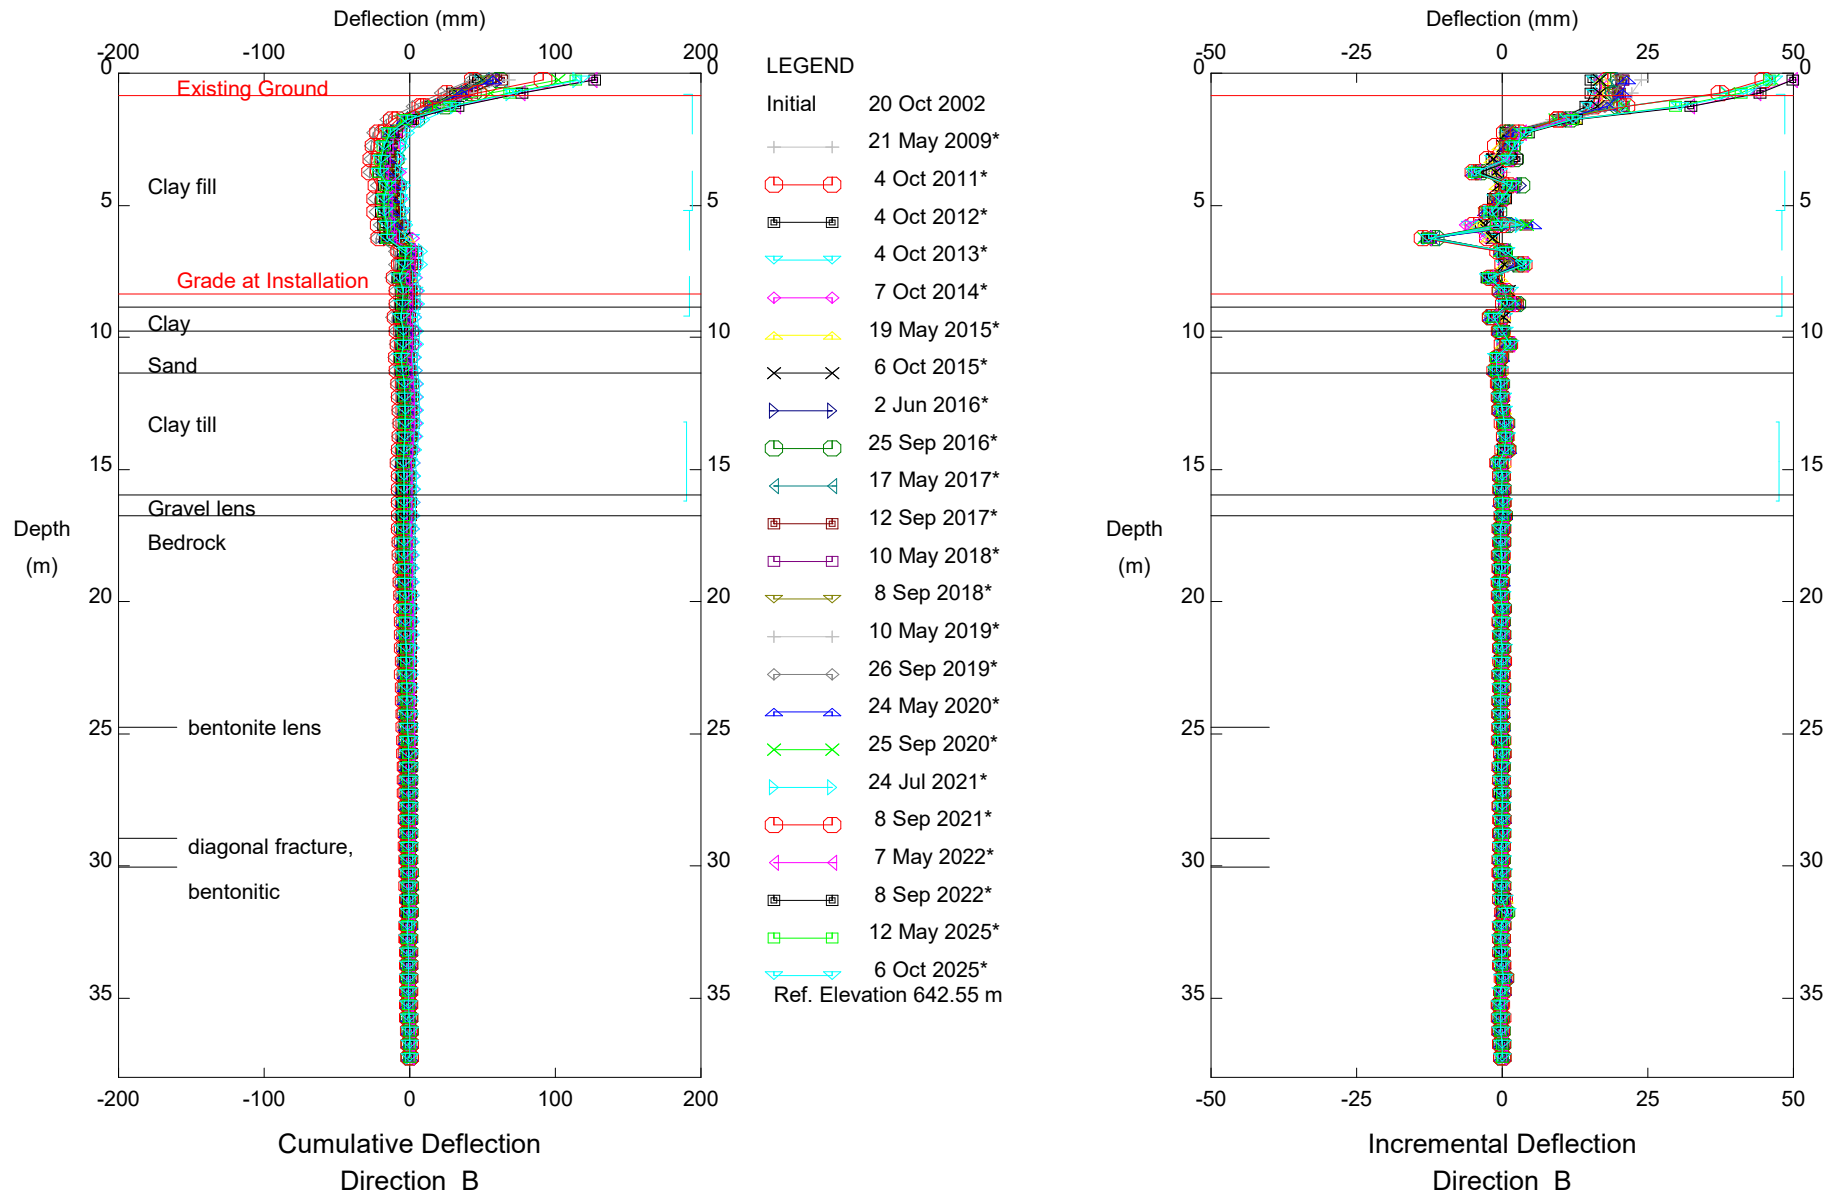
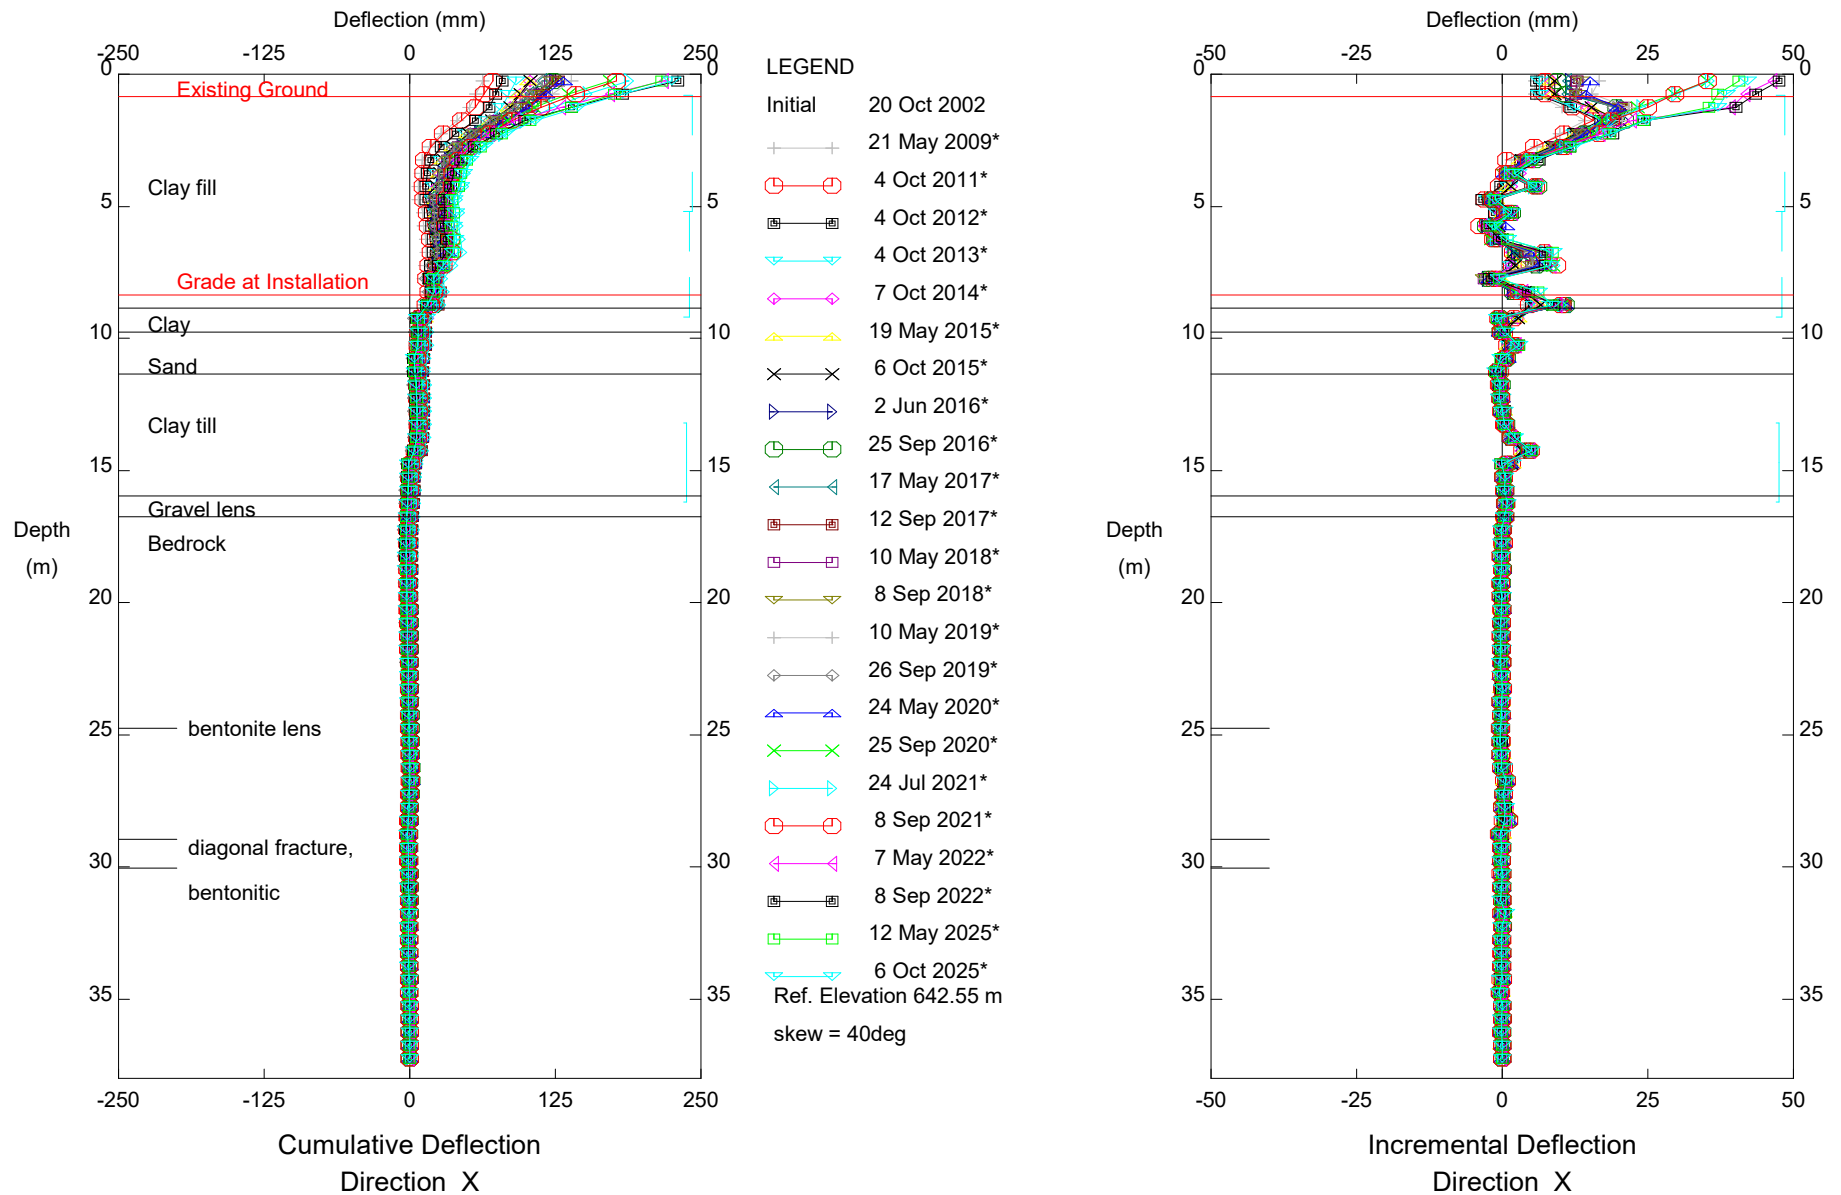
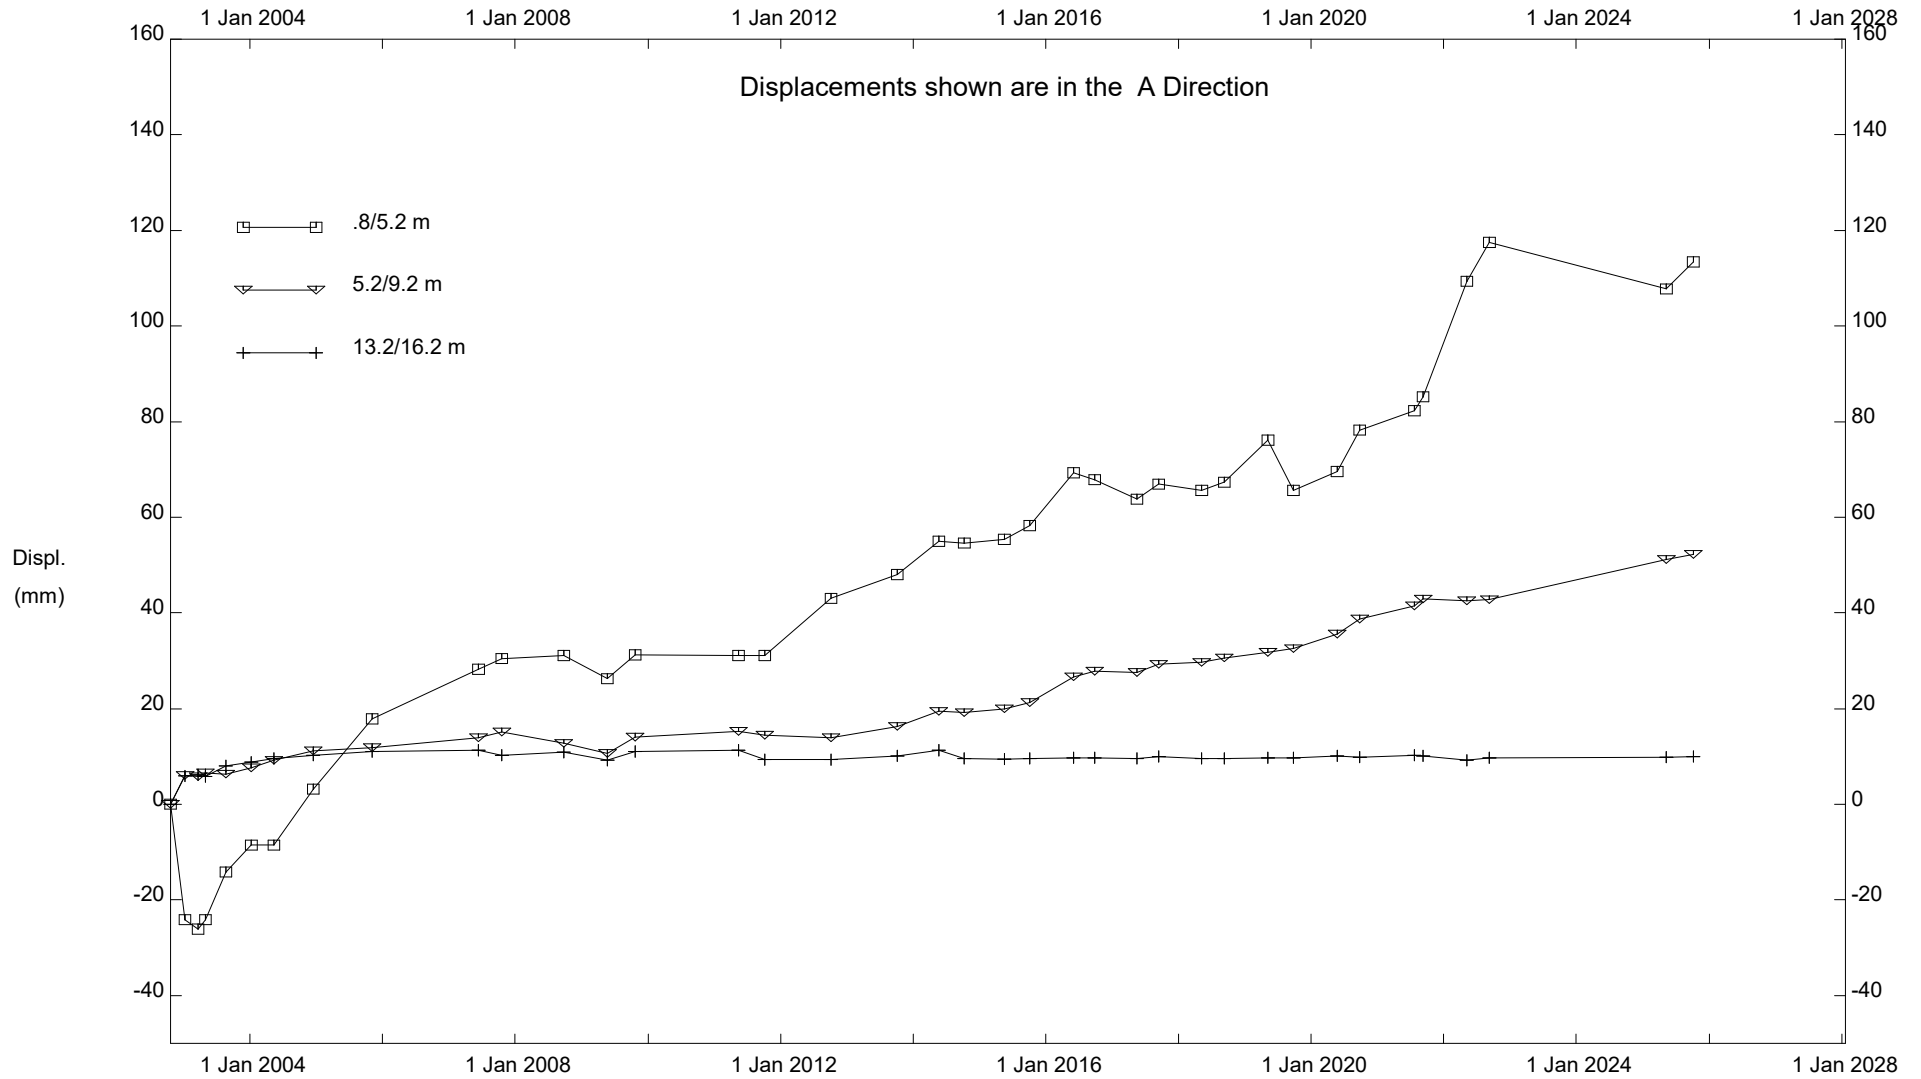
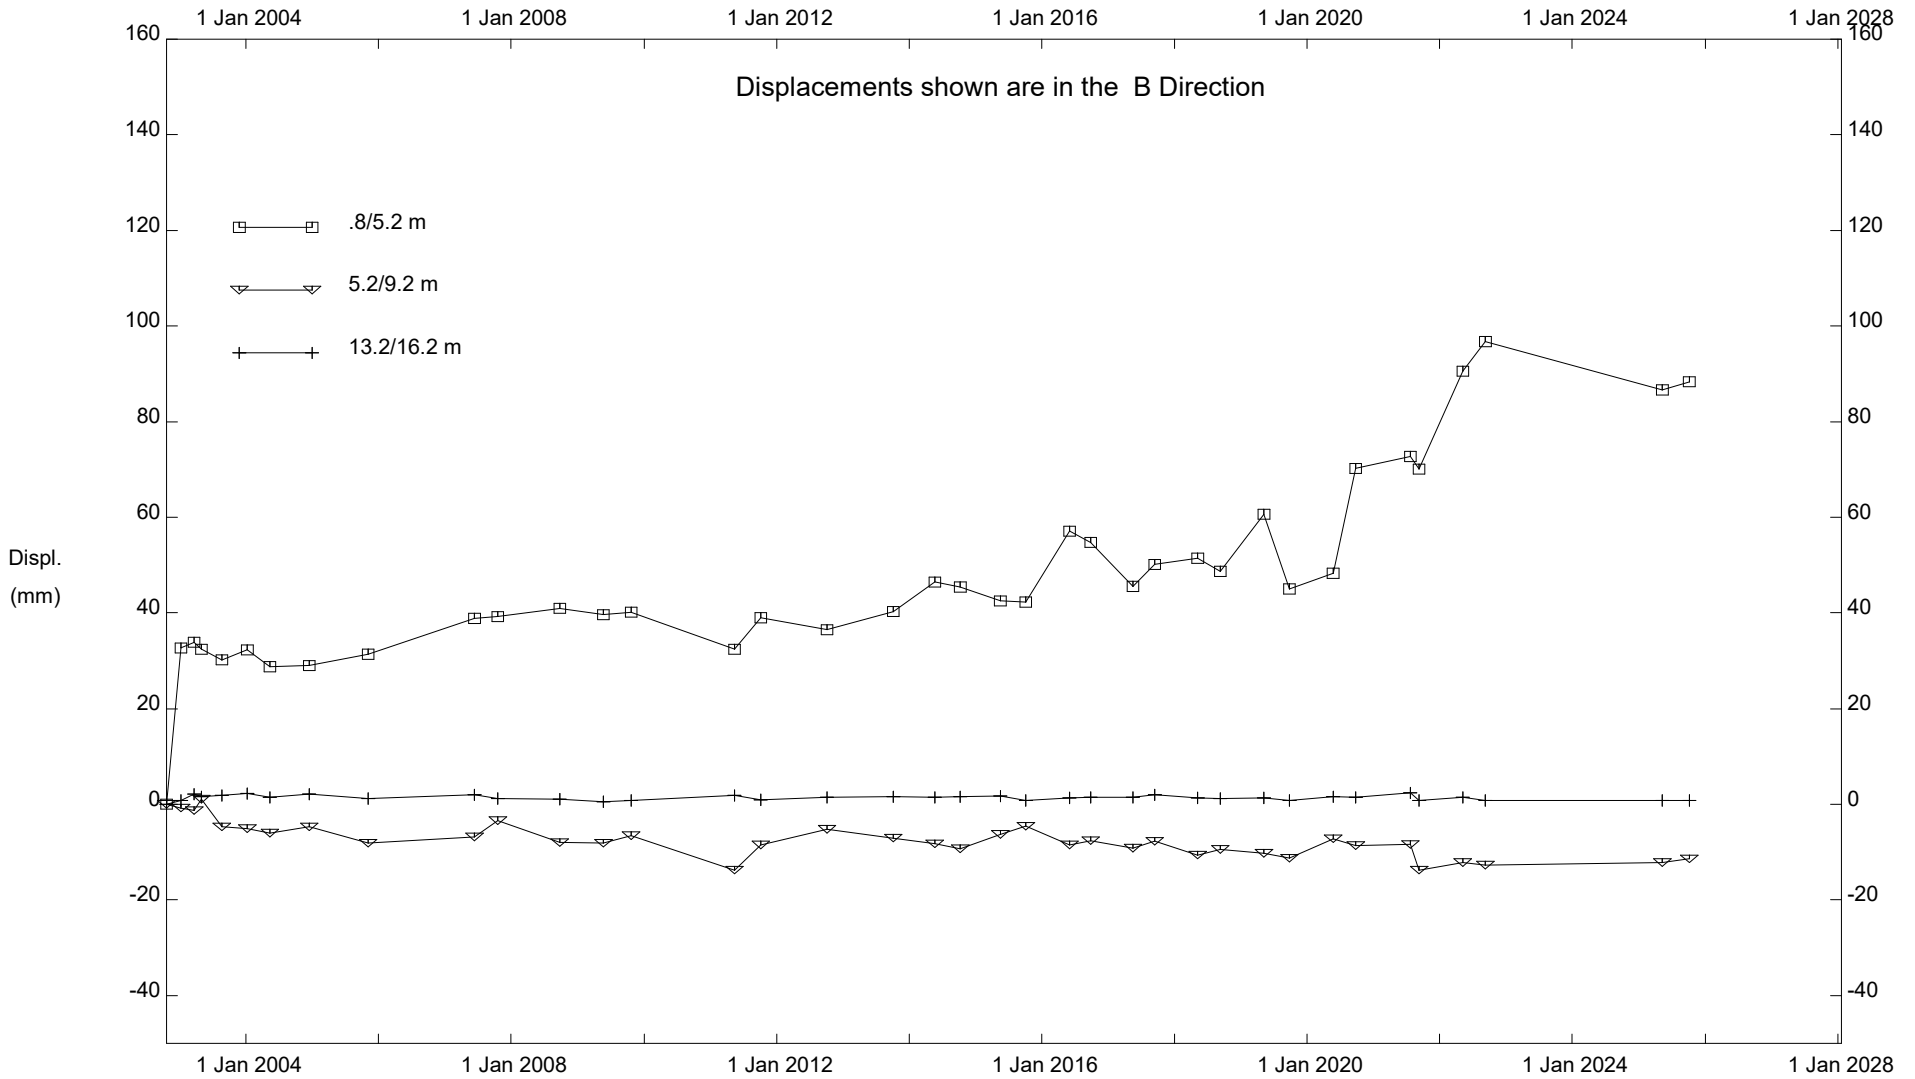
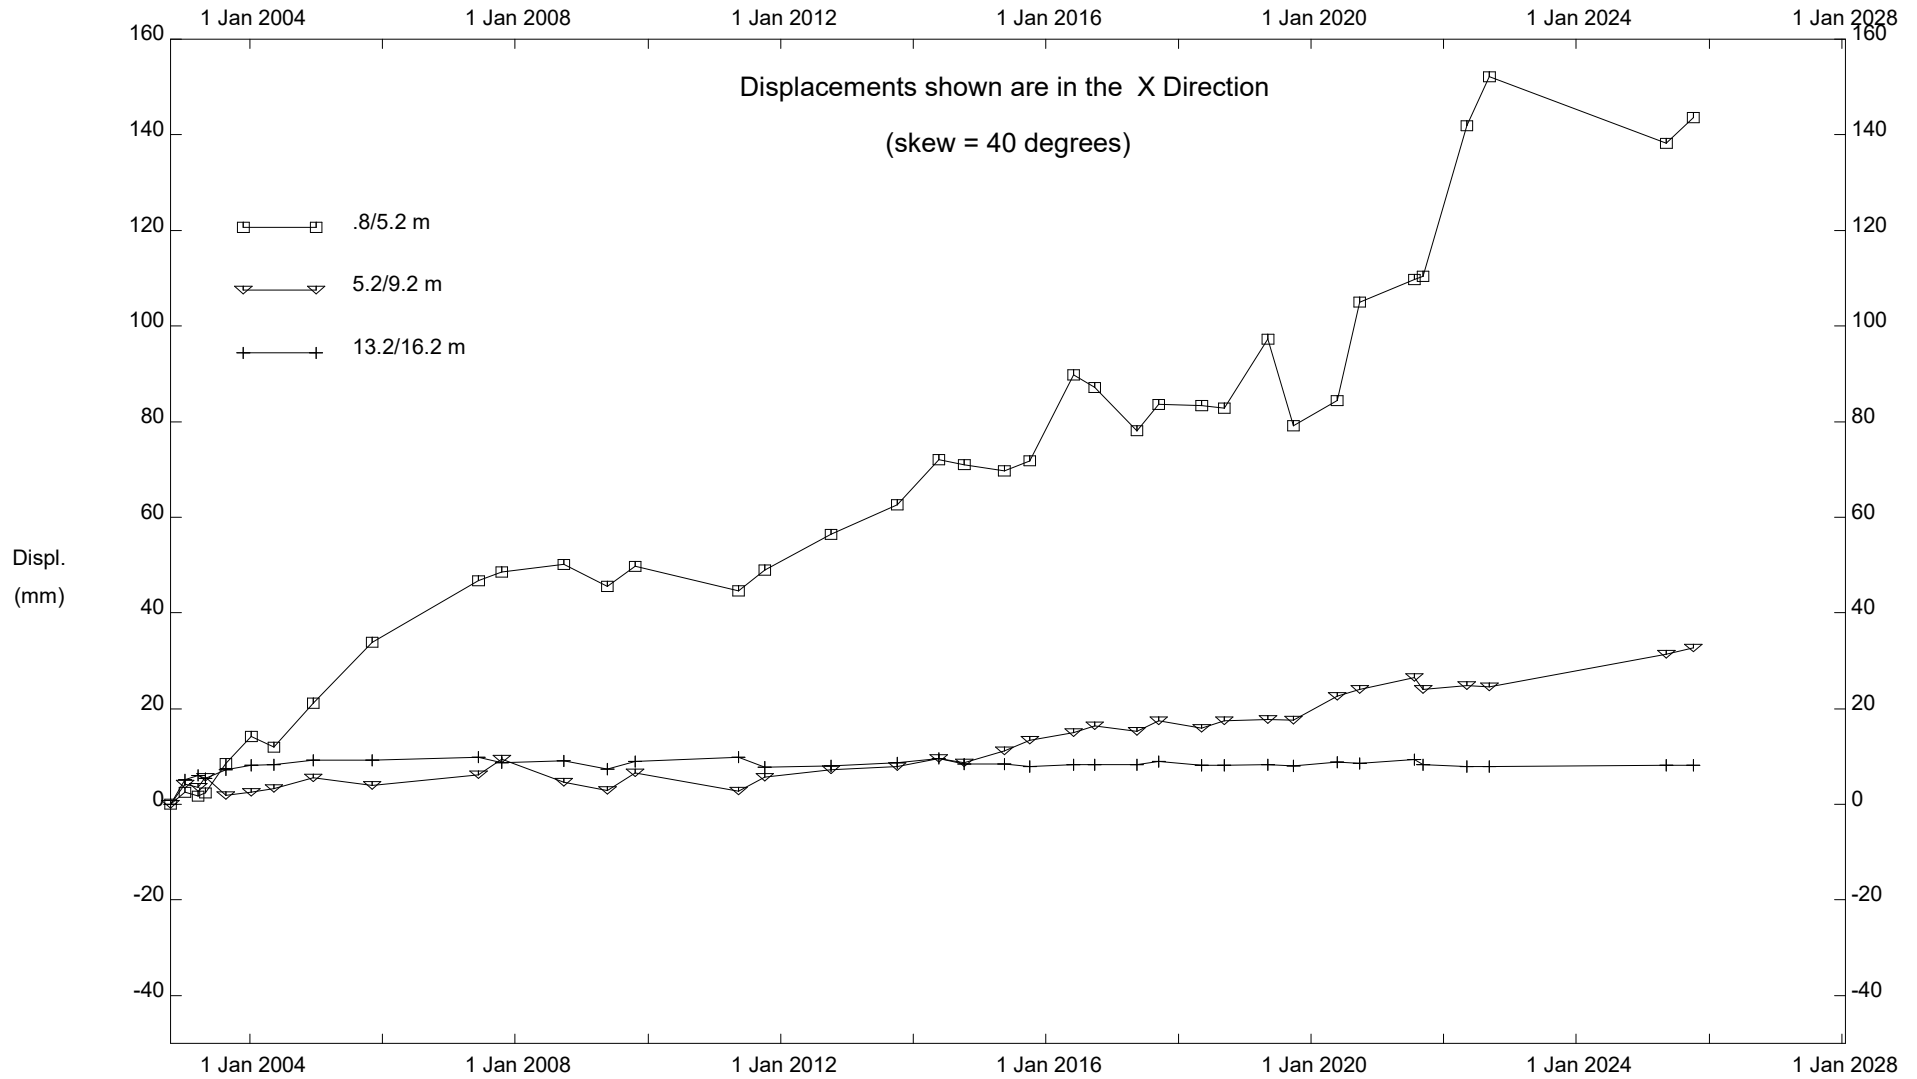
NC67, Inclinator SI-07

SI-07 has three zones of movement, 0.8 m to 5.2 m, 5.2 m to 9.2 m, 13.2 m to 16.2 m. The current movement rates are 13 mm/yr, 3 mm/yr, and less than 1 mm/yr for the shallow, middle, and deeper zones respectively. The cumulative movements are 144 mm, 33 mm, and 8 mm for the shallow, middle, and deeper zones respectively.

| Instrument Name | Date Initialized | Coordinates <sup>(1)</sup><br>(UTM 12U, NAD1983)<br>(m) | | Total Cumulative Resultant Movement, and Depth of Movement (mm) | Maximum Rate of Movement (mm/yr) | Current Status | Date of Previous Reading | Incremental Movement Since Previous Reading (mm) | Current Rate of Movement (mm/yr) | Change in Rate of Movement Since Previous Reading (mm/yr) |
|---|---|---|---|---|---|---|---|---|---|---|
| SI-07 | Oct. 20, 2002 | 5926736 | 326294 | 144 over 0.8 m to 5.2 m depth in 40° direction | 186 mm/yr; Jan. 2003 | Operational | May 12, 2025 | 6 | 13 | 10 |
| | | | | 33 over 5.2 m to 9.2 m depth in 40° direction | 45 mm/yr; Sept. 2021 | | | 2 | 3 | 0 |
| | | | | 8 over 13.2 m to 16.2 m depth 40° direction | 10 mm/yr; Jan. 2003 | | | <1 | <1 | <1 |
