| To: | Amy Driessen | From: | Leslie Cho and Lawrence Onwude |
| File: | 123315222 | Date: | October 31, 2025 |

**Reference: North Central Region, Stony Plain, Site NC067 - Highway 216:06 Anthony Henday Bridge, Fall 2025 Instrumentation Monitoring Report**

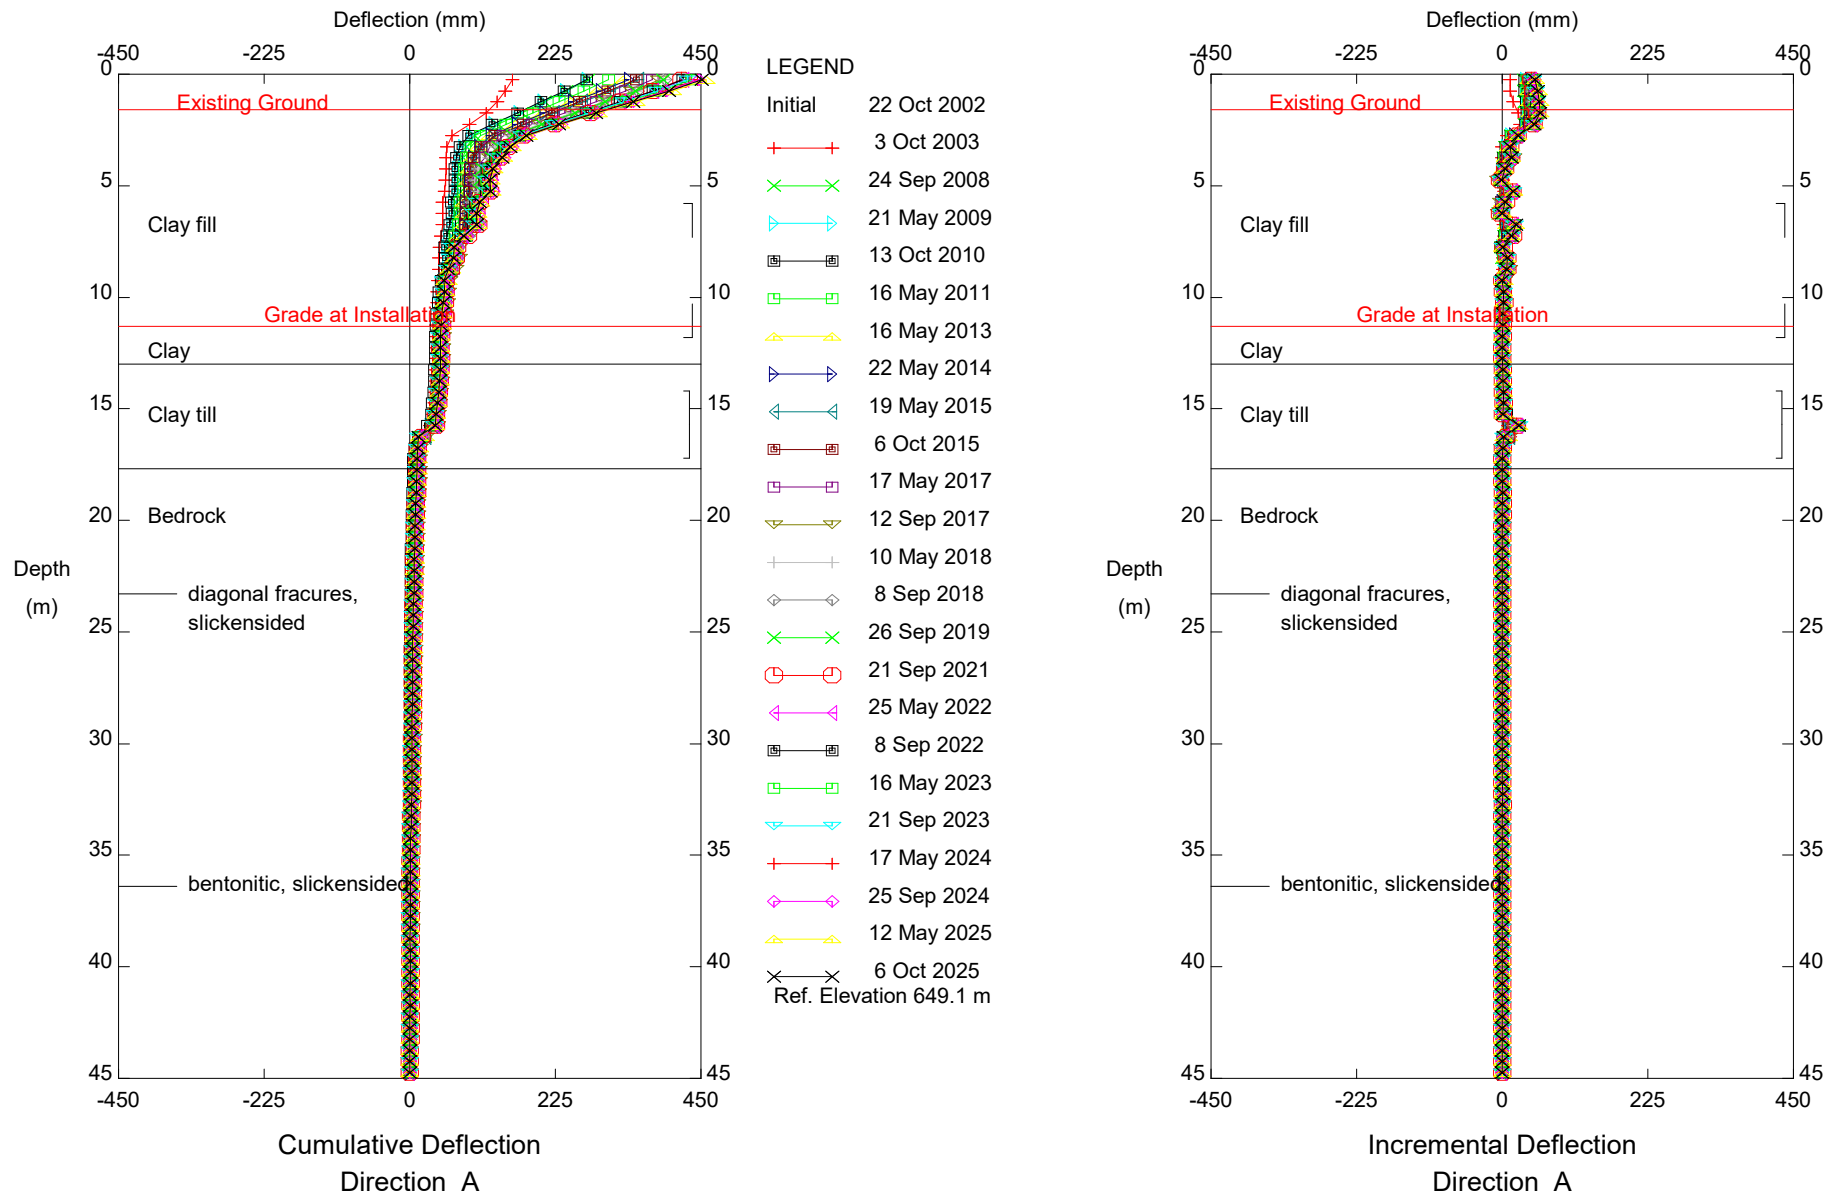
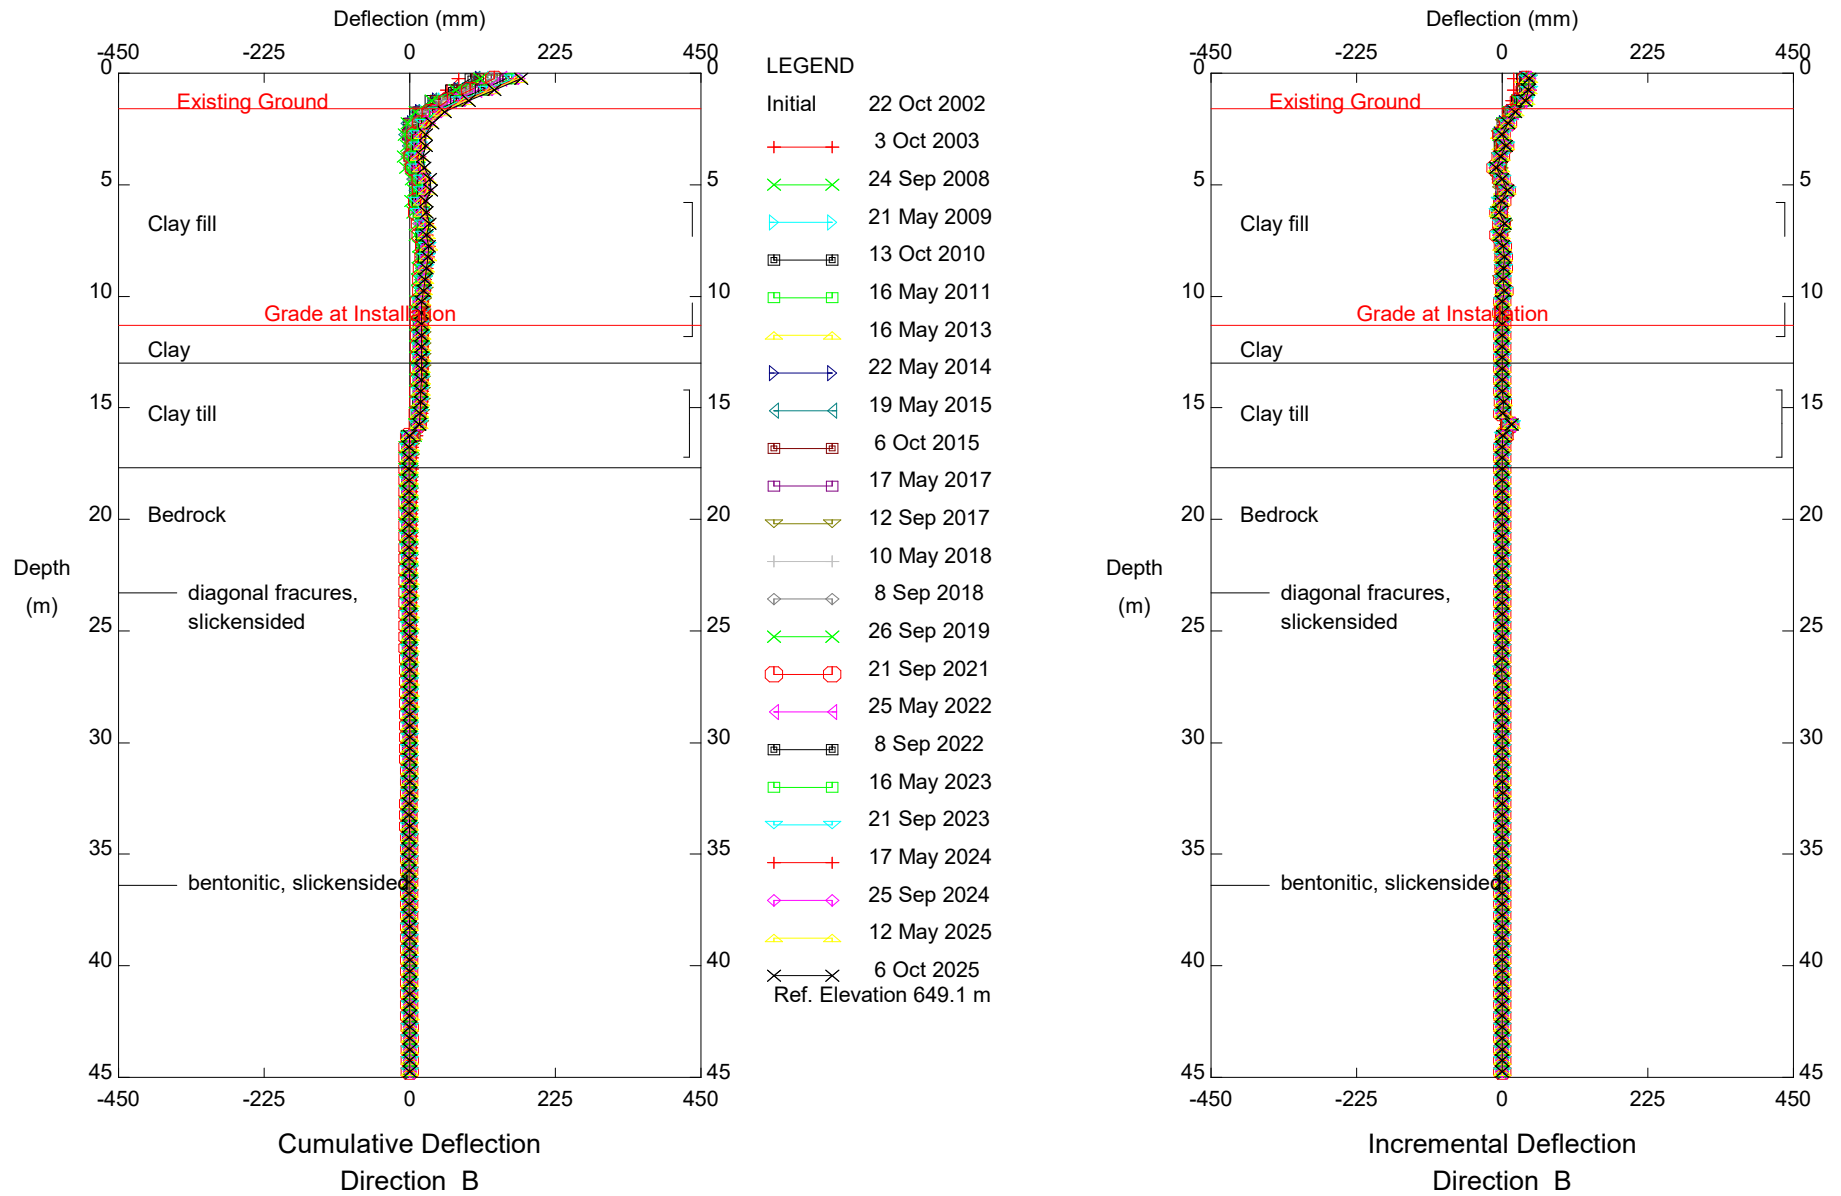
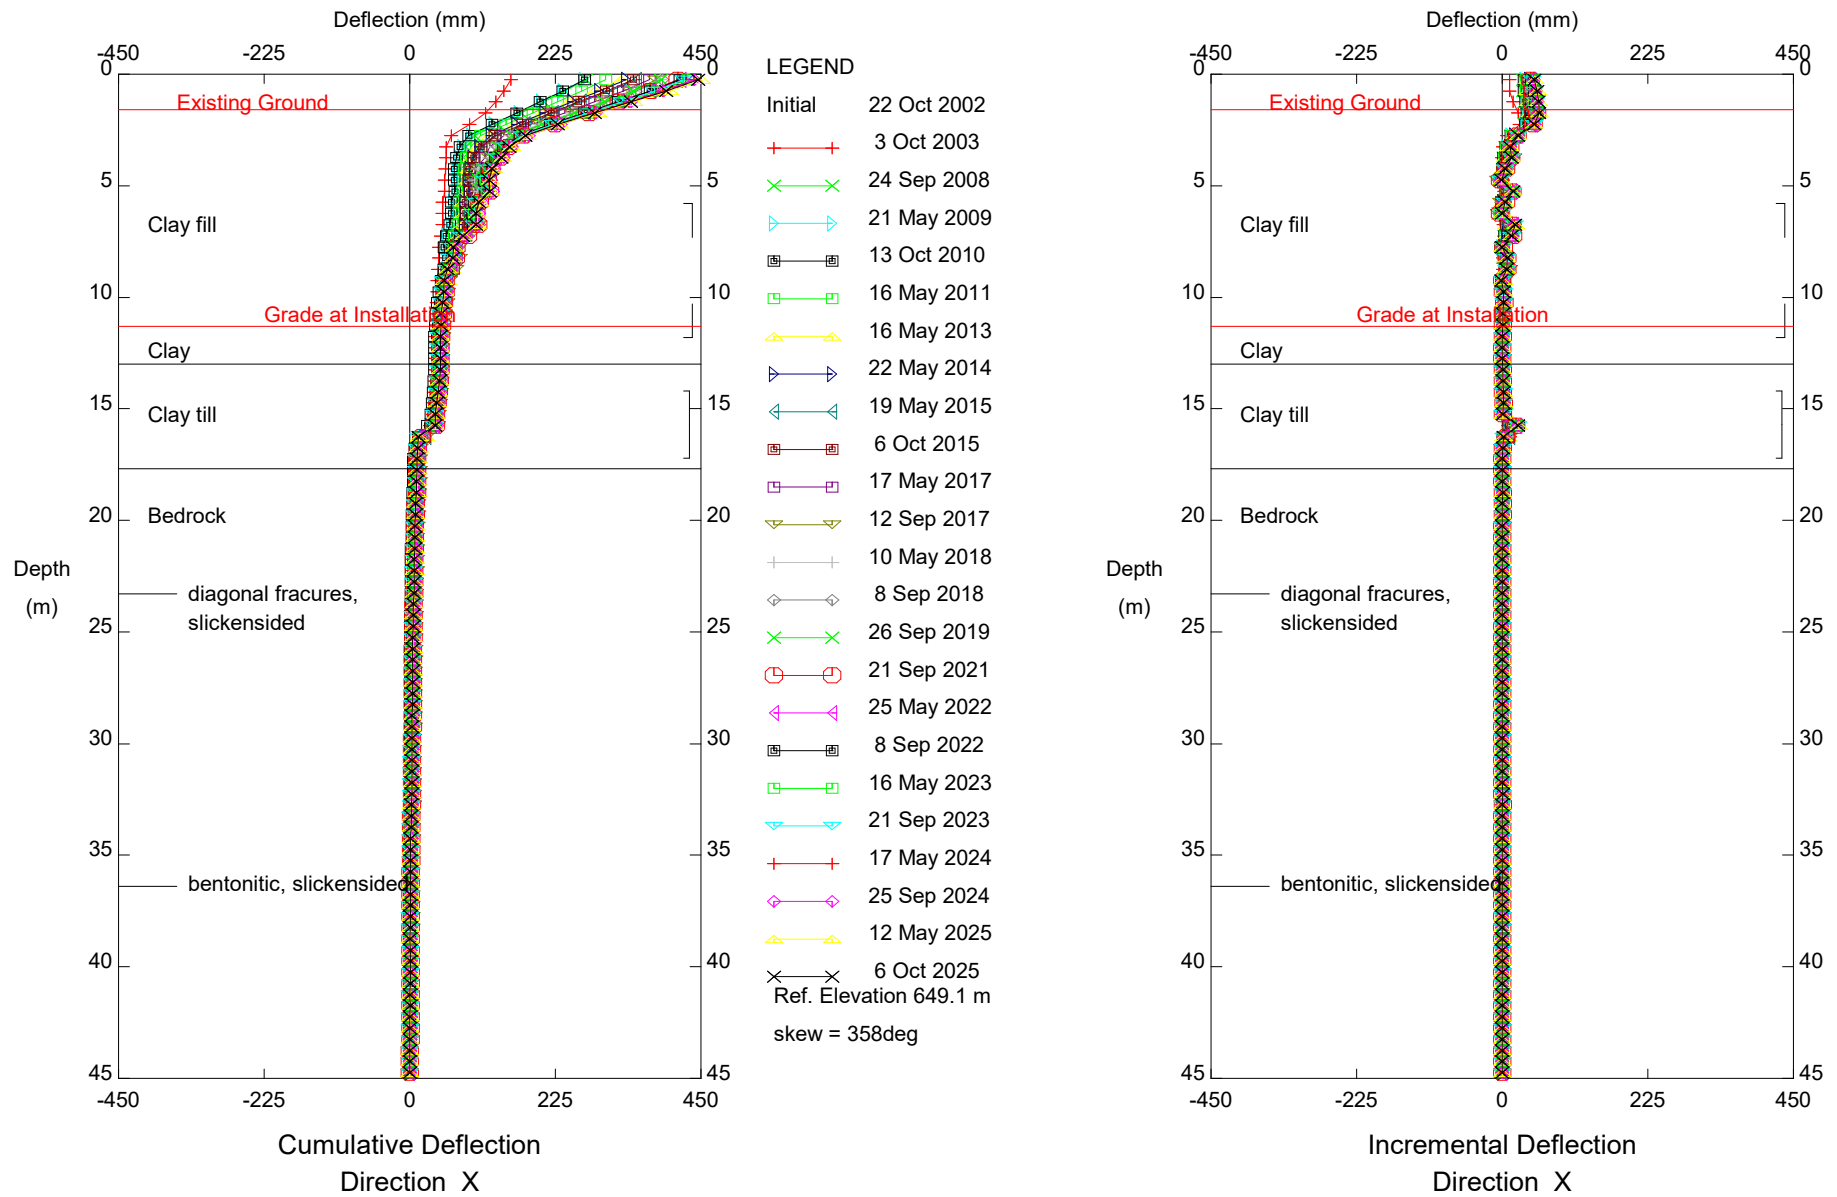
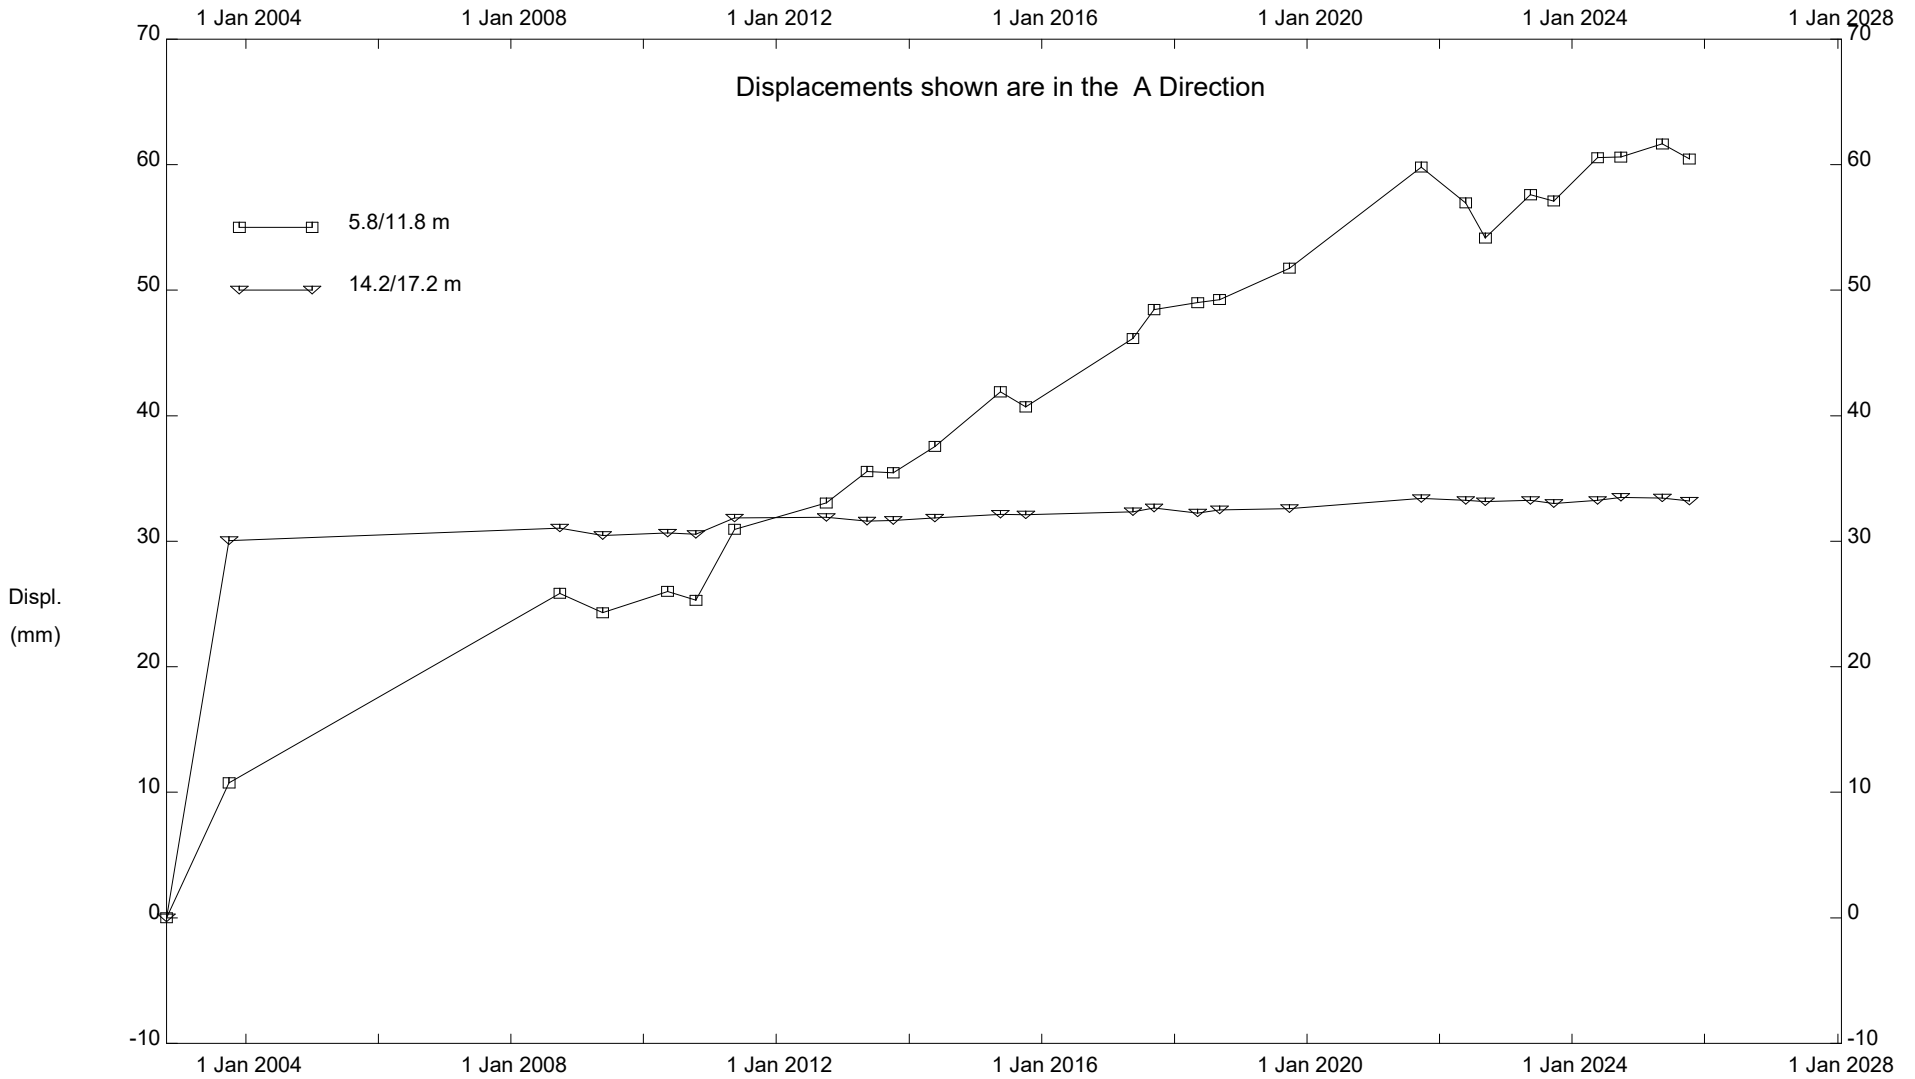
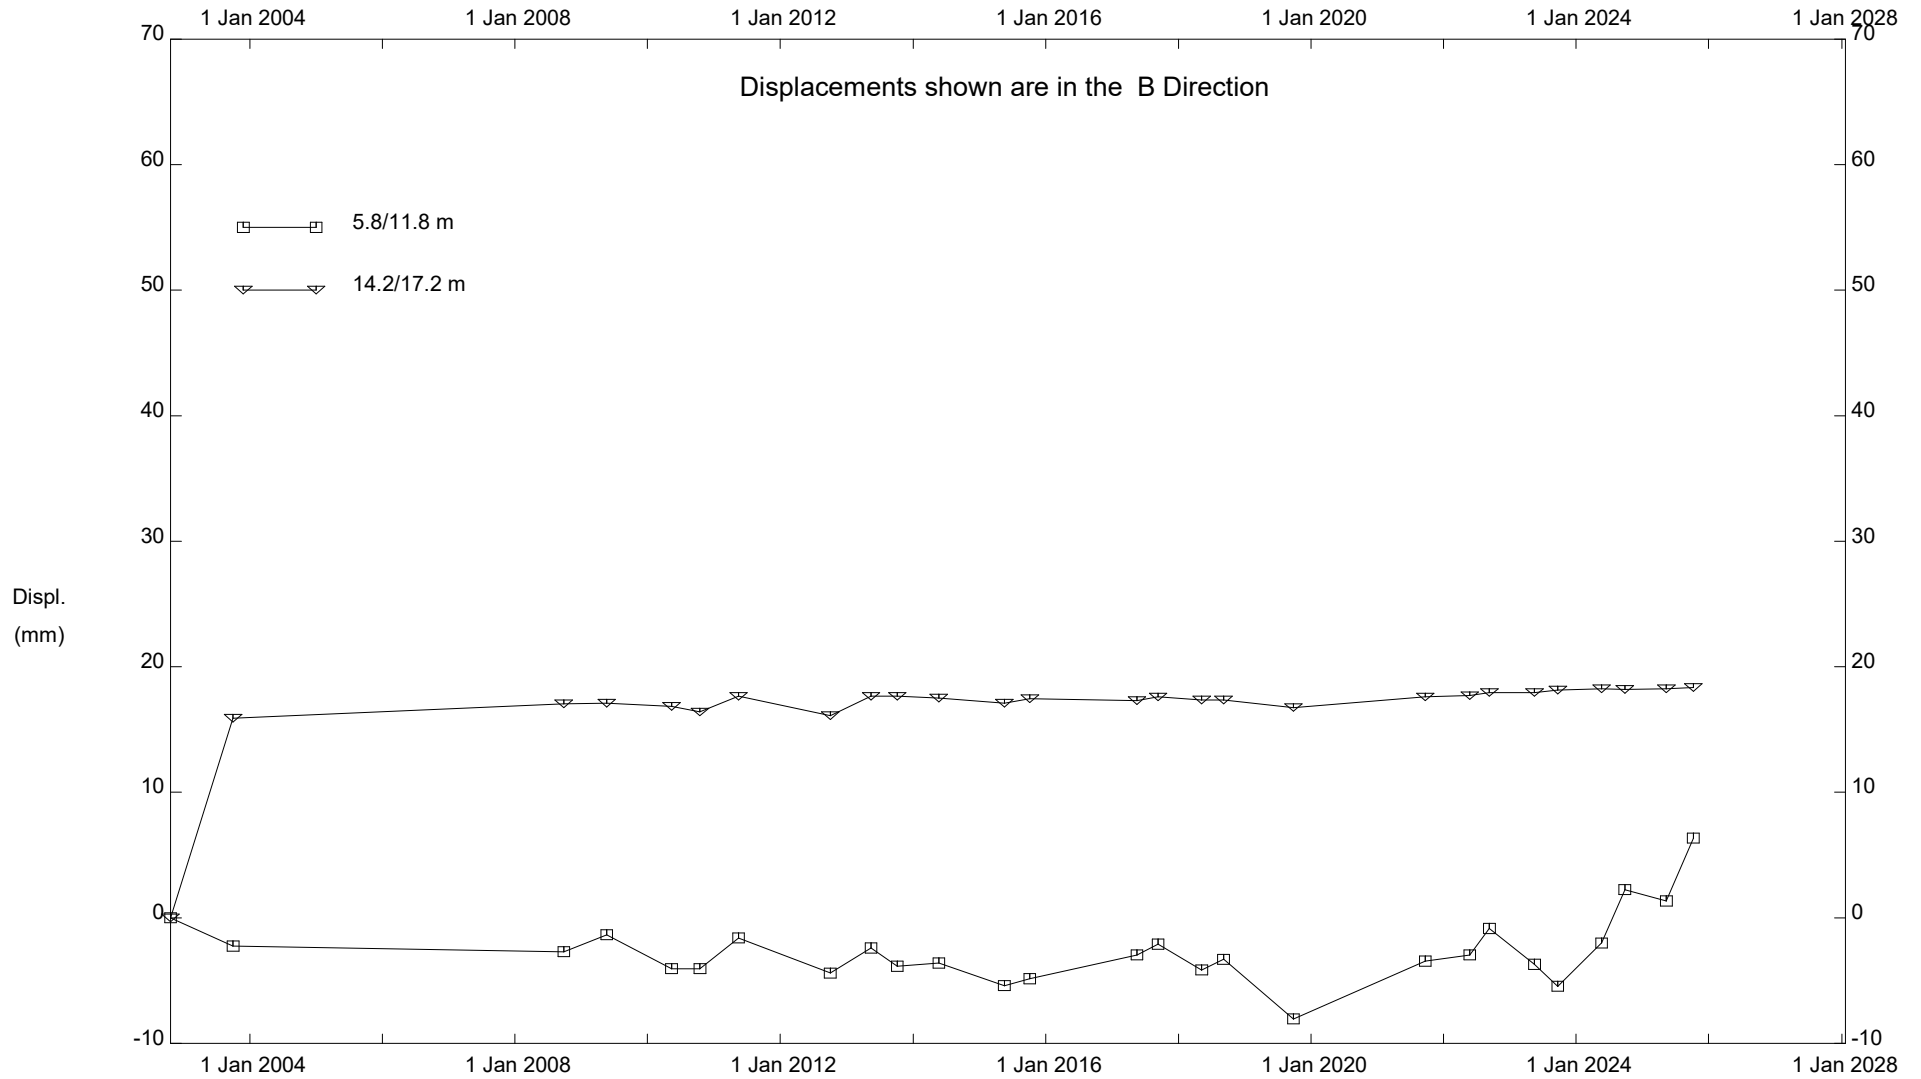
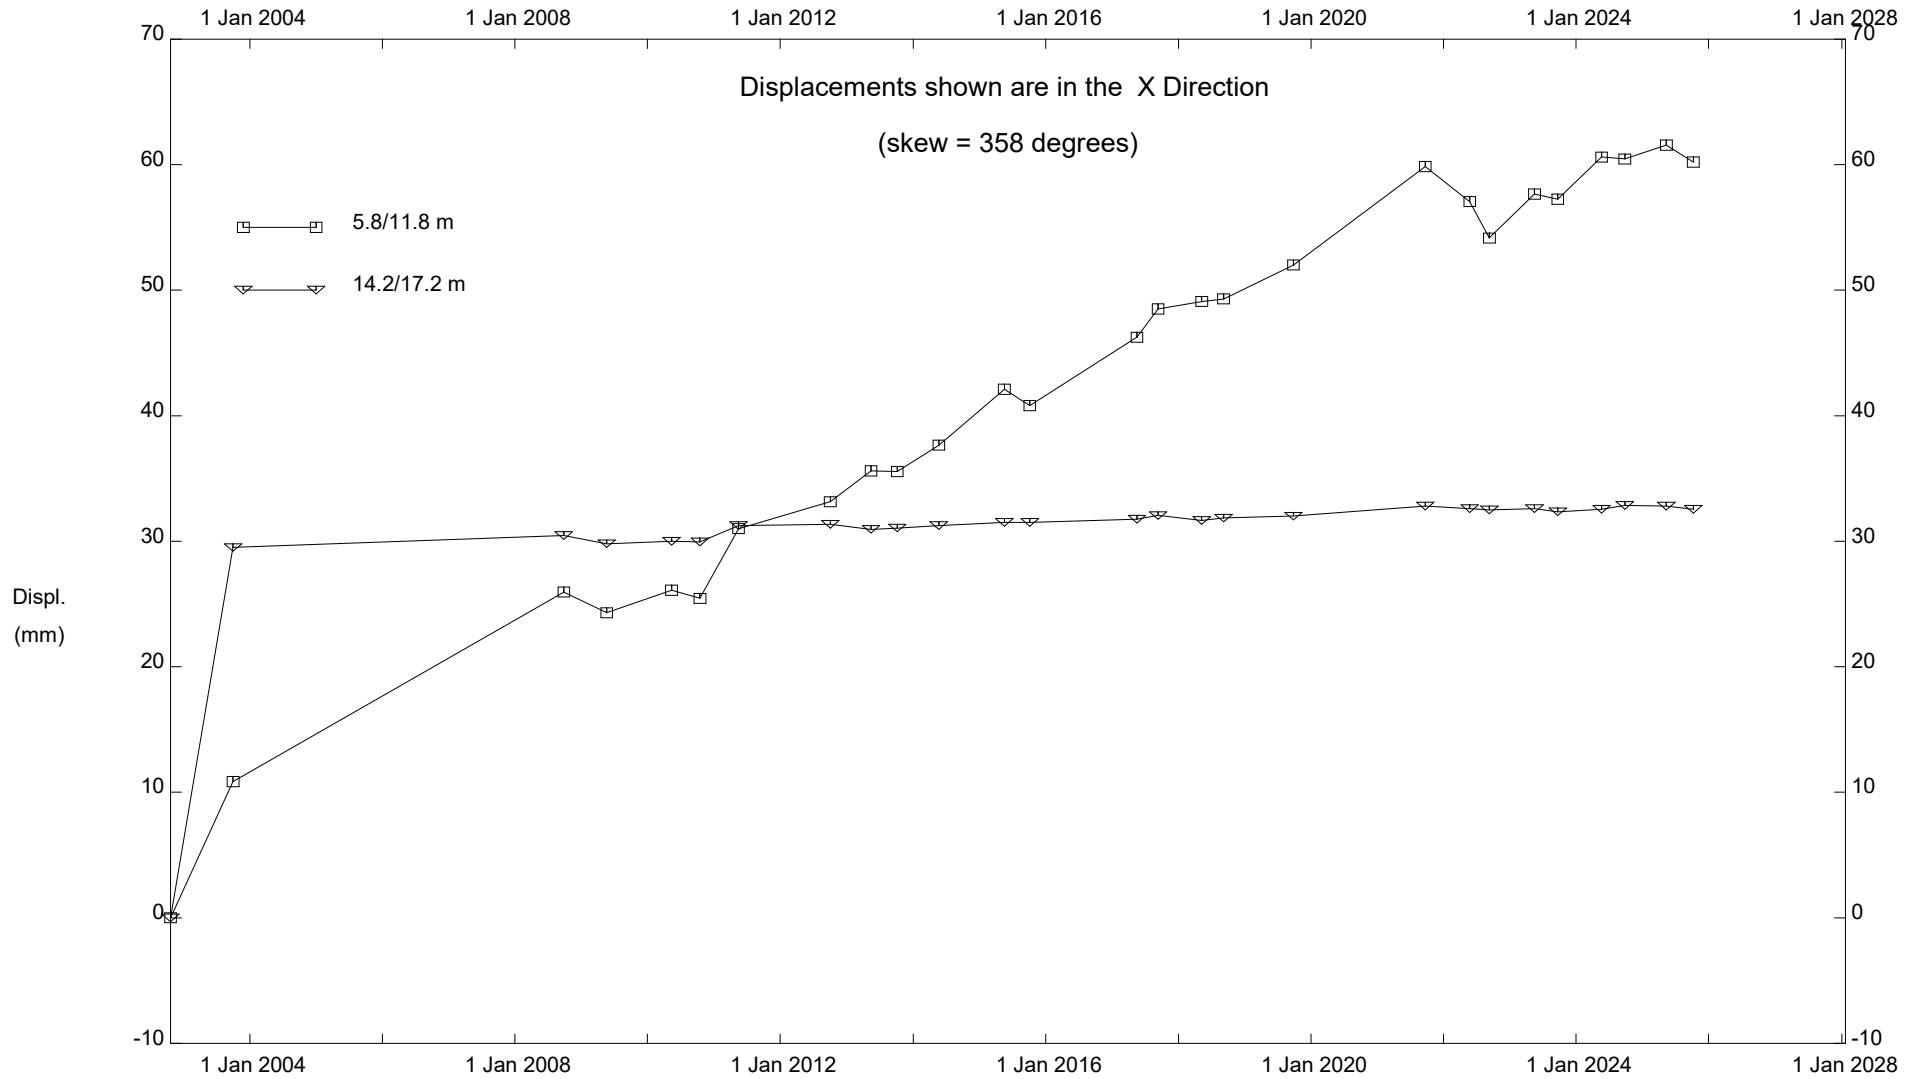
NC67, Inclinometer SI-08

SI-08 has two zones of movement observed at around 8 m and 16 m depth. The average rate of movement in the upper zone was about 3 mm/yr since 2003. Total cumulative movement appears to be erratically moving around 58 mm since Spring 2021 with its current total cumulative movement at about 60 mm. The lower movement zone appears to be creeping at a rate of less than 1 mm/yr since 2003.

| Instrument Name | Date Initialized | Coordinates <sup>(1)</sup><br>(UTM 12U,<br>NAD1983)<br>(m) | | Total Cumulative Resultant Movement and Depth of Movement to Date (mm) | Maximum Rate of Movement (mm/yr) | Current Status | Date of Previous Reading | Incremental Movement Since Previous Reading (mm) | Current Rate of Movement (mm/yr) | Change in Rate of Movement Since Previous Reading (mm/yr) <sup>(2)</sup> |
|---|---|---|---|---|---|---|---|---|---|---|
| SI-08 | Oct. 22, 2002 | 5926765 | 326270 | 60 over 5.8 m to 11.8 m depth in 358° direction. | 25 mm/yr; Sep. 2021 | Operational | May 12, 2025 | -2 | 3 | 2 |
| | | | | 33 over 14.2 m to 17.2 m depth in 358° direction. | 36 mm/yr; Oct. 2003 | | | -<1 | <1 | -<1 |
