| To: | Amy Driessen | From: | Leslie Cho and Lawrence Onwude |
| File: | 123315222 | Date: | October 31, 2025 |

**Reference: North Central Region, Stony Plain, Site NC067 - Highway 216:06 Anthony Henday Bridge, Fall 2025 Instrumentation Monitoring Report**

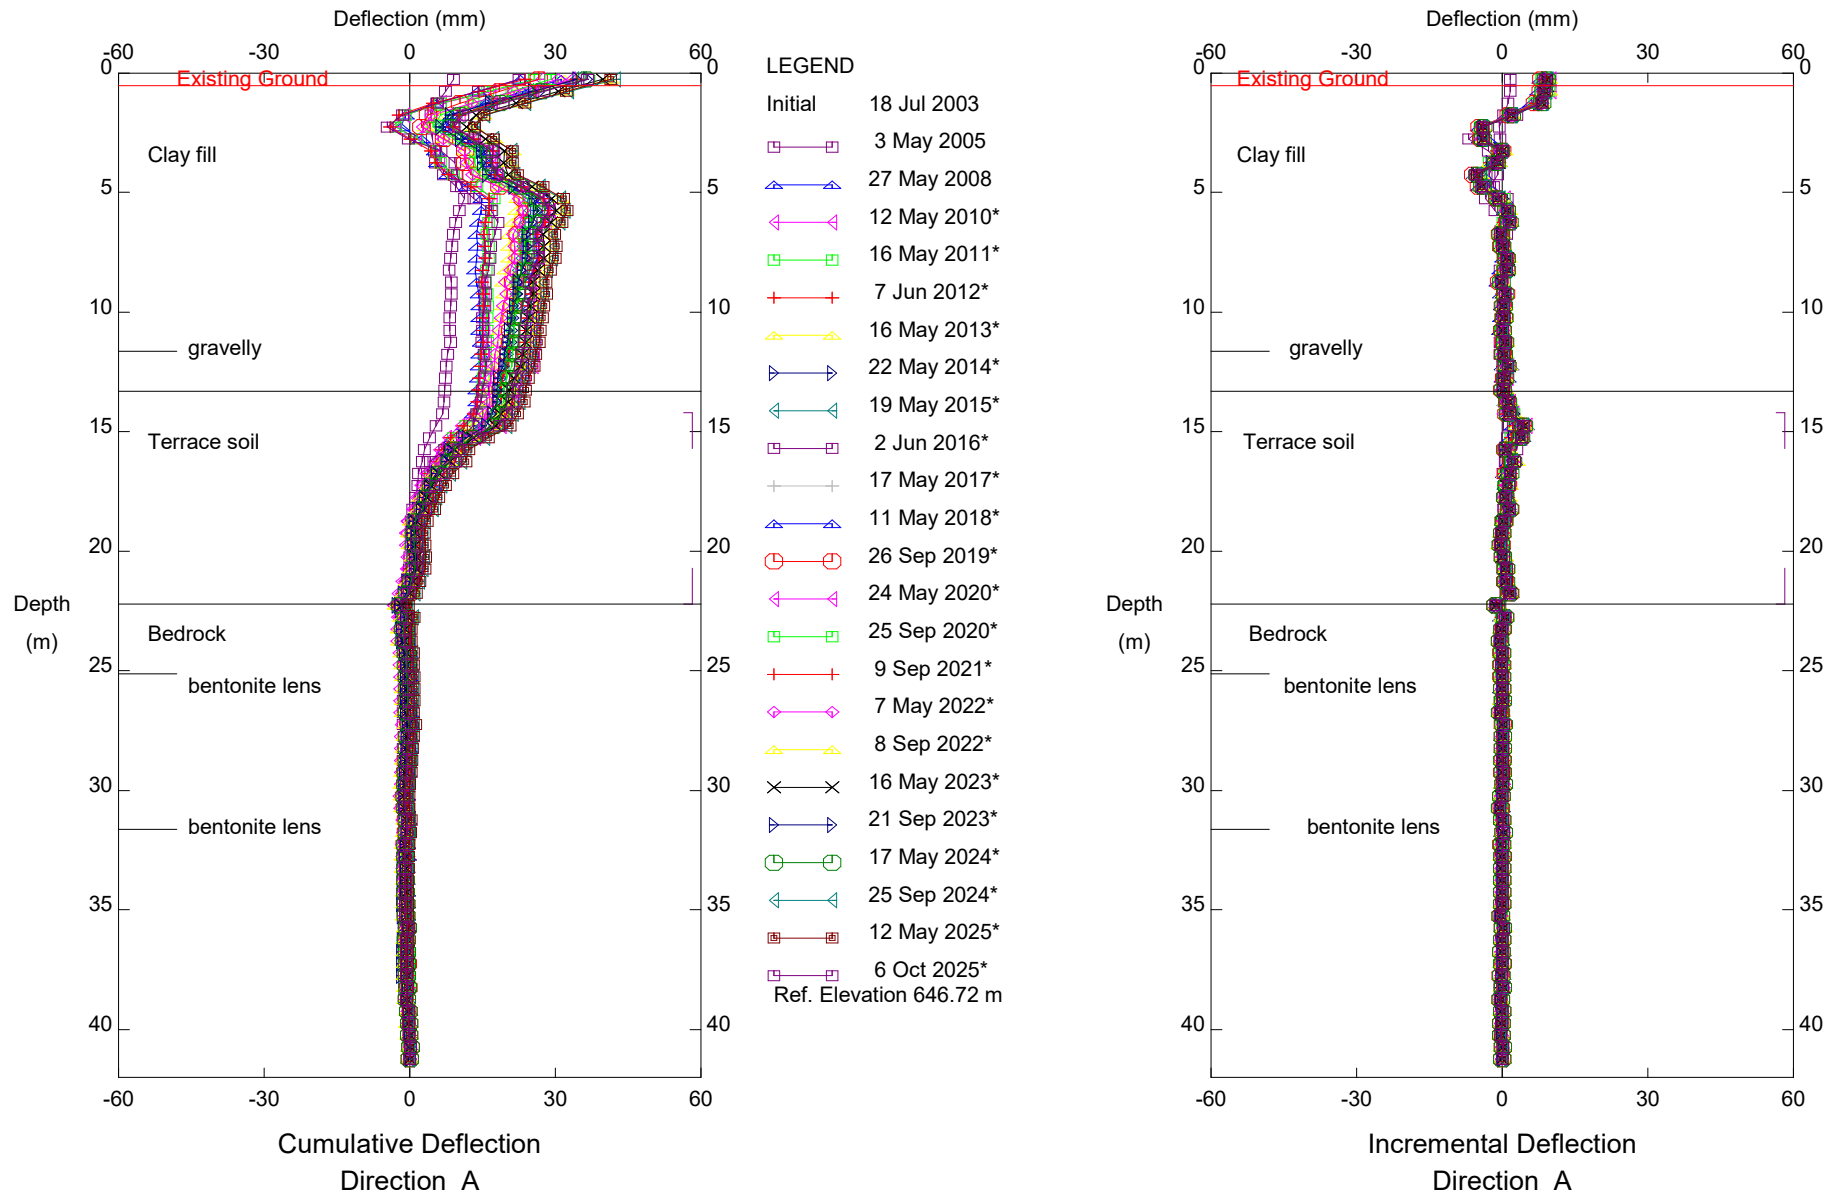
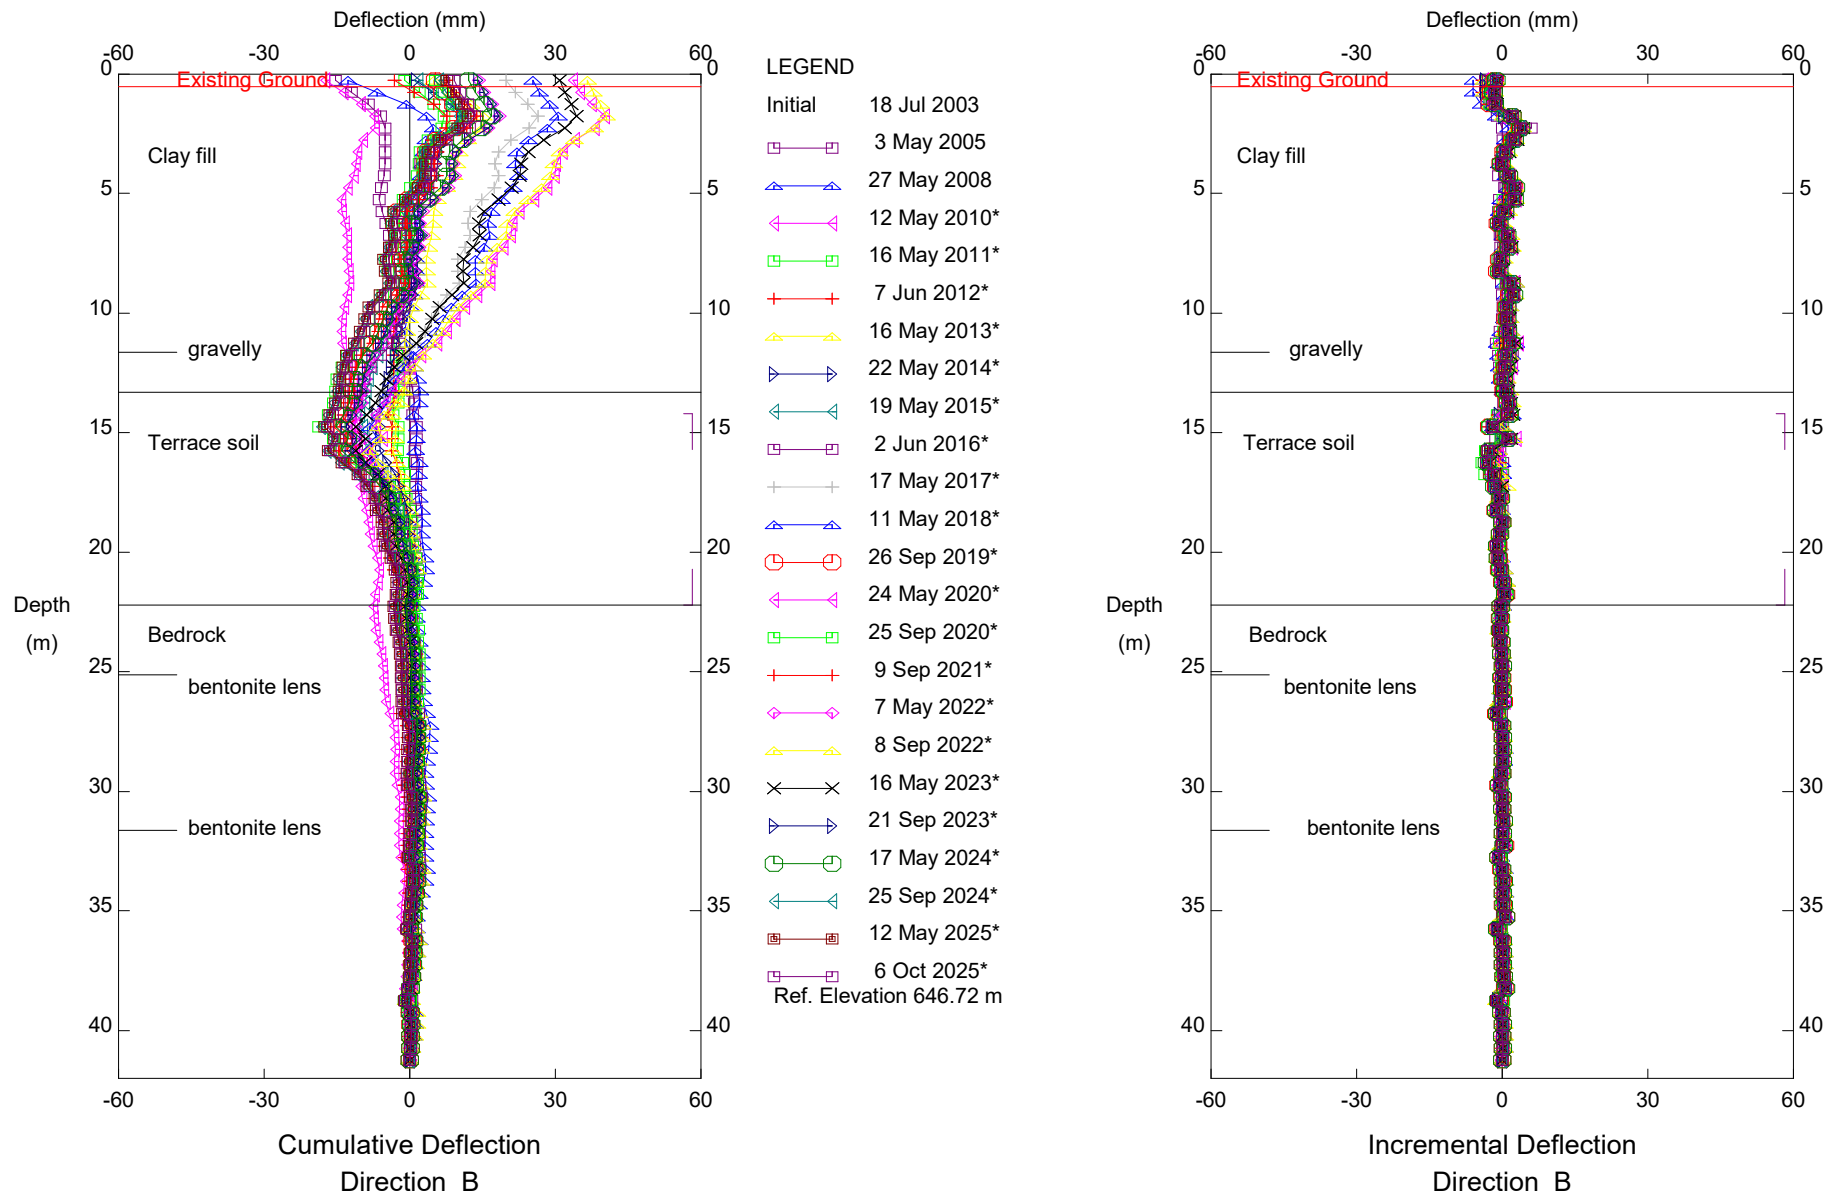
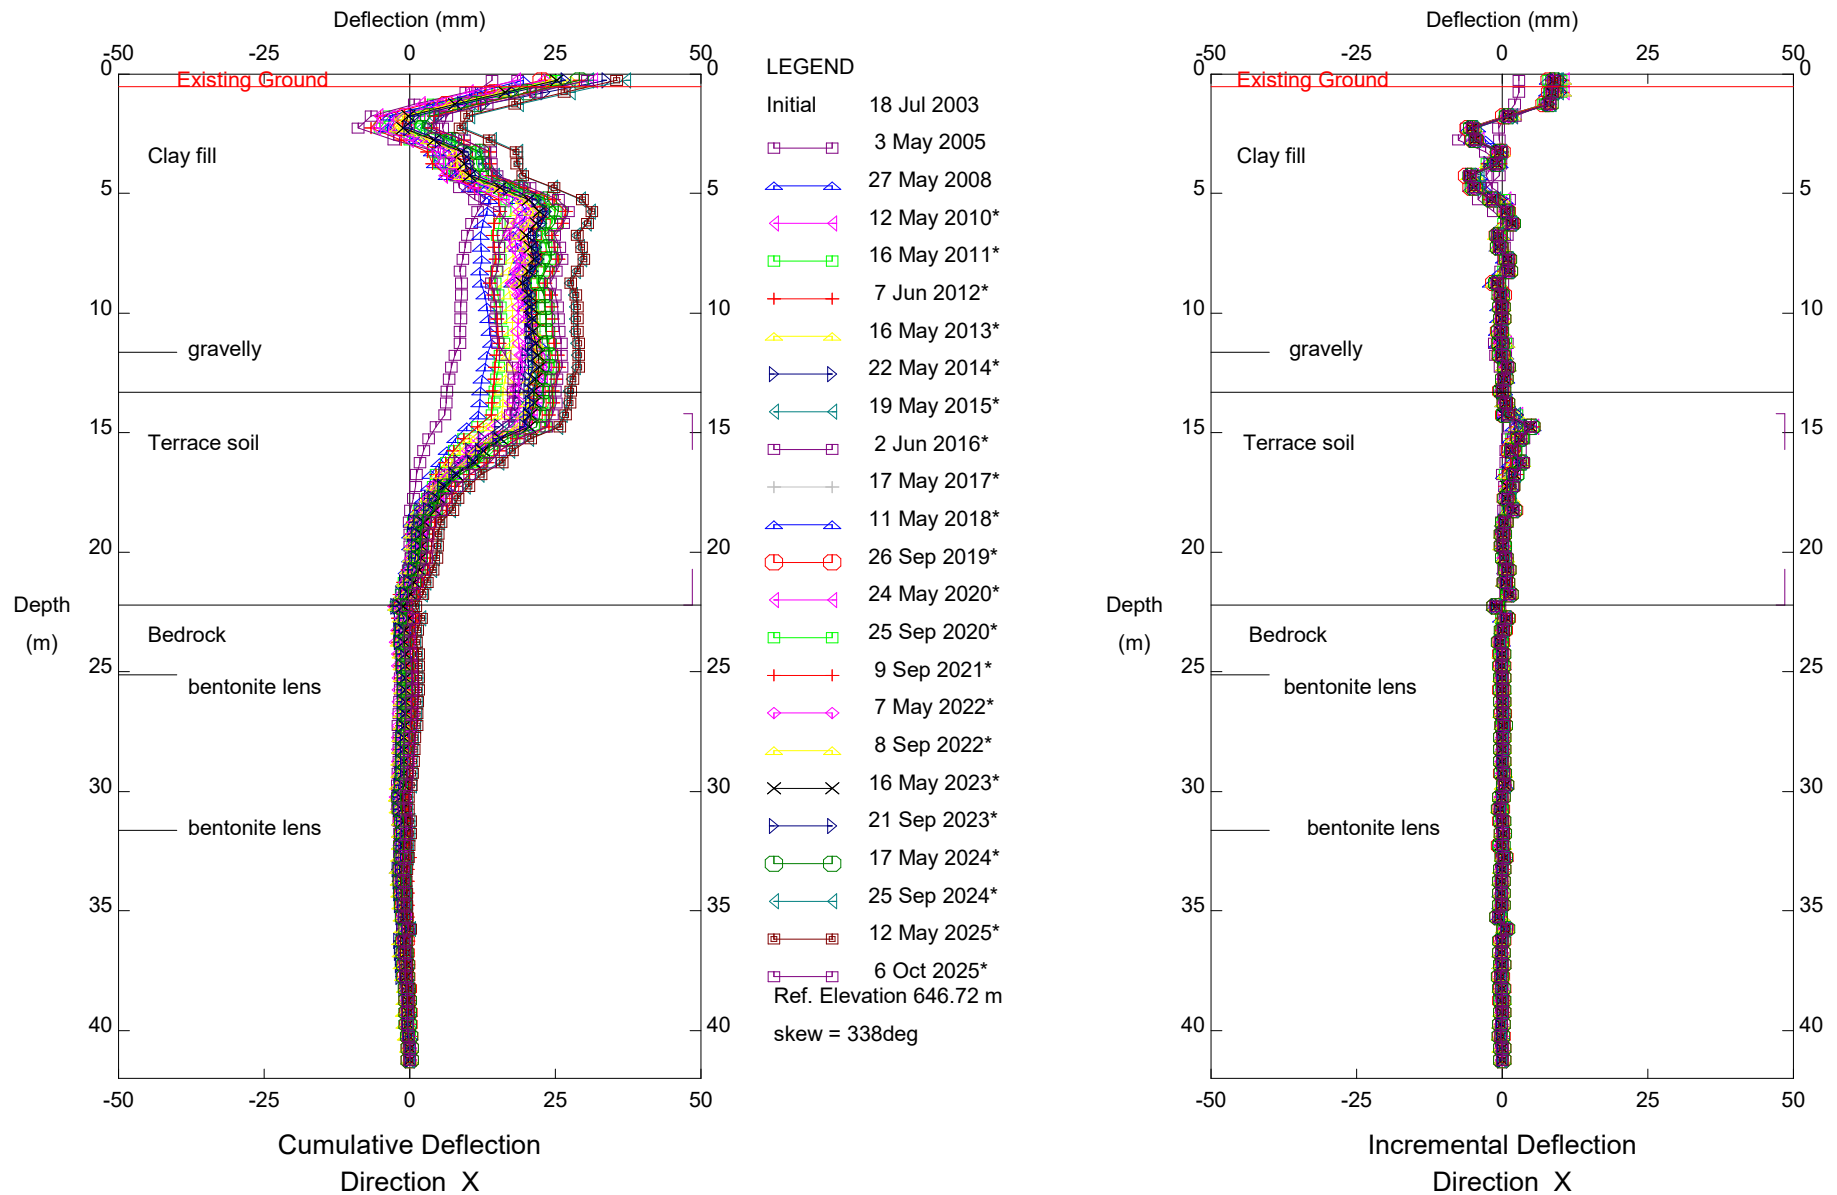
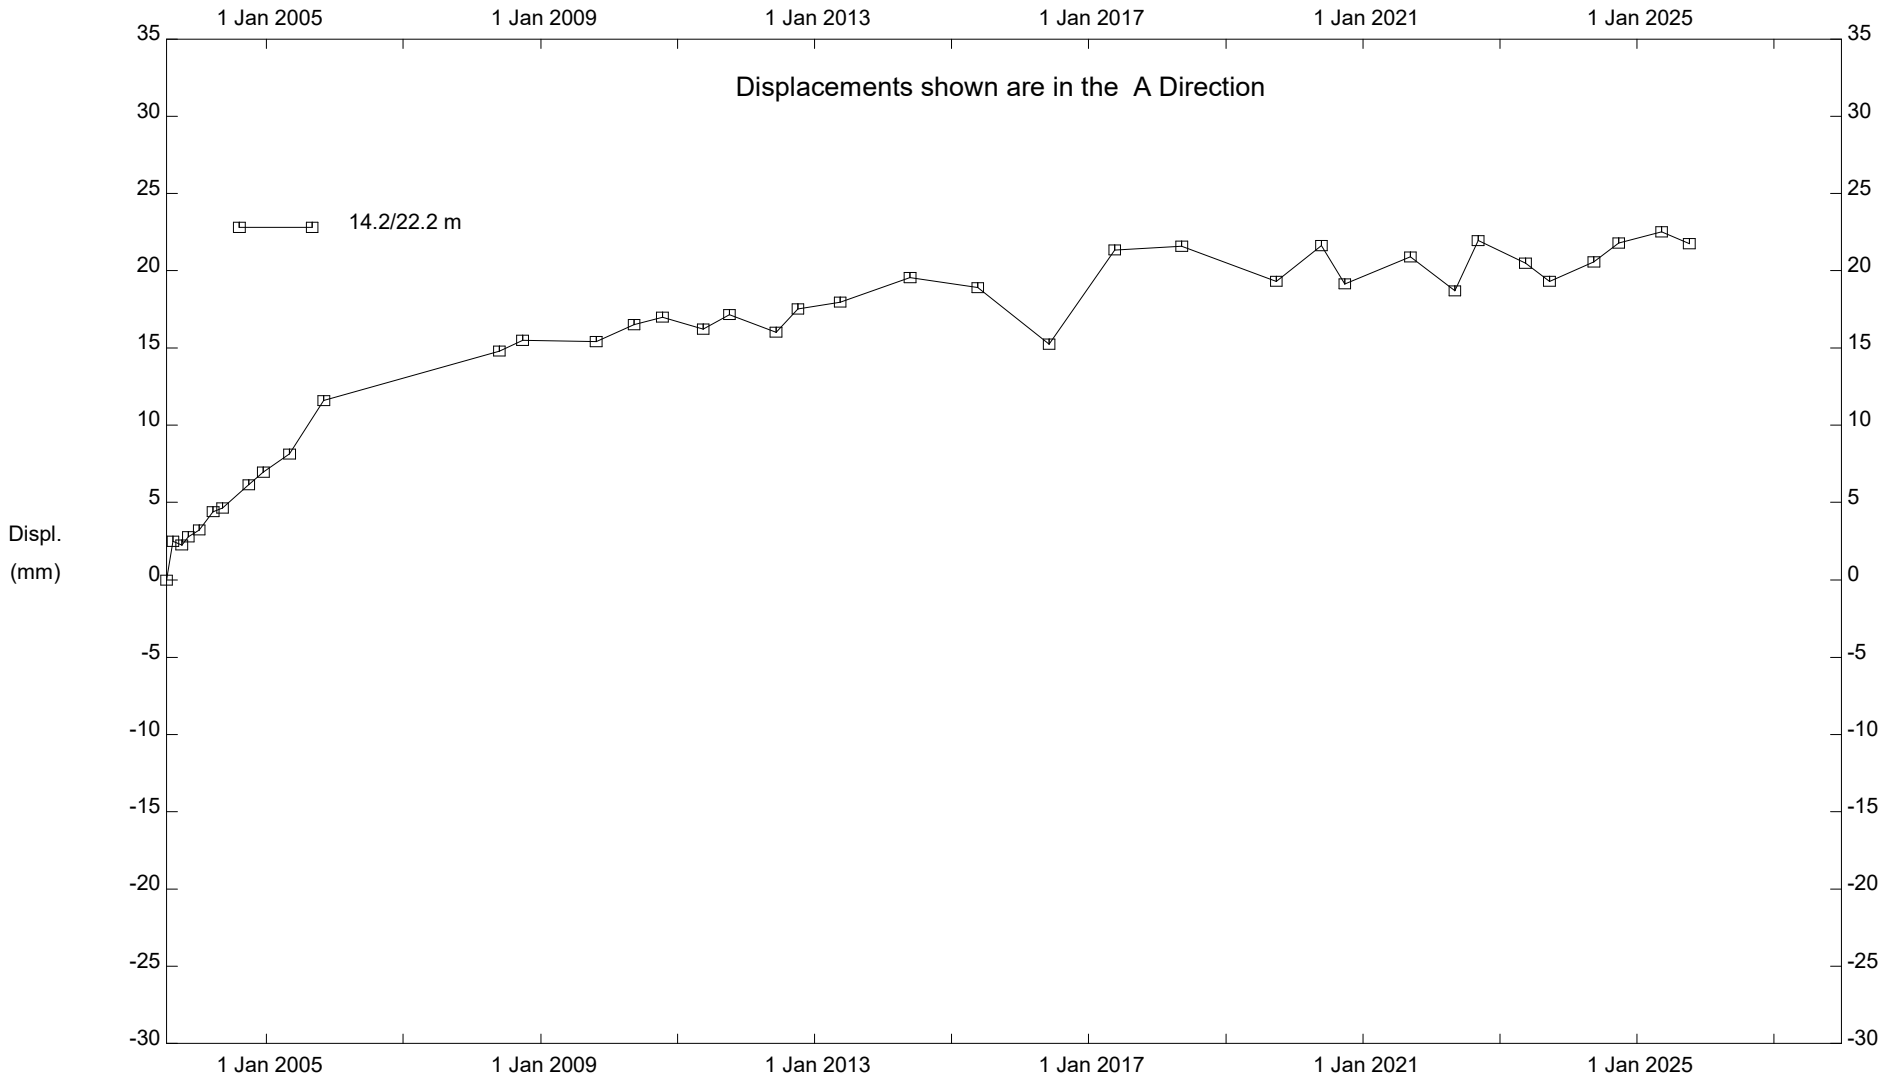
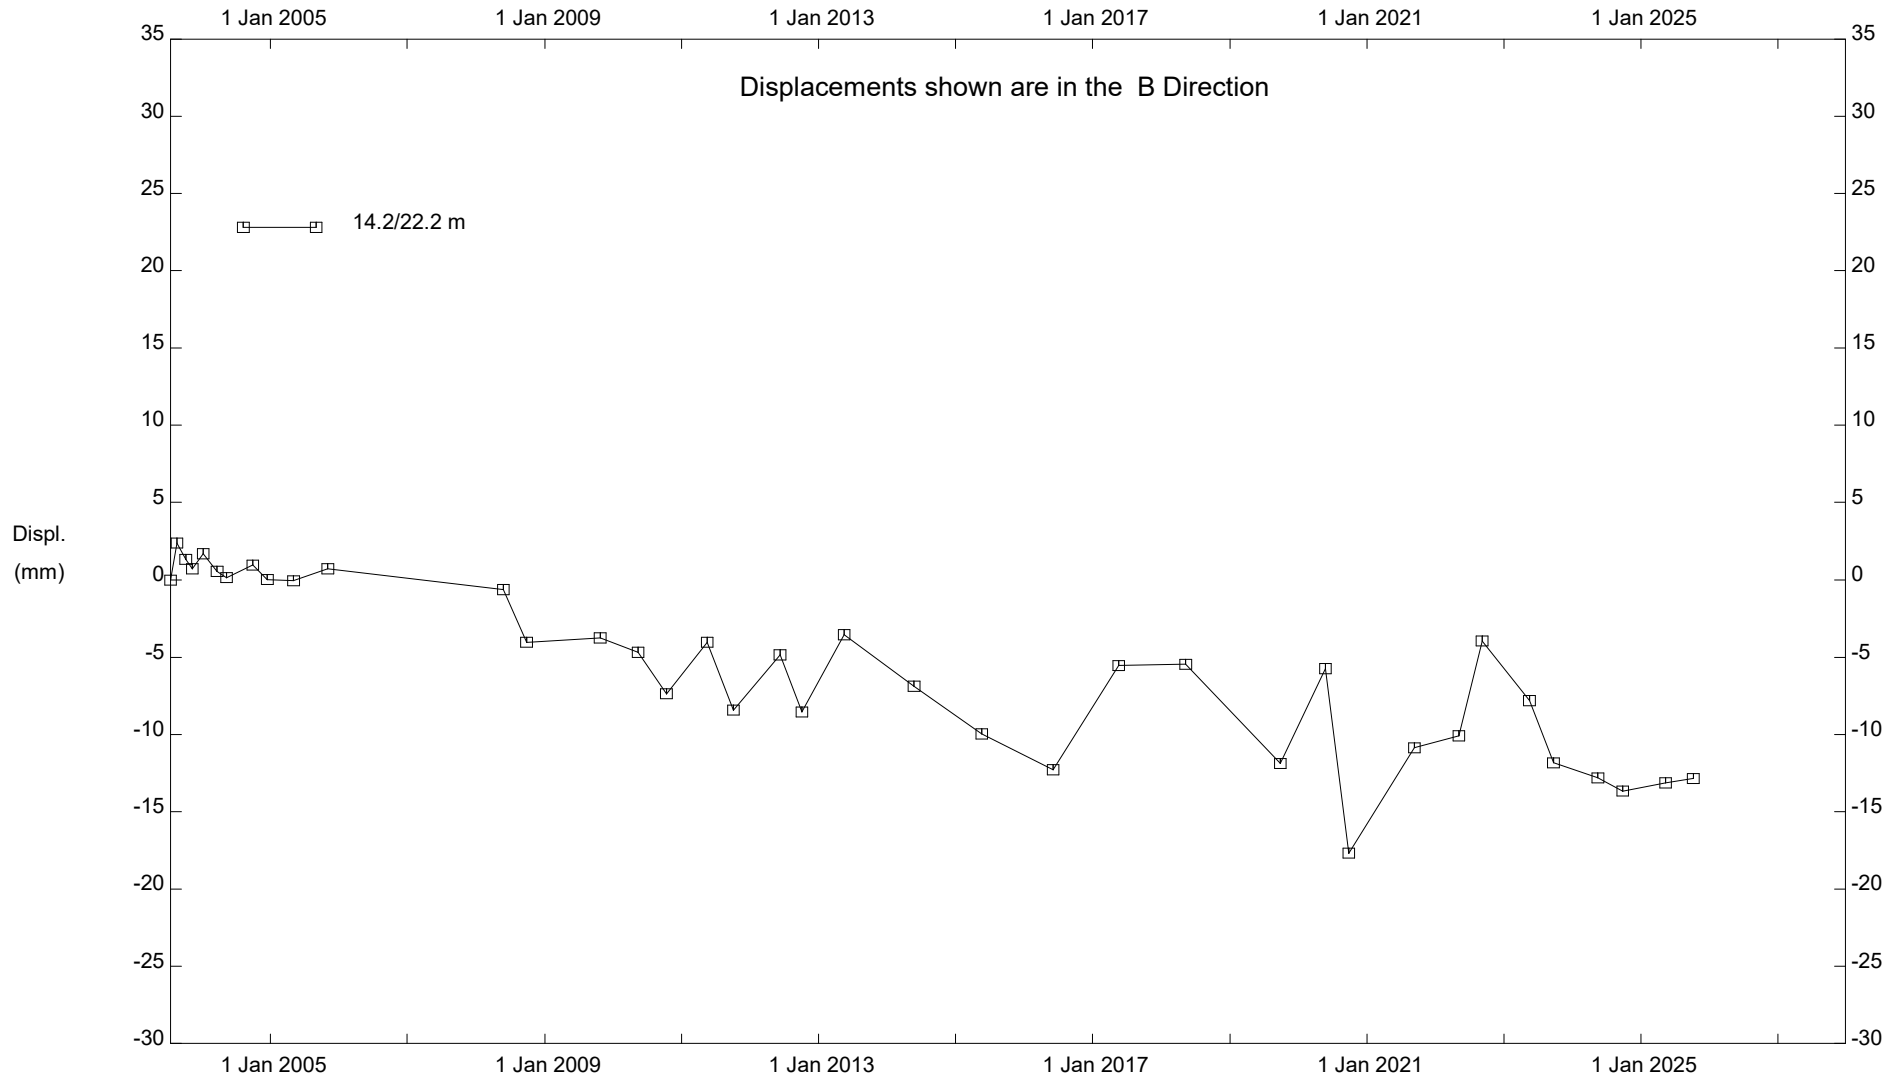
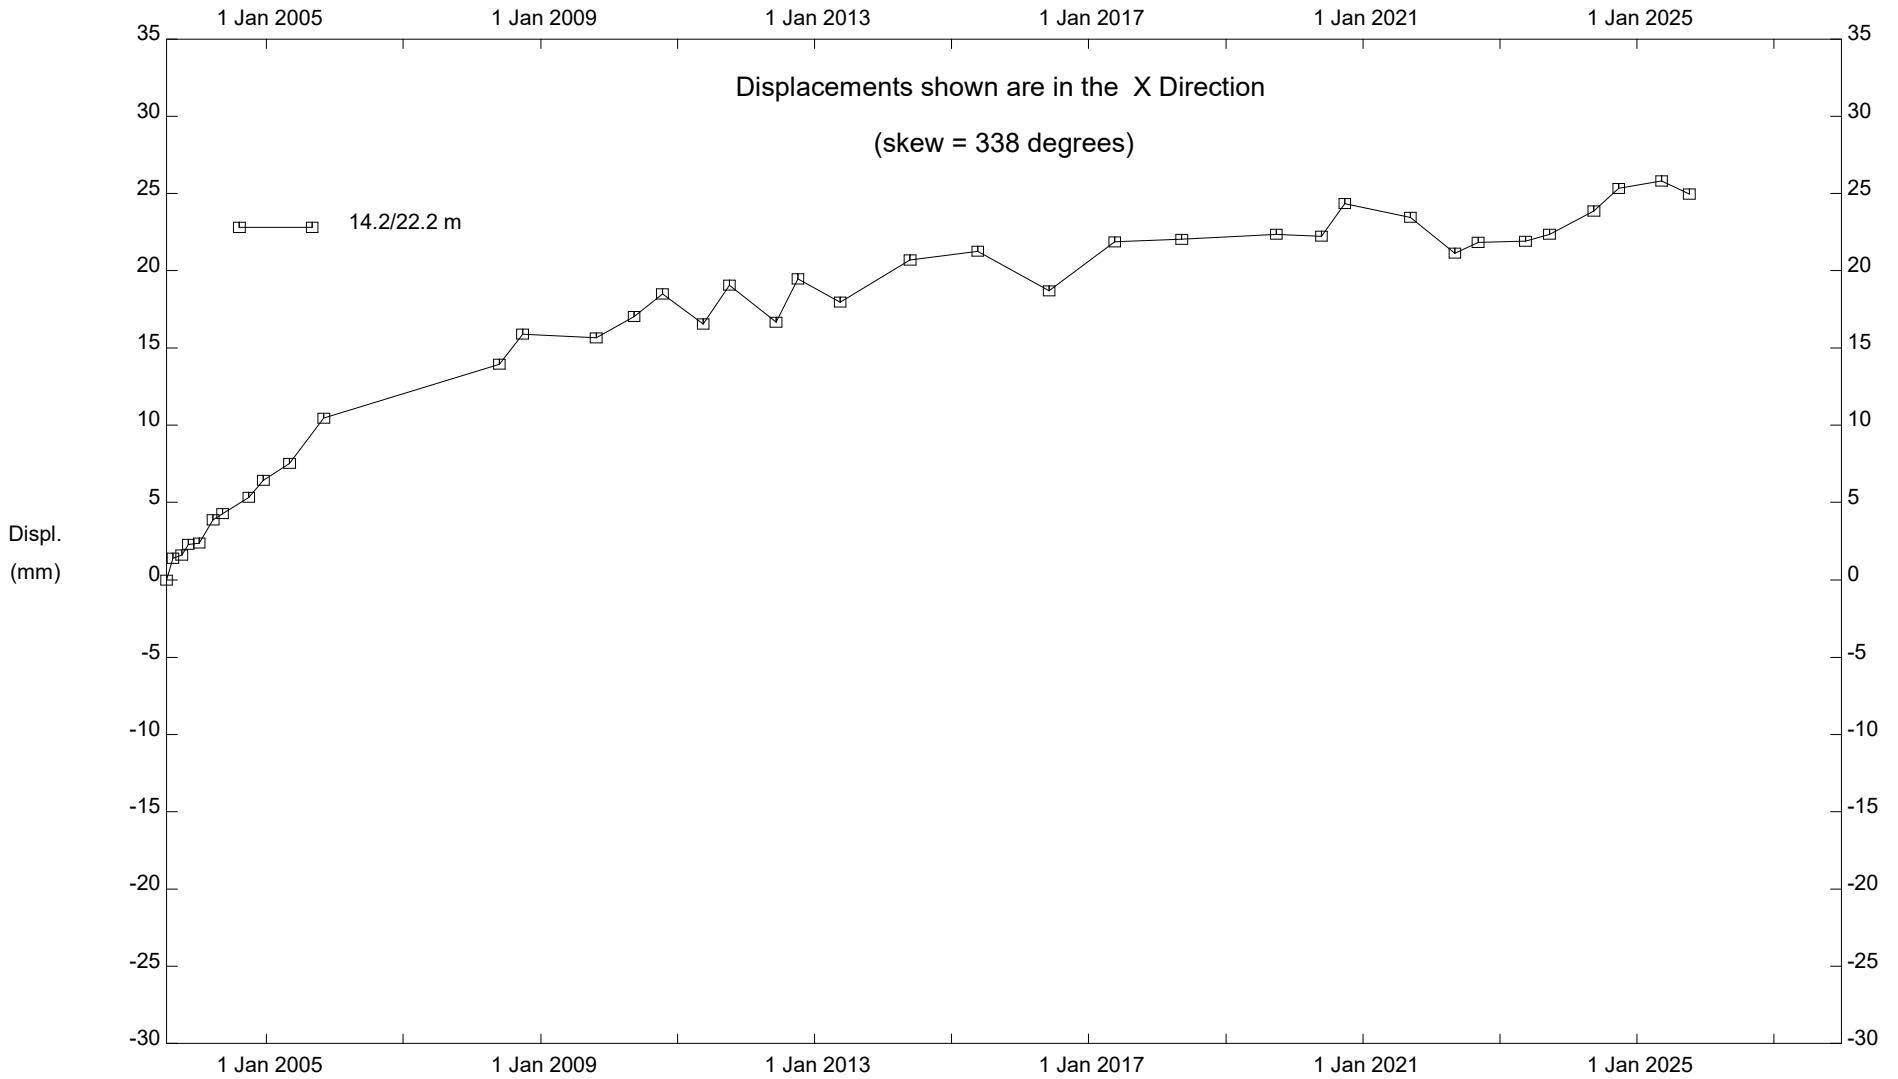
NC67, Inclinometer SI-10

SI-10 shows a current rate of movement of about 2 mm/yr along with a decrease of 1 mm in incremental movement during the current monitoring cycle. The average rate of movement since 2006 is about 1 mm/yr. The total cumulative movement is approximately 25 mm.

| Instrument Name | Date Initialized | Coordinates <sup>(1)</sup><br>(UTM 12U,<br>NAD1983)<br>(m) | | Total Cumulative Resultant Movement and Depth of Movement to Date (mm) | Maximum Rate of Movement (mm/yr) | Current Status | Date of Previous Reading | Incremental Movement Since Previous Reading (mm) | Current Rate of Movement (mm/yr) | Change in Rate of Movement Since Previous Reading (mm/yr) <sup>(2)</sup> |
|---|---|---|---|---|---|---|---|---|---|---|
| SI-10 | Jul. 18, 2003 | 5927005 | 326336 | 25 over 14.2 m to 22.2 m depth in 338° direction | 42 mm/yr; Sep. 2016 | Operational | May 12, 2025 | -1 | 2 | 1 |
