| To: | Amy Driessen | From: | Leslie Cho and Lawrence Onwude |
| File: | 123315222 | Date: | October 31, 2025 |

**Reference: North Central Region, Stony Plain, Site NC067 - Highway 216:06 Anthony Henday Bridge, Fall 2025 Instrumentation Monitoring Report**

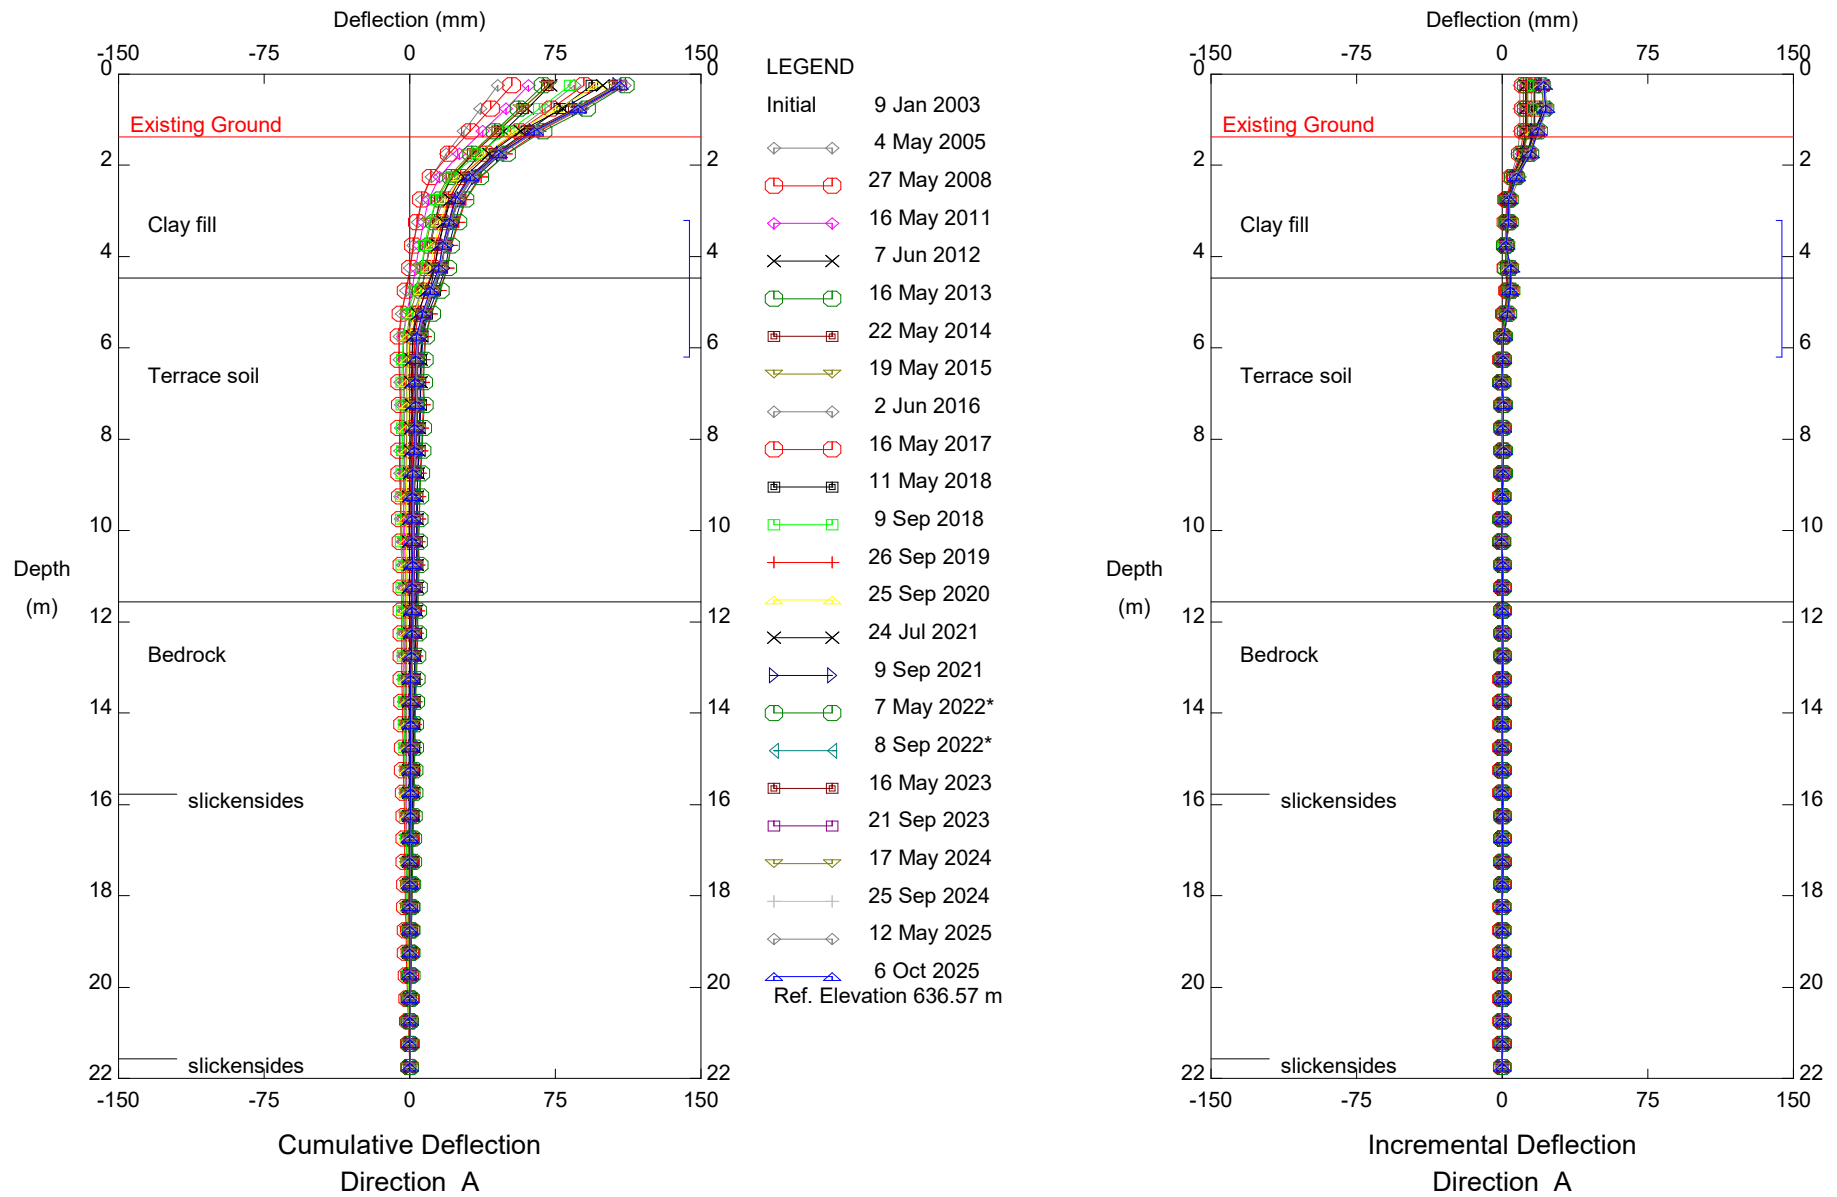
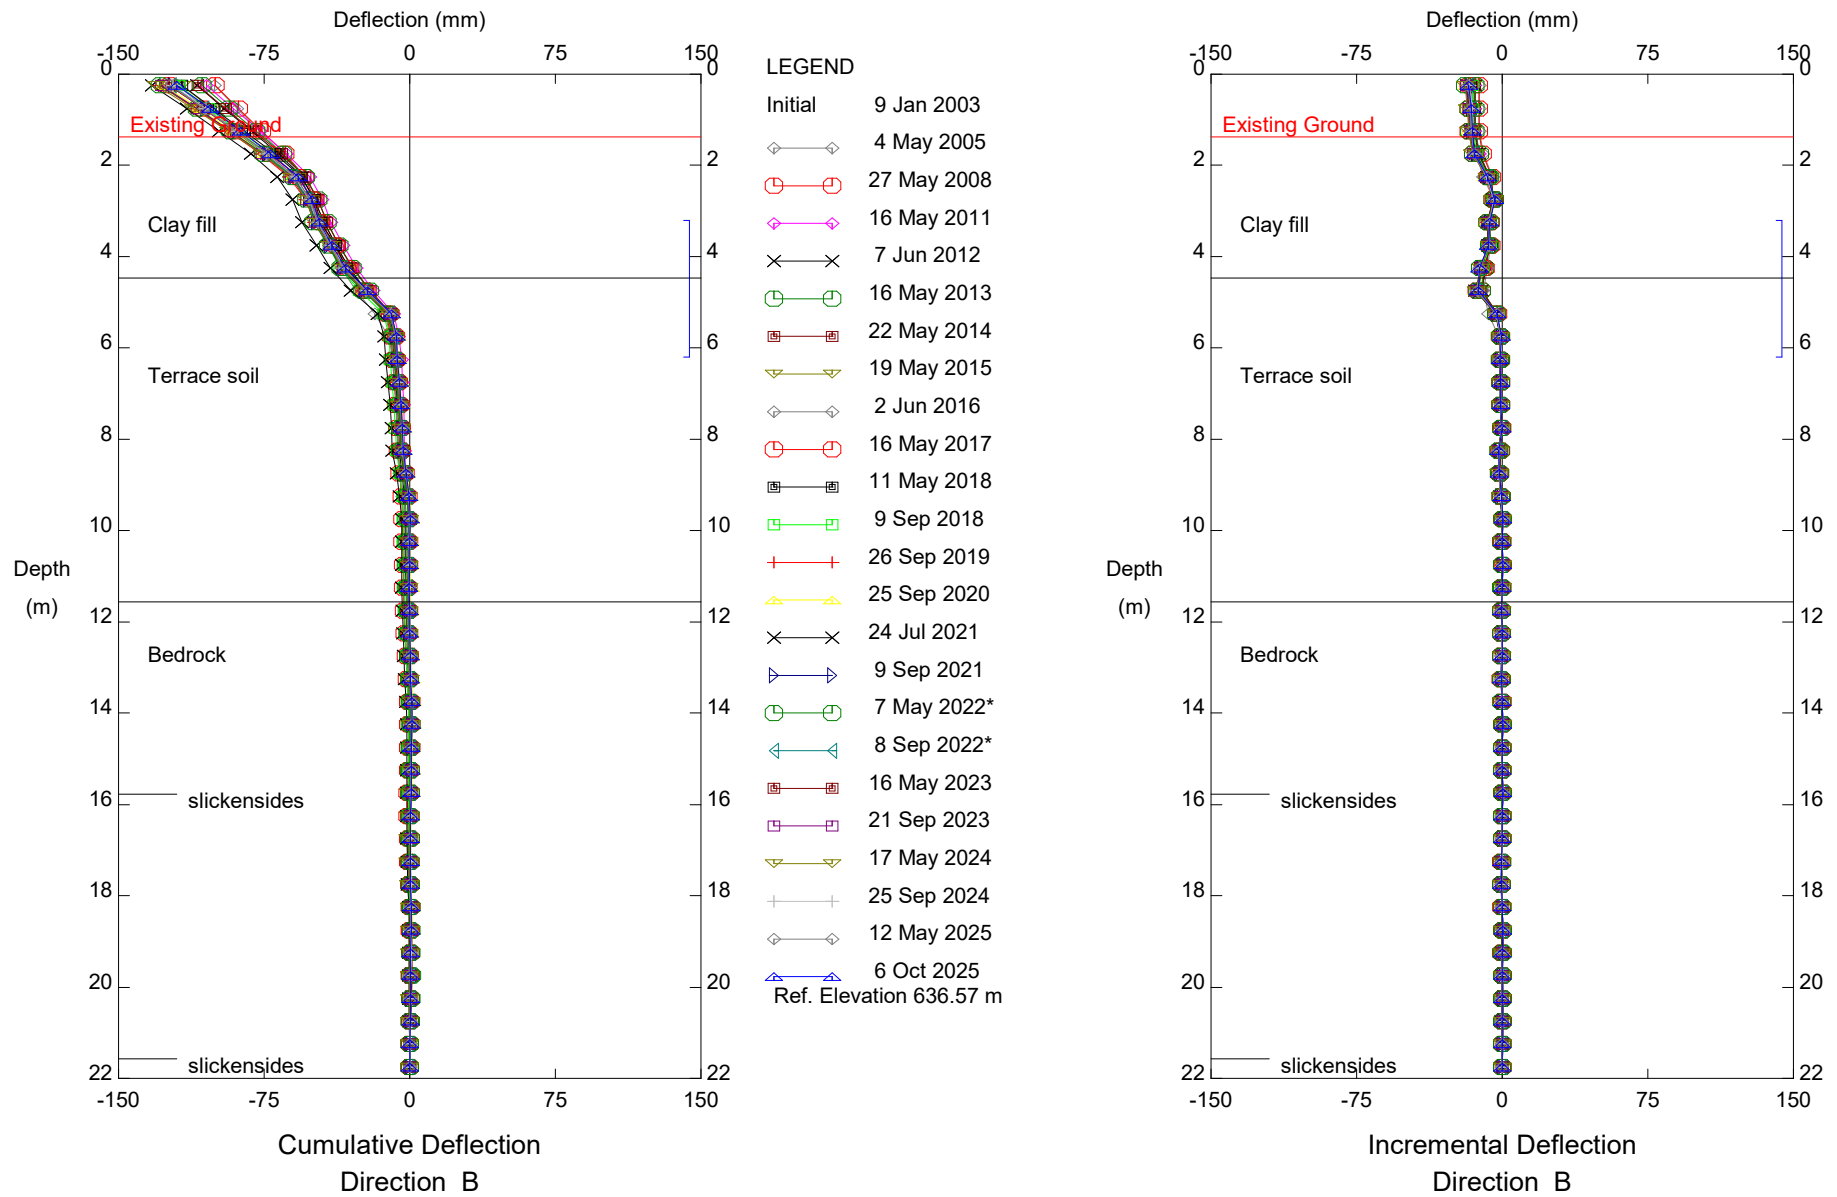
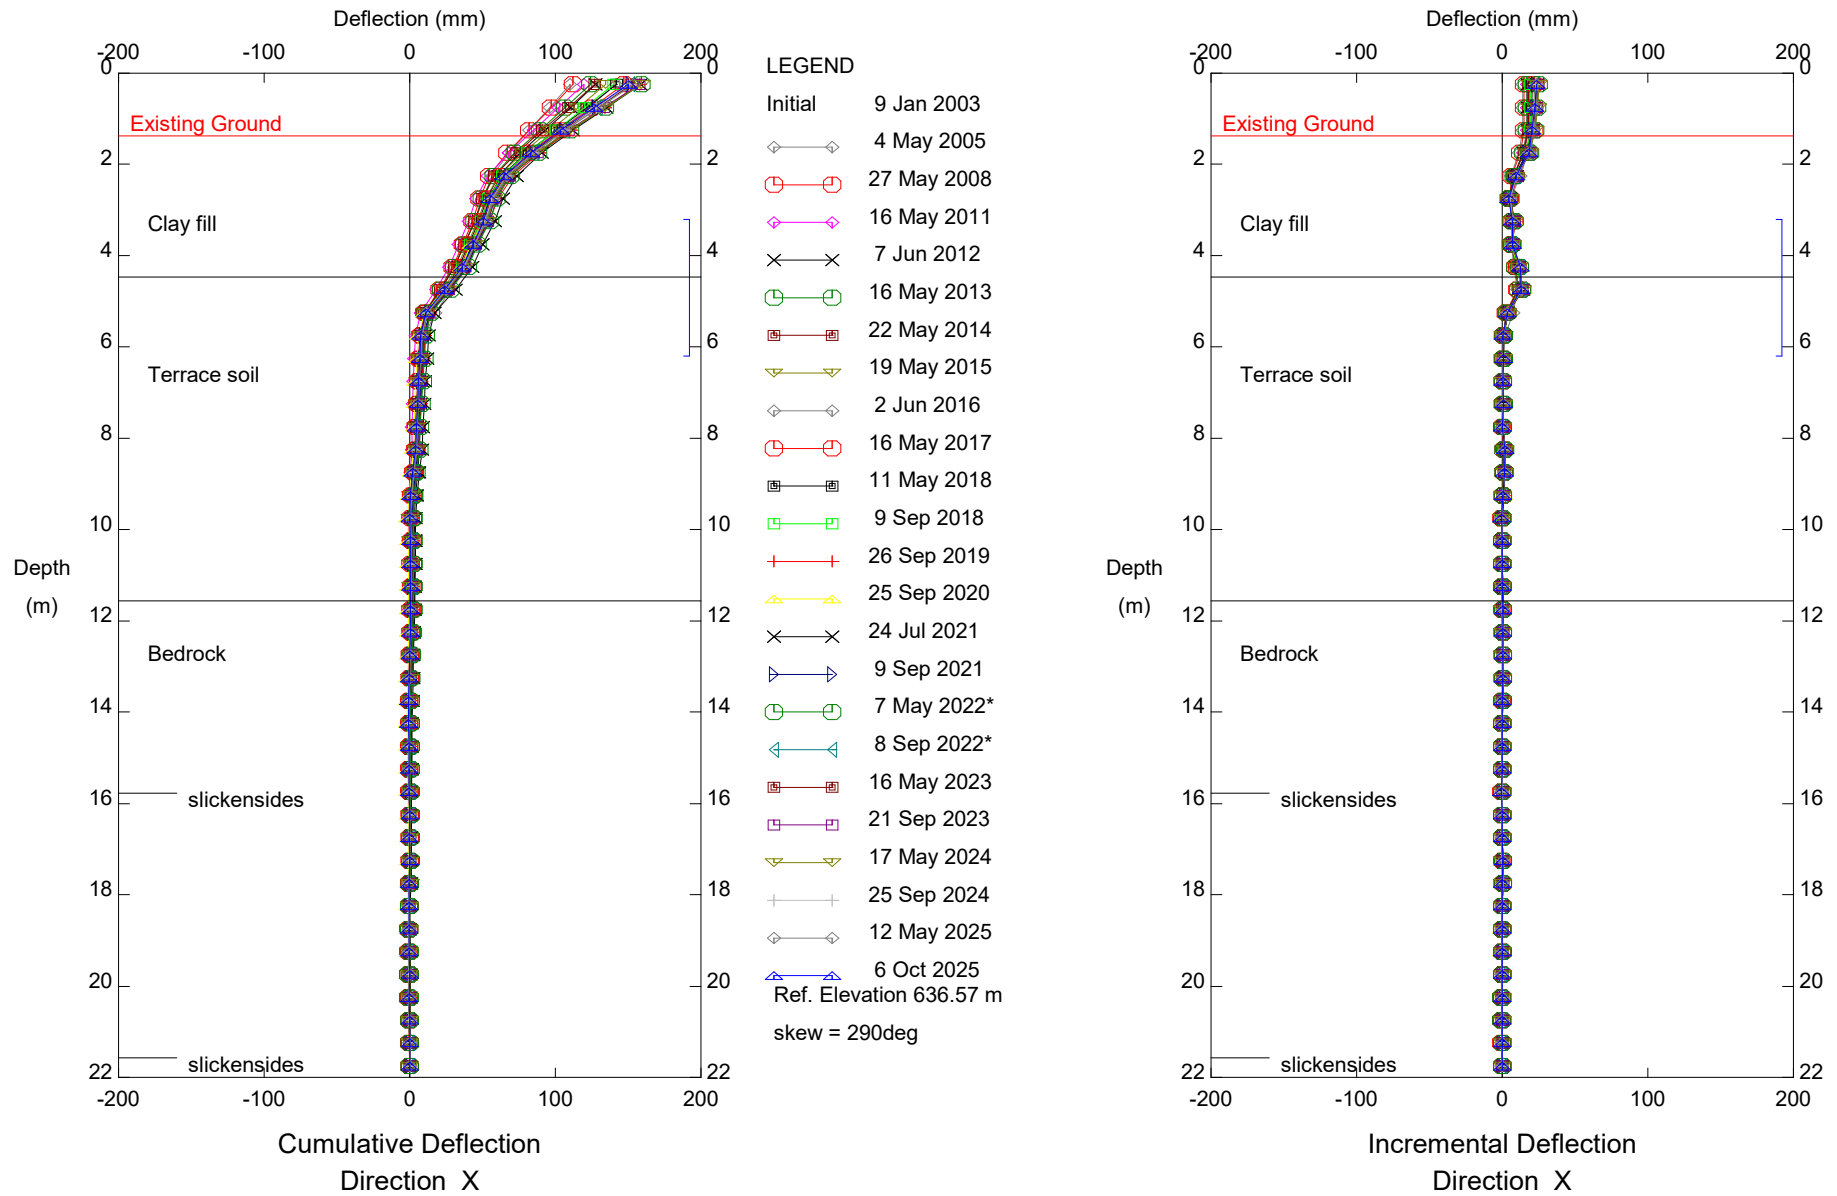
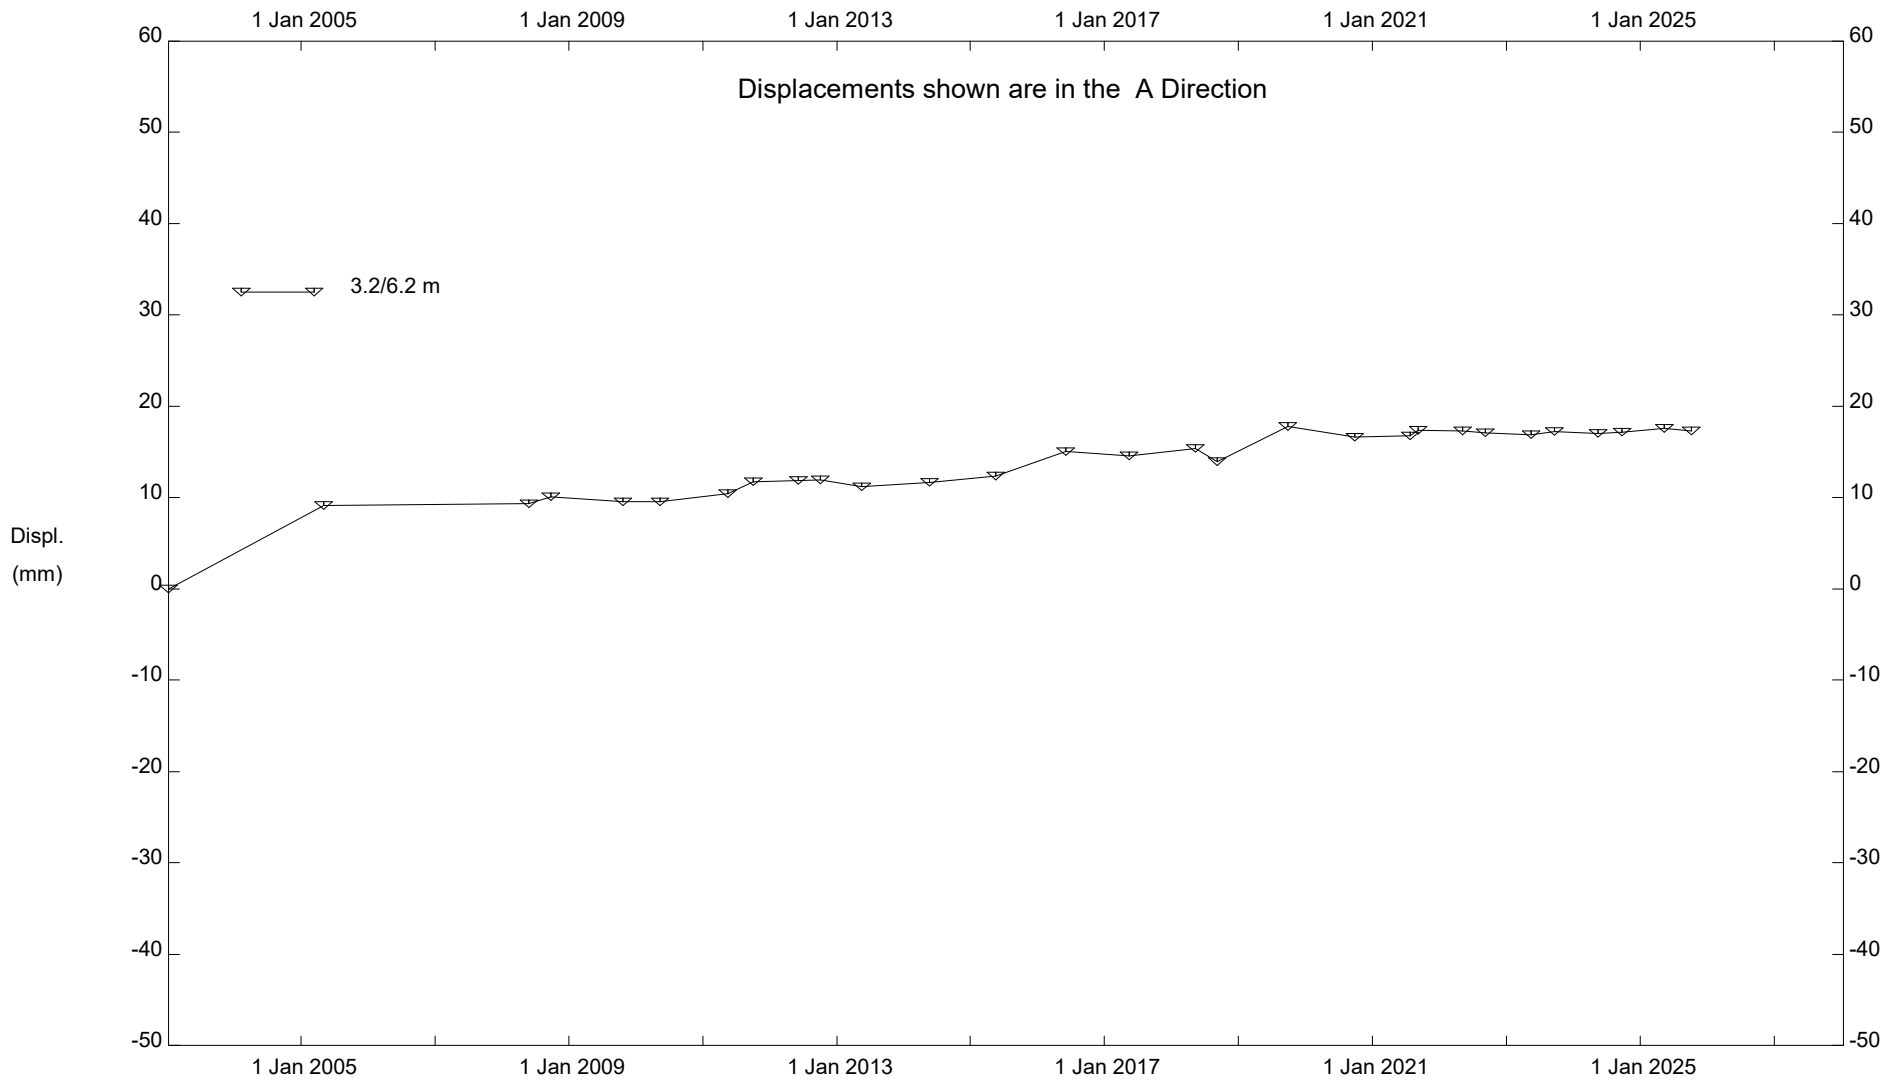
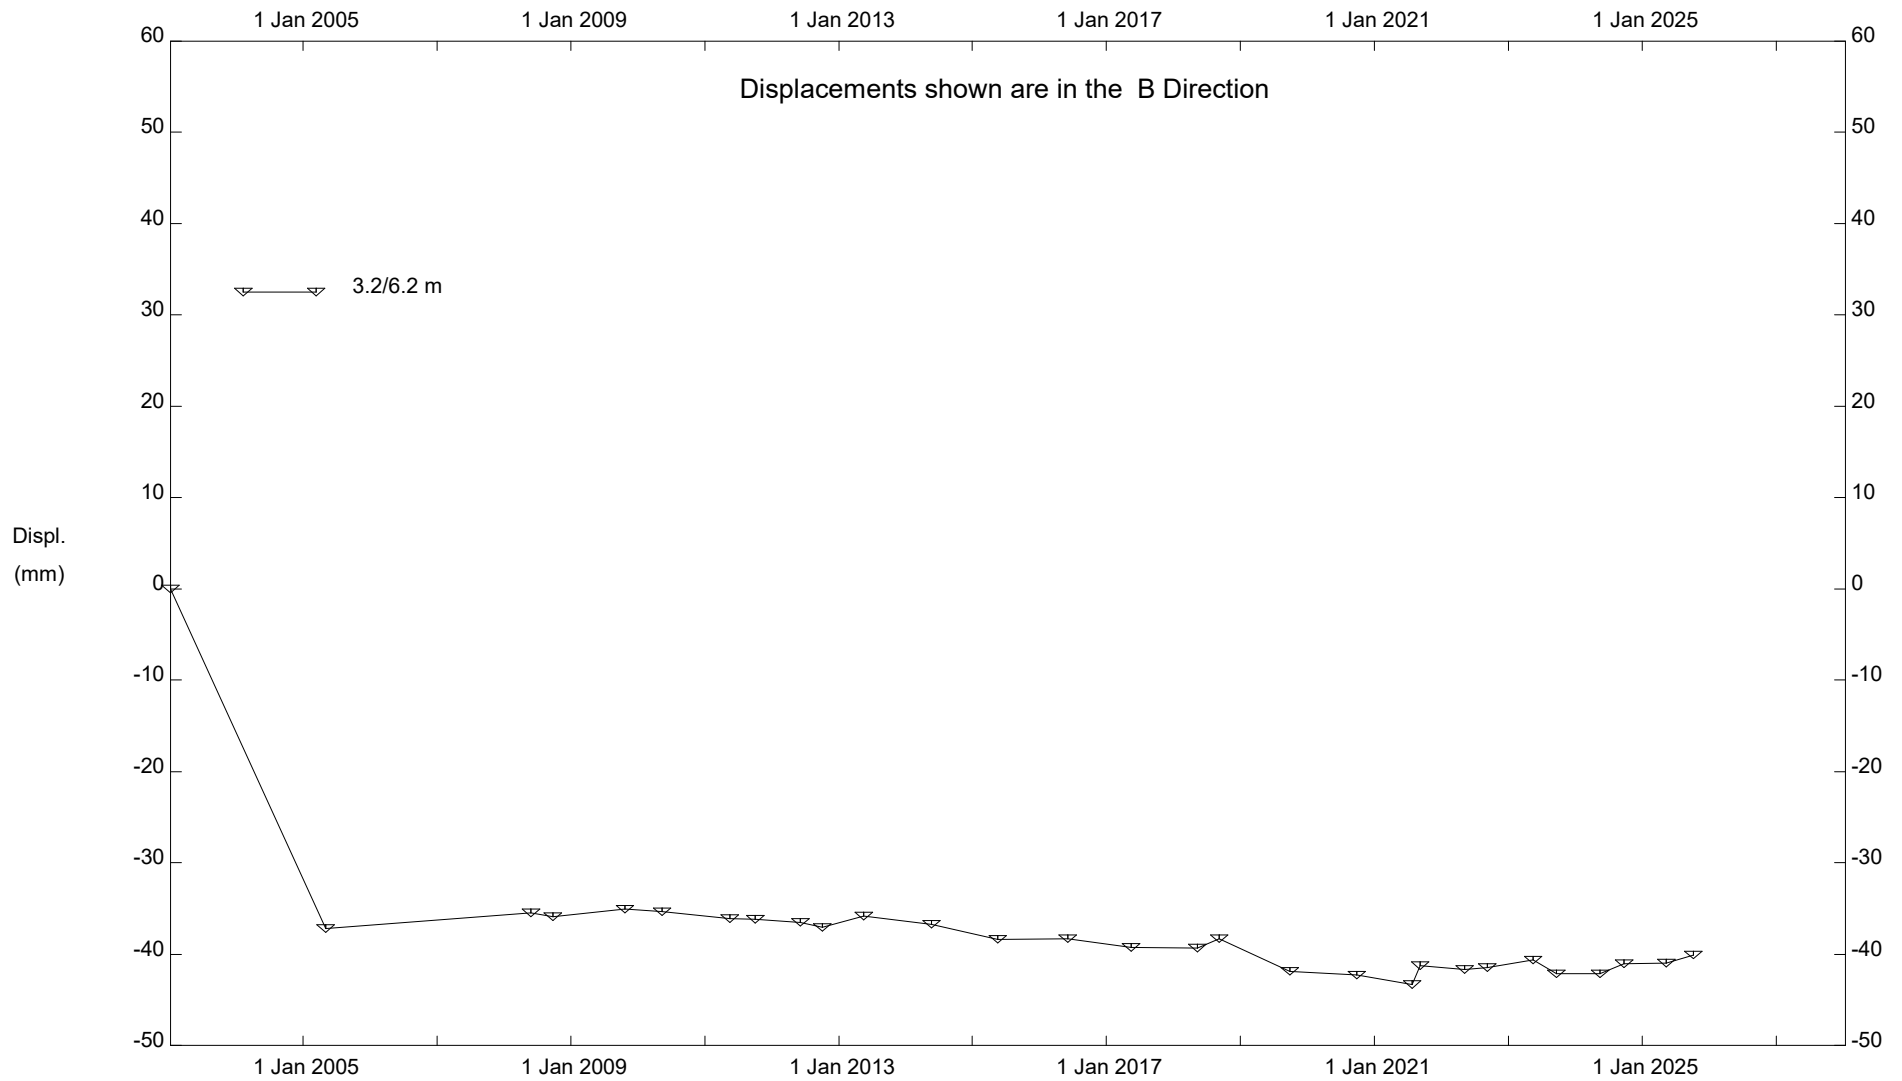
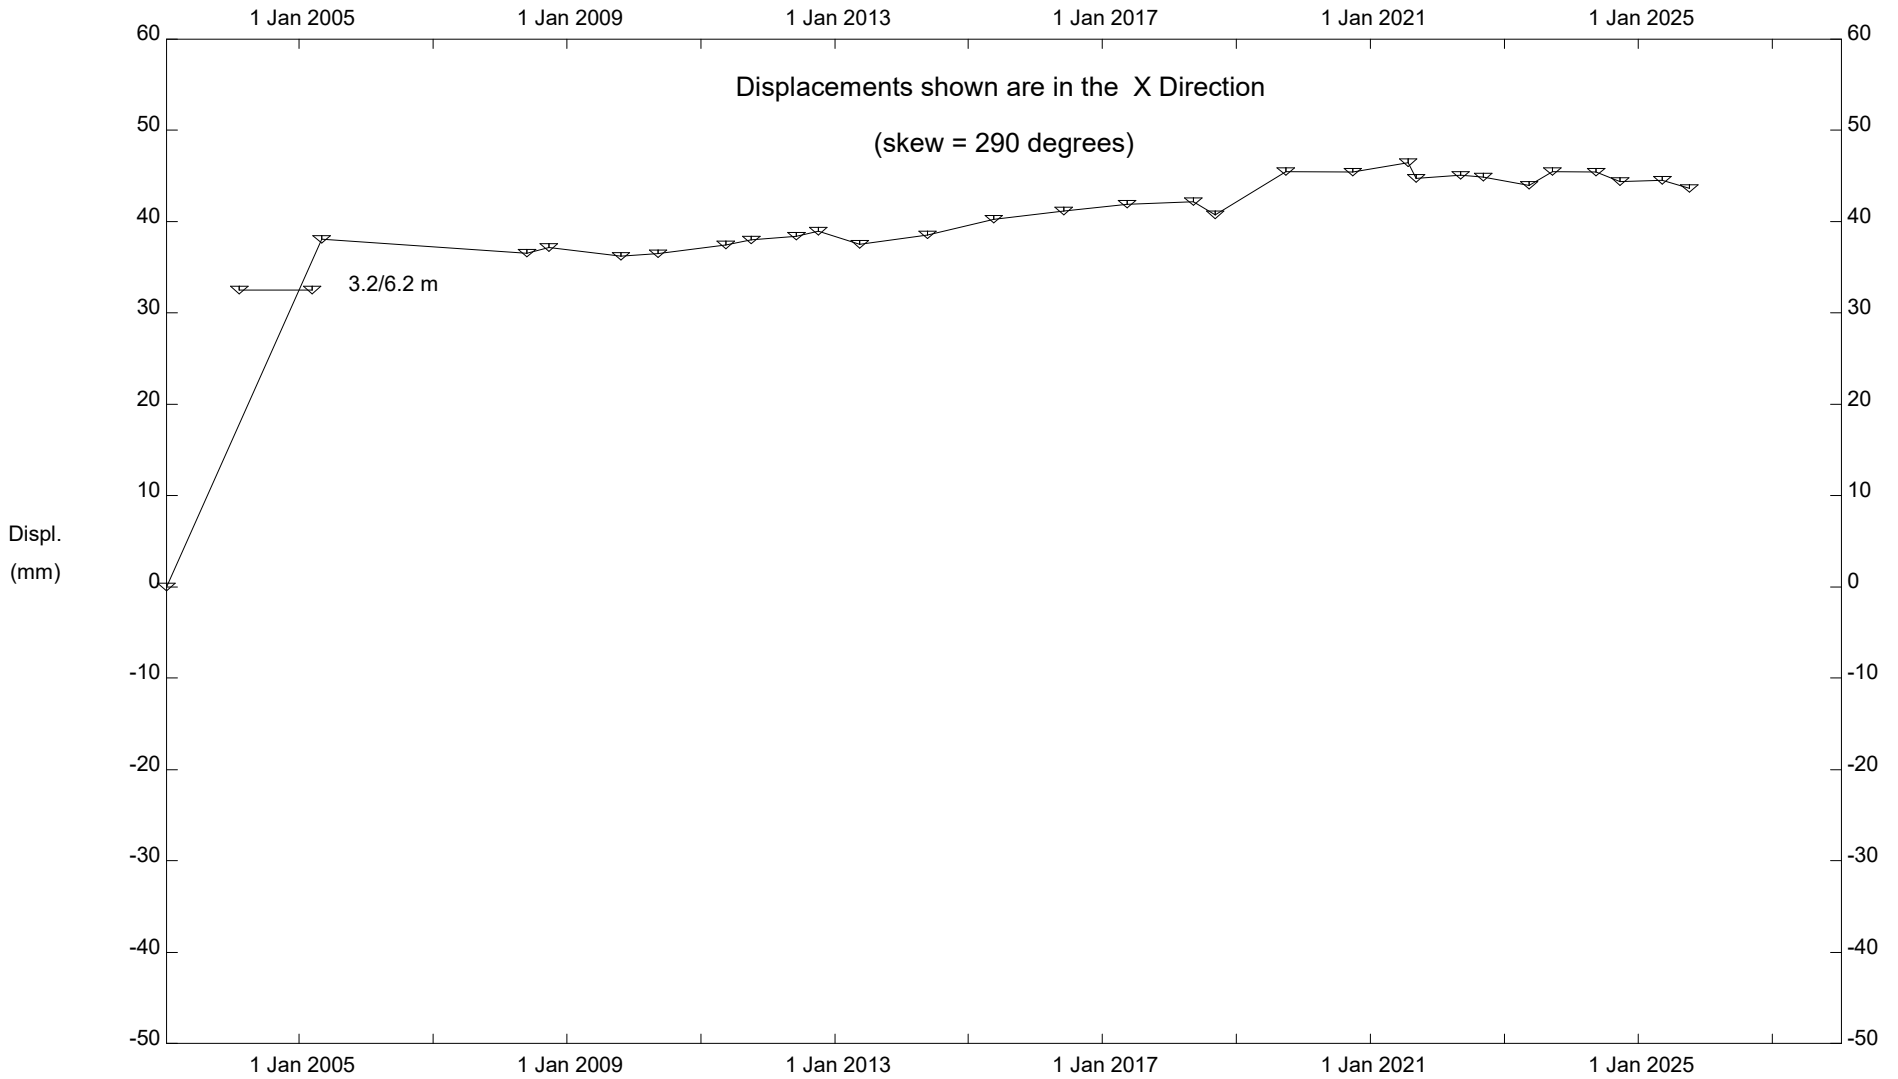
NC67, Inclinometer SI-12

SI-12 has a zone of movement between 3.2 m and 6.2 m and shows creep at a rate of about 1 mm/yr since 2008 with a total cumulative movement of 44 mm.

| Instrument Name | Date Initialized | Coordinates <sup>(1)</sup><br>(UTM 12U,<br>NAD1983)<br>(m) | | Total Cumulative Resultant Movement and Depth of Movement to Date (mm) | Maximum Rate of Movement (mm/yr) | Current Status | Date of Previous Reading | Incremental Movement Since Previous Reading (mm) | Current Rate of Movement (mm/yr) | Change in Rate of Movement Since Previous Reading (mm/yr) <sup>(2)</sup> |
|---|---|---|---|---|---|---|---|---|---|---|
| SI-12 | Jan. 9, 2003 | 5927242 | 326424 | 44 over 3.2 m to 6.2 m depth in 290° direction | 17 mm/yr; Sep. 2021 | Operational | May 12, 2025 | -1 | 2 | 2 |

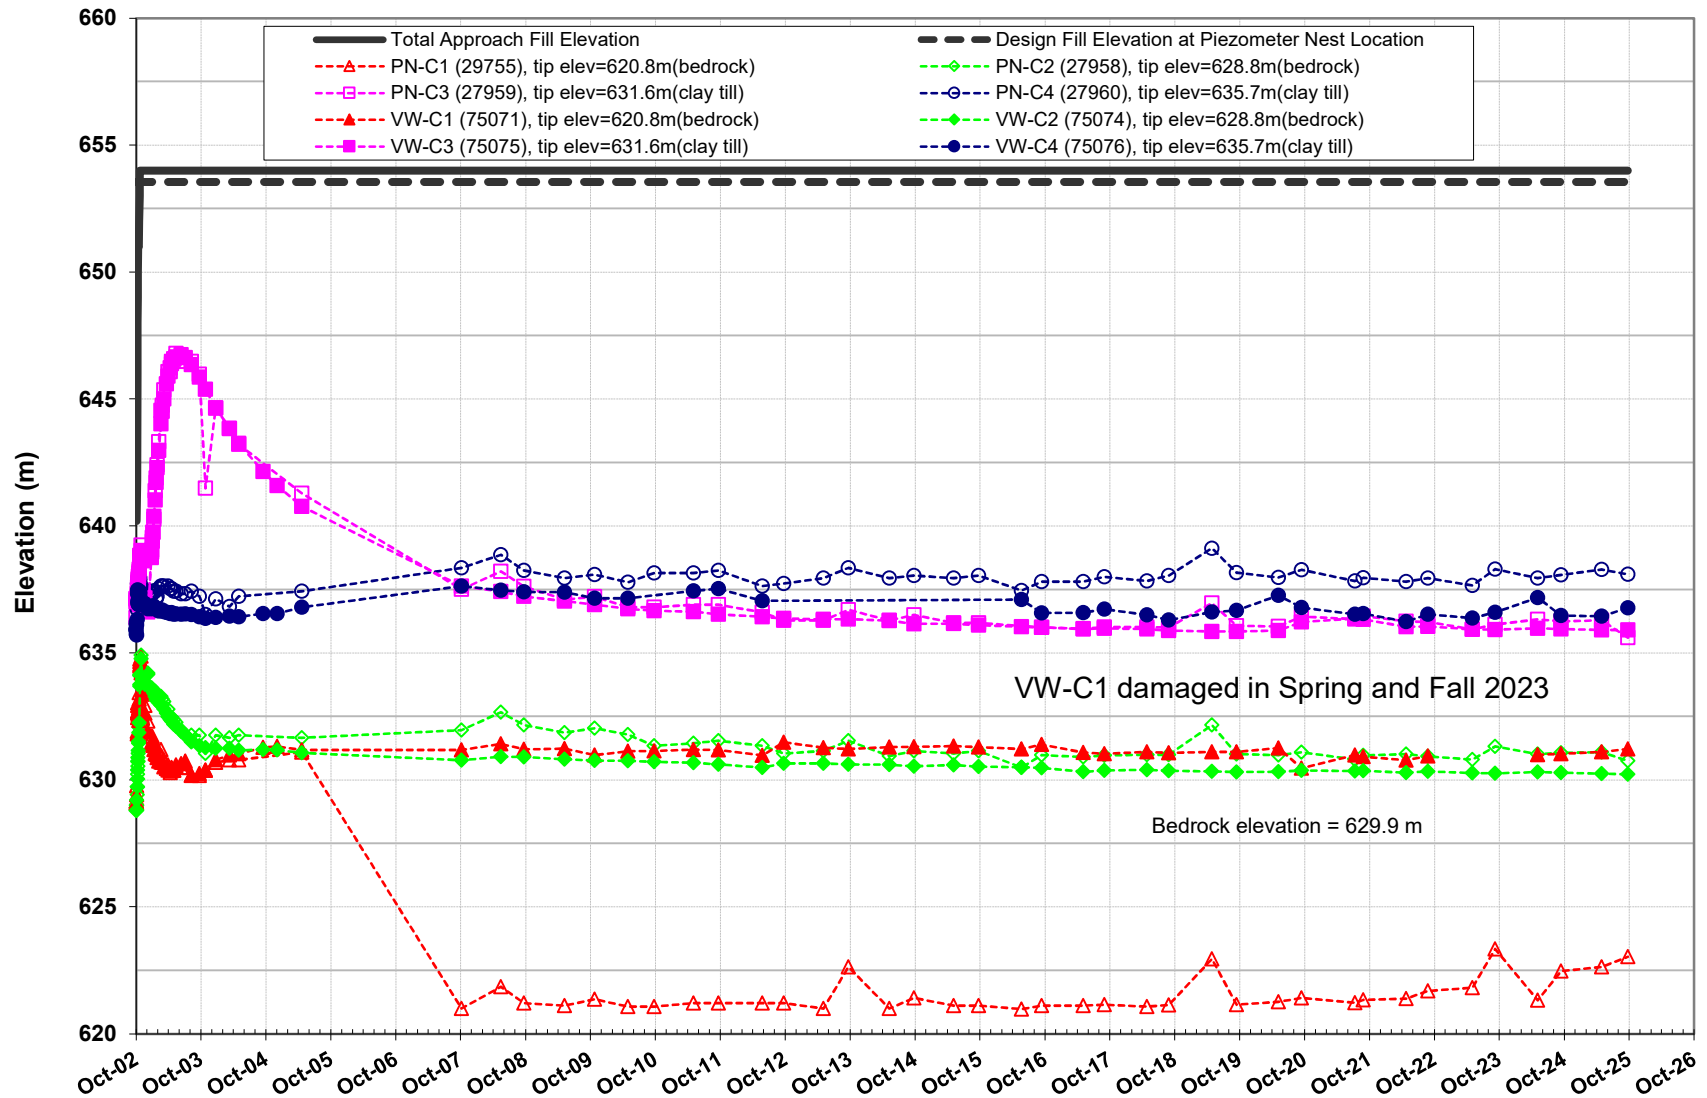
Piezometer Plots  
West Abutment  
Nest C

In general, the PNs in the west abutment showed a decrease in piezometric level difference between 0.1 m to 0.5 m, except for PN-C1 which increased by 0.4 m when compared to Spring 2025 readings.

| Instrument Name | Date Initialized | Tip Elevation (m aMSL) <sup>(1)</sup> | Current Status | Maximum Piezometric Elevation (m) | Piezometric Elevation (m aMSL) | Previous Piezometric Elevation (m aMSL) | Change in Piezometric Level Since Previous Reading (m) <sup>(3)</sup> |
|---|---|---|---|---|---|---|---|
| PN-C1 (29755) | Oct 14, 2002 | 620.8 | Operational | 634.9; Nov 2002 | 623.0 | 622.6 | 0.4 |
