NORTH CENTRAL REGION GRMP
EDSON / STONY PLAIN
SITE INSPECTION FORM

SITE NUMBER AND NAME: NC067 – Anthony Henday Bridge	HIGHWAY AND KM: 216:06, km 10.528	PREVIOUS INSPECTION: June 20, 2024	CURRENT INSPECTION: May 21, 2025
LEGAL DESCRIPTION: SE 4-52-25-W4	NAD83 COORDINATES: UTM12U 5926734N 326219E		RISK ASSESSMENT: PF: 7 CF: 10 Total: 70
AVERAGE ANNUAL DAILY TRAFFIC (AADT): 95,630 (2024)		CONTRACTOR MAINTENANCE AREA (CMA): AHD

2025 Site Inspection Photos at NC067

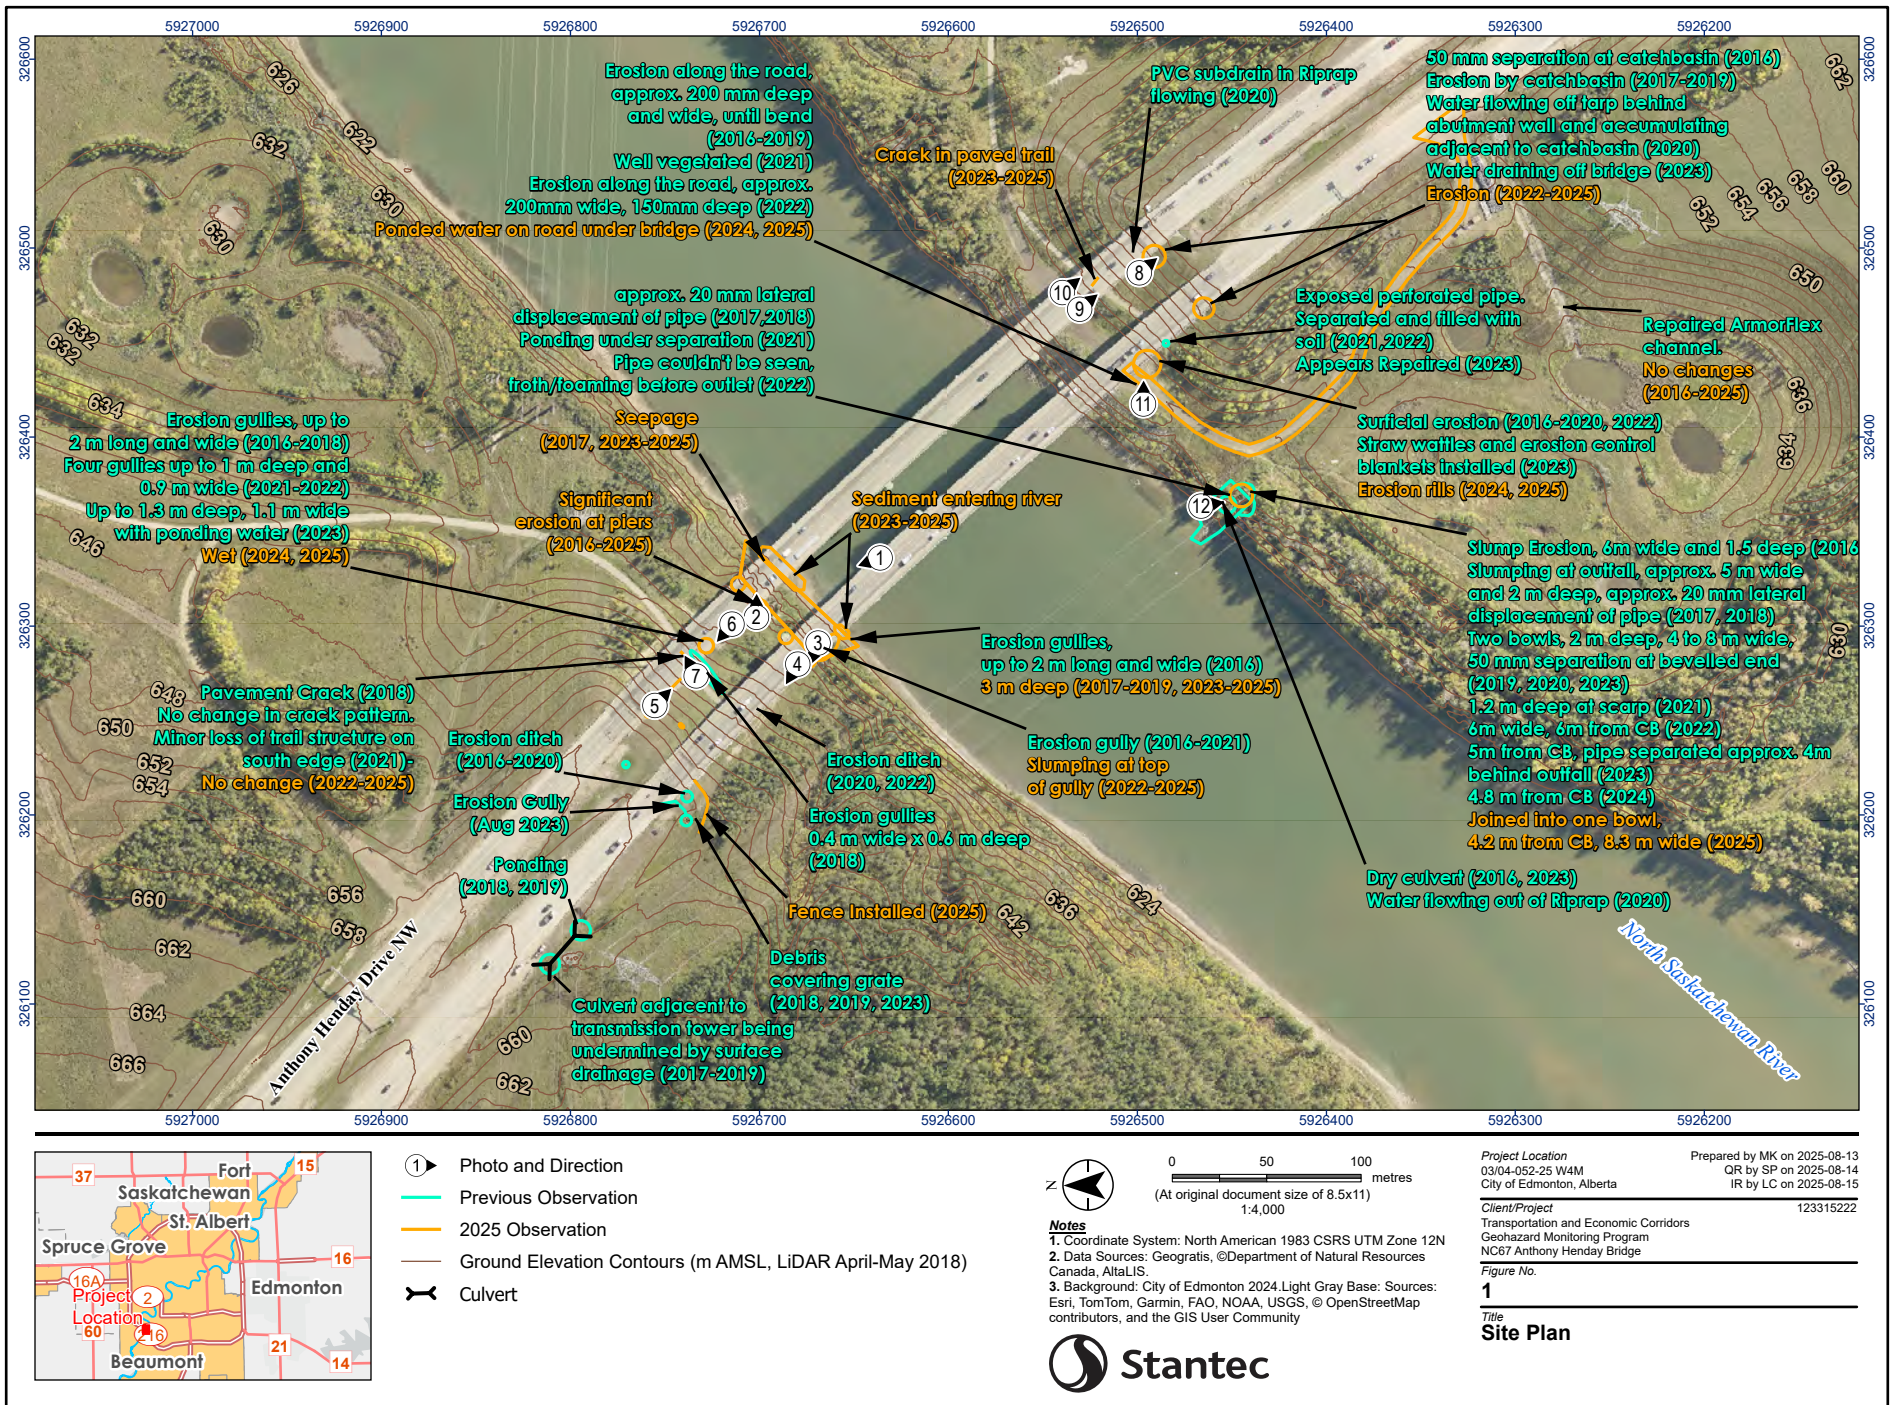
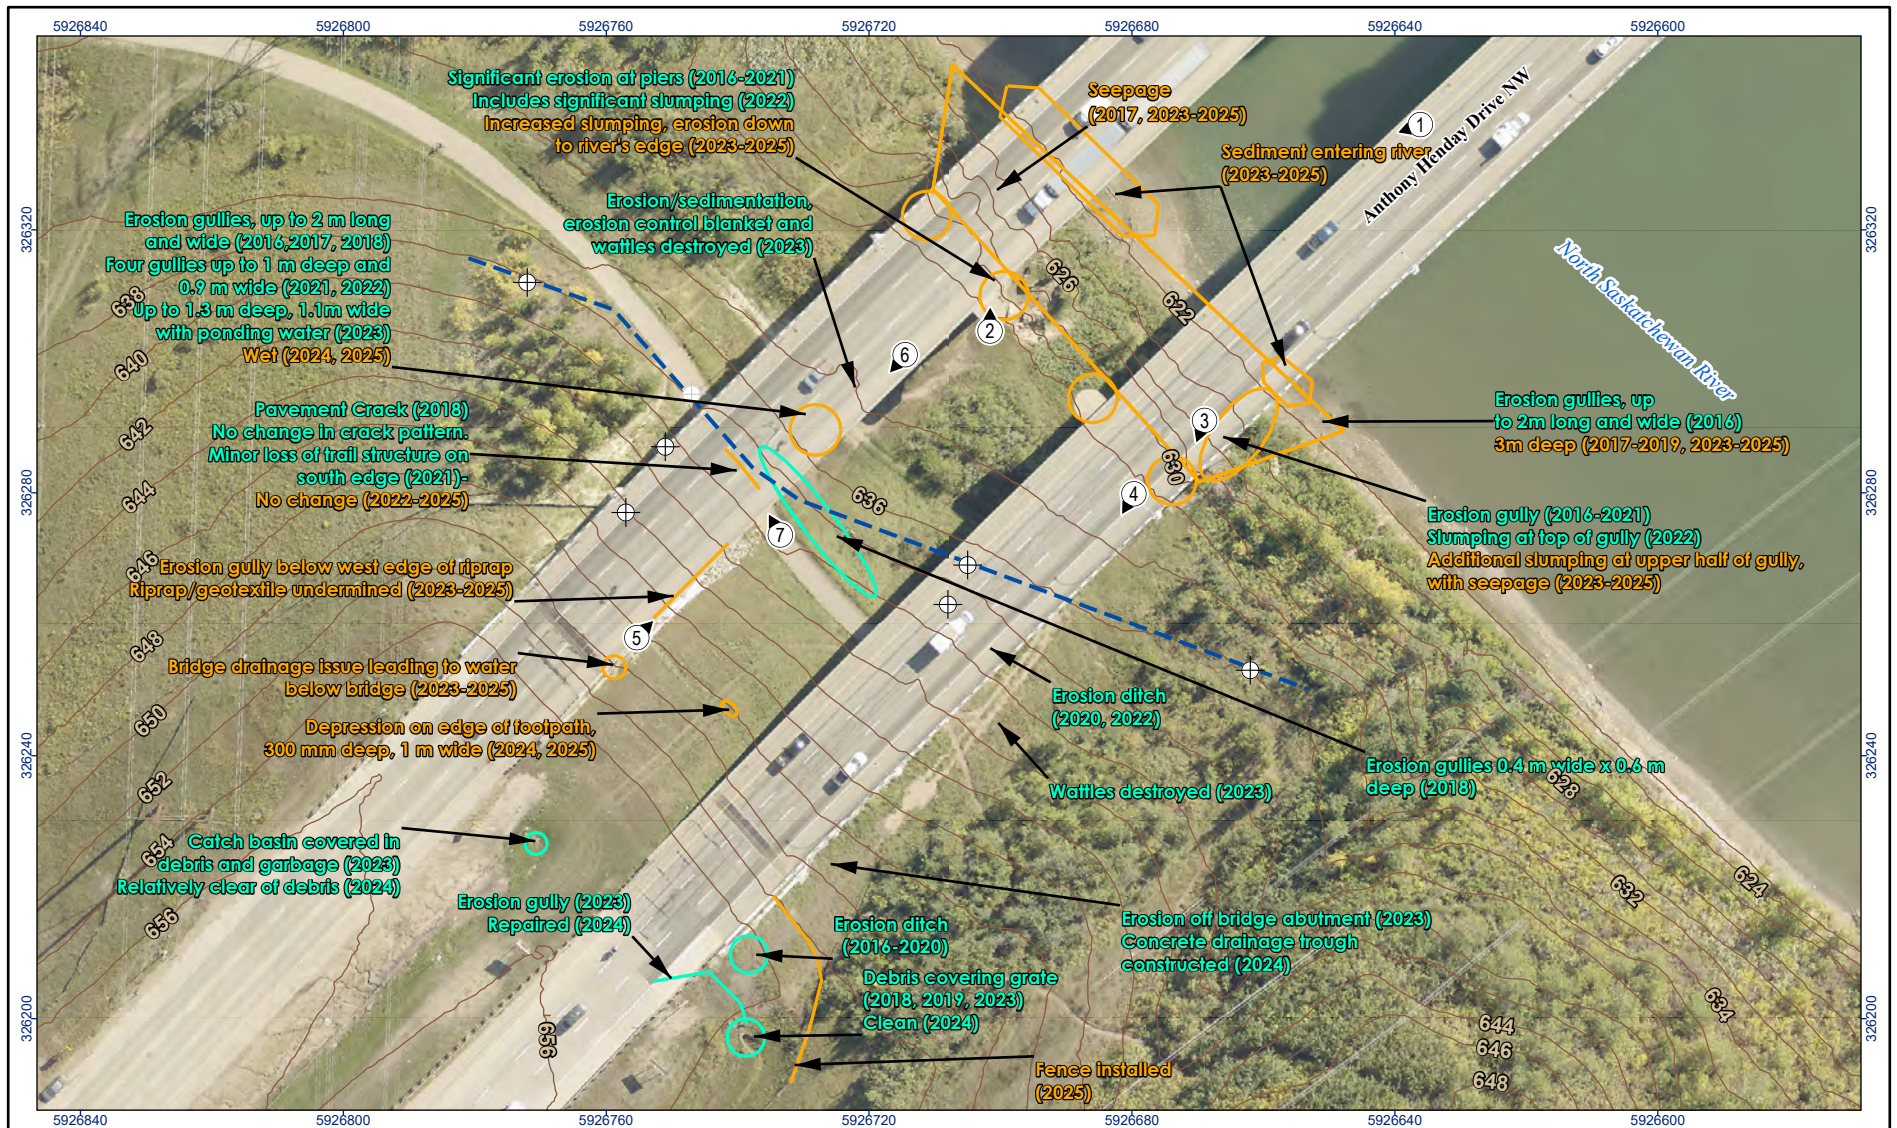
Site Plan - North Bank

- SI2 and SI7 previously showed movement in the fill. SI2 was installed in the pile wall and showed an average rate of movement of about 3 mm/yr in the upper zone (~3 m depth) since 2014 prior to being destroyed in 2022 during construction activities. SI7 showed a similar rate of movement as SI2 for the middle movement zone (~7 m depth) since 2009 and a slightly higher rate of movement than SI2 for the upper zone (3 mm/yr at about 3 m depth). An increase in movement rate to 32 mm/year was observed in the upper zone of SI7 during the 2022 instrument reading cycle which was likely due to excavations and spoil pile placed around the SI. SI7 was inferred to be blocked or sheared during the 2023 spring reading cycle, but a reading was possible in Spring 2025, showing a movement rate of 3 mm/yr. SI1 and SI3, installed in the pile wall, have shown no discernable movement in the pile wall aside from pile wall deformation, but do show movement in the fill (~2.5 m depth) with current rates of movement of less than 1 mm/yr. Approximate SI locations are shown on Figure 2.

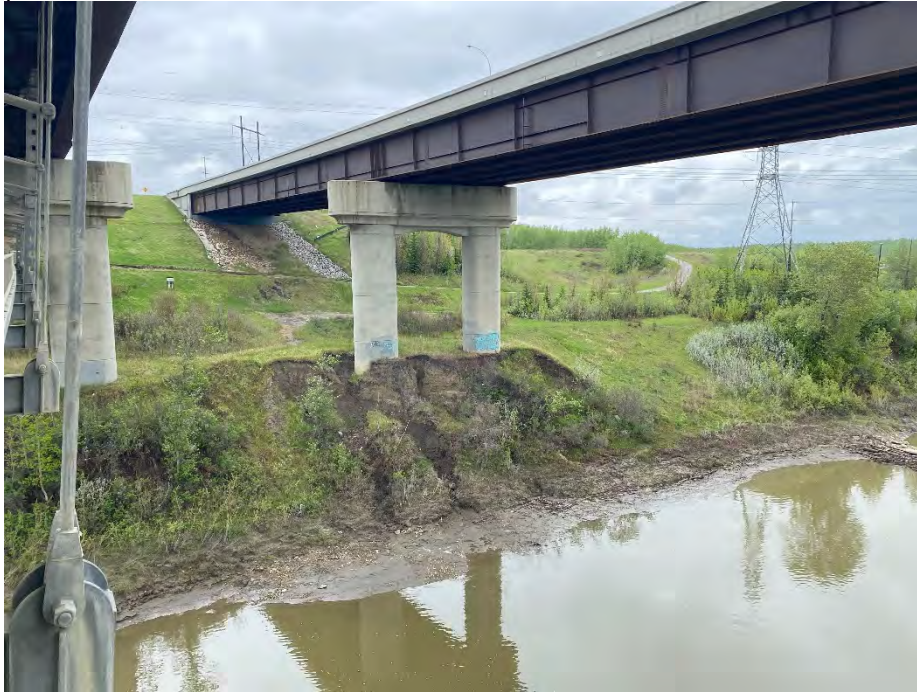
- Aside from ongoing erosion and slumping at the north abutment piers, the site appeared mostly unchanged.
- Significant erosion/slumping was observed at the land piers of the north bank (Photos 1 to 3). Ongoing erosion/slumping may be due to river scour and high intensity precipitation events. In discussion with TEC, bridge piers are typically designed without lateral support, to account for soil loss.

- Seepage and/or surface water flow (due to rain during site visit) was observed within the erosion and slumping at the north abutment piers, carrying fines to the river (Photos 1 and 2). The gullies have visibly increased in width near the river's edge.

Photo 1: Erosion of land piers at the north bank. Looking north.

- North abutment slope: remediation includes flattening the slope to 2.5H:1V and armoring the slope with riprap. Additional surface drainage improvements will also be constructed. The estimated cost for construction is approximately \$1,600,000, excluding engineering costs. Construction was previously scheduled for 2024 and was rescheduled to 2026.

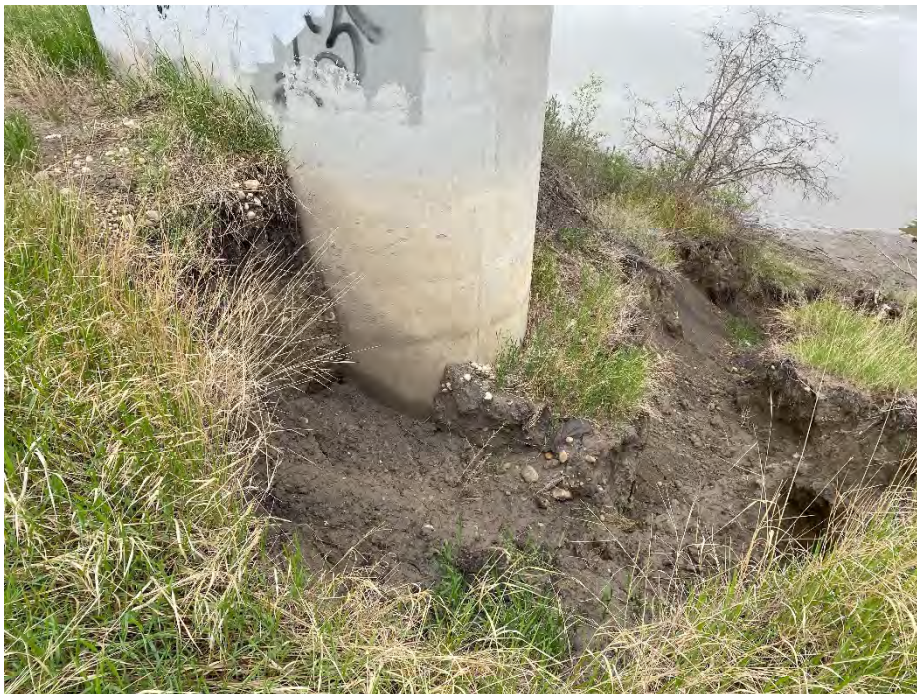
Photo 2: Loss of soil support at pier. Looking northeast.

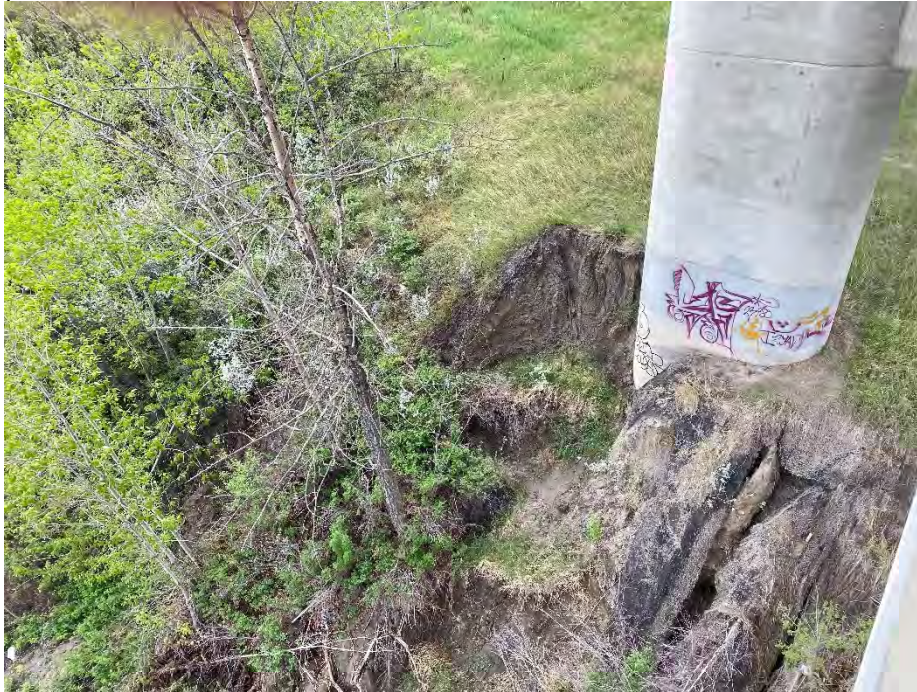
Photo 3: Erosion at outermost pier of southbound lane. Looking northwest.

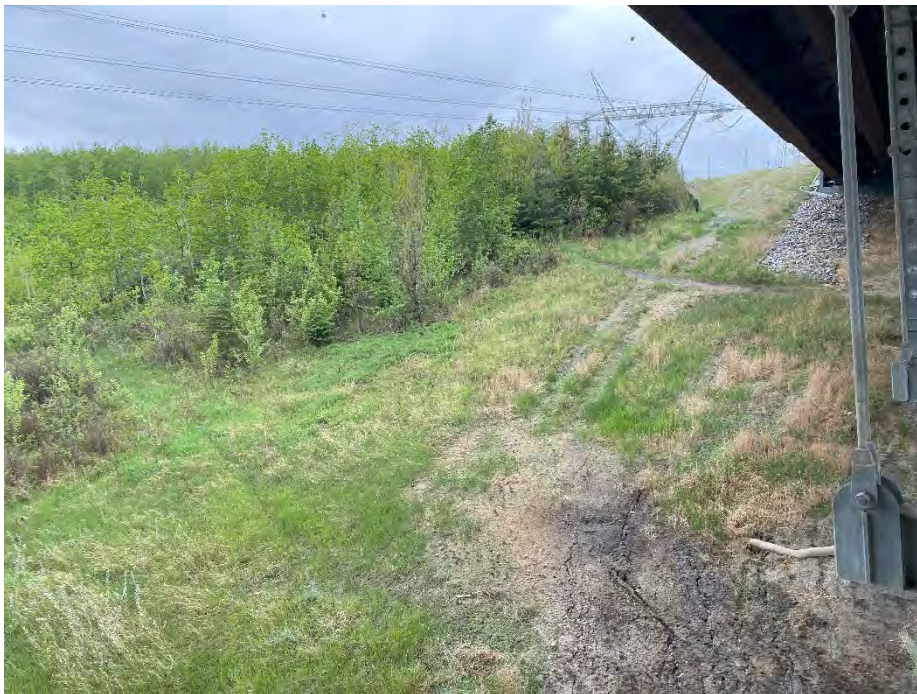
- The slope above the westernmost land pier was completed prior to the previous inspection and is now mostly vegetated with some areas of erosion (Photo 4).

Photo 4: Northwest slope above westernmost land pier. Looking northwest.

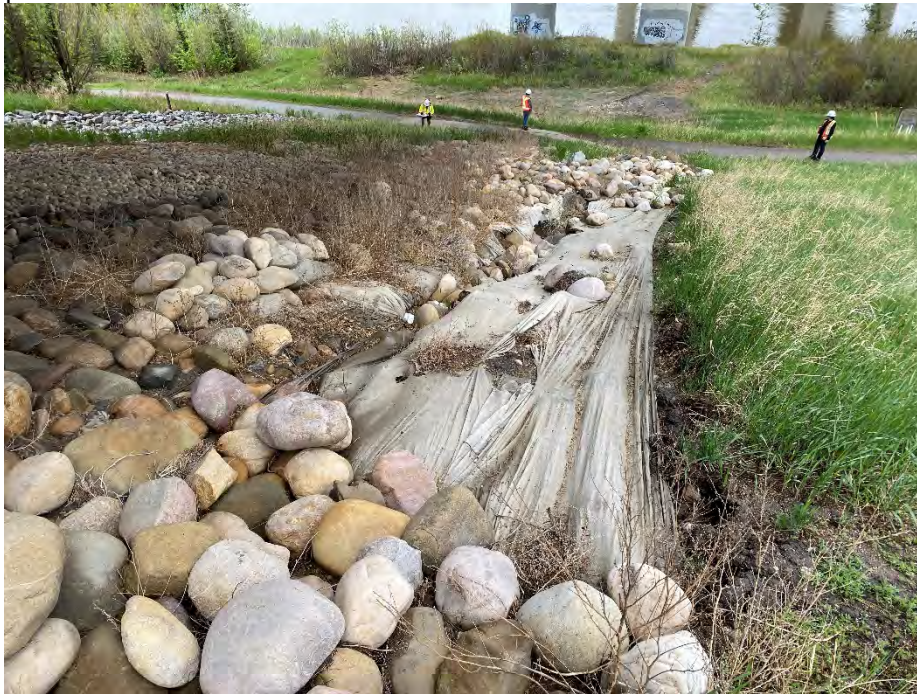
- Water draining from the west side of the north NBL bridge abutment appears to be flowing off the waterproofing membrane behind the abutment wall and missing the trough which is leading to erosion of the slope. The erosion gully below the NBL north abutment, on the west edge of the riprap appears to be in similar condition since the 2023 call out inspection (Photo 5). The erosion gully is undermining the geotextile, and riprap has fallen into the gully.

Photo 5: Erosion gully on west edge of riprap on the north bank under the NBL. Looking southeast.

- The waterproofing membrane behind the abutment walls on the NBL should be repaired to direct water into the drainage trough on both sides of the river. Any associated catch basins/ drainage chutes should be checked for blockage and cleaned as necessary.

- The erosion gullies should be regraded and reseeded to improve erosion protection and reduce the risk of additional loss of trail. At the north side, the undermined geotextile should be removed and replaced followed by backfilling with additional riprap. Alternatively, a concrete trough could be installed to direct water down the headslope. A concrete trough could also be considered for the erosion gully along the northbound lane abutment on the south side. Stantec submitted two tender packages for site remediation in 2019:

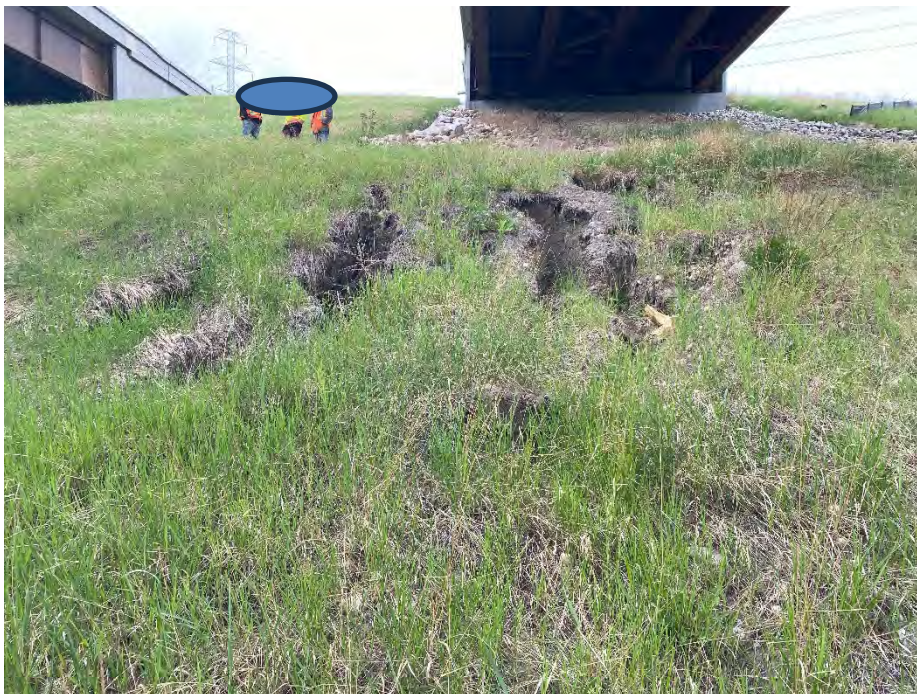
- The four large erosion gullies / scour holes downslope of the pedestrian trail below the NBL appeared to be similar in size as the previous inspection. The gullies are up to 1.3 m deep and 1.1 m wide (Photo 6). The material within the westernmost erosion gully was wet.

Photo 6: Four scour holes downslope of pedestrian trail under NBL. Looking northwest.

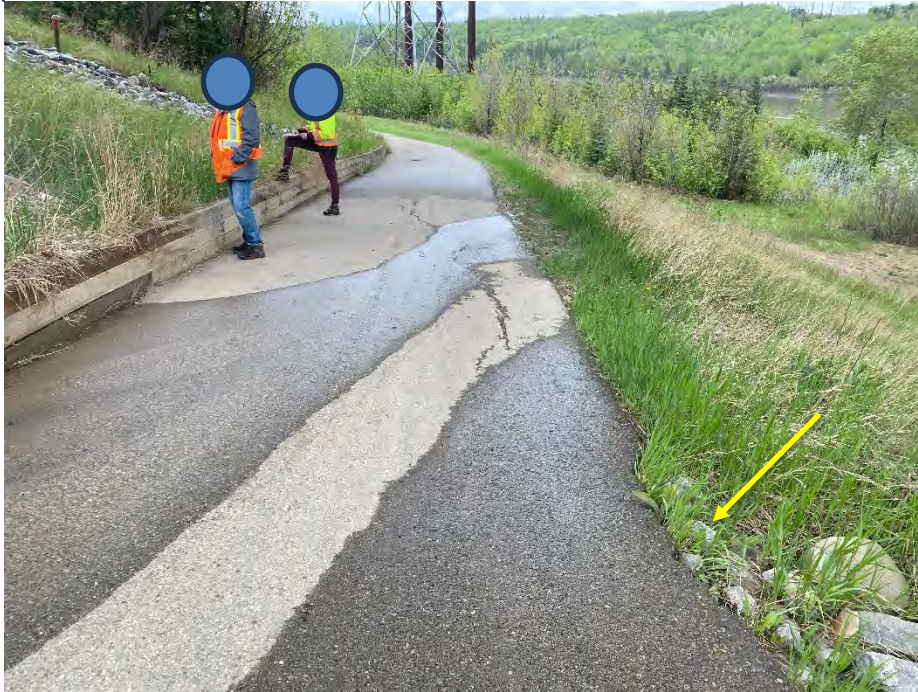
- Minor trail loss and pavement cracking appeared unchanged since the 2023 inspections (Photo 7).
- Erosion gullies up to 0.4 m wide and 0.6 m deep directly downslope from the trail between the two bridge alignments are unchanged since the 2022 site inspection.

Photo 7: No change to trail crack pattern. Minor loss of trail. Looking northeast.

- The site should be regularly monitored by the MCI until the following recommended remediation can be undertaken.
- Pavement cracks along the pedestrian trail should be sealed to reduce surface water infiltration into the slope.

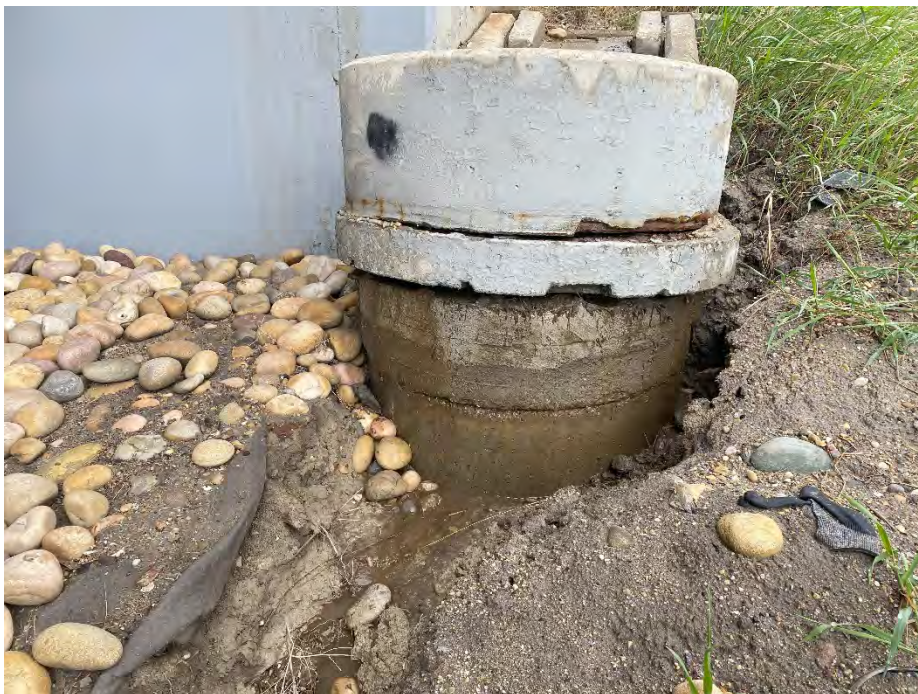
Photo 8: Catch basin on west side of NBL south abutment, not containing flow. Looking southeast.

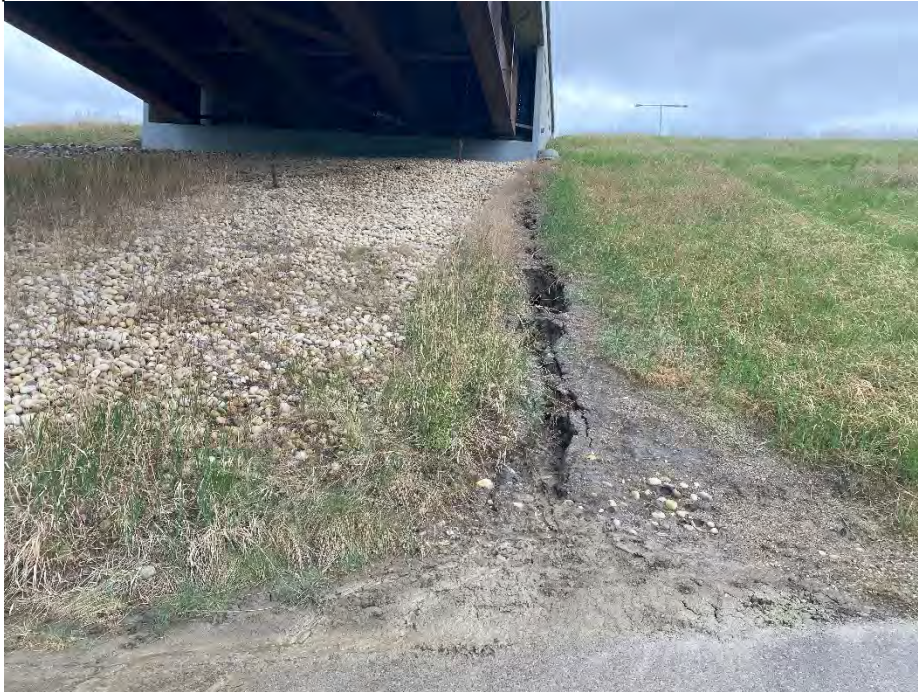
- Ponding water was observed along the access road below the bridge, similar to previous years.
- Ongoing erosion was observed on the south slope below the abutment of the NBL. Water was previously observed to be flowing off a waterproofing membrane behind the abutment wall, missing the trough that would direct water to a catch basin, and flowing downslope resulting in erosion of the head slope. A slight separation was observed between the catch basin and the underlying riser ring which could allow water flow onto the headslope (Photo 8). Furthermore, a buildup of sediment and debris was observed within the catchbasin, which could be blocking the flow. The gully remains 0.6 m wide and is up to 0.7 m deep suggesting a downcut of 0.1 m deeper than recorded in 2024 (Photo 9).

Photo 9: Erosion below the NB abutment on the south slope due to damaged waterproof membrane on abutment. Looking southeast.

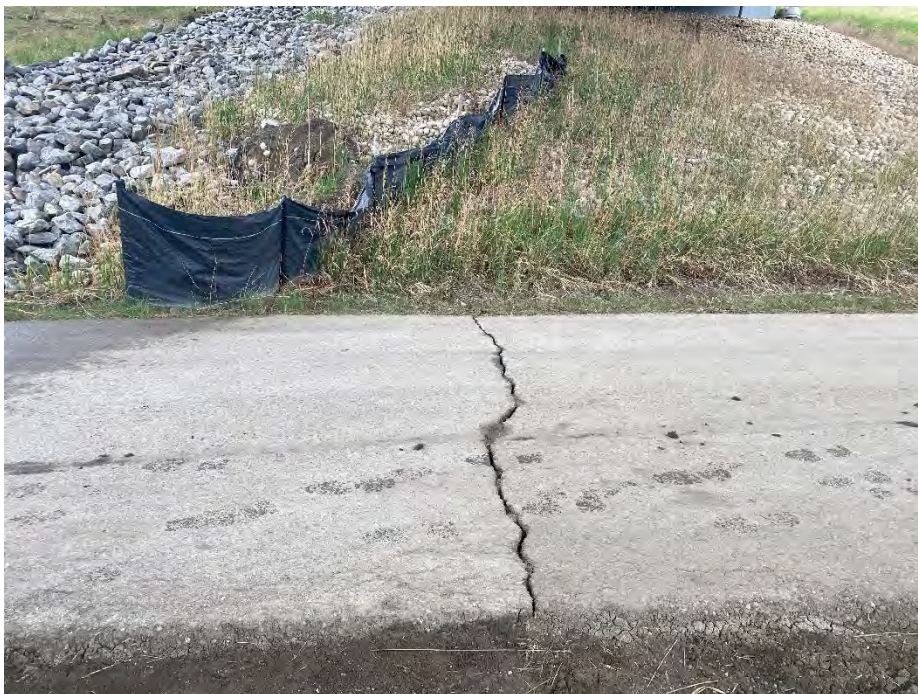
- The crack across the paved trail observed on the south slope below the NBL appeared relatively unchanged since 2023 (Photo 10).

Photo 10: Crack in the paved trail below the NB lane of south abutment. Looking southeast.

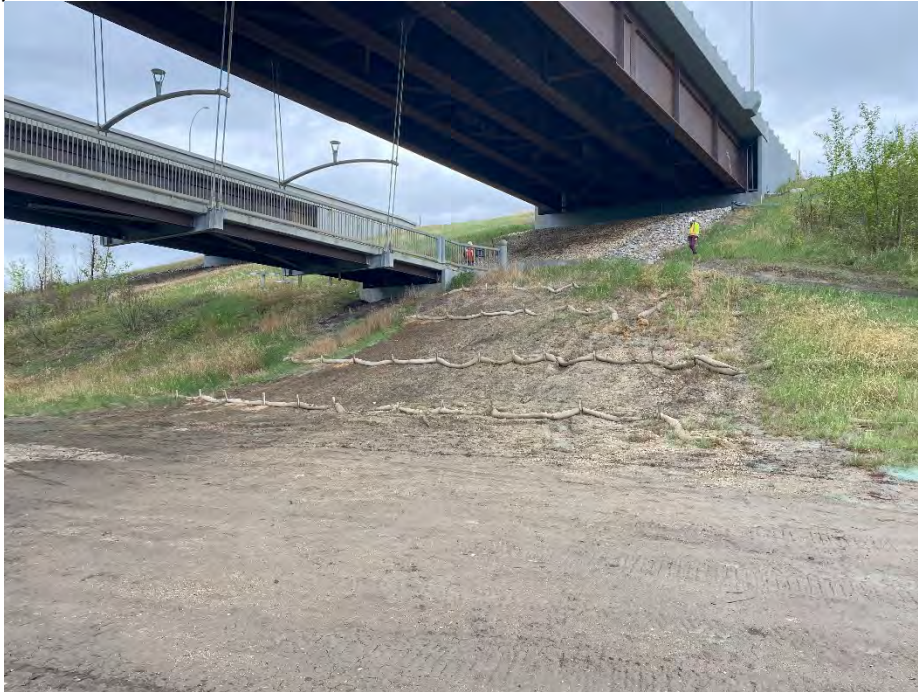
- Erosion is ongoing down the informal biking/ walking trail approximately below the southbound lane, similar to previous years.
- The slope to the west of the south end of the footbridge below the SBL remains unvegetated. The straw wattles installed in 2023 are still present (Photo 11)

Photo 11: Unvegetated slope on the west side of the footbridge below the SBL. Looking east.

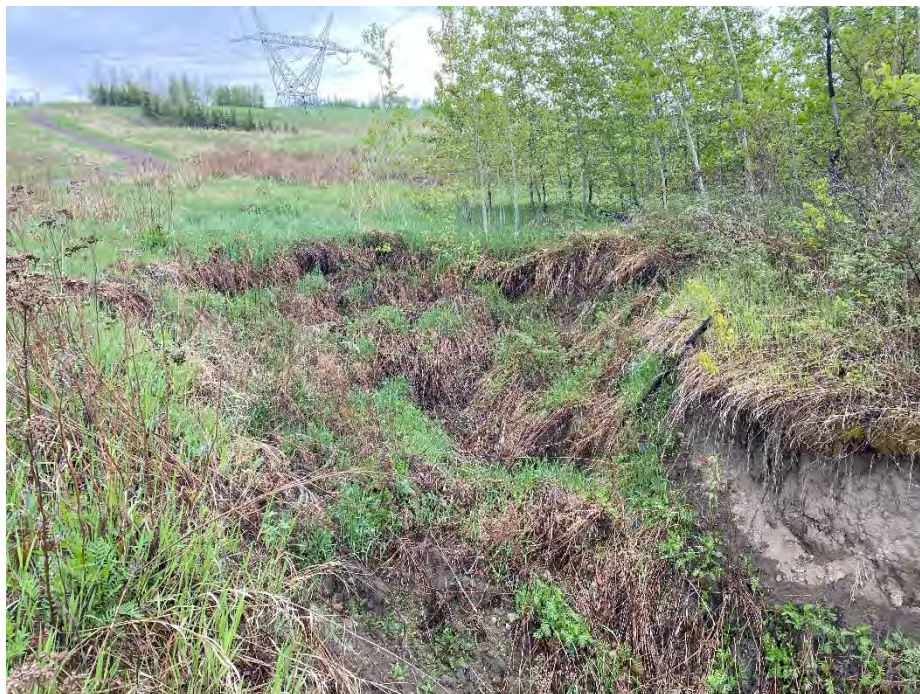
- The erosion/slumping around the outfall at the south abutment appeared to have progressed since the 2024 site inspection. The scarp is now 8.3 m wide (2.3 m increase) and has retrogressed 0.6 m southeast and is currently 4.2 m from the catch basin (Photo 12). There are no longer two separate bowls since they have joined into one.
- The pneumatic piezometers and vibrating wire piezometers on the south abutment show a general increase in groundwater levels since 2024. Increases were between 0.1 m and 1.0 m.

Photo 12: Slump around the outfall on the south bank of the river. Looking southeast.

- Outfall remediation as part of NC079 work: Replace separated sections of pipe with 750 mm reinforced concrete pipe. Reline storm sewer with cured-in-place pipe installed at 5% slope. The estimated cost for construction is approximately \$1,000,000, excluding engineering costs. Construction has been rescheduled for 2026.
