SITE NUMBER AND NAME: NC079 – Wedgewood Ravine Slides	HIGHWAY AND KM: 216:06, km 12.849	PREVIOUS INSPECTION: June 20, 2024	CURRENT INSPECTION: May 21, 2025
LEGAL DESCRIPTION: SE 28-52-25-W4	NAD83 COORDINATES: UTM12U 5927932N, 324250E		RISK ASSESSMENT: PF: 7 CF: 10 Total: 70
AVERAGE ANNUAL DAILY TRAFFIC (AADT): 86,620 (2024)		CONTRACTOR MAINTENANCE AREA (CMA): Anthony Henday Drive (AHD)

**NORTH CENTRAL REGION GRMP
EDSON / STONY PLAIN
SITE INSPECTION FORM**

Client/Project
Transportation and Economic Corridors
Geohazard Monitoring Program
NC79 Wedgewood Ravine Slides

2025 Site Inspection Photos at NC079

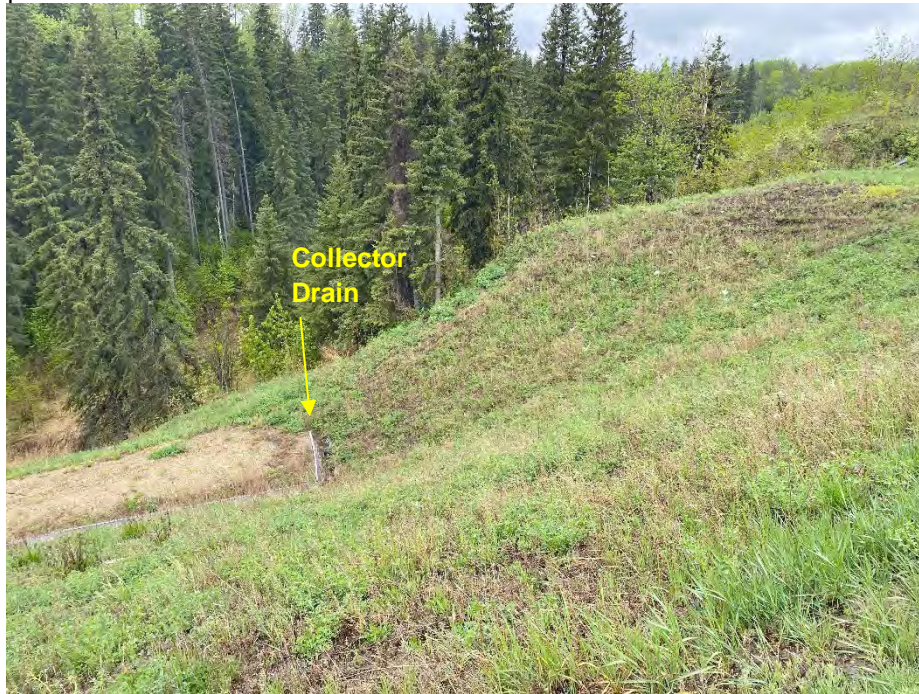
COMMENTS <ul style="list-style-type: none"> The repaired slopes near the northwest approach of AHD were well vegetated, and no significant erosion was observed. A steel half-culvert collector drain is present downslope to catch runoff and debris, and deposit the water into Wedgewood Creek (Photos 1 & 2). The crest of the regraded slope is approximately 2.8 m south from SI20-01 and 3.3 m south from SI20-02 (Figure 1). Garbage and sediment was observed within the half-culvert collector drain below the slope repair, similar to the previous inspection (Photos 1 & 2).

Photo 1: Soil nailed slope at north and south slides. Looking west.

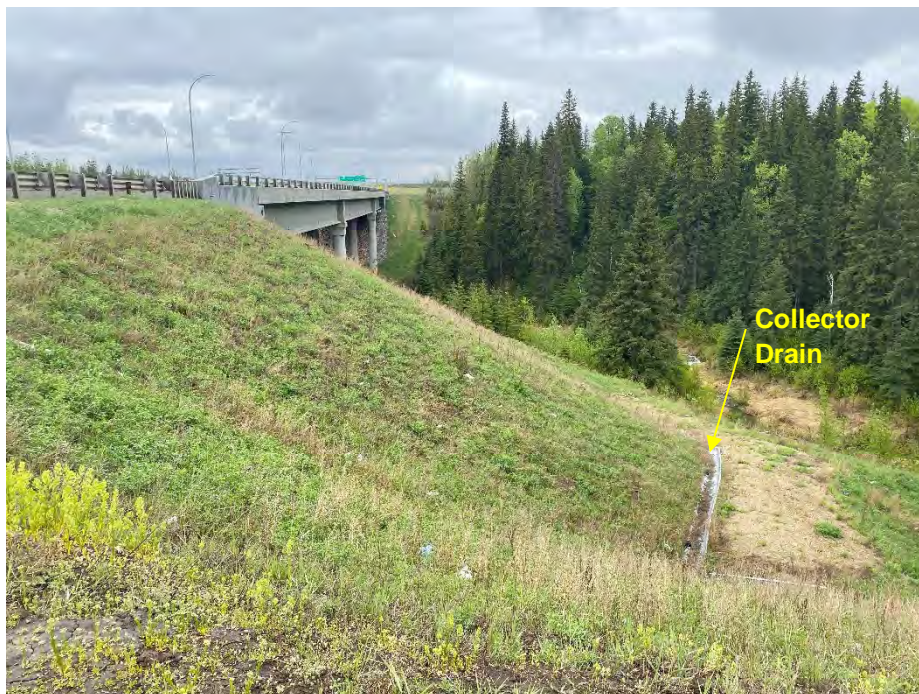
Photo 2: Soil nailed slope at north and south slide area, collector drain installed at toe of repaired slope. Looking southeast.

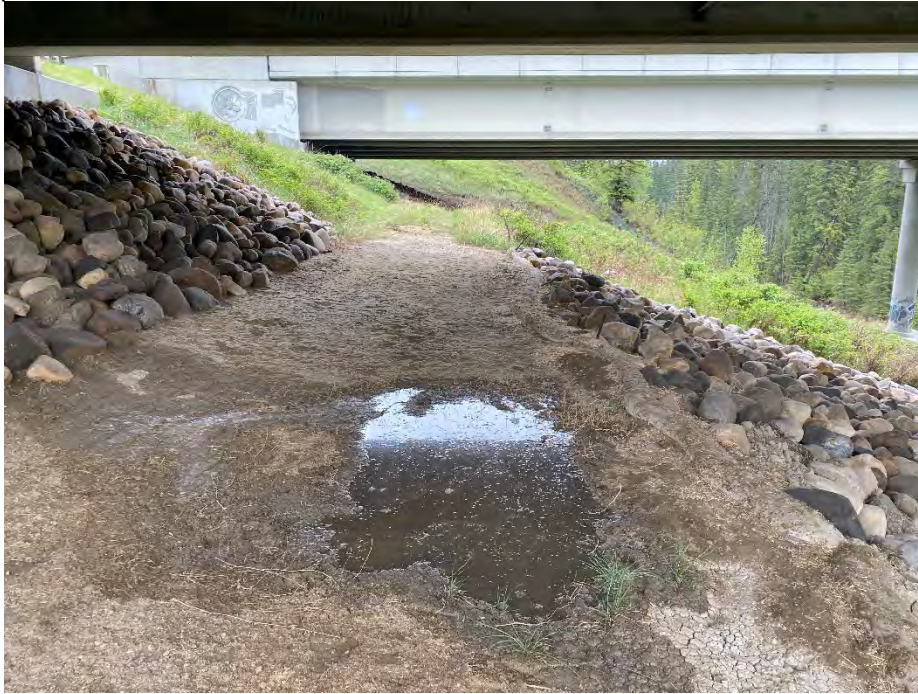
- Wedgewood Creek's water level was moderate at time of inspection likely due to spring runoff and recent wet weather.
- Erosion rills were observed on the slope near the southwest end of the footpath near the northwest abutment for the SBL. Ponded water was observed on the footpath (Photo 3).

Photo 3: Erosion and ponded water on footpath near NW abutment for SBL. Looking northeast.

- The site should be regularly monitored by the MCI until remediation can be undertaken.
- A concrete trough may be considered upslope of the footpath to direct surface water towards the riprap instead of into existing erosion channels.

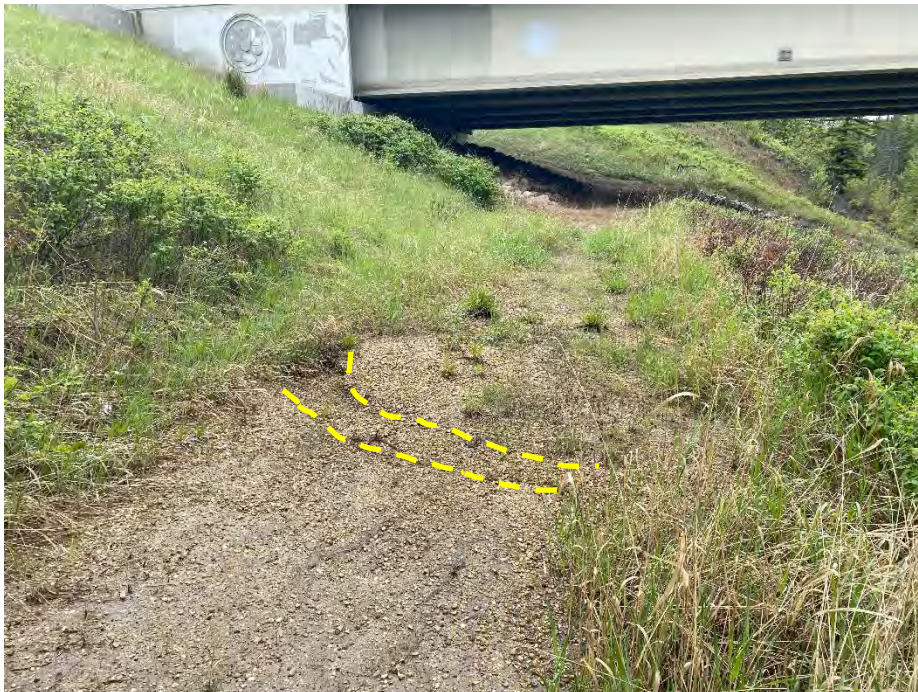
- Erosion was observed on the footpath on the west slope (Photo 4), between the southwest and northwest bridge abutments, below an erosion gully located on the slope above the footpath.

Photo 4: Erosion gully on the footpath between the NW and SW abutments, partially infilled with sand and sediment. Looking northeast.

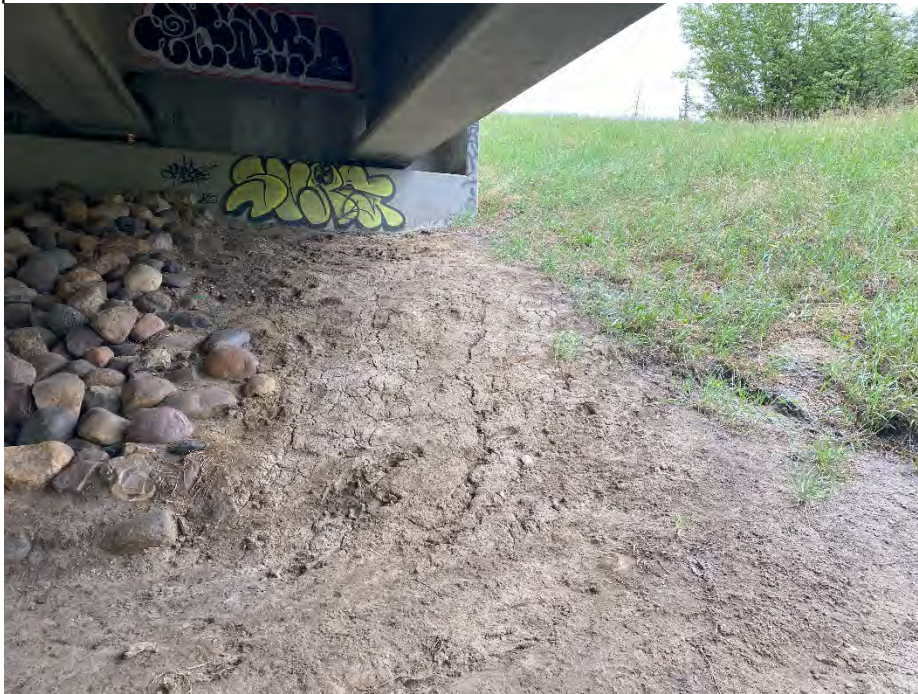
- Erosion rills were observed on a bare slope on the north corner below the northbound lane abutment down to the footpath. In 2023 and 2024, erosion gullies were present but have possibly been filled with sediment leading to the current state (Photo 5).

Photo 5: Erosion at the north corner of NW abutment. Looking northwest.

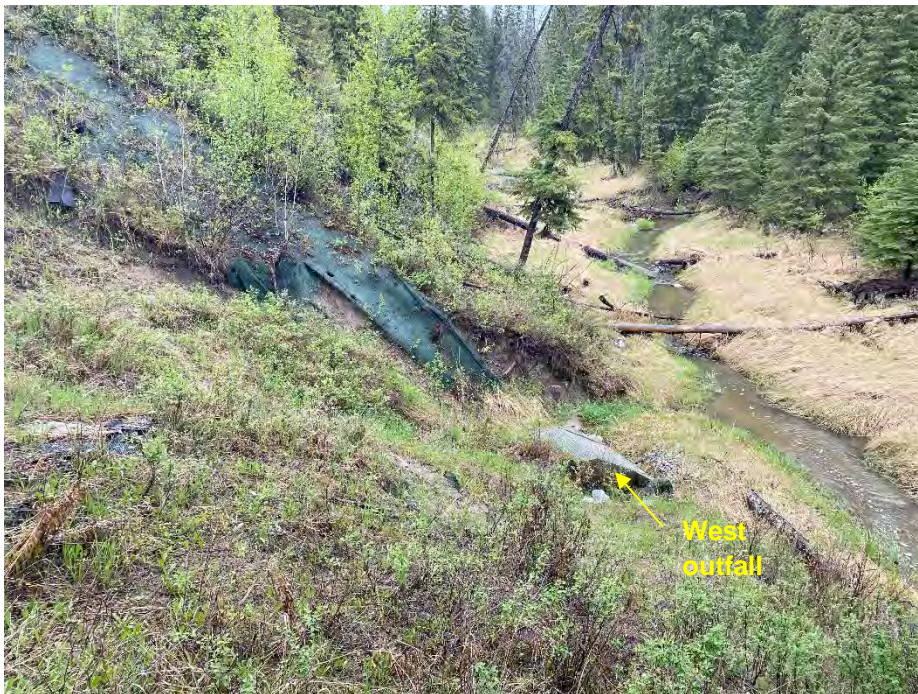
- Erosion was observed behind both outfalls located on the west and east sides of Wedgewood Creek north of AHD (Photos 6, 7 & 8). Erosion above west outfall appears to be similar to 2024. Due to the slippery conditions of the slope, Stantec was not able to observe the condition of the outfalls closely.

- It is surmised that water is flowing out of the separated pipe upslope from the west outfall and eroding the west creekbank. A small channel is still present from the outfall to the creek due to erosion, and appears similar to 2024.

Photo 6: Looking downslope on west slope, east of NBL towards west outfall. Facing northeast.

- Stantec submitted a tender package for outfall remediation consisting of replacing the disjointed and broken pipe segments with new pipe and regrading the surrounding slopes. The existing outfalls will be removed and replaced with an energy dissipater consisting of Class 2 riprap. Construction is understood to be scheduled for 2026. Given the time between design and construction, the design and tender package should be reviewed for feasibility and applicability against newer TEC specifications. The estimated cost for construction is approximately \$1,000,000 excluding engineering costs.

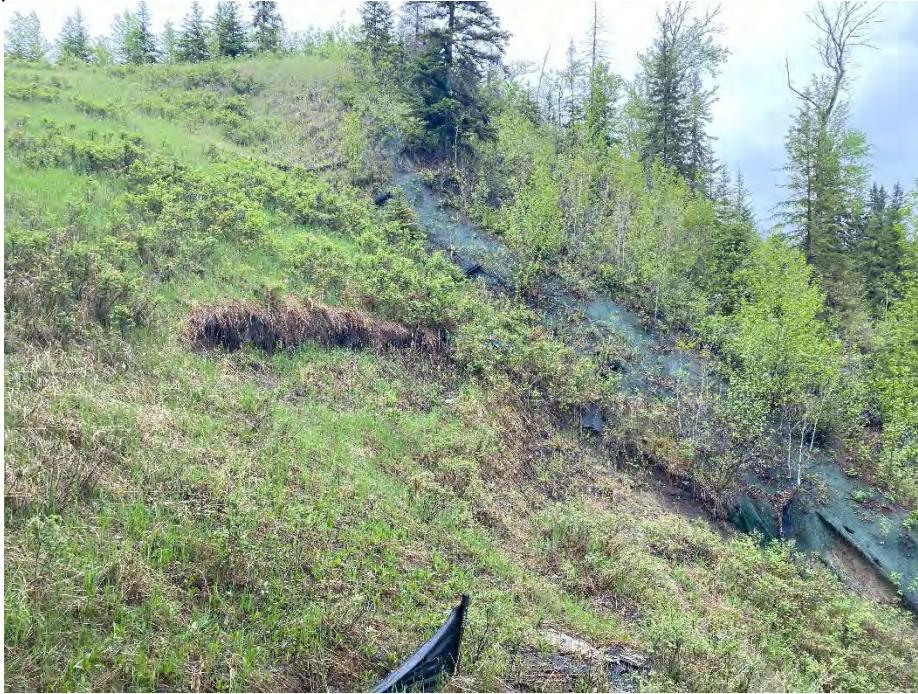
Photo 7: Slide above west outfall. Looking northwest.

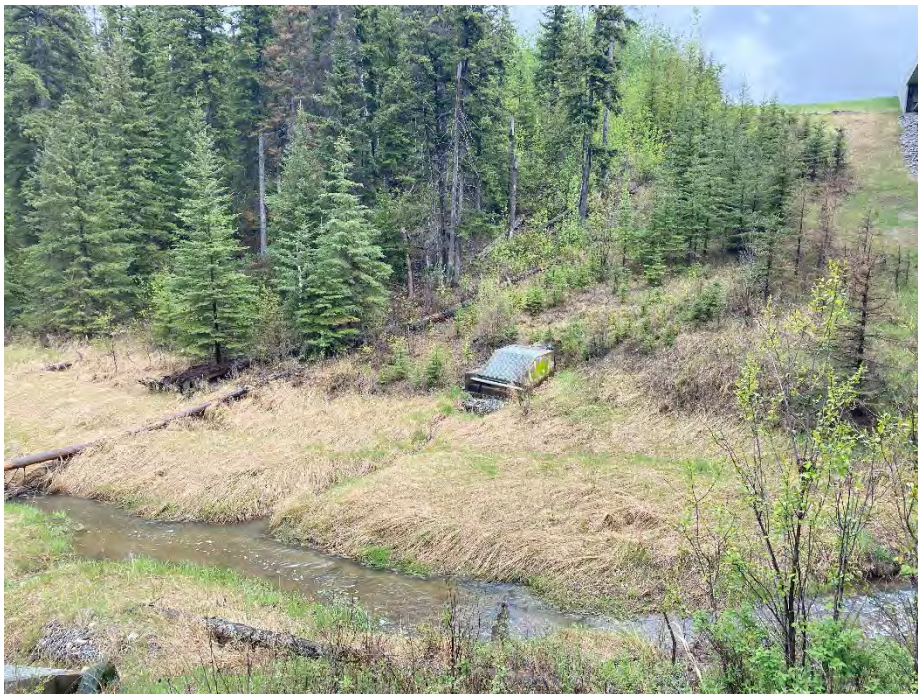
- The condition of the east outfall looked similar to the previous inspection (Photo 8). The separation in the pipe behind the outfall could not be measured, but was previously 270 mm in 2024.

Photo 8: East outfall. Looking east.

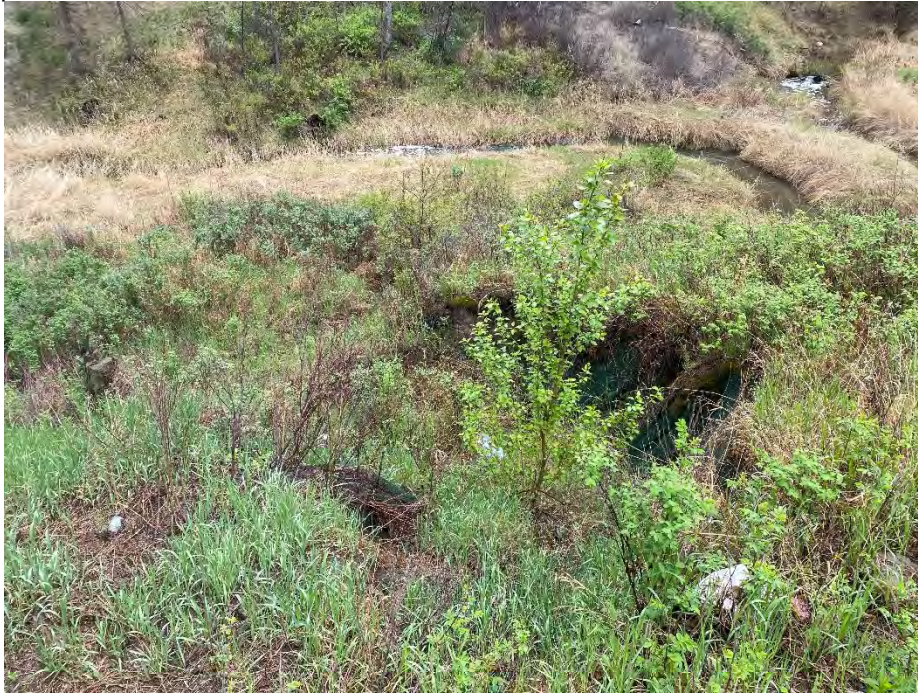
- The gap (fill settlement) at the northeast corner of the northernmost pedestal increased from 240 mm in 2024 to 250 mm.
- The two slumps on the west slope between the concrete piers appear relatively unchanged since 2022. The scarp of the north slump was measured to be 0.7 m away from the concrete pedestal (Photo 9).

Photo 9: Eastern slump in middle of the west slope, between pedestals. Looking south.

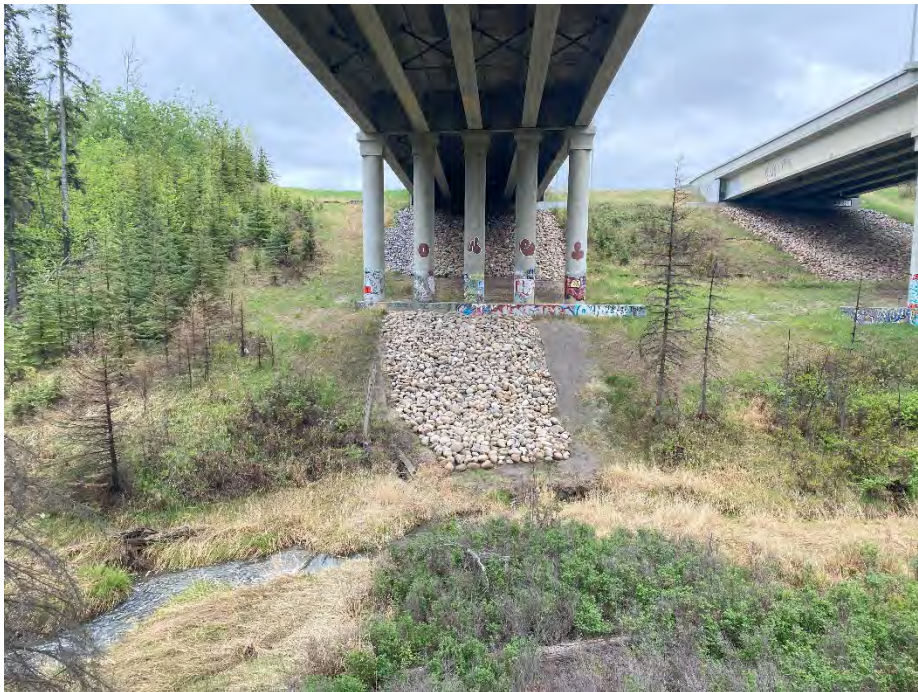
- The erosion mat below the north pedestal on the west bank is exposed, but appears similar to previous inspections.
- The slope failure repair below the northernmost pedestal on the east bank appears to be in good condition. A portion of the repaired slope to the south of the riprap remains largely unvegetated (Photo 10).

Photo 10: Repaired slope failure on east bank below AHD northbound pedestal. Looking southeast.

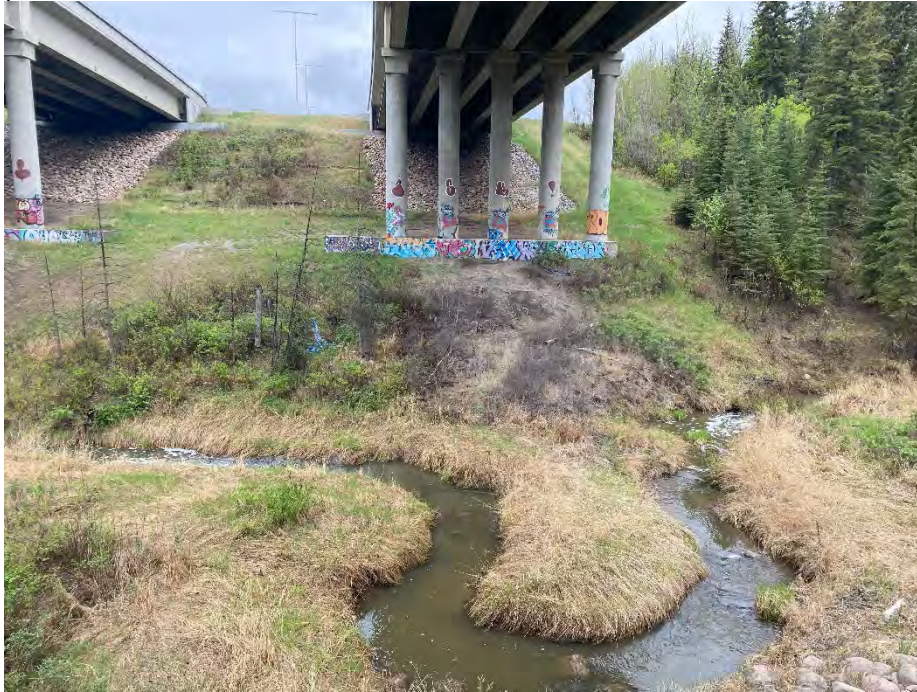
- The vegetation on the east bank below the AHD southbound pedestal appears to be dead, similar to previous inspections (Photo 11).
- The slope inclinometer SI20-02 shows a current rate of movement of less than 1 mm/year at approximately 1.2 m and 4.2 m. SI20-01 was found blocked at 6 m during the Spring 2025 reading cycle.

Photo 11: Dead vegetation on east bank below the AHD southbound pedestal. Looking southeast.
