| <b>SITE NUMBER AND NAME:</b><br>NC094 – 100 Ave at NB AHD | <b>HIGHWAY AND KM:</b><br>216:06, km 20.550 | <b>PREVIOUS INSPECTION:</b><br>June 20, 2024 | <b>CURRENT INSPECTION:</b><br>May 21, 2025 |

| <b>PRIMARY SITE ISSUE:</b><br>Slumping of the side slope embankment south of 100 Ave between two overpass bridges (81038 S2-7 and 81038 N1-1) for the Anthony Henday Drive (AHD). | |

Client/Project  
 Transportation and Economic Corridors  
 Geohazard Monitoring Program  
 NC094 – 100 Ave at NB AHD

2025 Site Inspection Photos at NC094

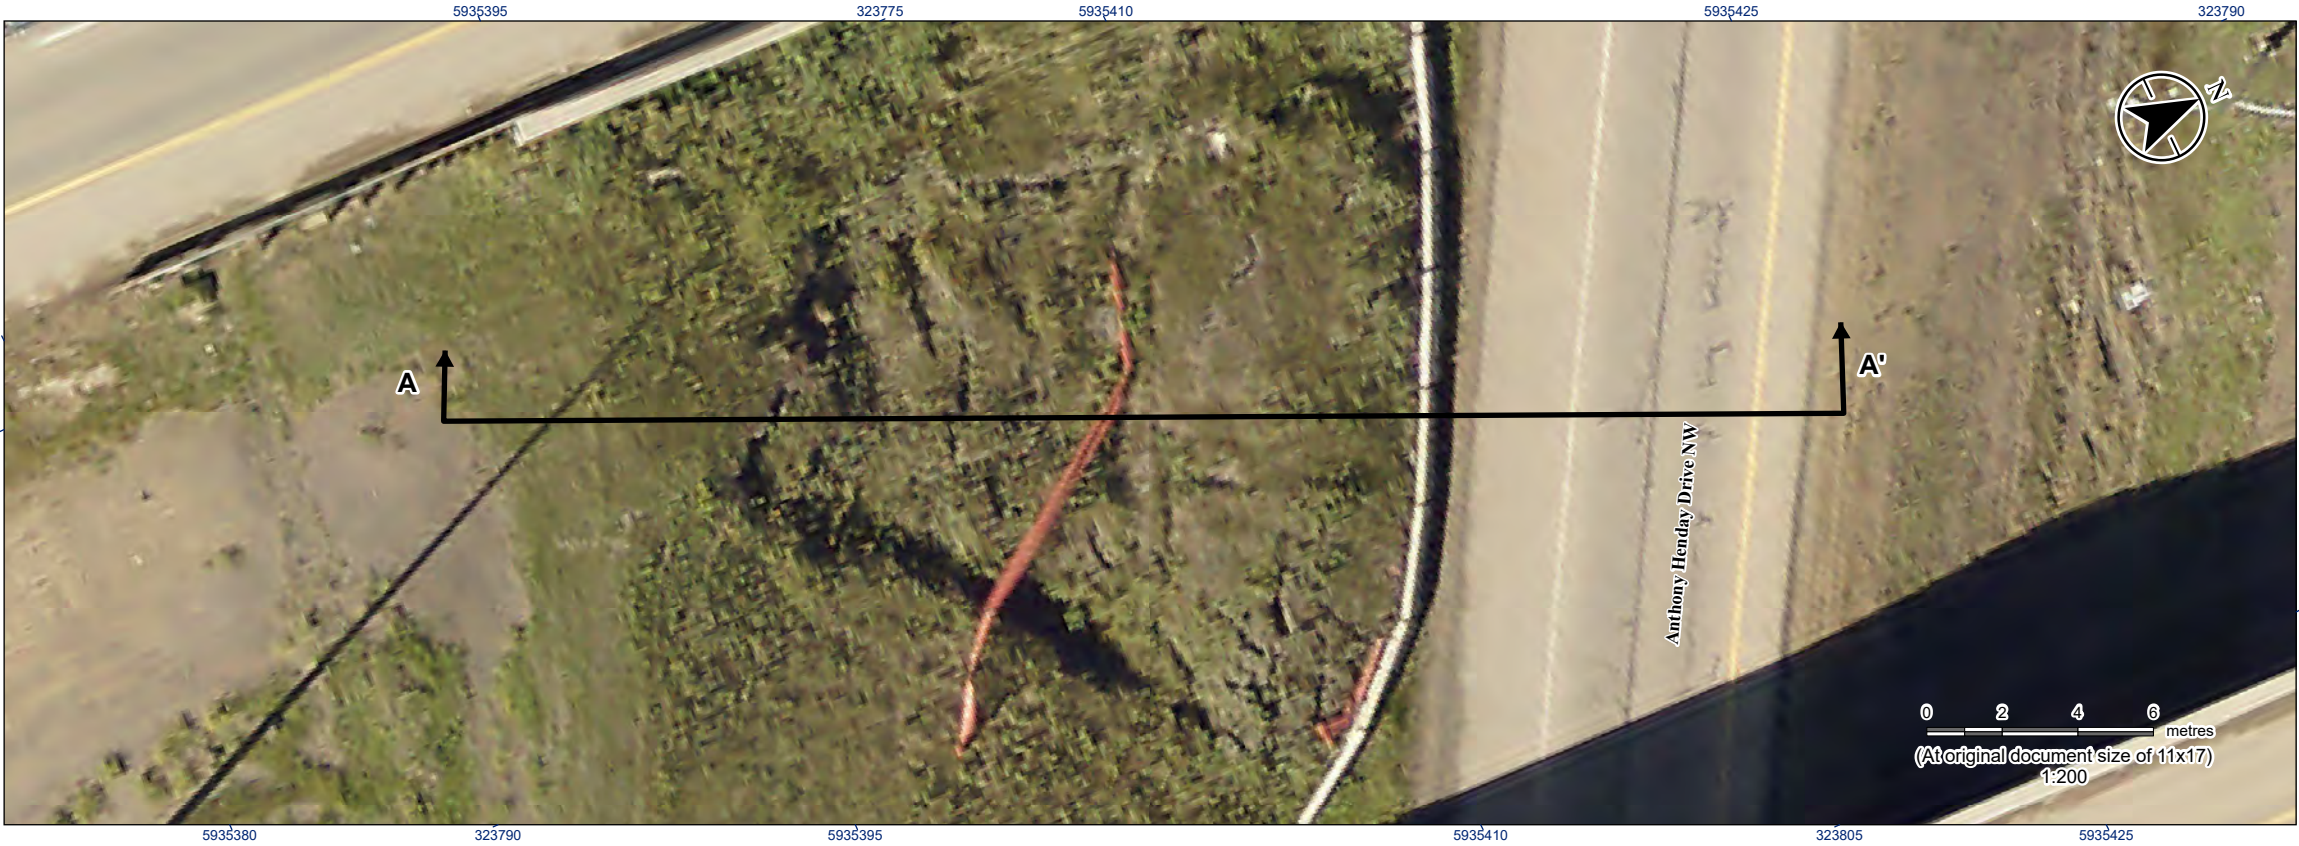
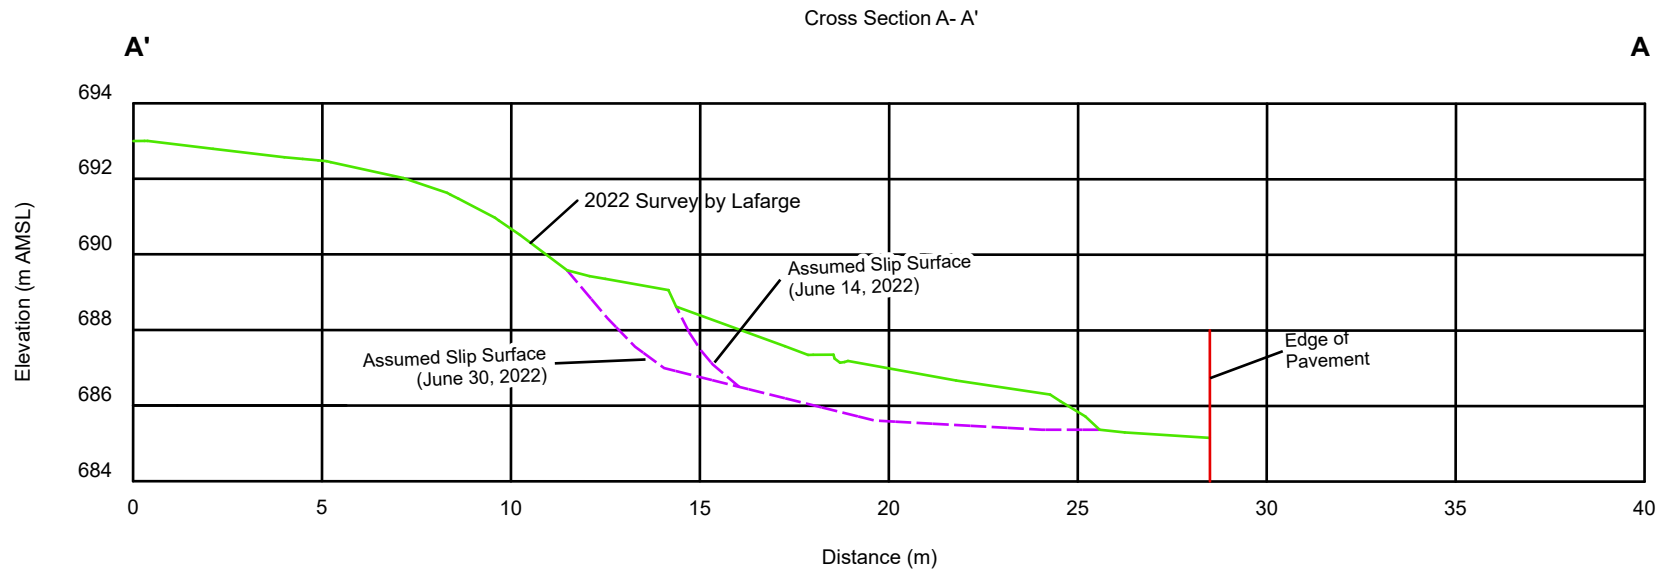
**Title**  
**Ground Profile of Section A-A'**

- The landslide appears to be a shallow failure limited to the bridge/embankment fill. The landslide may be due to a combination of poor-quality embankment backfill and softening of the embankment fill near mid-slope. In addition, typical bridge and embankment compaction methods often result in less compaction at the slope face since compaction equipment cannot adequately compact the edges and slopes. These less compacted areas could allow water to infiltrate the slope more easily.

- The MCI and/or HMC should monitor the slump for progression towards 100 Avenue and the jersey barriers should be adjusted or maintained, as necessary.
- Stantec has completed the landslide remediation design for removal and replace. The design includes excavating the landslide mass in benches with an overall slope of 2H:1V followed by rebuilding the embankment with granular fill reinforced with geogrid.
- TEC could consider annual surveys to monitor the movement of the slide.
- Site inspection frequency should continue annually.

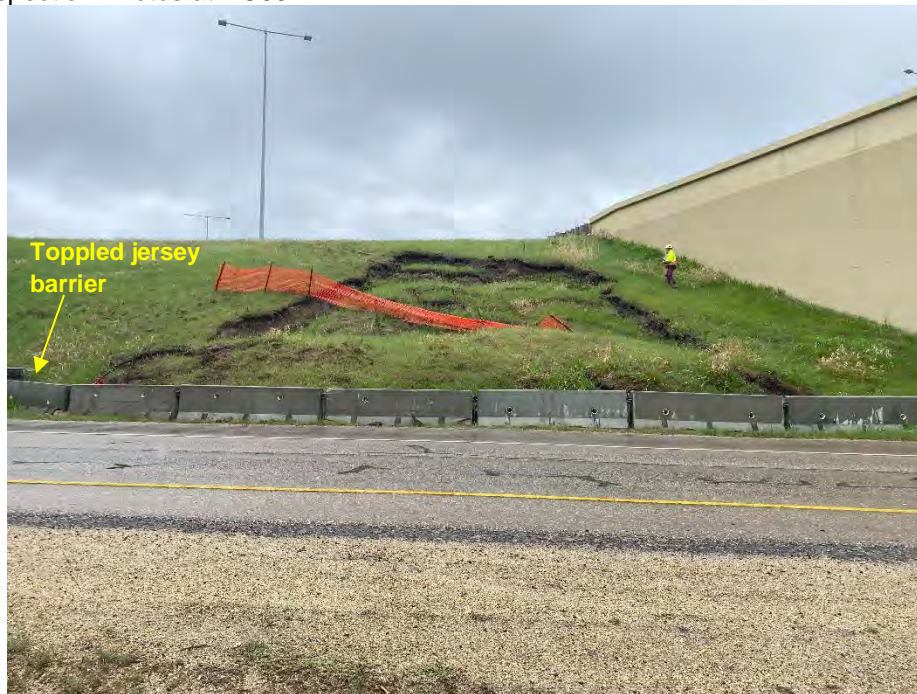
| <b>COMMENTS</b> <ul style="list-style-type: none"> <li>The overall embankment is about 33 m wide and 8 m high. The slump exists between the two bridge abutments south of the 100 Avenue on-ramp to AHD northbound (Photo 1).</li> <li>The landslide is slightly west of center of the embankment. The scarp was measured to be approximately 2.6 m from the crest of the embankment, similar to the previous two inspections. The scarp was observed at the upper portion of the embankment and remains up to 1.1 m high (Photos 1 to 6).</li> <li>The east and west flanks of the landslide are approximately 12.5 m and 4.6 m from the east and west bridge abutment walls, respectively. These measurements have not changed since the 2022 investigation.</li> <li>The toe bulge appears relatively unchanged, with a distance of 1.1 m to the edge of pavement. The toe bulge remains approximately 1.5 m high (Photos 4 and 5).</li> </ul> |

**Photo 1:** Slump on south embankment. Looking southwest.

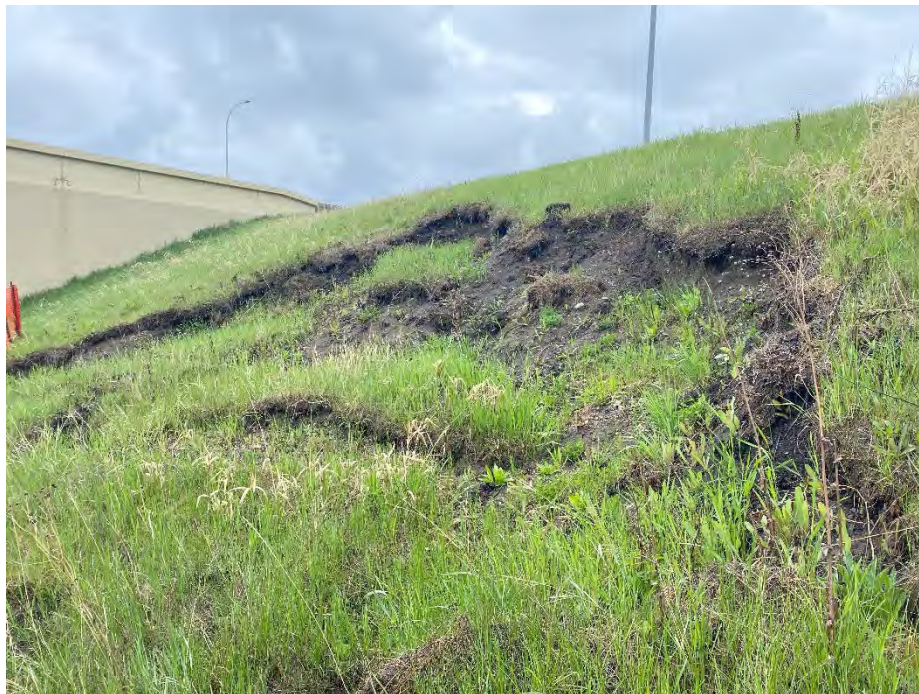
- Surface material within the slide has moved further downslope, exposing more material near the scarp (Photo 2).
- Ponding water was observed to the east of the embankment toe.

**Photo 2:** Scarps near top of slump. Looking southeast.

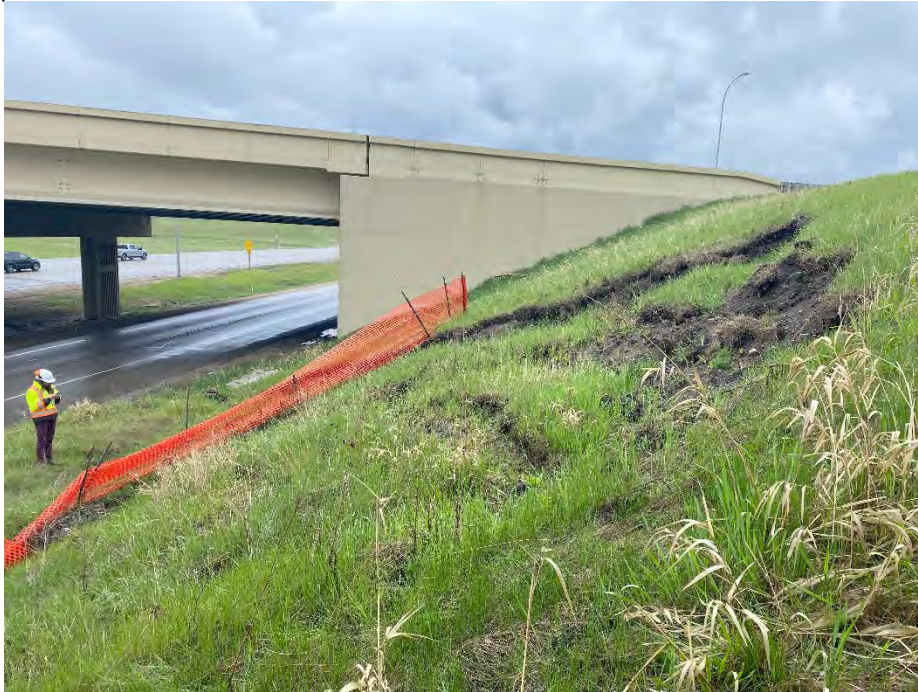
- Snow fence previously placed above the slump has shifted down the embankment, and most of the snow fence placed below the slump is buried beneath the toe bulge. The snow fence appeared to be in a similar position as observed in 2023.

**Photo 3:** Mid to upper portion of slump with displaced snow fence, looking east.

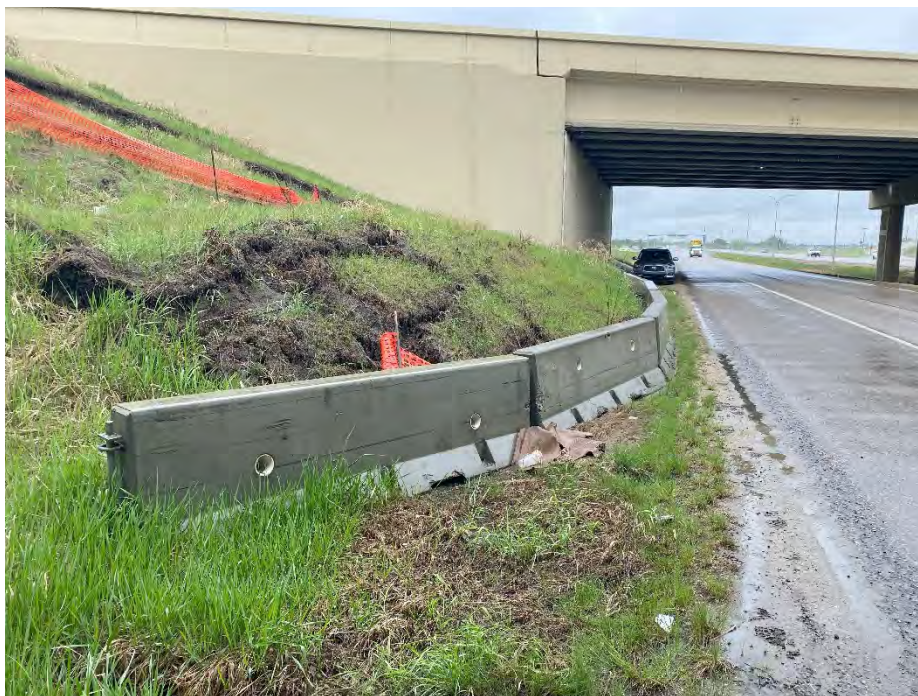
- Jersey barriers have been placed around the toe of the landslide and anchored into the ground. The edge of the jersey barrier is 0.9 m from the edge of the pavement, similar to 2024's measurement, and the toe of the slump is pushed against the back of the jersey barriers (Photos 4 and 5).

**Photo 4:** Toe bulge of slump with scarping/cracking. Looking northwest.

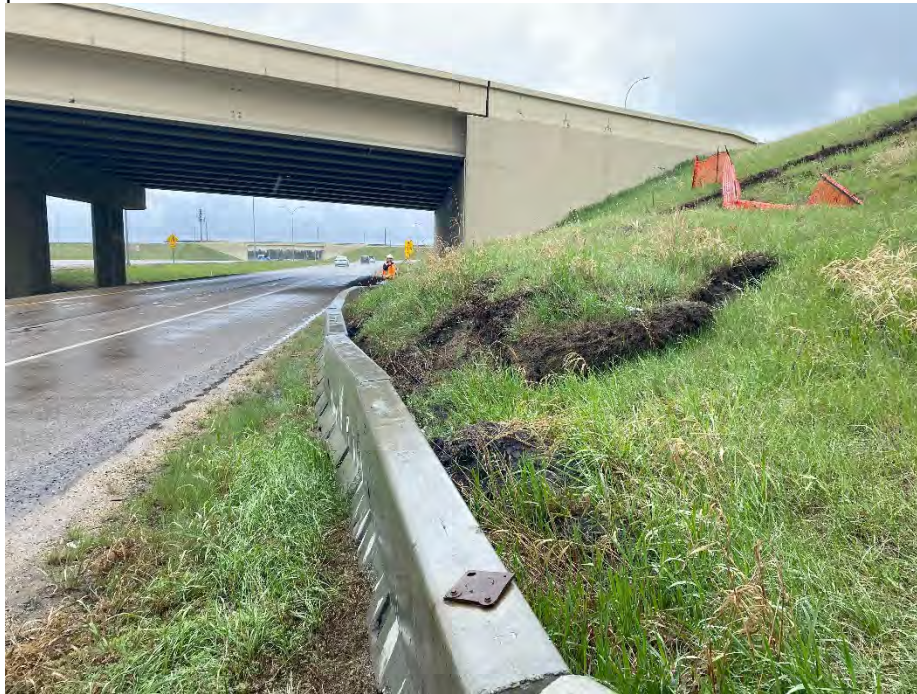
**Photo 5:** Toe of the embankment/slump. Looking southeast.

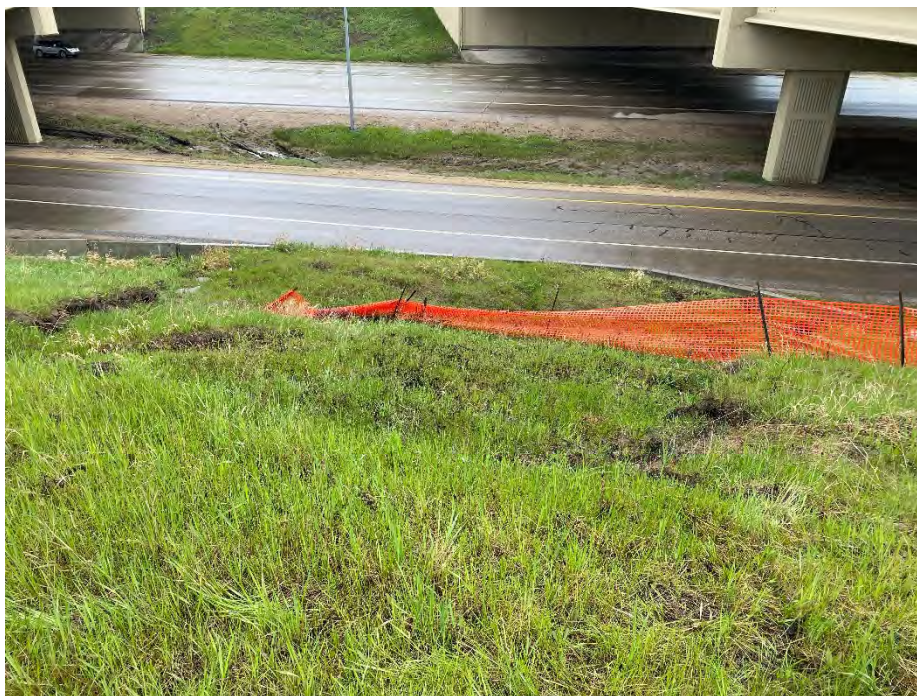
**Photo 6:** Slumping viewed from the crest of the embankment. Looking north.

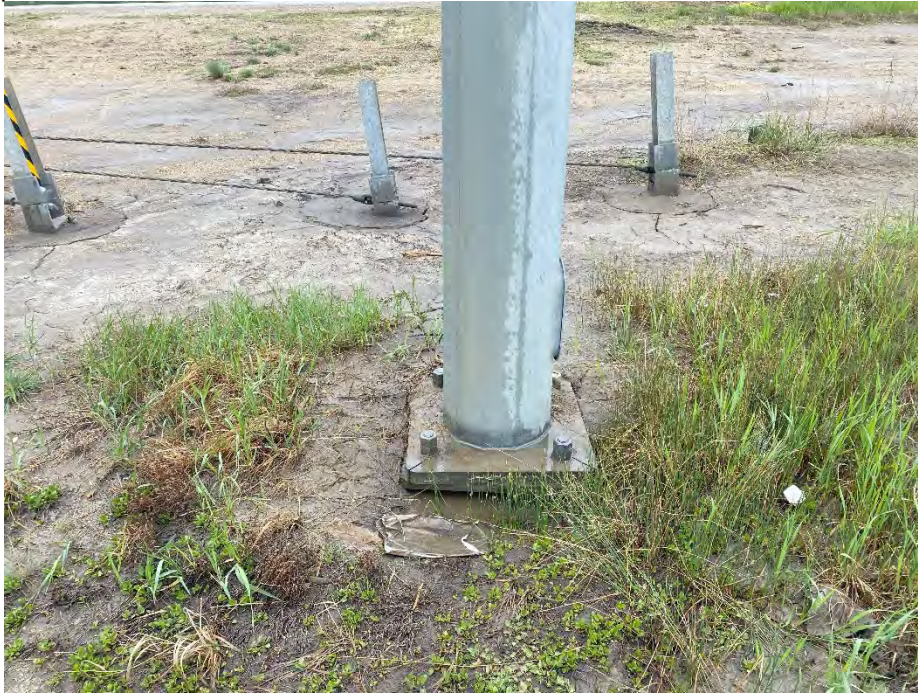
- The settlement at the base of the light standard near the crest of the embankment appeared similar to 2024, with the depression measured 70 mm deep (Photo 7).

**Photo 7:** Scouring/settlement of ground around the light standard closest to the embankment. Looking west.

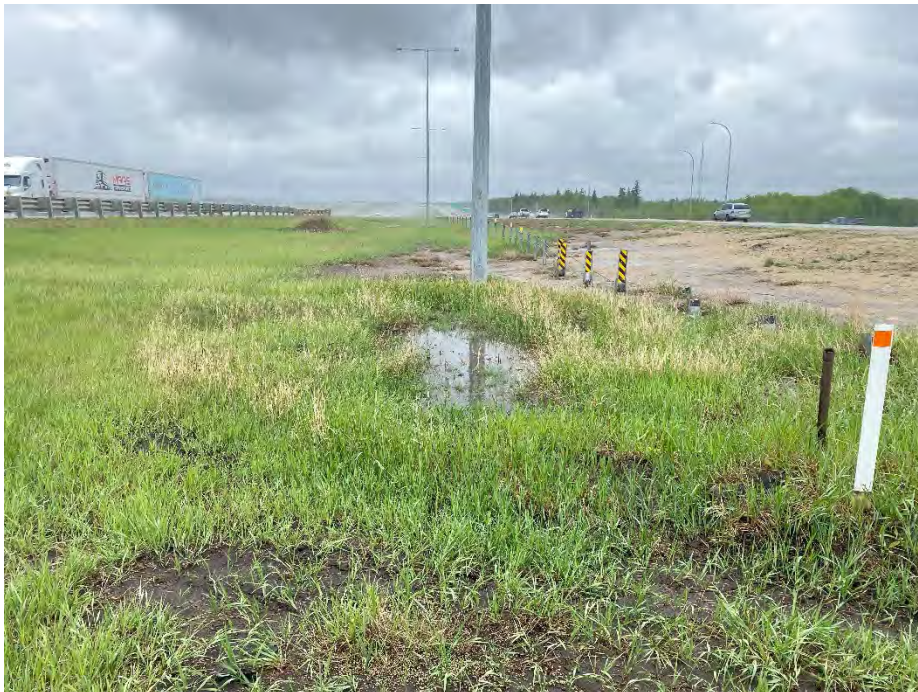
- Ponded water was observed north of the light standard within the low area during this site visit. Water appears to be directed to this location from the overpass bridges from both sides of the embankment (Photo 8).

**Photo 8:** Low area south of embankment crest, ponded water present. Looking south.

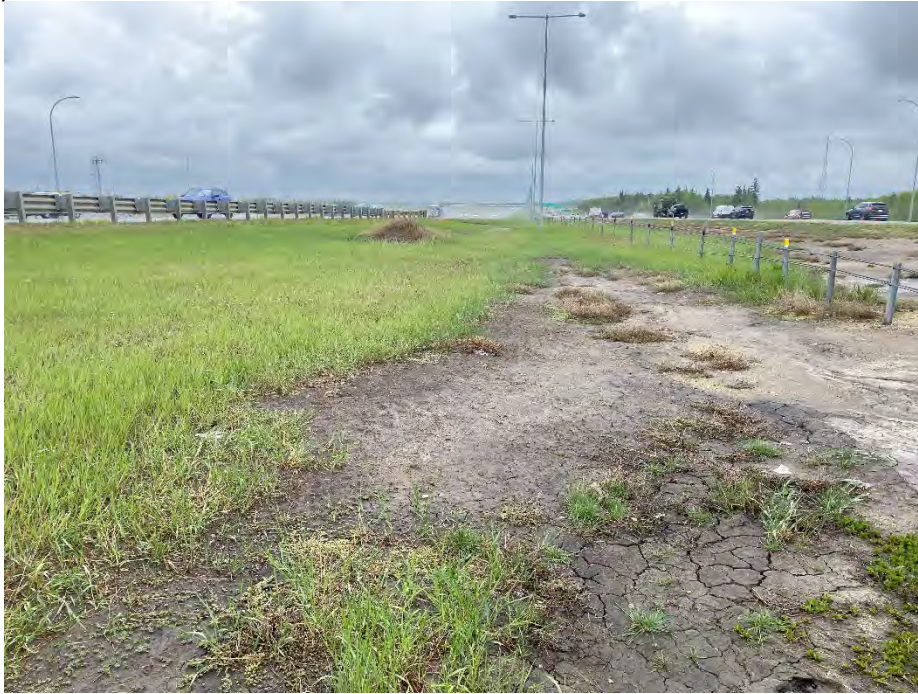
- An area within the highway median, south from the light standard near the crest of the embankment, is lacking vegetation (Photo 9).
- During the call-out inspection in 2022, the exposed soils within the slump appeared wet and pieces of concrete and occasional pockets of grey fill material were observed throughout the slope. The grey fill material is believed to be from the bottom ash used during bridge abutment construction.

**Photo 9:** Highway median, lacking vegetation. Looking south.
