SITE NUMBER AND NAME: NC112 - Slide South of TWP 522	HIGHWAY AND KM: 22:30, km 42.513	PREVIOUS INSPECTION: June 14, 2024	CURRENT INSPECTION: May 20, 2025
LEGAL DESCRIPTION: SW-09-52-07-W5M, SE-08-52-07-W5M	NAD83 COORDINATES: UTM11U 5927044 N, 633771 E		RISK ASSESSMENT: PF: 11 CF: 4 Total: 44
AVERAGE ANNUAL DAILY TRAFFIC (AADT): 3,430 (2024)		CONTRACTOR MAINTENANCE AREA (CMA): 509

SUMMARY OF INSTRUMENTATION: N/A	INSPECTED BY: Stantec: Leslie Cho, Sonja Pharand TEC: Kristen Tappenden
PRIMARY SITE ISSUE: Landslide resulting in differential pavement cracking in the southbound lane	
APPROXIMATE DIMENSIONS: 20 m long x 33 m wide	
DATE OF ANY REMEDIAL ACTION: N/A

Client/Project
Alberta Transportation and Economic Corridors
Geohazard Monitoring Program
NC112 Hwy 22:30 Slide

2025 Inspection Photos at NC112

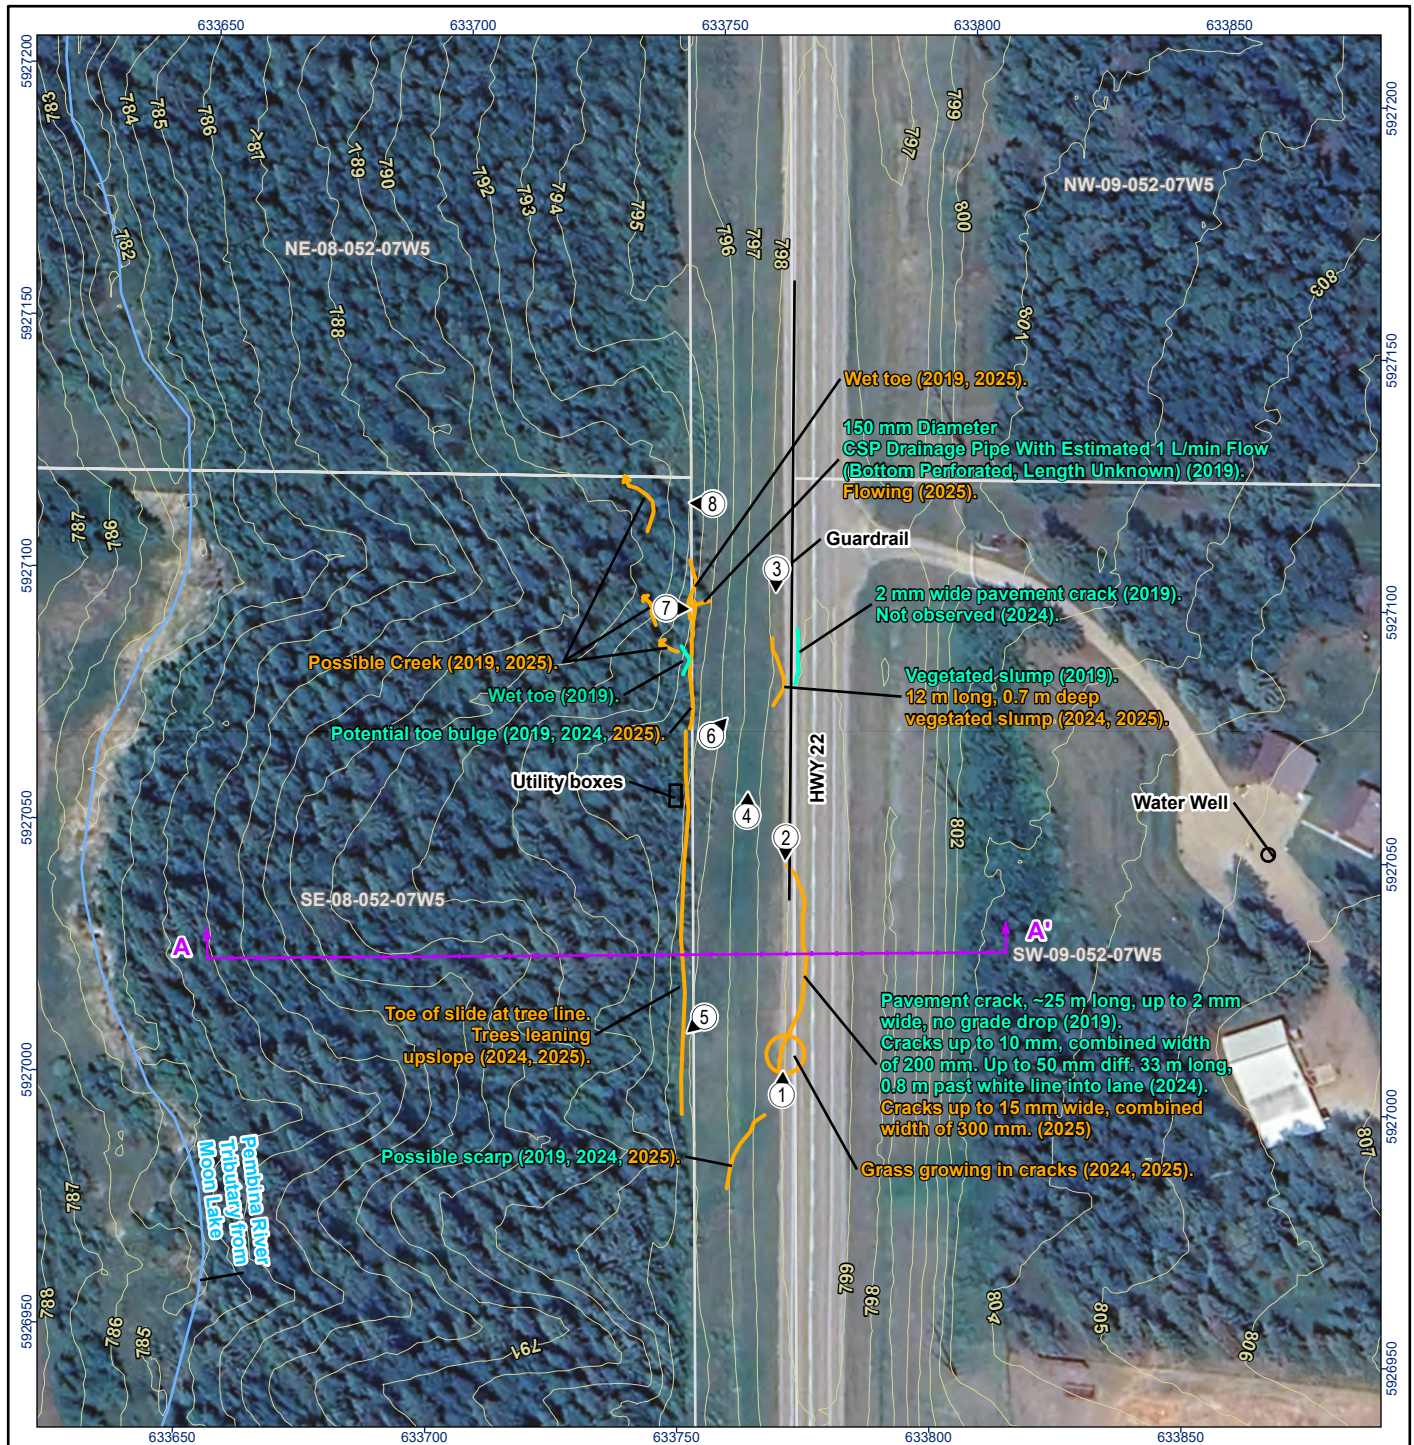
Figure No.
1

Title
Site Plan

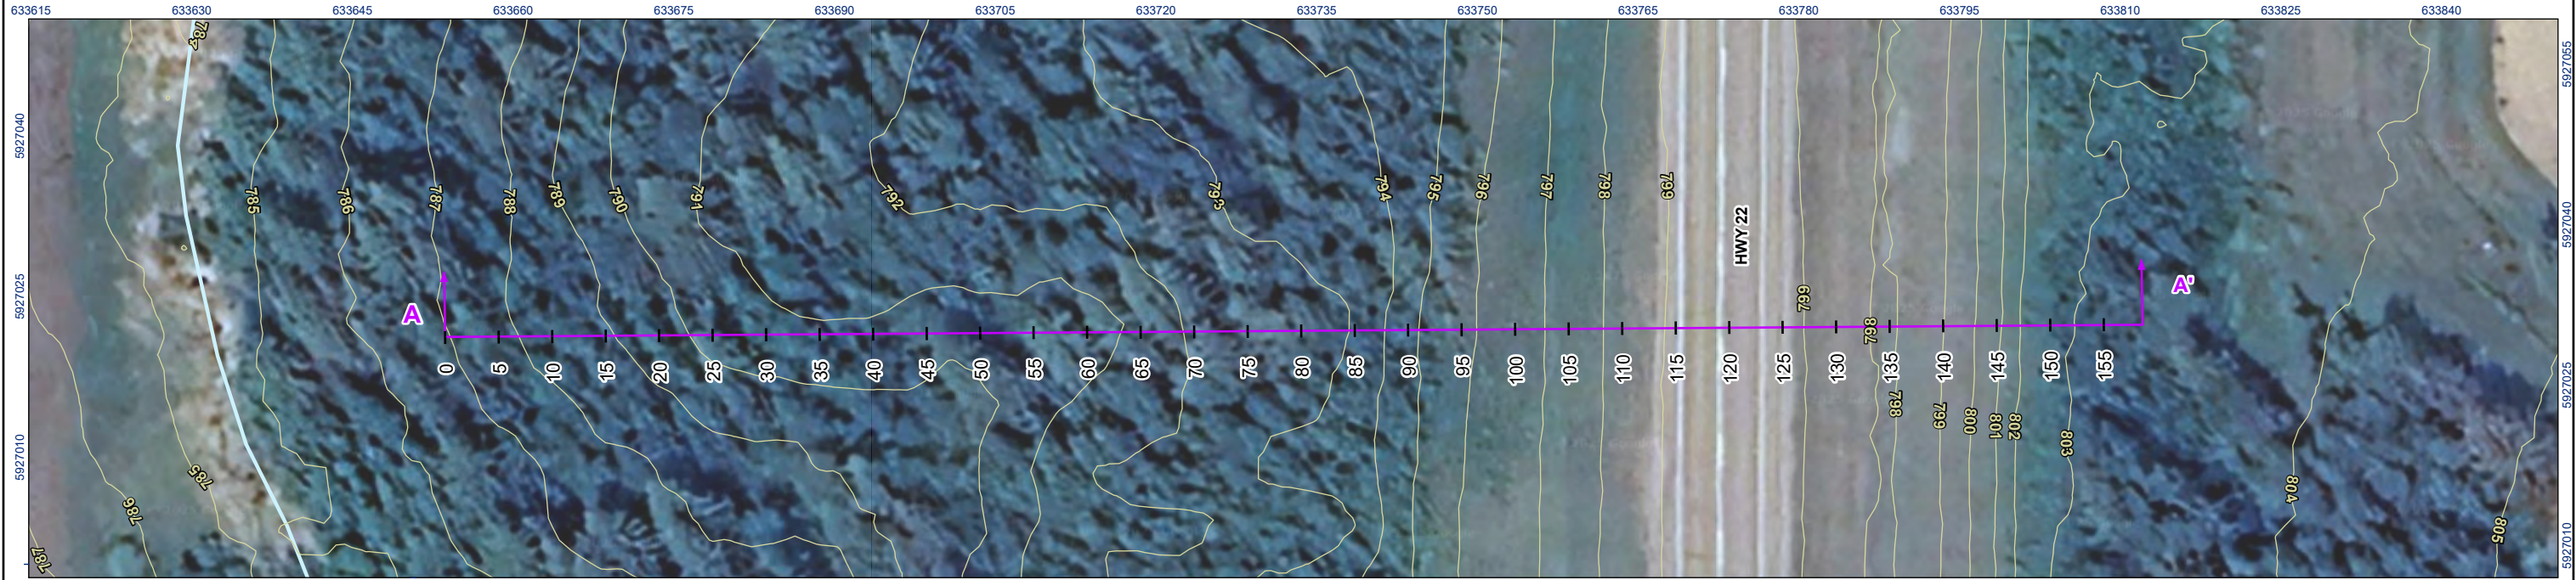
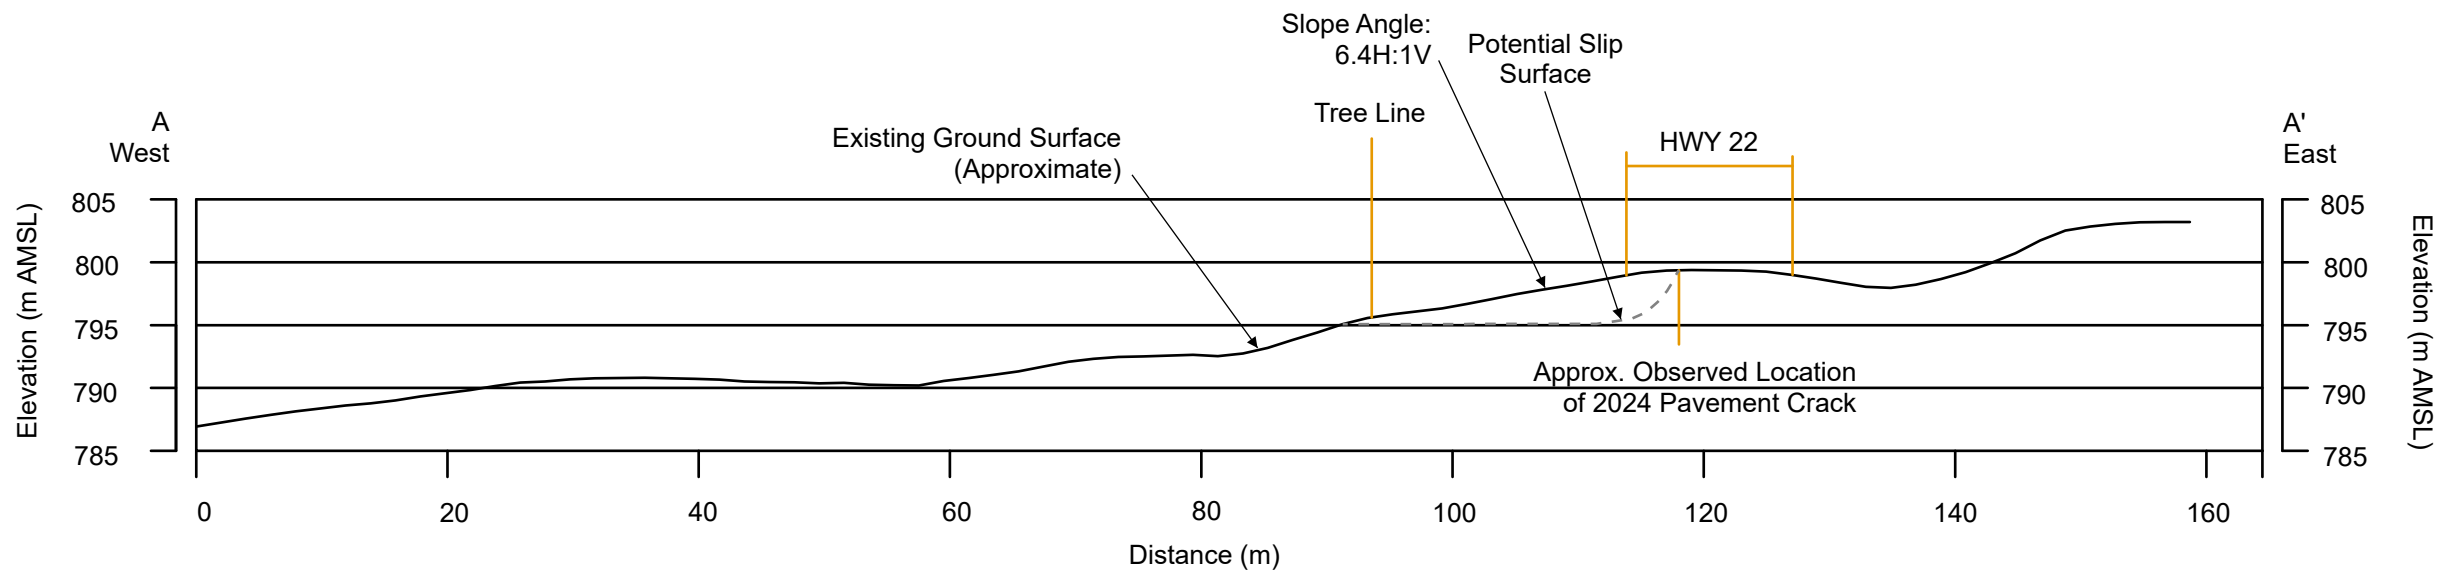
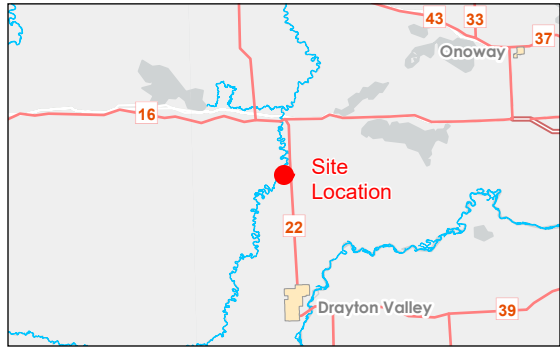
2

Highway 22 Cross-Section

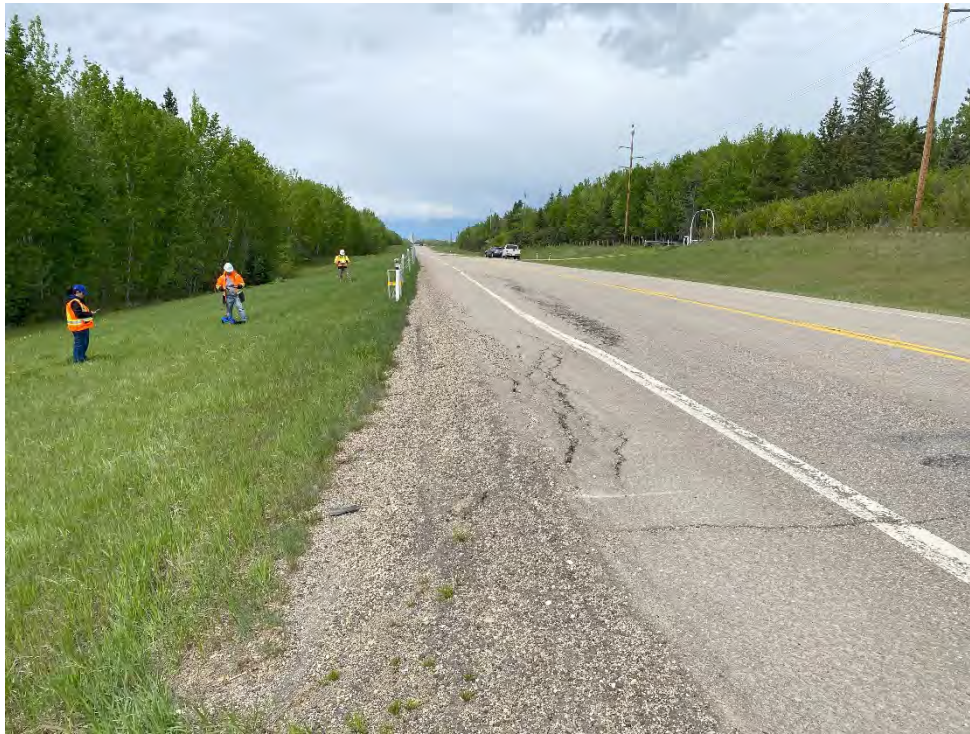
COMMENTS <ul style="list-style-type: none"> Highway 22 appears to be constructed as a sidehill cut-fill based on the surrounding topography (Photos 9 & 10). The crest of the landslide appears to be within the southbound land of Highway 22, approximately 0.8 m east from the painted white line, similar to 2024. Pavement cracking is apparent within the southbound lane of Highway 22, with cracks up to 15 mm wide, collectively creating a curved cracking path up to 300 mm wide and 33 m long. The width of the cracking path has increased approximately 100 mm since the 2024 inspection. A vertical difference up to about 50 mm was observed on either side of the cracks, similar to 2024. The cracks start and stop at the edge of the pavement. Vegetation is growing out of the cracks toward the south end of the crack (Photos 1 & 2). A rough road warning sign is posted approximately at the vegetated slump (north slide) (Photo 3). The west slope is generally vegetated with horsetail, which is a plant that favours moist to wet environments suggesting a potentially wet embankment slope.

Photo 1: Cracking in the southbound lane, south end. Looking north.

- In the short term, the pavement on the highway surface could be milled and re-paved to reduce any hazards the pavement difference and cracking may present to road users. The final paved surface should not be higher than the current roadway surface such that no net addition of load is applied to the embankment slope. Furthermore, pavement crack sealing could be completed to prevent surface water infiltration into the embankment.

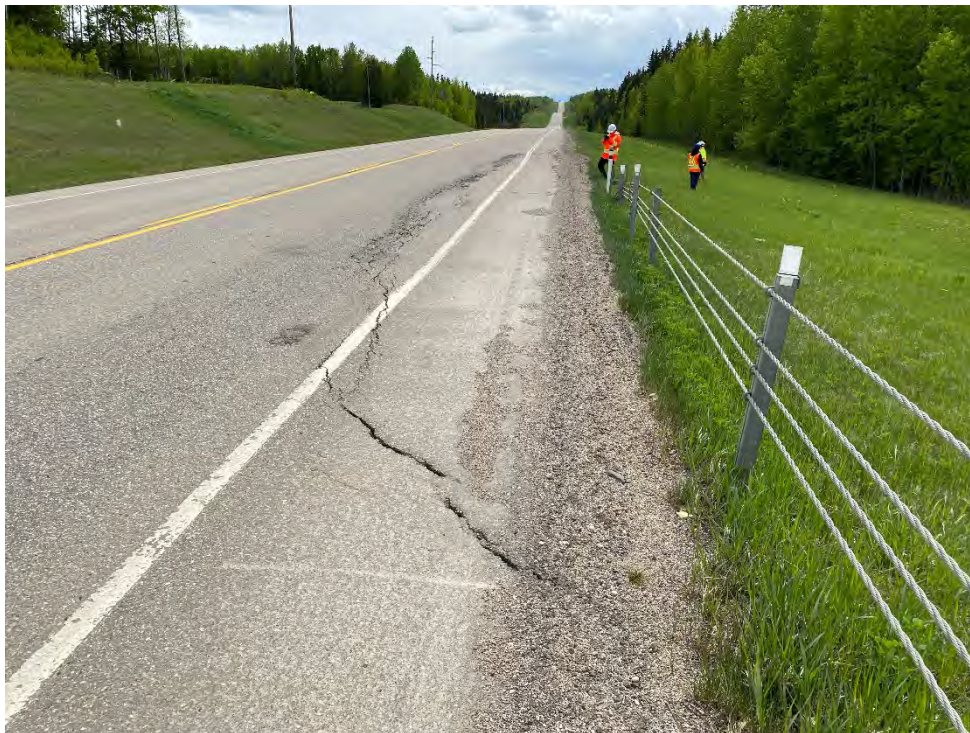
Photo 2: Cracking in the southbound lane, north end. Looking south.

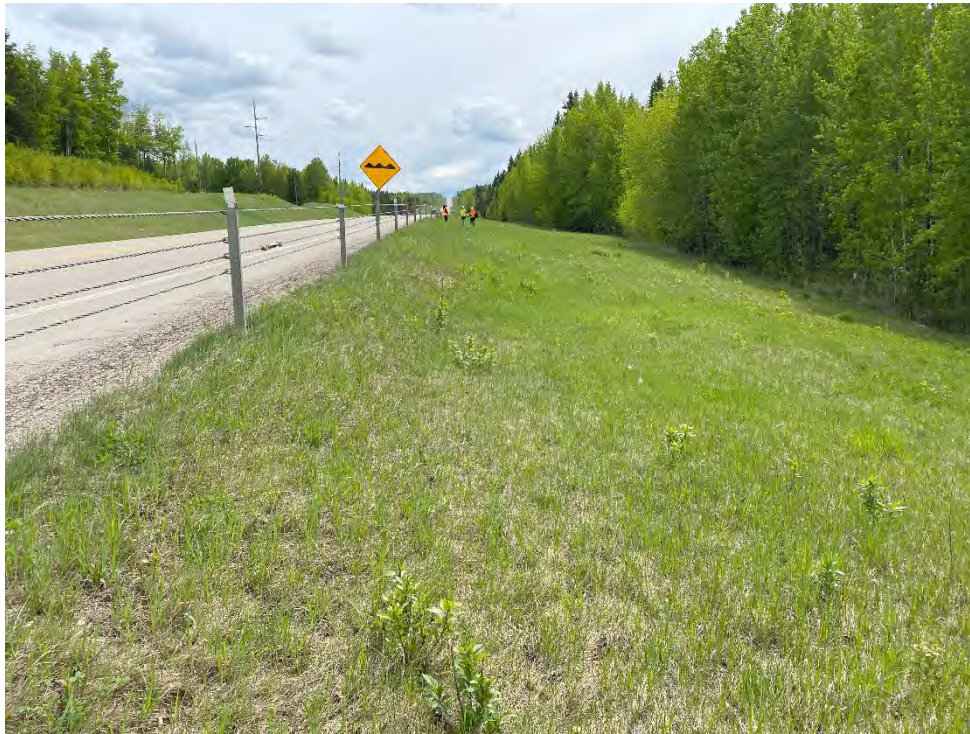
Photo 3: Rough road warning sign posted north from the pavement cracking. Looking south.

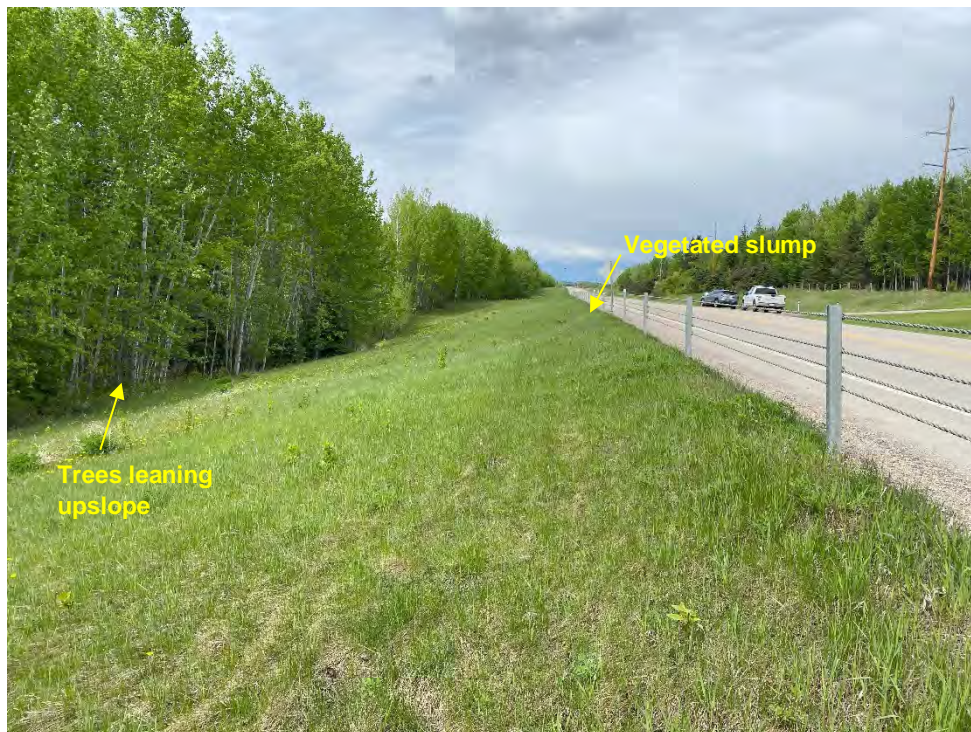
- The toe of the landslide appears to be just beyond the western tree/fence line. Many of the trees are leaning upslope (Photos 4 & 5).
- A vegetated slump approximately 12 m long and 0.7 m deep is located on the upper west slope, approximately 0.5 m to 1.0 m from the edge of the pavement. This slump is north from the pavement cracking (Photos 4 & 6). Little to no change was observed at the vegetated slump since 2019.

Photo 4: West embankment slope and tree line. Looking north.

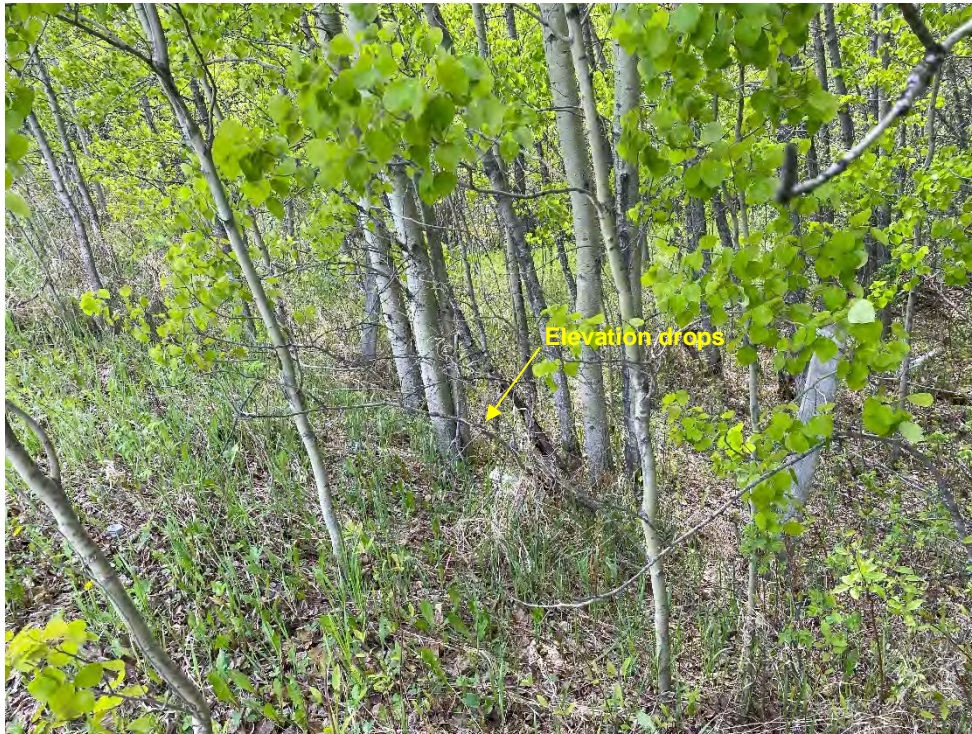
Photo 5: Toe of landslide just behind tree line. Fence present. Looking southwest.

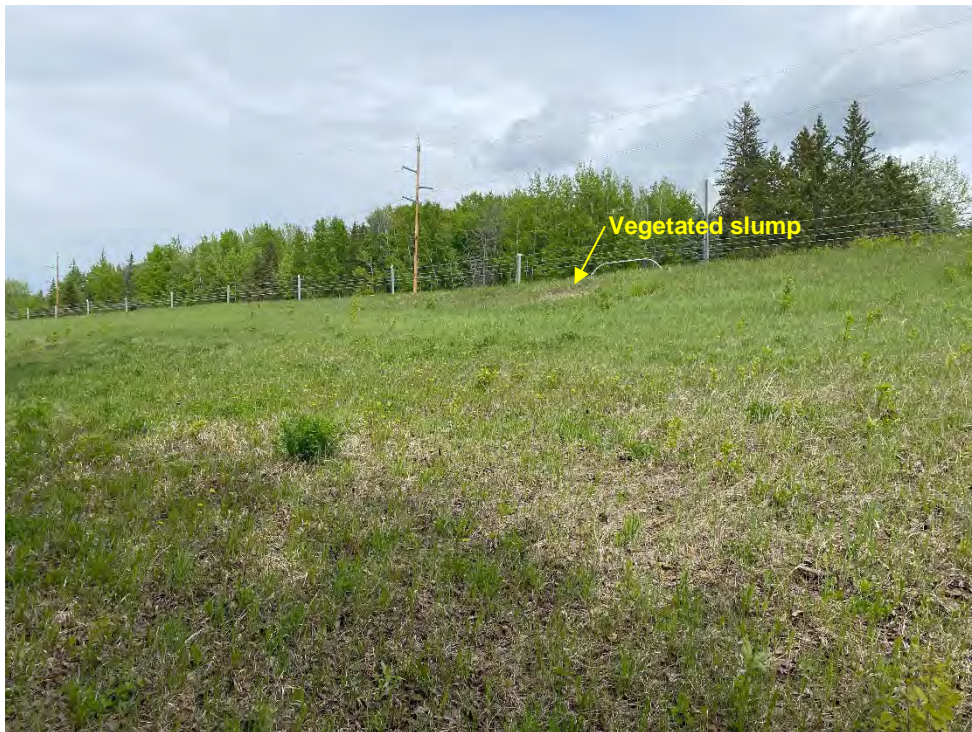
Photo 6: Vegetated slump, looking northeast from tree line.

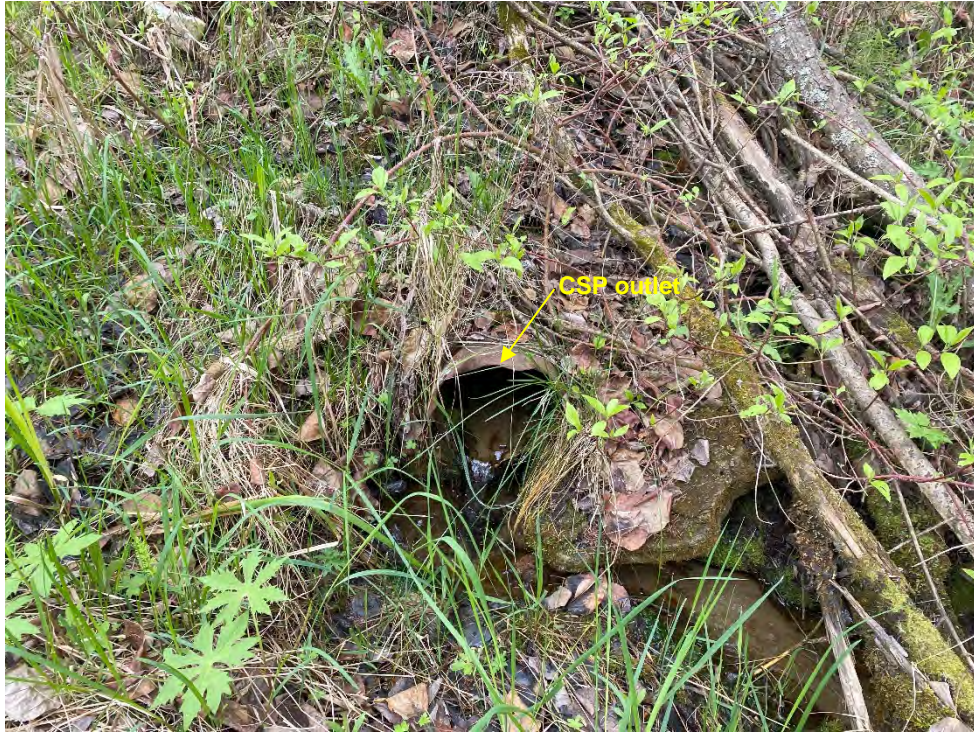
- A bulge, approximately 0.5 m high and 4 m long is present on the upper west slope to the south of the pavement cracking.
- A 150 mm diameter CSP culvert outlet was observed in 2019 near the toe of the slope within the treed area. This outlet was not observed during the 2024 inspection but was located again during the 2025 inspection. Water was actively flowing from the culvert outlet (Photo 7).

Photo 7: 150 mm diameter CSP outlet within treed area, on west side of Highway. Looking east.

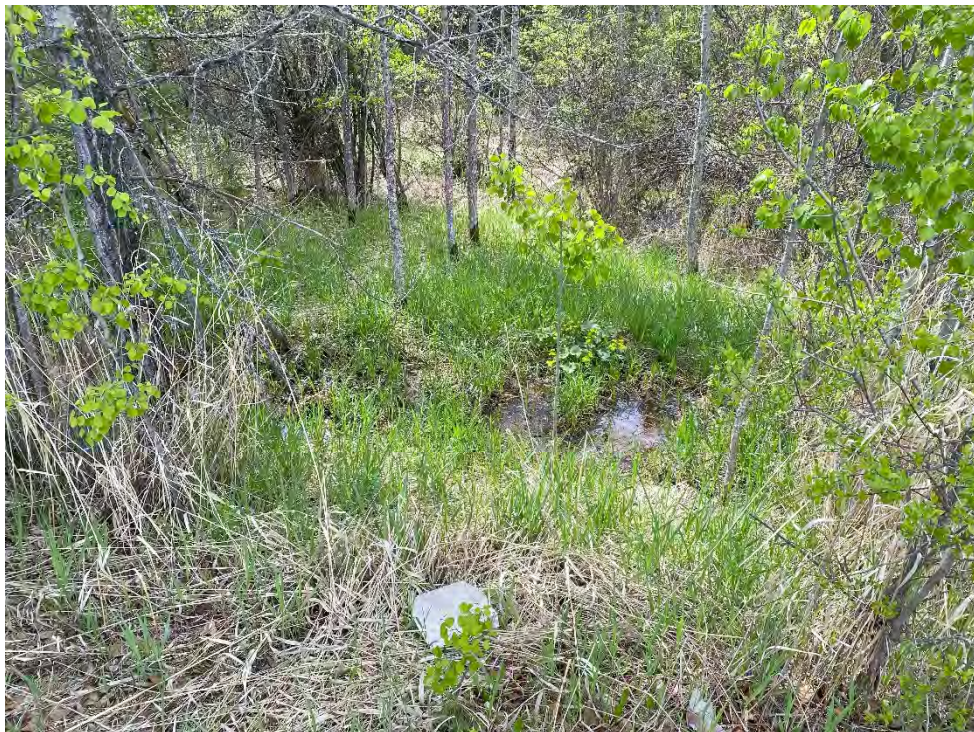
- A potential slow flowing creek appears to be present within the treed area (Photo 8).
- 2014 LiDAR shows two features downslope from the pavement cracking and highway Right of Way that appear to be drainage channels. It is possible that subsurface water continues to flow through the old drainage channels leading to the softening of the foundation soils at this section of Highway 22, and resulting in the observed slope failure.

Photo 8: Possible creek observed within treed area of slope. Looking west.

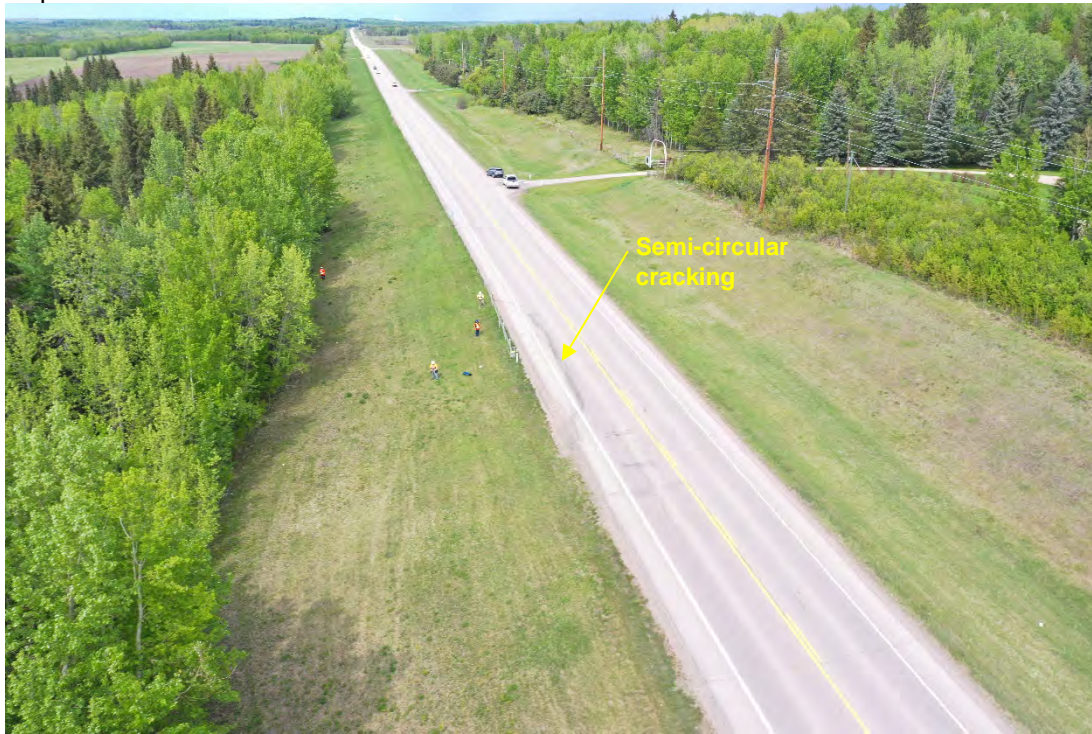
Photo 9: Aerial photo of Highway 22 cracking and slope, facing northeast. Taken by drone.

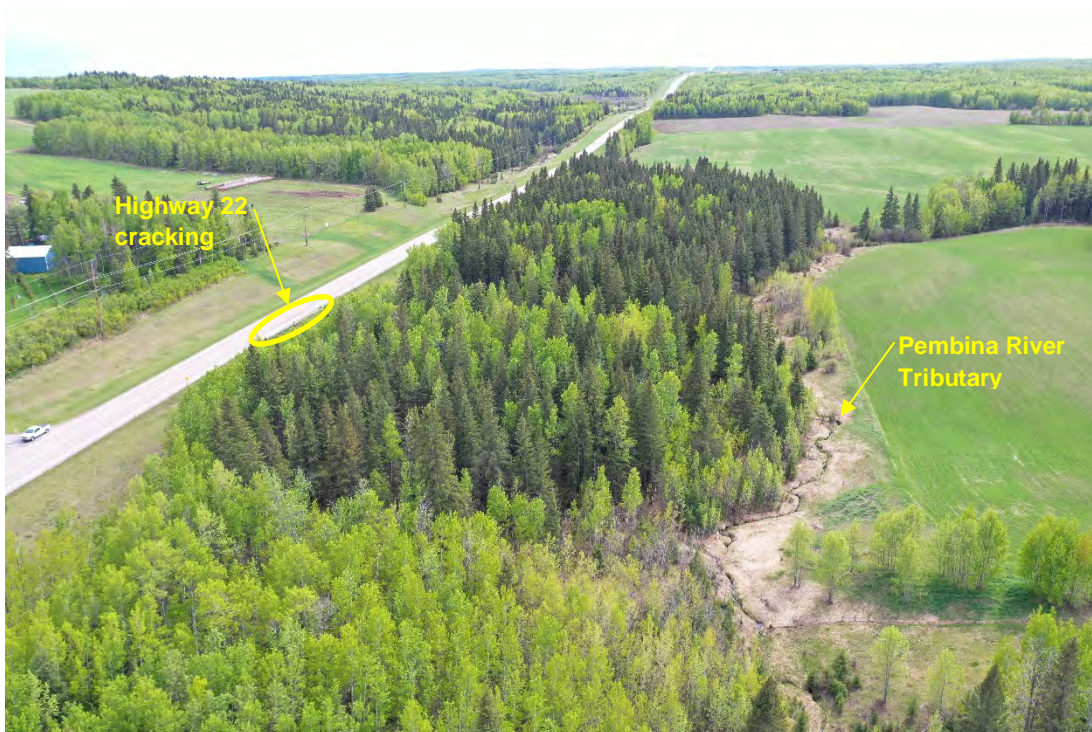
Photo 10: Aerial photo of Highway 22 and Pembina River Tributary, facing south. Taken by drone.
