SITE NUMBER AND NAME: Highway 22 Slide South of TWP 522	LOCATION: Highway 22 southbound, across from 52115 Highway 22, Entwistle, Alberta	HIGHWAY: 22:30:C1	KM: 42.513
LEGAL DESCRIPTION: SW-09-52-07-W5M, SE-08-52-07-W5M	NAD83 COORDINATES: UTM11U 5927044 N, 633771 E		
AVERAGE ANNUAL DAILY TRAFFIC (AADT): 3,340 (2023)		CONTRACTOR MAINTENANCE AREA (CMA): 509

DATE	PF	CF	TOTAL
PREVIOUS INSPECTION:	May 14, 2019	7	2	14
CURRENT INSPECTION:	June 14, 2024	11	4	44
INSPECTED BY:	Stantec: Leslie Cho and Sonja Pharand TEC: Kristen Tappenden			
REPORT ATTACHMENTS:	Figure 1 – Site Plan Figure 2 – Site Cross-Section Site Photographs

PRIMARY SITE ISSUE: Landslide resulting in differential pavement cracking in the southbound lane
APPROXIMATE DIMENSIONS: 20 m long by 33 m wide
SITE BACKGROUND AND HISTORY: <ul style="list-style-type: none"> Fenton, M.M., Waters, E.J., Pawley, S.M., Atkinson, N., Utting, D.J. and McKay, K. (2013): Surficial geology of Alberta; Alberta Energy Regulator, AER/AGS Map 601. <ul style="list-style-type: none"> Surficial geology consists of glaciolacustrine deposits comprising primarily of fine-grained, distal sediments deposited in or along the margins of glacial lakes. Prior

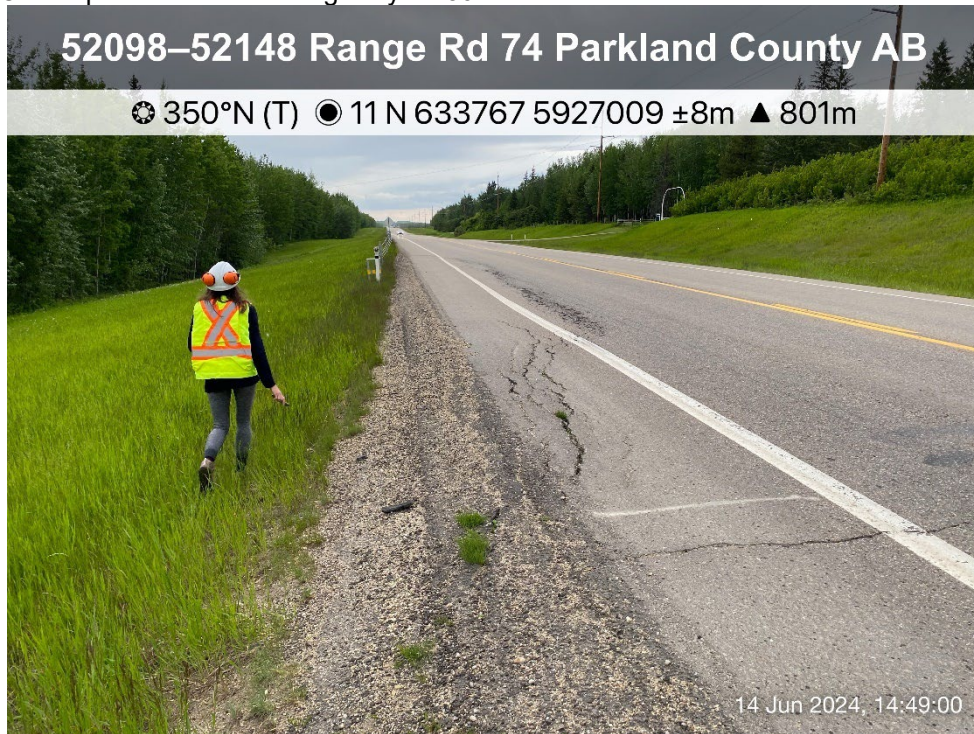
- Pavement cracking is apparent within the southbound lane of Highway 22, with cracks up to 10 mm wide, collectively creating a curved cracking path up to 200 mm wide and 33 m long. In 2019, no vertical difference was observed in the pavement cracking; however, a vertical difference up to about 50 mm was observed on either side of the cracks during the current inspection. The cracks start and stop at the edge of the pavement. Vegetation is growing out of the cracks toward the south end of the crack (Photos 1 & 2).

Photo 1: Highway 22 cracking in the southbound lane, south end. Looking north.

- In the short term, the pavement on the highway surface could be milled and re-paved to reduce any hazards the pavement difference and cracking may present to road users. The final paved surface should not be higher than the current roadway surface such that no net addition of load is applied to the embankment slope.

Furthermore, pavement crack sealing could be completed to prevent surface water infiltration into the embankment.

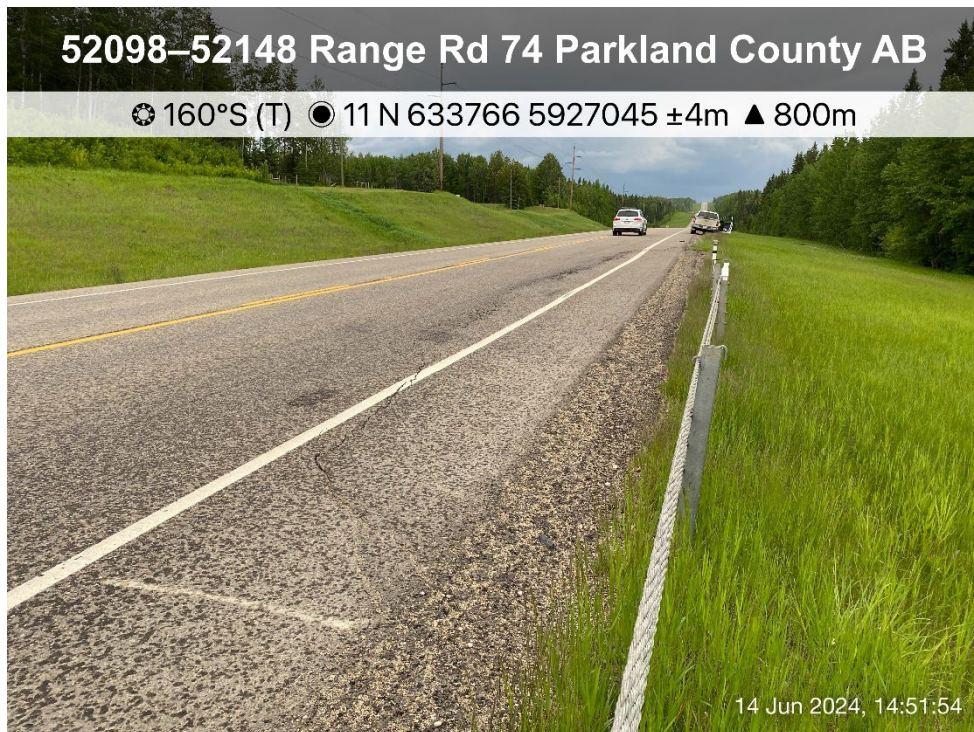
Photo 2: Highway 22 cracking in the southbound lane, north end. Looking south.

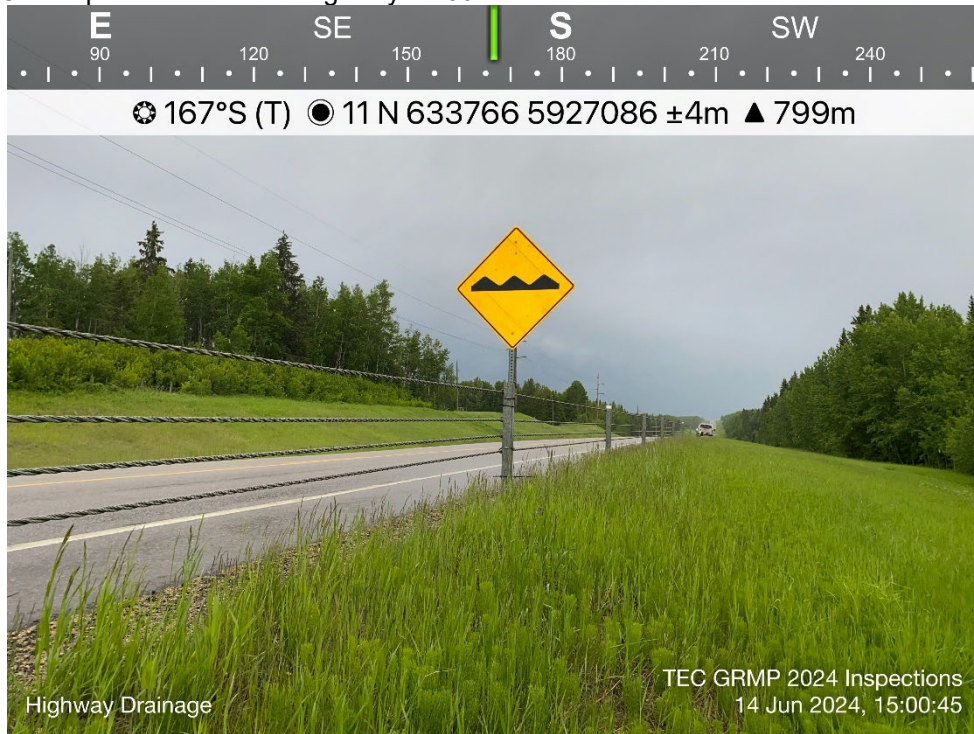
- A rough road warning sign is posted approximately at the vegetated slump (north slide) (Photo 3).
- A 150 mm diameter drain pipe was observed in 2019 near the toe of the slope within the treed area. This drain pipe was not observed during the 2024 inspection, possibly due to relatively thick grass cover.

Photo 3: Rough road warning sign posted north from the pavement cracking. Looking south.

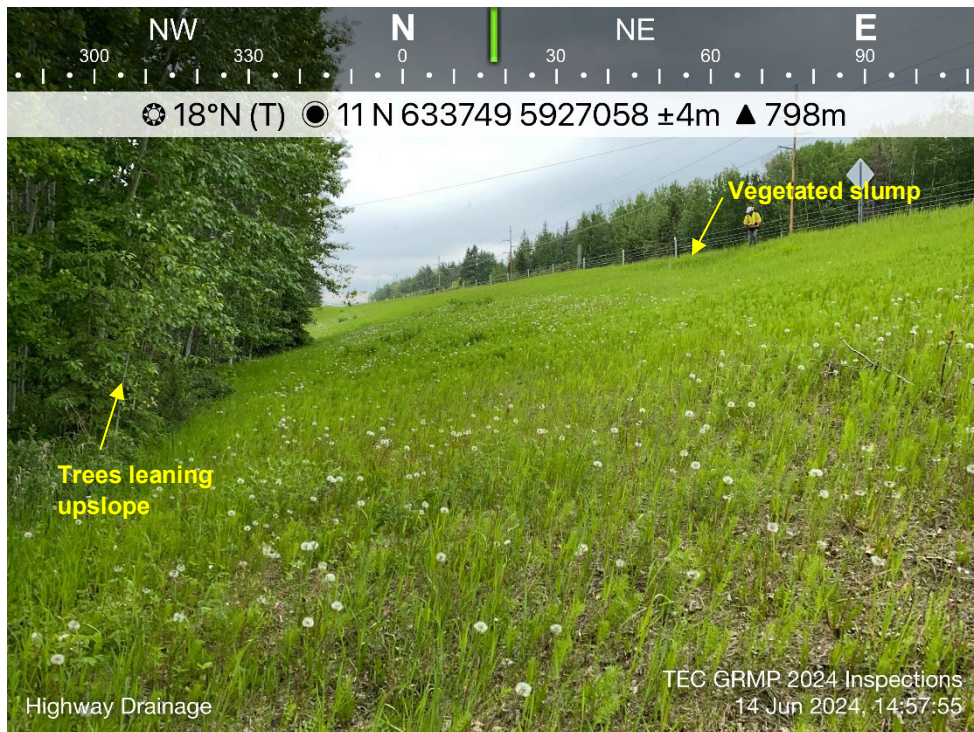
- The toe of the landslide appears to be just beyond the western tree/fence line. Many of the trees are leaning upslope (Photos 4 & 5).
- A vegetated slump approximately 12 m long and 0.7 m deep is located on the upper west slope, approximately 0.5 m to 1.0 m from the edge of the pavement. This slump is north from the pavement cracking (Photos 4 & 6). Little to no change was observed at the vegetated slump since 2019.

Photo 4: West embankment slope and tree line. Looking north.

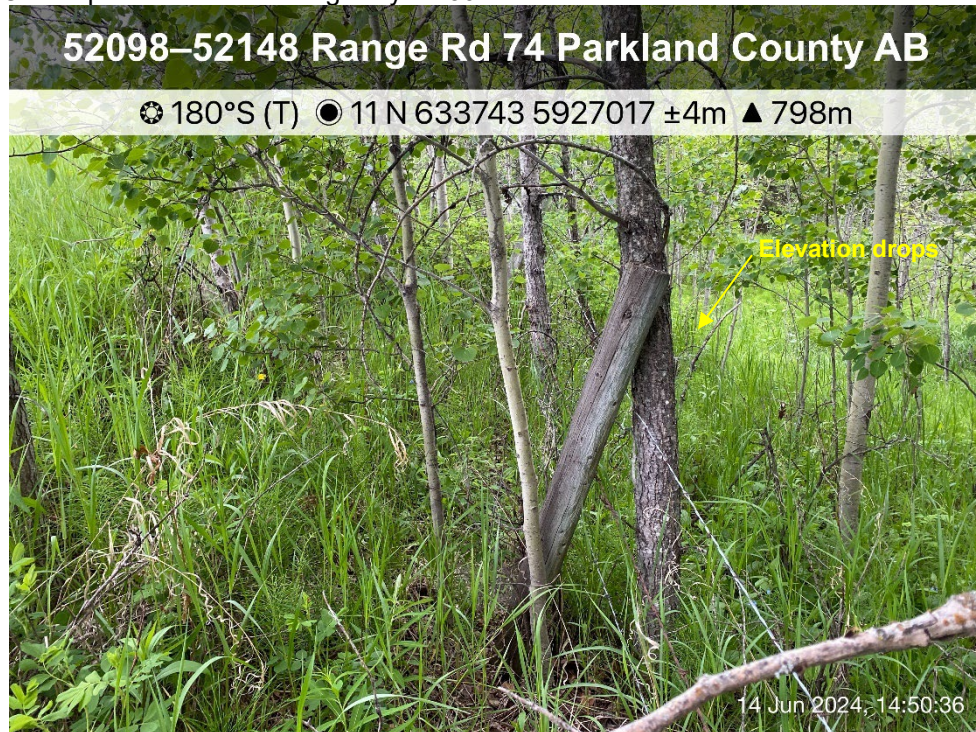
Photo 5: Toe of landslide just behind tree line. Fence present. Looking south.

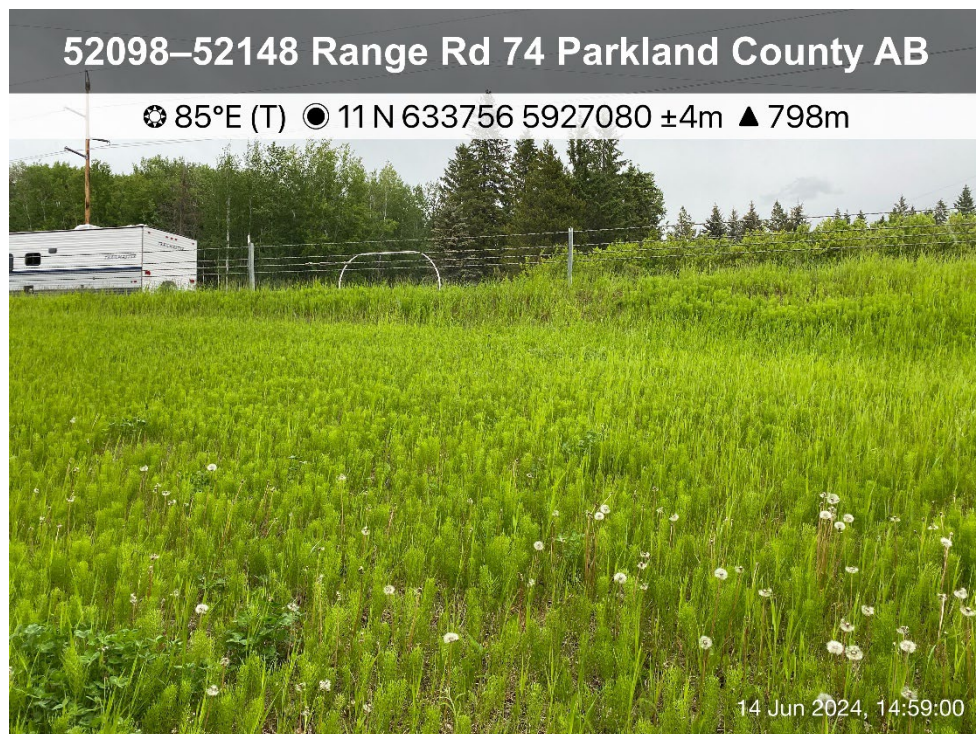
Photo 6: Vegetated slump, looking east towards highway from bottom end.
