To:	Amy Driessen	From:	Leslie Cho and Lawrence Onwude
	Transportation and Economic Corridors		Stantec Consulting Ltd.
File:	123315222	Date:	October 31, 2025

Reference: North Central Region, Stony Plain, Site NC052 - Highway 621:02 Pembina River Bridge Abutment, Fall 2025 Instrumentation Monitoring Report

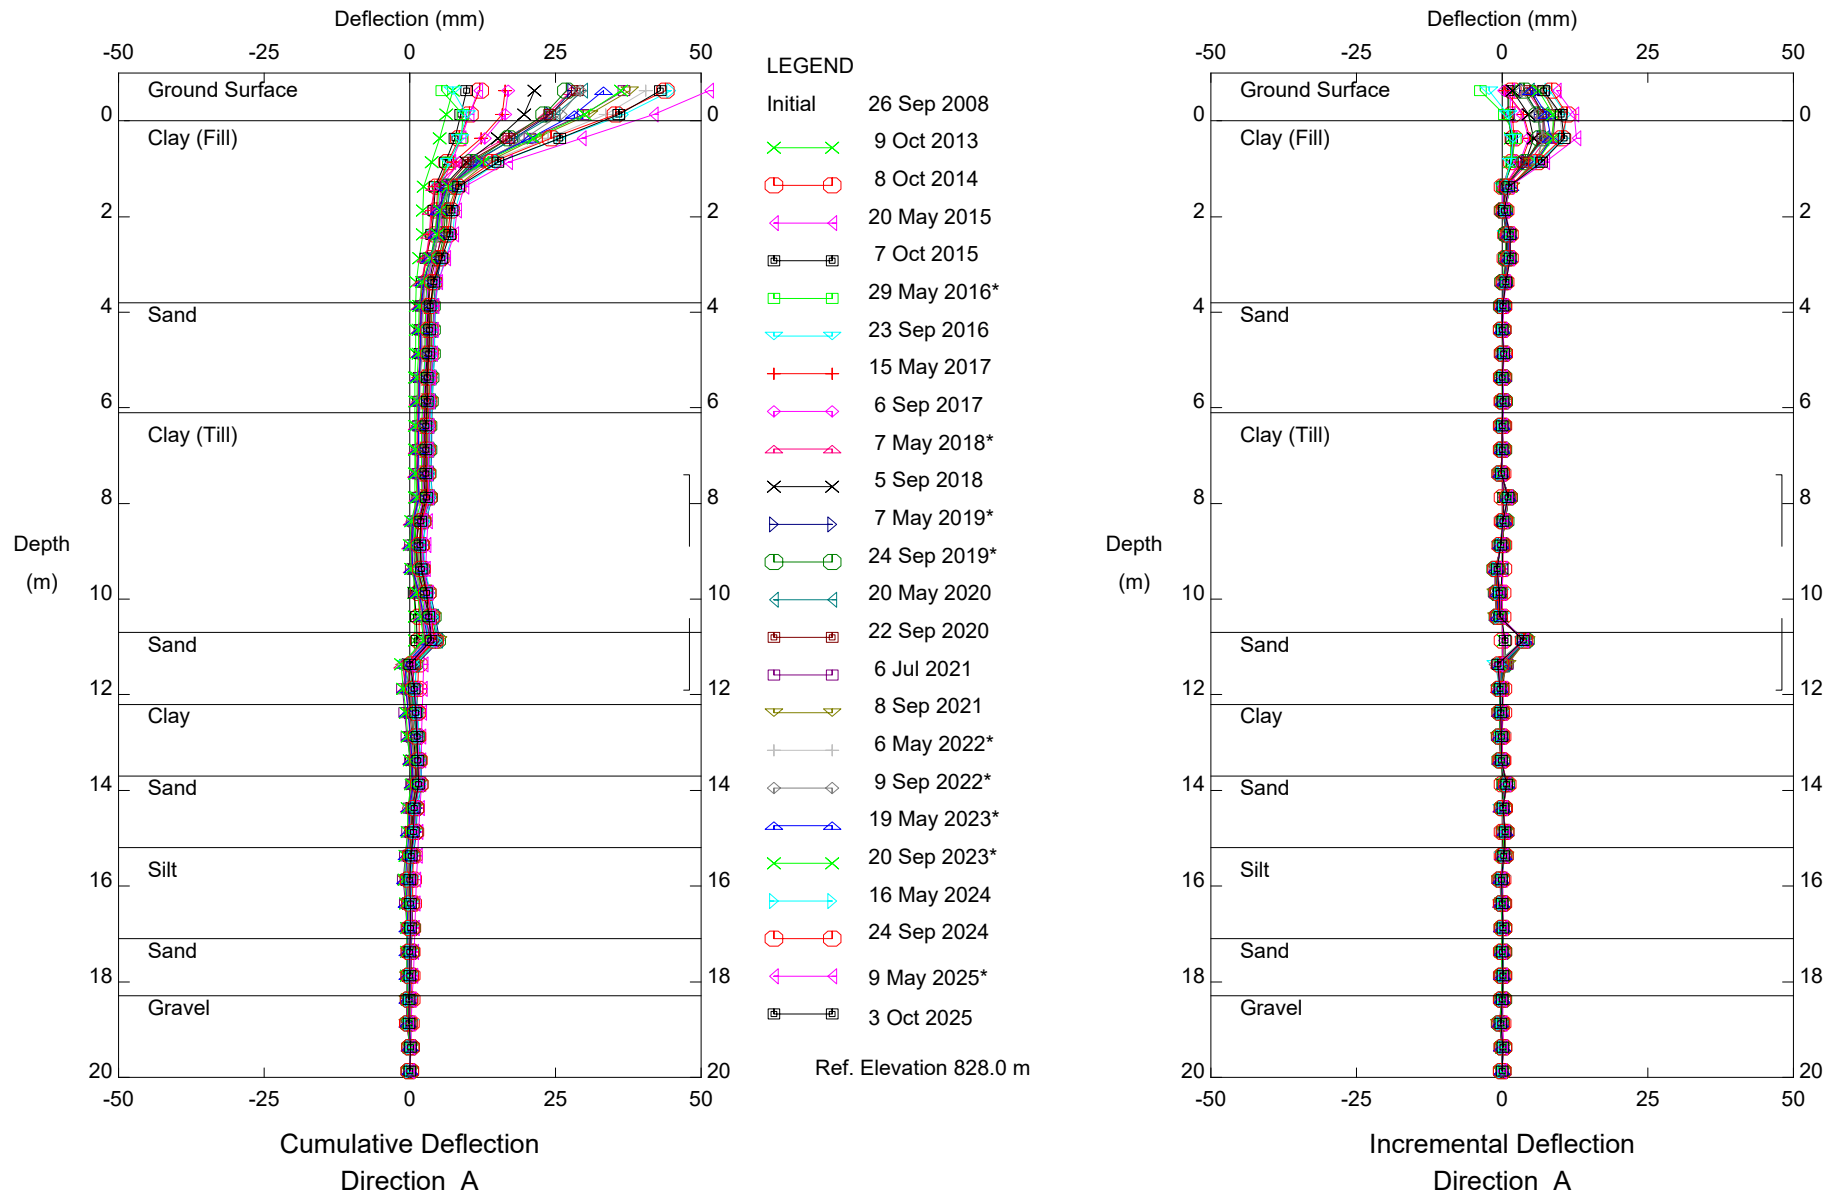
NC052, Inclinometer SI-1

SI-1 shows negligible movement over the zone of movement at about 11 m depth. Total cumulative movement observed since 2006 is about 3 mm.

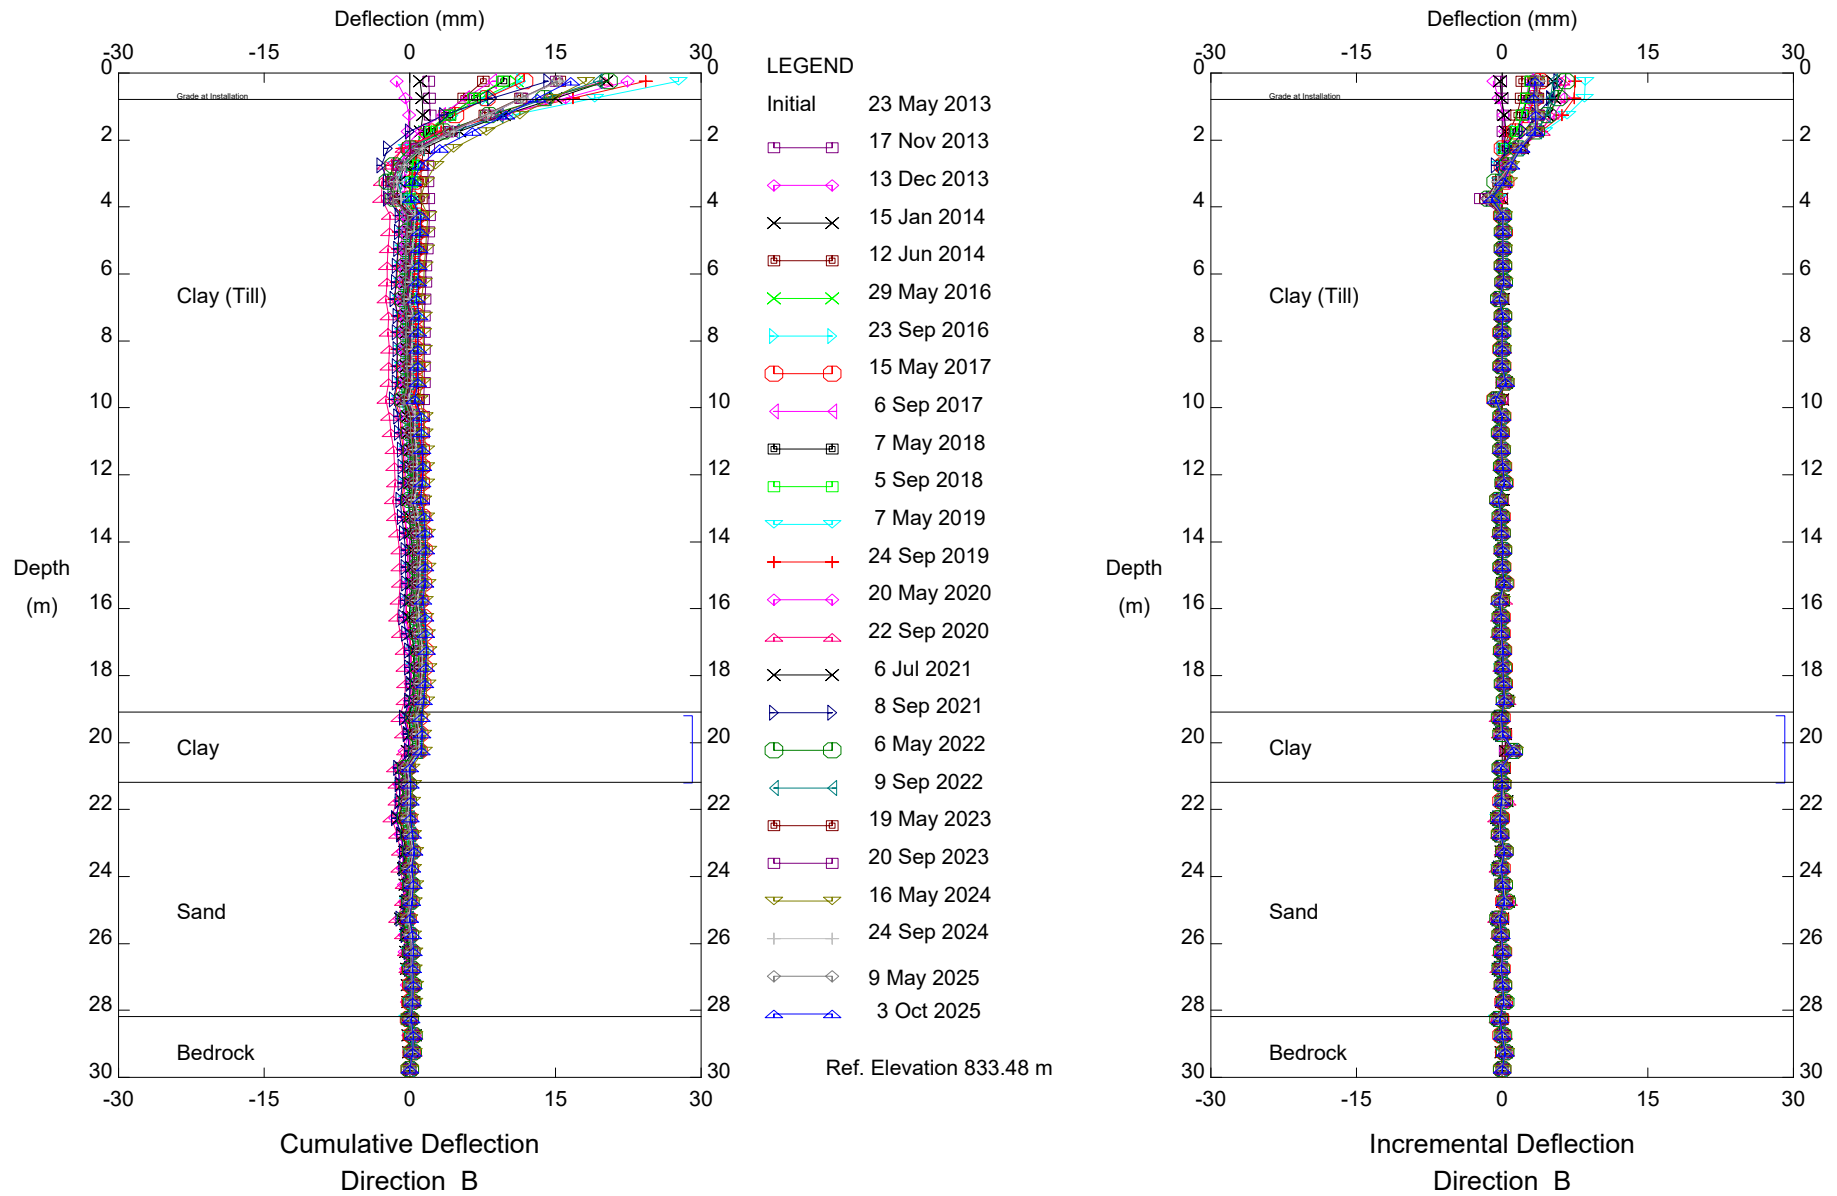
NC052, Inclinometer SI13-3
Transportation & Economic Corridors

SI13-3 has recorded about 6 mm of cumulative movement since 2014. The recorded movement is likely related to construction activities in winter 2014. Little to no movement was observed since 2016.

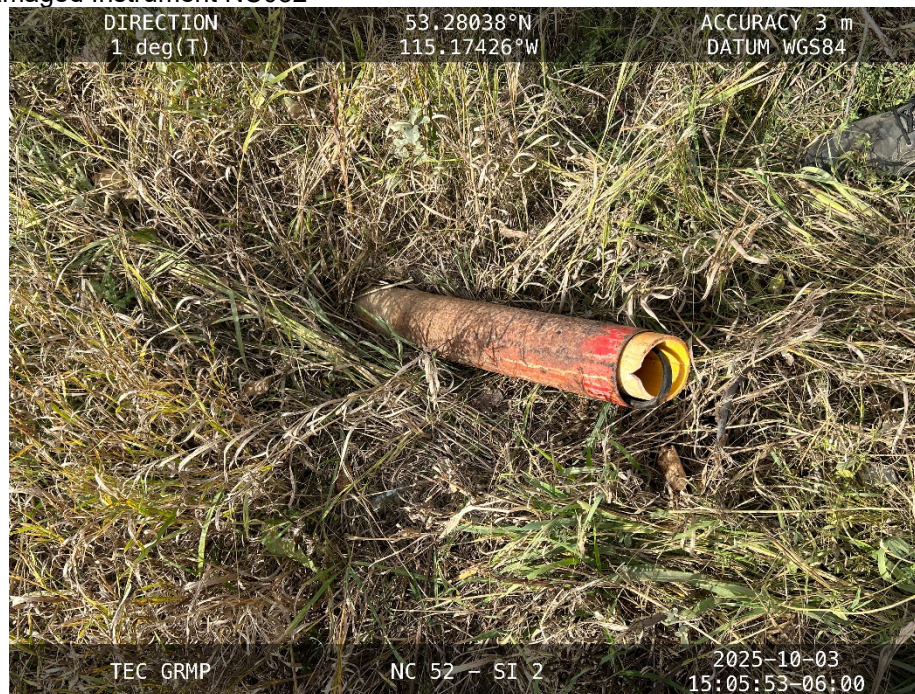
The Fall 2025 reading cycle consisted of instrument readings of two slope inclinometers (SI-1 and SI13-3), one pneumatic piezometer (PN-02), one vibrating wire piezometer (VW13-3), and one standpipe piezometer (SP13-3A). During the site visit, slope inclinometer (SI-2) was found to be cut off at 0.72 m and could not be read. The site plan is shown on **Figure 1** attached. The instrument readings were taken by Akintola Fakinlede, GIT and Adham Zahr, Geotechnical EIT and on October 3, 2025.

Photo 1: SI 2 sheared at approximately 0.72 m.

SI-2 was found broken at 0.72 m (approximately 0.2 m from ground surface) during 2025 Fall reading cycle. The sheared portion of the SI casing could be removed and a coupler with new casing could potentially be installed to allow for continuous reading in the future.

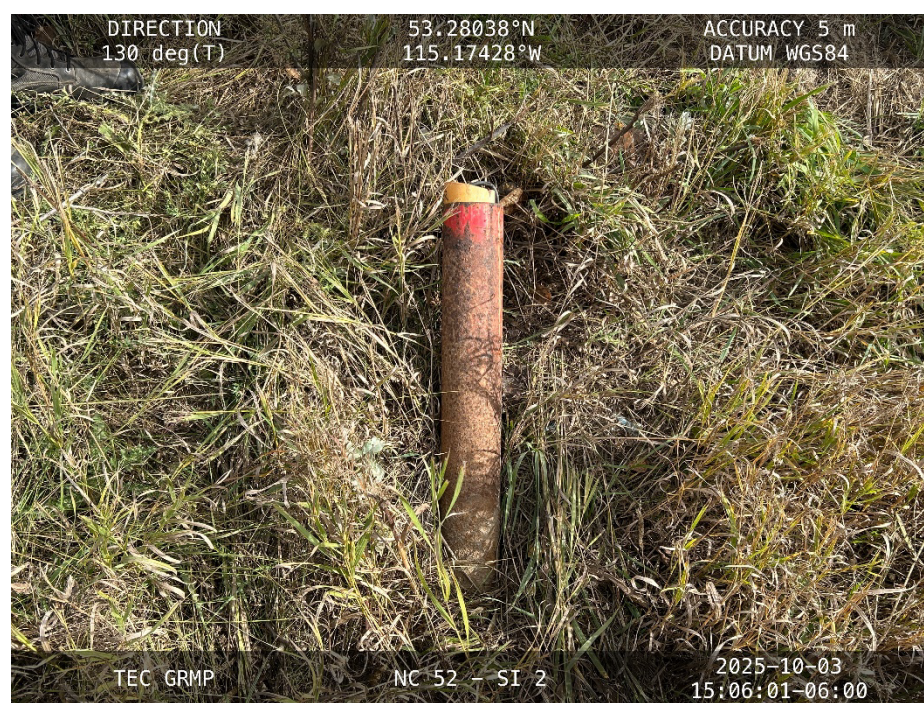
Photo 2: Broken part of SI 2 on the ground surface.
