<b>SITE NUMBER AND NAME:</b> NC052 – Pembina River Bridge	<b>HIGHWAY AND KM:</b> 621:02, km 16.420	<b>PREVIOUS INSPECTION:</b> June 14, 2024	<b>CURRENT INSPECTION:</b> May 20, 2025
<b>LEGAL DESCRIPTION:</b> SE 01-50-09-W5	<b>NAD83 COORDINATES:</b> UTM11U 5905008N, 621749E		<b>RISK ASSESSMENT:</b> PF: 10 CF: 10 Total: 100
<b>AVERAGE ANNUAL DAILY TRAFFIC (AADT):</b> 1,030 (2024)		<b>CONTRACTOR MAINTENANCE AREA (CMA):</b> 509

Client/Project  
Transportation and Economic Corridors  
Geohazard Monitoring Program  
NC52 HWY 621-02 Pembina River Bridge

2025 Site Inspection Photos at NC052

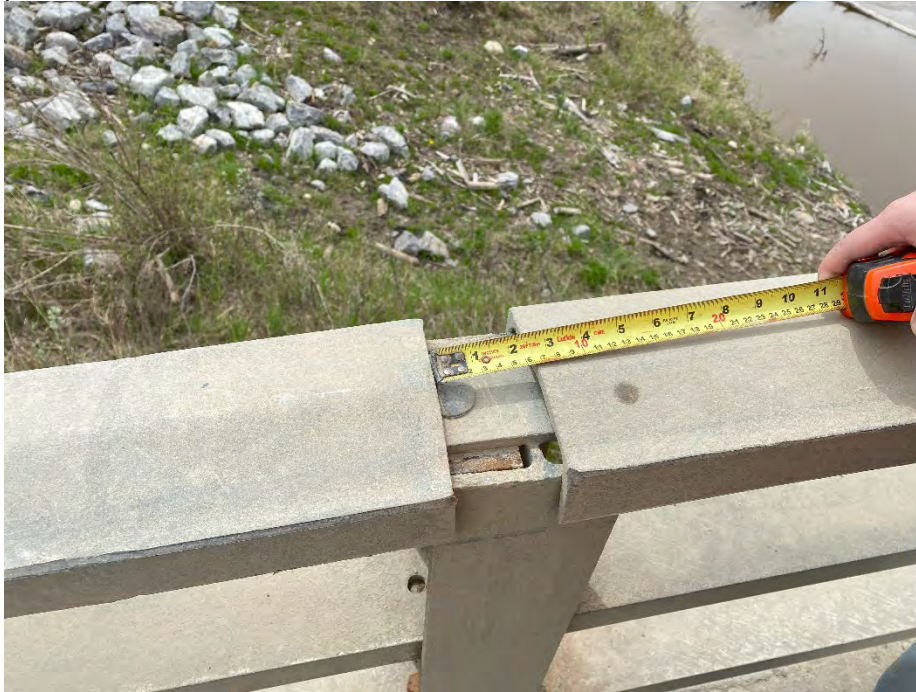
<b>COMMENTS</b> <ul style="list-style-type: none"> <li>Bridge rotation appears unchanged since 2021. The separation of the guardrails along the bridge deck have remained relatively unchanged with 30 mm, 70 mm, 45 mm, and 20 mm of separation at the NE, SE, NW, and SW corners, respectively (Photos 1 to 4).</li> <li>The expansion joint at the east abutment has a gap 35 mm wide in the westbound lane where the rubber has fallen below the bridge deck, similar to the previous inspections in 2023 and 2024 (Photo 5).</li> <li>The three tiltmeters installed at the bridge are all non-operational.</li> <li>Spring 2025 SI readings show signs of creeping a rate of less than 1 mm/year in SI-1. SI-2 previously showed signs of creeping from Spring 2014 to Spring 2022 whereafter cumulative displacements returned to 2014 levels.</li> <li>Piezometric levels have been relatively stable since installing the horizontal drains.</li> </ul>

**Photo 1:** Guardrail separation at southeast corner of bridge. Looking south.

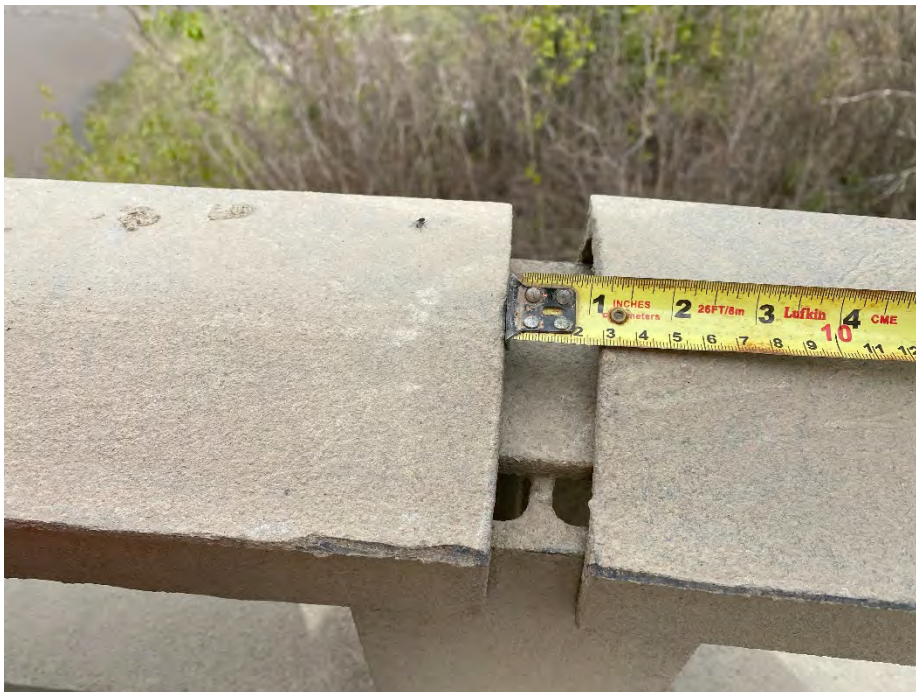
**Photo 2:** Guardrail separation at northeast corner of bridge. Looking north.

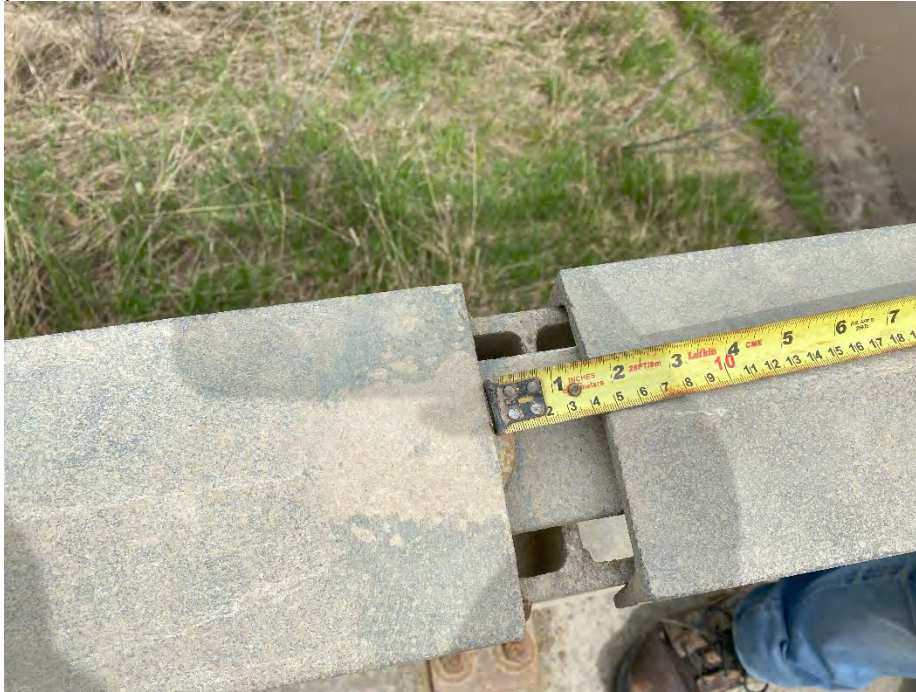
**Photo 3:** Guardrail separation at northwest corner of bridge. Looking north.

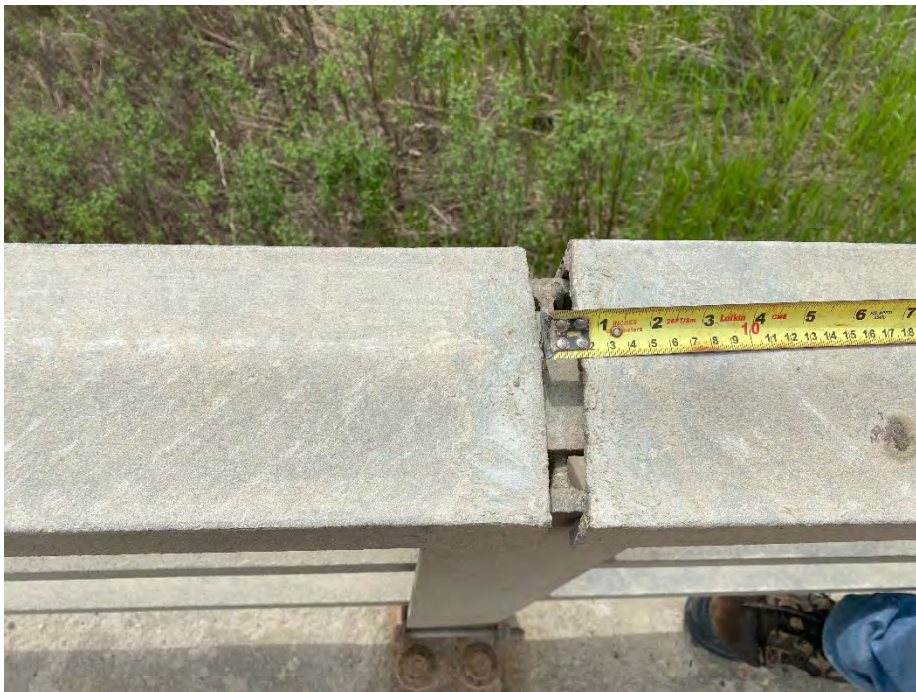
**Photo 4:** Guardrail separation at southwest corner of bridge. Looking southwest.

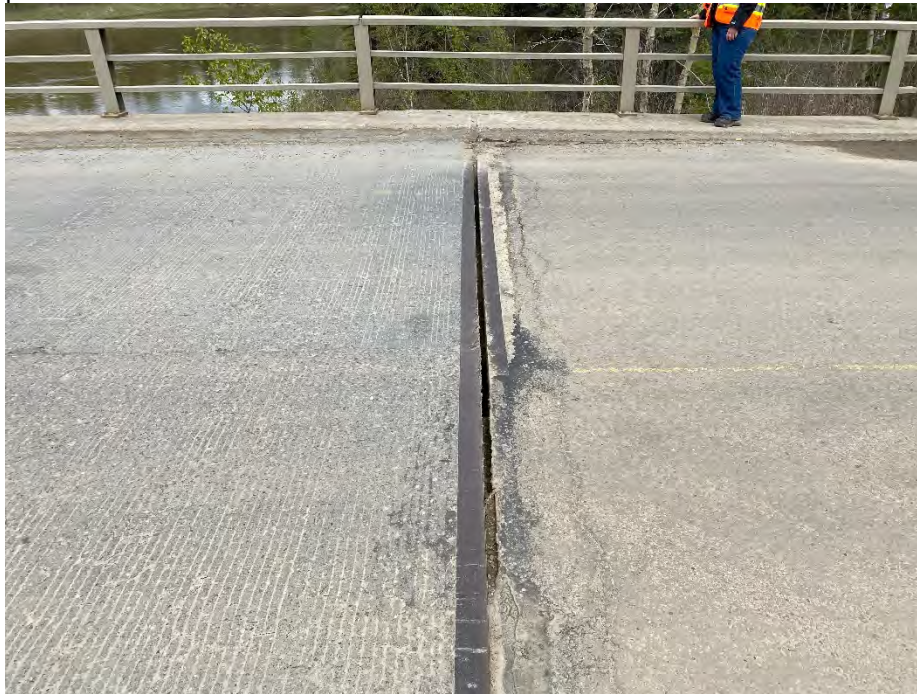
**Photo 5:** Gap at expansion joint with rubber seal missing. Looking north.

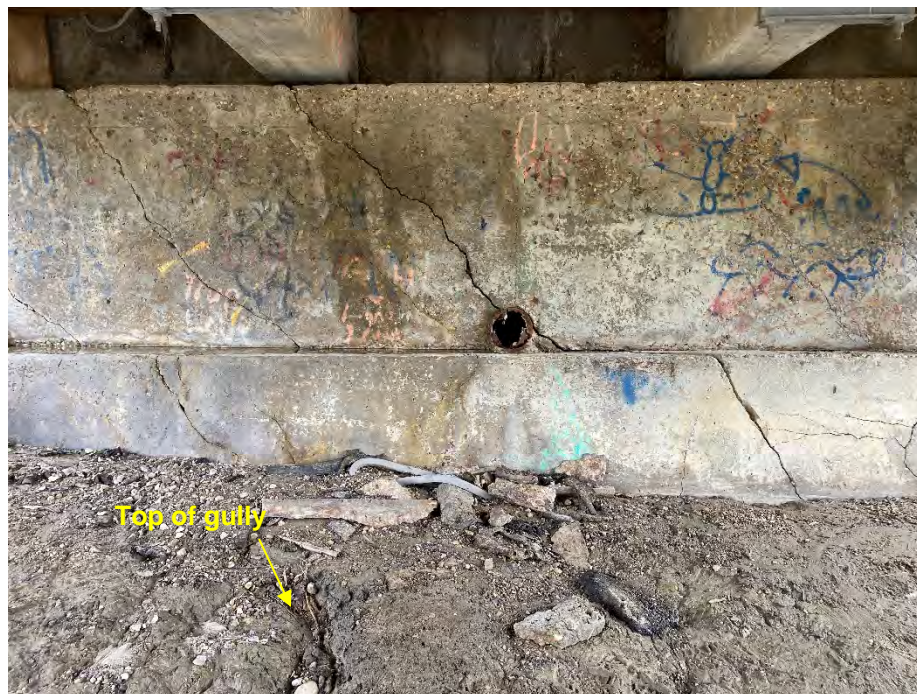
- Concrete cracks at both east and west abutment seats appear unchanged (Photos 6 and 8). A 20 mm gap was written onto the crack at the west abutment at an unknown date. This same gap was measured to be 20 mm by Stantec since 2016.

- Erosion gullies remain present on the headslope below the east abutment (Photo 6).
- The girders were in contact with the abutment backwall at the east abutment. The bearing plates appear to be crushed at both abutments, similar to previous inspections (Photo 7).

**Photo 6:** Cracking of east abutment and gullies on headslope. Looking east.

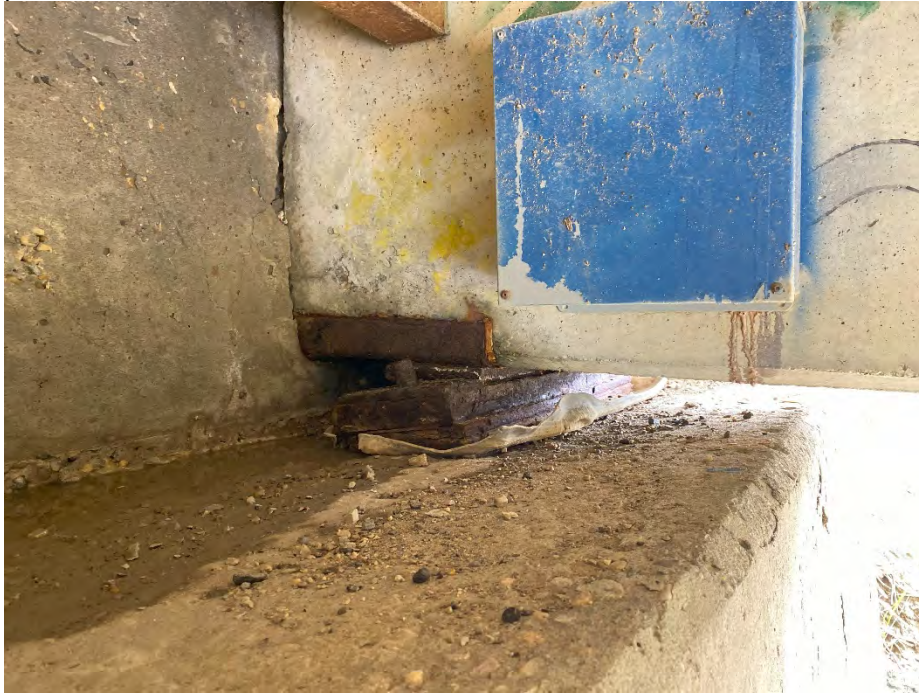
**Photo 7:** Girders in contact with east abutment. Movement of bearing plate. Looking south.

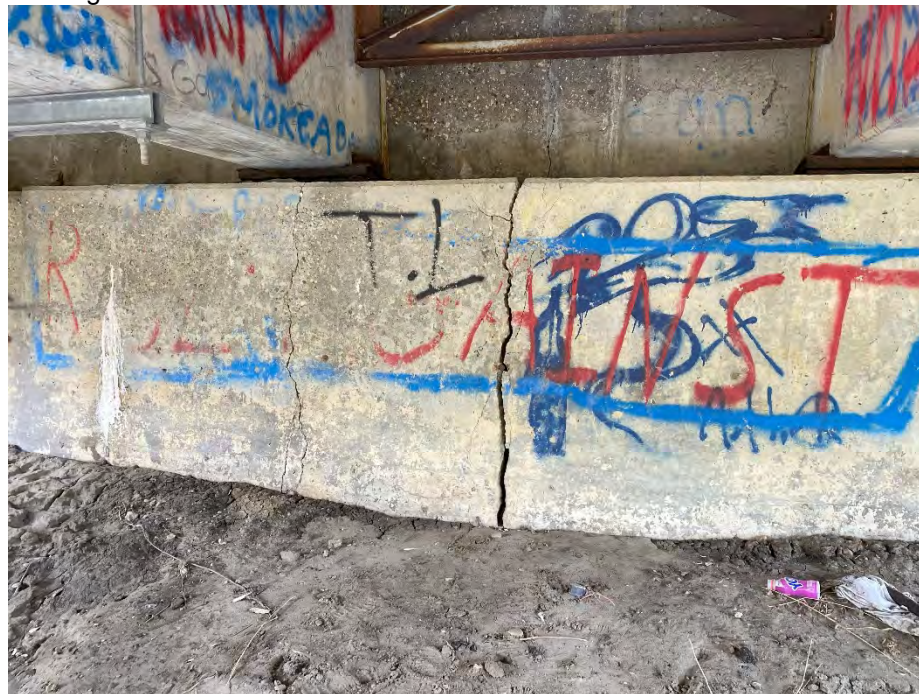
**Photo 8:** 20 mm crack at west abutment. Looking west.

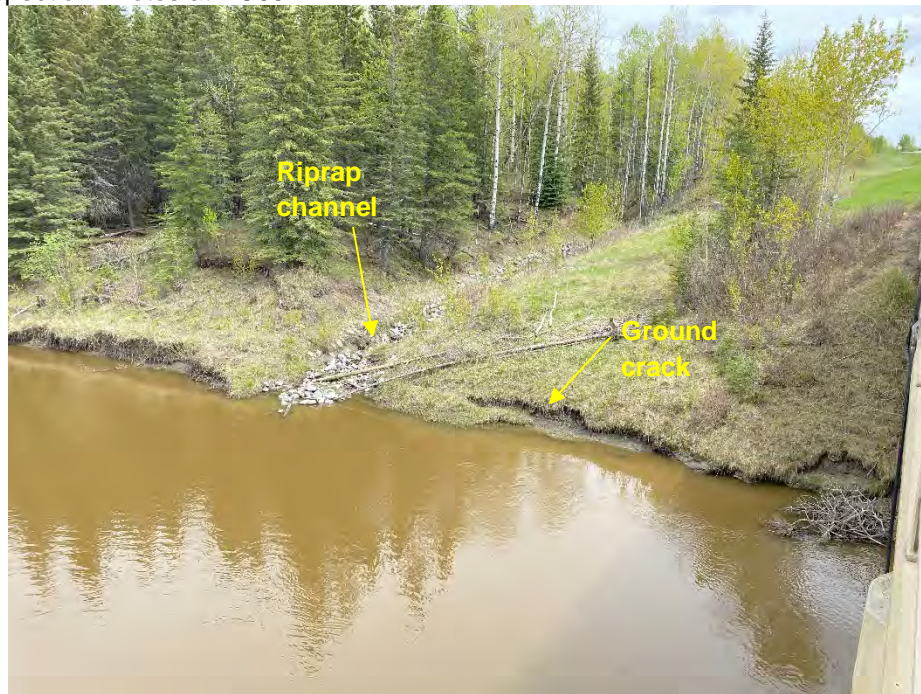
- Slow flow was observed at the gabion outfall.
- The ground crack south of the riprap channel near SI14-01 appeared unchanged at about 7 m long with vertical difference up to about 0.4 m high (Photo 9).

**Photo 9:** Riprap lined channel and ground crack north of east abutment. Looking northeast.

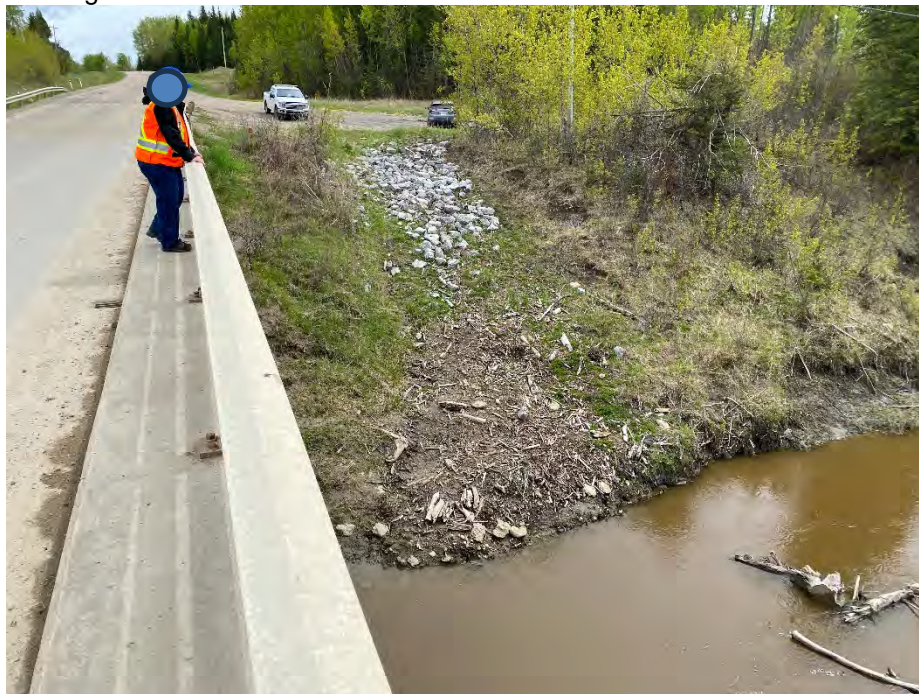
- No apparent change was observed in the riprap channel and erosion south of the bridge at the east abutment slope (Photo 10).
- Driftwood was observed (Photo 10) against the south and east sides of the east pier. Less driftwood was present than observed during the 2024 inspection. Two pieces of driftwood are still stuck behind the underslung diaphragms against the east side of the bridge, above the east pier.

**Photo 10:** Riprap placed south of bridge along previous erosion channel. Driftwood collected near the east pier. Looking southeast.

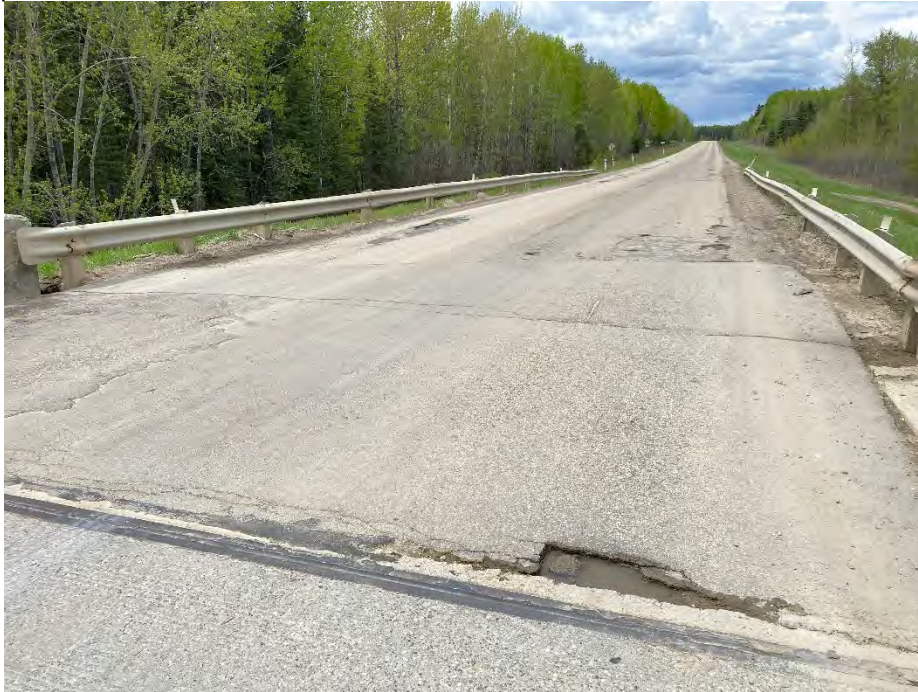
- Potholes are present in both lanes at the west abutment and east of the east patch (Photos 11 and 12).
- Erosion channels were observed off the south lane (eastbound) near the west bridge abutment (Photo 13).

**Photo 11:** Pavement surface at west abutment with multiple potholes. Looking west.

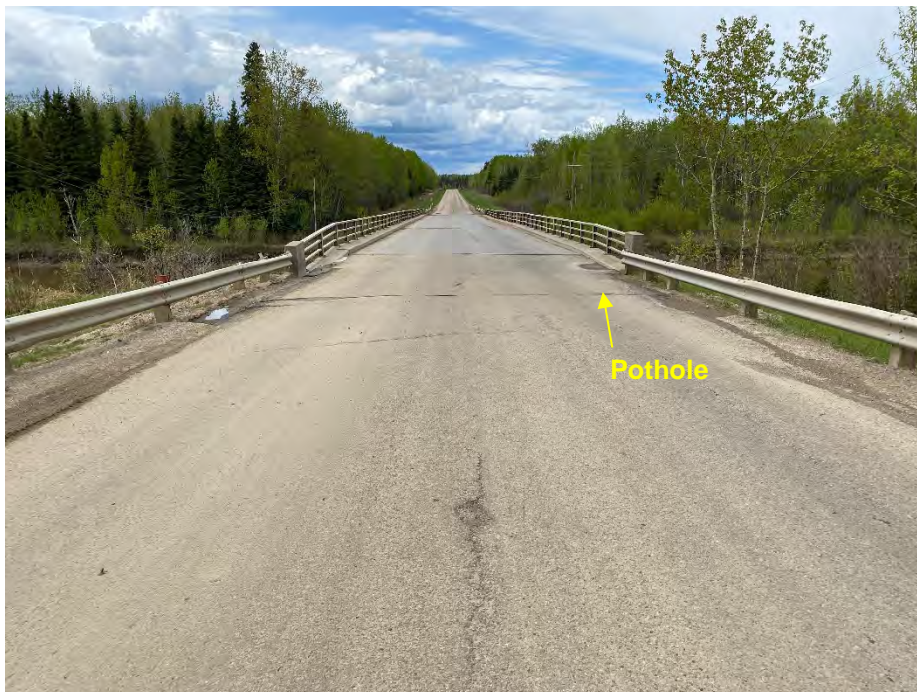
**Photo 12:** Pavement surface at east abutment. Looking west.

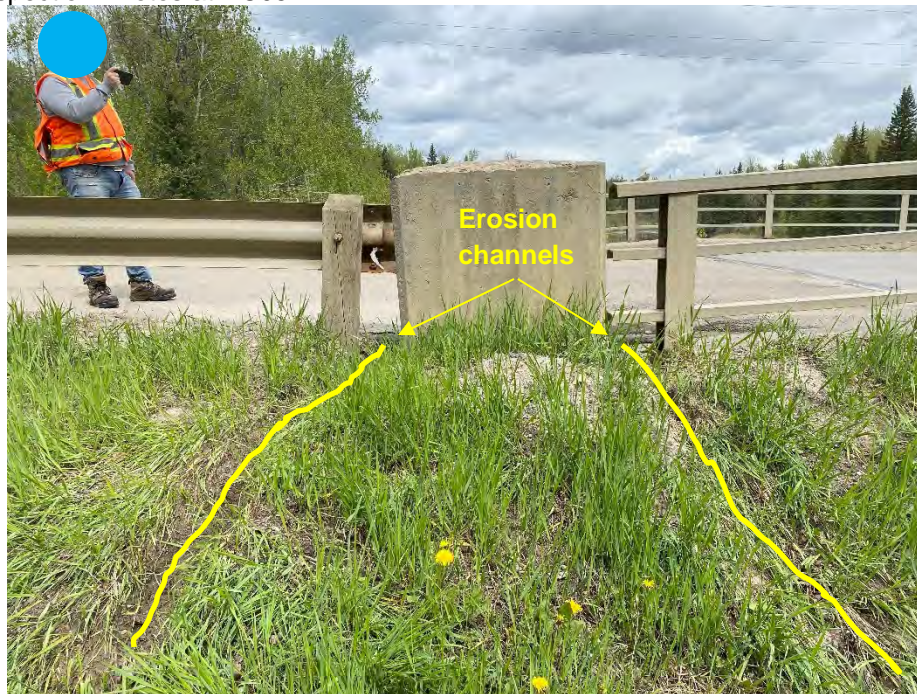
**Photo 13:** Erosion channels forming off the east bound lane at the west abutment. Looking north.
