To:	Amy Driessen	From:	Leslie Cho and Lawrence Onwude
	Transportation and Economic Corridors		Stantec Consulting Ltd.
File:	123315222	Date:	October 31, 2025

**Reference: North Central Region, Stony Plain, Site NC057 - Highway 624:02, Fall 2025 Instrumentation Monitoring Report**

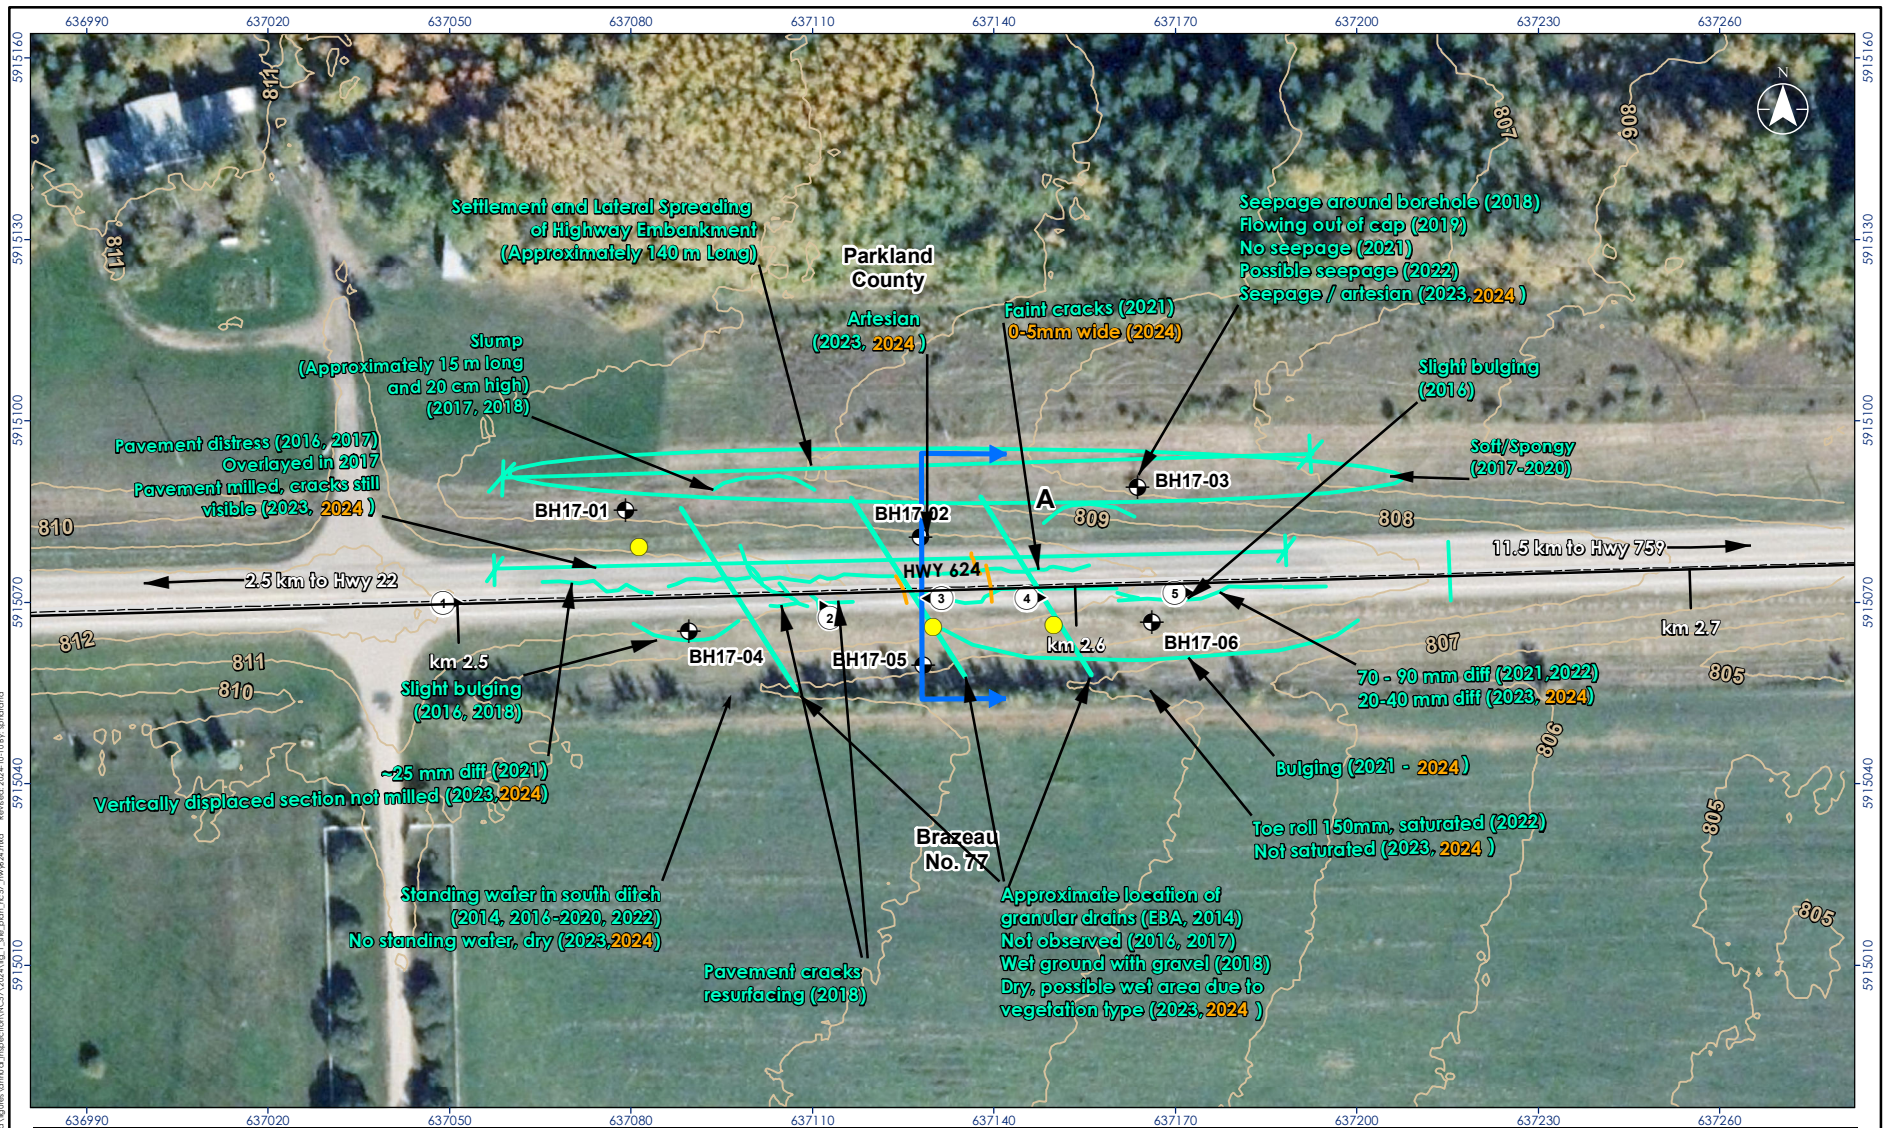
Title  
**Site Plan**

The Fall 2025 reading cycle consisted of instrument readings of two vibrating wire piezometers (VW17-02a and VW17-02b) and one standpipe piezometer (SP17-06). An instrumentation location plan is provided in the attached Figure 1. The instruments were read by Akintola Fakinlede, GIT and Adham Zahr, Geotechnical EIT on October 3, 2025.

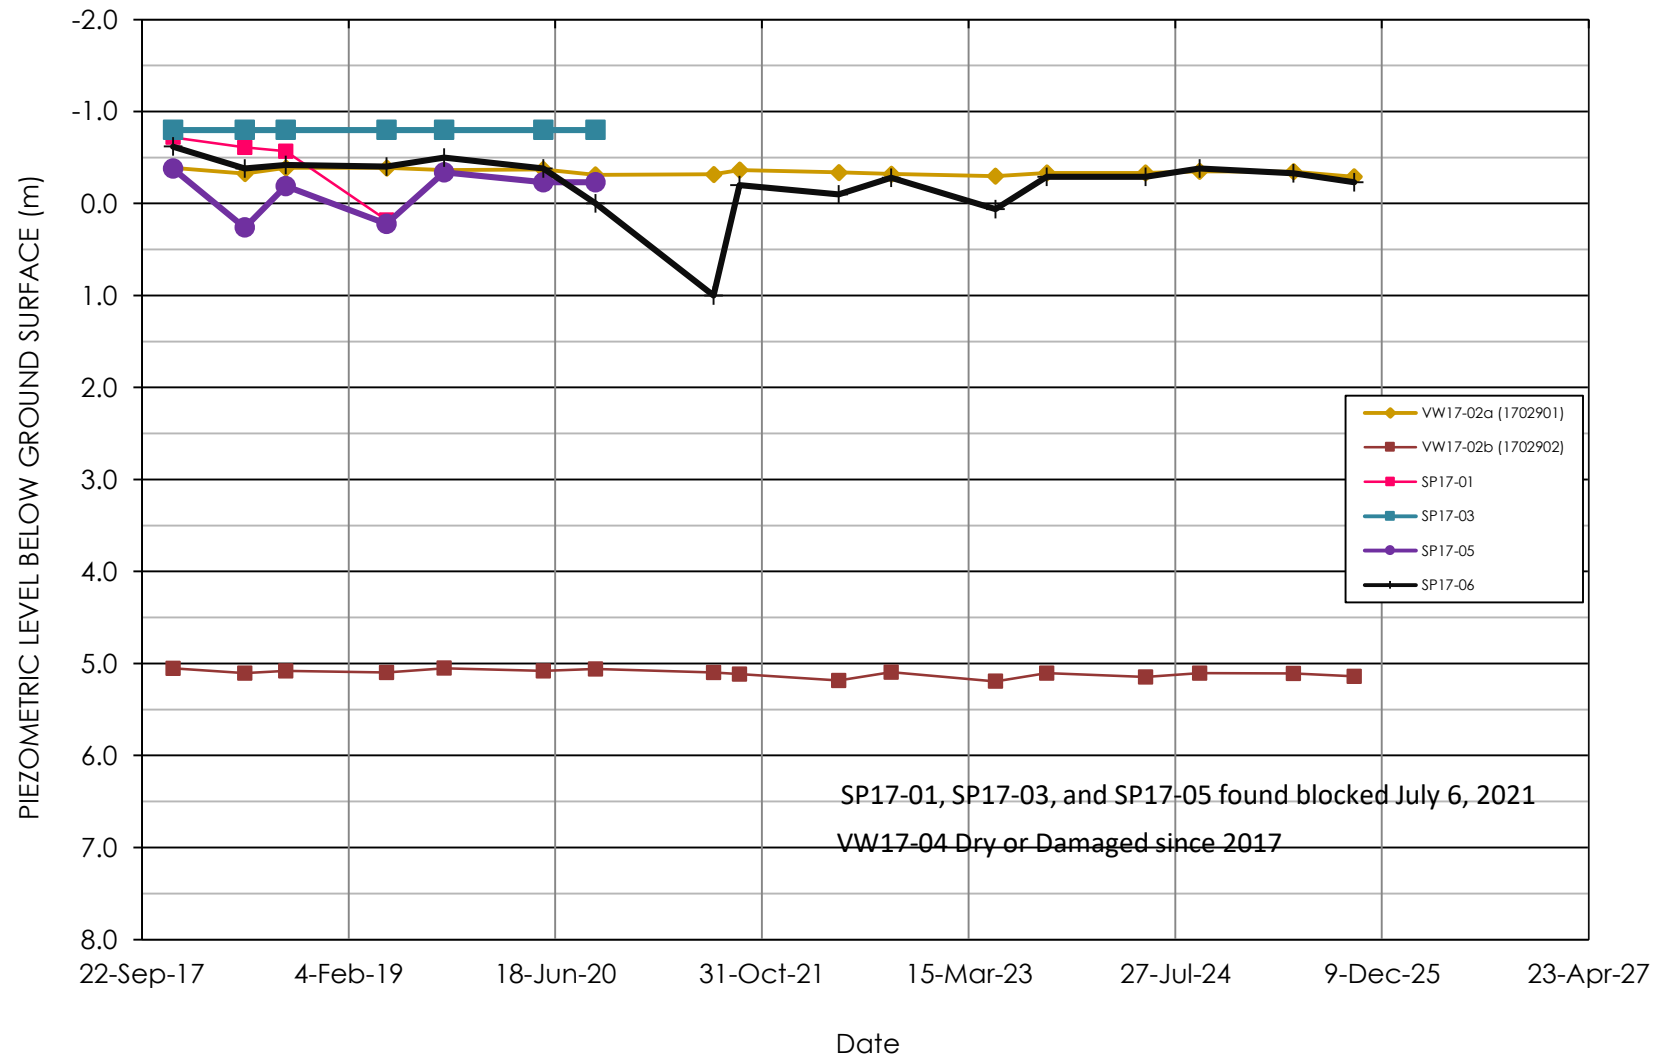
## PIEZOMETER DATA

The water levels in most of the piezometers remained relatively steady since the first reading in December 2017.

Compared with the water level measured during the Spring 2025 reading cycle, the water level in VW17-02a showed a decrease of less than 0.1 m during the Fall 2025 reading cycle. The water level in VW17-02b also showed little to no change. The water level in VW17-02a and VW17-02b is about 0.4 m above ground surface (artesian) and approximately 5.1 m below ground surface respectively.

SP17-06 showed a decrease in water level of 0.1 m since the previous reading in Spring 2025 and indicated a piezometric level of 0.2 m above ground surface.
