SITE NUMBER AND NAME: NC057 – Highway 624 Embankment Failure	HIGHWAY AND KM: 624:02, km 2.571	PREVIOUS INSPECTION: June 14, 2023	CURRENT INSPECTION: May 20, 2025
LEGAL DESCRIPTION: NE & NW 34-50-07-W5	NAD83 COORDINATES: UTM11U 5915066N, 637131E		RISK ASSESSMENT: PF: 10 CF: 6 Total: 60
AVERAGE ANNUAL DAILY TRAFFIC (AADT): 1,540 (2024)		CONTRACTOR MAINTENANCE AREA (CMA): 509

Transportation and Economic Corridors
Geohazard Monitoring Program
NC57 Hwy 624 Embankment Failure

2025 Site Inspection Photos at NC057

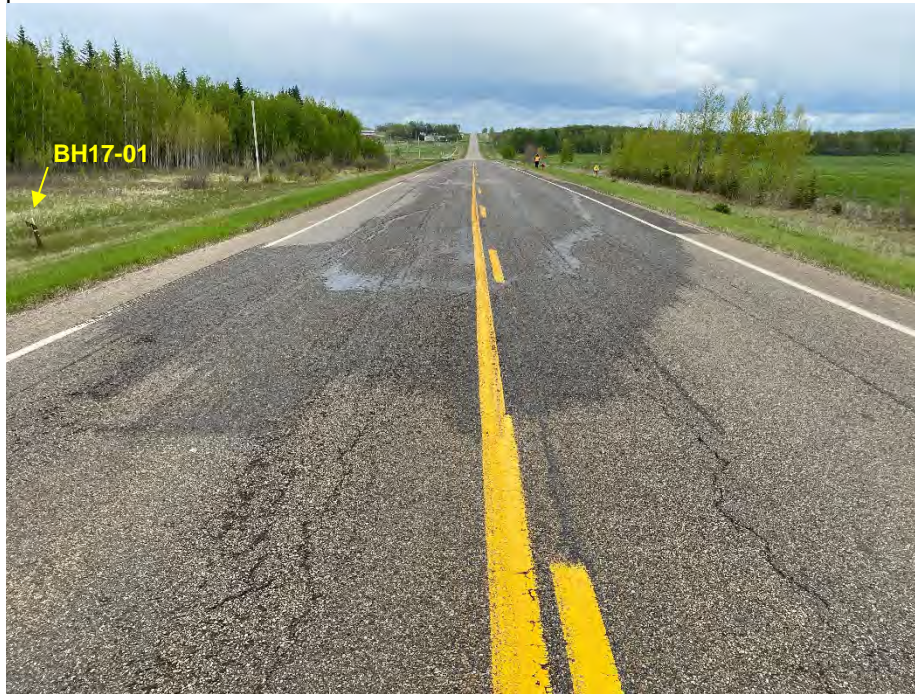
COMMENTS In general, little change was observed since the 2024 inspection. The following summarizes Stantec's observations: <ul style="list-style-type: none"> Pavement cracks are visible within the milled asphalt surface (Photos 1 to 6). The cracks were observed to be up to 5 mm wide and extend past the milled portion of the highway. Additional diagonal cracking was observed during this inspection. On the WBL, cracking has progressed to about 25 m east of BH17-02, similar to the observation in 2024. Vertical displacement was observed at the west extents of the pavement cracks on the WBL due to transition from milled to non-milled pavement (Photo 1).
--

Photo 1: West extent of milled pavement. Looking east.

- Pavement cracks should be sealed to reduce surface water infiltration into the embankment. Additional pavement patches are not recommended since it is considered an additional driving force on the embankment. Mill and fill could be completed to address the vertical displacement until remediation is completed.

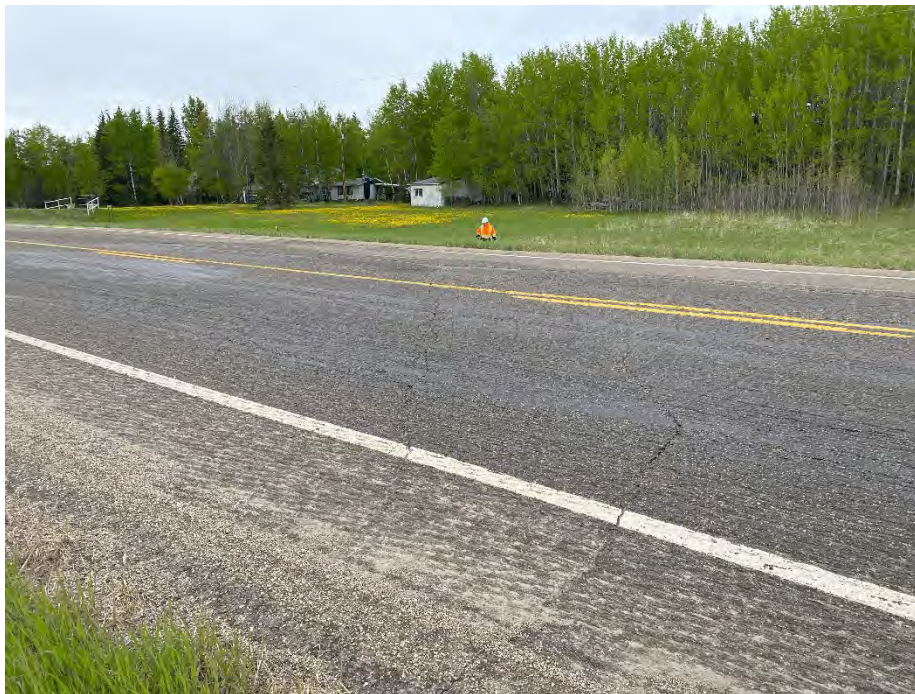
Photo 2: Diagonal cracking across milled pavement, looking northwest.

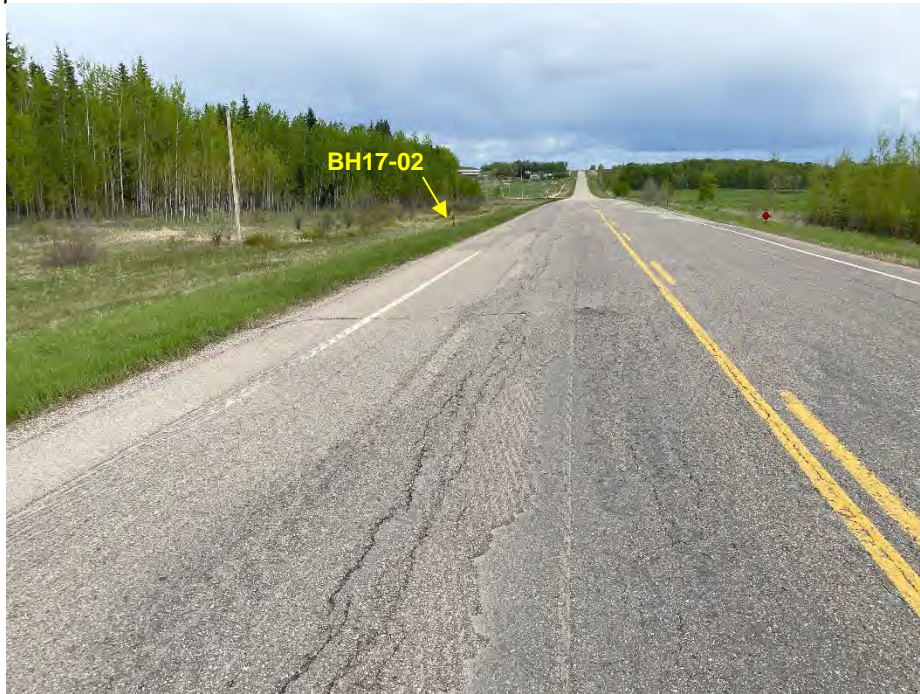
Photo 3: Middle section of milled pavement, looking east.

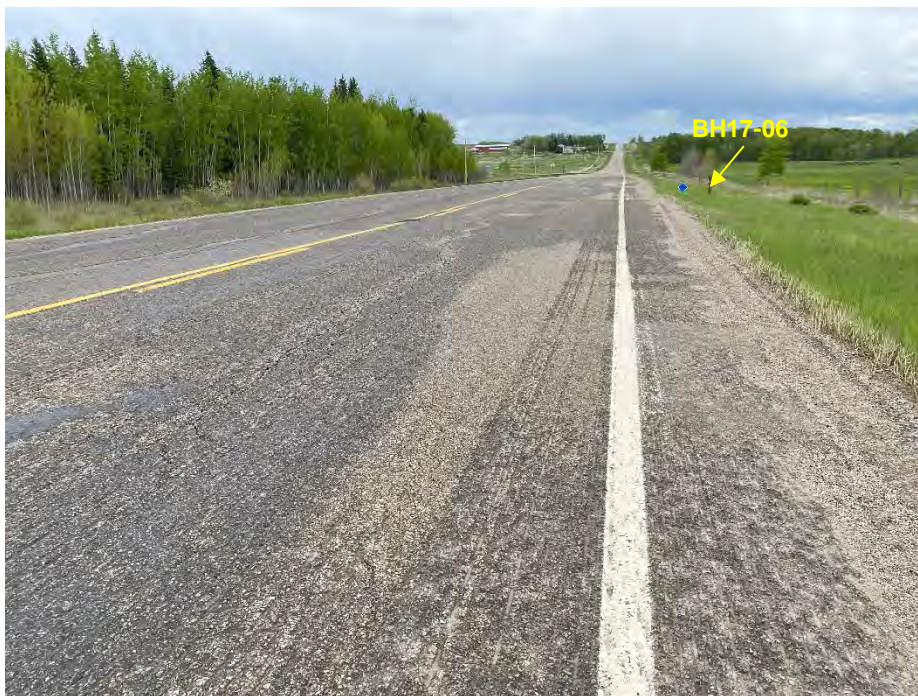
- The EBL pavement cracks near BH17-06 show about 30 to 50 mm vertical displacement, approximately 10 mm more than observed in 2024. A portion of pavement near BH17-06, at the location of the greatest vertical displacement south of the crack, was not milled (Photos 4 and 5).

Photo 4: Pavement cracking on EBL. Looking east.

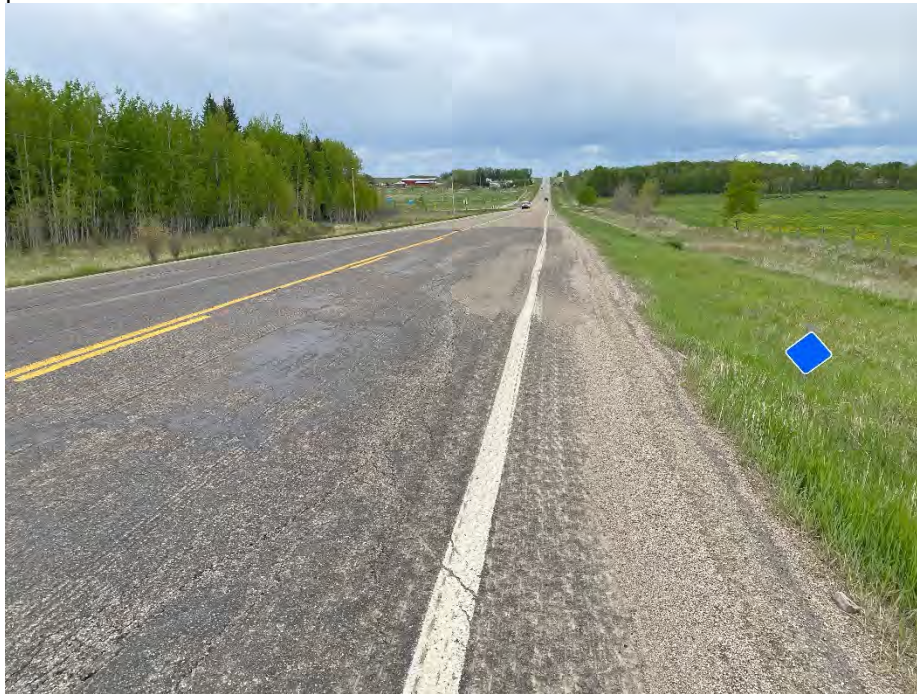
Photo 5: Pavement cracking on EBL. Looking east.

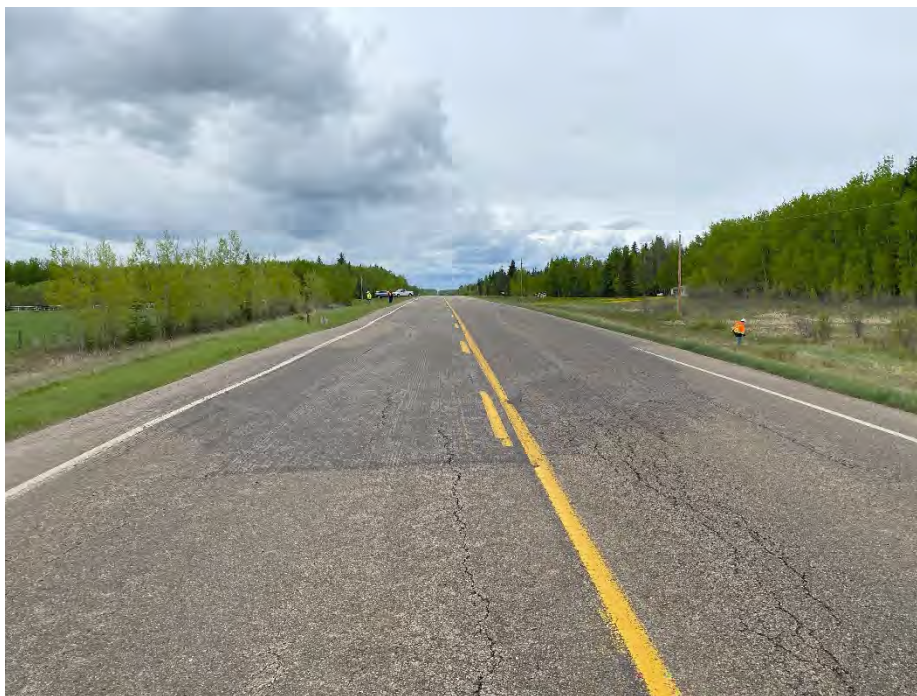
Photo 6: East extent of milled pavement. Looking west.

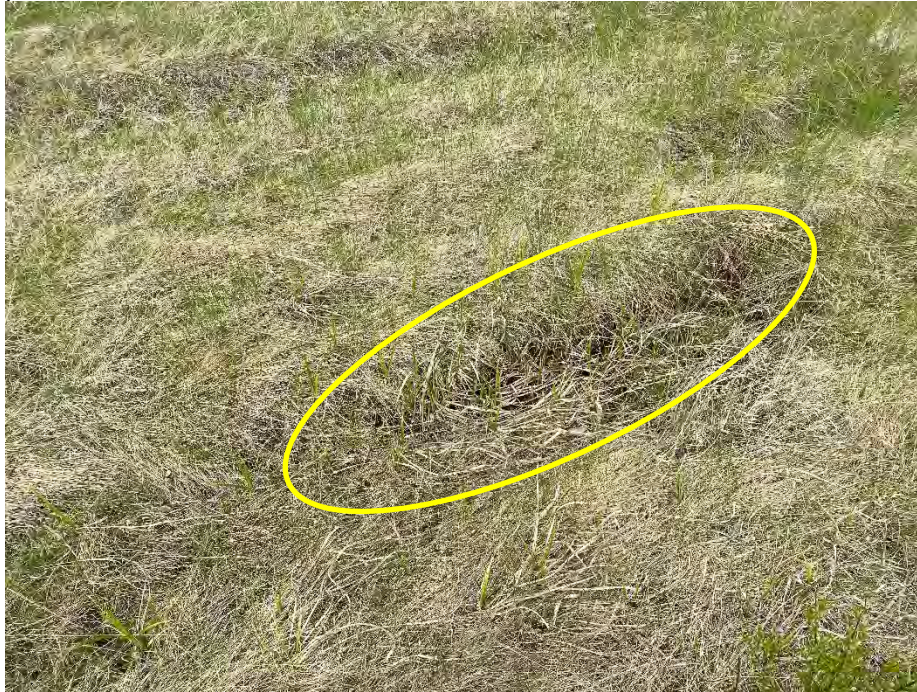
- The potential bulge south of BH17-06 approximately halfway down the embankment slope appeared similar to 2024.
- Two depressions in the north ditch near BH17-01 were observed, one approximately 1.5 m long and 0.3 m wide and the other approximately 0.4 m in diameter (Photo 7). A potential toe bulge was observed in this same area.

Photo 7: Depression in the north ditch near BH17-01. Looking north.

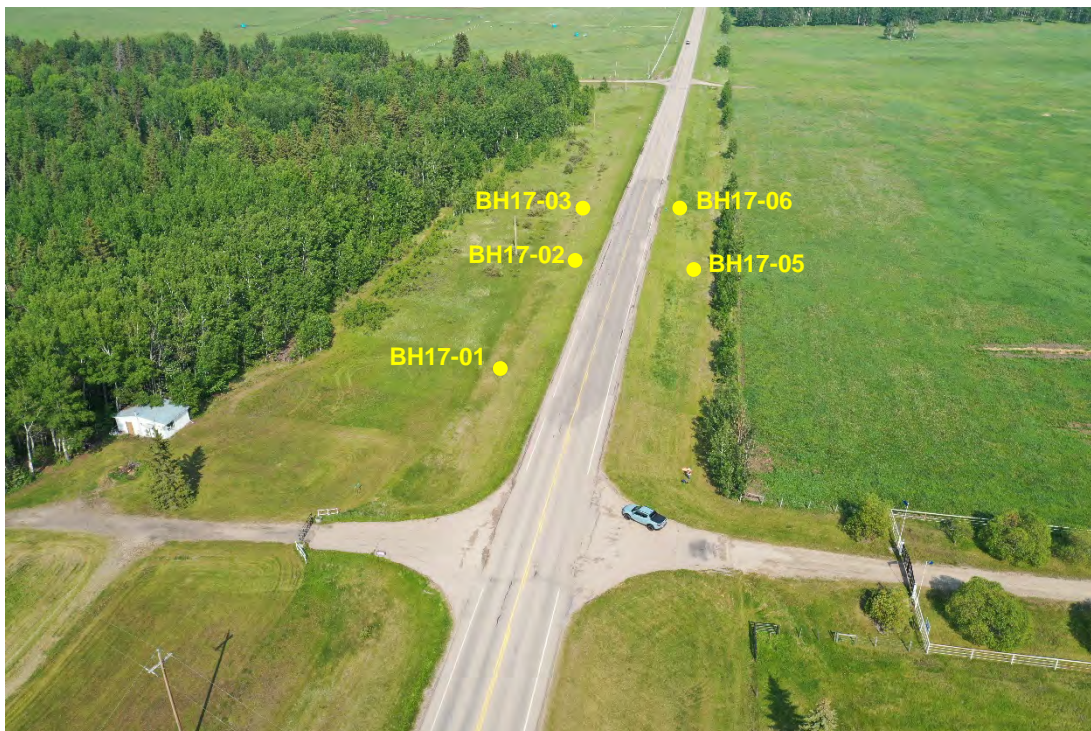
Photo 8: Site overview, photo taken by drone. Looking east.

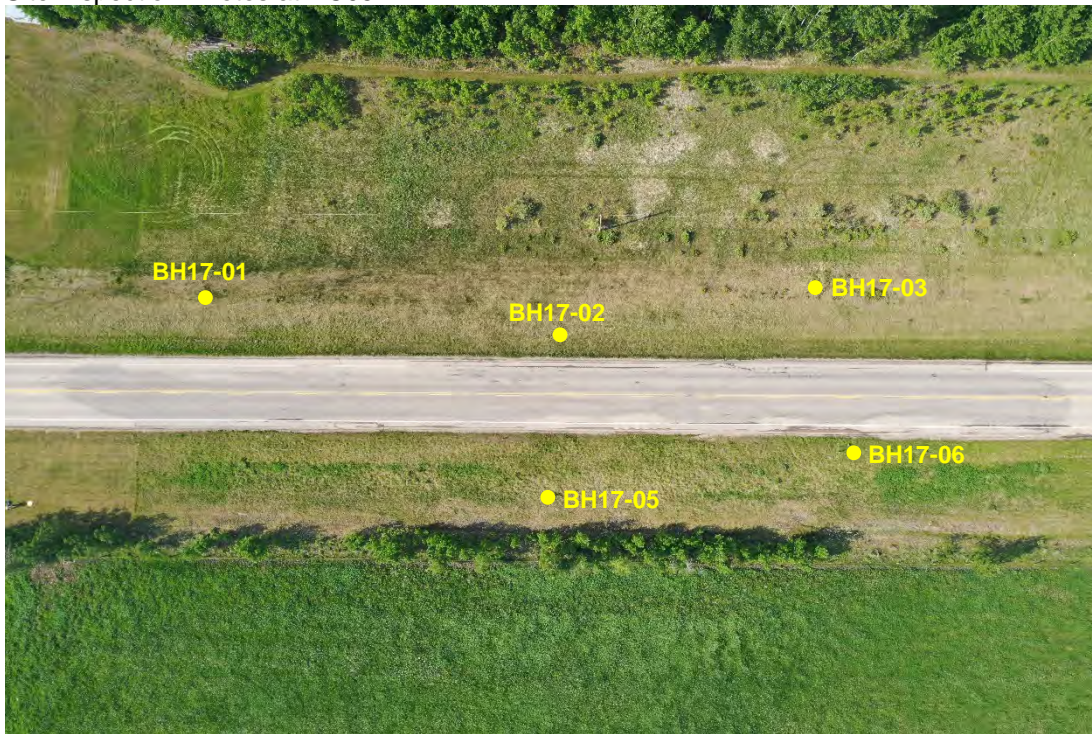
Photo 9: Site overview, taken by drone. Looking northeast.
