SITE NUMBER AND NAME: NC040 – North of N. Sask River	HIGHWAY AND KM: 759:02, km 12.587	PREVIOUS INSPECTION: June 14, 2024	CURRENT INSPECTION: May 20, 2025
LEGAL DESCRIPTION: NE-12-13-50-6-W5 NW-9-14-50-6-W5	NAD83 COORDINATES: UTM11U 5909780 N, 649396 E		RISK ASSESSMENT: PF: 13 CF: 5 Total: 65
AVERAGE ANNUAL DAILY TRAFFIC (AADT): 1,790 (2024)		CONTRACTOR MAINTENANCE AREA (CMA): 509

2025 Inspection Photos at NC040

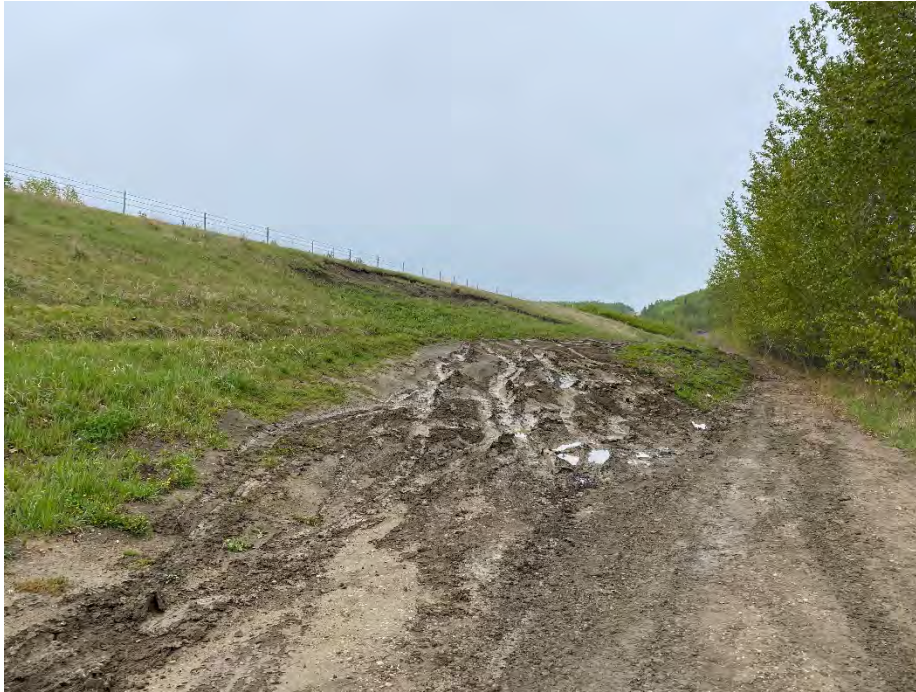
COMMENTS <ul style="list-style-type: none"> The regraded soils on the landslide on the west embankment have failed. The toe is still approximately 1.5 m high, and the service road has been blocked again (Photos 1 to 3). The exposed scarp is 1.8 m from the edge of the highway, similar to the measurement in 2024. The slope is moderately vegetated. Cracking was observed within the toe bulge of the landslide on the west embankment. No landslide related pavement cracks were observed along the highway as shown on Photos 4 and 5.
--

Photo 1: Failure at north extent of west side slope. Service road at landslide toe has been blocked. Looking south.

- In the short-term, the slides should be monitored by the HMC for further movement.
- Stantec has prepared a Section F remediation design of the west embankment slope, and submitted a scope change cost estimate in early 2025 to add remediation design of the east embankment slope. The preferred remediation option is understood to be removal and replacement.
- Site inspections should continue annually.

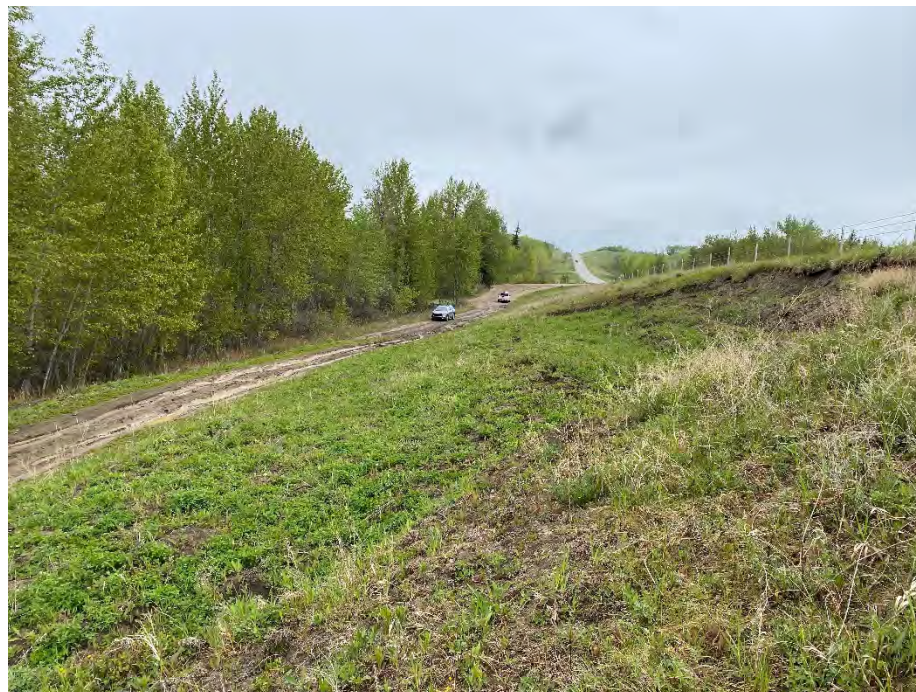
Photo 2: Failure at south extent of west side slope. Looking north.

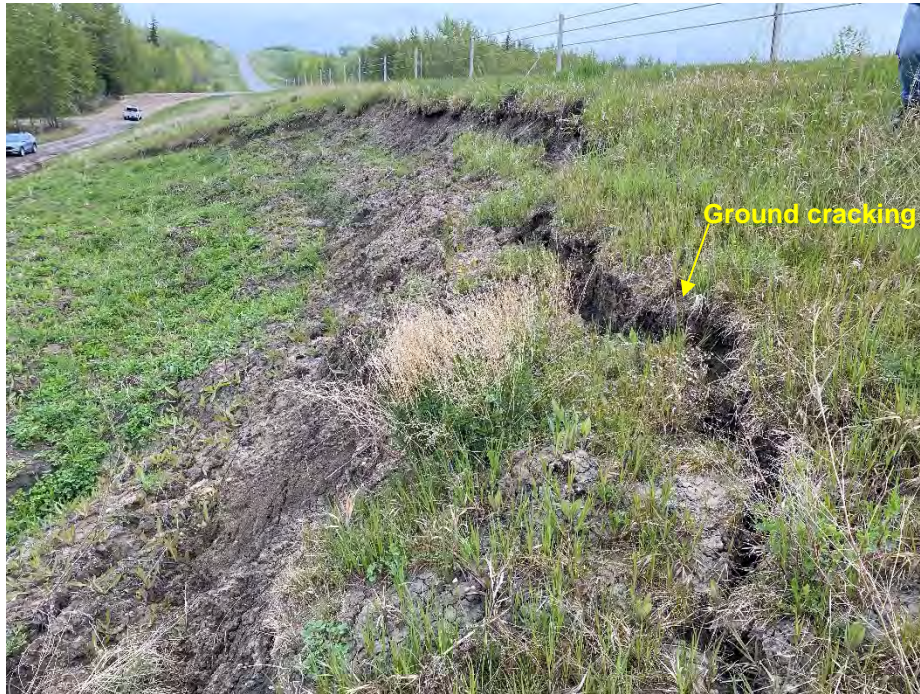
Photo 3: Backslope of failure and ground cracking to the south of the scarp. Looking northeast.

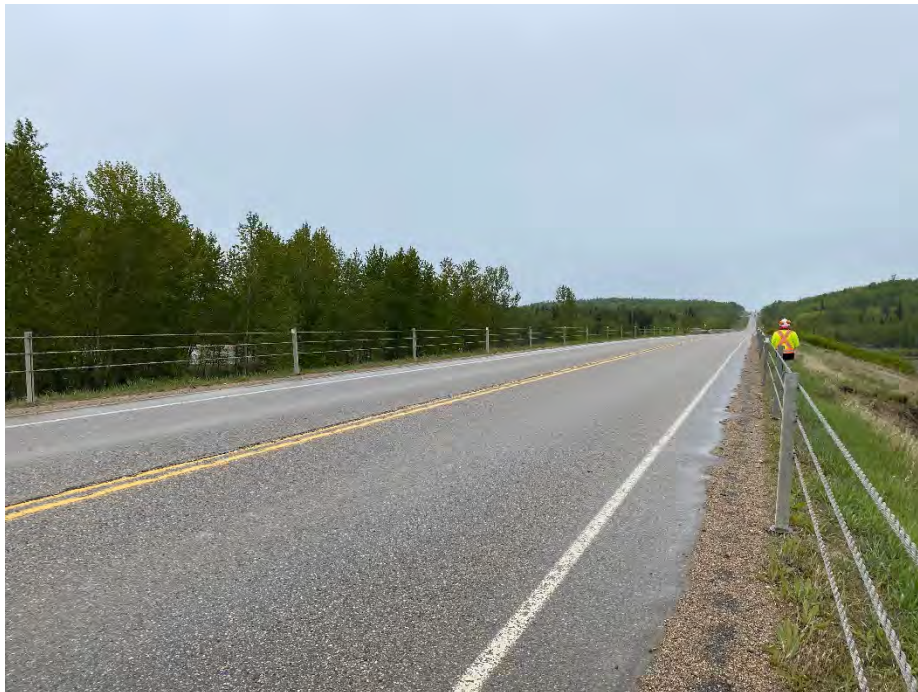
Photo 4: Highway surface above west sideslope failure. Looking southeast.

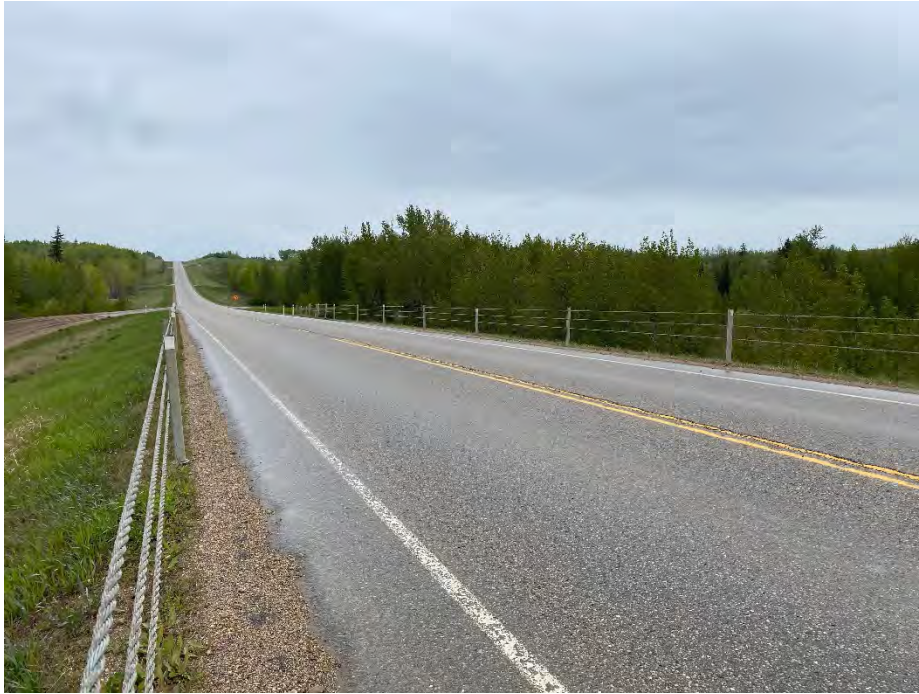
Photo 5: Highway surface above west sideslope failure. Looking northeast.

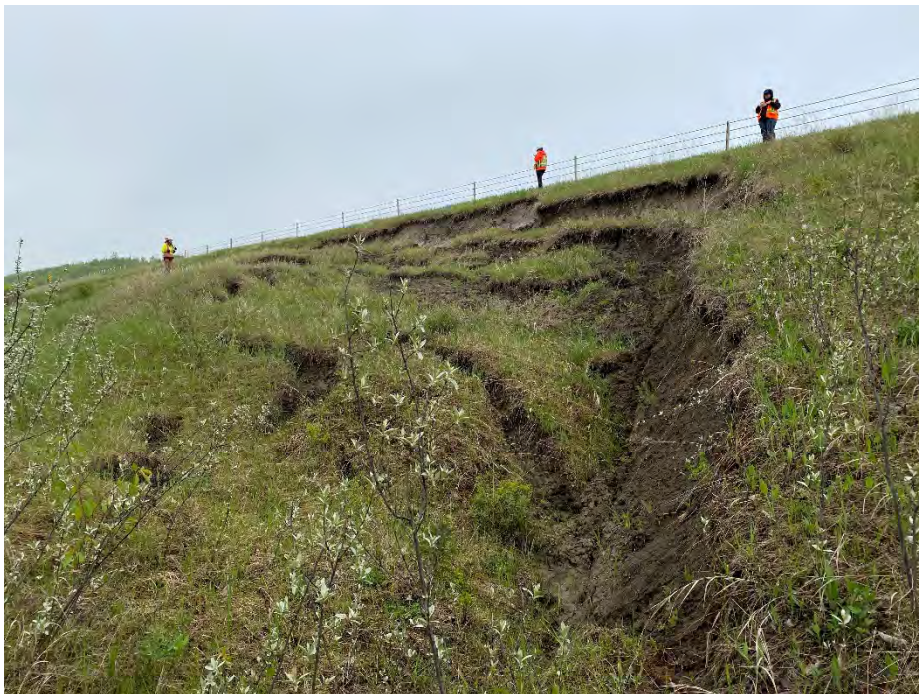
- The landslide at the north end of the east embankment has extended south to join the slumping at the middle of the embankment. The scarp of the landslide was measured to be up to 1.8 m high and 2.9 m from the edge of the highway at its closest point, similar to the previous inspection in 2024. The toe bulge appears to be pushing against the shrubs, upslope from the tree line (Photos 6 and 7). It is possible that the toe of the slide is located on private land.

Photo 6: Slump on north end of east sideslope. Looking southwest from toe.

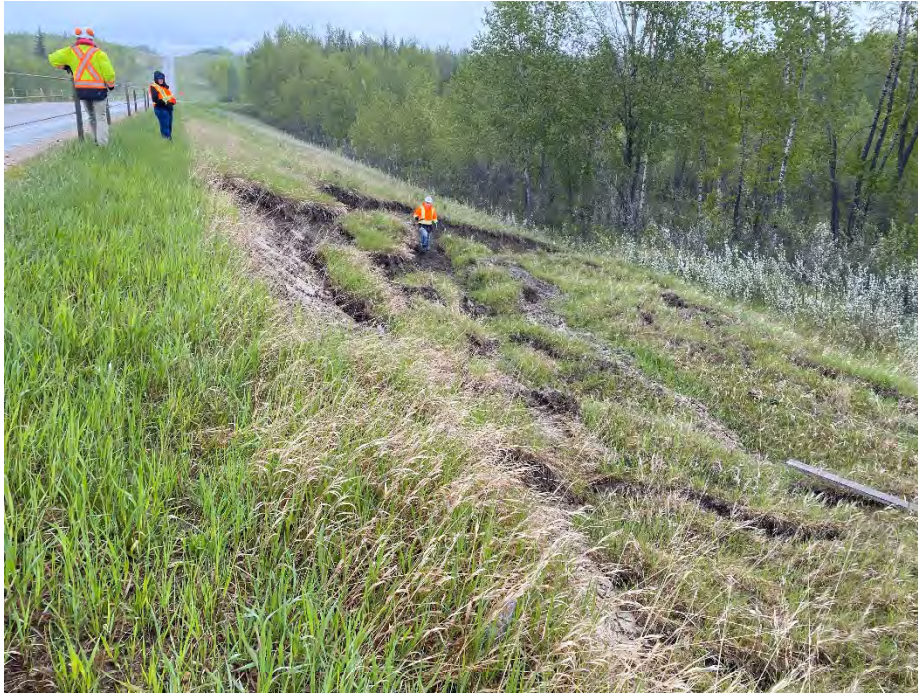
Photo 7: Northern slump on east sideslope. Looking northeast.

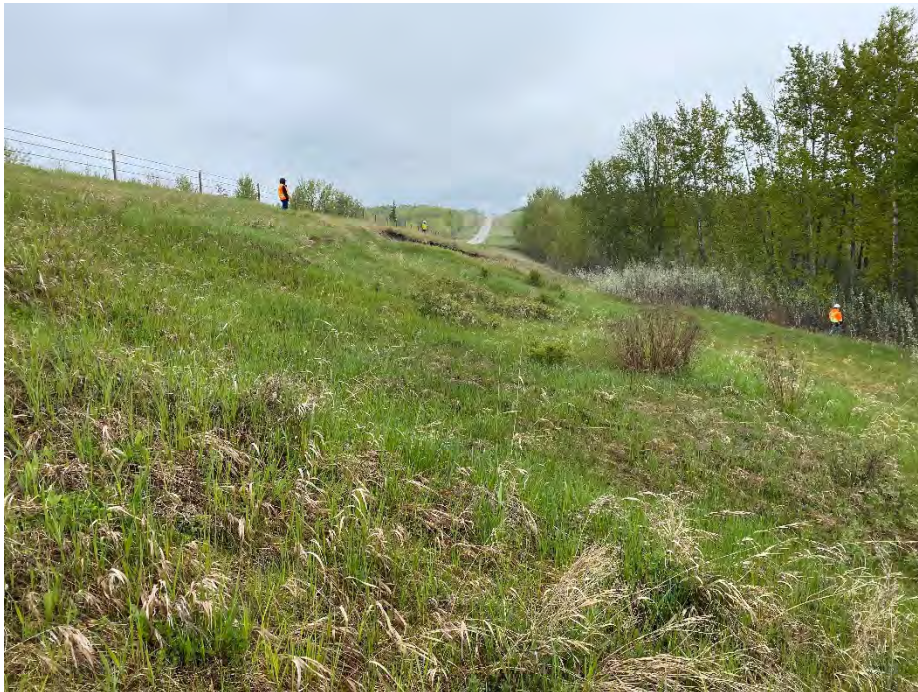
- Little to no change was observed at the other two embankment failures on the east side slope since Stantec's previous inspection in 2024 (Photos 8 to 10).

Photo 8: Middle slump on east sideslope. Looking north.

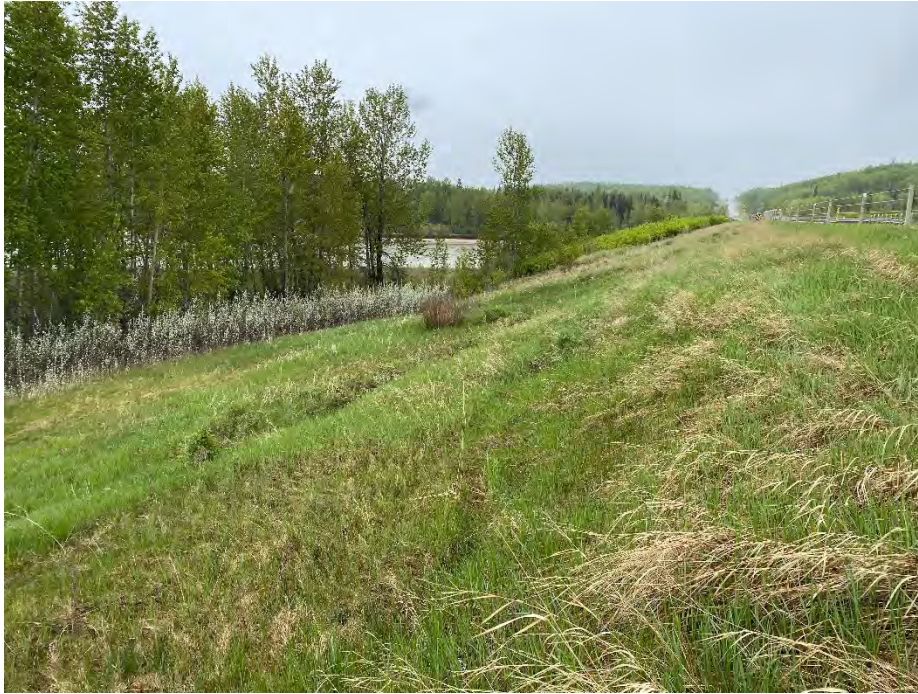
Photo 9: East sideslope at middle slump. Looking south.

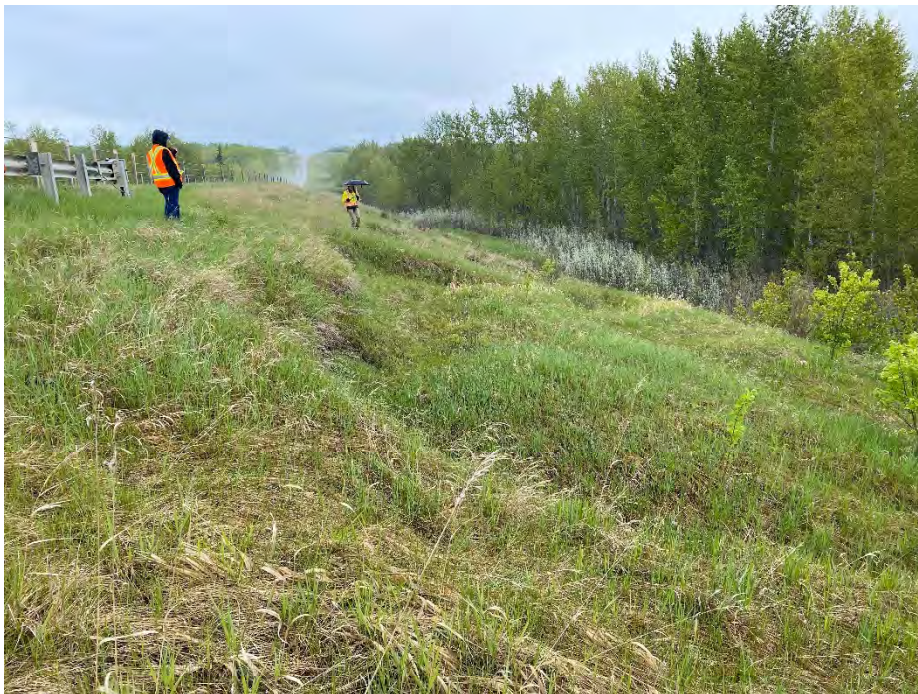
- The crest of the south slump on the east side slope was measured to be 3.6 m from the guardrail at its closest point since 2018. The backscarp appears well vegetated similar to the previous inspection in 2024 (Photo 10).

Photo 10: South slump on east sideslope relatively unchanged. Looking north.
