<b>SITE NUMBER AND NAME:</b> NC039 – South of Sturgeon River Crossing	<b>HIGHWAY AND KM:</b> 825:02, km 9.1	<b>PREVIOUS INSPECTION:</b> June 1, 2023	<b>CURRENT INSPECTION:</b> May 21, 2025
<b>LEGAL DESCRIPTION:</b> NW 28-55-22-W4M	<b>NAD83 COORDINATES:</b> UTM12U 5962150N, 353532E		<b>RISK ASSESSMENT:</b> PF: 3 CF: 4 Total: 12
<b>AVERAGE ANNUAL DAILY TRAFFIC (AADT):</b> 5,090 (2024)		<b>CONTRACTOR MAINTENANCE AREA (CMA):</b> 510

<b>SUMMARY OF INSTRUMENTATION:</b> No instruments.	<b>INSPECTED BY:</b> Stantec: Leslie Cho, Sonja Pharand TEC: Kristen Tappenden
<b>PRIMARY SITE ISSUE:</b> Erosion and slumping east of north bridge abutment.	
<b>APPROXIMATE DIMENSIONS:</b> 10 m wide x 12 m long	
<b>DATE OF ANY REMEDIAL ACTION:</b> 2004/ 2005 riprap was added in the west ditch south of bridge. Pavement dip patched in 2006. Ditch regraded with riprap added in the west ditch south of the bridge in 2015. Highway milled and re-paved in 2016. Highway patched north of bridge in mid-May 2020. Bridge superstructure replaced, highway milled and paved, bridge embankments and highway ditches repaired in 2022.

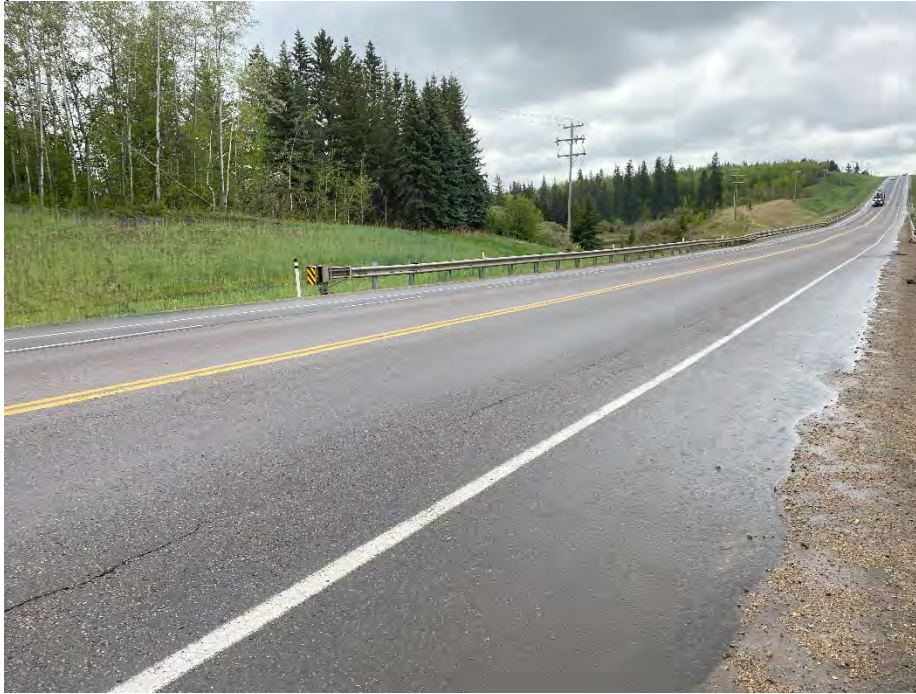
<b>COMMENTS</b>
<ul style="list-style-type: none"> <li>Minor lateral pavement cracking was observed across the site, however the pavement appears to be in similar condition as seen in 2023 (Photo 1).</li> <li>Diagonal cracks across the highway were observed near the north bridge abutment which were not present during the 2023 inspection (Photo 8).</li> <li>Standing water was observed in the ditch south of the entrance to Township Road 555. Two culverts have been installed across this entrance, with riprap surrounding the beveled outlet end. Erosion channels and sedimentation were observed within the ditch, off the corner of Township Road 555 and Highway 825 (Photo 2).</li> <li>The east ditch was observed to be wet and moderately vegetated, with the turf reinforcement mat still visible. Debris was observed in the ditch, with possible tire tracks with ponding water (Photo 3).</li> <li>The west ditch was generally well vegetated (Photo 4). A fallen tree was observed in the west ditch, extending across all the way to the guardrail. A group of leaning trees was also observed near the gabion mattresses.</li> <li>Potential hydrovac depressions or trenches were observed in the west ditch and on the backslope.</li> </ul>

**Photo 1:** Highway 825, looking south.

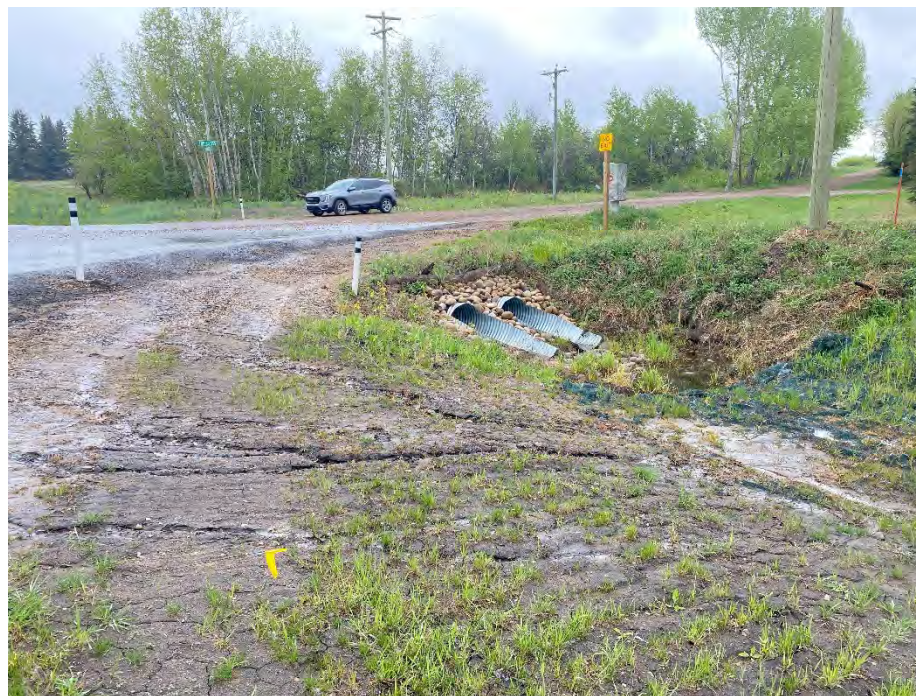
**Photo 2:** Repaired culvert outlets, with erosion channels off highway. Looking northeast.

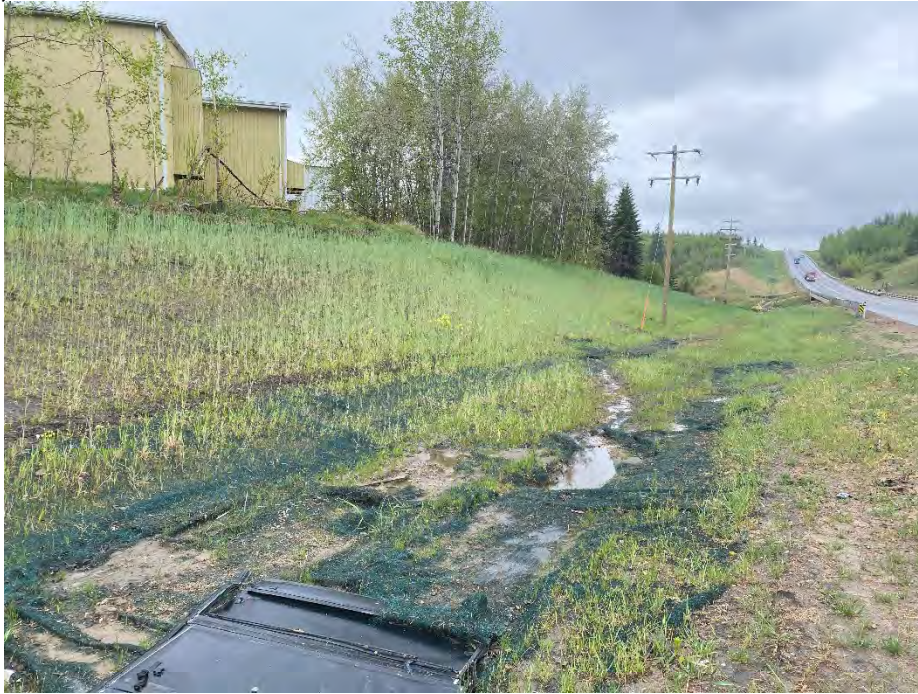
**Photo 3:** Erosion control blankets, debris and ponded water in east ditch, looking south.

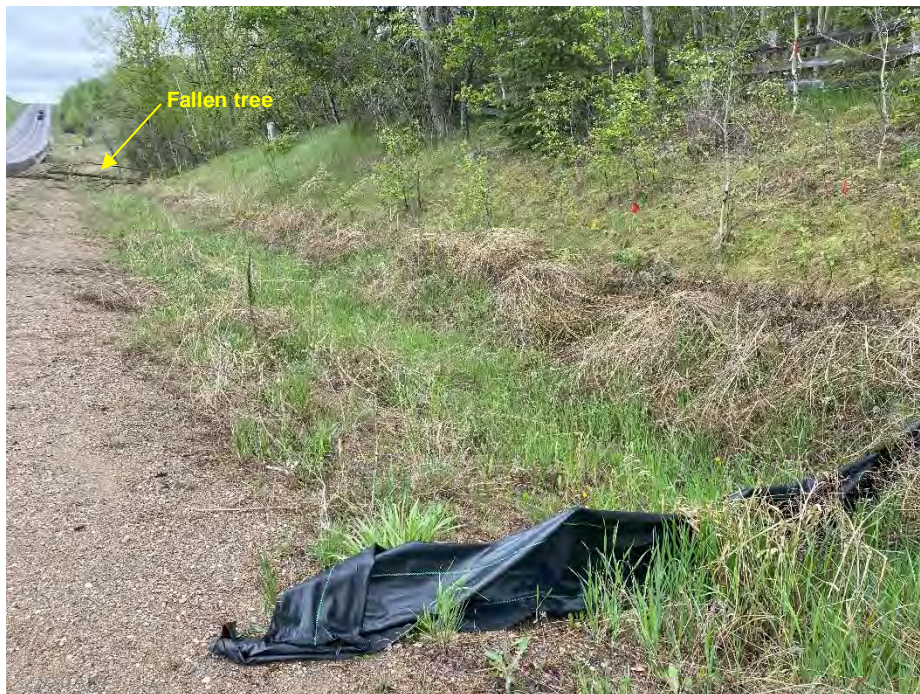
**Photo 4:** West ditch, generally vegetated. Looking southwest.

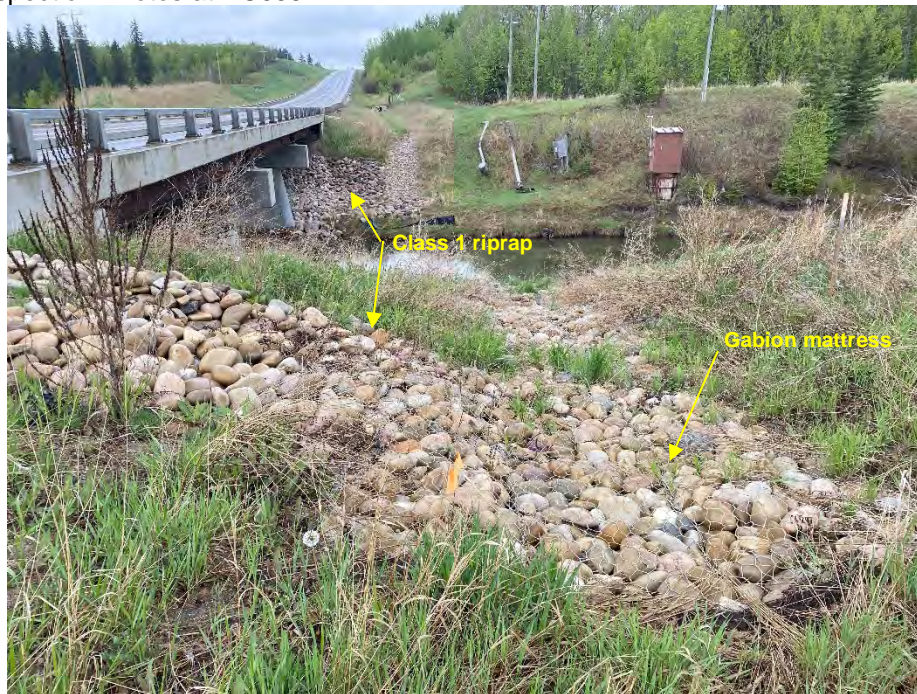
- The gabion mattresses installed on the west side of the north bridge abutment appeared to be in similar condition to 2023 (Photo 5).
- The straw wattles observed during the 2023 inspection were not observed, possibly due to tall grasses on the slope (Photo 5).

- The tension cracking and soft soils observed on the west and east sides of the gabion mattresses on the northwest slope in 2023 were not present. The slope is now moderately vegetated (Photo 5).

**Photo 5:** Remediation on west side of bridge, looking south.

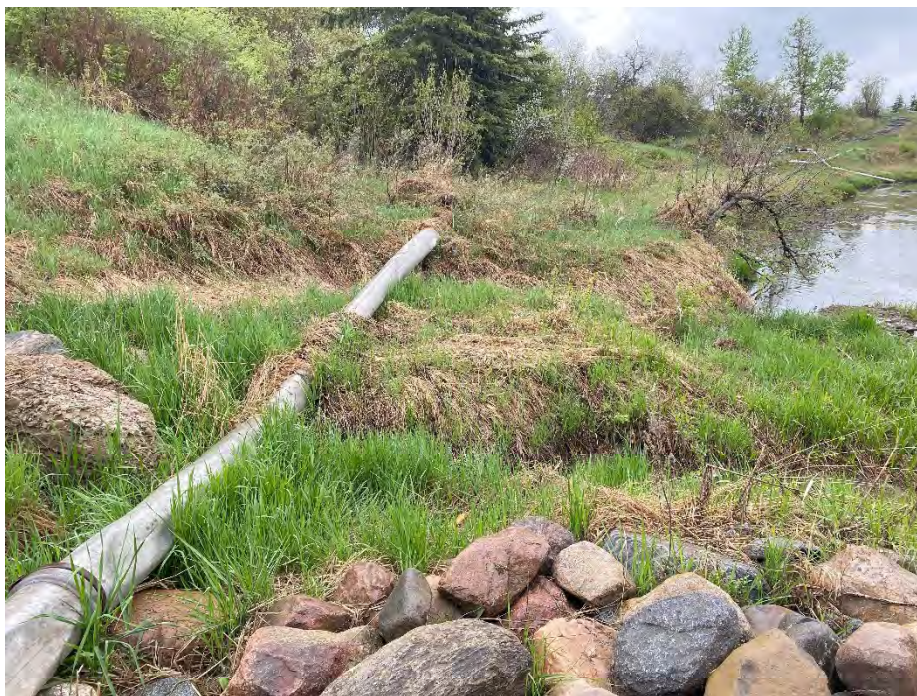
- The failure repair on the north bank above the irrigation pipe appears similar to 2023. The backfilled area is largely vegetated with long grasses. At the irrigation pipe the slump remains approximately 6 m wide, and the material below the pipe on either side of the erosion channel is vegetated with long grasses (Photo 6 and 7).

- The erosion channel slightly downslope from the undermined irrigation pipe to the river is approximately 1.5 m wide.

**Photo 6:** Undermined irrigation pipe along north bank, east of the bridge. Looking southeast.

- The site should be monitored regularly by the MCI for retrogression of the scarp towards the roadway and bridge structure.
- The contractor should be asked to return to the site and remove the silt fencing that is still present at the site.
- Any pavement cracks that may appear should be crack sealed to reduce infiltration of water into the highway structure.
- It's recommended that this site is removed from the monitoring program.

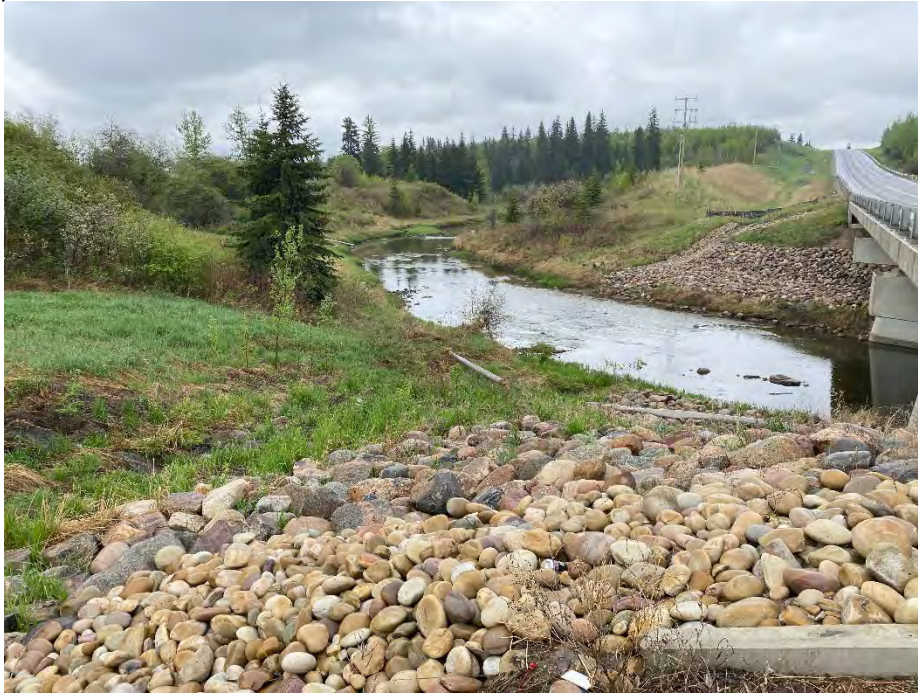
**Photo 7:** Remediation on east side of the bridge. Looking southeast.

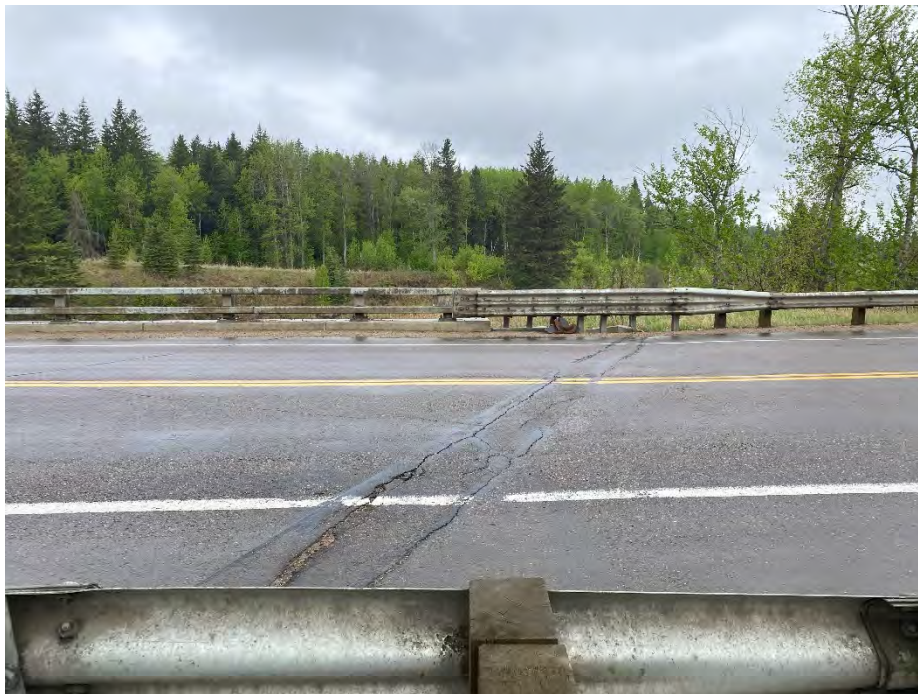
**Photo 8:** Pavement cracking at north abutment. Looking west.
