THURBER ENGINEERING LTD.

October 6, 2004

**CALL-OUT FOR MENNO SIMONS EROSION SITE (PH 14)
LOCATED 800 m SOUTH OF HWY 64, 6 KM WEST OF HWY 726
SW8-85-8-W6M**

HWY 64 - MENNO SIMONS EROSION SITE (PH14)

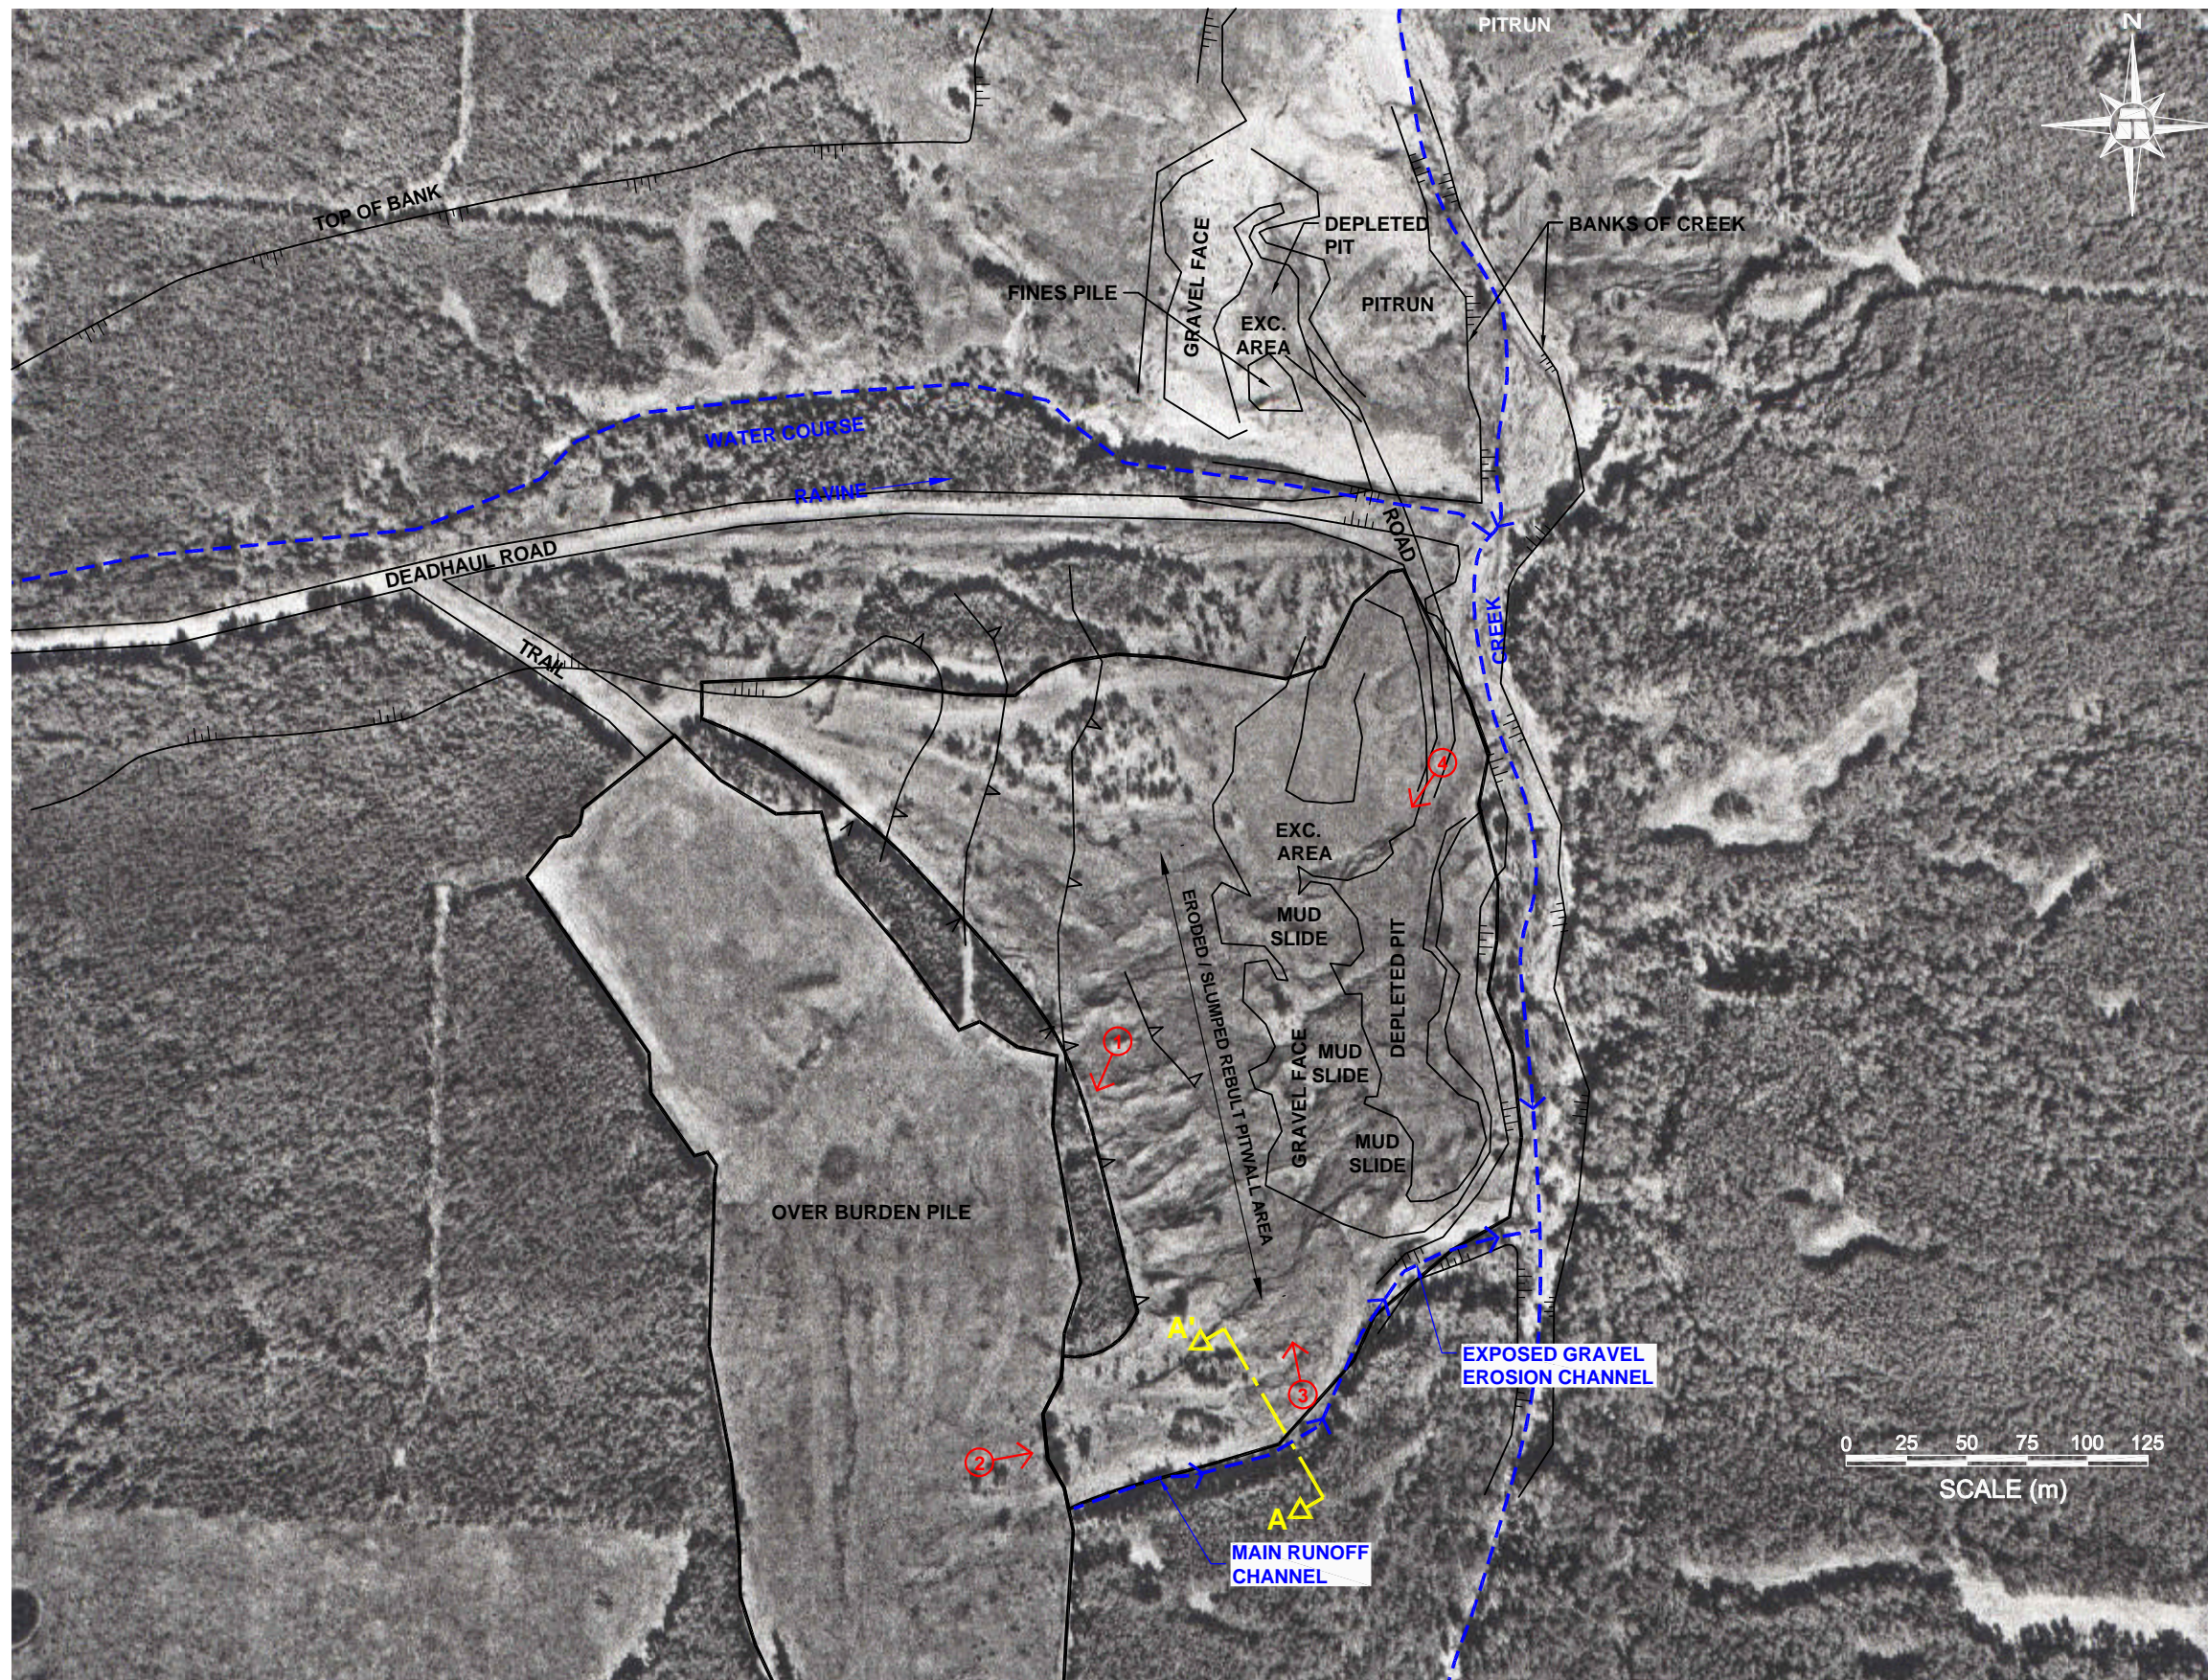
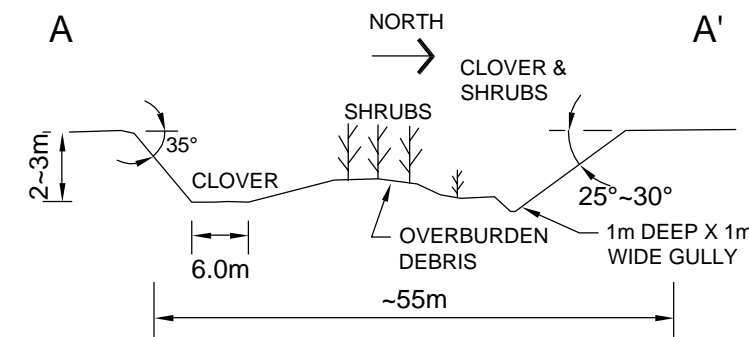
FIGURE 1 SITE PLAN & CROSS-SECTION A-A'
PH14-MENNO SIMONS EROSION SITE
 JULY 6, 2004 CALL OUT

A plan view of the erosion site and an approximate cross-section of the main runoff channel at the south end of the site are provided on Figure 1. A May 2003 1:5000 scale airphoto was used for the background of the figure and site features were taken from AT's pit plan dated June 17, 2003 and updated/adjusted based on our July 6, 2004 site observations. Views of the slide area are also shown on Photographs #1 to #4, attached.

At the southern edge of the pitwall fill, a fairly prominent runoff channel had formed, which originated from the base of the overburden pile and extended down to the creek. It is anticipated that this channel carries the bulk of the runoff originating from the overburden pile and flatter treed area in-between it and the top of the rebuilt pit wall. A cross-section taken near the upper portion of the slope across this channel is shown on Figure 1, and shows that it possessed a double legged bottom. The south leg of the channel was gravelly, while the northern leg appeared to be based in clay and was in a "V" shape. The area between the legs contained random and disordered topsoil slumps. This channel contained a slope of about 11° in its upper reach from the base of the overburden pile to the crest of the original slope, and approached about 12° to 20° below this. The very bottom of the channel from the base of the pitwall fill to the creek, exposed a clean, fine, sandy gravel, which sloped down at about 30° , and was in a "V" shape about 2 to 3 m deep.

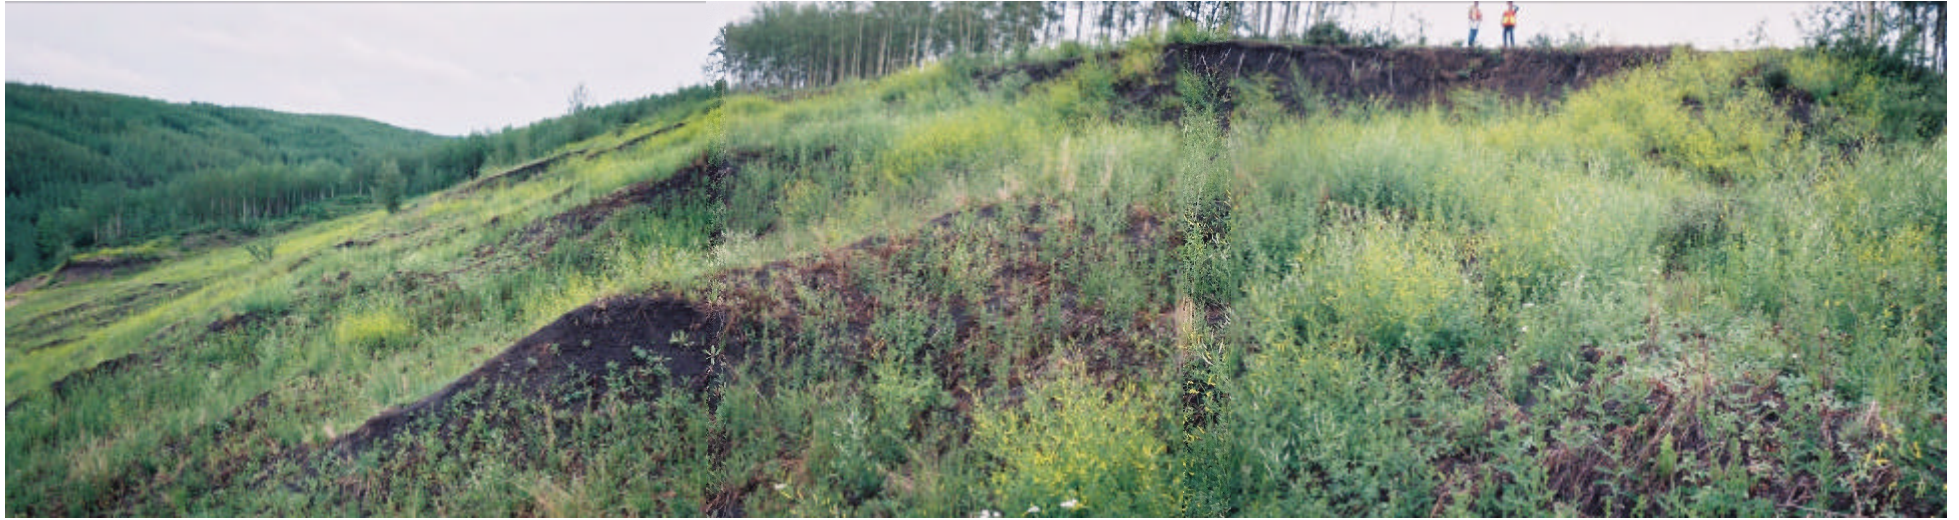
The overburden pile contained exposed shallow slumps and erosion rills/gullies up to 1 m deep through its sparse clover/grass covered surface. It possessed slopes of about 10° on the west side, and between about 13° to 15° on the east side. The soil exposed at surface appeared to contain a significant amount of topsoil/organics, but also contained a substantial clay/silt/sand content.

PHOTO 1 LOOKING SOUTH TO WEST ALONG UPPER PORTION OF REBUILT PIT SLOPE FROM APPROXIMATE CENTER OF STUDY AREA

As a minimum, it is recommended that the existing pitwall slope face be recontoured by filling in the erosion rills/gullies to reduce the potential for concentrated flow and future erosion that could destabilize the slope. Material from the existing overburden pile could be used for this purpose, which should also be recontoured in a similar manner. During the regrading process, zones containing higher topsoil content should be separated and deposited at the finished surface of the gully fills to the extent practicable, to promote future vegetation growth. Subsequent to grading/recontouring, these slope faces should be re-seeded with the appropriate seedlings (including possible water resistant species such as willows).

Prior to regrading, a more detailed examination of the existing overburden pile slopes should be made. It may be necessary to flatten the slopes of the overburden pile to improve the stability of this pile. The reserve boundary may have to be extended to the west to allow for flattening of the pile which would involve some tree clearing.

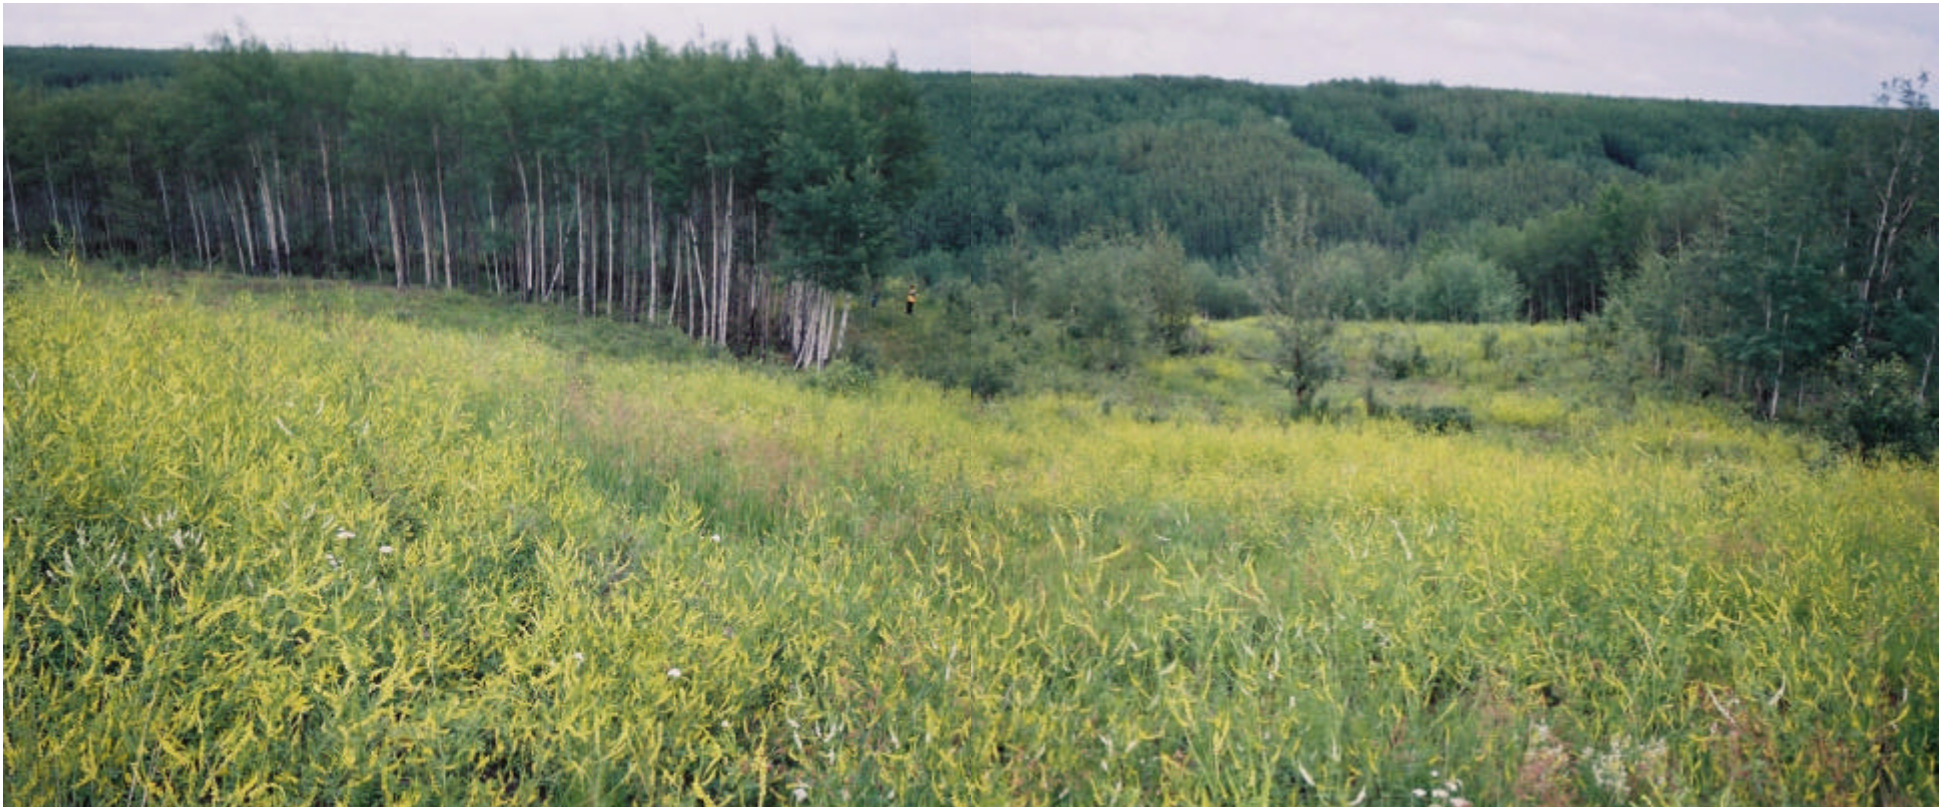
PHOTO 2 LOOKING EAST ALONG SOUTH EDGE OF REBUILT PIT WALL AT MAIN DRAINAGE CHANNEL FROM ABOUT 1/2 WAY UP THE OVERBURDEN PILE

One of the issues that needs to be address is the ongoing runoff from the overburden pile that is eroding the reclaimed pit slope. This could be addressed by constructing a runoff interceptor ditch in the flat area between the overburden pile and pit slope crest. Since the ground surface actually drains from north to south, it would make sense to drain the interceptor ditch into the main runoff channel located at the south end of the site. The interceptor ditch will need to be lined, possibly with high flow soil covering and the main runoff channel will need to be recontoured and armored, possibly with heavy rip rap or gabion mattress. A silt fence (assuming some routine maintenance can be implemented), or possibly a more resistant structure such as rock berm or gabion wall based into the existing soil, should be installed on the west side of this channel to reduce soil infill and sedimentation in the ditch. A sedimentation pond may be required at the base of the slope at the downstream end of the channel(s) on the ledge in front of (the west side of) the creek to catch/retain sediment that would otherwise run into the creek. The interceptor ditch, runoff channel and sedimentation pond designs should be further assessed during the detailed design with input from a hydraulic engineer.

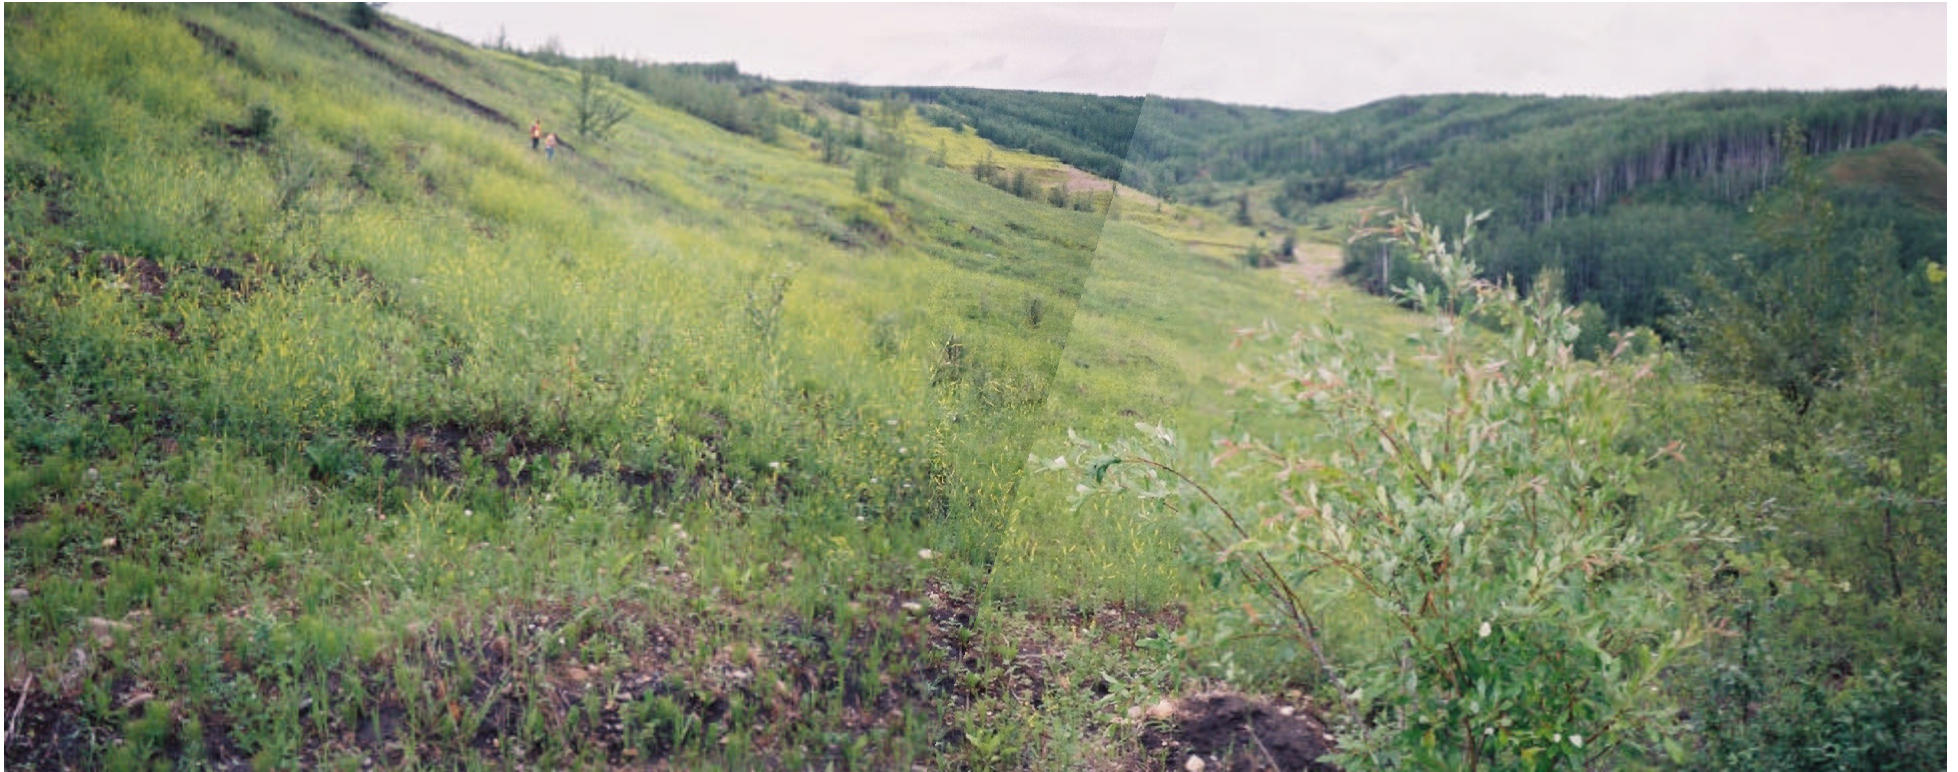
Below the treed area, the reclaimed pit wall contained a 3 m high, intermittent exposed scarp along the crest. This scarp appeared to be predominantly in sandier soil, and was inclined at 35° to 50° . Below the scarp, a disordered array of erosion gullies and slumps existed on the pitwall surface. In many areas the slumped material had moved downslope where noticeable toe rolls were evident. The exposed soil at surface was quite variable, consisting of a mixture of topsoil, organics, clay, silt and sand, which was exposed through a vegetative cover consisting of clover, grass and a few small trees/shrubs. The overall slope was measured to be in the order of about 20° , from the crest to the toe of the lower plateau above the creek.

PHOTO 3 LOOKING EAST ALONG REBUILT PITWALL SLOPE FROM ABOUT MIDSLOPE AT THE SOUTH END

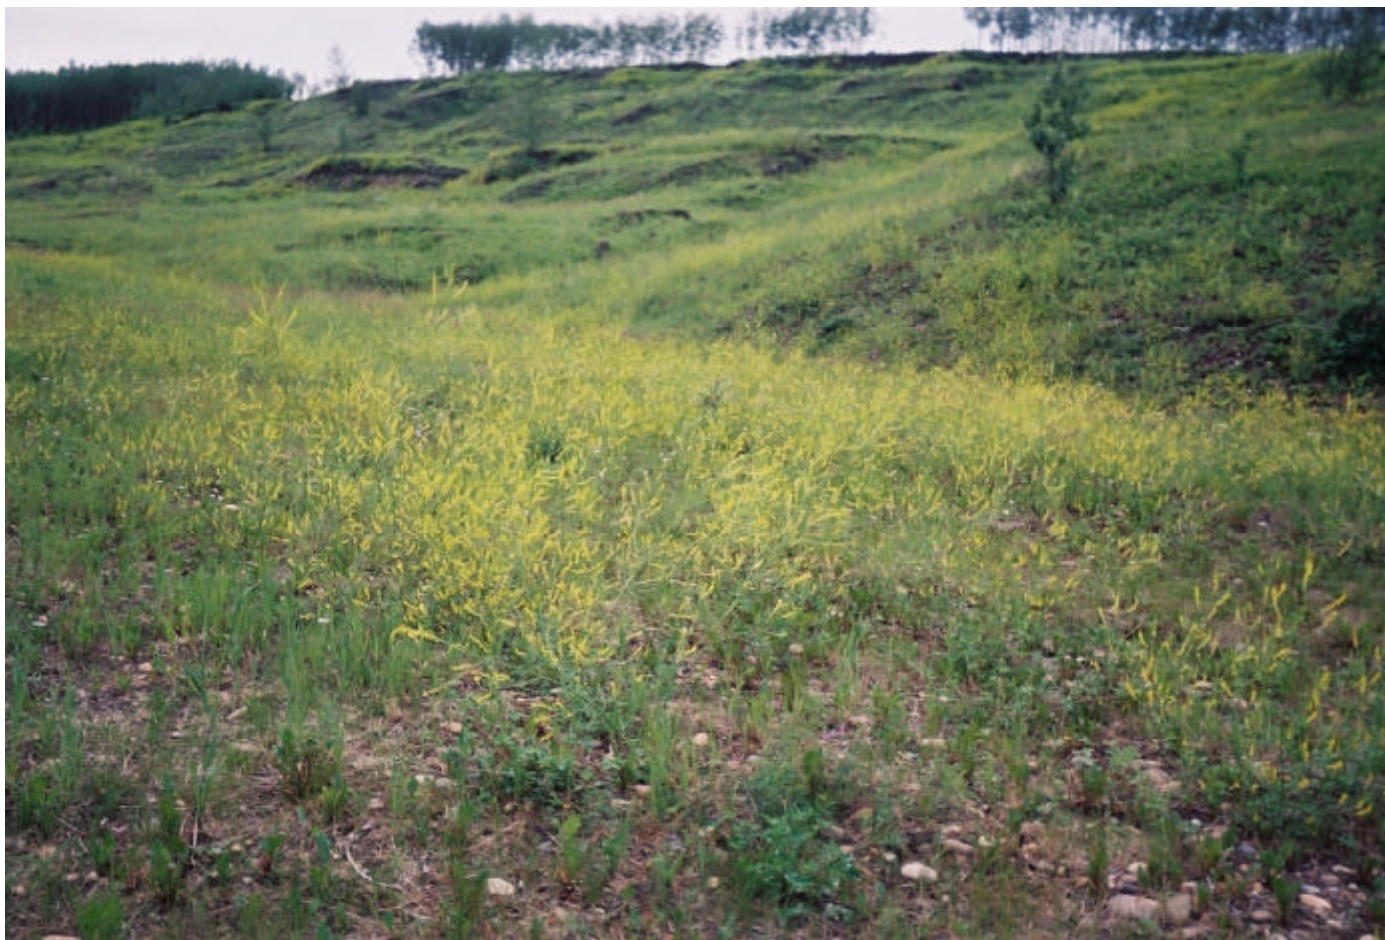
The 20 m wide ledge between the base of the pitwall slope and creek appeared to have a gravelly surface. There was no evidence of the overburden soil mixture containing topsoil being washed into the creek at the time of the site visit. A shallow berm existed above the creek bank which may be preventing widespread overburden runoff into the creek, however there were about four (4) locations observed where runoff/sediment could possibly infiltrate the creek, at two locations near the south end and at two lower areas of the berm further north.

PHOTO 4 LOOKING SOUTHWEST AT OLD PIT FACE FROM LEDGE ABOVE THE CREEK

Potential silt migration from the lower ledge area into the creek also needs to be addressed. The berm along the top of the creek bank could be regarded where required, an/or consideration could be given to construction of a swale in front of the berm, as a second line of defense to drain surface water into the proposed stilling pond at the outlet of the runoff channel.
