**ALBERTA TRANSPORTATION  
GEOHAZARD ASSESSMENT PROGRAM  
PEACE REGION – PEACE RIVER/HIGH LEVEL  
2017 INSPECTION**

Site Number	Location	Name	Hwy	km
PH 76	~5 km W. Cleardale	Culvert Slide	64:02	30.15
Legal Description		UTM Co-ordinates (NAD 83)		
SW6-85-10-W6		11V N 6246803	E 340894

**2017 PH076-1 INSPECTION  
DESIGN FINAL GRADE**

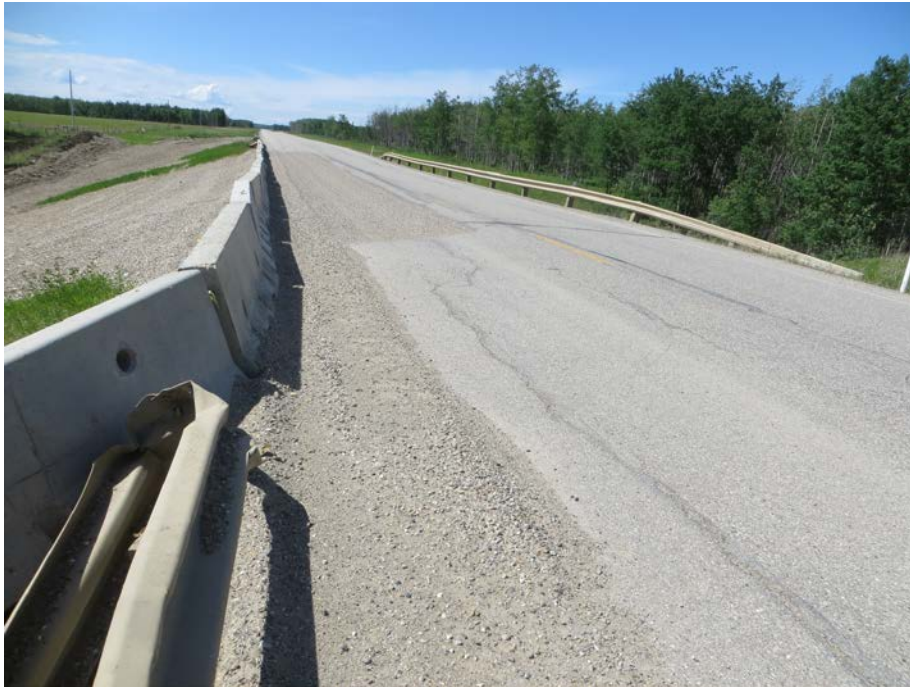
Photo 1 – Looking west along the highway over the repaired slide area.

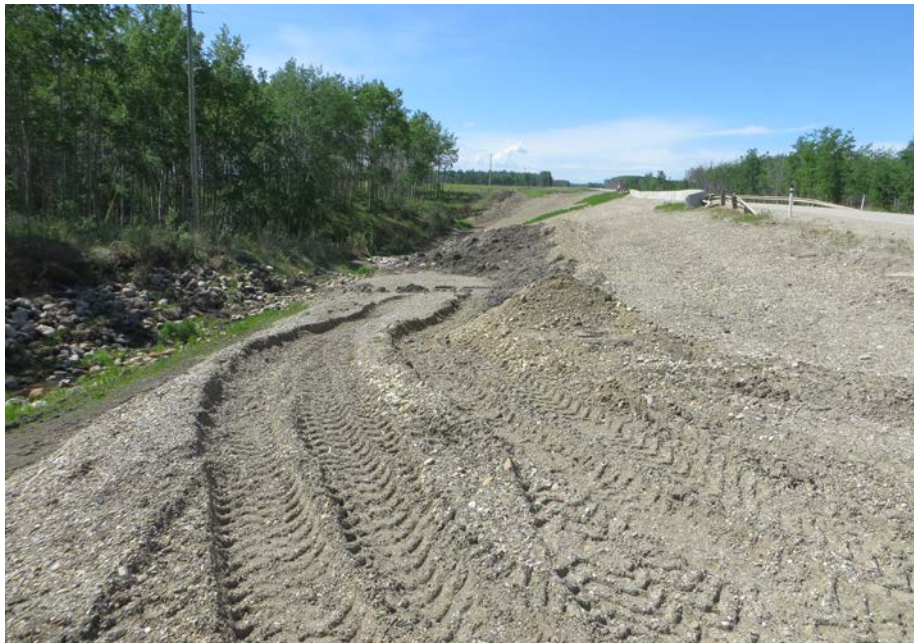
Photo 2 – Looking west along the south highway embankment slide area from the east end (construction on-going).

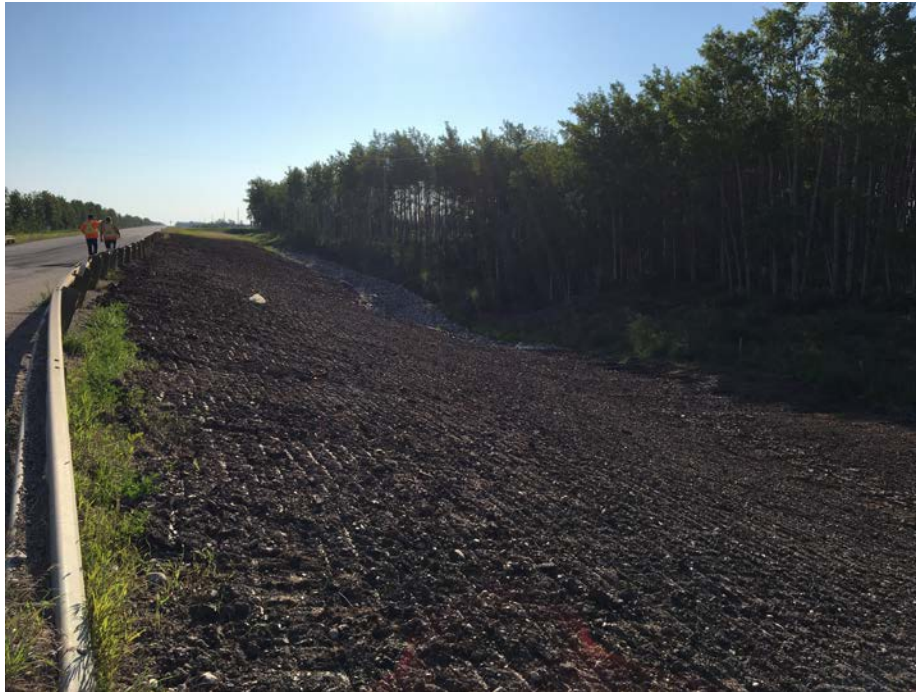
Photo 3 – Looking east along the repaired highway embankment (July, 2017).

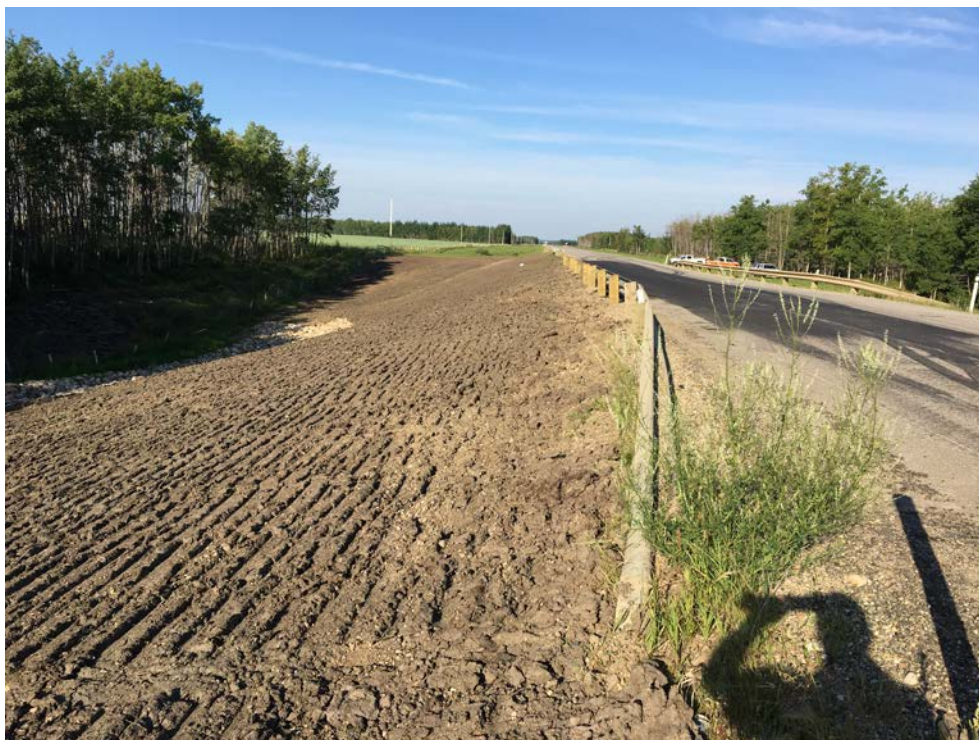
Photo 4 – Looking west along the repaired south hwy embankment (July, 2017).

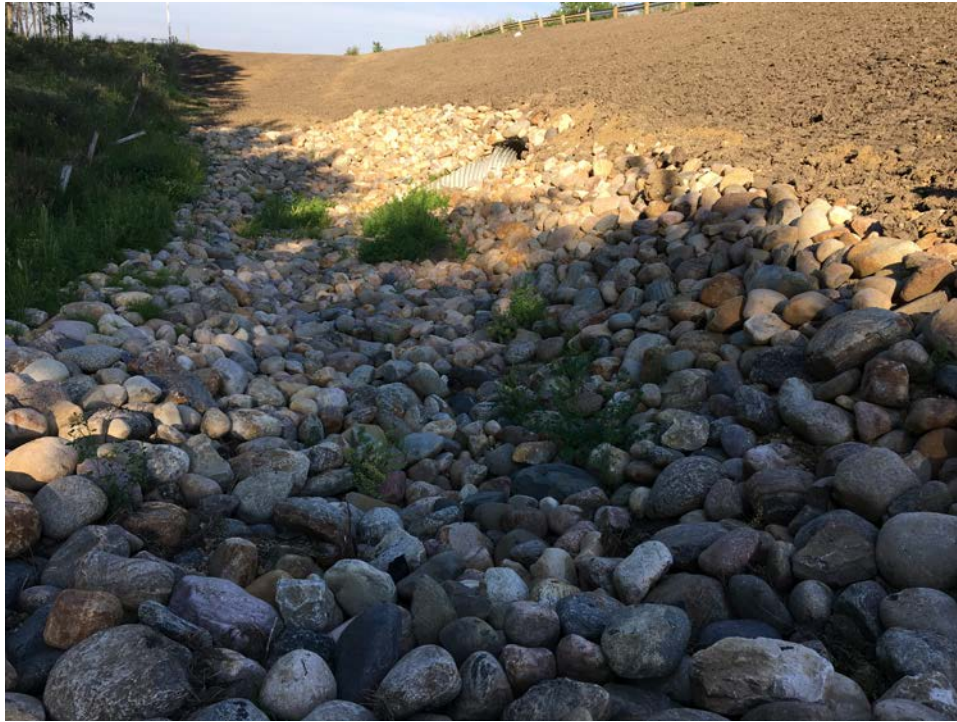
Photo 5 – Looking west across the freshly riprapped culvert outlet (July, 2017).

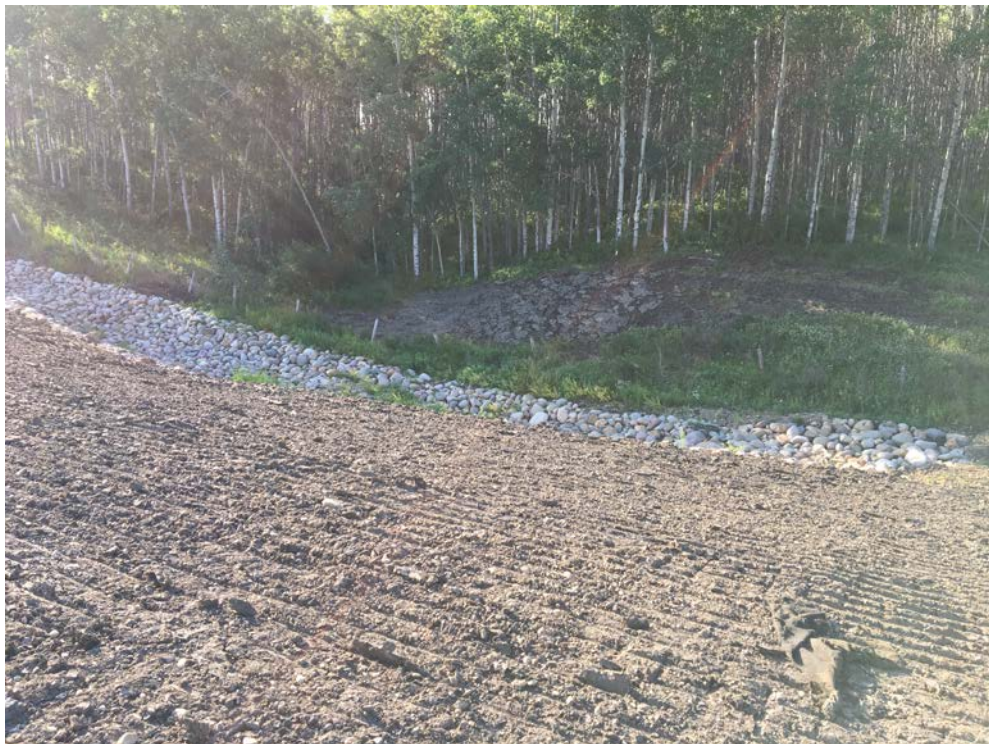
Photo 6 - Looking south over the new embankment and culvert outlet area (July, 2017).
