**ALBERTA TRANSPORTATION
GEOHAZARD ASSESSMENT PROGRAM
PEACE REGION – PEACE RIVER/HIGH LEVEL
2018 INSPECTION**

THURBER ENGINEERING LTD.

Site Number	Location	Name	Hwy	km
PH 76	~5 km W. Cleardale	Culvert Slide	64:02	30.15
Legal Description		UTM Co-ordinates (NAD 83)		
SW6-85-10-W6		11V N 6246803	E 340894

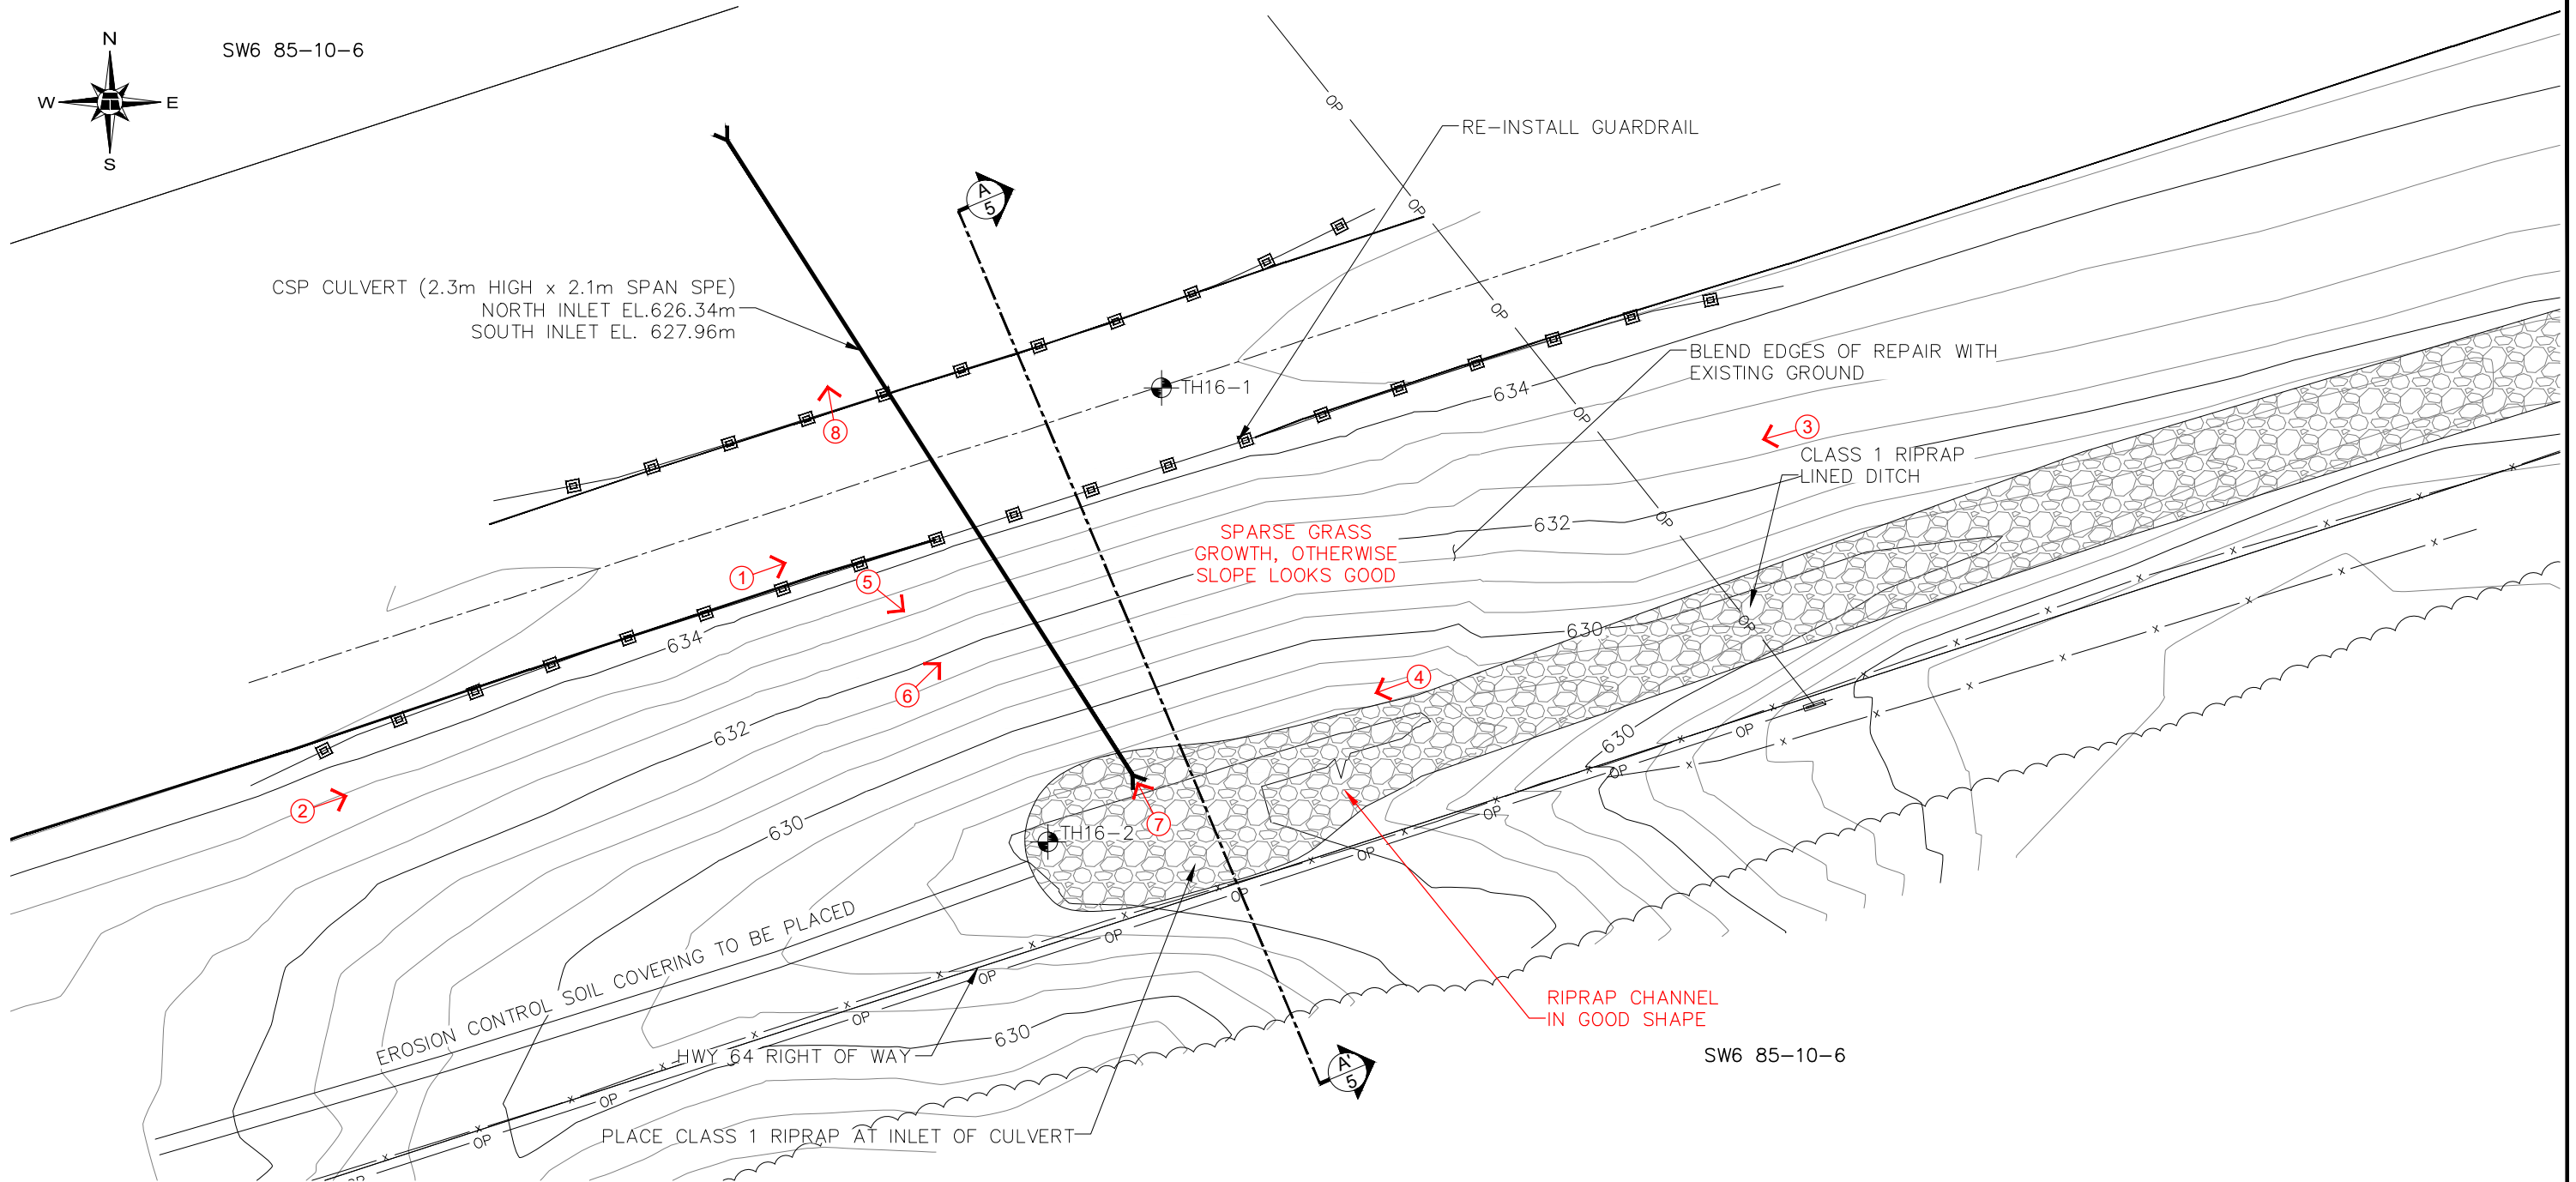
FIGURE PH076-1-1

NOTES :
1. MAY 18, 2018 OBSERVATIONS SHOWN IN RED

**2018 PH076-1 INSPECTION
DESIGN FINAL GRADE**

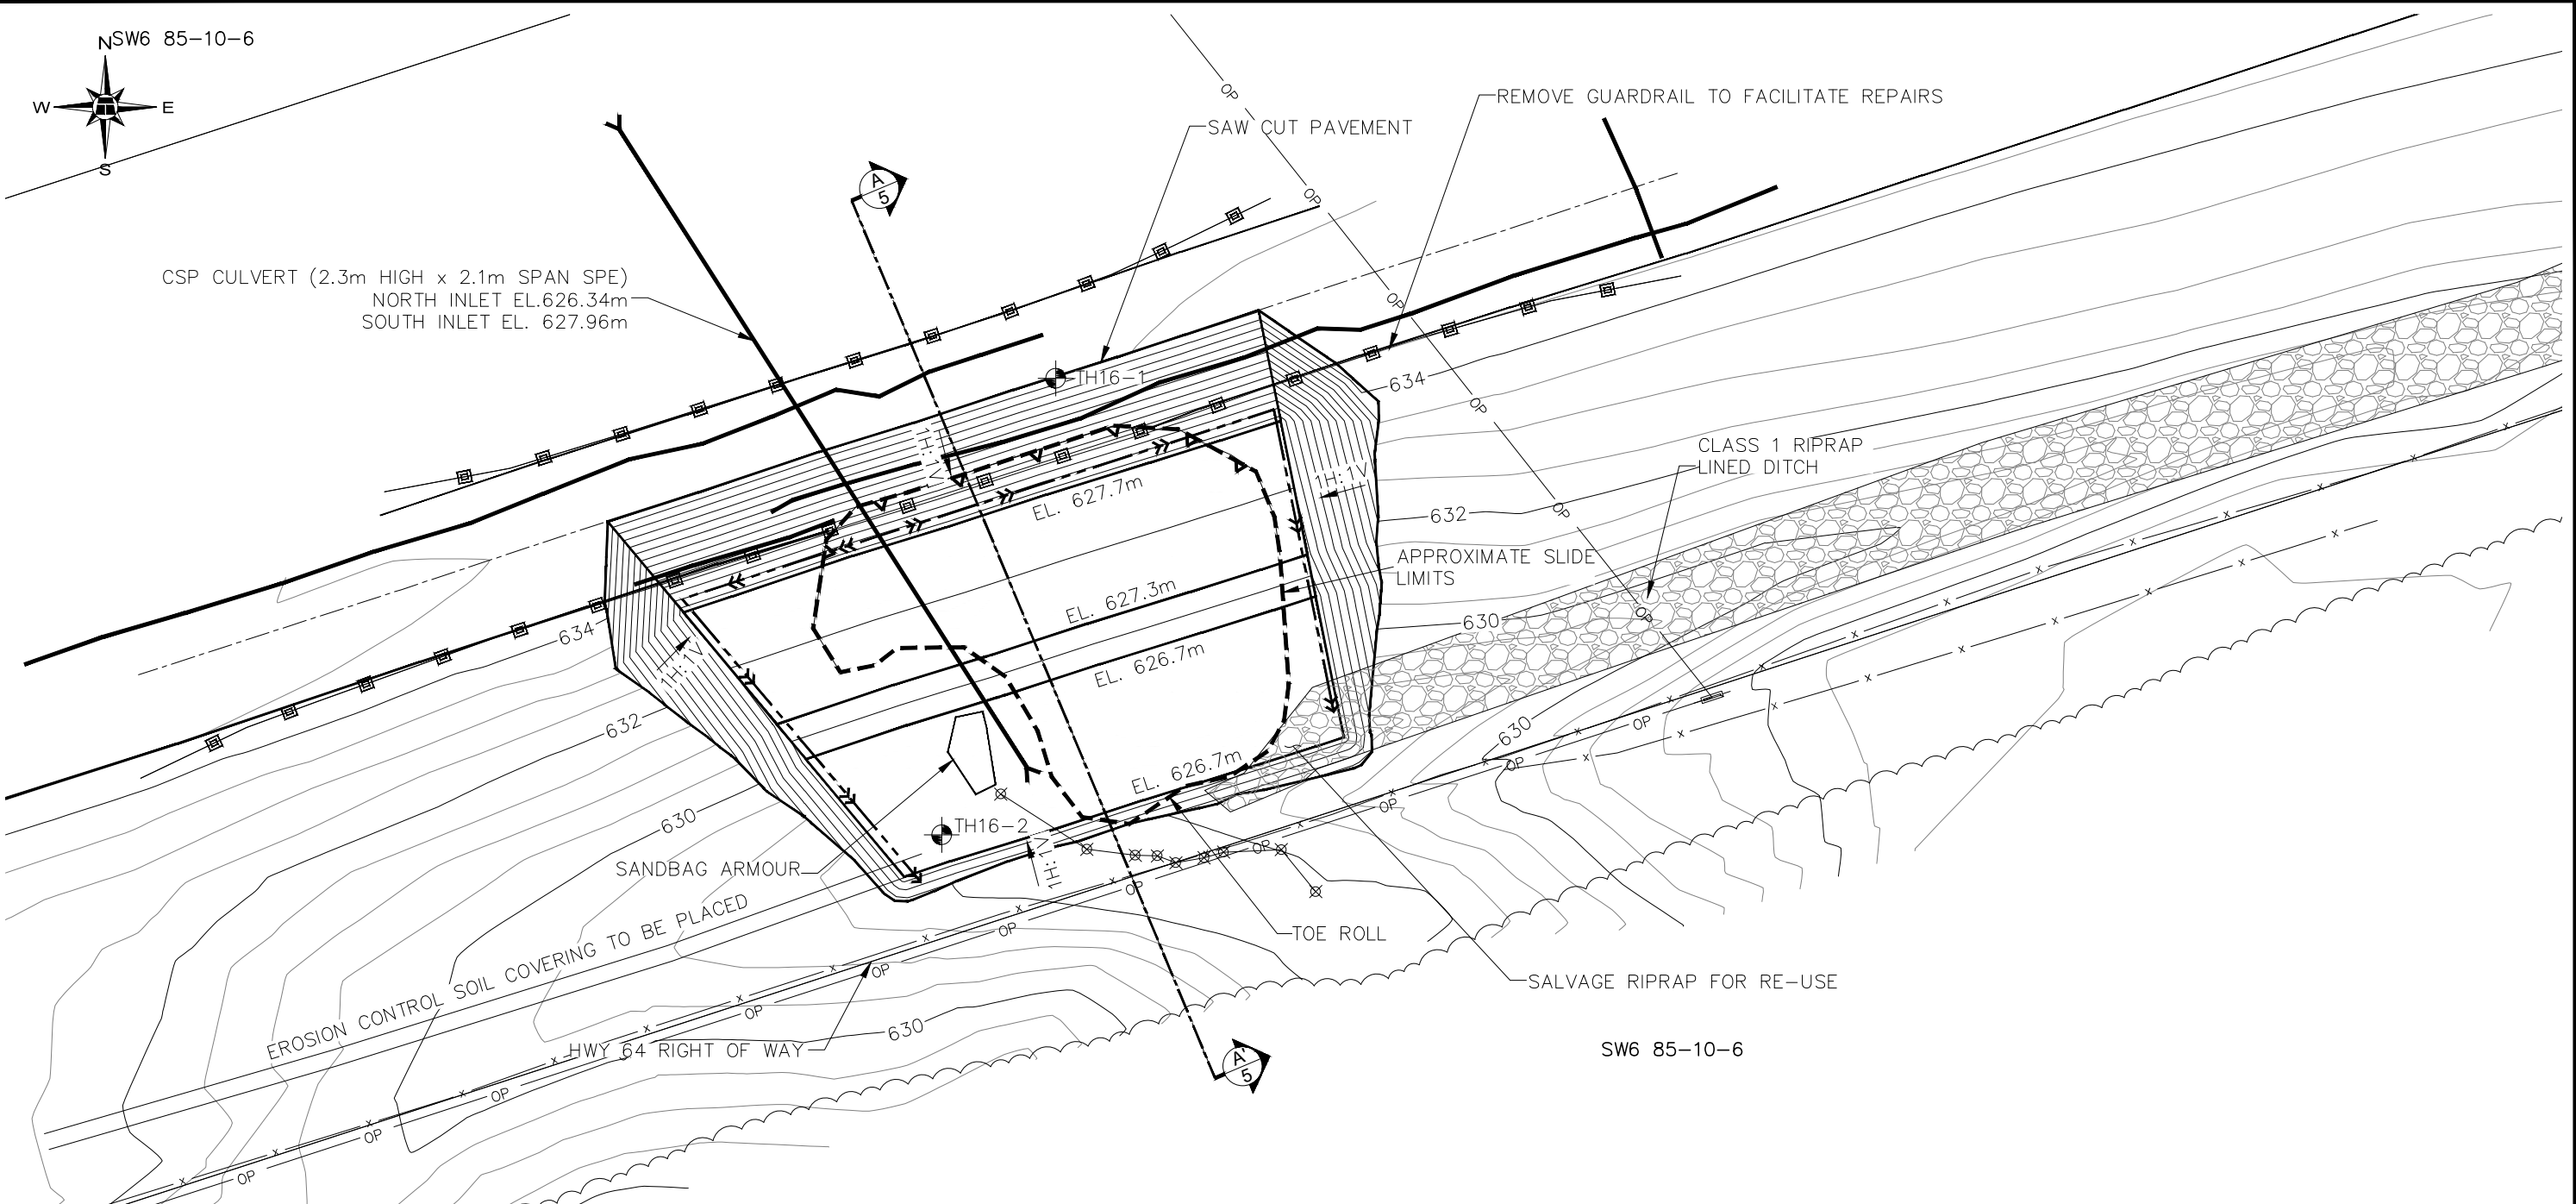
FIGURE PH076-1-2

NOTES:
 1. MAY 18, 2018 OBSERVATIONS SHOWN IN RED

**2018 PH076-1 INSPECTION
 DESIGN EXCAVATION PLAN**

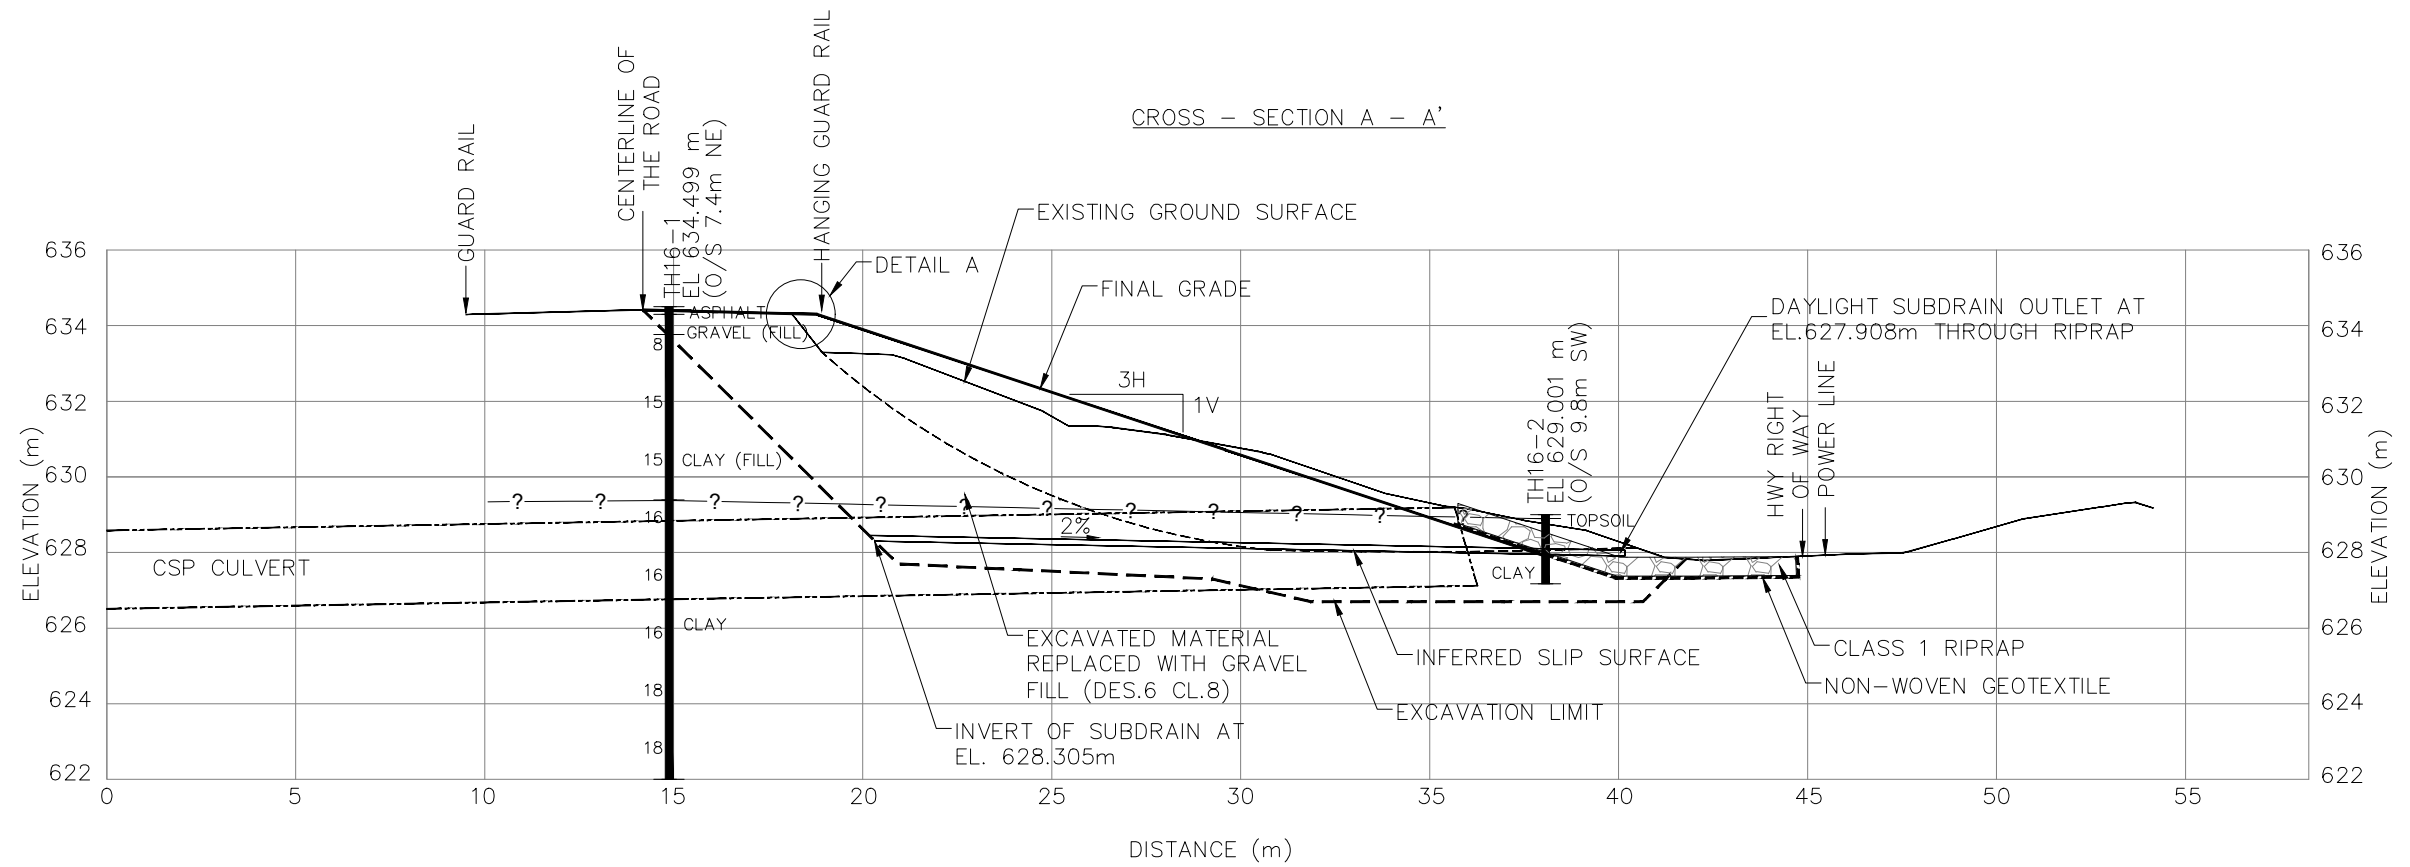
FIGURE PH076-1-3

2018 PH076-1 INSPECTION
CROSS - SECTION A - A'

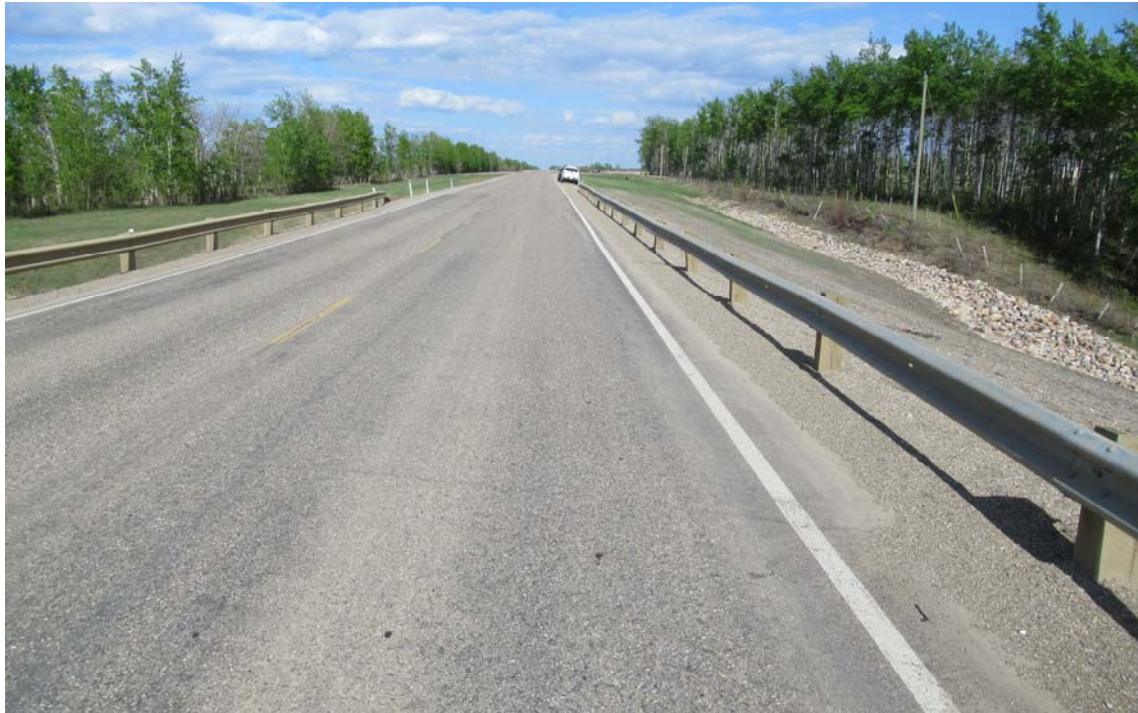
Photo 1 – Looking east along the highway over the repaired slide area.

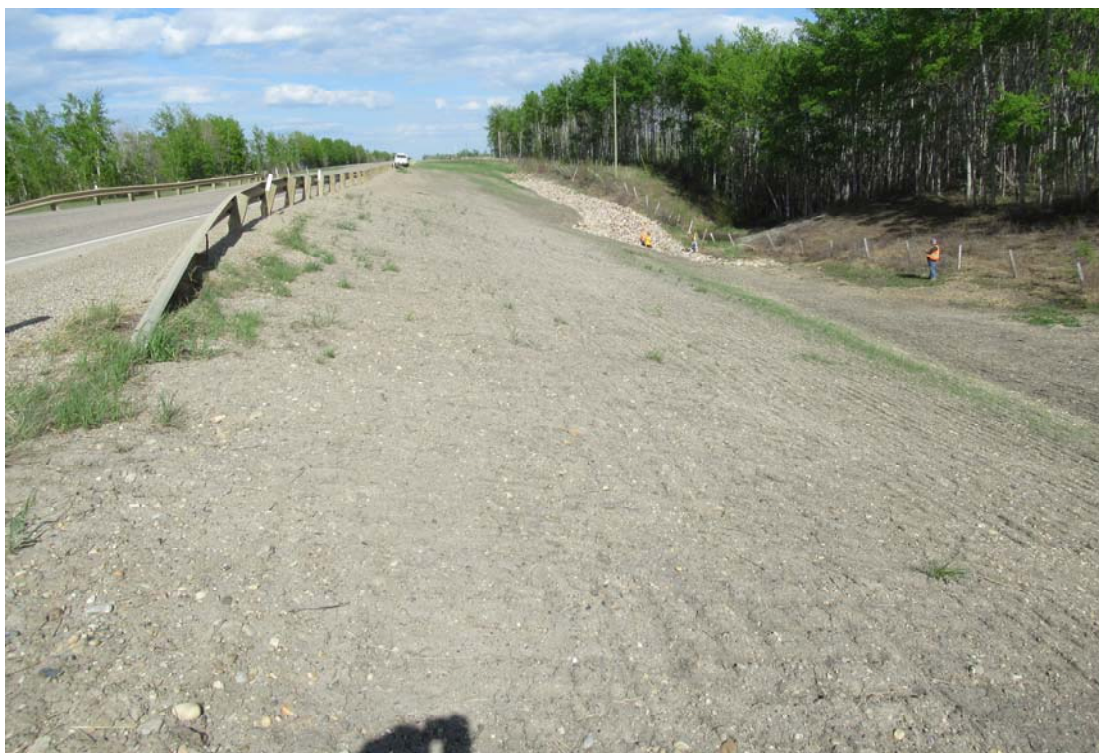
Photo 2 – Looking east along the repaired highway embankment.

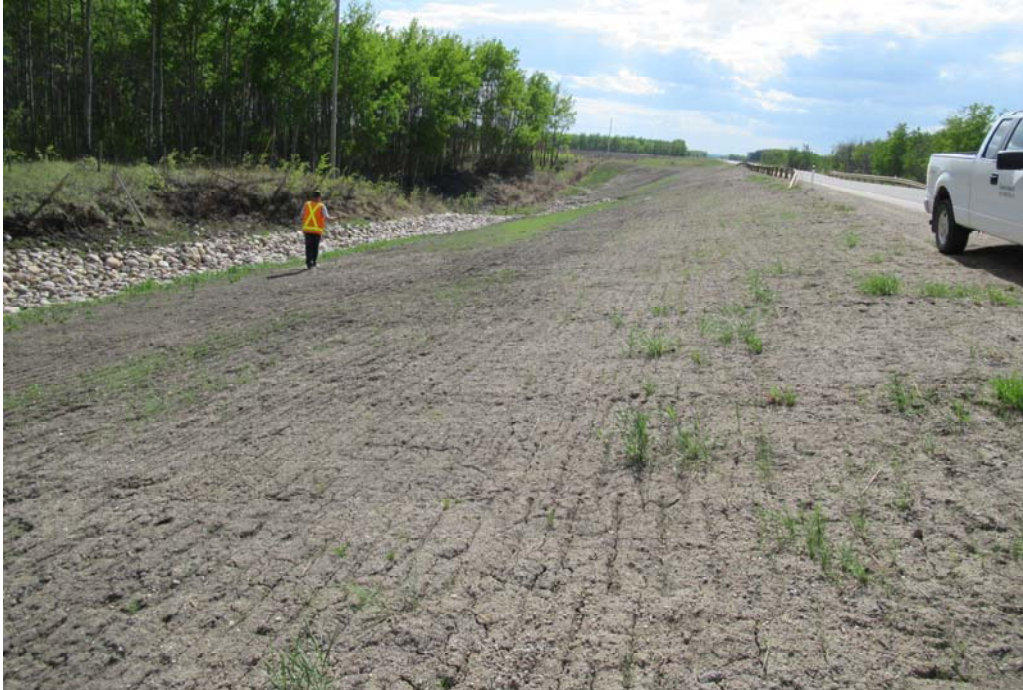
Photo 3 – Looking west along the south highway embankment from the east end.

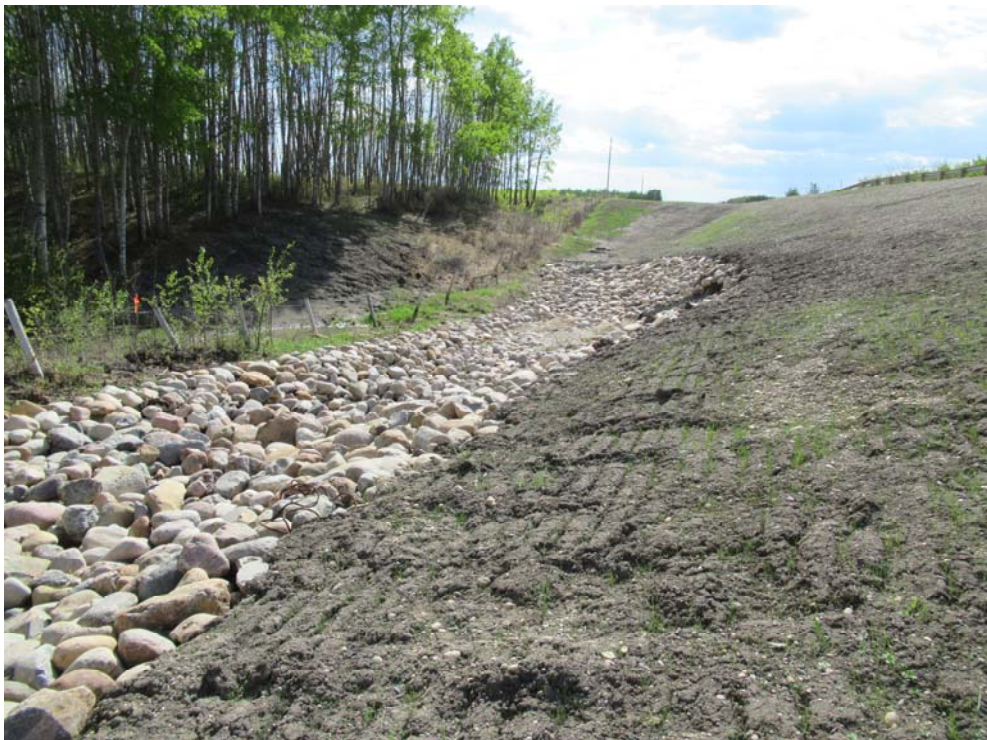
Photo 4 – Looking west along the toe of the repaired south highway embankment, and re-constructed riprap channel leading to the culvert inlet.

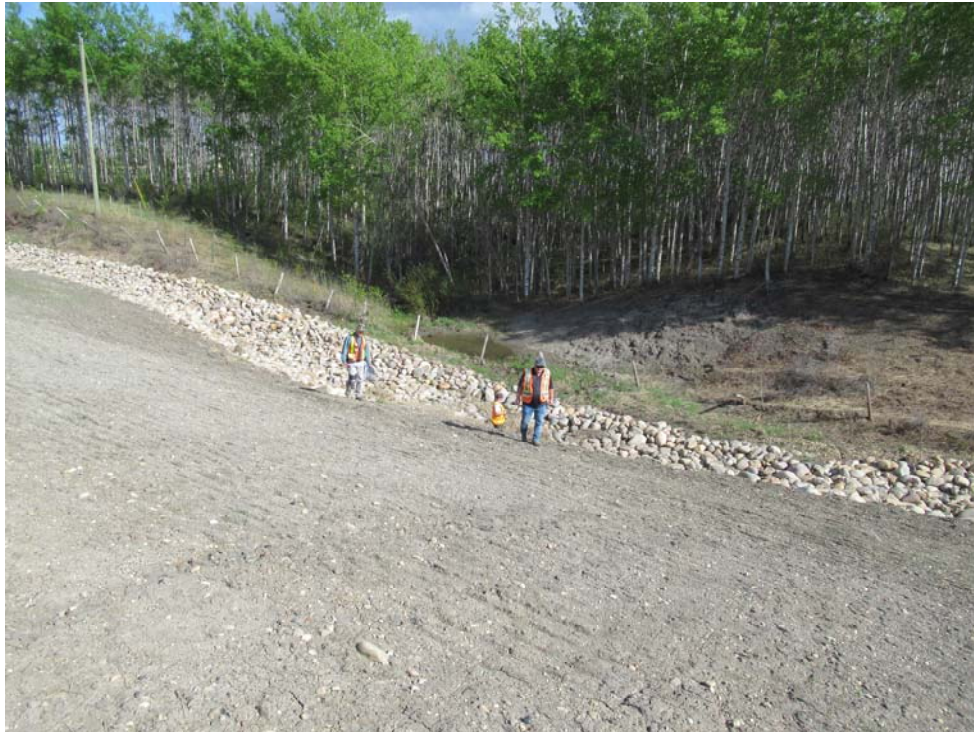
Photo 5 – Looking south over the new embankment and culvert inlet area.

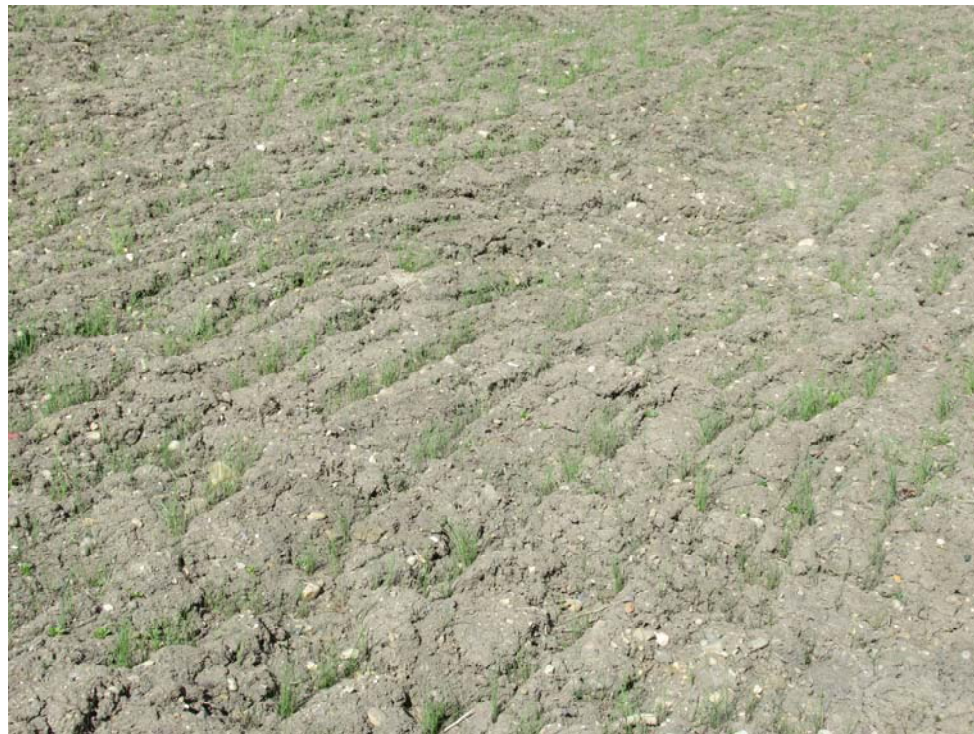
Photo 6 – Close-up view of the grass beginning to grow in the bottom of the furrows.

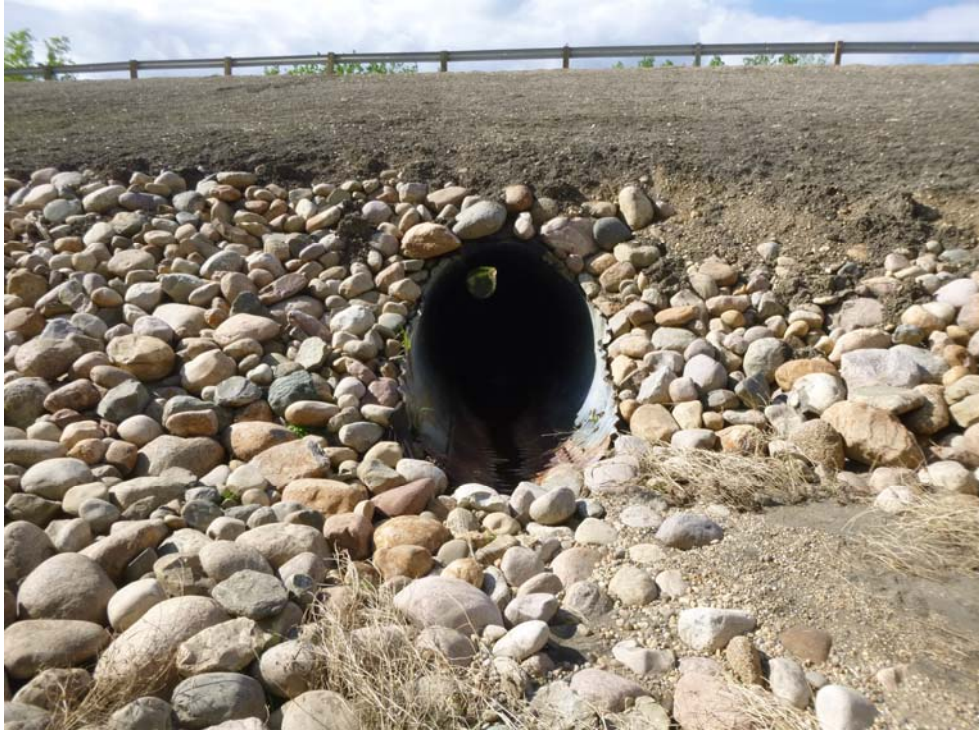
Photo 7 – Looking north through the culvert from the inlet area.

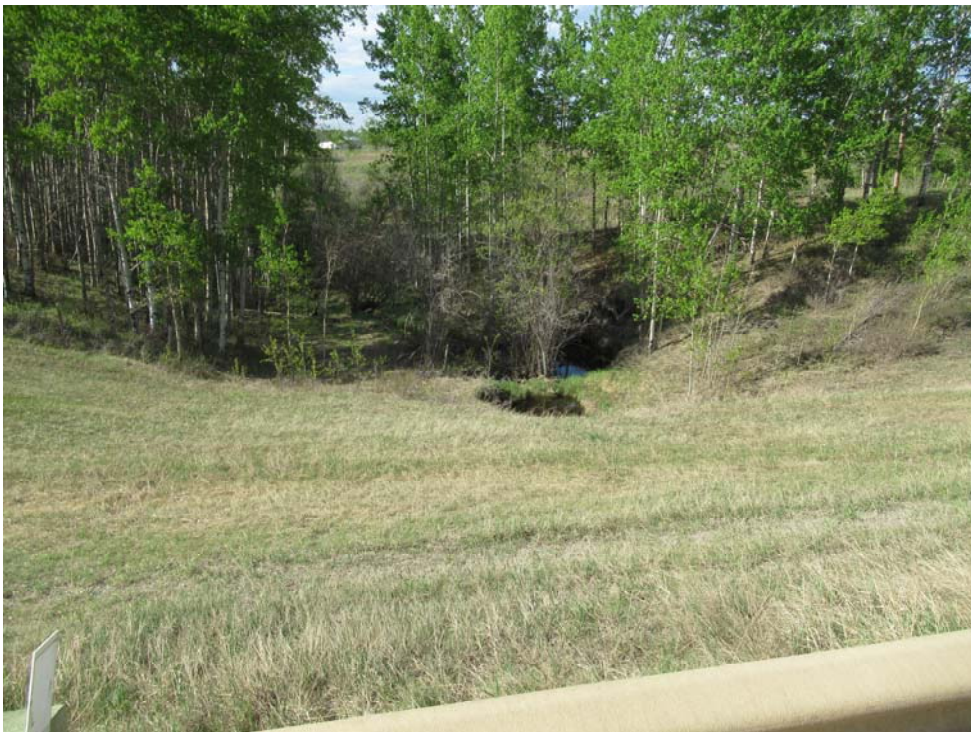
Photo 8 – Looking north across the downstream highway embankment and culvert outlet area.
