# **ALBERTA TRANSPORTATION GEOHAZARD ASSESSMENT PROGRAM PART A: FILE REVIEW**

## **PEACE REGION – PEACE-HIGH LEVEL**

### **PH46 SOUTH RINGS CREEK**

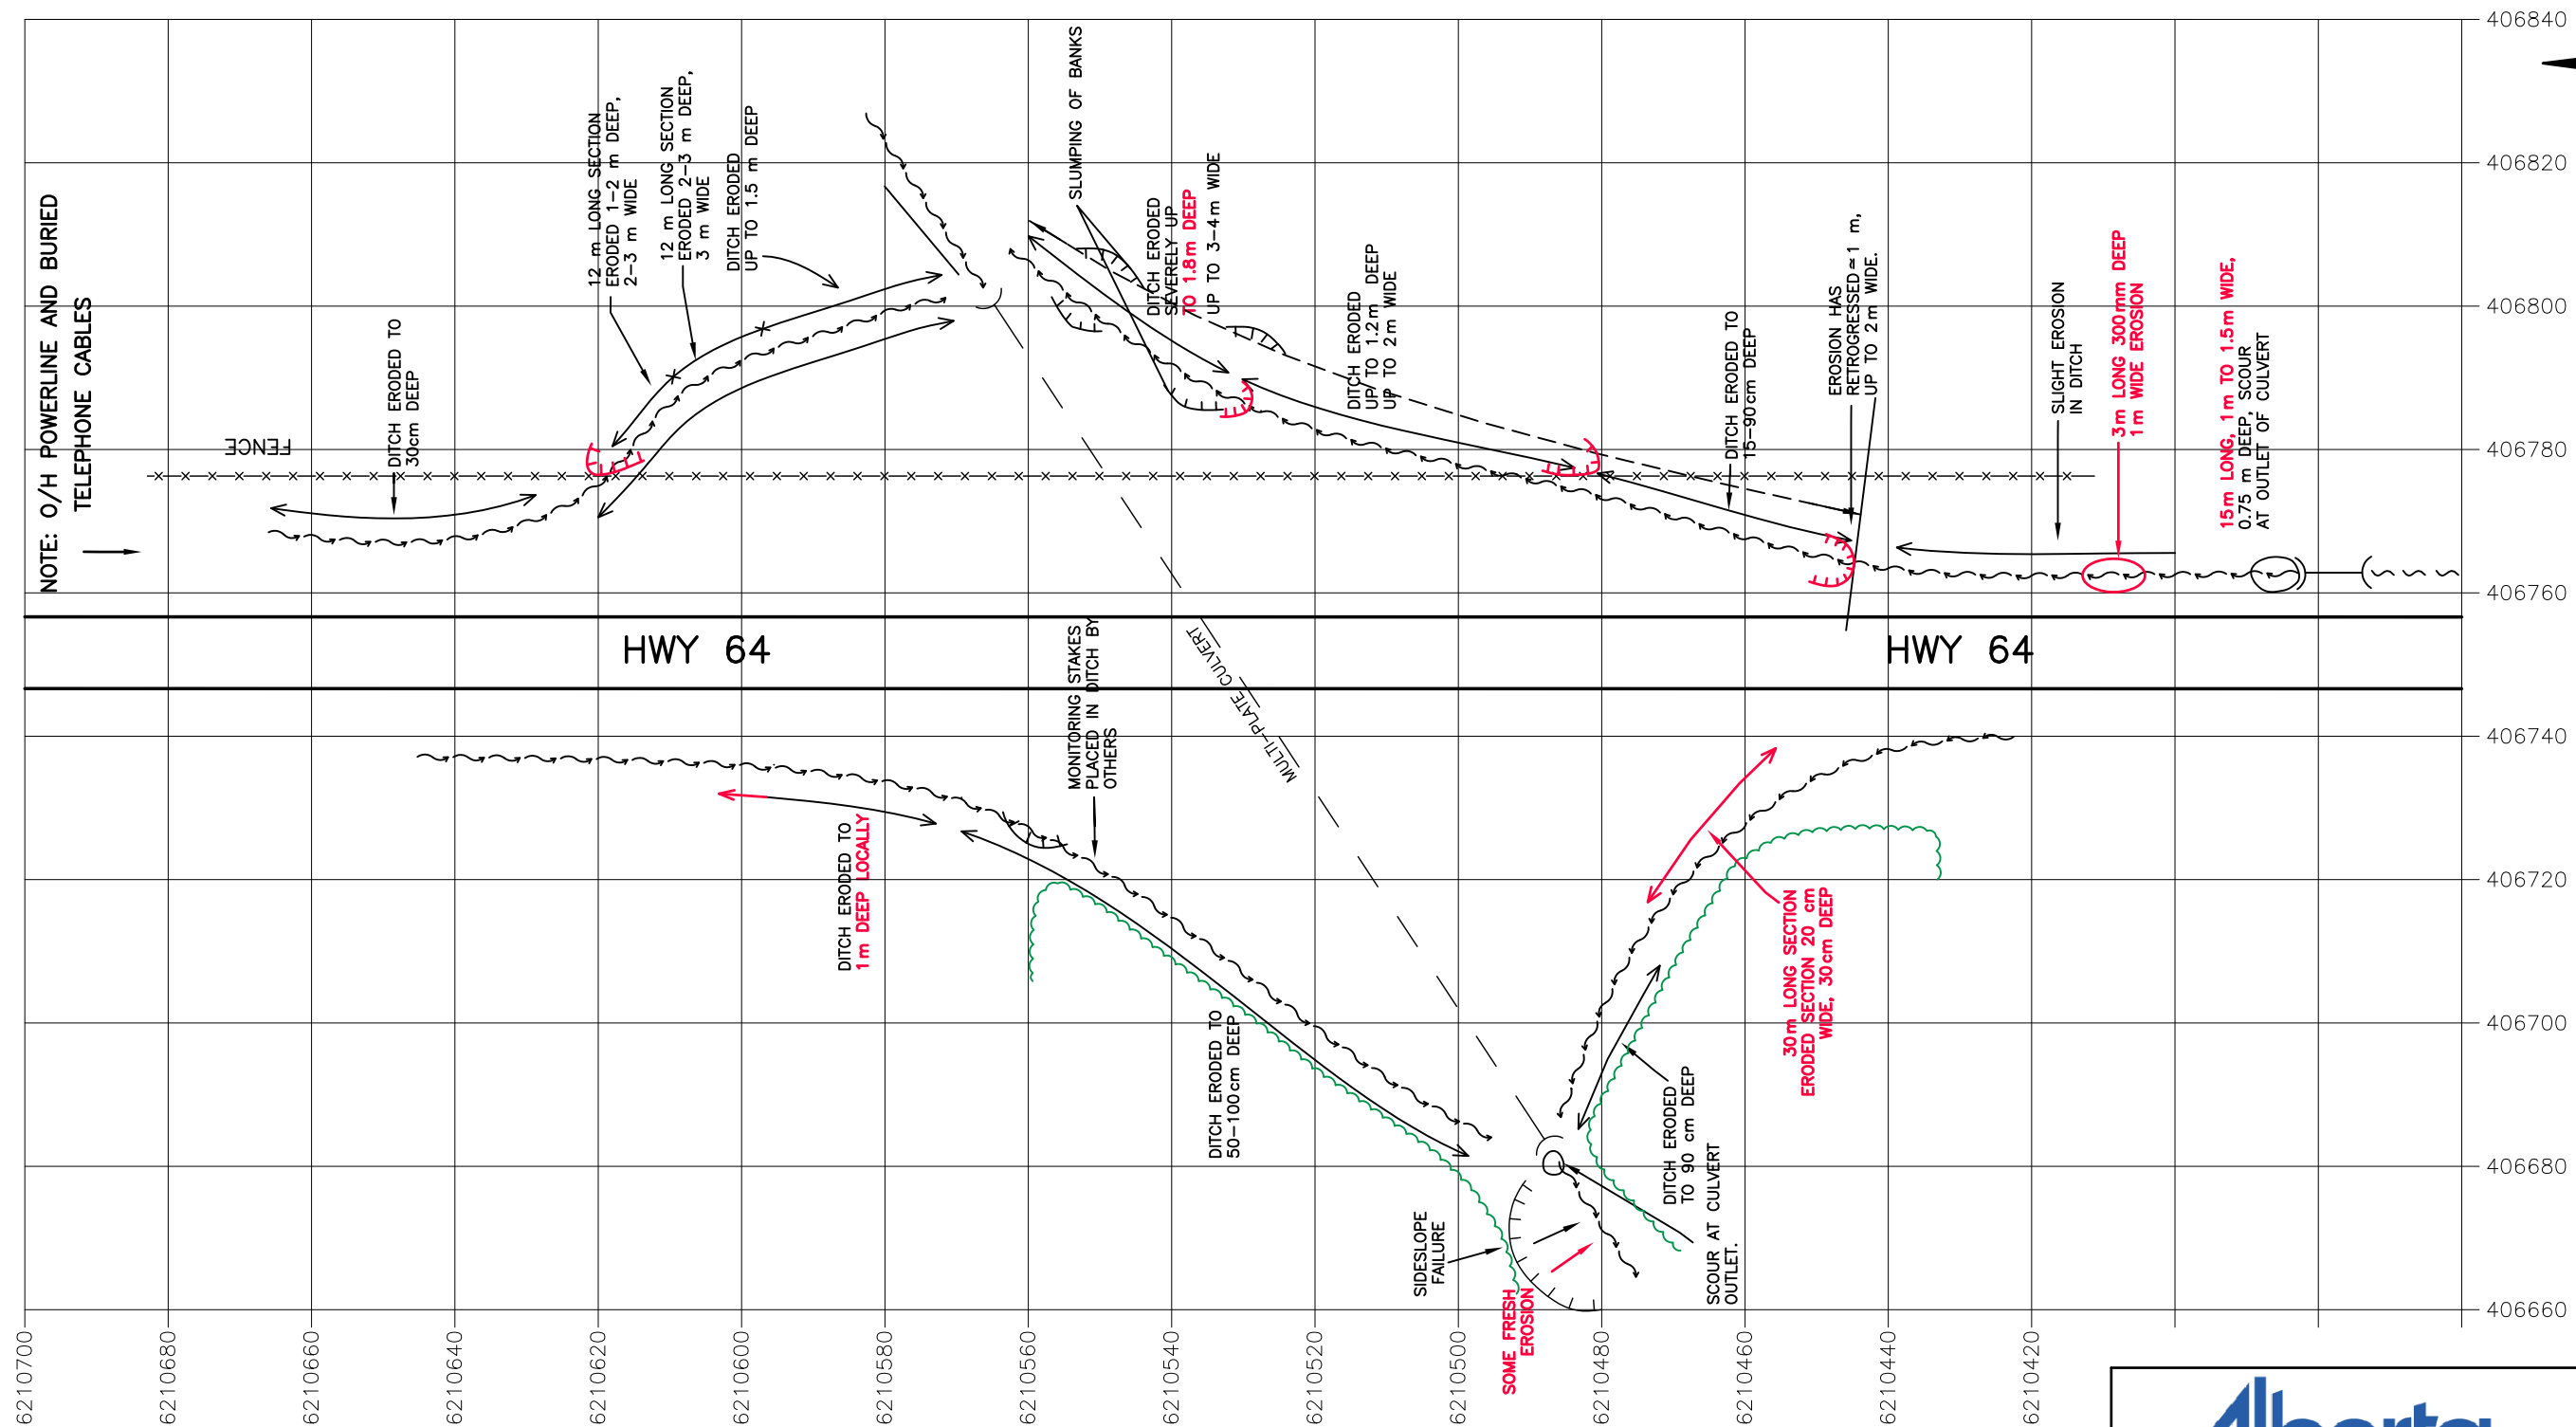
**FIGURE 2**

The location of the site is shown on Figure 1, while site details are shown on Figure 2, based on the last inspection.

1990	Culvert structure re-built.
June 2005	Callout site visit as part of annual geohazard assessments. Severe erosion is occurring in the ditches running down the margins of the fill, particularly on the east side of the road.
June 2006	Erosion in the ditches along the margins of the embankment fill has worsened.
May 2007	Erosion in the ditches along the margins of the embankment fill has worsened.
June 2008	Erosion in the ditches along the margins of the embankment fill has worsened.
