GEOHAZARD ASSESSMENT PROGRAM

PEACE REGION – PEACE-HIGH LEVEL

2013 INSPECTION

Site Number	Location	Name	Hwy	km
PH46	Fairview	South Rings Creek	64:06	25.96
Legal Description		UTM Co-ordinates		
SW¼ 24-081-04 W6M		11V E 406752	N 6210542

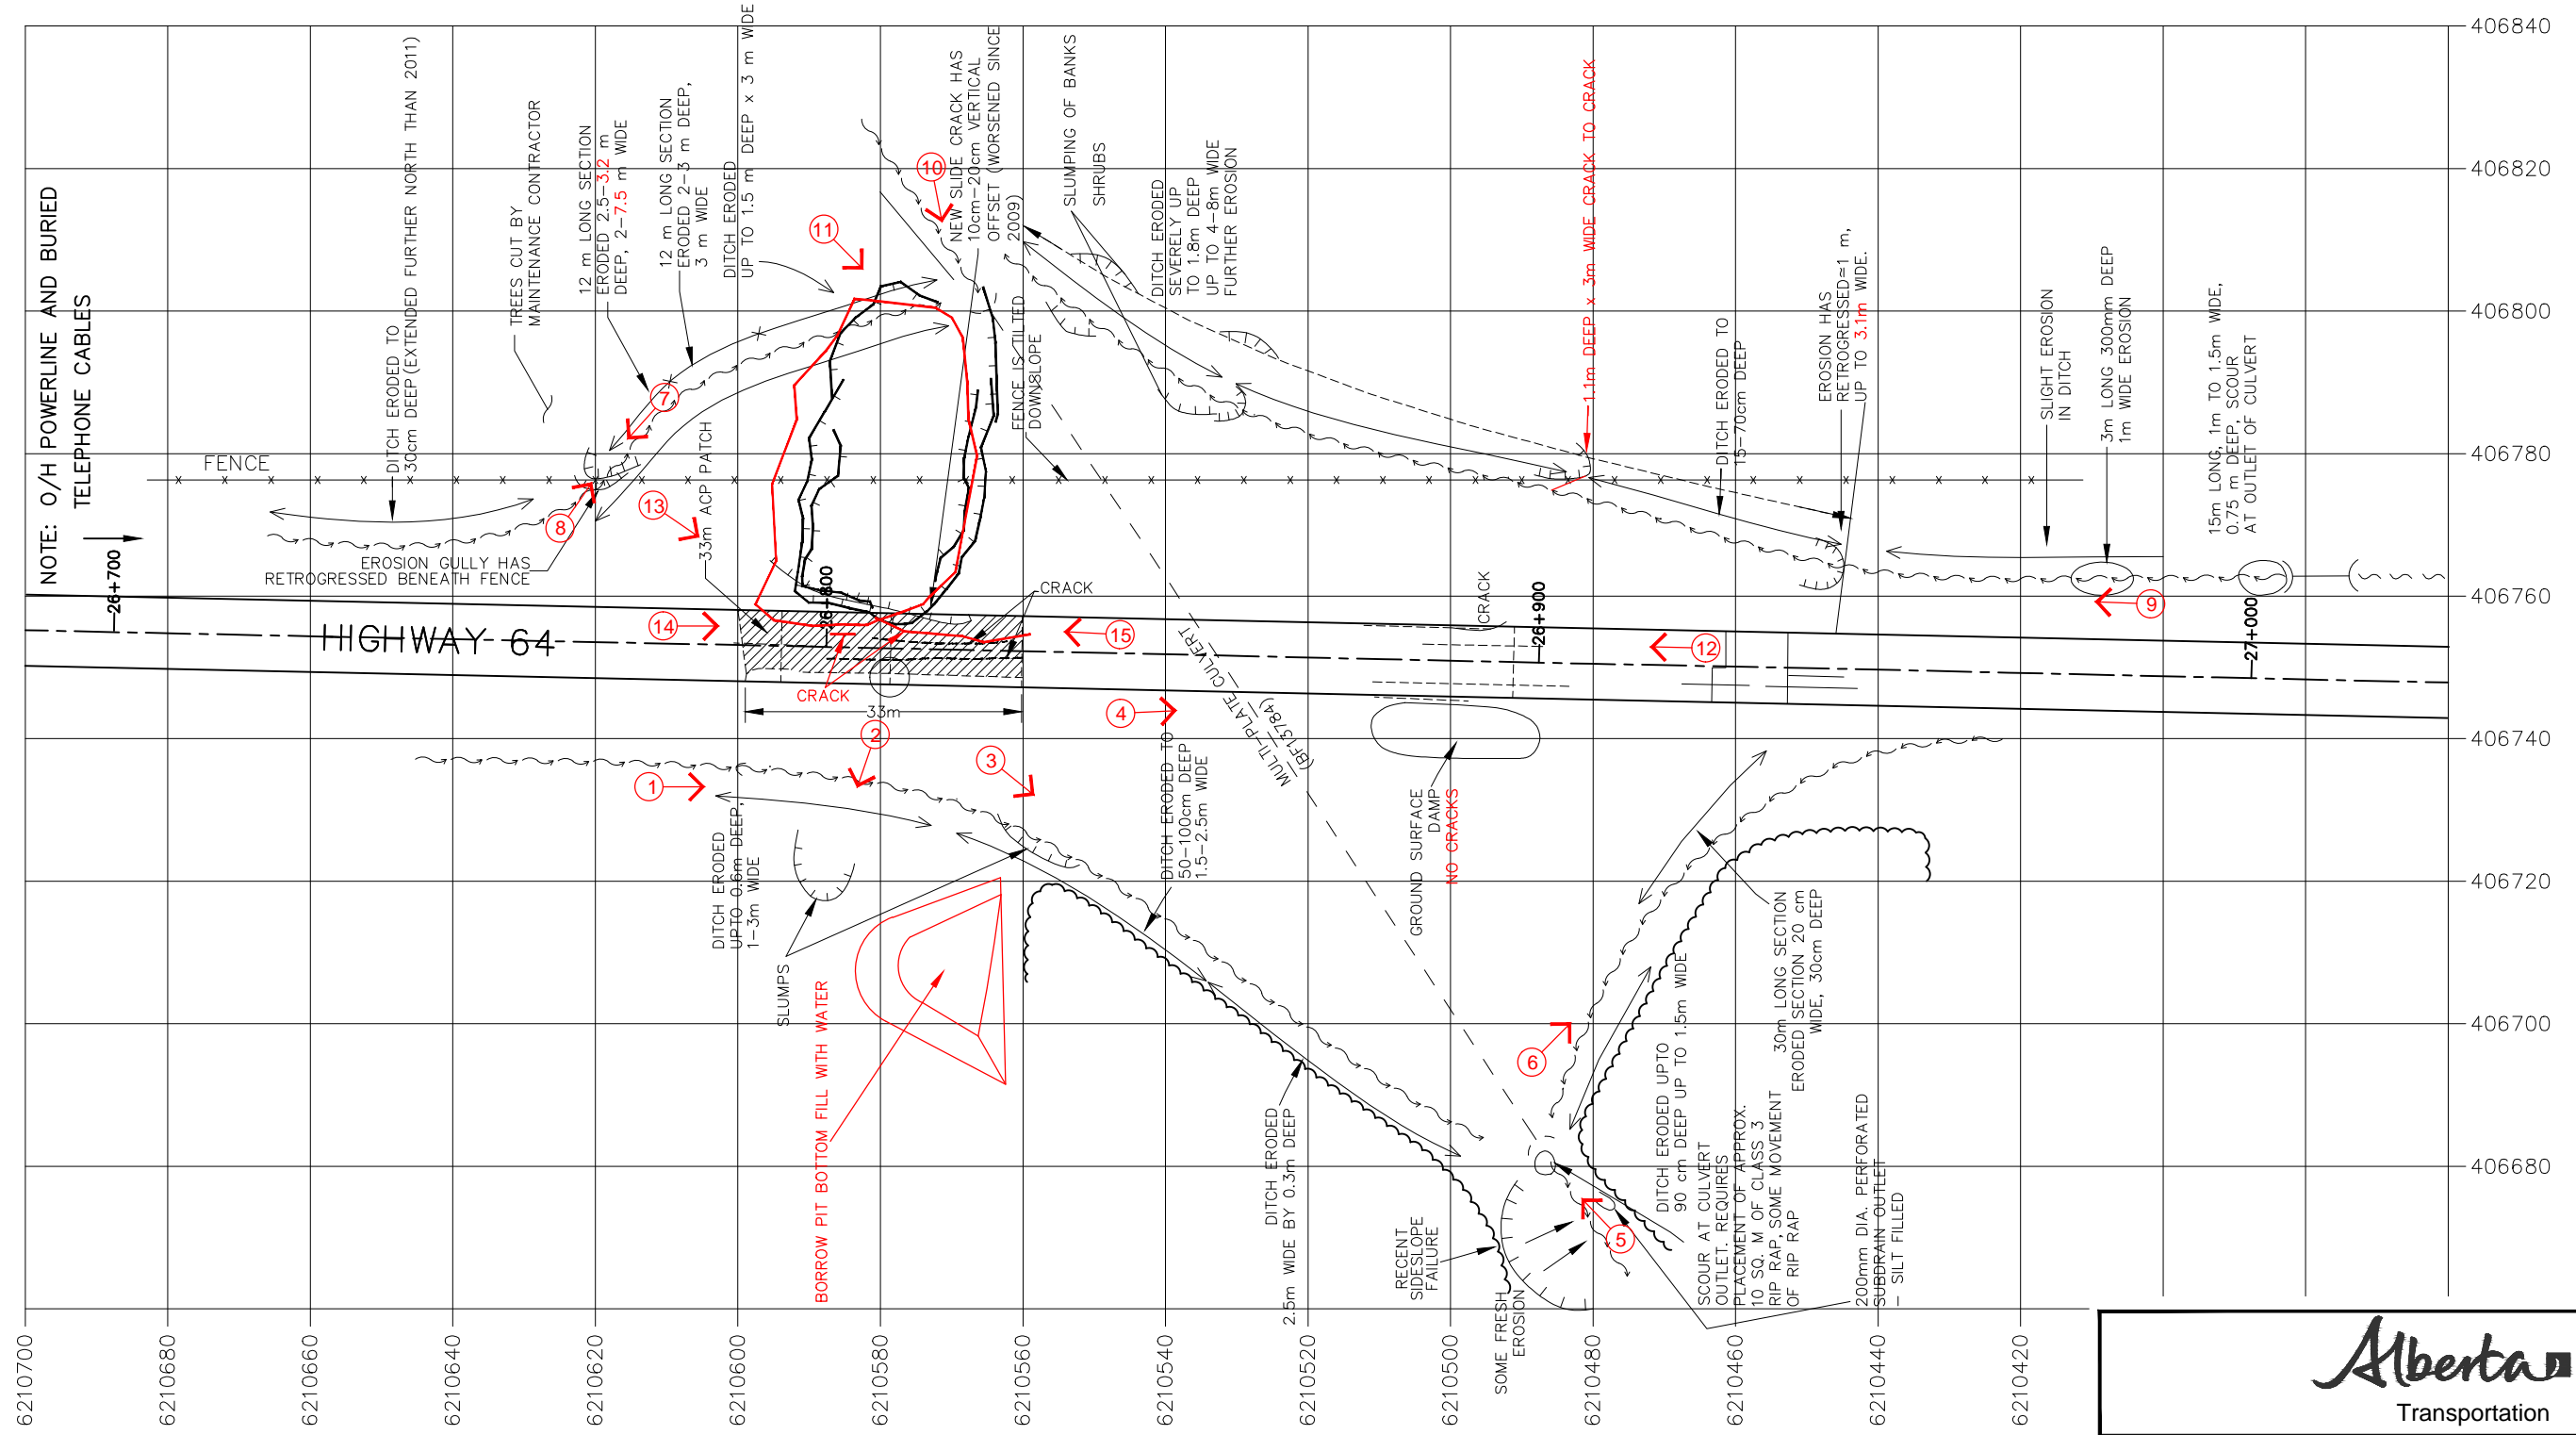
FIGURE 1

EROSION GULLY HAS RETROGRESSION BENEATH FENCE

12 m LONG SECTION ERODED 2.5-3.2 m DEEP, 2-7.5 m WIDE

12 m LONG SECTION ERODED 2-5 m DEEP, 3 m WIDE

DITCH ERODED UP TO 1.5 m DEEP x 3 m WIDE

NEW SLIDE CRACK HAS 10cm-20cm VERTICAL OFFSET (WORSENER SINCE 2009)

DITCH ERODED SEVERELY UP TO 1.8m DEEP UP TO 4-8m WIDE FURTHER EROSION

1.1m DEEP x 3m WIDE CRACK TO CRACK

DITCH ERODED TO 15-70cm DEEP

EROSION HAS RETROGRESSION UP TO 3.1m WIDE

3m LONG 300mm DEEP 1m WIDE EROSION

15m LONG, 1m TO 1.5m WIDE, 0.75 m DEEP, SCOUR AT OUTLET OF CULVERT

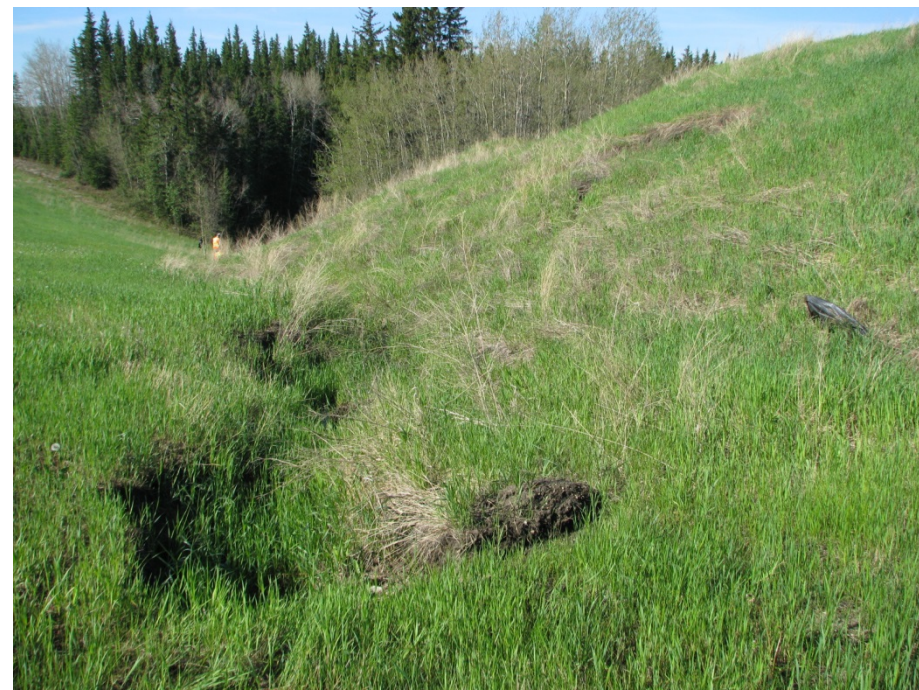
Photo 1.
Looking southwest at NW corner of the site with ditch along the cut/fill contact.

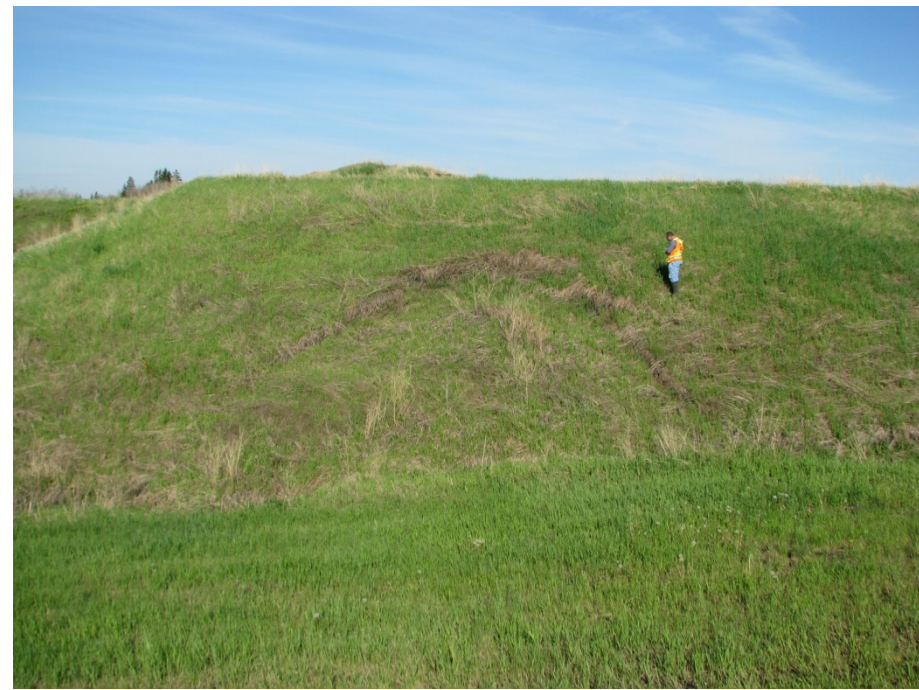
Photo 2.
Slump in the NW corner of the site. No significant change since 2012.

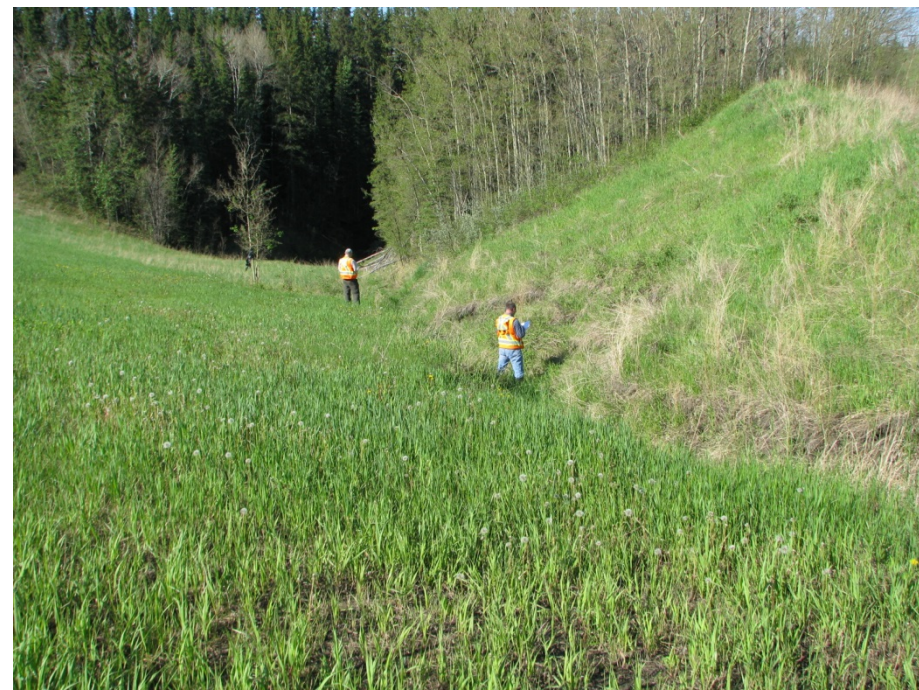
Photo 3.
Looking southwards
along the west side of
the road.

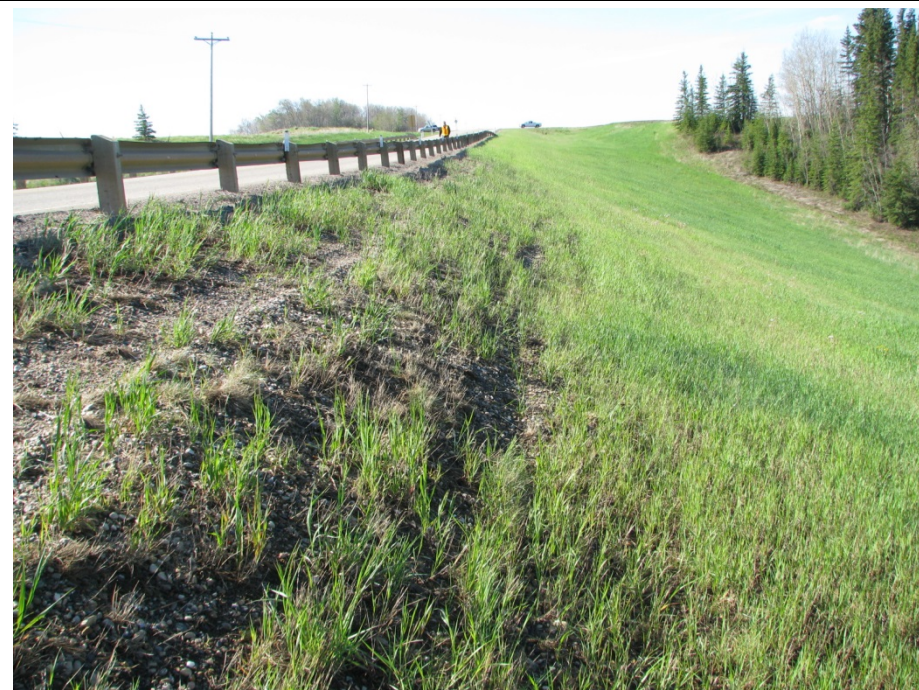
Photo 4.
Looking south
along the west side of the
road. Winter highway
salt is likely impeding
vegetation growth
below the shoulder.

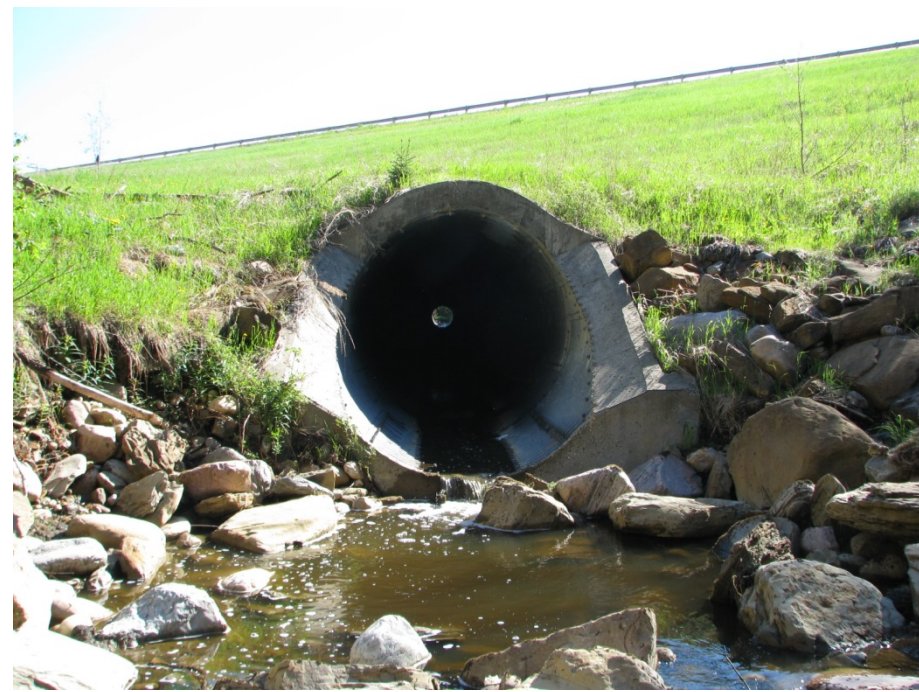
Photo 5.
Outlet (west end) of the multi-plate culvert under the highway. No significant change since 2009.

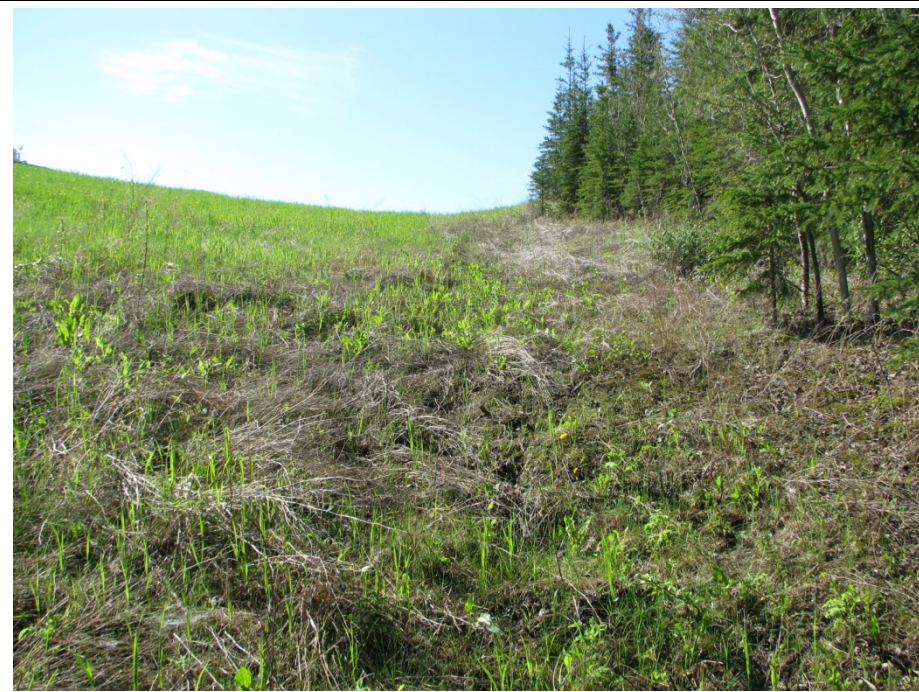
Photo 6.
Small erosion rill along the downstream end of the ditch in the SW corner of the site. No significant change since 2012.

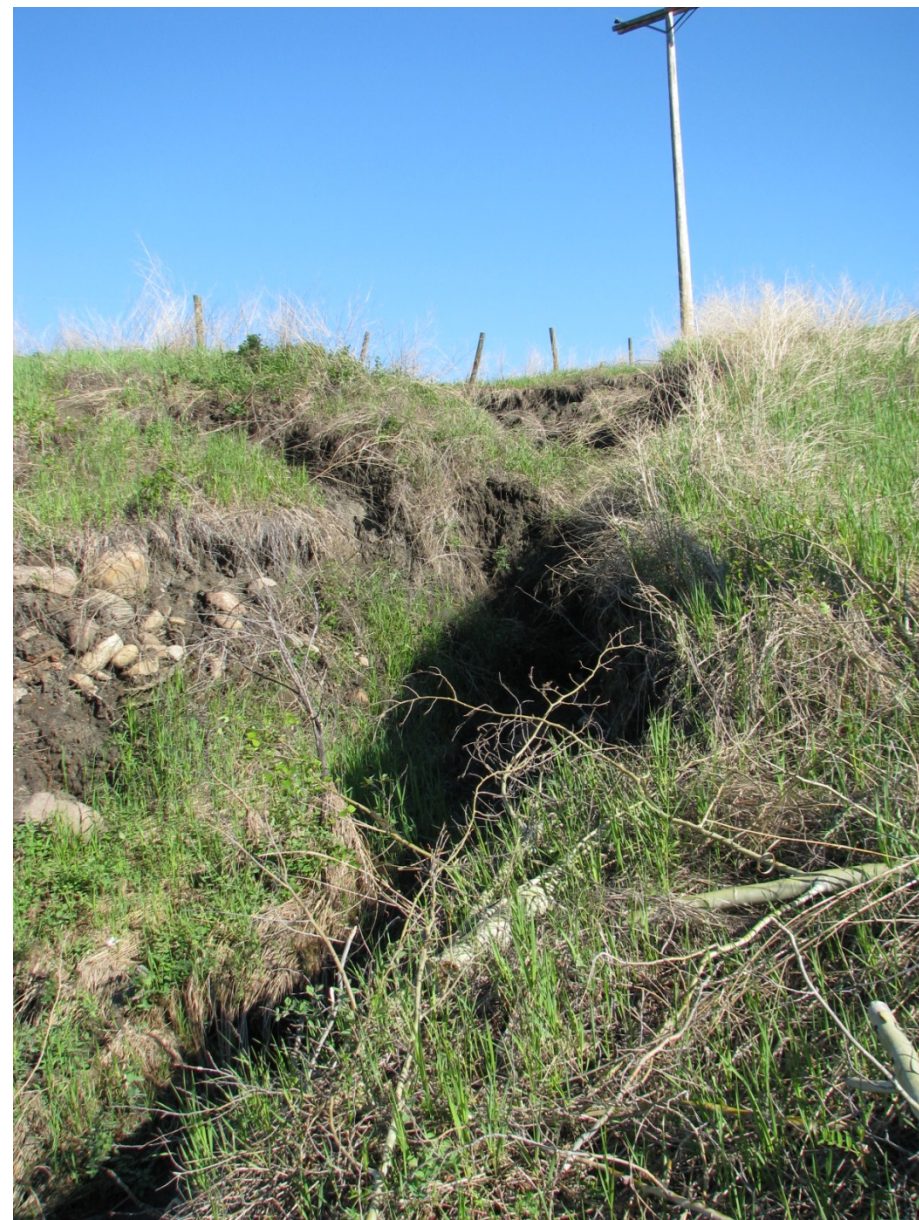
Photo 7.
Middle portion of the ditch in the NE corner of the site has worsened since 2012 with the gully sidewalls failing and falling into the bottom.

- Digging out the slide and northbound lanes of the highway and rebuilding the east sideslope with gravel fill.
- NW, NE and SW ditch erosion repairs with gabion mats and RECP.
- Enhancements to rip rap to accommodate gabion matting at culvert inlet and outlet.

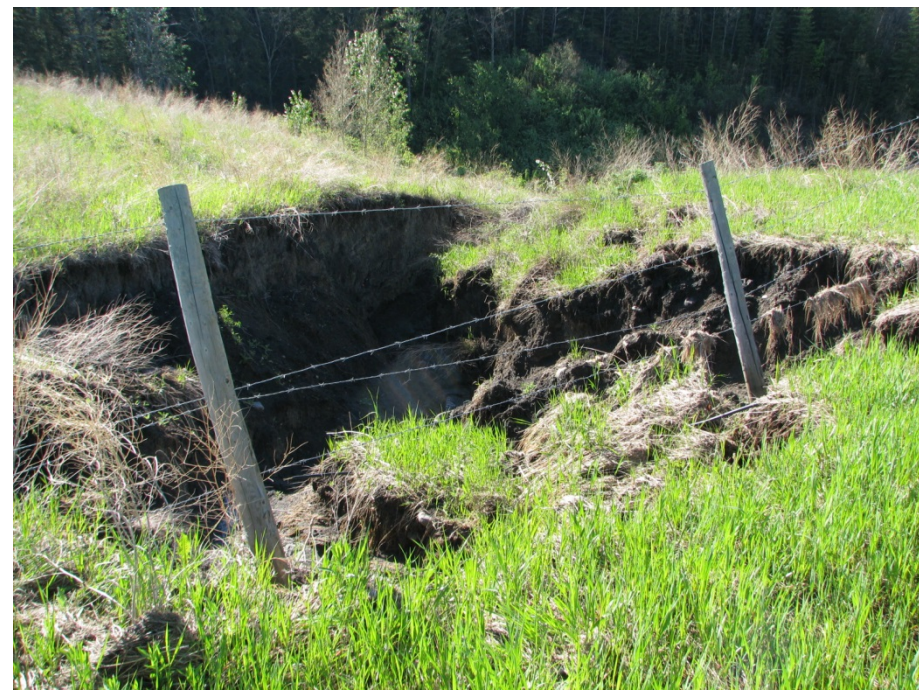
Photo 8.
Ditch gullying at upper portion of the ditch at the NE corner of the site has extended further north and west than observed in 2012.

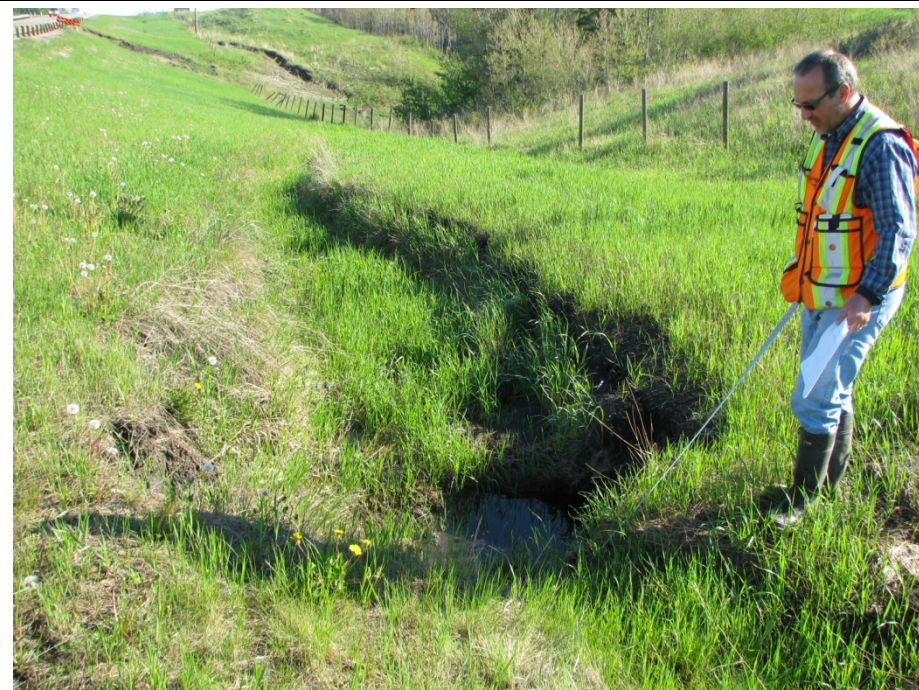
Photo 9.
Looking northwards along the ditch in the SE corner of the site. Erosion gullies have slightly widened with sod falling into their base.

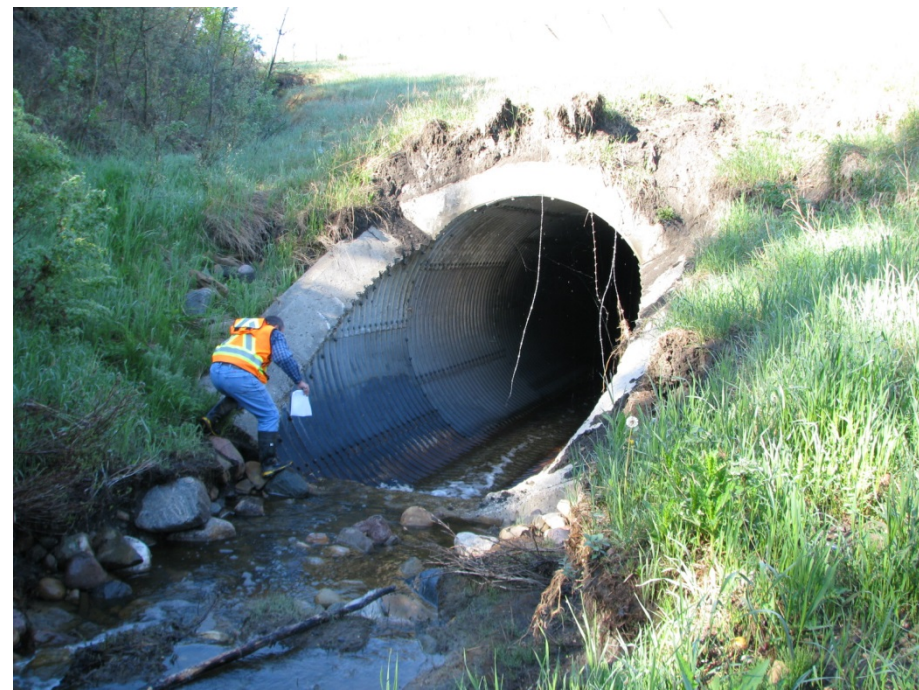
Photo 10.
Looking southwest at culvert inlet. Slide material and barbed wire from fence originally situated about 23 m upslope of the culvert is now draped over the pipe.

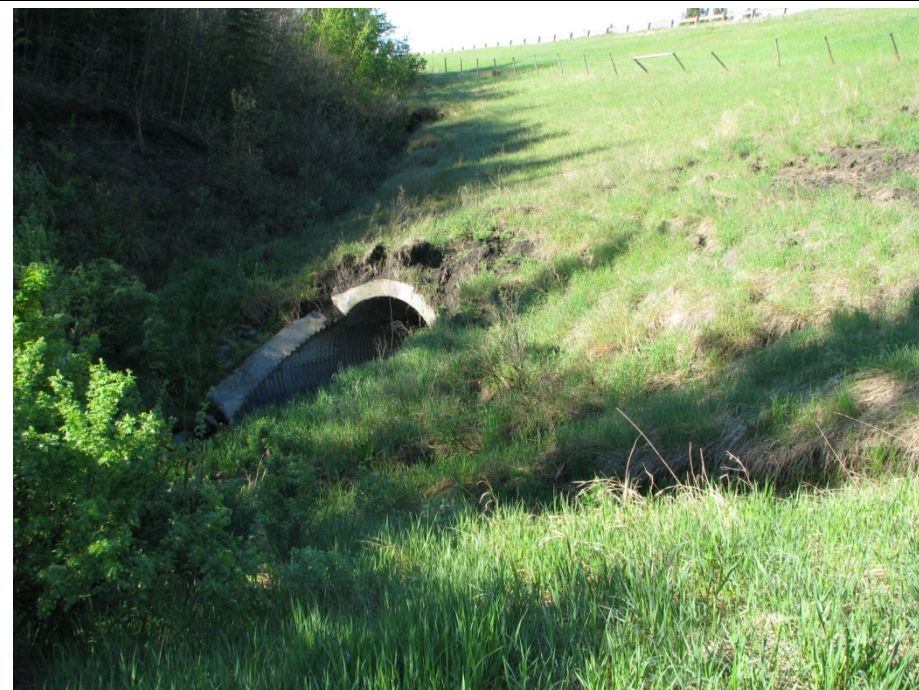
Photo 11.
Looking southwest at toe of slide area. Slide debris continues to move gradually downslope towards the culvert inlet.

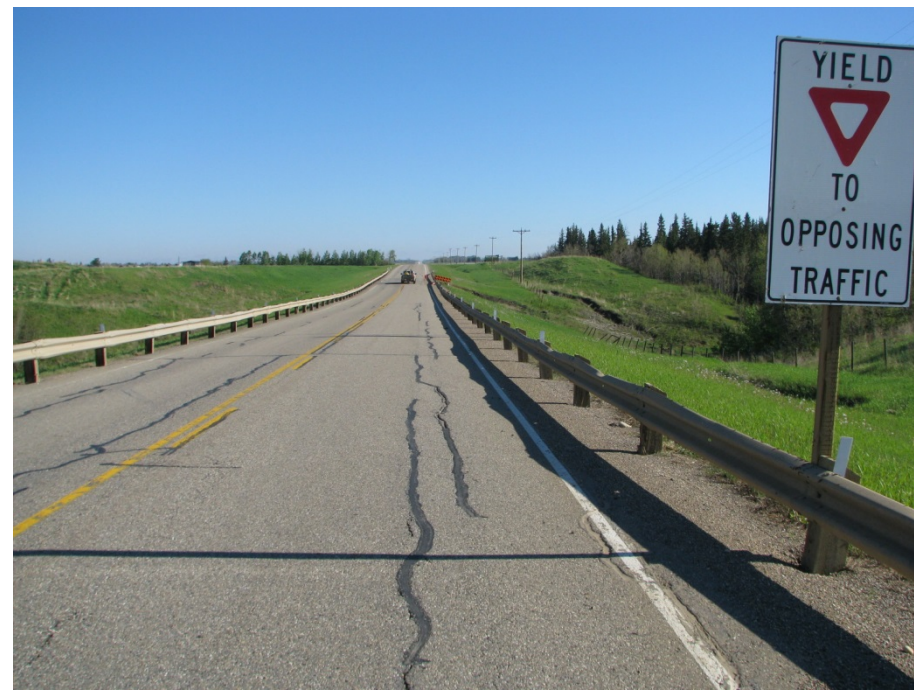
Photo 12.
Looking northwards along the east side of the highway near 26+890. Backscarp has encroached into the northbound lane with traffic having to cross centerline to avoid.

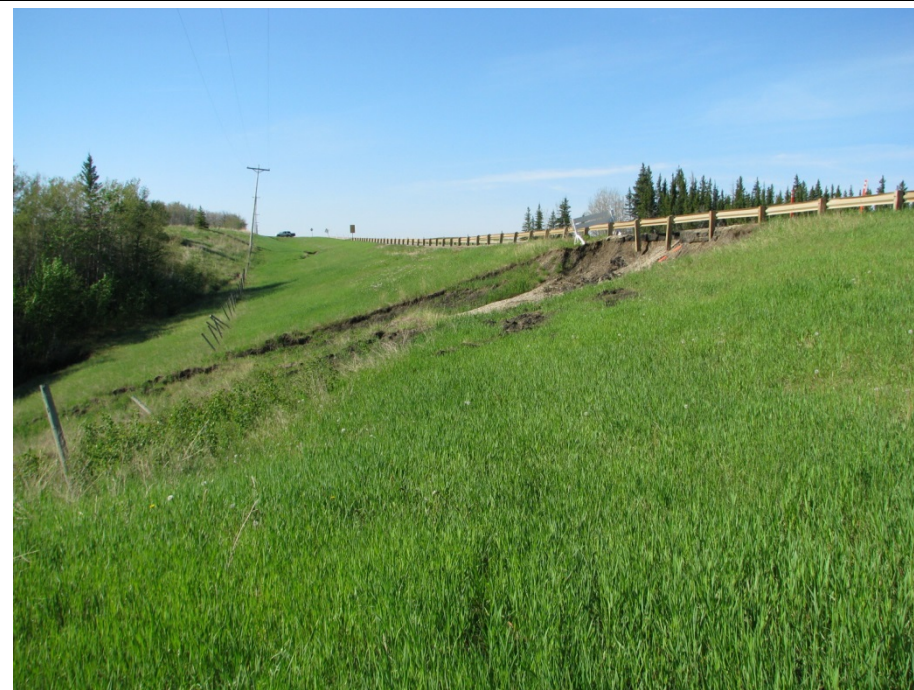
Photo 13.
Looking along the east side of the road near 26+800. Three guardrail posts are now hanging

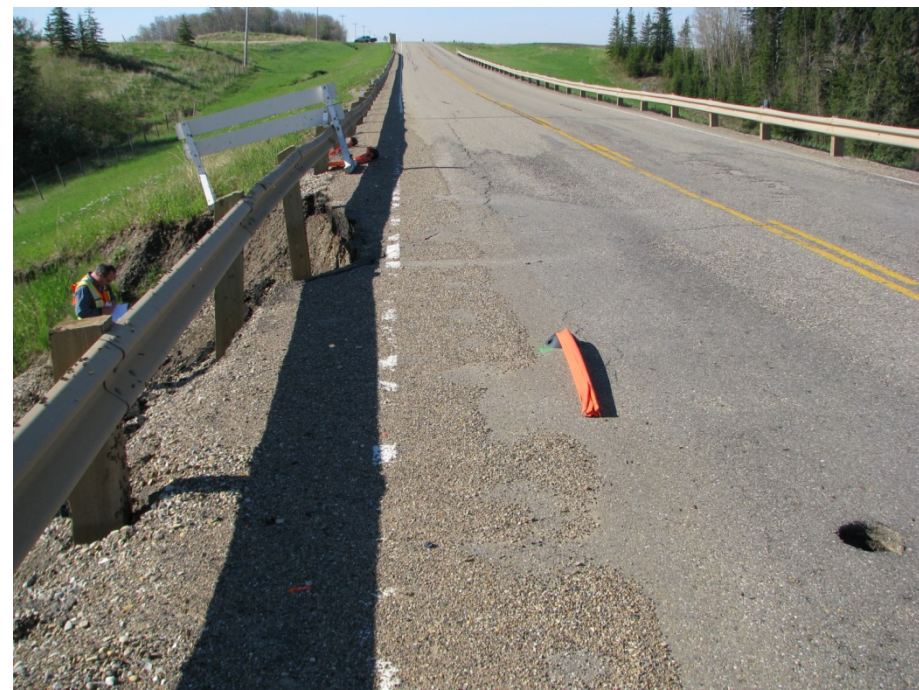
Photo 14.
Looking southwards along the road near 26+800 at backscarp of east side slide which is encroaching about 0.7 m beyond the guardrail. Pavement cracks have grown in the middle of the northbound lane since 2012. Thurber test hole TH12-1 from September 2012 investigation can be seen in lower left corner.

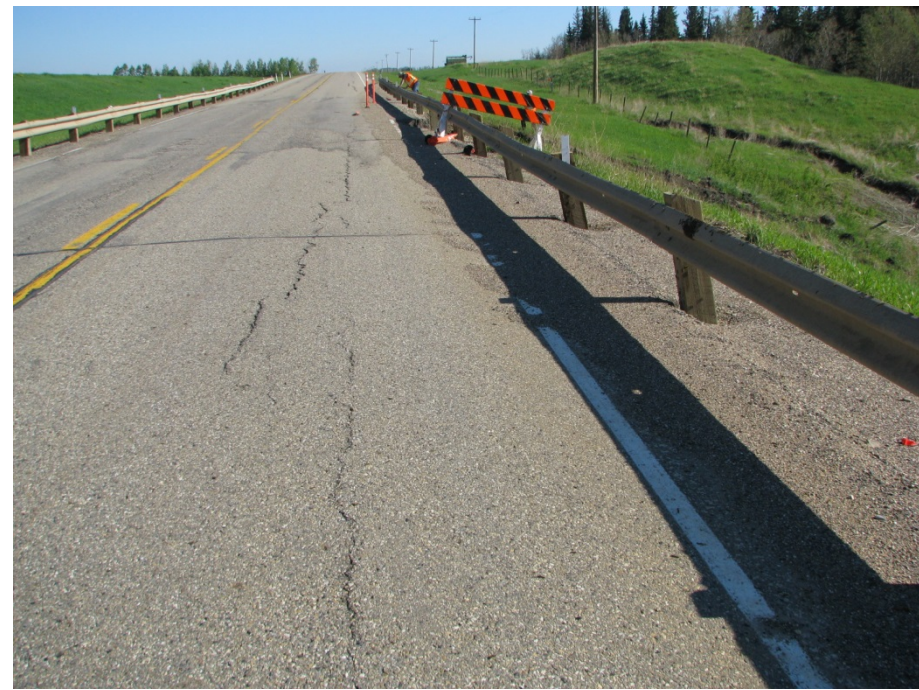
Photo 15.
Asphalt cracking extends south of patched area.
