GEOHAZARD ASSESSMENT PROGRAM

PEACE REGION – PEACE-HIGH LEVEL

2015 INSPECTION

Site Number	Location	Name	Hwy	km
PH46	Fairview	South Rings Creek	64:06	25.96
Legal Description		UTM Co-ordinates		
SW¼ 24-081-04 W6M		11V E 406752	N 6210542

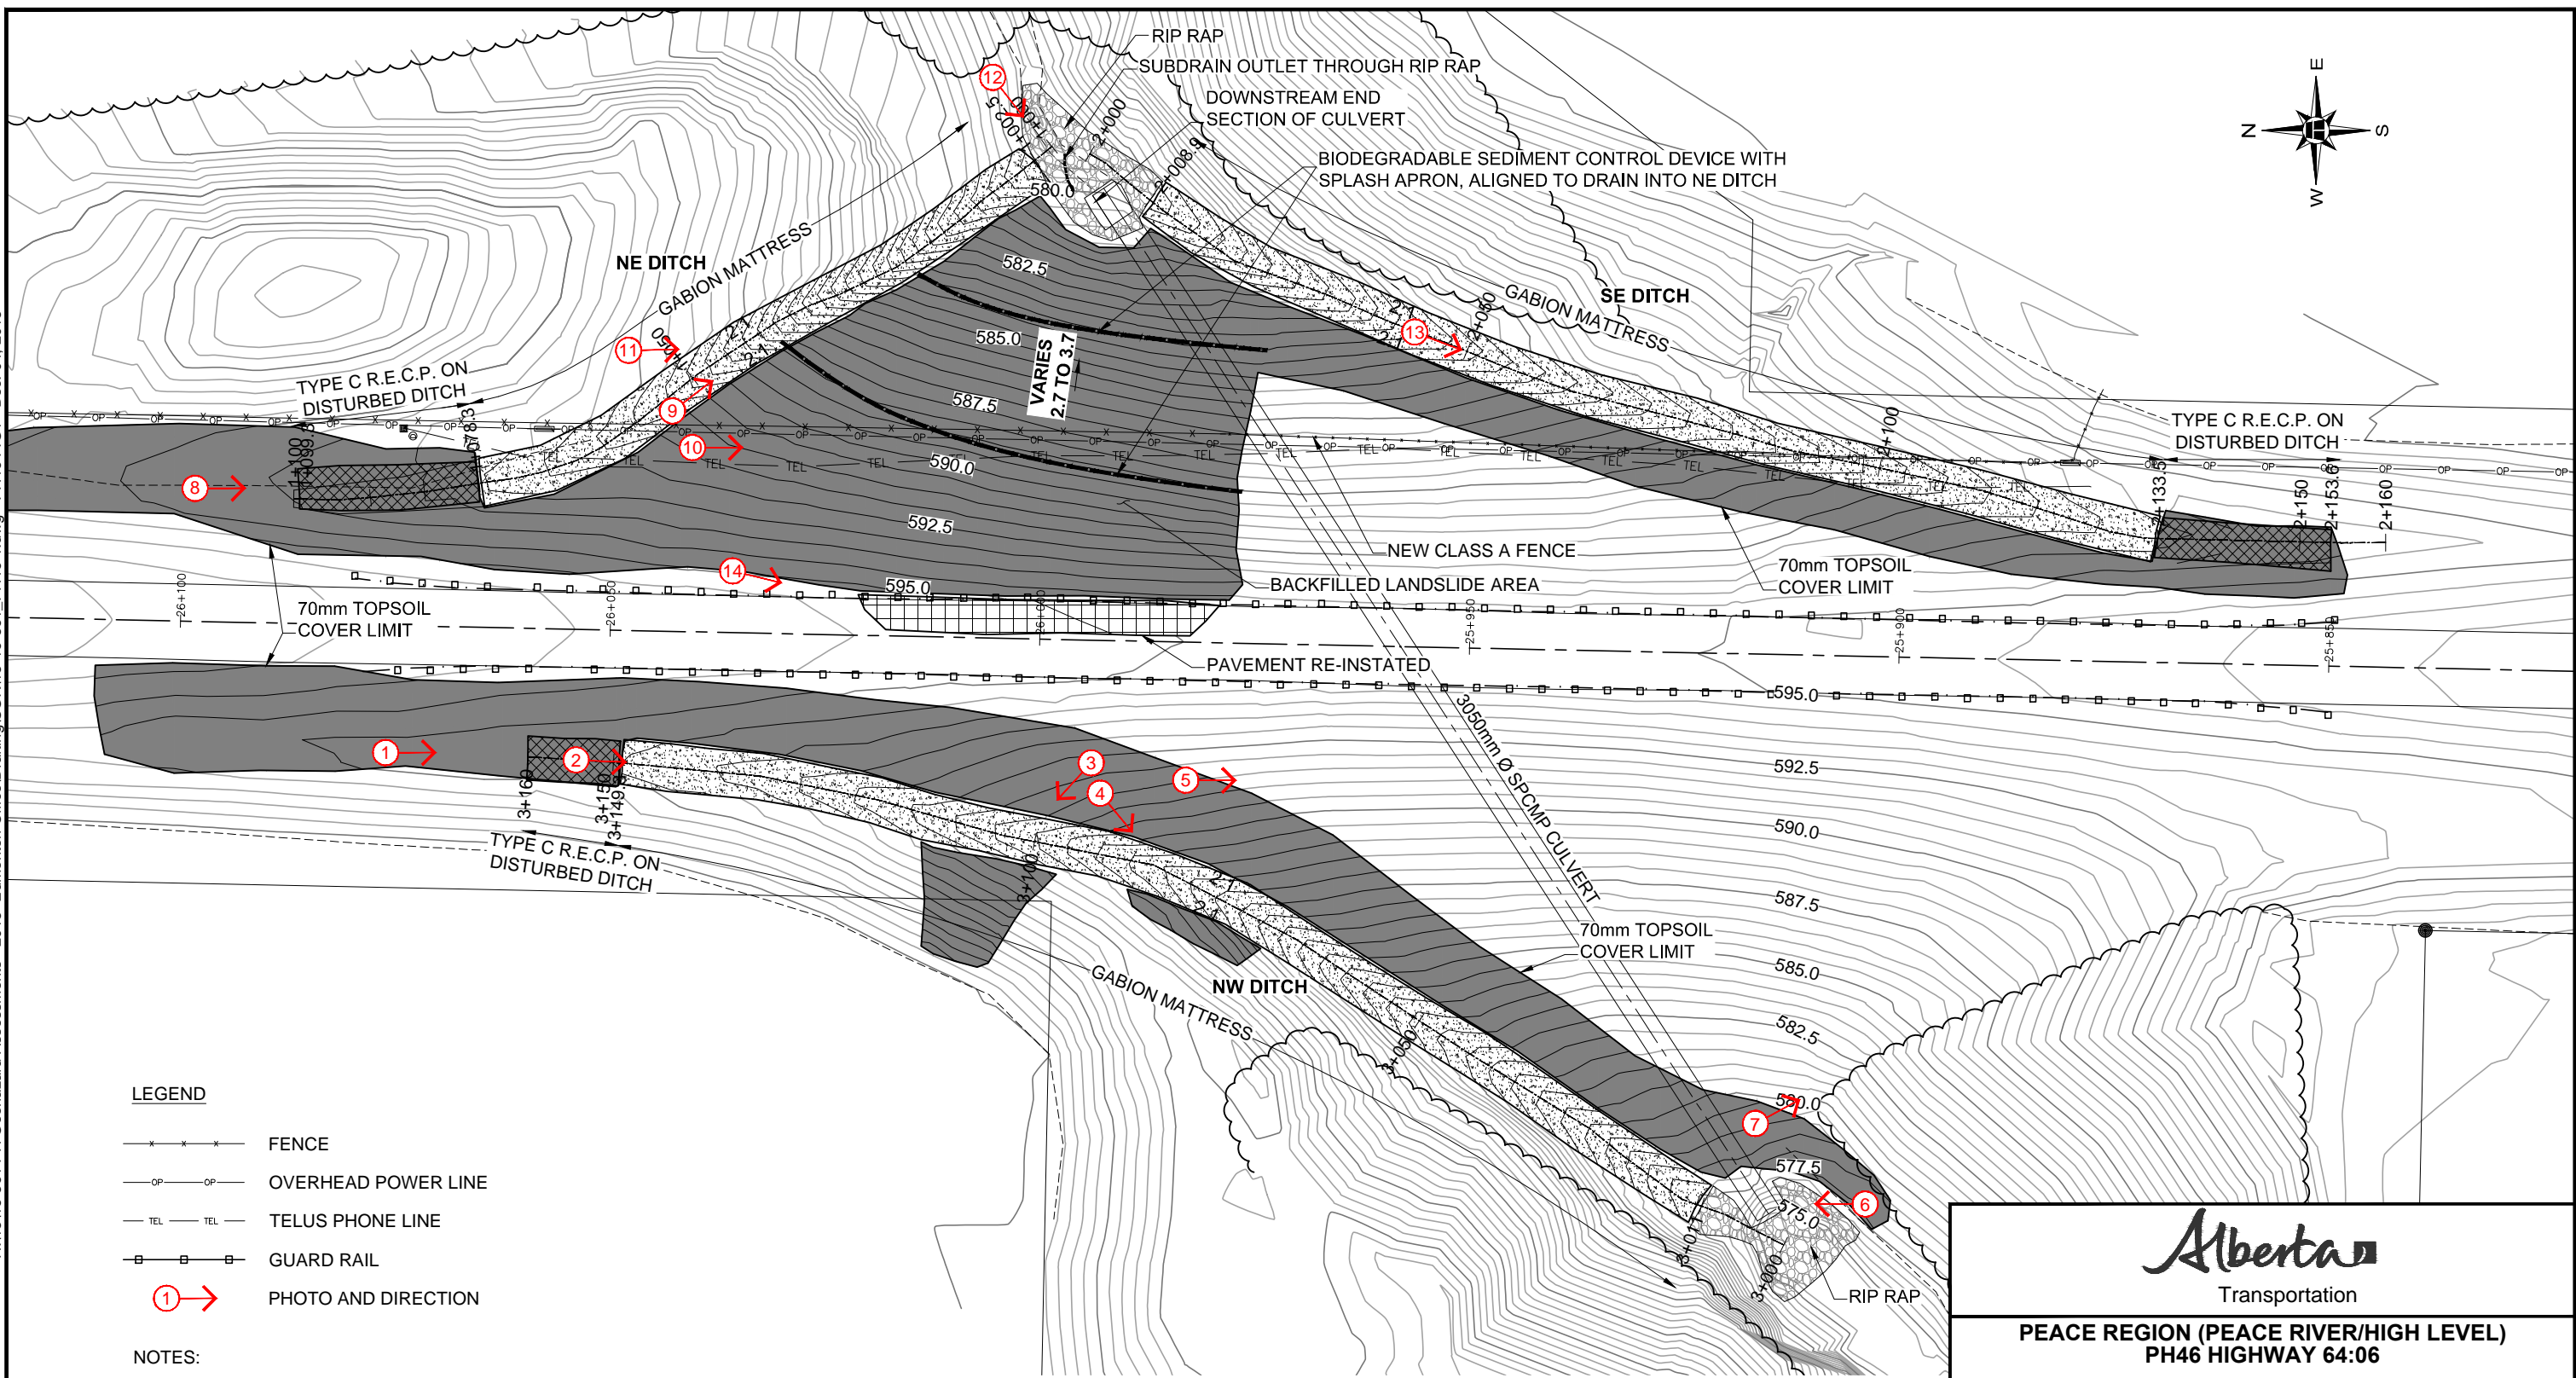
FIGURE 1

2015 PH46 INSPECTION PLAN

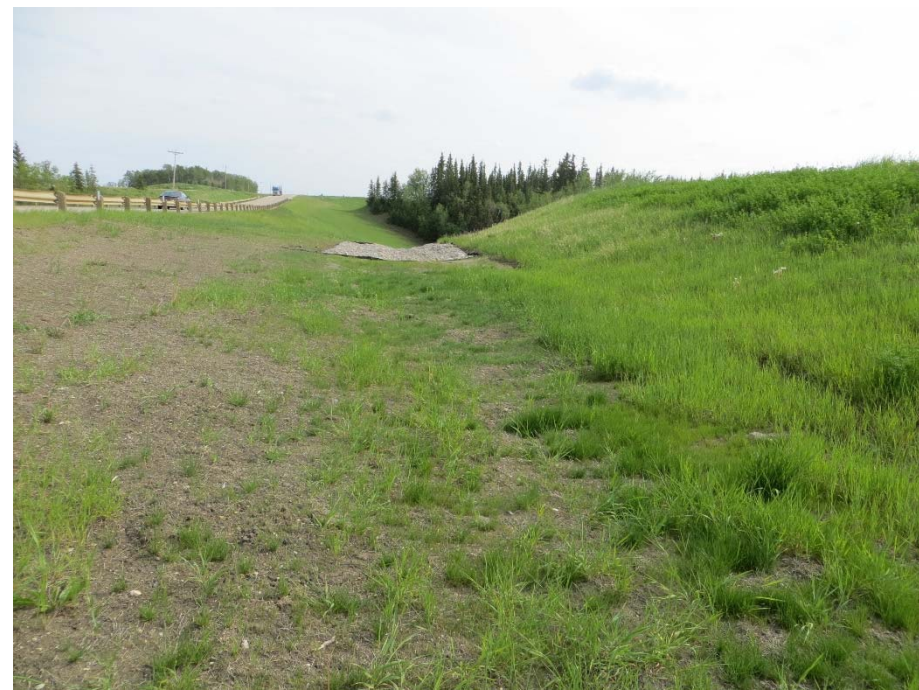
Photo 1.
Looking south at RECP and gabion mattress placed in 2014 in NW corner of the site in ditch along the cut/fill contact.

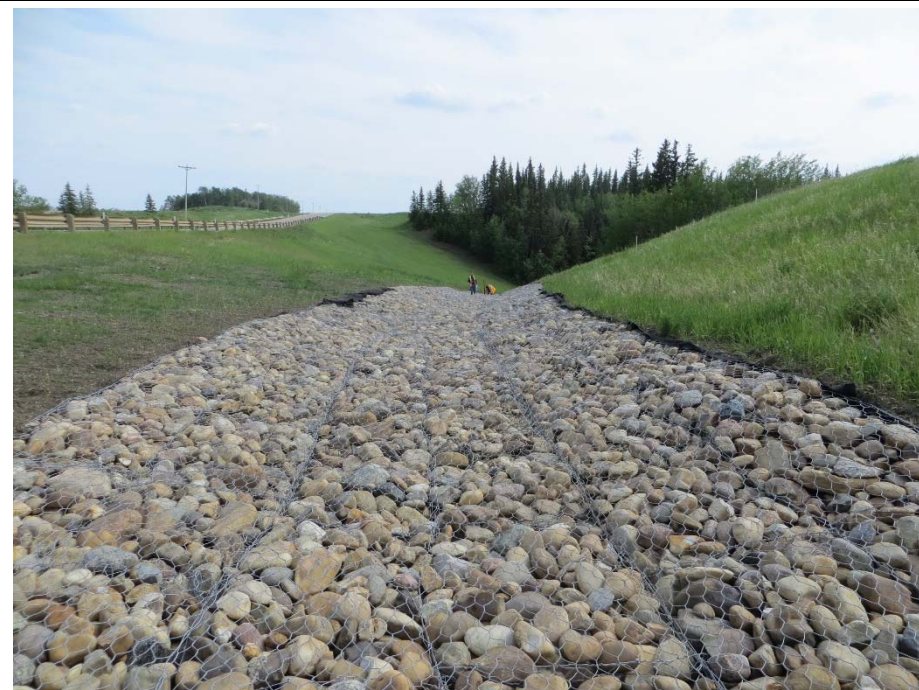
Photo 2.
Looking south at gabion mattress placed in 2014 in NW corner of the site in ditch along the cut/fill contact.

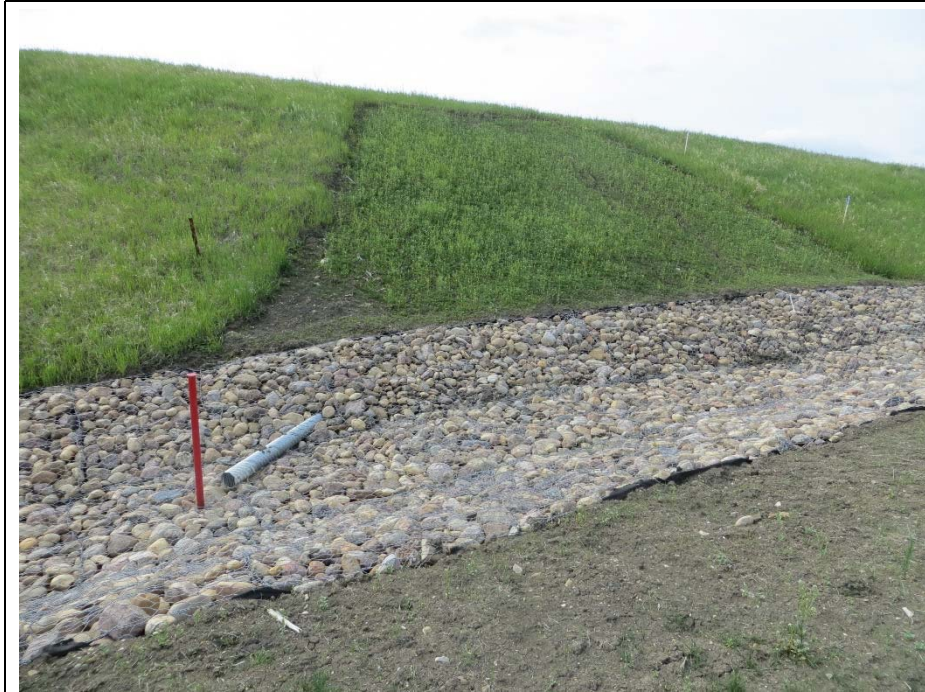
Photo 3.
Looking northwest at a repaired backslope slump in the NW corner of the site. Failure was excavated in June 2014, a perforated subdrain pipe was placed in the resulting base, the excavation backfilled with compacted clay and the disturbed area was topsoiled and seeded. Vegetation has taken well with a few sparse areas along the perimeter of the disturbed area.

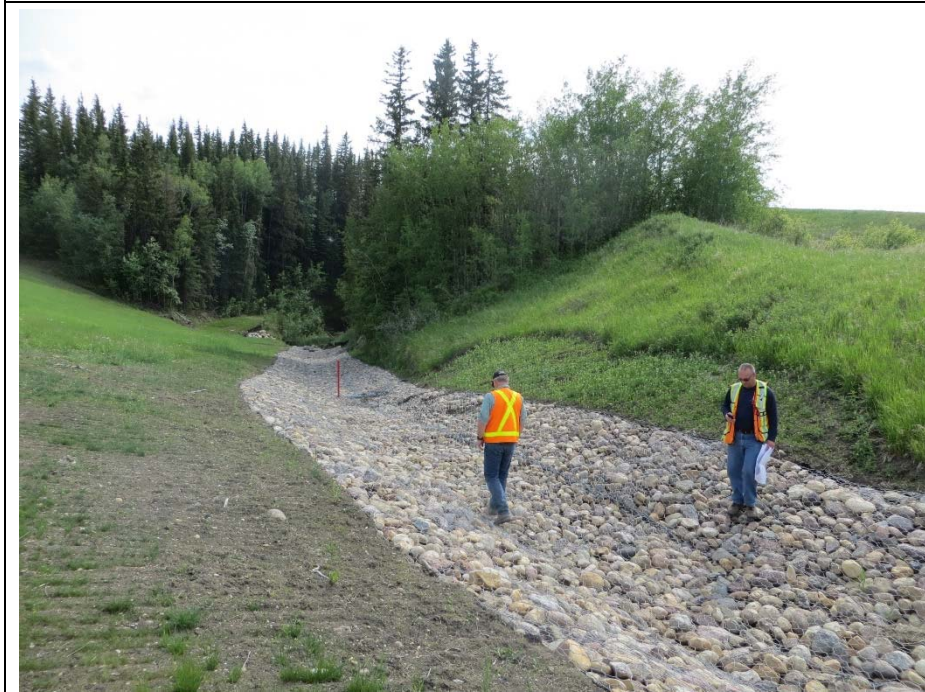
Photo 4.
Looking southwest at a backslope failure above the northwest ditch that was repaired in June 2014 using the same method as the failure shown in Photo 3. Vegetation is sparse along the east side of the gabion mattress.

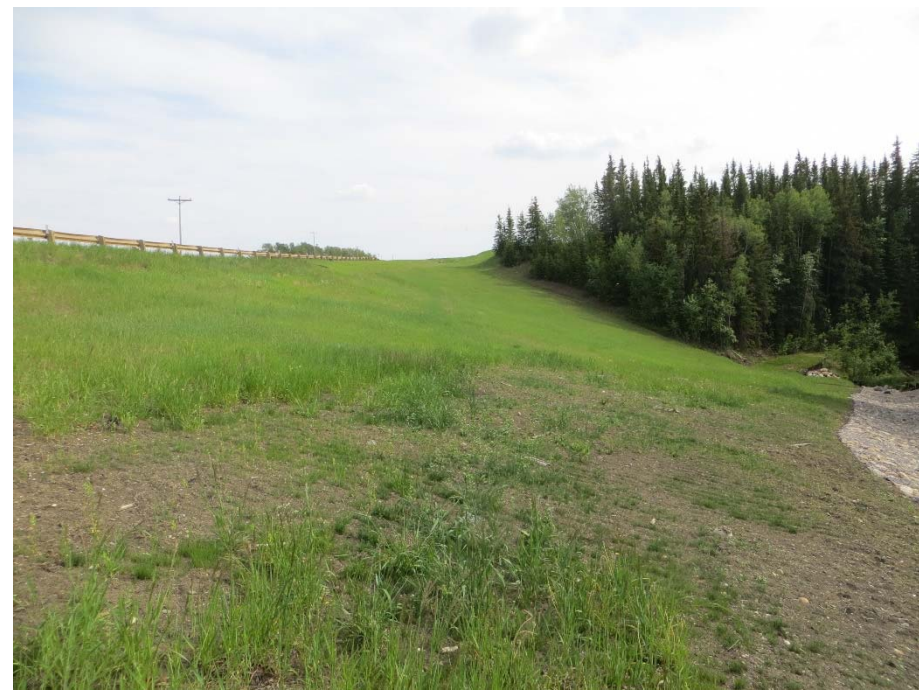
Photo 5.
Looking south along the west side of the highway. Vegetation is sparse above the gabion mattresses.

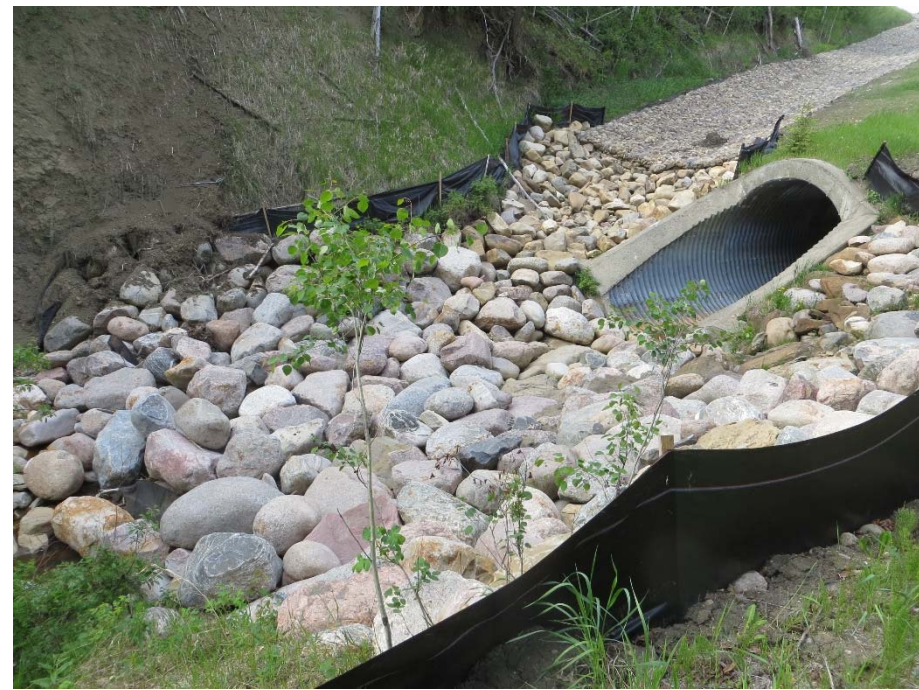
Photo 6.
Looking north at outlet (west end) of the multi-plate culvert under the highway. Enhancements to the rip rap armouring were performed in June 2014 and northwest ditch gabion mattress was launched in the rip rap.

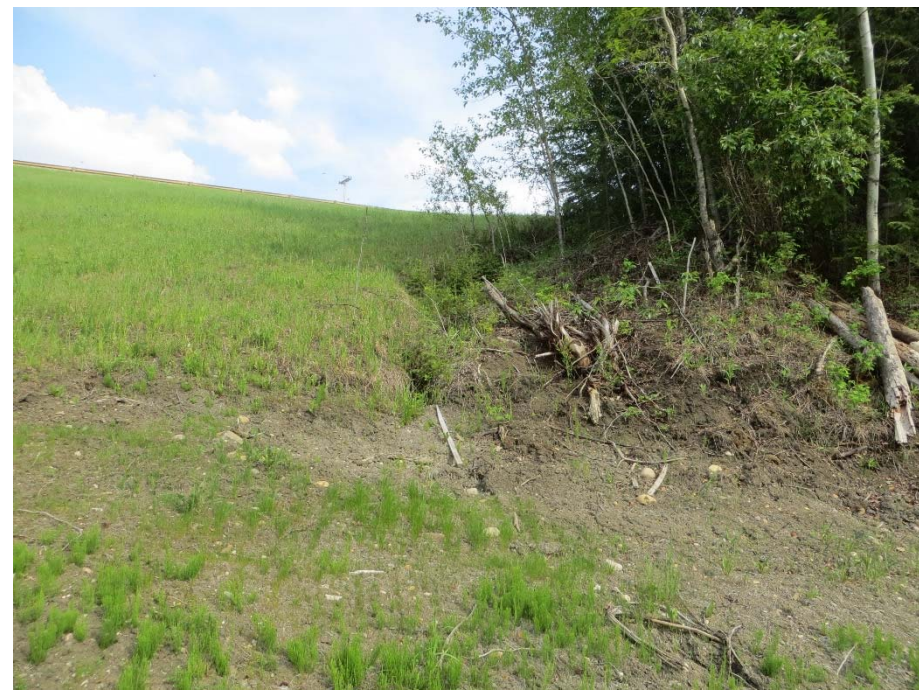
Photo 7.
Looking southeast at small erosion rills along the downstream end of the ditch in the SW corner of the site. No significant change since 2014.

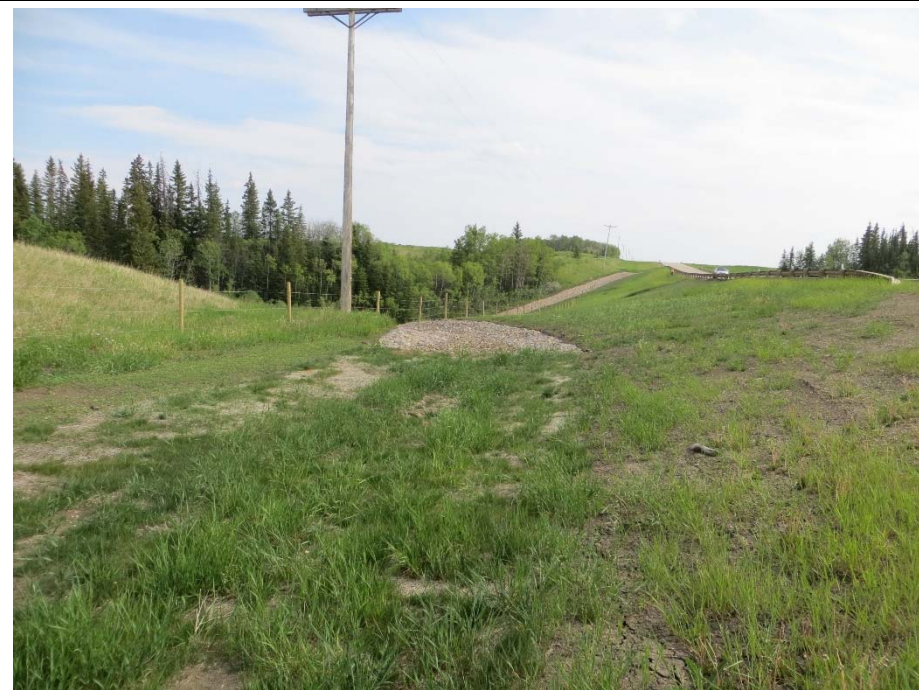
Photo 8.
Looking south at RECP and gabion mattresses installed in June 2014 along the ditch bottom. Vegetation is sparse upslope towards the highway.

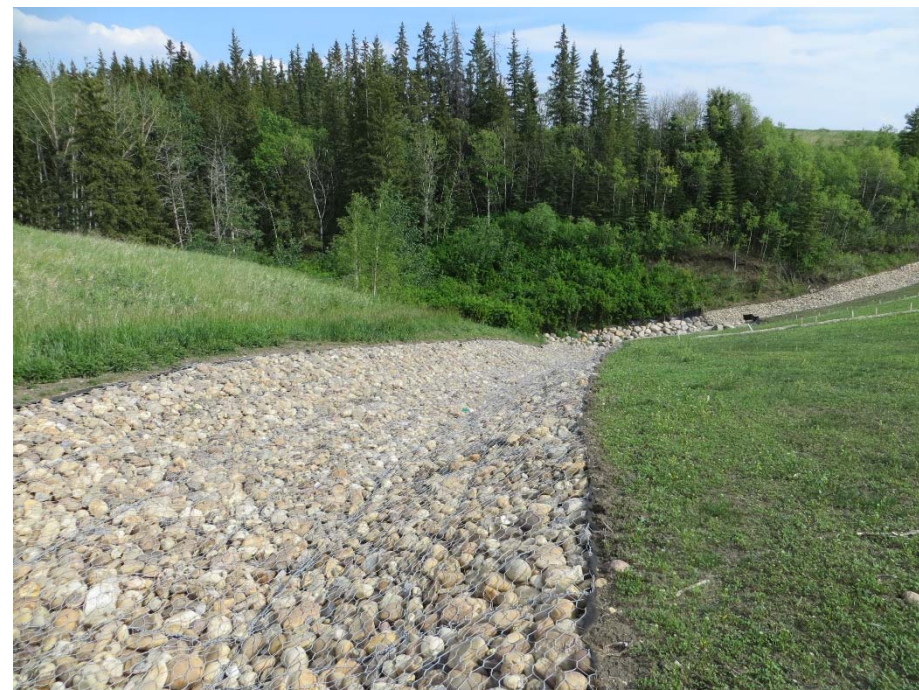
Photo 9.
Looking southeast along gabion mattresses installed in northeast ditch in June 2014.

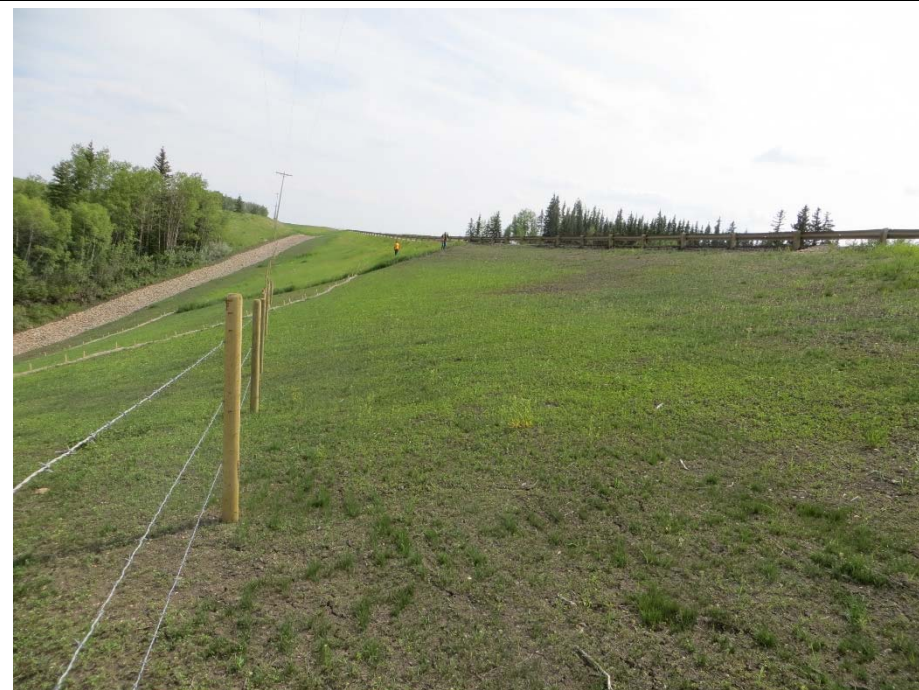
Soils at this site appear to be particularly susceptible to erosion by concentrated flowing water. It is likely that high precipitation events combined with a progressive loss of cohesion in the clay embankment fill due to weathering were the triggering mechanism for this landslide.

Local experience suggests that for embankments constructed using high plastic clay fill, failures begin to occur sometime between 10 years and 20 years after construction (this structure was first re-built in 1990). Long-term stable slopes in similar materials are typically 5H: 1V, while current highway clay sideslopes slopes are at angles of 2.75H: 1V to 3H: 1V.

Photo 10.
Looking south from northeast ditch at new type A fence and main landslide repair in highway sideslope. The failed rea was excavated in the fall of 2013 and backfilled with pit run gravel with a subdrain placed at the base extending into the centerline culvert inlet rip bowl. The disturbed area was then capped with clay, topsoiled and seeded in June 2014.

- Digging out the slide and northbound lanes of the highway and rebuilding the east sideslope with gravel fill.
- NW, NE and SW ditch erosion repairs with gabion mats and RECP.
- Enhancements to rip rap to accommodate gabion matting at culvert inlet and outlet.

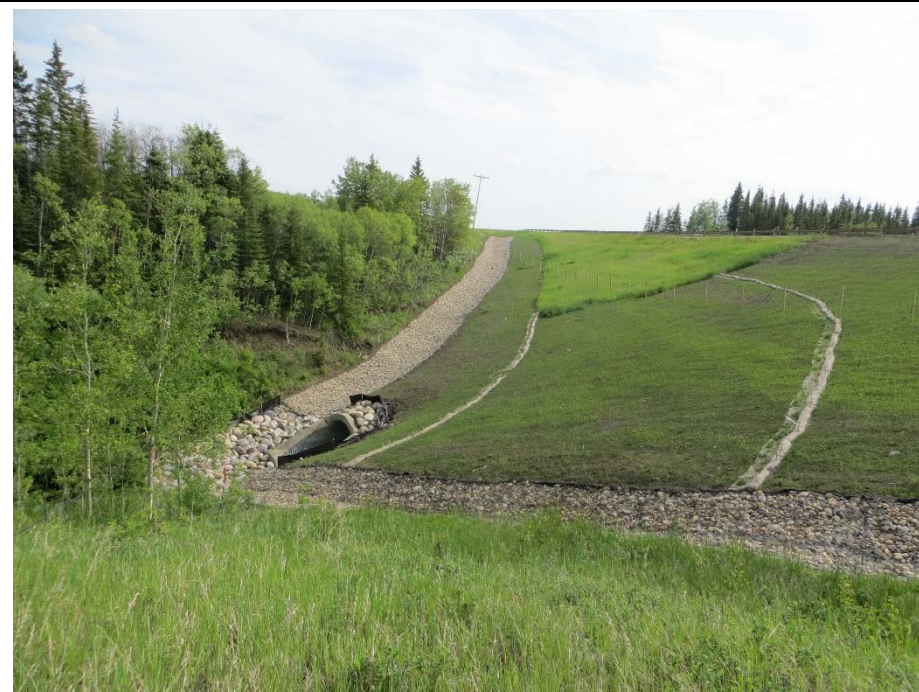
Photo 11.
Looking southwest at culvert inlet. Two biodegradable sediment control devices were placed diagonally across the repaired sideslope to shed the water gradually towards the gabion mattresses. Vegetation along the constructed sideslope is relatively sparse when compared to the existing grass of the undisturbed sideslope in the background.

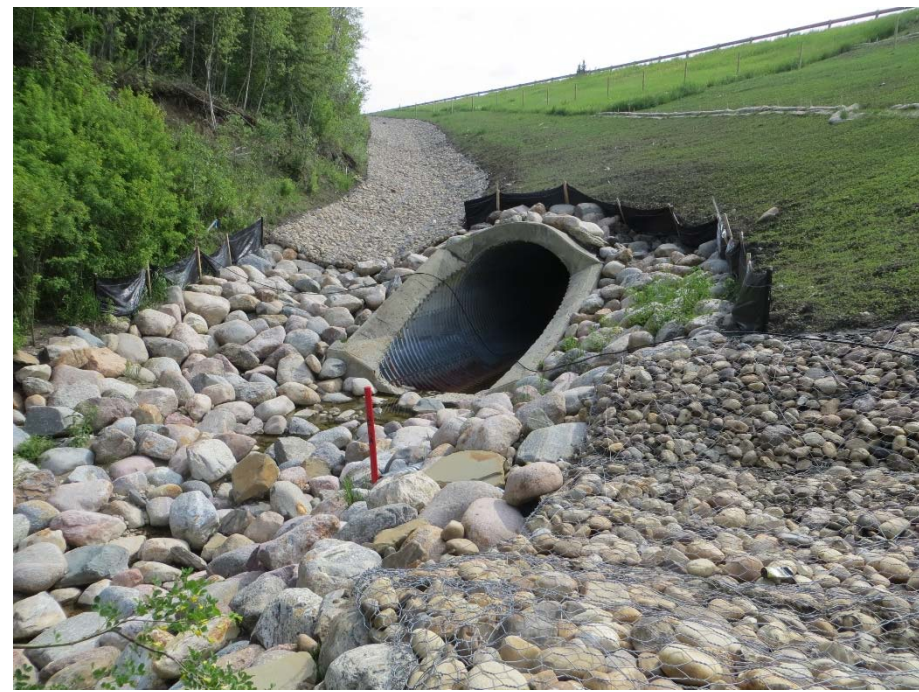
Photo 12.
Looking southwest at the highway centerline culvert inlet. The landslide debris had buried the culvert inlet in 2013. The culvert clay cap was exposed and the rip rap replaced and enhanced to accommodate the gabion mattress tie-in overlaps from the northeast and southeast ditches.

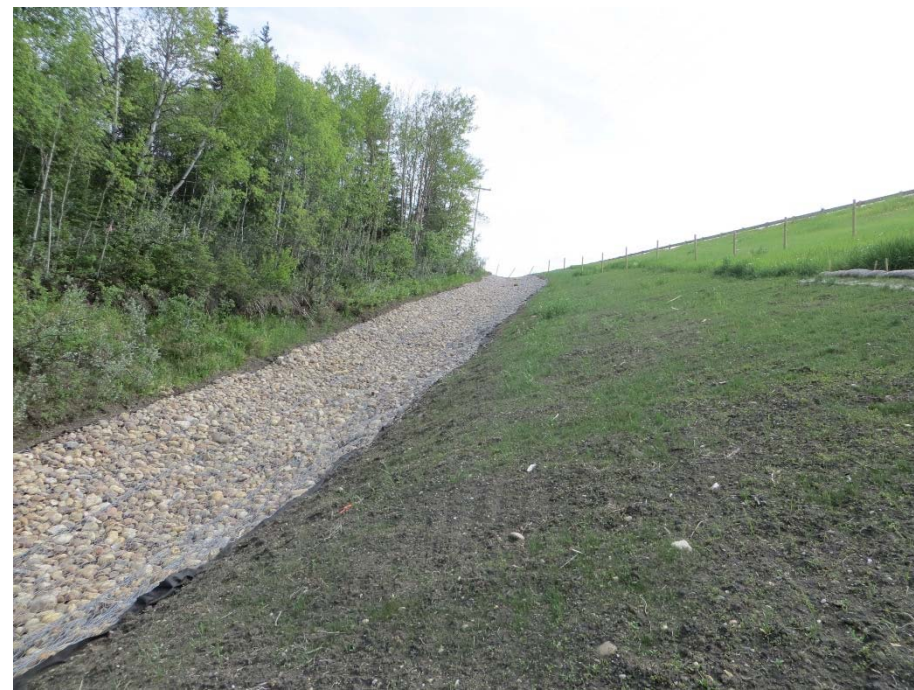
Photo 13.
Looking southwest along the southeast ditch gabion mattress. Vegetation is sparse in the disturbed area along the highway sideslope (to the left of the mattresses).

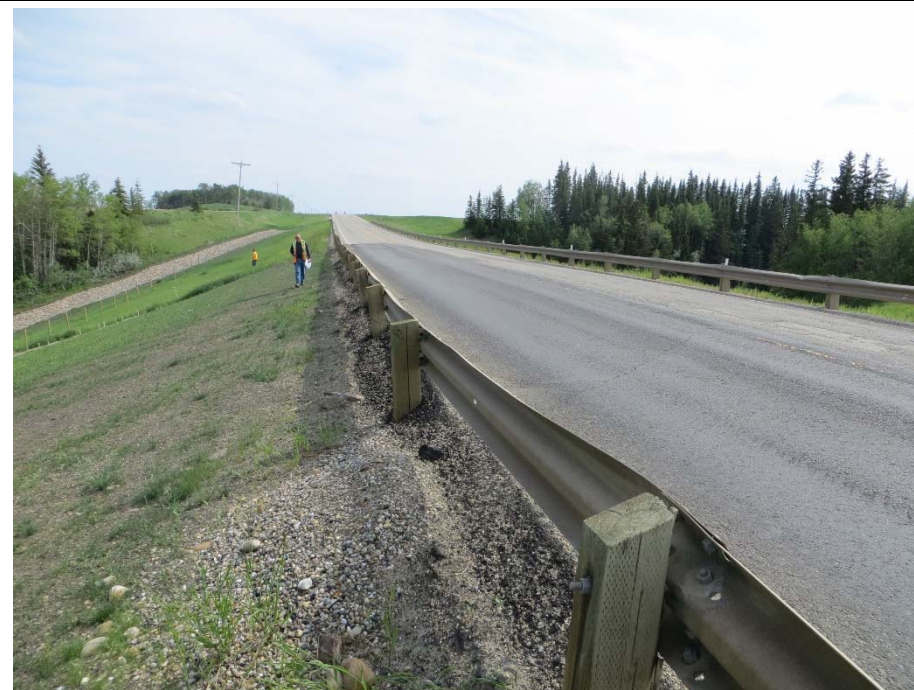
Photo 14.
Looking southwest from the north end of the previous landslide backscarp in the roadway pavement. The asphalt pavement from the 2013/2014 repair has performed well. Some settlement is visible along the sawcuts and are reflecting through the new patch from October 2014.
