Slide Name: (GP 19) SH 677:02 W. of Woking and E. of SH 731:02
Inspection Date: N/A
Inspection By: N/A

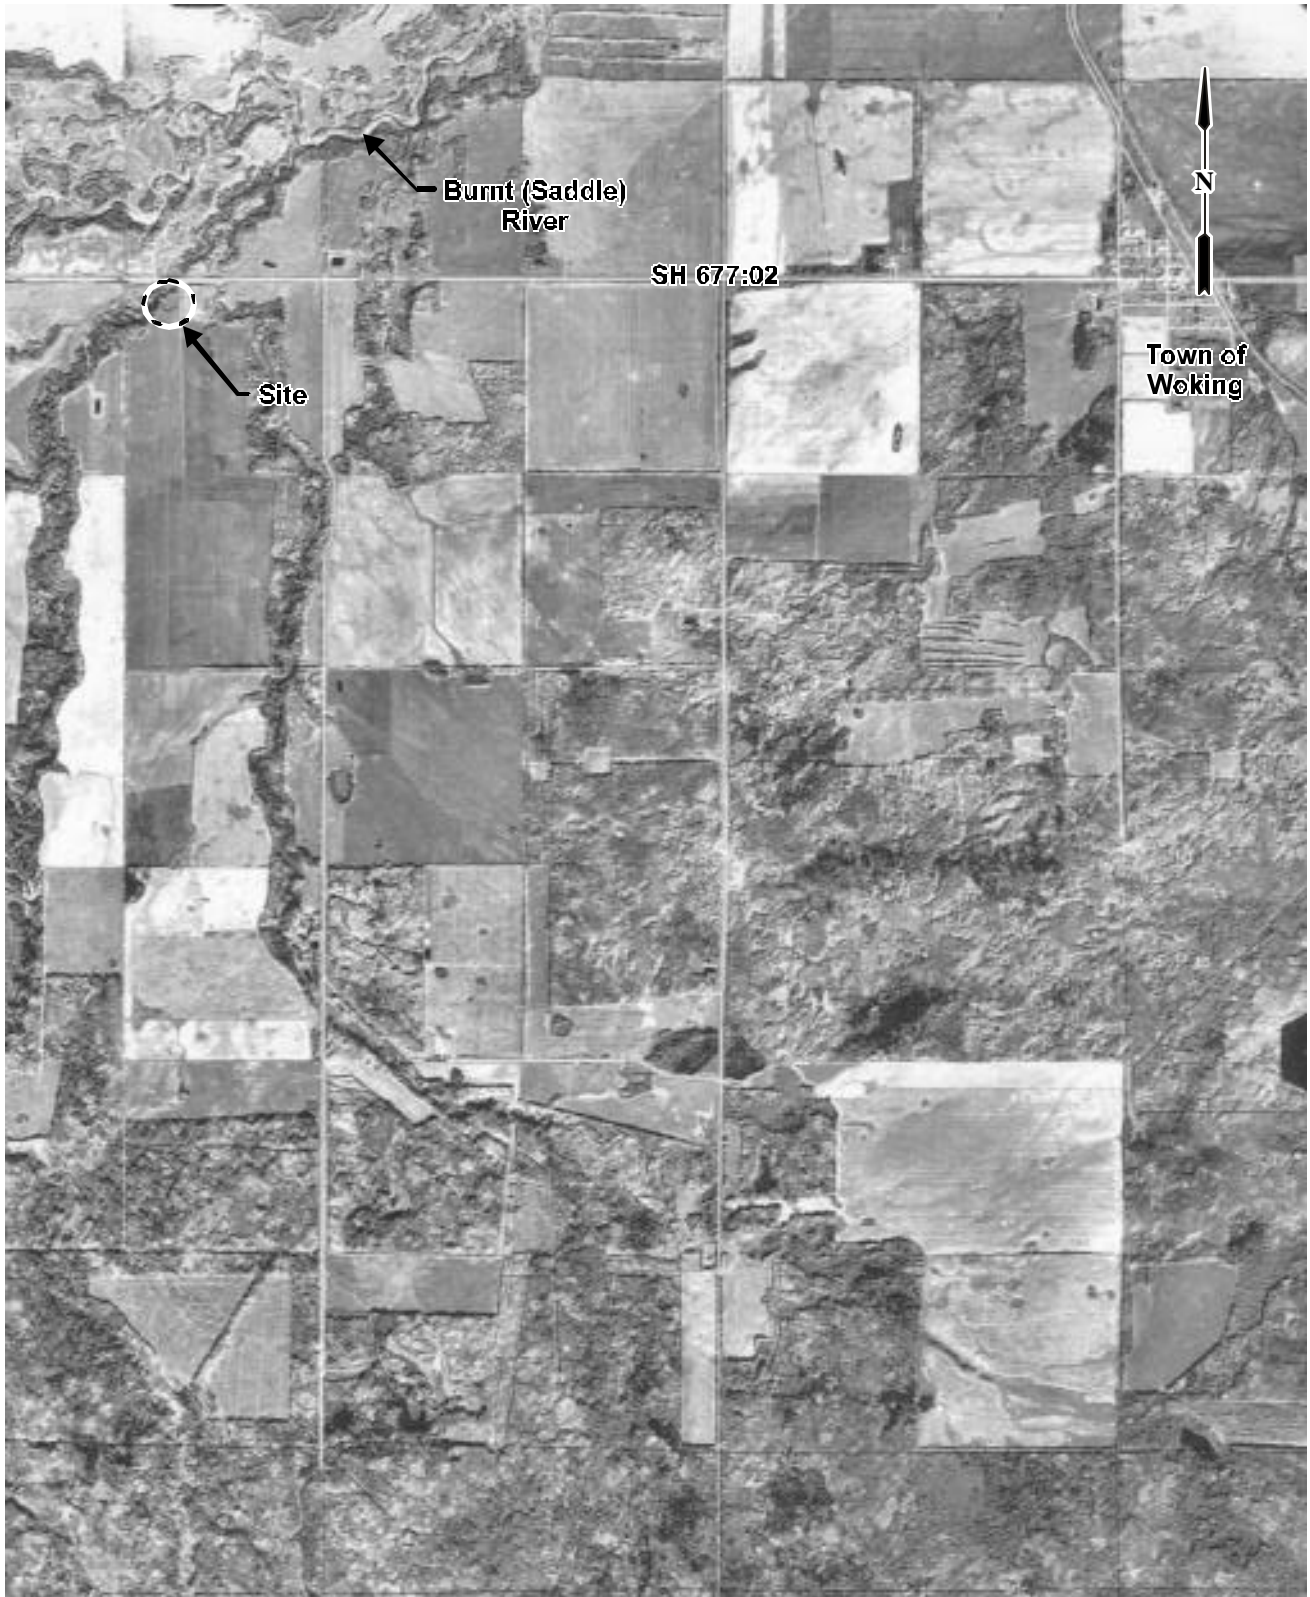
Figure 1
Site Plan

Based on 1995 Aerial Photograph
