**Slide Name:** (GP 21) SH 719 Henderson Creek (BF 73982)  
**Inspection Date:** June 25, 2003  
**Inspection By:** – Alberta Transportation and EBA Staff listed on Page 1  
– Ajit Paramapathy, P.Eng., David Morrison (AT Bridge Engineering Staff, Peace River)

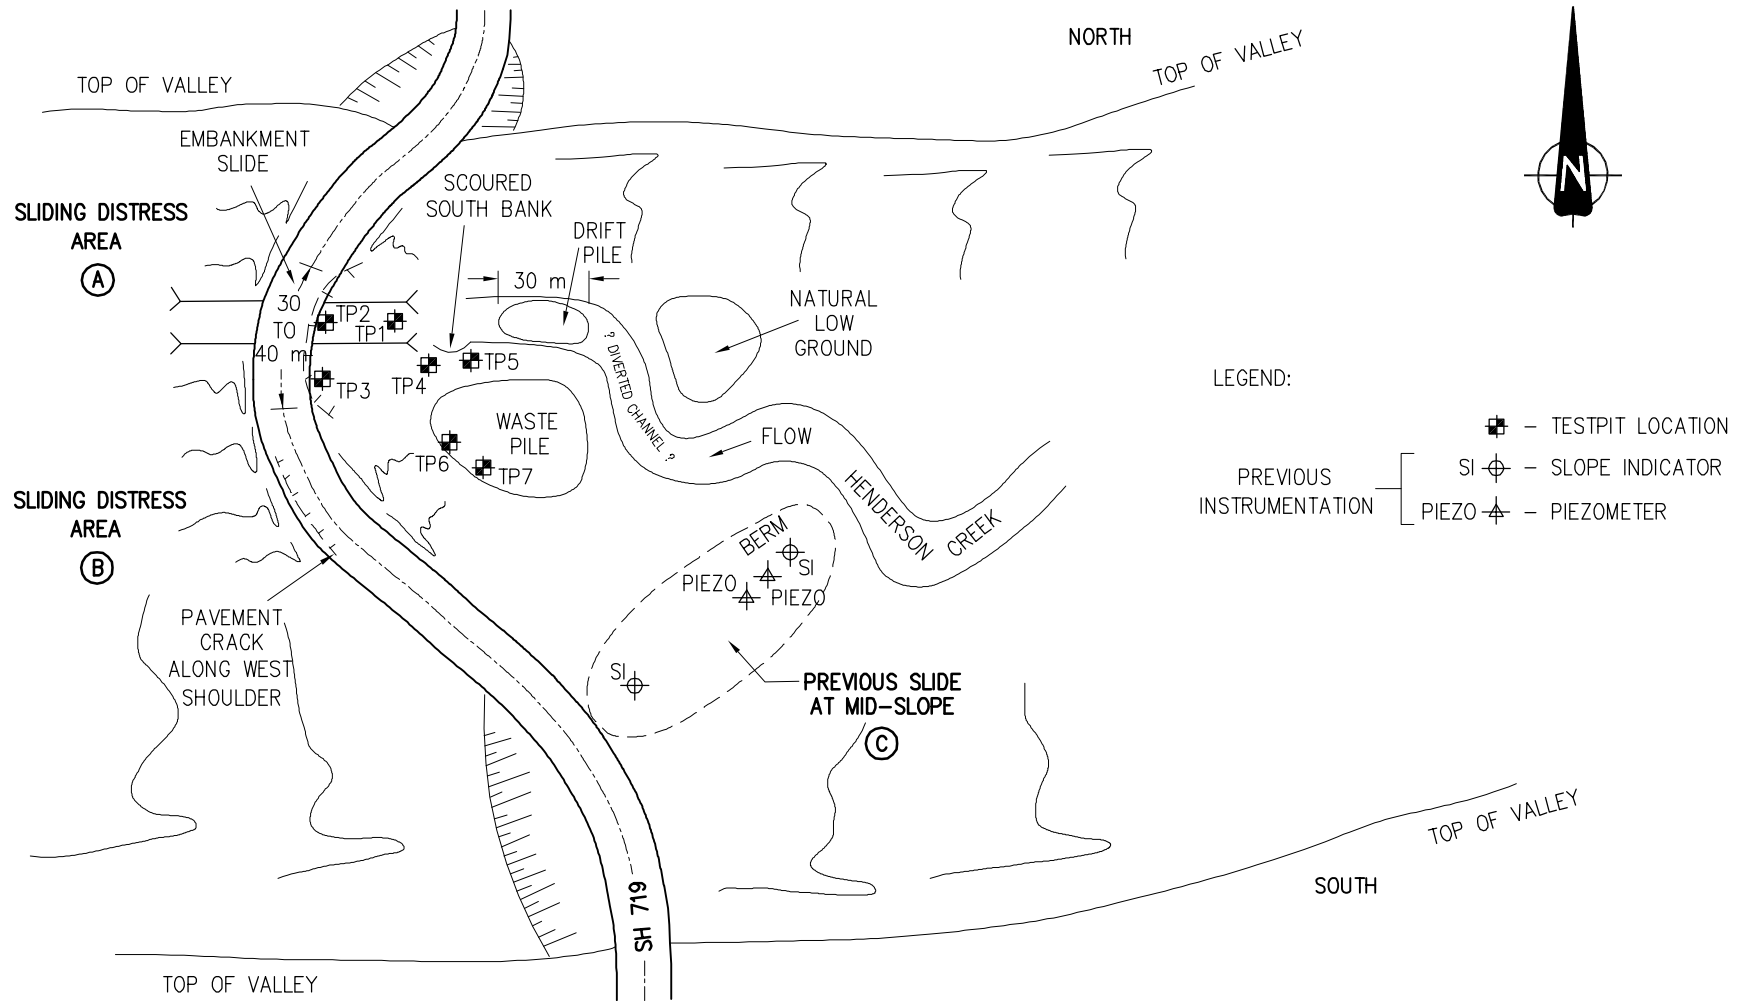
Figure 2  
GP 21  
SH 719 Henderson Creek North of Hwy 49

NOTES: 1) TP4 AND TP5 REVEALED BURIED 1-2m THICK ORGANIC AND WOOD DEPOSIT BENEATH FILL AND ABOVE RIVER GRAVEL  
2) DRAWING NOT TO SCALE

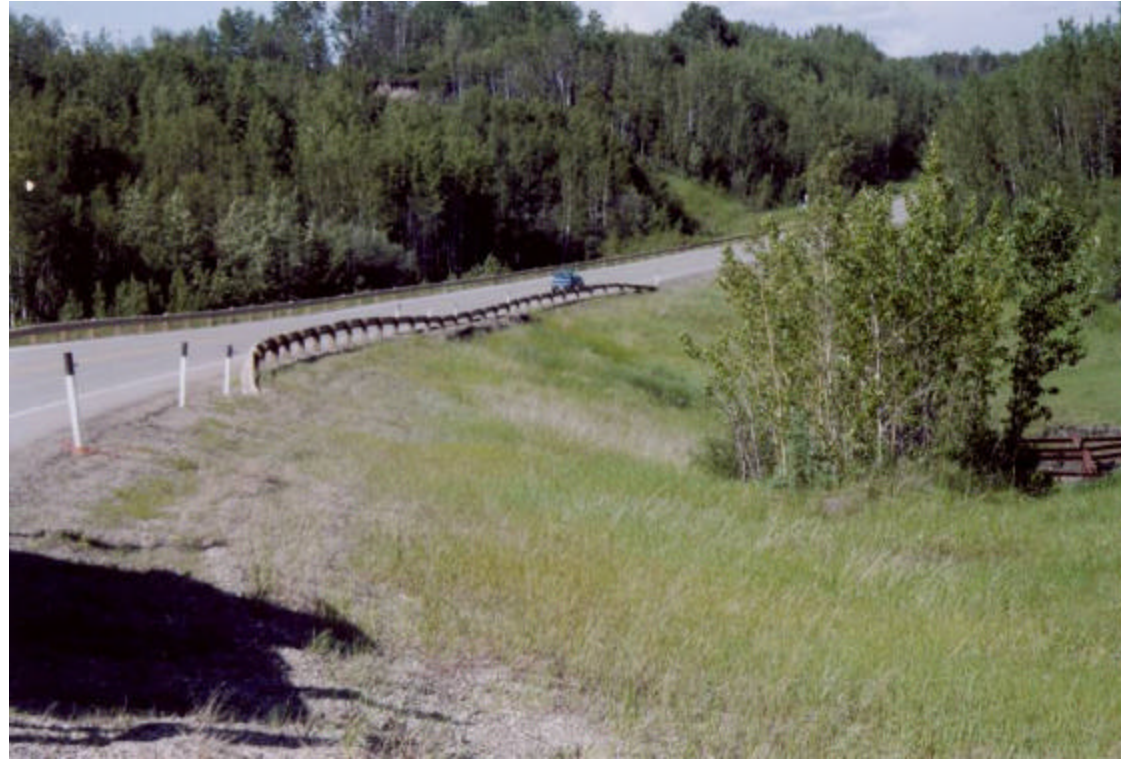
**Photo 1**

- The width of headscarp along the shoulder edge has increased to 40 m since 2001/2002 due to the continual erosion of the slope toe. Thus, a 40 m length of retaining wall would have to be designed. A 3 m high, tie-back retaining wall, with two rows of tie-backs at 1.5 m (lateral and vertical) spacing, will be considered.
- It was discussed that construction of the tie-back retaining wall may be carried out during the fall of 2003.

- Headscarp progressed to cause sagging of guardrail
- Looking at upstream slope face with flow from right to left

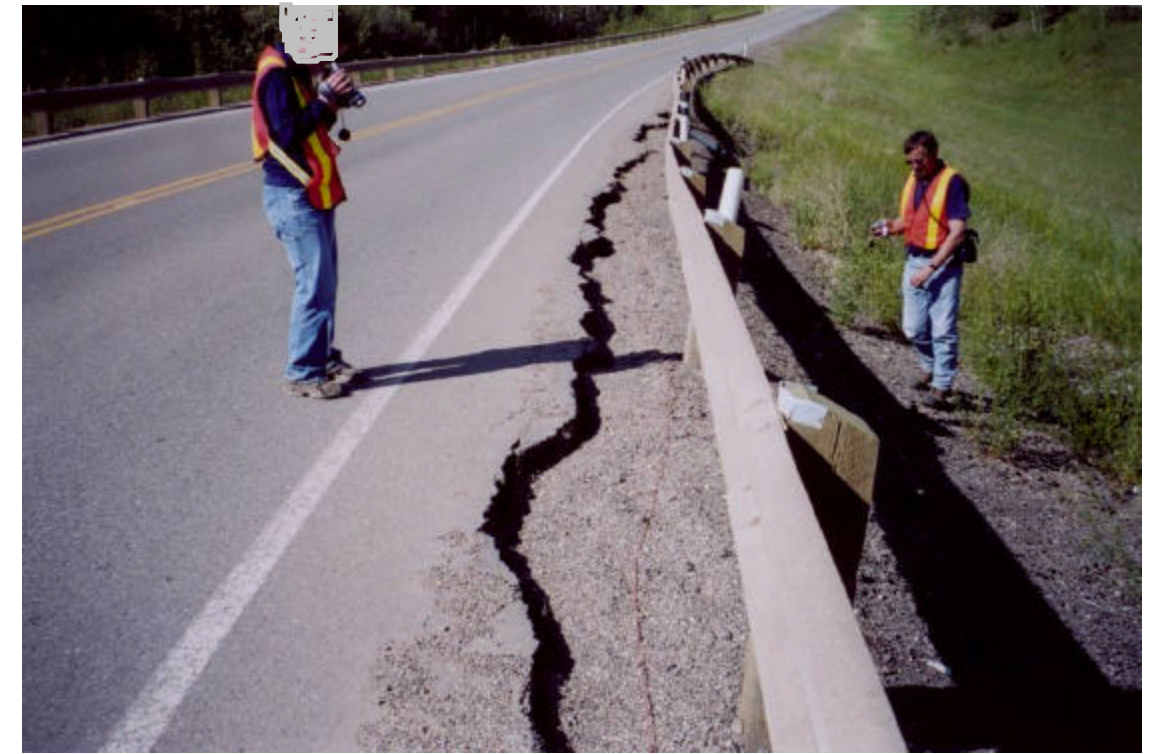
**Photo 2**

- A new, small drift pile was observed accumulating at the culvert inlet around the drift rack. The drift rack was last cleaned in spring 2002.
- The extent of toe scour has increased since the 2002 inspection as the previous rip-rap protection was washed out. This toe scour has widened the headscarp from 20 m (in 2001/2002) to 40 m (in 2003) along the road shoulder edge.

Widening of headscarp crack to 40 m along roadway shoulder

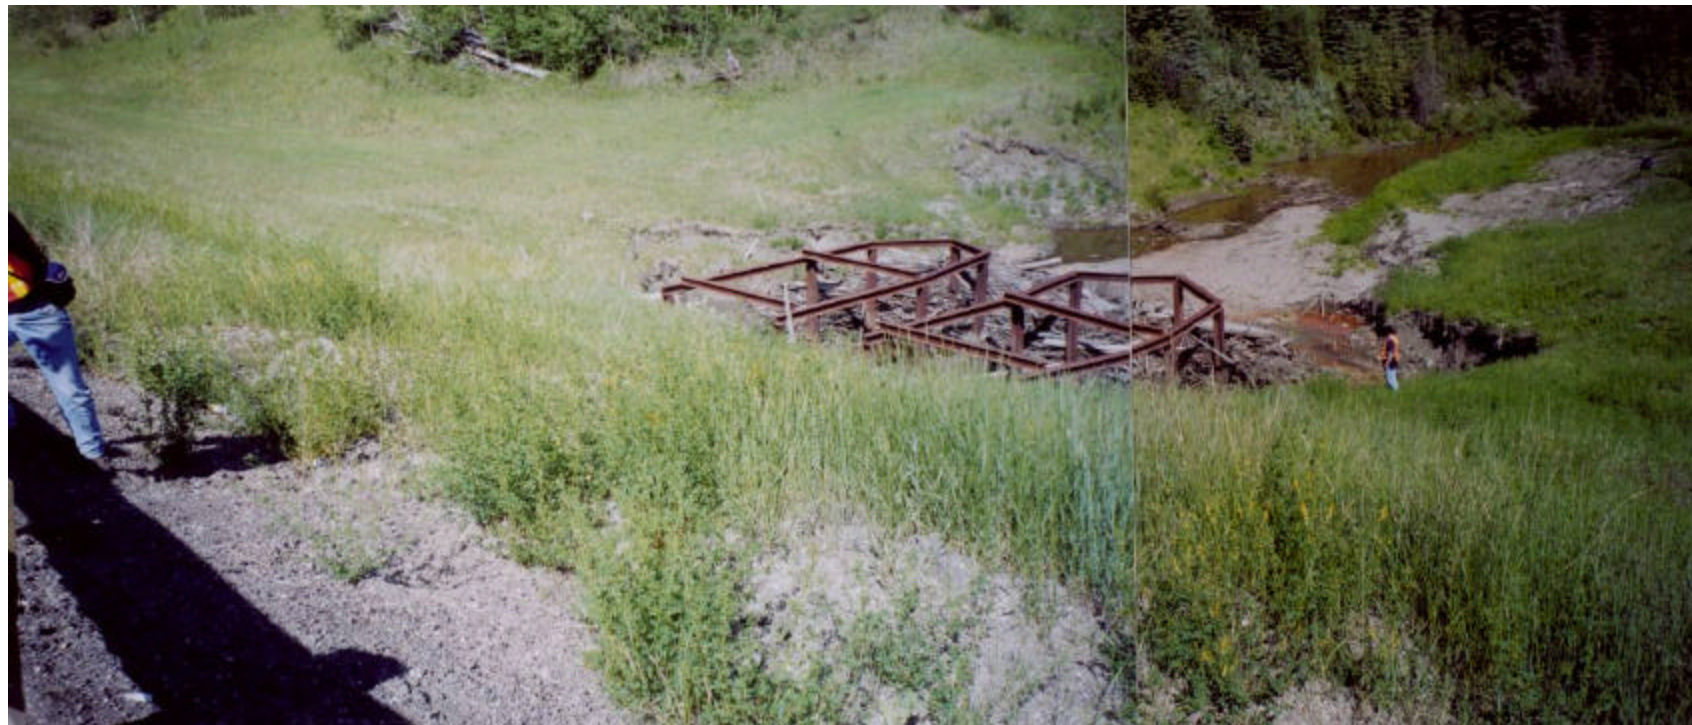
**Photo 3**

- Looking upstream
- Accumulation of drift after 1 year (last cleared out in spring 2002)
- Bank scour extends ~10 m on either side of drift rack (previous 2001 scour extended ~5 m on either side of drift rack)
- Buried organics at toe of fill and bank areas

- Temporary erosion control measures will be constructed in fall 2003 at the upstream toe area. The temporary measure will entail rip-rap protection of precast concrete panels (used material in-stock) that will be installed and/or gabion rock structure along the eroded areas along the toe. The required sub-excavation of buried organic material at the toe, as proposed in EBA's December 2001 report recommendations, will not be carried out as part of the works.
