**ALBERTA TRANSPORTATION
GEOHAZARD ASSESSMENT PROGRAM
PEACE REGION – GRANDE PRAIRIE
2019 INSPECTION**

Site Number	Location	Name	Hwy	km
GP040	4.7 km's N. of Rycroft	Spirit River Bridge (BF75106)	2:68	4.7
Legal Description		UTM Co-ordinates		
SE¼ 34-078-5 W6M		11U E 394291	N 6184727

**GP40-1: HWY 2-68 KM 4.7 SPIRIT RIVER BRIDGE
2019 INSPECTION PLAN**

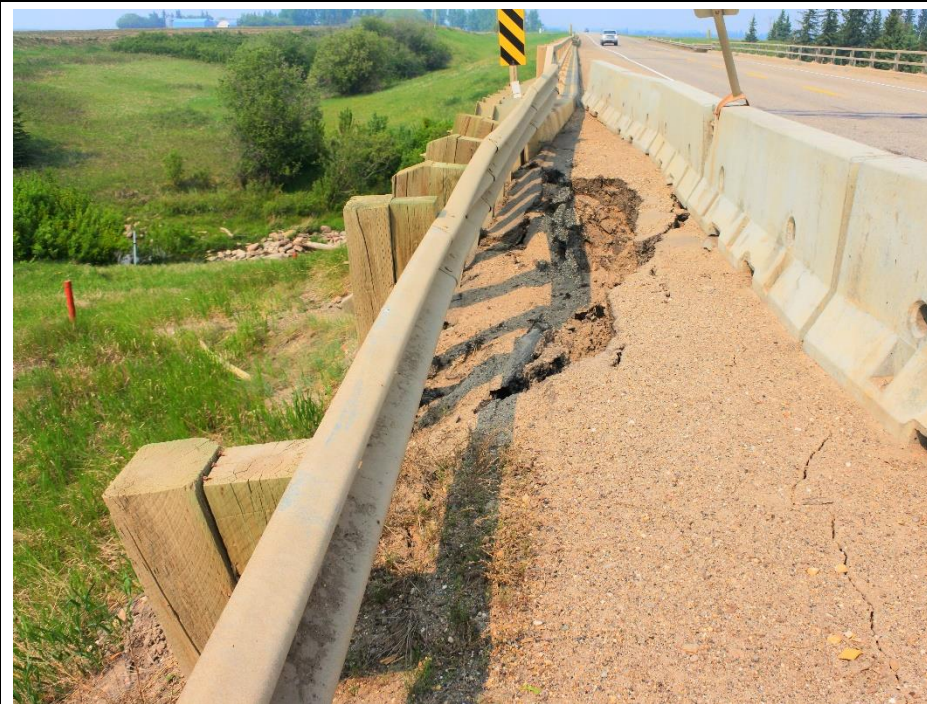
Observations:	Description	Worsened?
<input checked="" type="checkbox"/> Pavement Distress	Cracks were present along the backscarp of the landslide in the shoulder of the SBL of Hwy 2:68 at the south abutment (Photo 1) and on the east side of jersey barriers, these appeared to be in similar condition in 2019.	<input type="checkbox"/>
<input checked="" type="checkbox"/> Slope Movement	A landslide occurred on the west side of the south abutment headslope (Photos 2 and 3). A 35 m long tension crack has formed on the terrace below the main backscarp and another localized slide failure is present below the south abutment which extends northeast which has worsened since the last inspection. Two dips were present in the south headslope. Soil loss/settlement were evident at the crest of the south abutment headslope. There was a 1 m high scarp observed on the north abutment which may be exacerbated during highwater.	<input checked="" type="checkbox"/>

Photo 1.
Looking north at
the Slide 1 scarp
cracks along the
edge of the SBL.

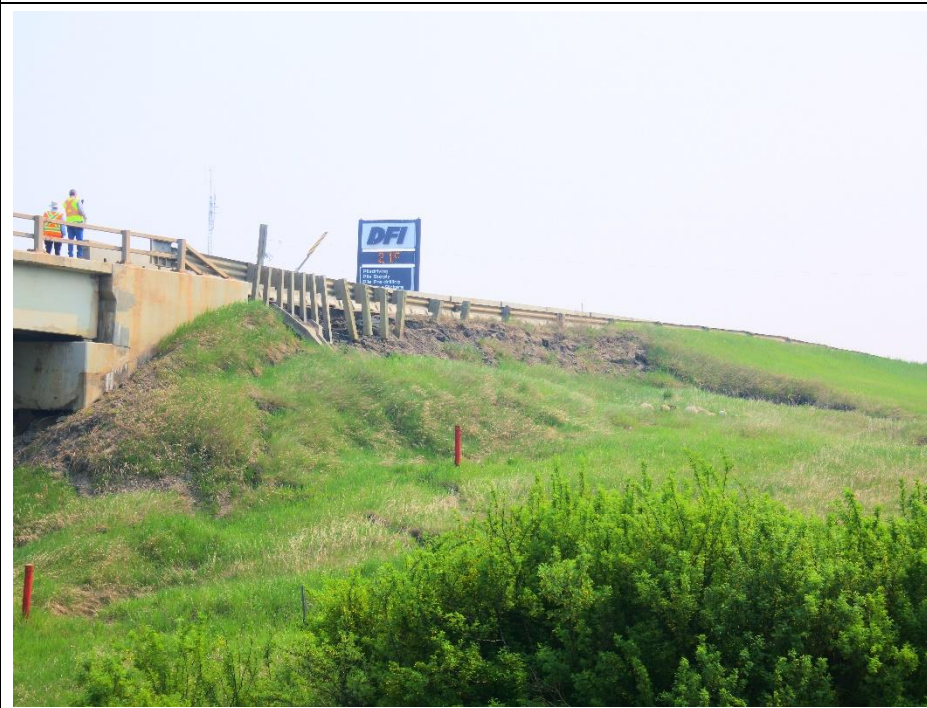
Photo 2.
Looking east at the
Slide 1 scarp along
the edge of the
road.

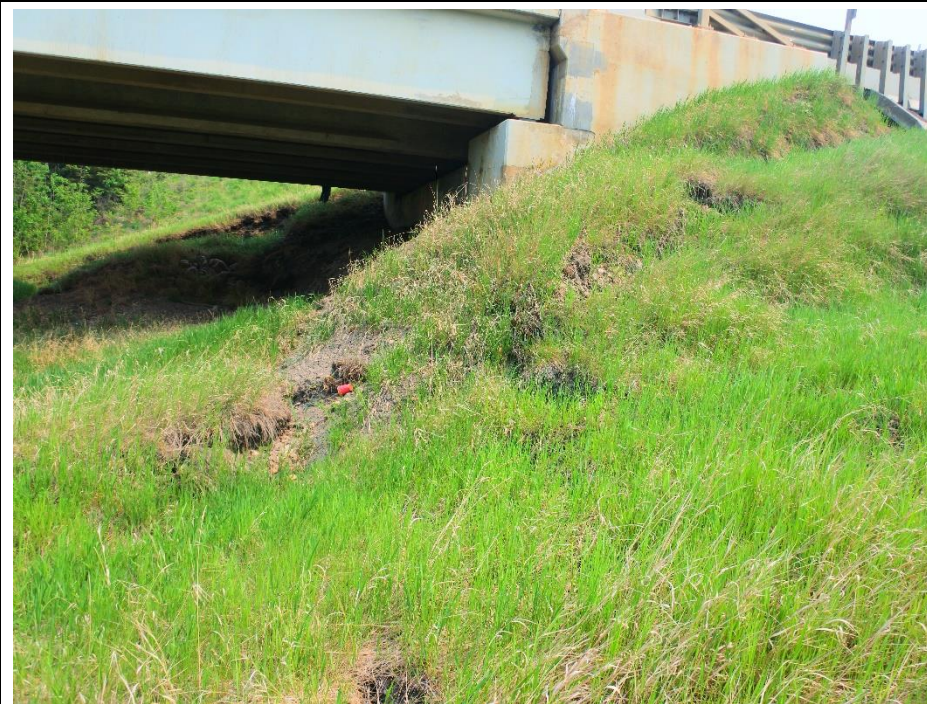
Photo 3.
Looking east at the flank of Slide 1.

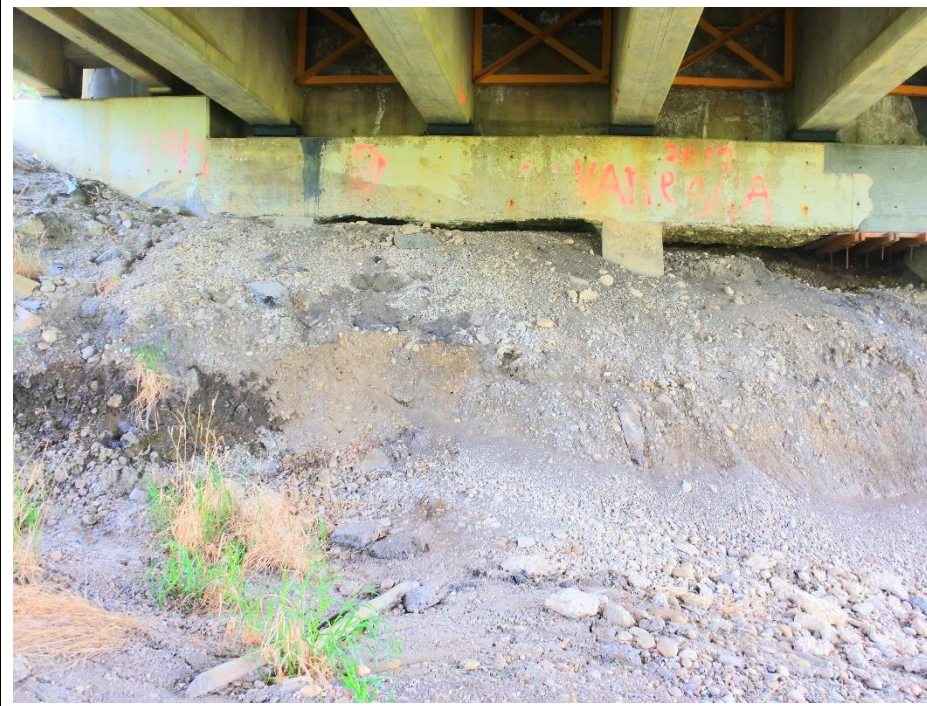
Photo 4.
Looking south at the west side of the south abutment. Note the settlement of the soil. It appears that the bridge was widened after the original construction. Concrete counterforts are under the original bridge and steel H piles with cables are under the widened part.

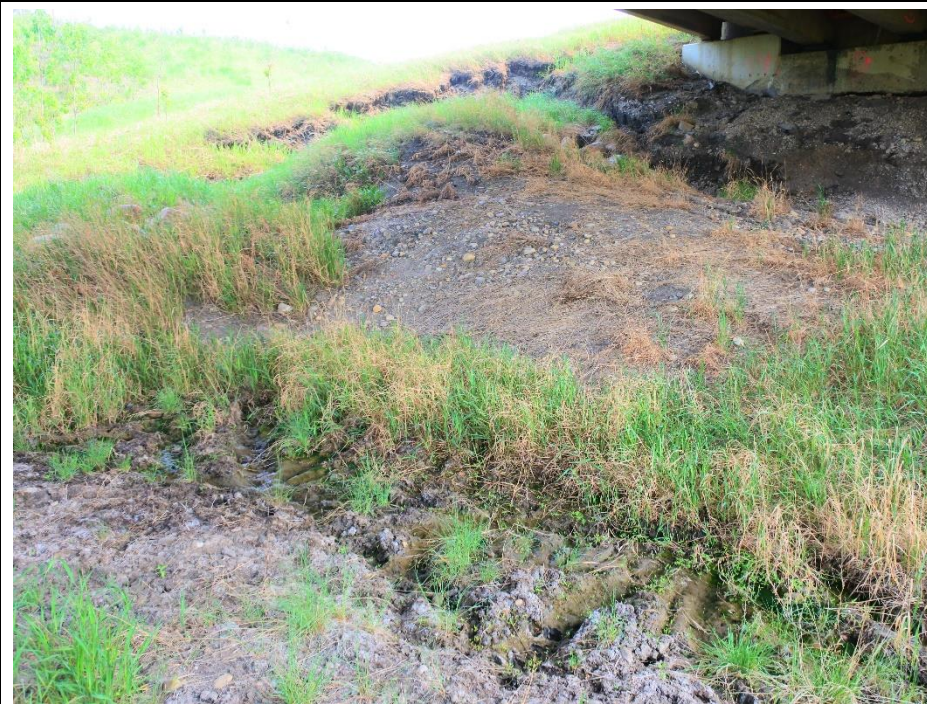
Photo 5.
Looking southeast
at the scarp and
flank of Slide 2.

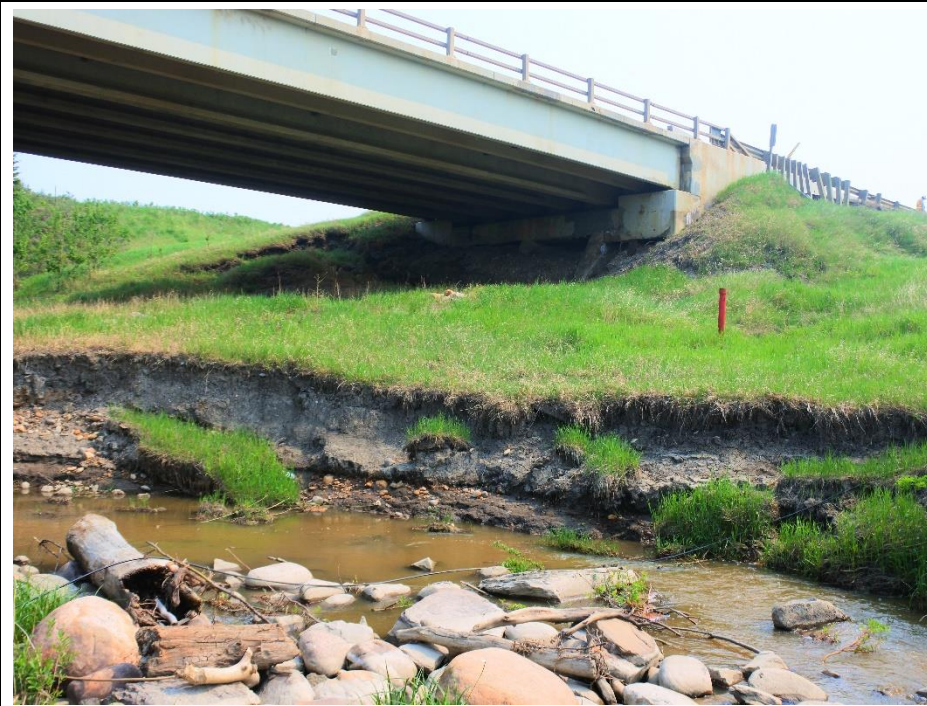
Photo 6.
Looking at the
south abutment.
Note the river bank
slumping.

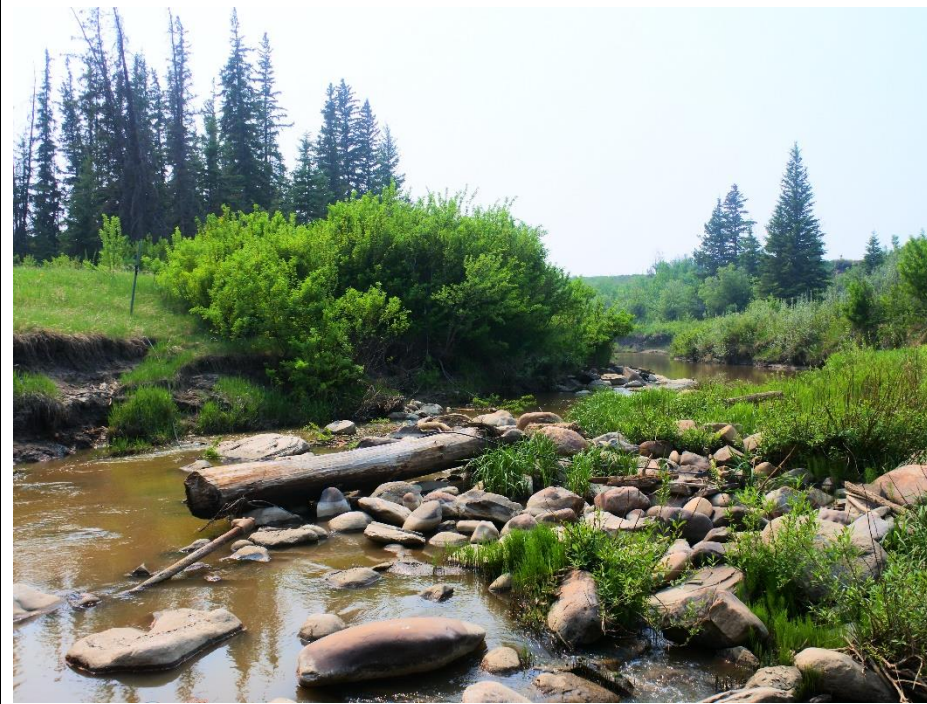
Photo 7.
Looking upstream of the bridge at the river bank erosion/slumping. The toe of Slide 1 is located at the caragana bushes.

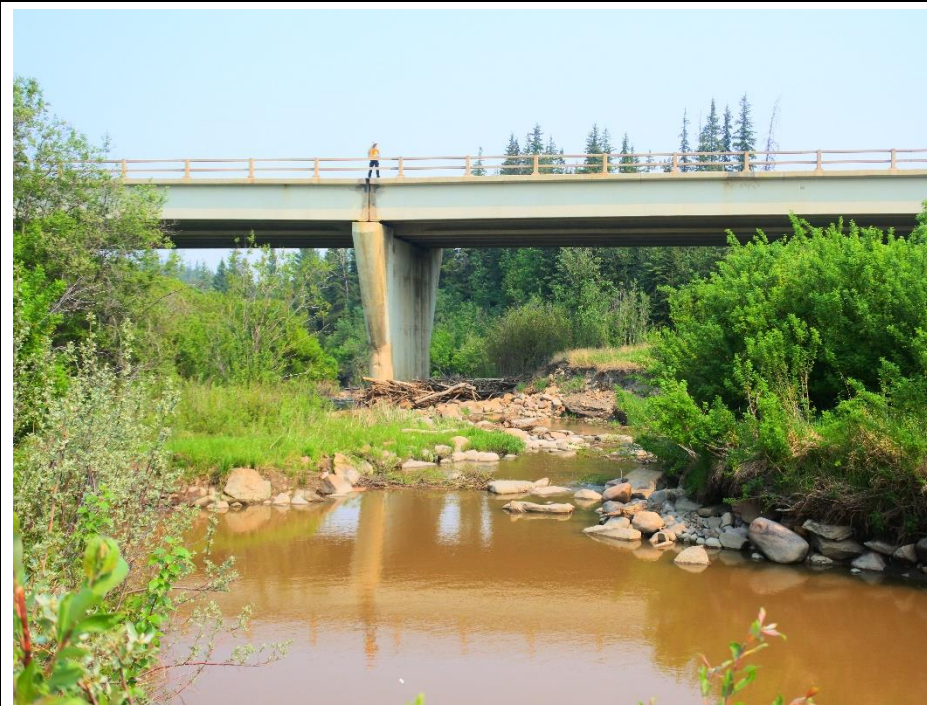
Photo 8.
Looking downstream towards the bridge pier and bank erosion below the south abutment.

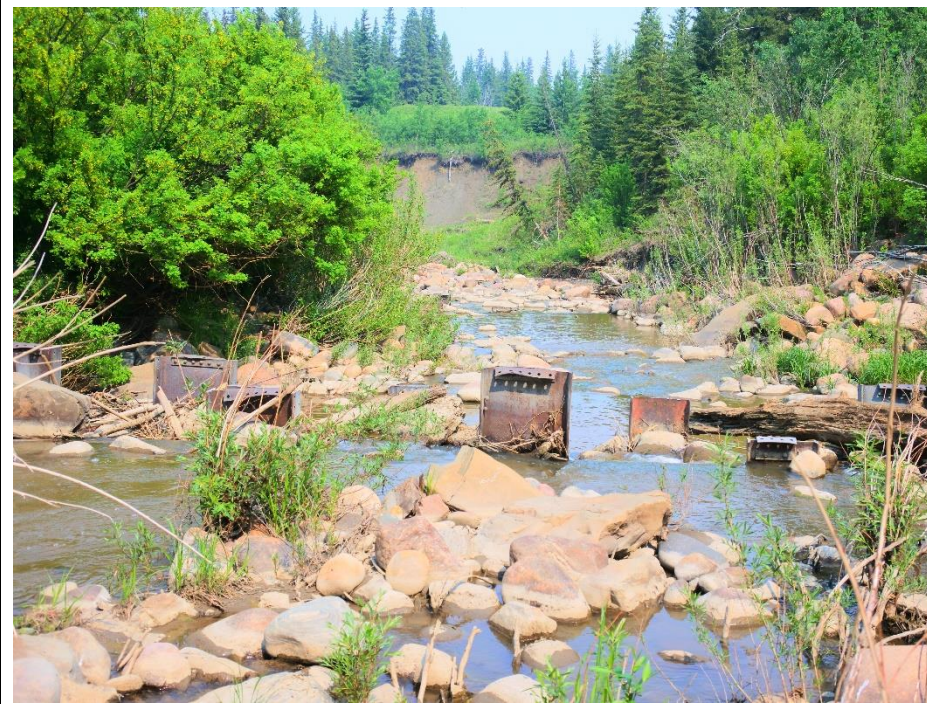
Photo 9.
Pile weirs located
in the streambed
downstream of the
bridge.

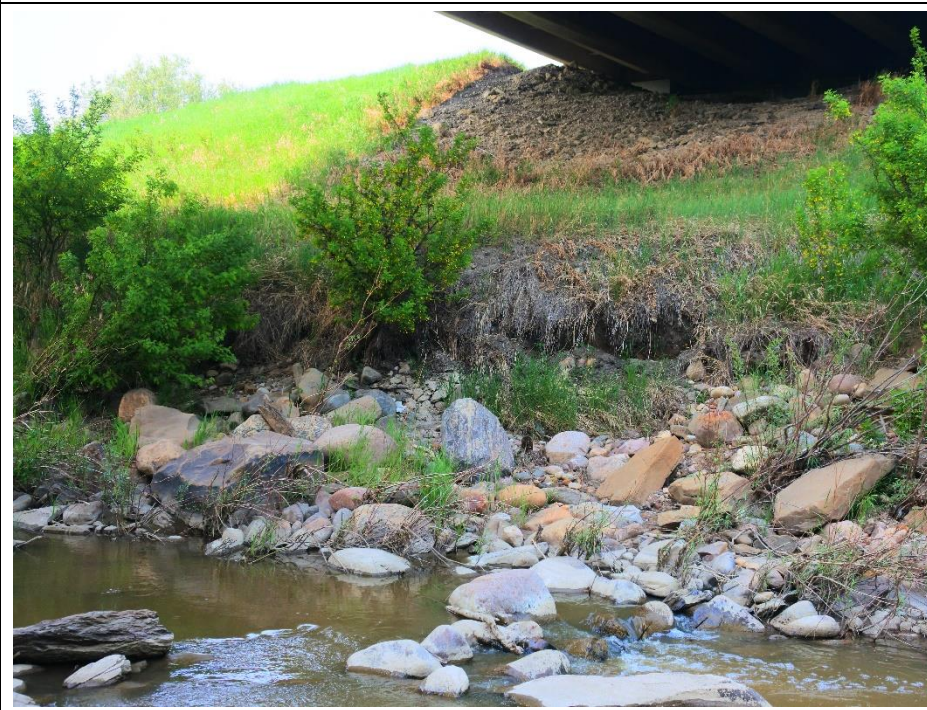
Photo 10.
Looking north at
1m high scarp on
north abutment.

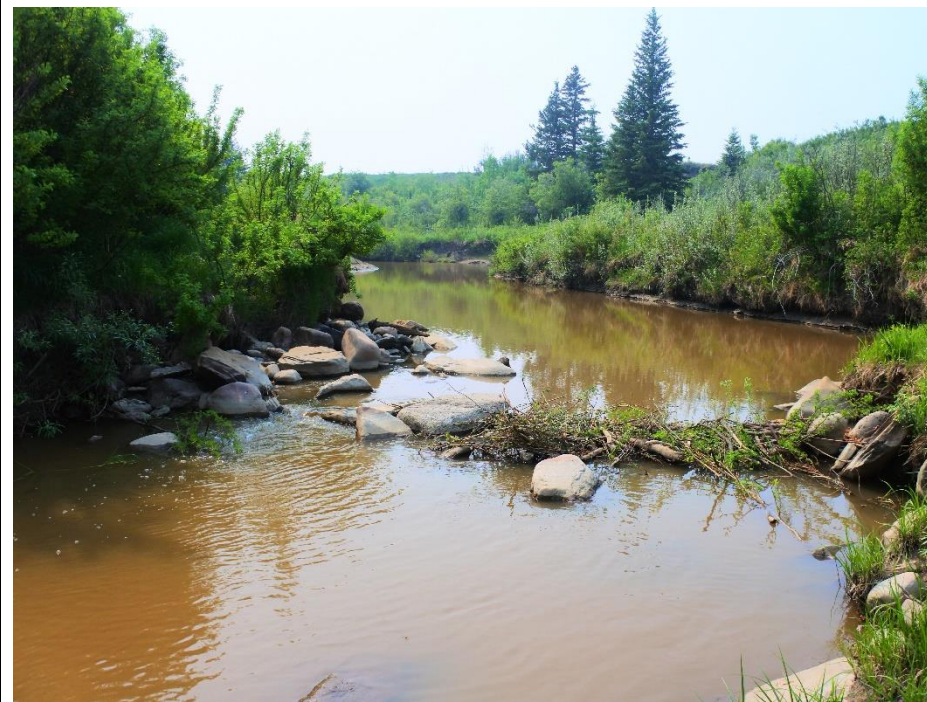
Photo 11.
Looking west
towards beaver
dam.

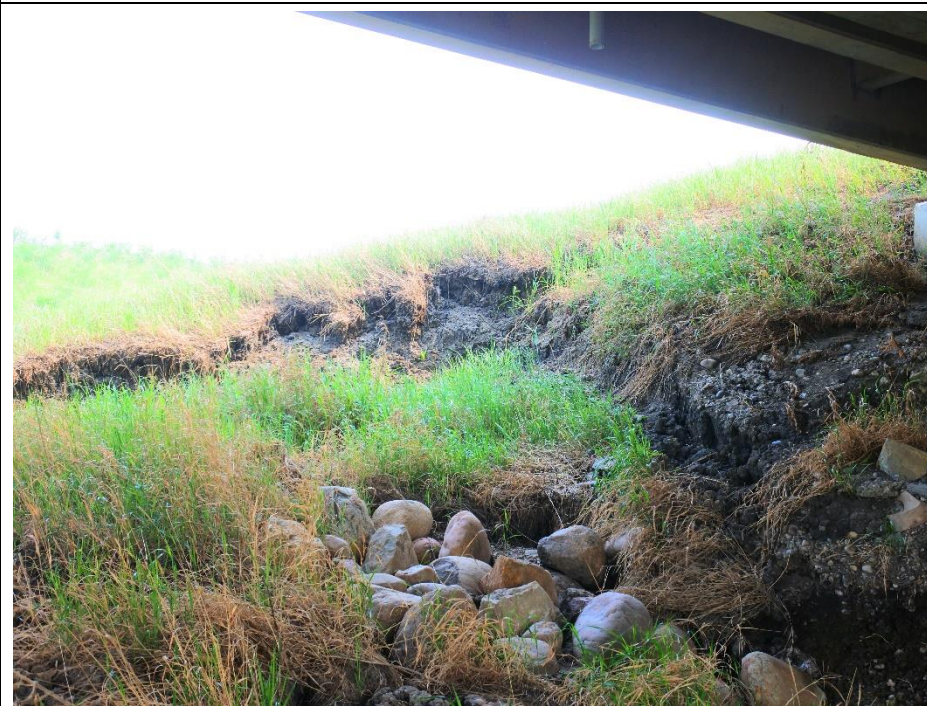
Photo 12.
Looking southeast
at the scarp and
flank of Slide 2.
