**ALBERTA TRANSPORTATION  
GEOHAZARD ASSESSMENT PROGRAM  
PEACE REGION – GRANDE PRAIRIE  
2020 INSPECTION**

Site Number	Location	Name	Hwy	km
GP040	4.7 km's N. of Rycroft	Spirit River Bridge (BF75106)	2:68	4.7
Legal Description		UTM Co-ordinates		
SE¼ 34-078-5 W6M		11U E 394291	N 6184727

**GP40-1: HWY 2-68 KM 4.7 SPIRIT RIVER BRIDGE  
2020 INSPECTION PLAN**

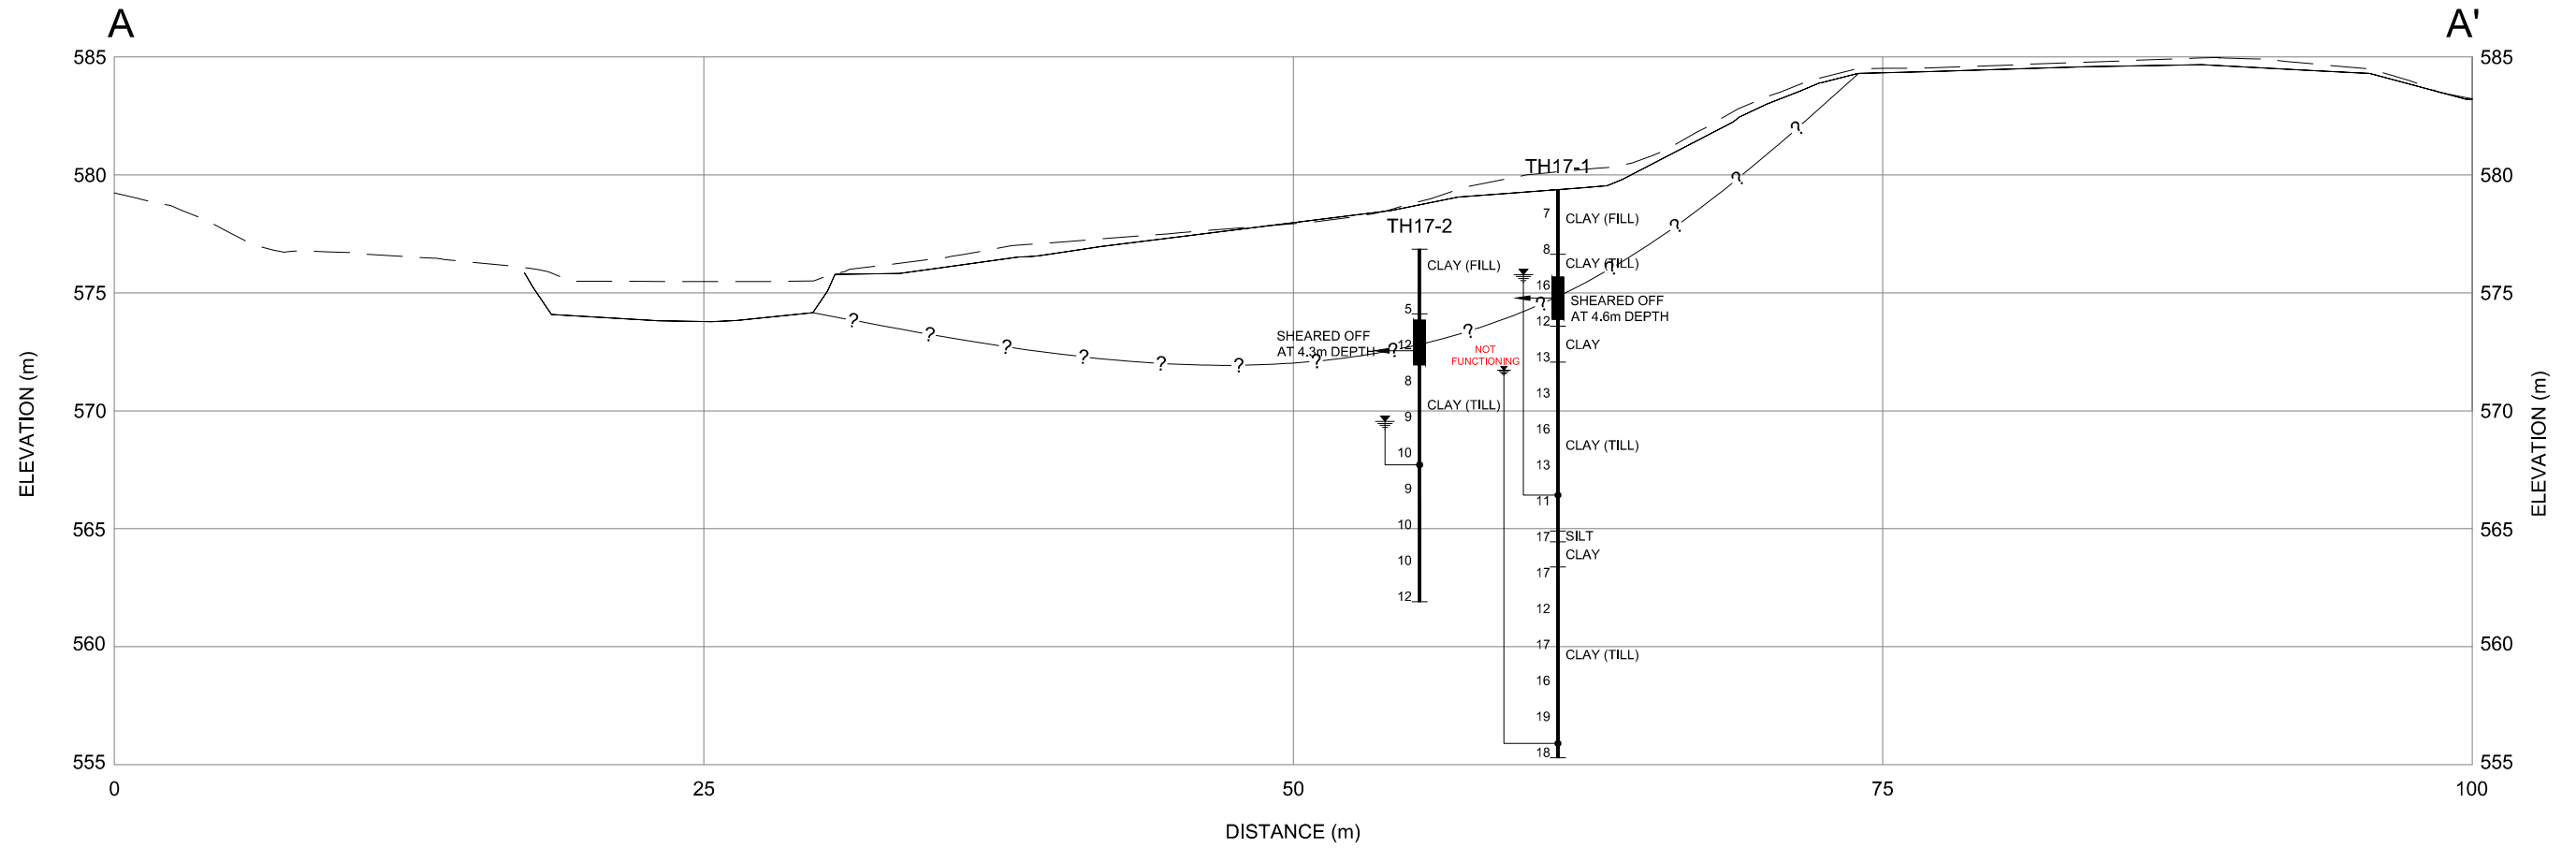
**GP40-1: HWY 2-68 KM 4.7 SPIRIT RIVER BRIDGE  
CROSS - SECTION A - A'**

<input type="checkbox"/> Other		<input type="checkbox"/>
<b>Instrumentation June 22, 2020: Inclinometers SI17-1 = Sheared off at 4.6 m depth; SI17-2 = Sheared off at 4.3 m depth; SI17-3 = movement between 0.2 m to 3.9 m at a rate of 19.4 mm/yr in summer 2020. Piezometers PN17-1A = not functioning; PN17-1B = 3.6 m BGS; PN17-2 = 7.3 m BGS; PN17-3 = not functioning.</b>		
<b>Assessment:</b> <p>In 2013, as a result of heavy rains, the water level in the Spirit River rose and shifted toward the south. The raised river level which caused erosion at the toe of the south bridge abutment headslope and sideslope, resulting in the occurrence of the landslide in the south abutment fill.</p> <p>It is important that the abutment headslope and sideslope be stabilized in order to avoid causing further distress to the bridge structure.</p> <p>A geotechnical investigation consisting of three test holes with slope inclinometers and pneumatic piezometers was performed in summer of 2017. Simplified stratigraphic cross sections are attached on Drawing No. 13353-GP40-1-2 and 3, which show the soil conditions encountered in the boreholes, piezometric conditions and inferred slip surface of the landslides. The slip surface appears to be based in high plastic clay and clay till, toeing out at the river.</p>

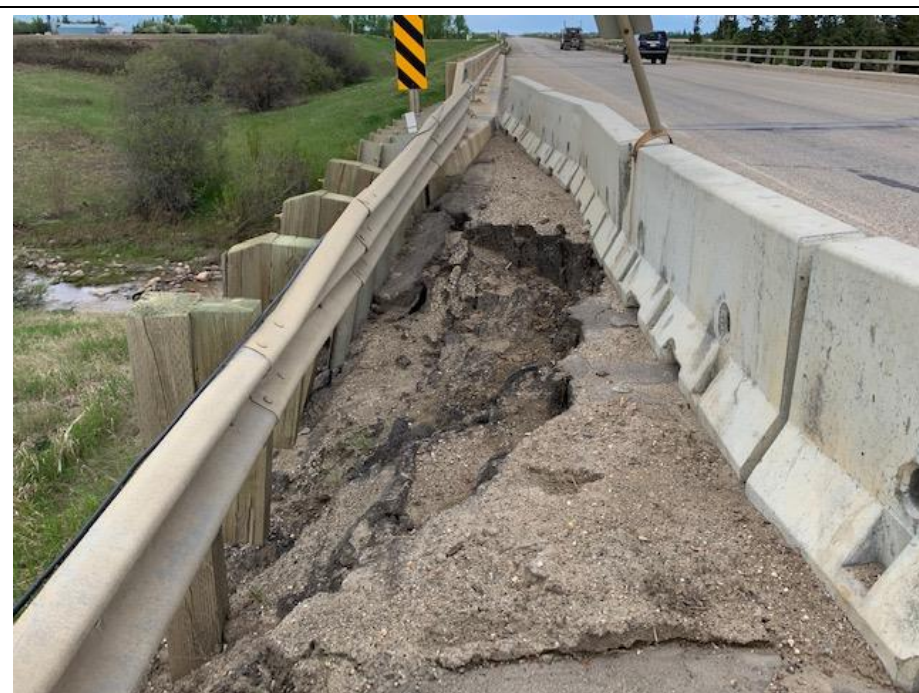
<b>Observations:</b>	<b>Description</b>	<b>Worsened?</b>
<input checked="" type="checkbox"/> Pavement Distress	Cracks were present along the backscarp of the landslide in the shoulder of the SBL of Hwy 2:68 at the south abutment (Photo 1) and on the east side of jersey barriers, these appeared to be in similar condition in 2020.	<input type="checkbox"/>
<input checked="" type="checkbox"/> Slope Movement	A landslide occurred on the west side of the south abutment headslope (Photos 2 and 3). A 35 m long tension crack has formed on the terrace below the main backscarp and another localized slide failure is present below the south abutment which extends northeast which appeared it has worsened since the last inspection. Two dips were present in the south headslope. Soil loss/settlement were evident at the crest of the south abutment headslope. There was a 1 m high scarp observed on the north	<input checked="" type="checkbox"/>

**Photo 1.**  
Looking north at  
the Slide 1 scarp  
cracks along the  
edge of the SBL.

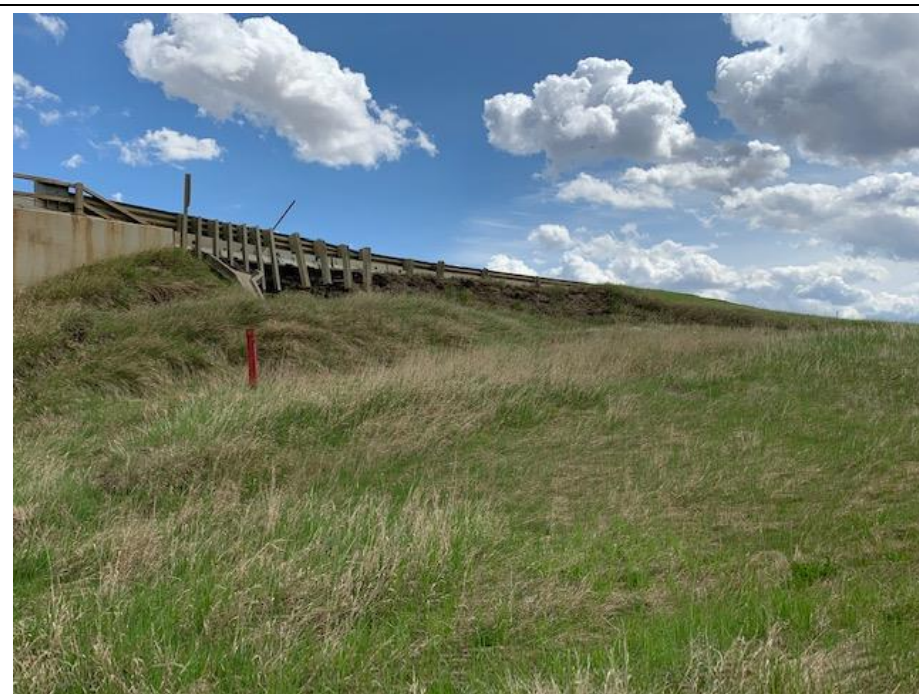
**Photo 2.**  
Looking east at the  
Slide 1 scarp along  
the edge of the  
road.

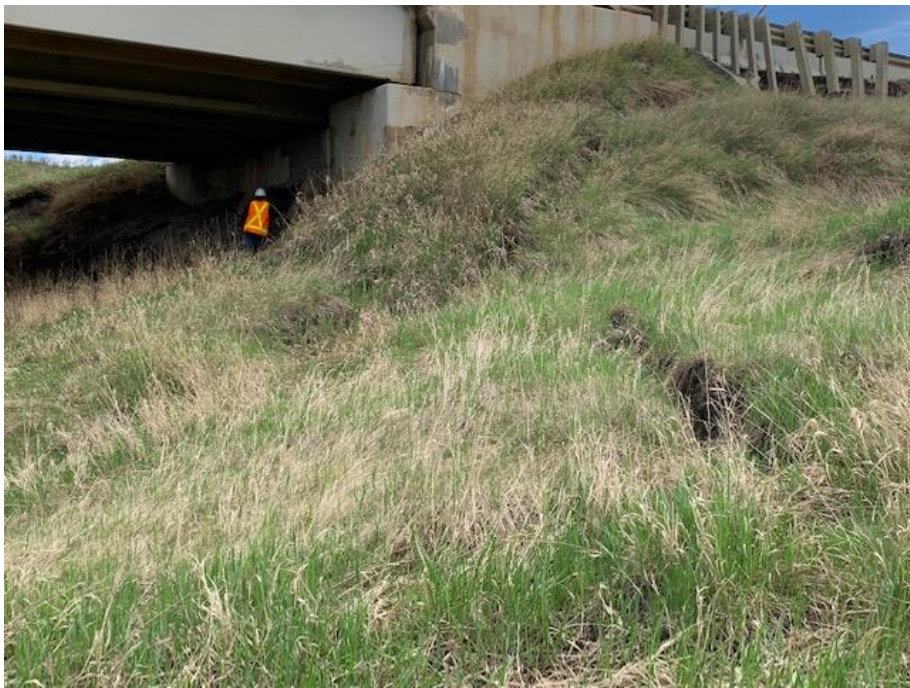
**Photo 3.**  
Looking east at the flank of Slide 1.

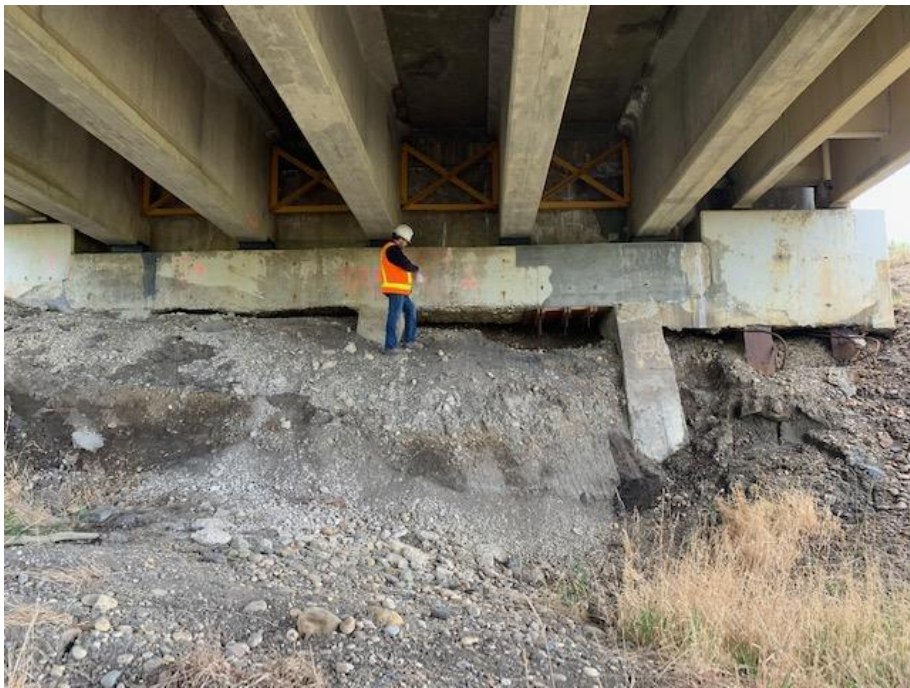
**Photo 4.**  
Looking south at the south abutment. Note the settlement of the soil. It appears that the bridge was widened after the original construction. Concrete counterforts are under the original bridge and steel H piles with cables are under the widened part.

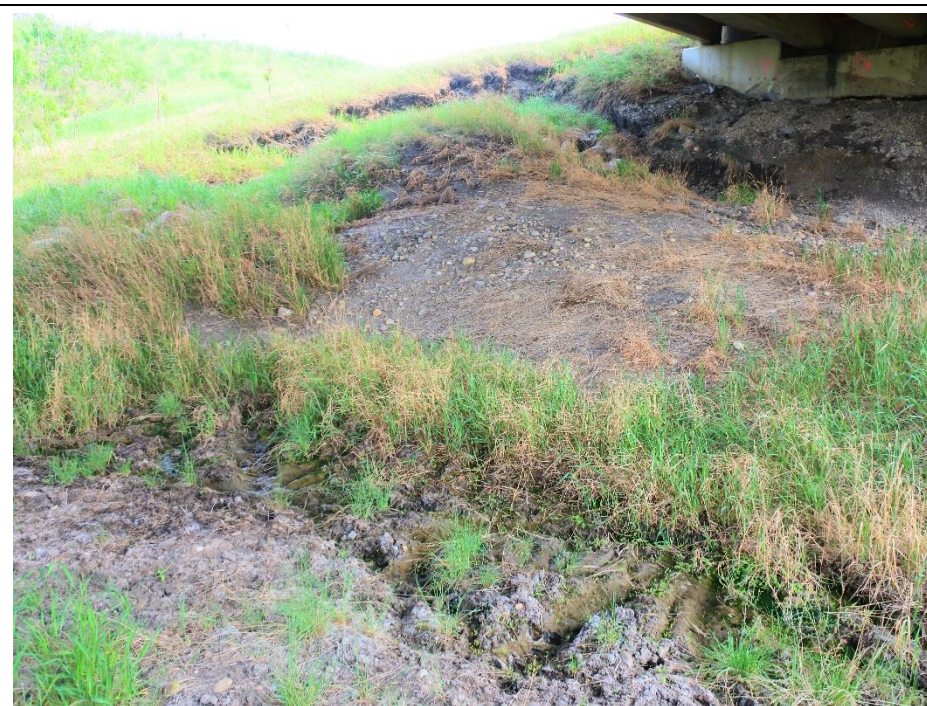
**Photo 5.**  
Looking southeast  
at the scarp and  
flank of Slide 2.

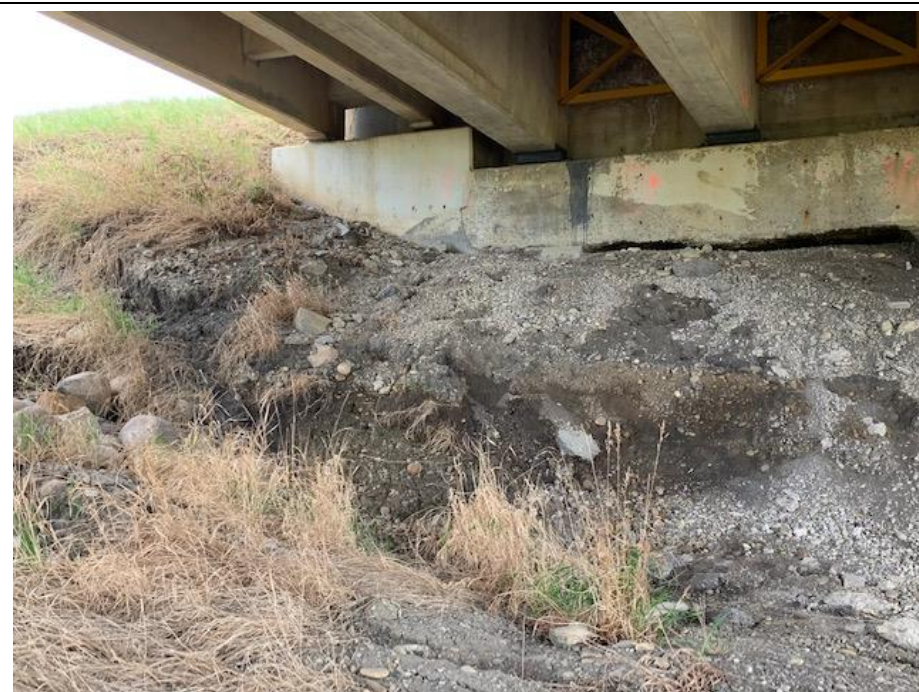
**Photo 6.**  
Looking at the  
south abutment  
and seepage  
coming out of it.

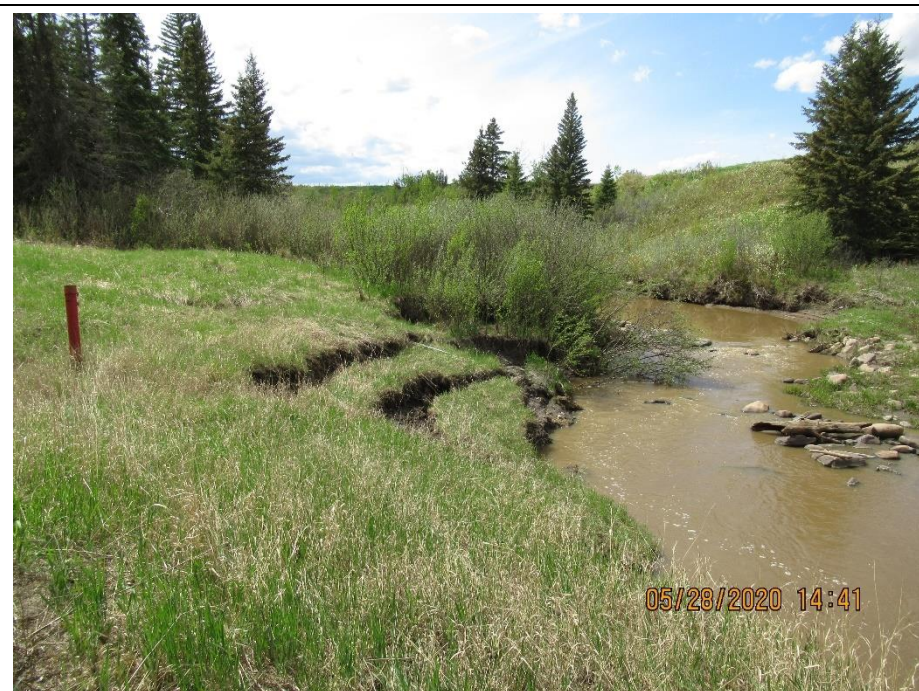
abutment which may be exacerbated during highwater.	
<input checked="" type="checkbox"/> Erosion	Erosion was observed at the toe of the south abutment headslope beneath the bridge and has extended further east. It appears that river erosion is contributing to slump retrogression on the south bank just west of the bridge. (See Photo 7).	<input checked="" type="checkbox"/>
<input checked="" type="checkbox"/> Seepage	The ground was moist near SI17-2 and water was also observed on the south abutment head slope (Photo 5). Seepage was also noted within the scarp that has formed on the east side of the south abutment.	<input checked="" type="checkbox"/>
<input checked="" type="checkbox"/> Bridge/Culvert Distress	The top of the southeast abutment of the bridge appeared to be pushing against and spalling the girders. The south abutment is being undermined and it looks like 3 concrete counterforts were constructed under the centre with 2 H piles at each edge with cables under the bridge widening section.	<input type="checkbox"/>

**Photo 7.**  
Looking upstream of the bridge at the river bank erosion/slumping. The toe of Slide 1 is located at the caragana bushes.

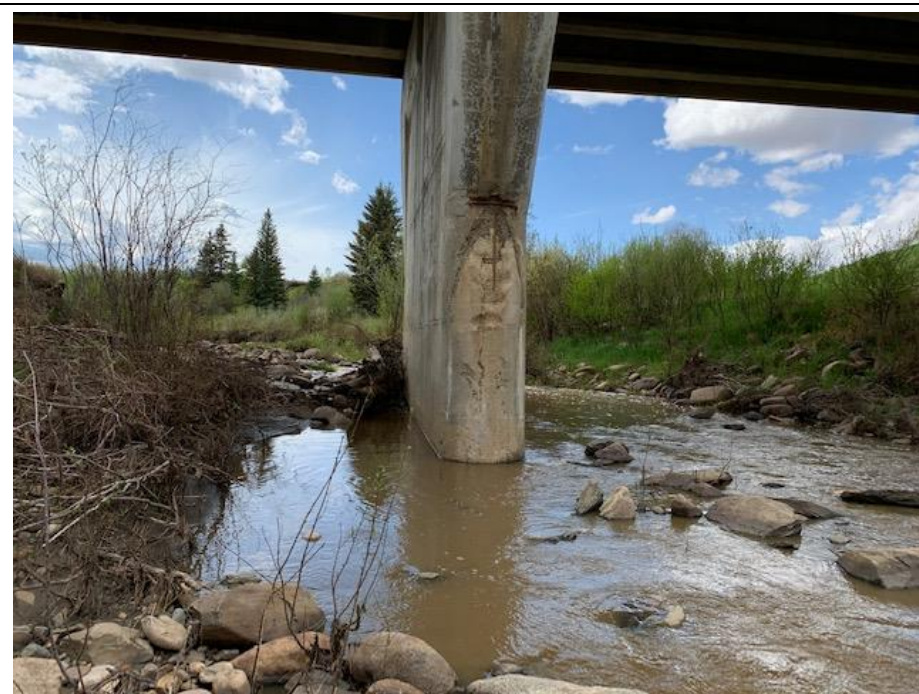
**Photo 8.**  
Looking upstream towards the bridge pier and build of debris against the pier.

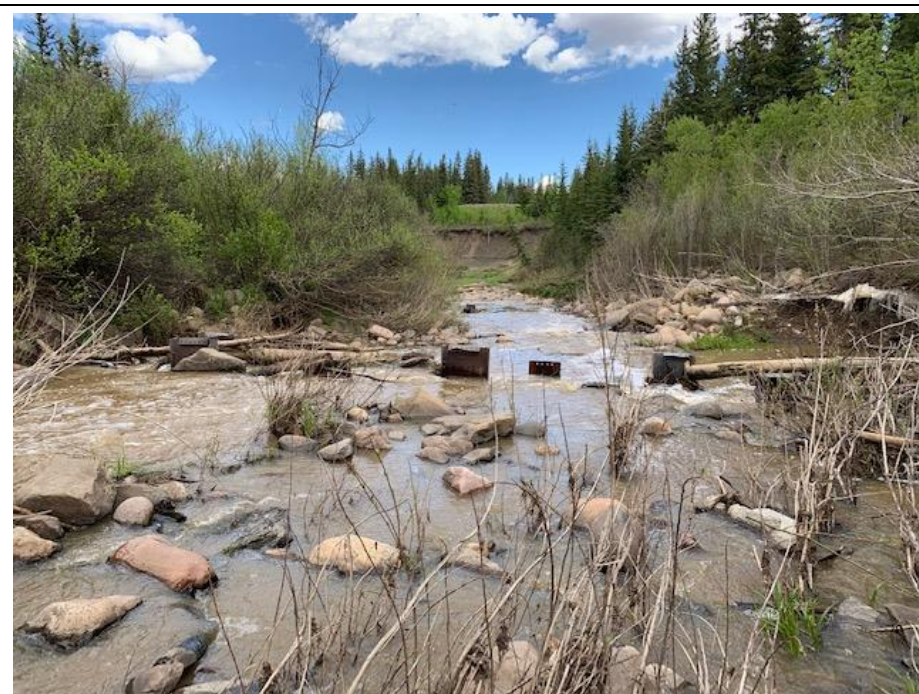
**Photo 9.**  
Pile weirs located  
in the streambed  
downstream of the  
bridge.

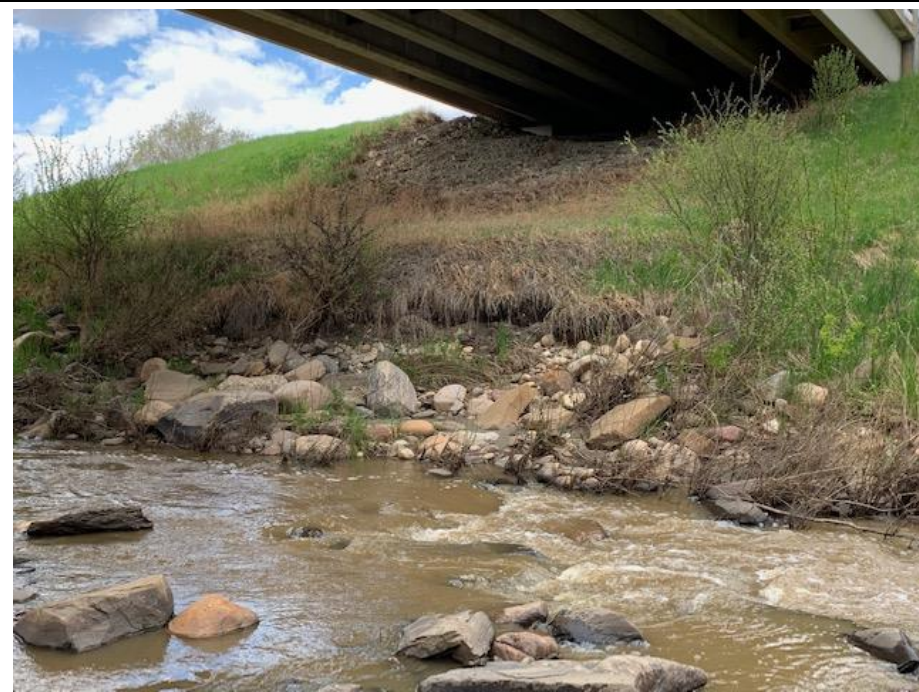
**Photo 10.**  
Looking north at  
1m high scap on  
north abutment.

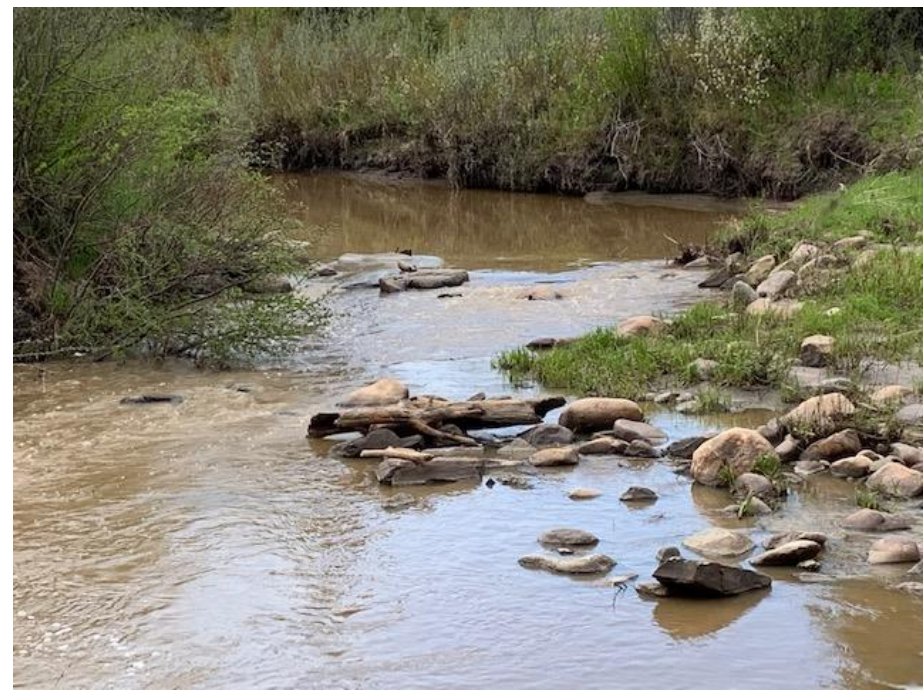
**Photo 11.**  
Looking west  
towards beaver  
dam.

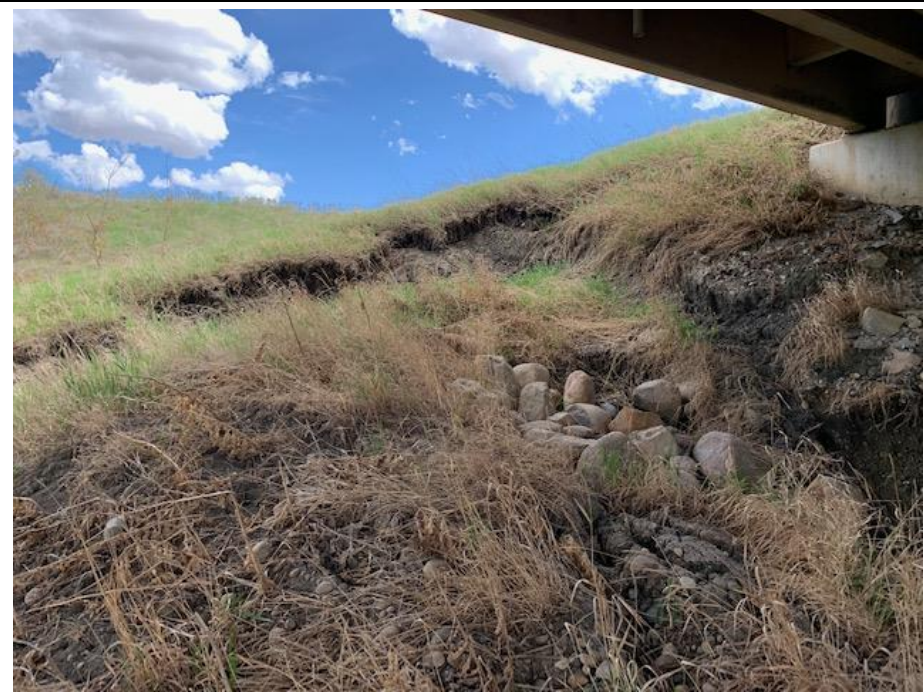
**Photo 12.**  
Looking southeast  
at the scarp and  
flank of Slide 2.
