**ALBERTA TRANSPORTATION AND  
ECONOMIC CORRIDORS GRMP  
PEACE REGION  
(GRANDE PRAIRIE DISTRICT - NORTH)  
INSTRUMENTATION MONITORING – FALL 2025**

Site Number	Location	Name	Hwy	km
GP040	Hwy 2, 5 km North of Rycroft	Spirit River Bridge	2	5 km North of Rycroft
<b>Legal Description:</b>		<b>UTM Co-ordinates</b>		
16-4-77-5 W6		11U E 394305	N	6184771

<b>Current Monitoring:</b>	1-Oct-2025	<b>Previous Monitoring</b>	17-June-2025
<b>Instruments Read By:</b>	Mr. Niraj Regmi, G.I.T. and Mr. Angelo Castillo, of Thurber

**SITE GP040: HWY 2, 5 km NORTH OF RYCROFT – SPIRIT RIVER HEAD SLOPE SLIDE**

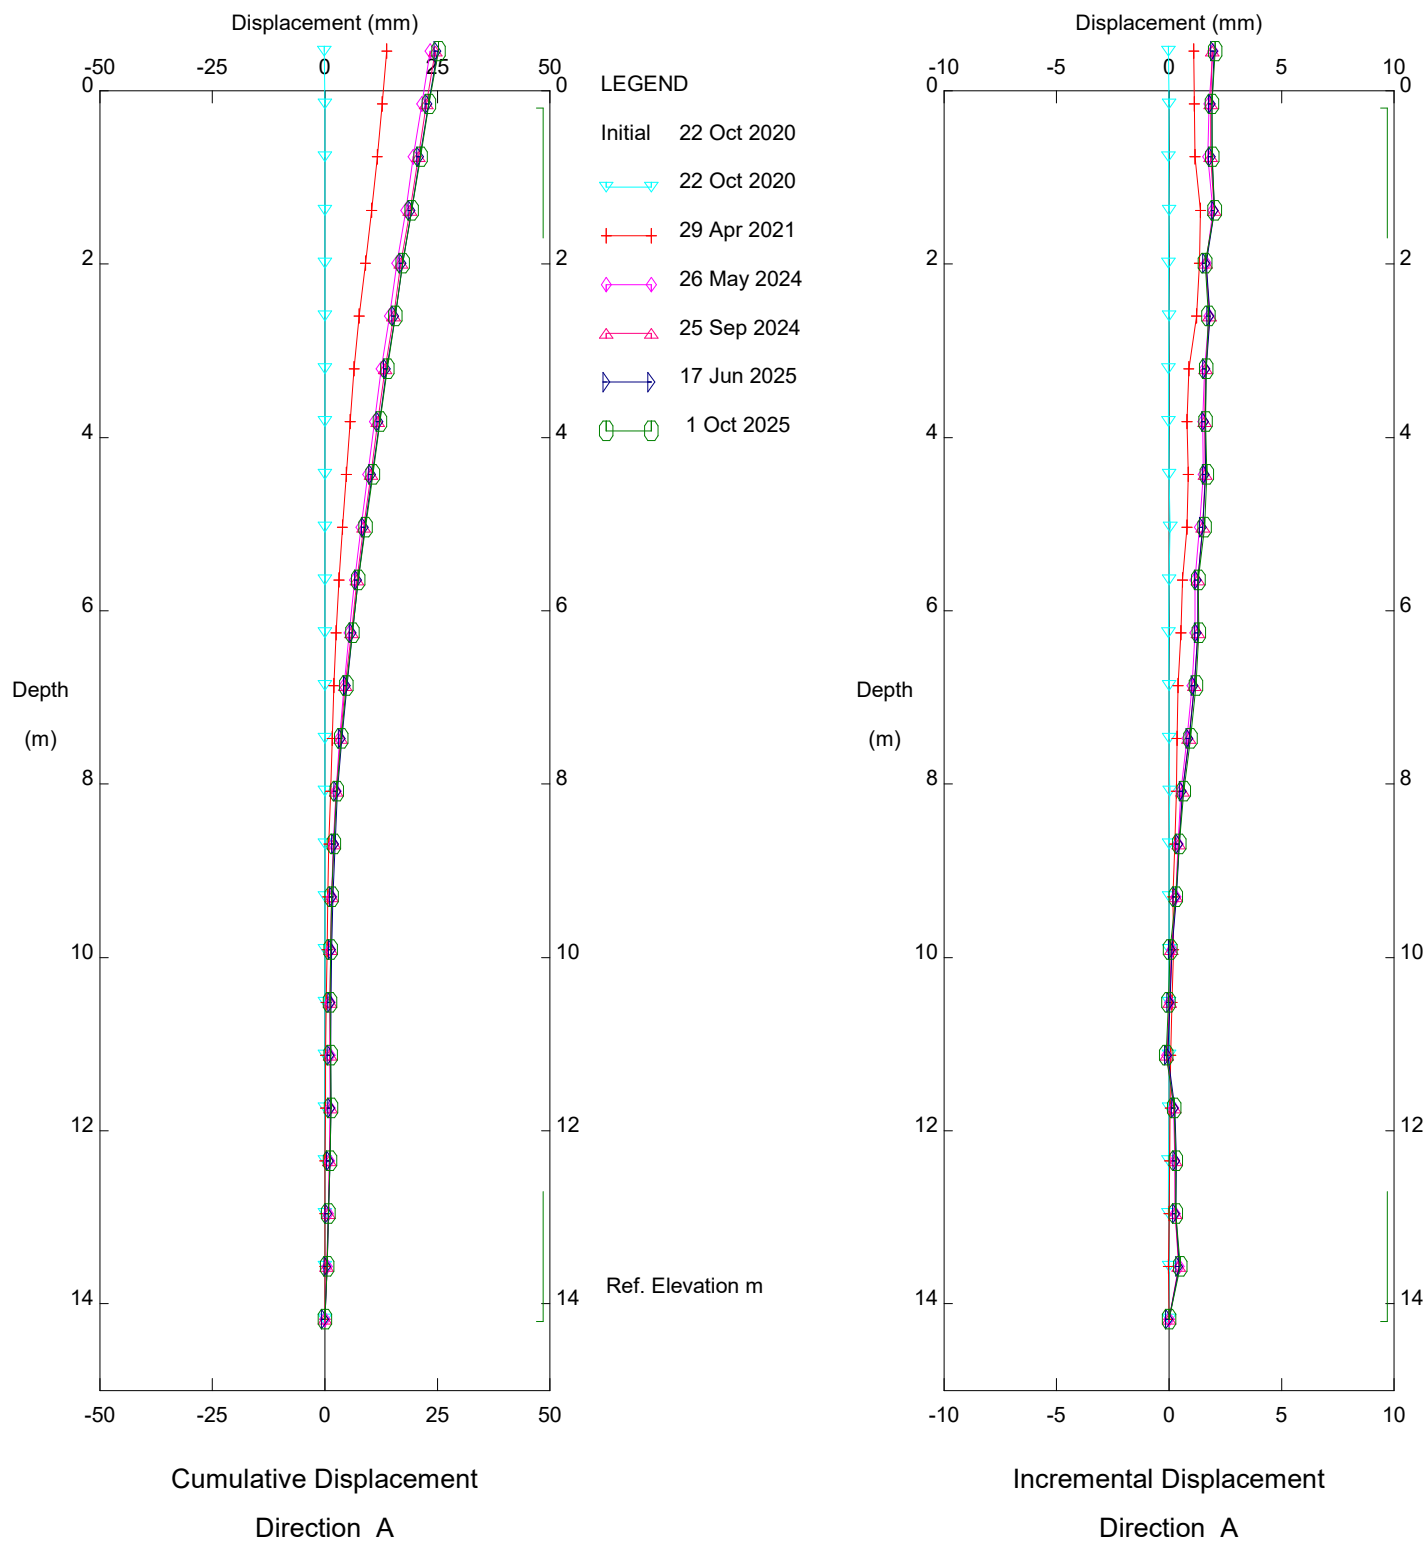
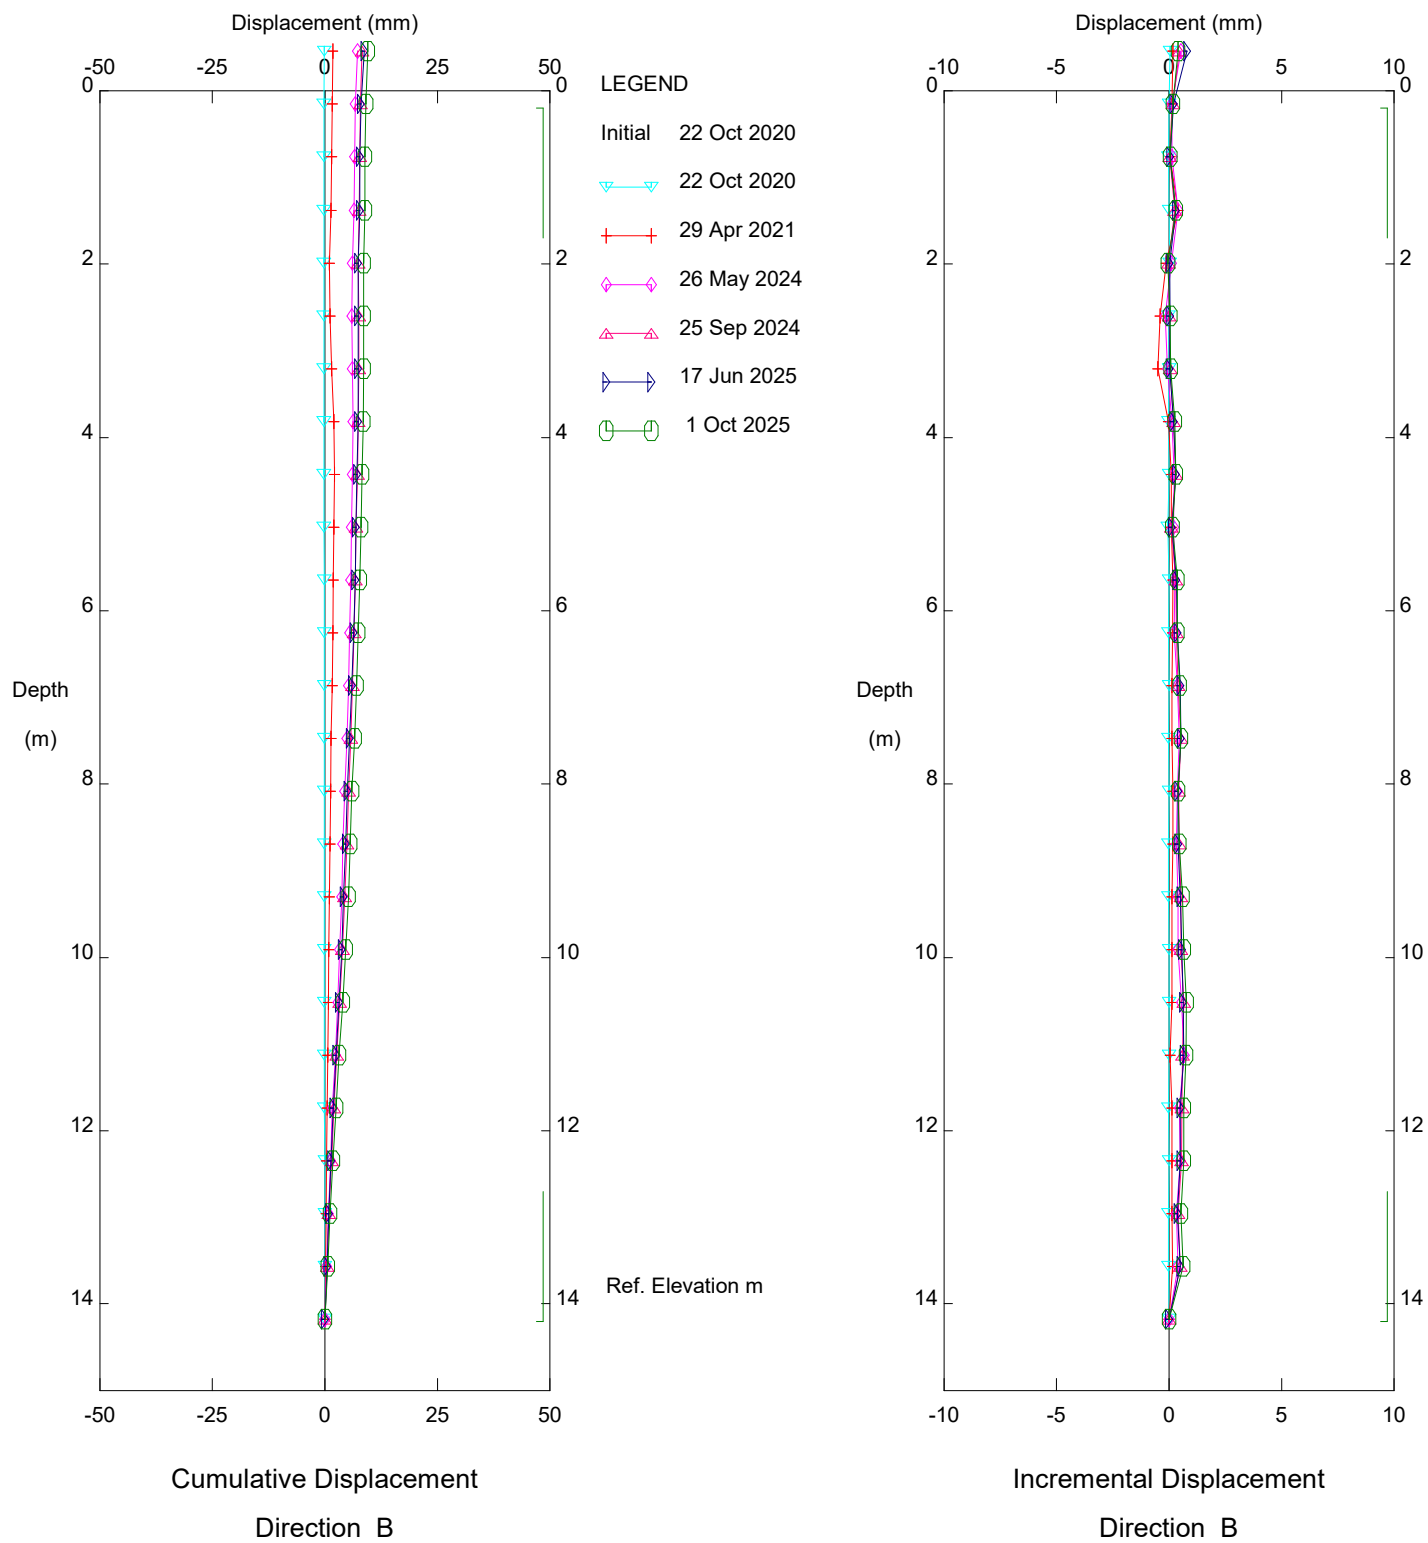
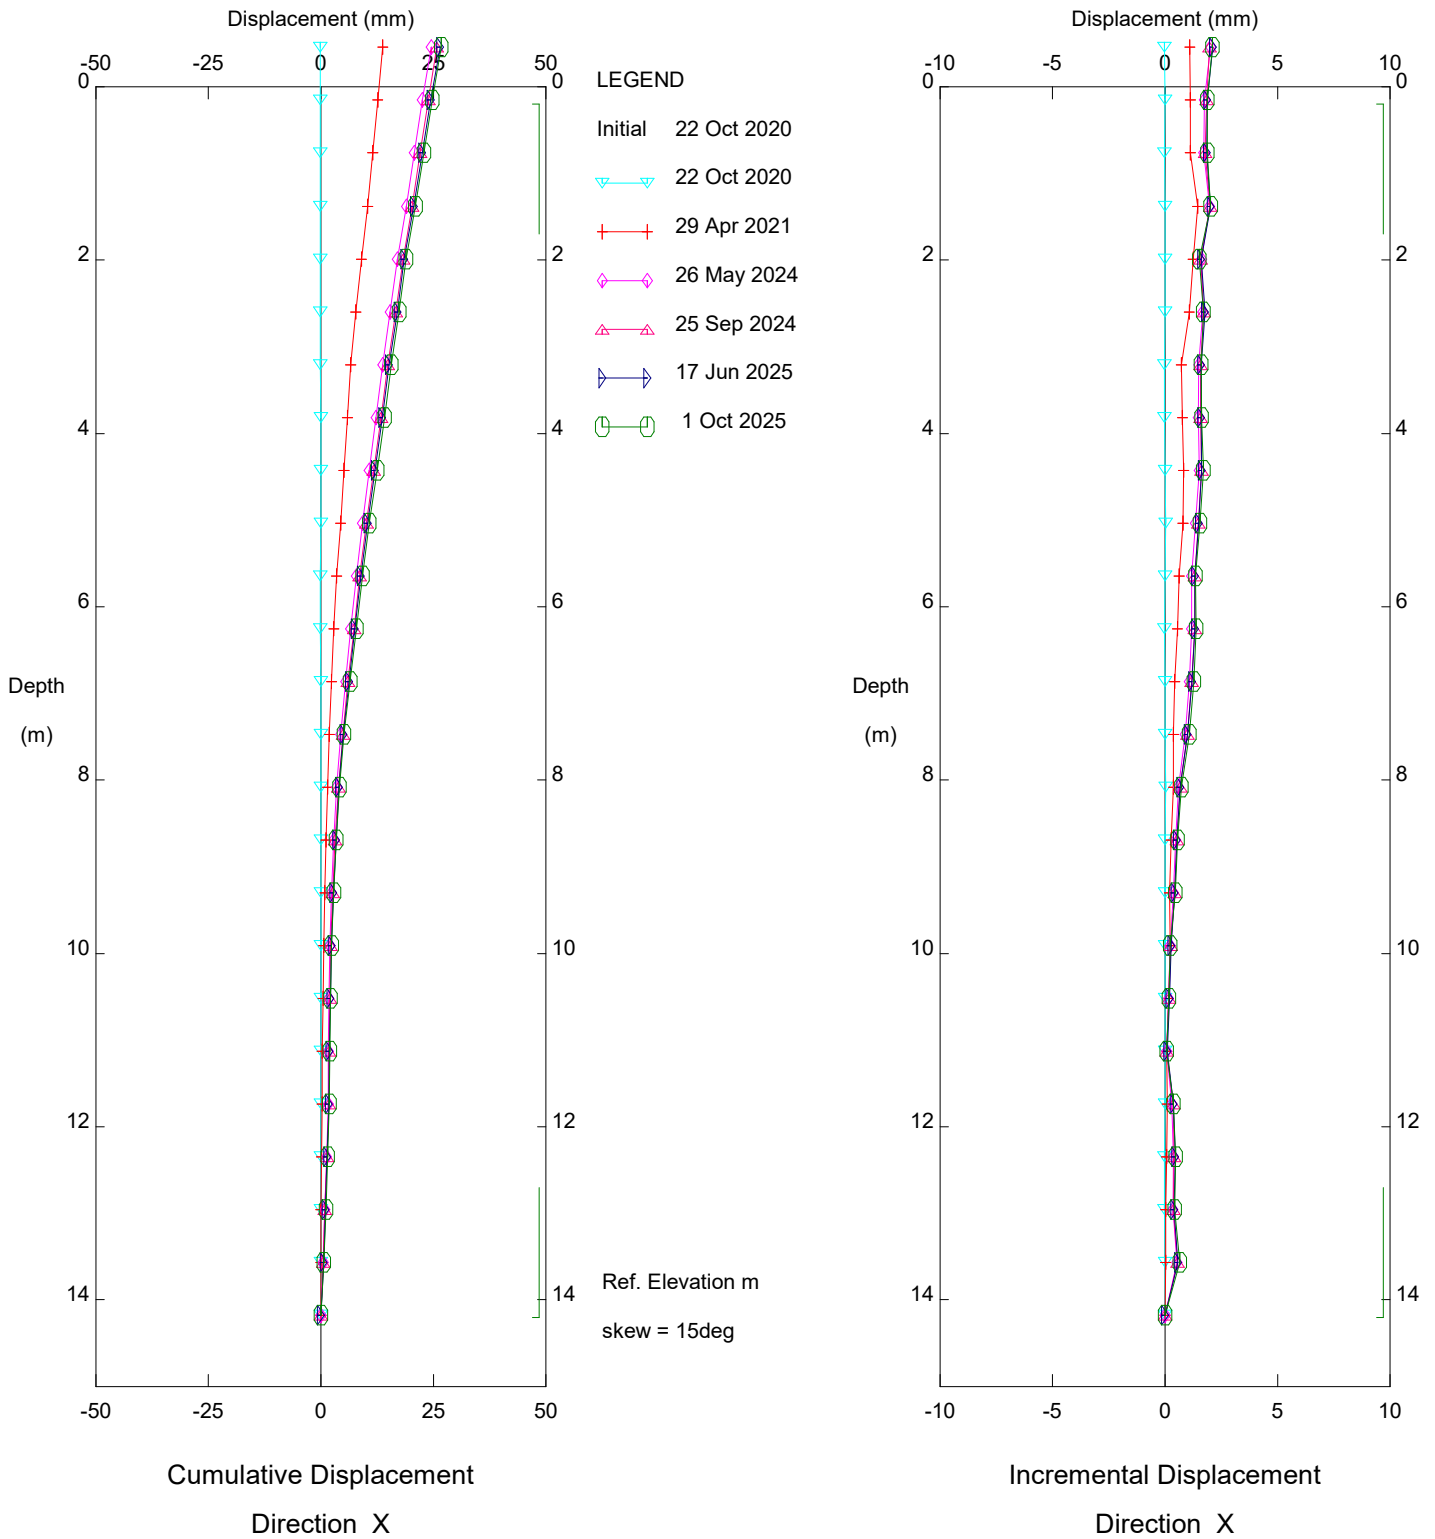
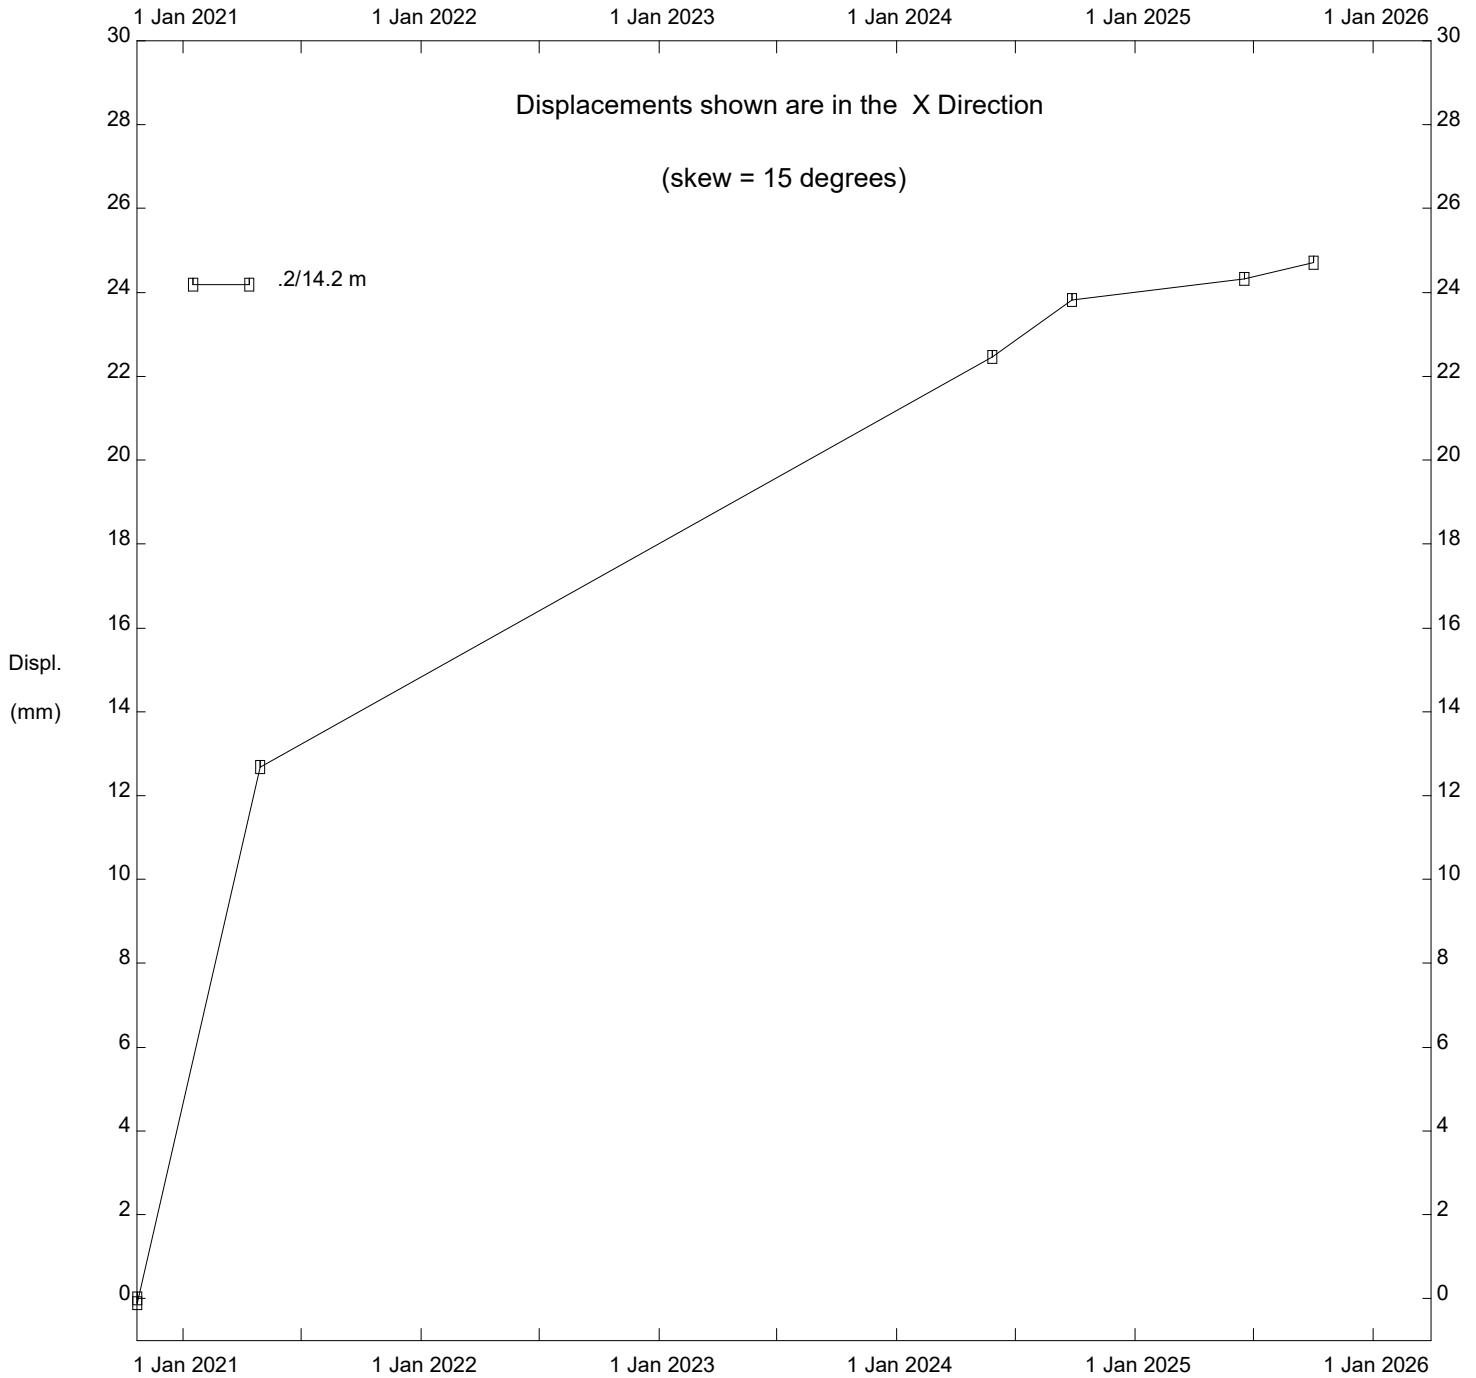
Spirit River Bridge, Inclinometer SI20-1

<b>Zones of New Movement:</b>	None
<b>Interpretation of Monitoring Results:</b>	<p>Slope inclinometer SI17-3 was found to have been blocked or sheared at 3.27 m below the top of casing since June 22, 2020.</p> <p>SI20-1 is located within the pile wall on the east side of the south abutment. It showed a gentle tilt pattern of movement of 0.4 mm and a rate of movement of 1.3 mm/yr over 0.2 m to 14.2 m depth since the previous reading on June 17, 2025. This corresponds to an increase in the rate of movement of 0.7 mm/yr since the previous reading. The total pile head deflection to date has been 24.7 mm. The readings are consistent with the cantilevered concrete pile wall performance expectations.</p> <p>All of the pneumatic piezometers on this site were previously damaged.</p>
<b>Future Work:</b>	Due to there being only one active instrument left on the site, we recommend reading this site once annually. The instruments should be read again in the fall of 2026.
