**ALBERTA TRANSPORTATION
AND ECONOMIC CORRIDORS
GEOHAZARD ASSESSMENT PROGRAM
PEACE REGION – GRANDE PRAIRIE DISTRICT - NORTH
2025 INSPECTION**

Site Number	Location	Name	Hwy	km
GP040	4.7 km's N. of Rycroft	Spirit River Bridge (BF75106)	2:68	4.7
Legal Description		UTM Co-ordinates		
SE¼ 34-078-5 W6M		11U E 394291	N 6184727

Date	PF	CF	Total
Previous Inspection:	29-May-2023	12	2	24
Current Inspection:	5-May-2025	8	2	16
Road AADT:	3,160		Year:	2024
Inspected By:	Robert Senior, TEC Chris Newman, TEC		Nicole Wilder, Thurber Don Proudfoot, Thurber	
Report Prepared By:	Nicole Wilder, Don Proudfoot (Review)			
Report Attachments:	<input checked="" type="checkbox"/> Photographs <input checked="" type="checkbox"/> Plans <input type="checkbox"/> Maintenance Items

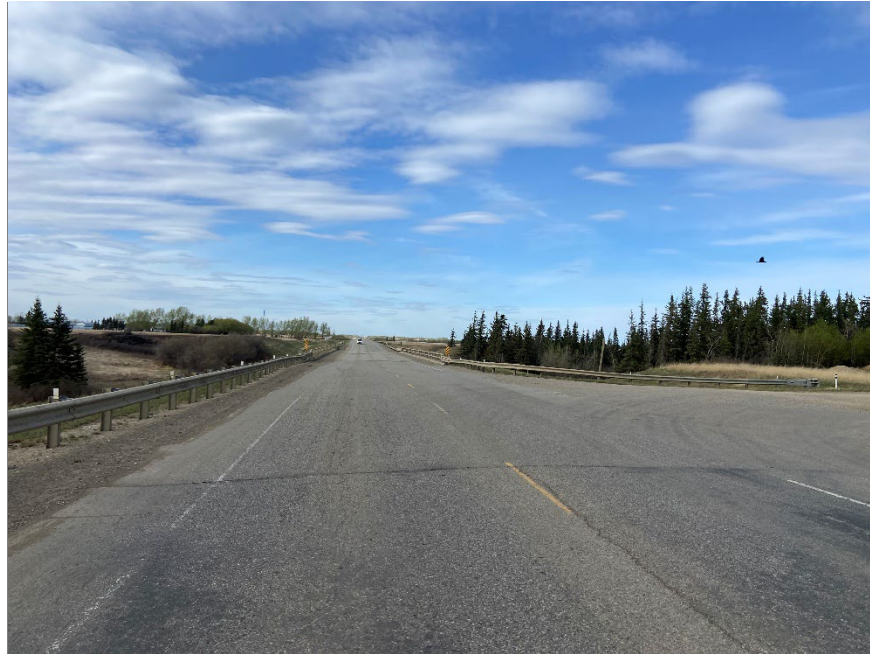
Photo 1. Looking north along the southbound lane of the highway.

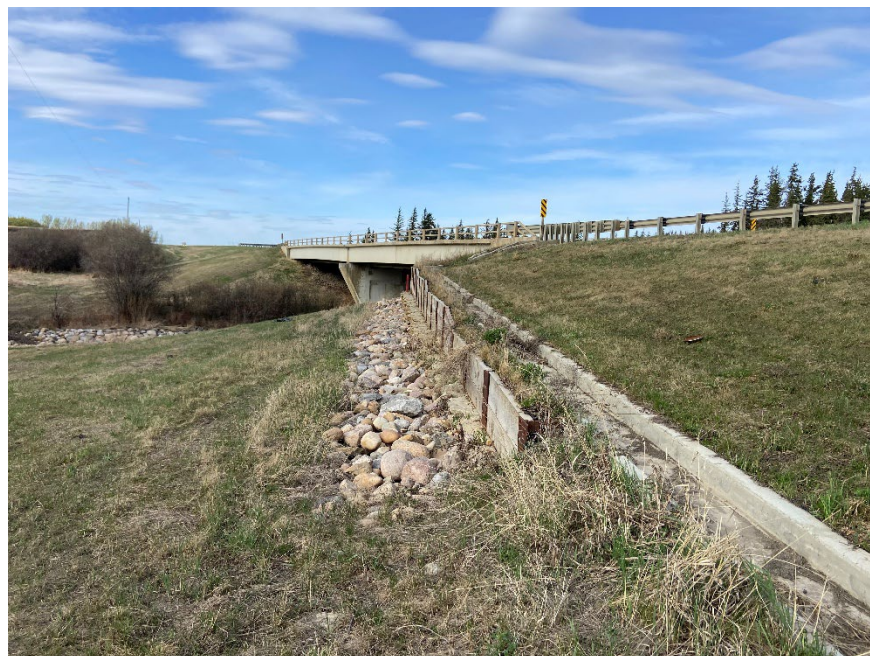
Photo 2. Looking northeast at the concrete drain trough above the west pile wall.

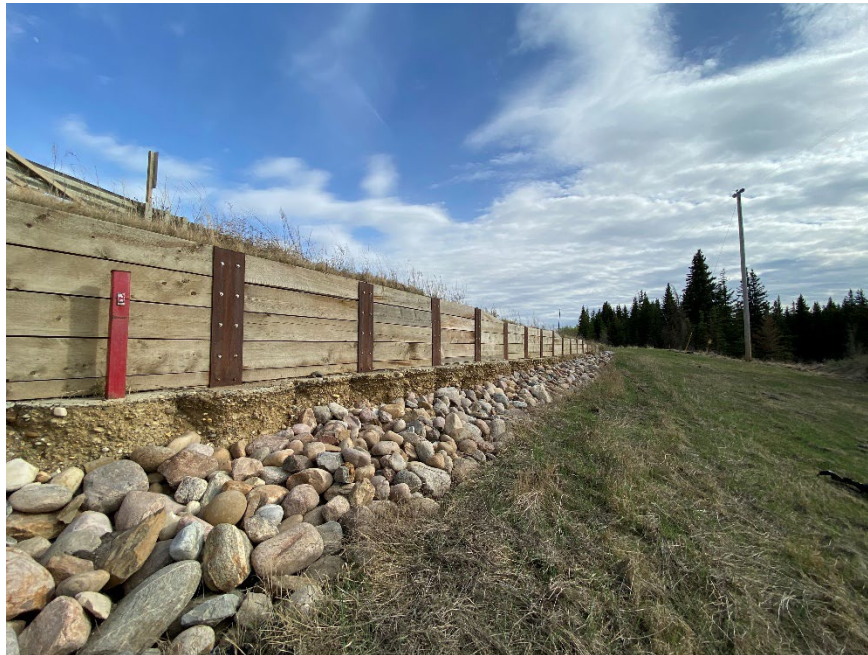
Maintenance:		
Observations:	Description	Worsened?
<input type="checkbox"/> Pavement Distress	No new pavement cracks were observed since the repair.	<input type="checkbox"/>
<input checked="" type="checkbox"/> Slope Movement	The slope downslope of both pile walls appeared to have settled between 0.54 m on the west wall and about 2.1 m on the east wall.	<input checked="" type="checkbox"/>
<input checked="" type="checkbox"/> Erosion	Erosion was observed within the area that was previously repaired east of the bridge. The erosion gully was about 1100 mm wide and 900 mm deep which has expanded since 2024.	<input checked="" type="checkbox"/>
<input checked="" type="checkbox"/> Seepage	The erosion gully was slightly wet.	<input checked="" type="checkbox"/>
<input type="checkbox"/> Bridge/Culvert Distress		<input type="checkbox"/>

Photo 3. Looking southeast at riprap that appeared to have settled on the downslope side of the pile wall.

Recommendations:		Cost
<p>Regularly monitor the site for activity, settlement and erosion.</p> <p>It is recommended to keep this site on the annual geohazard monitoring program at least for a few more years to confirm that there is no further settlement of the soil downslope of the walls. Additionally, the erosion gully on the east side of the south abutment should be repaired by:</p> <ol style="list-style-type: none"> 1) Remove all loose fill by excavation down to the base of the erosion gully 2) Re-build the bottom of the ditch by compacting the excavated clay back into the erosion channel in thin lifts then topsoiling, seeding then placing TRM ECB overtop. Riprap over non-woven geotextile could also be used for a more robust fix. <p>As mentioned above, the beaver dam should also be removed.</p>		Maintenance

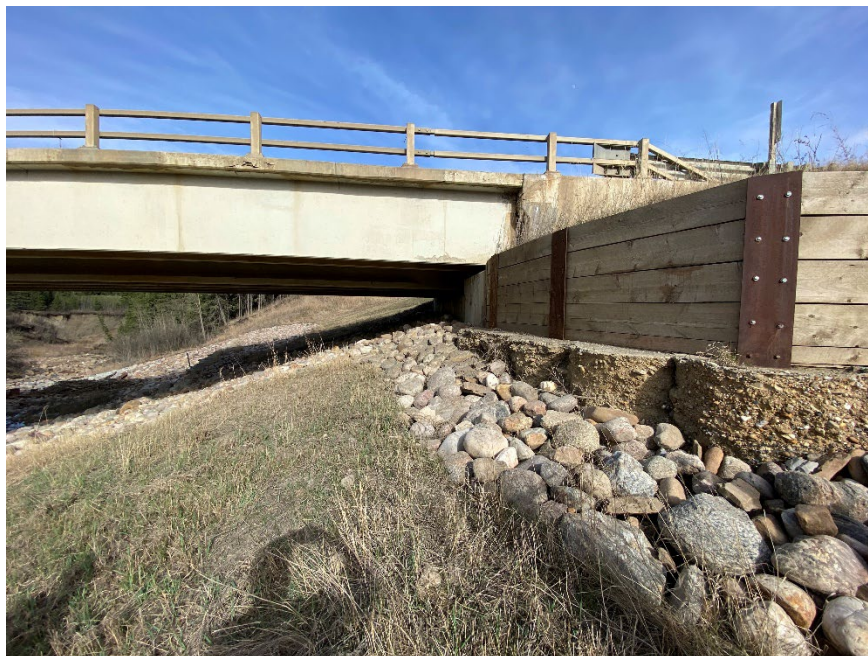
Photo 4. Looking east at the corner of the pile wall and settled riprap.

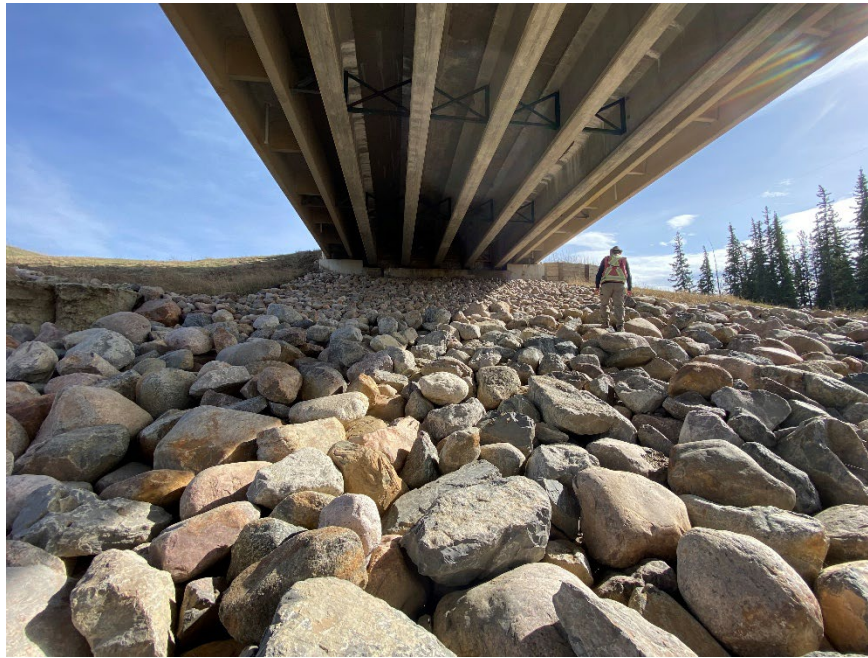
Photo 5. Looking south at the south abutment and head slope.

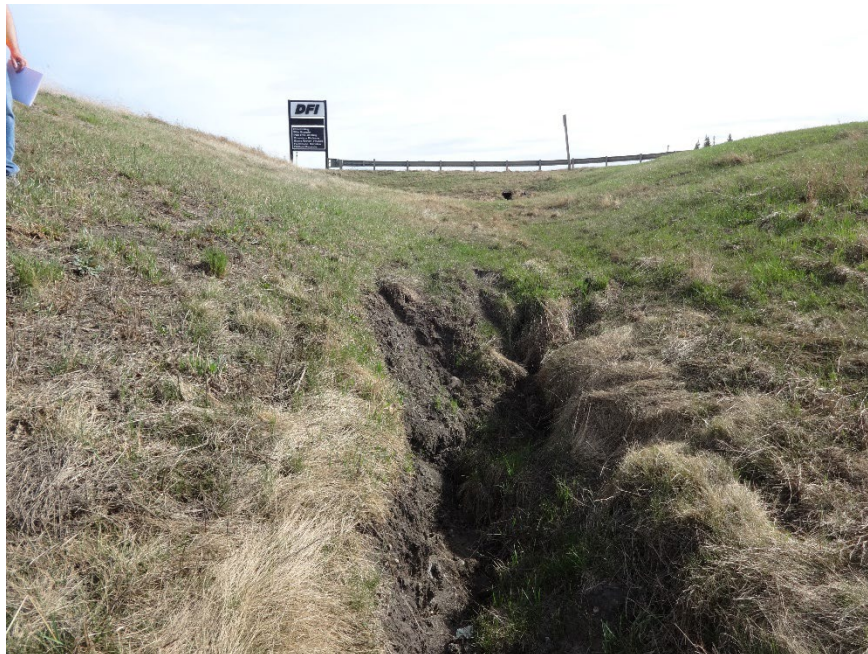
Photo 6. Looking south at erosion gully that has formed east of the south side of the bridge.

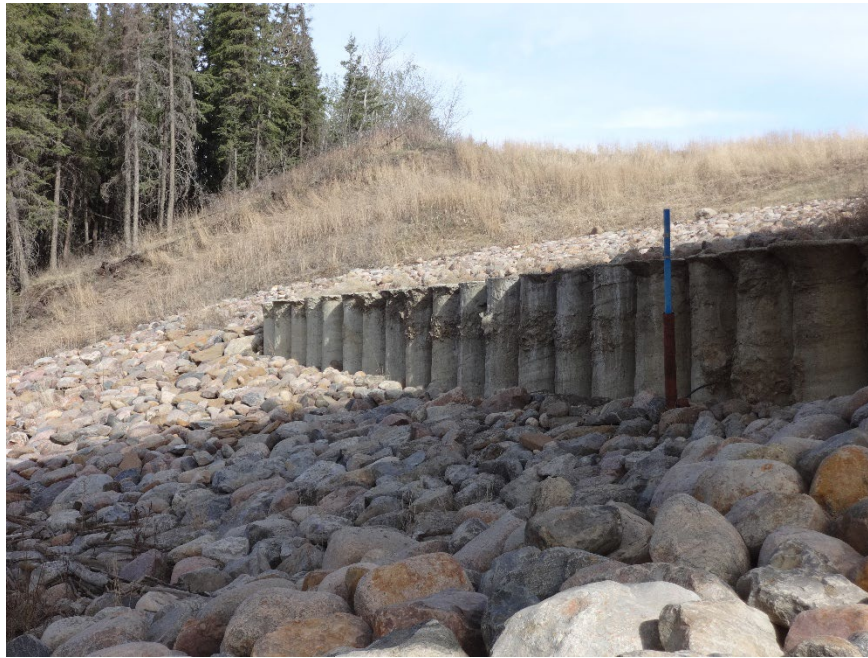
Photo 7. Looking southeast at riprap that settled below the east pile wall.

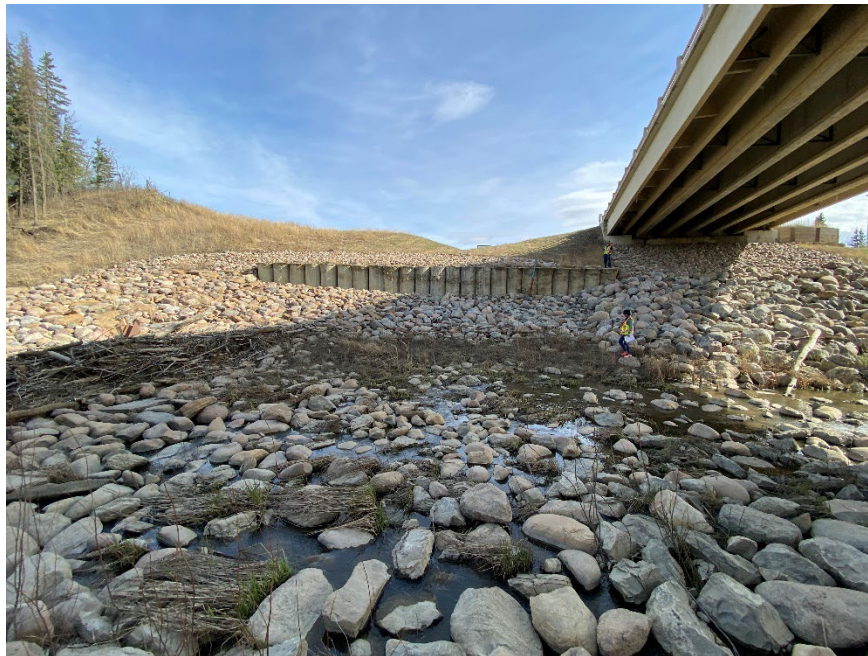
Photo 8. Looking south towards the east pile wall and riprap.

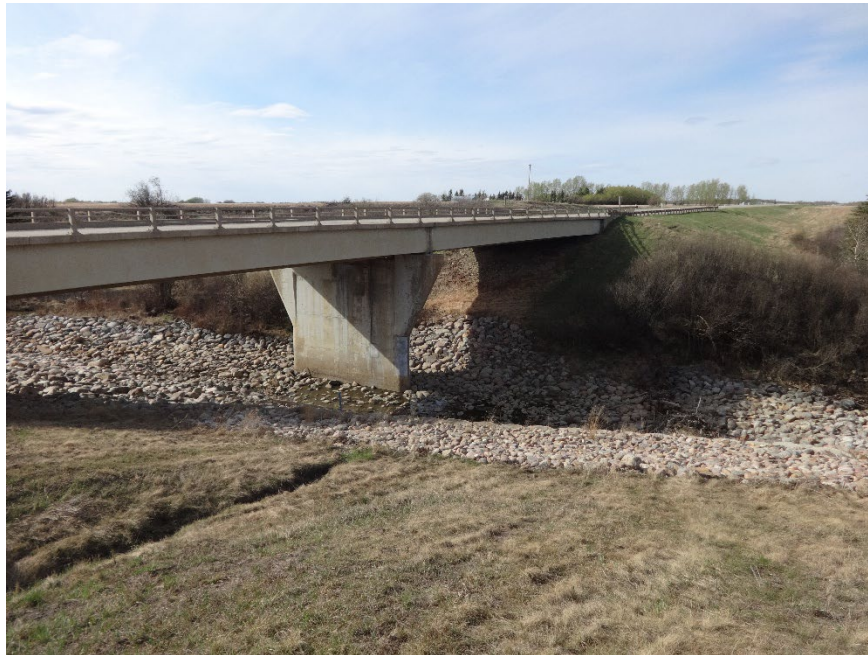
Photo 9. Looking northwest at the pier and riprap.

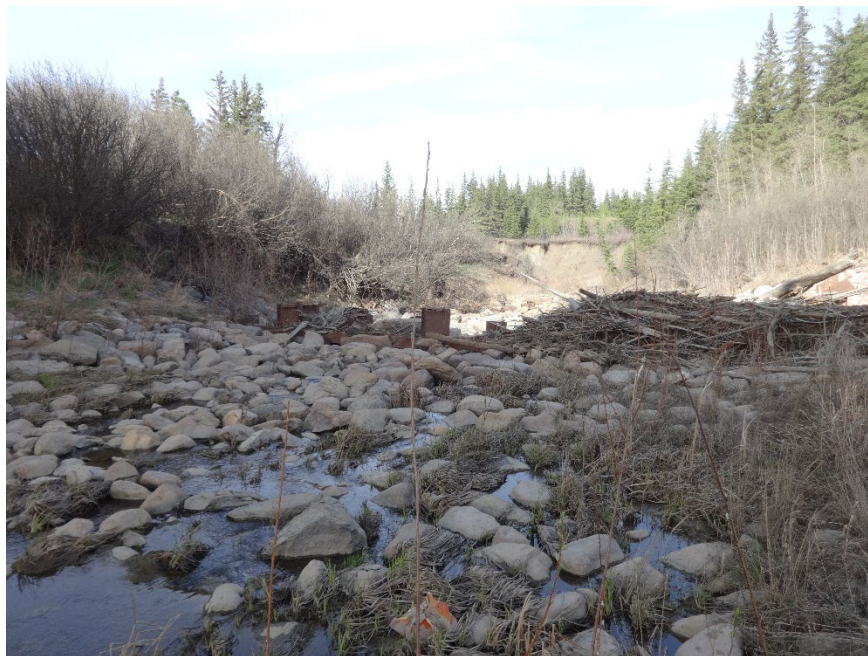
Photo 10. Looking northeast at debris that has accumulated in the pile weirs.

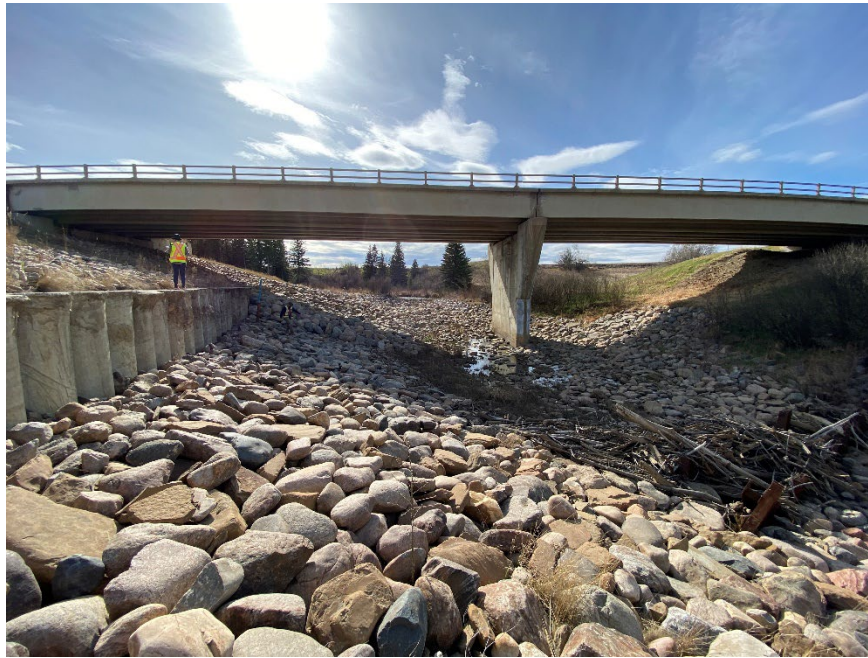
Photo 11. Looking west at the south headslope and east pile wall.

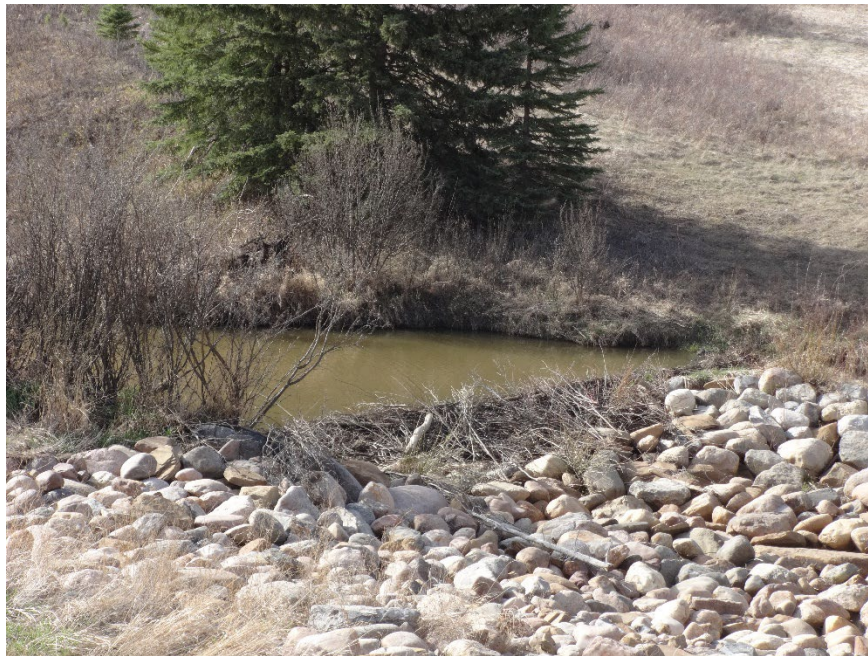
<input checked="" type="checkbox"/> Other	There was a large beaver dam upstream of the bridge completely blocking off water above the riprap. Consideration should be given to dismantling this.	<input checked="" type="checkbox"/>
<p>Instrumentation June 17, 2025: Inclinometers SI20-1 = Installed in the west pile wall showed a gentle tilt pattern of movement of 0.5 mm and a rate of movement of 0.7 mm/yr over 0.2 m to 14.2 m depth since the previous reading on September 25, 2024. This corresponds to a decrease in rate of movement of 3.4 mm/yr since the previous reading. The total pile head deflection to date has been 24.3 mm. The readings are consistent with the cantilevered concrete pile wall performance expectations. SI17-1 = Sheared off at 4.6 m depth prior to the October 5, 2017 readings; SI17-2 = Sheared off at 4.3 m depth prior to the October 5, 2017 readings; SI17-3 = This SI was last read June 22, 2020 and showed movement between 0.2 m to 3.9 m depth and a rate of 19.4 mm/yr and has since sheared off at a depth of 3.27 m.</p> <p>Piezometers were last read June 22, 2020, none read in 2025 PN17-1A = not functioning; PN17-1B = 3.6 m BGS; PN17-2 = 7.3 m BGS; PN17-3 = not functioning.</p>

Photo 12. Looking northwest at the beaver dam upstream of the placed riprap.
