ALBERTA TRANSPORTATION AND
ECONOMIC CORRIDORS GRMP
PEACE REGION
(GRANDE PRAIRIE DISTRICT - NORTH)
INSTRUMENTATION MONITORING – SPRING 2025

Site Number	Location	Name	Hwy	km
GP040	Hwy 2, 5 km North of Rycroft	Spirit River Bridge	2	5 km North of Rycroft
Legal Description:		UTM Co-ordinates		
16-4-77-5 W6		11U E 394305	N	6184771

Current Monitoring:	17-June-2025	Previous Monitoring	25-Sept-2024
Instruments Read By:	Mr. Niraj Regmi, G.I.T. and Mr. Godfred Etiendem, of Thurber

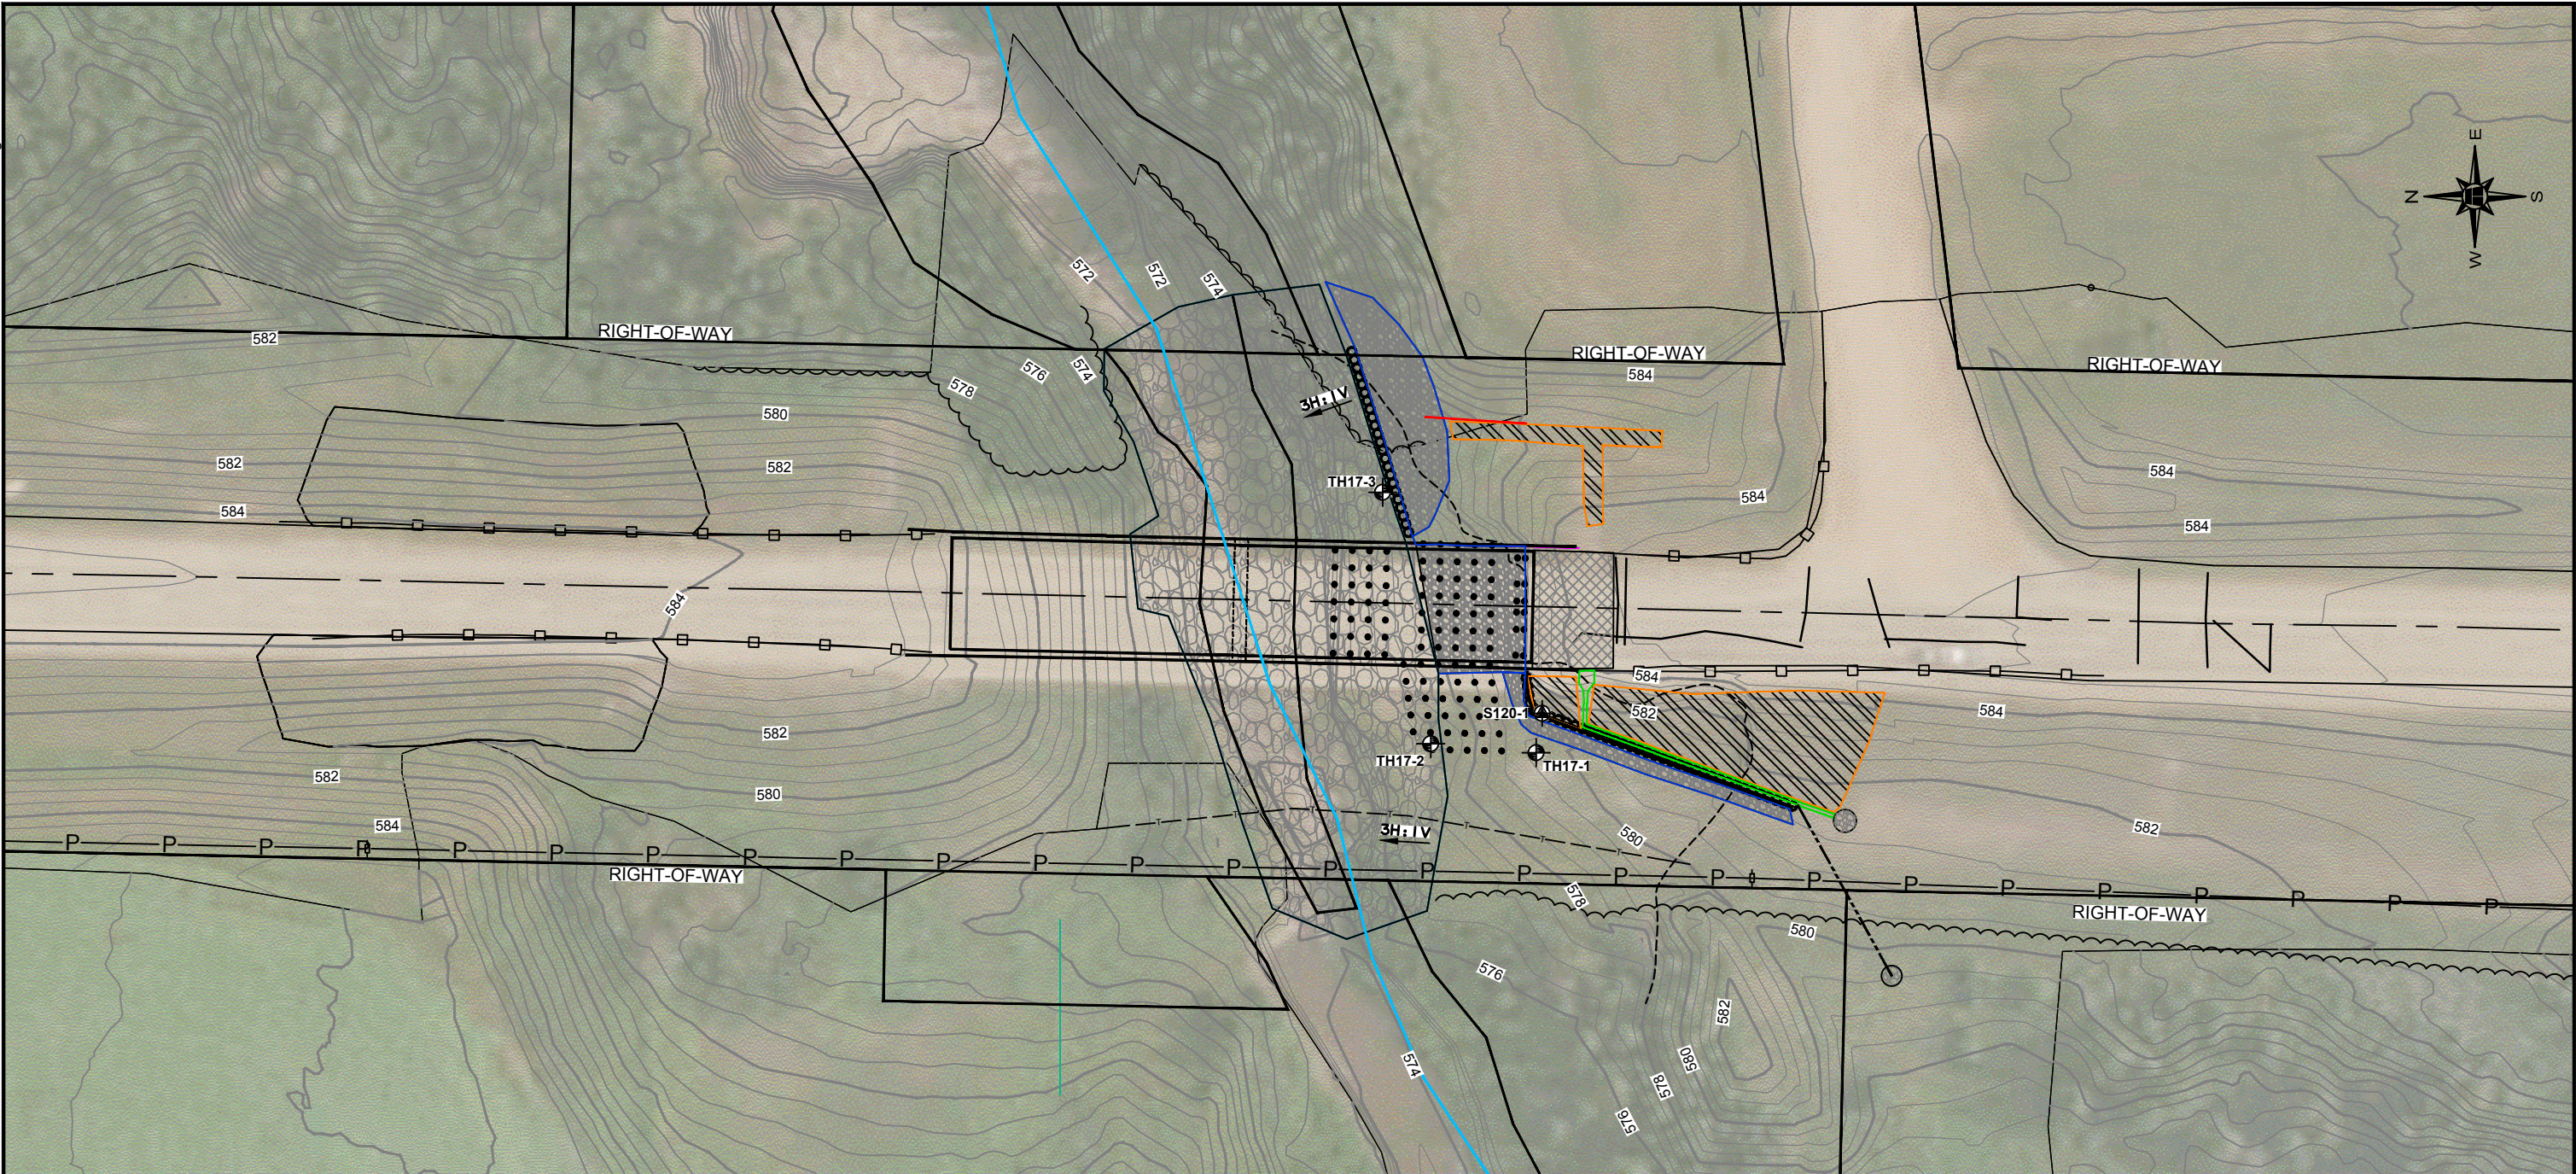
DWG No. 32123-GP040-1

GP040-1: HWY 2:68 - SPIRIT RIVER BRIDGE (BF75106)
2023 INSPECTION PLAN

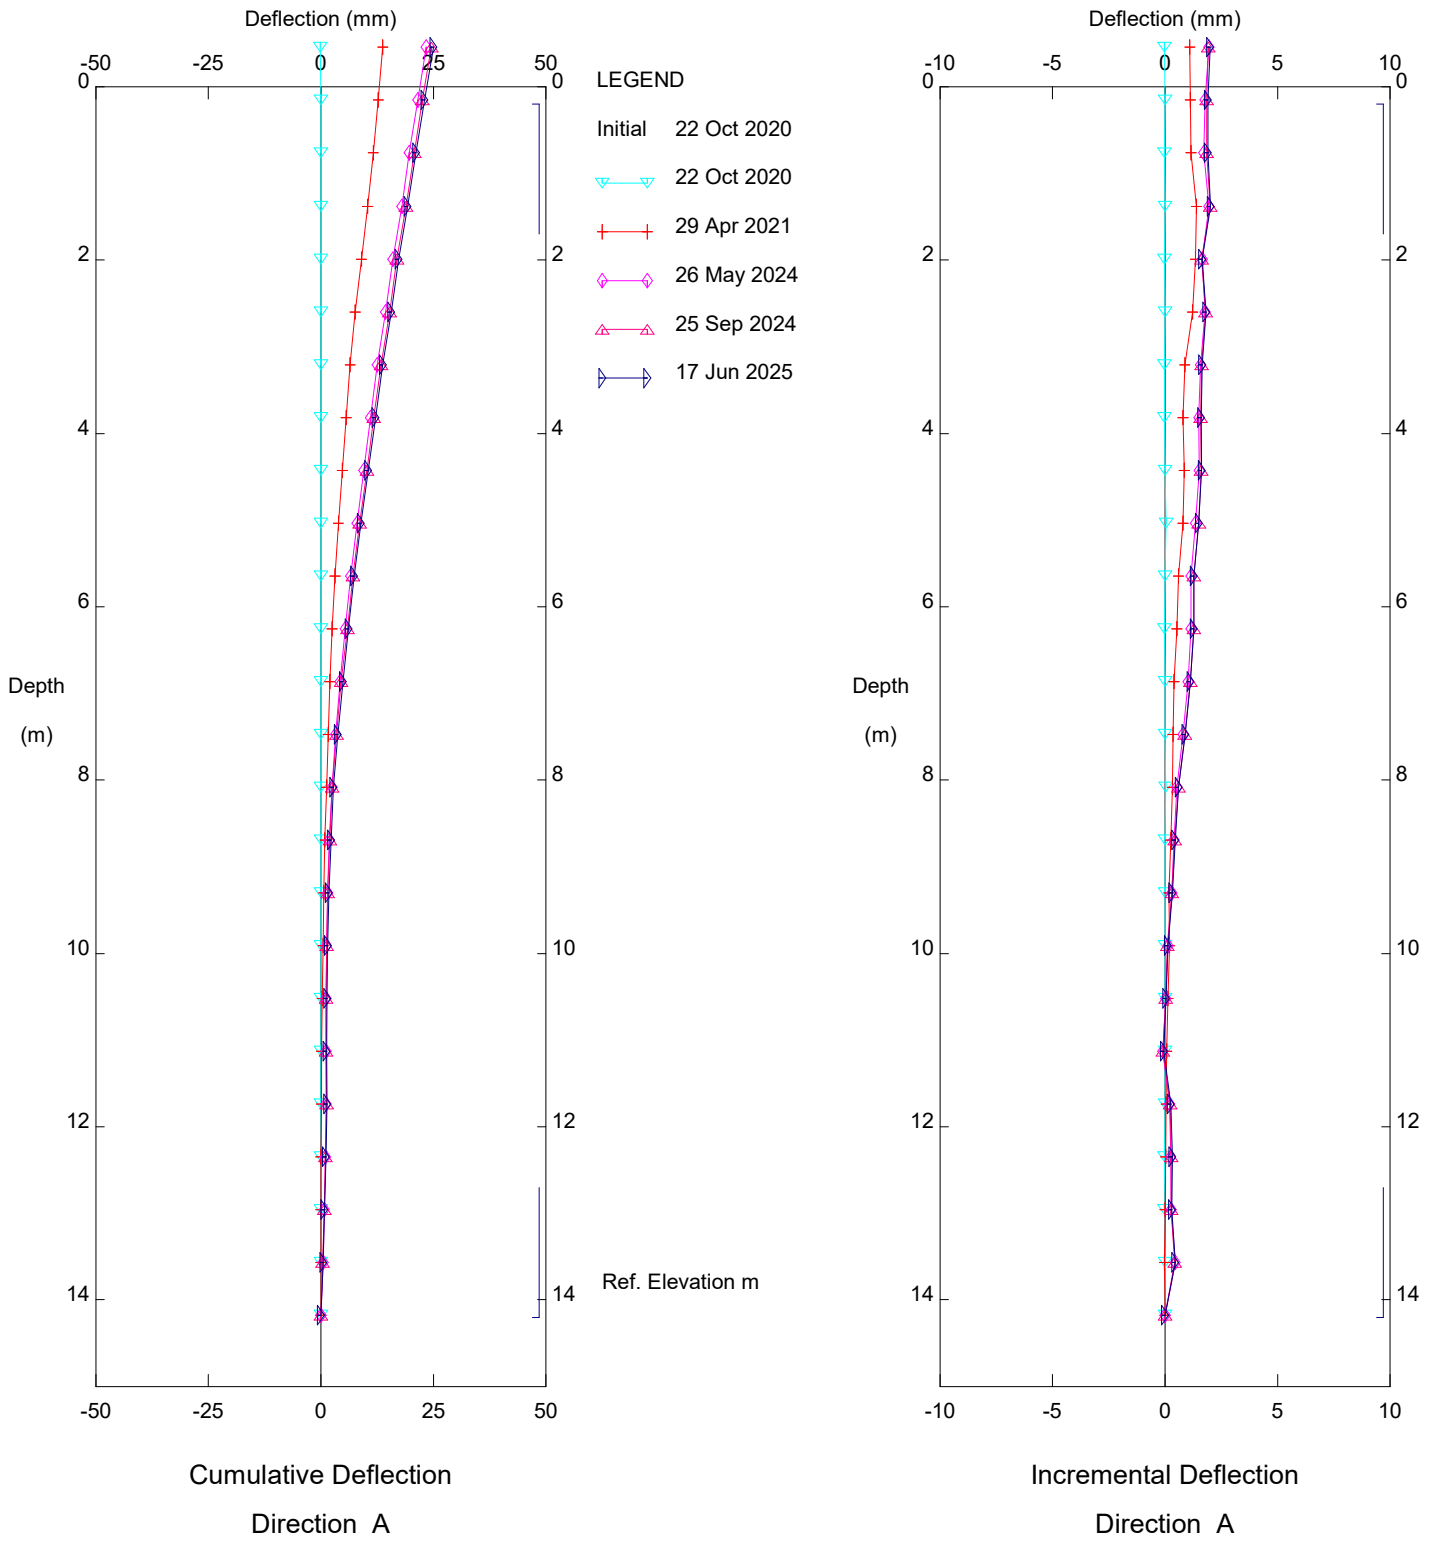
Spirit River Bridge, Inclinator SI20-1

Zones of New Movement:	None
Interpretation of Monitoring Results:	<p>Slope inclinometer SI17-3 was found to have been blocked or sheared at 3.27 m below the top of casing since June 22, 2020.</p> <p>SI20-1 is located within the pile wall on the east side of the south abutment. It showed a gentle tilt pattern of movement of 0.5 mm and a rate of movement of 0.7 mm/yr over 0.2 m to 14.2 m depth since the previous reading on September 25, 2024. This corresponds to a decrease in rate of movement of 3.4 mm/yr since the previous reading. The total pile head deflection to date has been 24.3 mm. The readings are consistent with the cantilevered concrete pile wall performance expectations.</p> <p>All of the pneumatic piezometers on this site were previously damaged.</p>
Future Work:	Due to there being only one active instrument left on the site, we recommend reading this site once annually. The instruments should be read again in the fall of 2026.

Instrumentation Repairs:	No instrument repairs are required at this time.
Additional Comments:	Due to the relatively large, but expected, cumulative movement recorded in SI20-1, during the next site visit, it is recommended to inspect the timber lagging of the wall to confirm that the boards are still well supported by the flange of the "H" piles and are not slipping away.

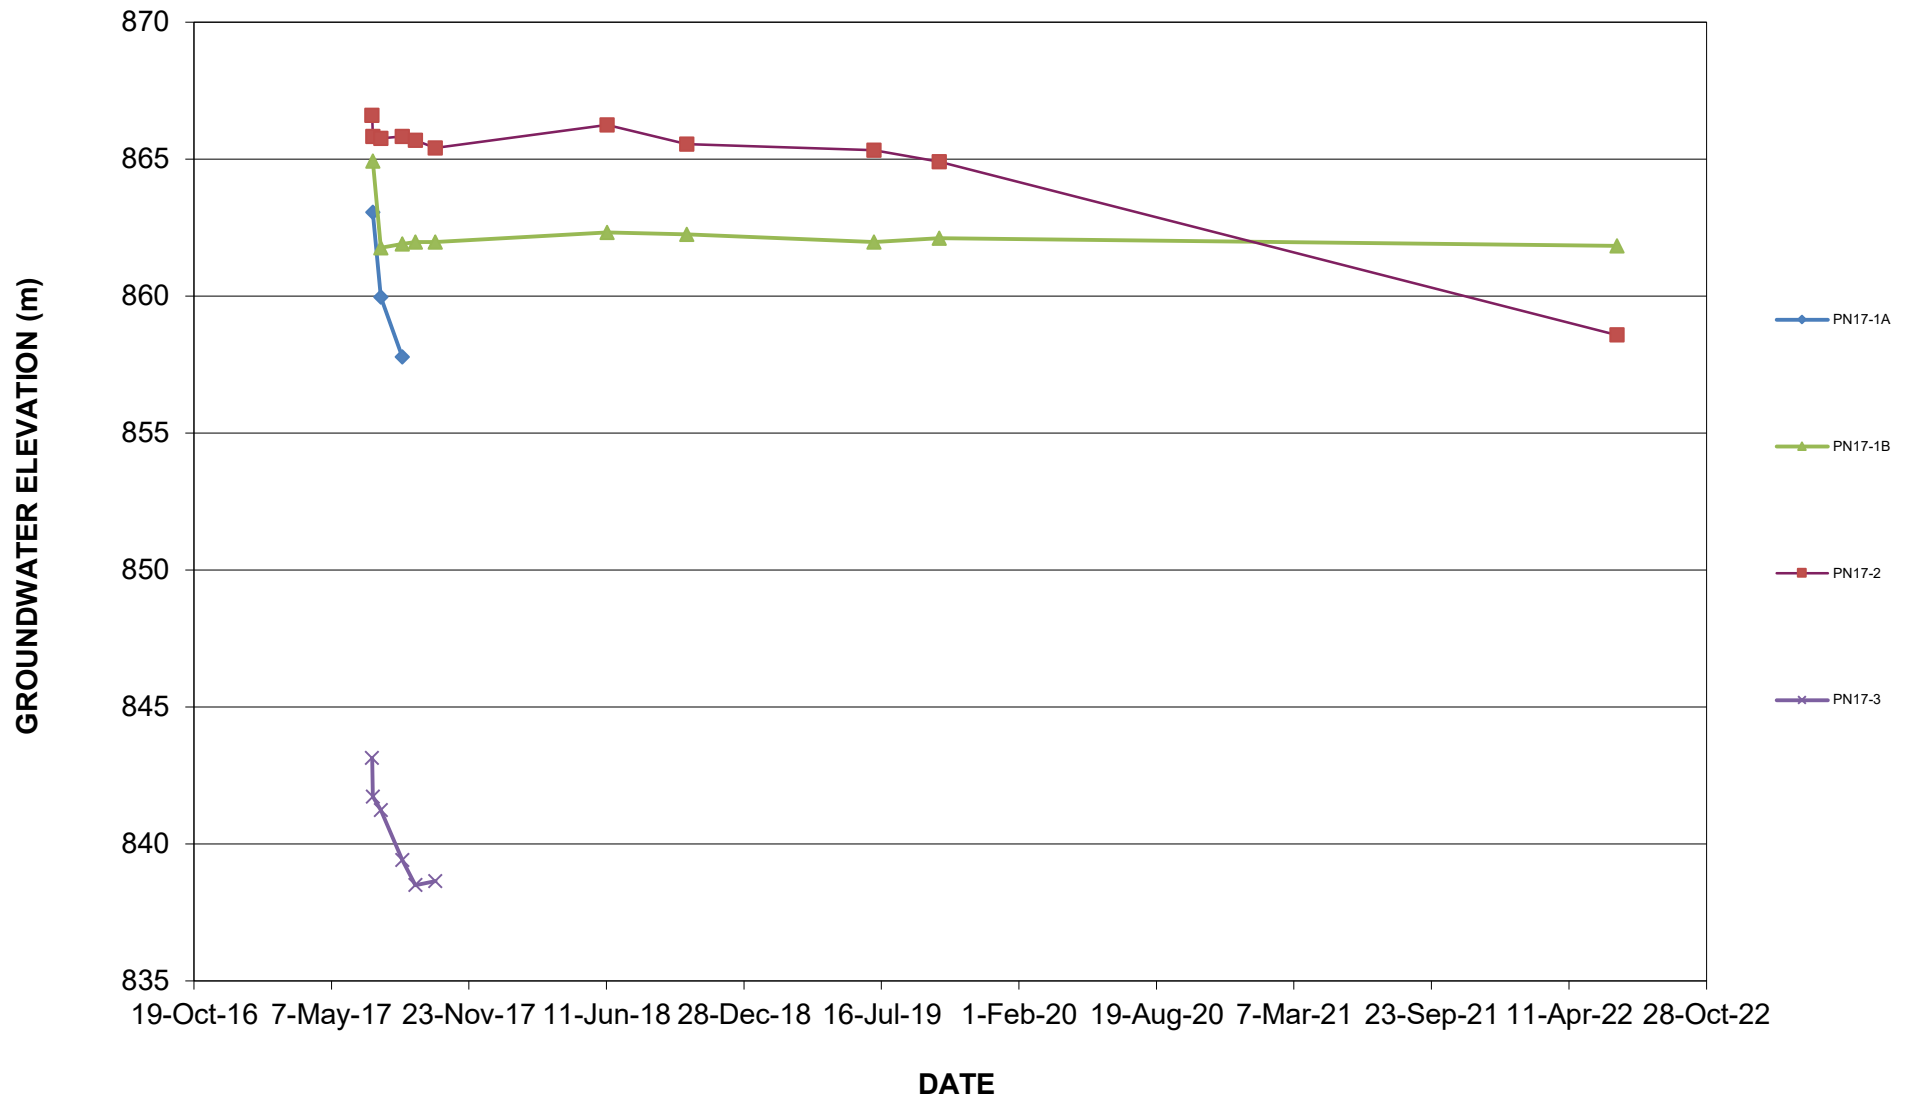
FIGURE GP040-1
PIEZOMETRIC ELEVATIONS FOR HWY 2:68 4.7 km NORTH OF RYCROFT

INSTRUMENT #	DATE INITIALIZED	TIP ELEV. (m)	GROUND ELEV. (m)	CURRENT STATUS	HIGHEST MEASURED WATER ELEVATION (m)	MEASURED PORE PRESSURE (kPa)	CURRENT WATER ELEVATION (m)	PREVIOUS WATER ELEVATION (m)	CHANGE IN WATER LEVEL SINCE PREVIOUS READING (m)
PN17-1A	July 6, 2017	841.96	865.43	Damaged	863.05 in July 2017	N/A	N/A	857.78 (August 18, 2017)	N/A
PN17-1B	July 6, 2017	852.48	865.43	Damaged	864.92 in July 2017	N/A	N/A	861.83 (June 22, 2020)	N/A
PN17-2	July 5, 2017	856.89	865.89	Damaged	866.59 in July 2017	N/A	N/A	858.58 (June 22, 2020)	N/A
PN17-3	July 5, 2017	837.23	851.56	Damaged	843.14 in July 2017	N/A	N/A	838.64 (October 5, 2017)	N/A
